Draft Report: Results of Stainless Steel Canister Corrosion Studies and Environmental Sample Investigations

Fuel Cycle Research & Development

FCRD-UFD-2014-000316

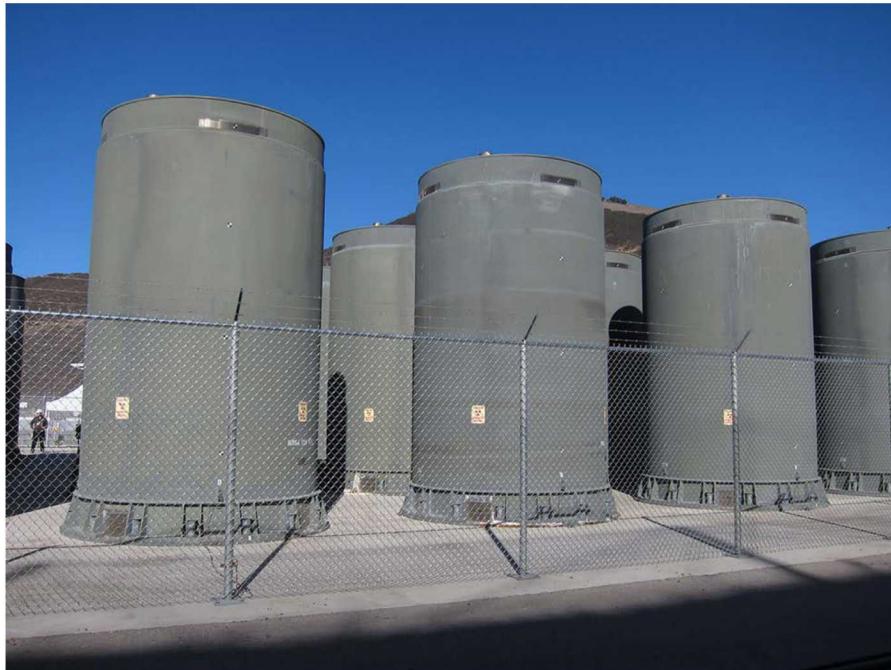
Figure 1. Holtec HI-STORM dry cask storage systems at Diablo Canyon.

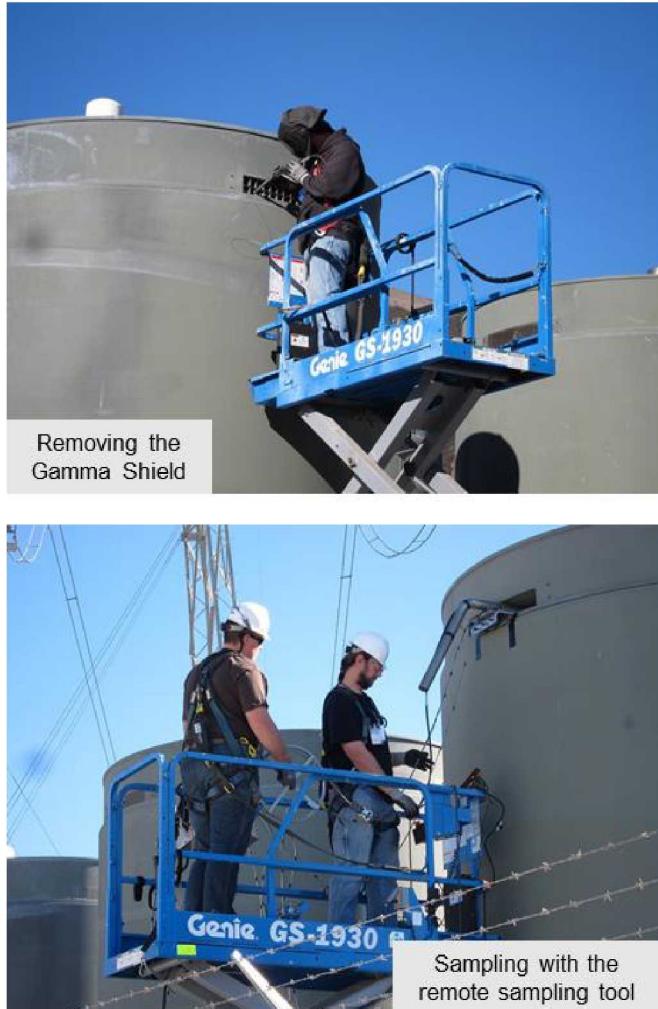
Figure 2. Sampling dust from the surface of interim storage canisters within their overpacks.

Dry dust samples were collected using a similar remote sampling tool, equipped a scraper tool instead of the SaltSmart™ sensor. The scraper tool consisted of a rectangular piece of a mildly abrasive Scotch-Brite™ sponge-like pad, backed with a steel plate. Once in position, the pad was pneumatically pushed against the canister surface, and a second pneumatic controller moved the pad back and forth across the surface, to dislodge and collect the dust.

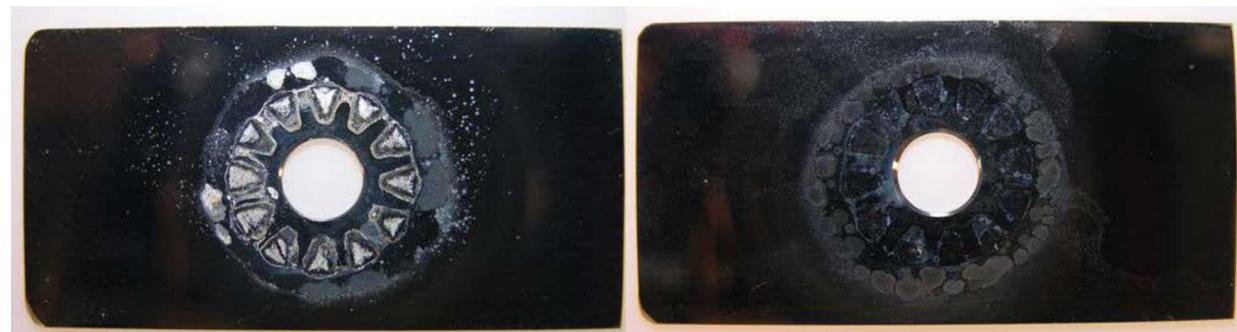
Figure 38. 304SS coupon with $200 \mu\text{g}/\text{cm}^2$ and 7 day exposure after crevice former removal (L) and rinsing (R).
