DOT/FAA/AR-xx/xx

# **A Quantitative Assessment of Advanced NDI Techniques for Detecting Flaws in Composite Laminate Aircraft Structures**

D. P. Roach  
T. M. Rice

Final Report

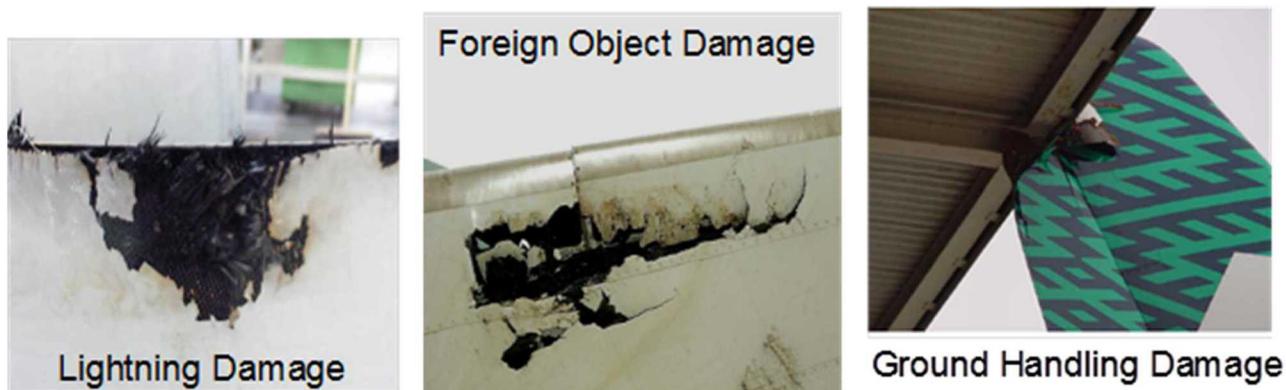
**Figure 2-2: Sample Sources of Damage to Composite Structures**

Impact damage can be especially hard to detect since this damage mode often produces subsurface damage while leaving no external surface demarcations or visual clues. Figures 2-9 to 2-11 describe the physics behind this impact damage scenario and include photos of this type of “blind” damage in both solid laminate and honeycomb structures. For example, hailstorm damage can produce subsurface interply delaminations while low-velocity, high mass impacts (e.g. ground handling equipment) can produce substructure damage (e.g. stringer-to-skin disbonds, frame fracture), both of which can be challenging to detect.

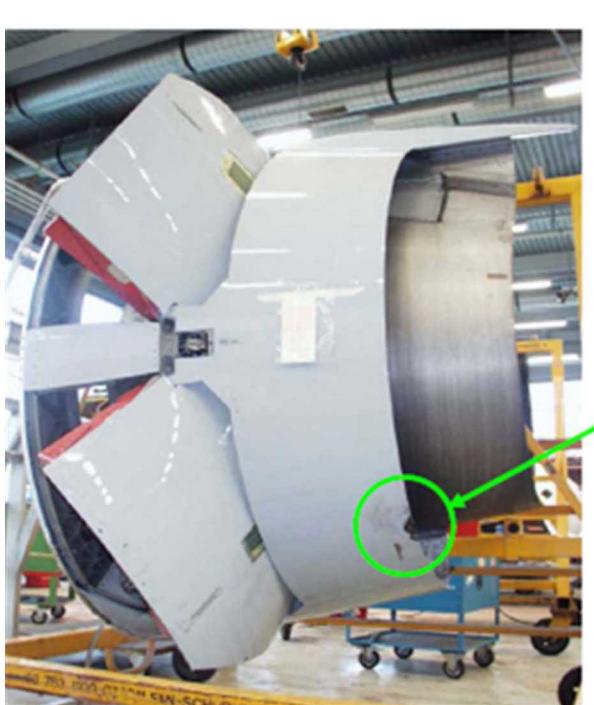
Lightning Strike on Thrust Reverser

Figure 2-5: Sample Damage from Impacts During Flight

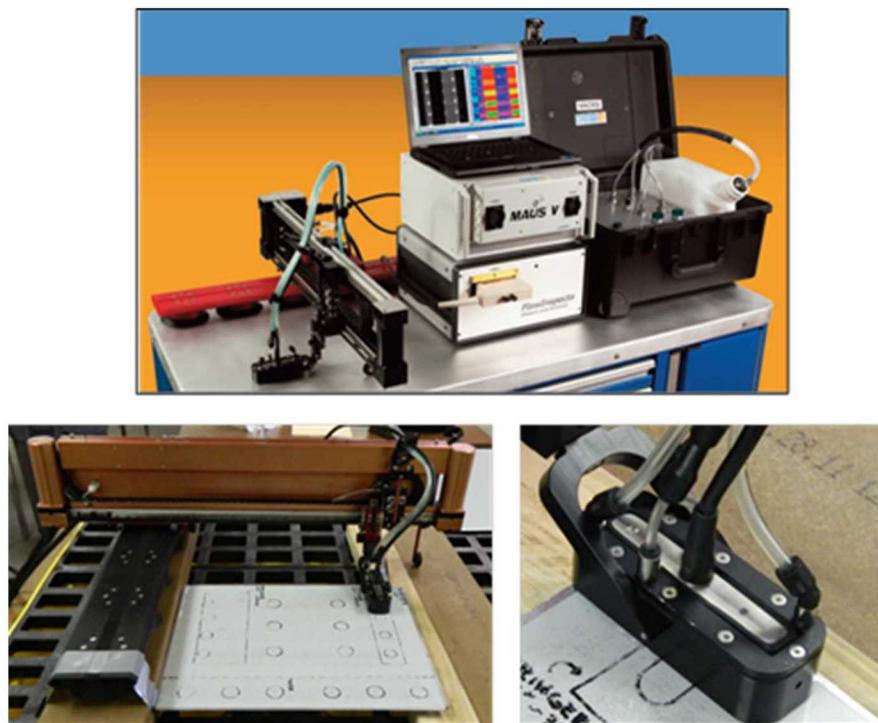
**Figure 3-16: FlawInspecta Linear Array UT System Deployed on MAUS V Scanner Platform – Linear Array UT Probe Includes a Delay Line Shoe**

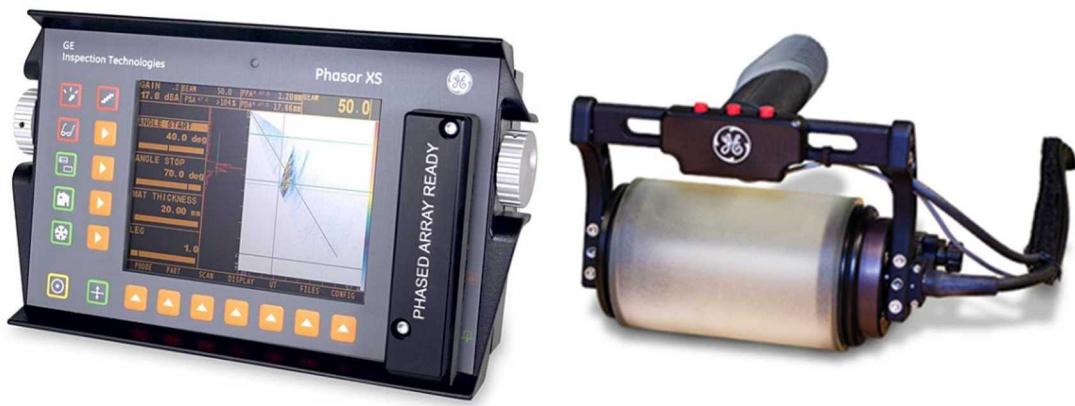
**Figure 3-20: GE Phasor XS RotoArray Wheel Probe Containing a 5 MHz. 64 Element Linear Array**

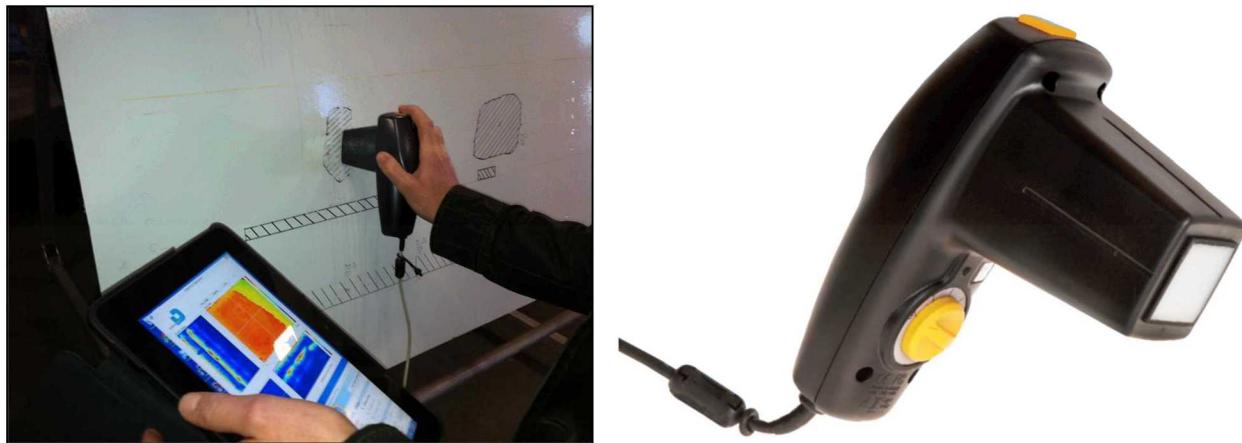
**Figure 3-43: DolphiCam Handheld Portable Ultrasound Video Camera**

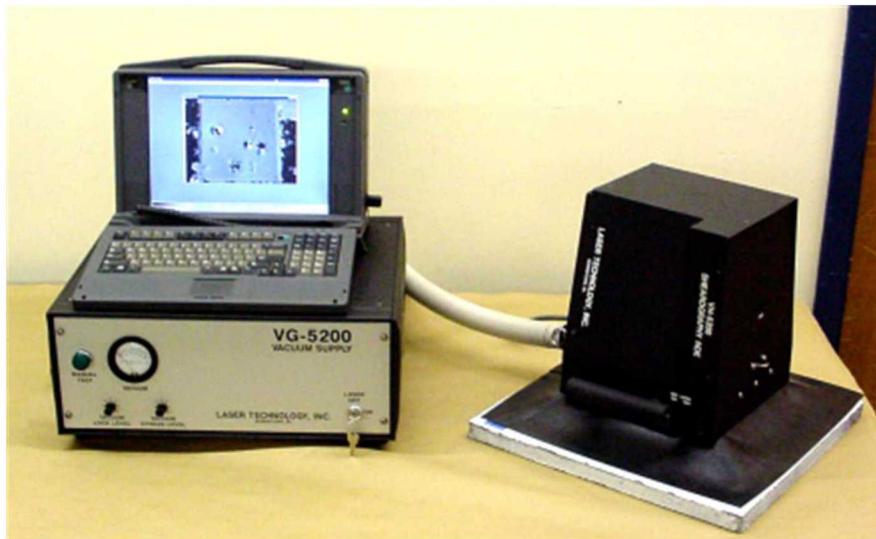
Figure 3-51: LTI-5200 Portable Shearography System with Camera on Test Specimen

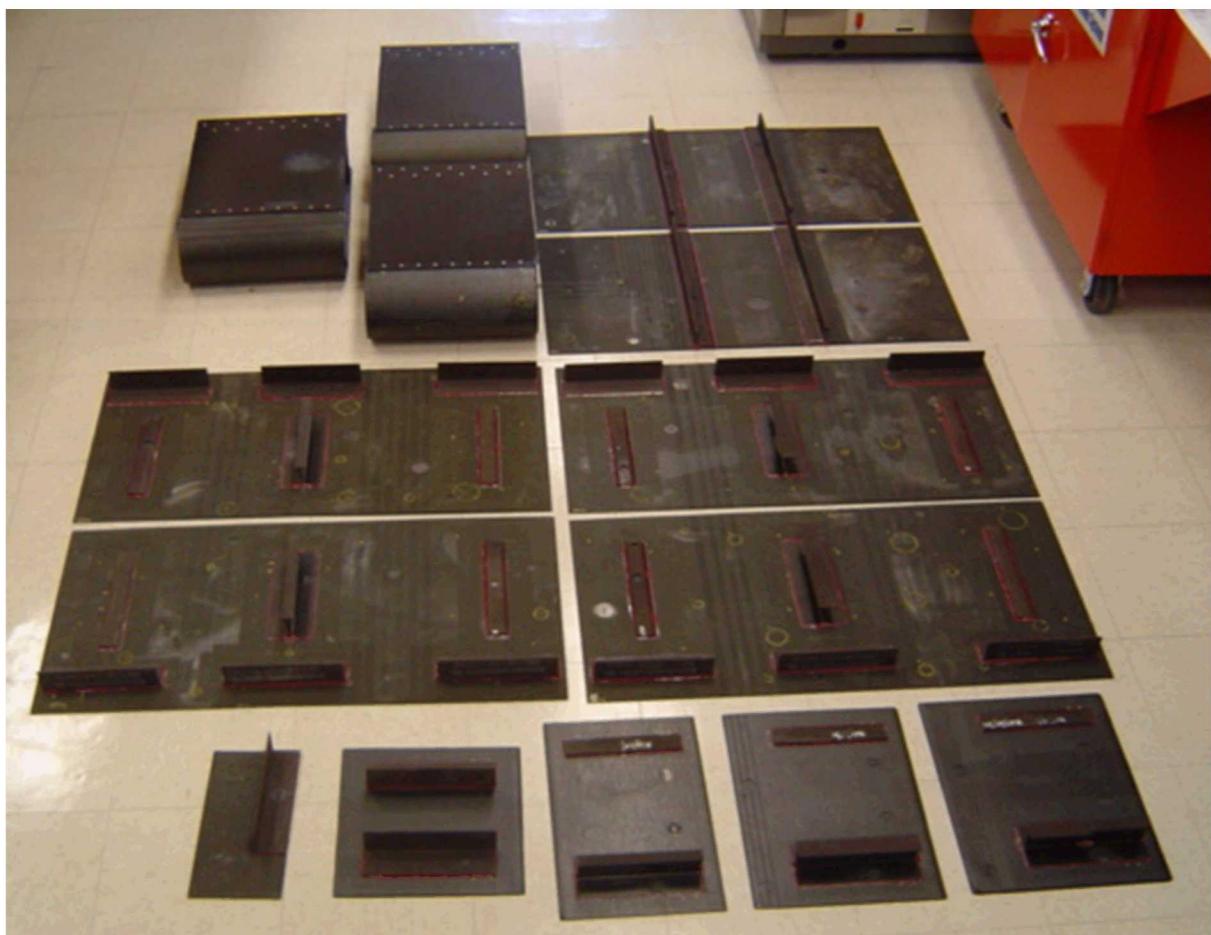
**Figure 4-1: Subset of the Fifteen Solid Laminate Test Specimens and Five NDI Feedback Specimens**

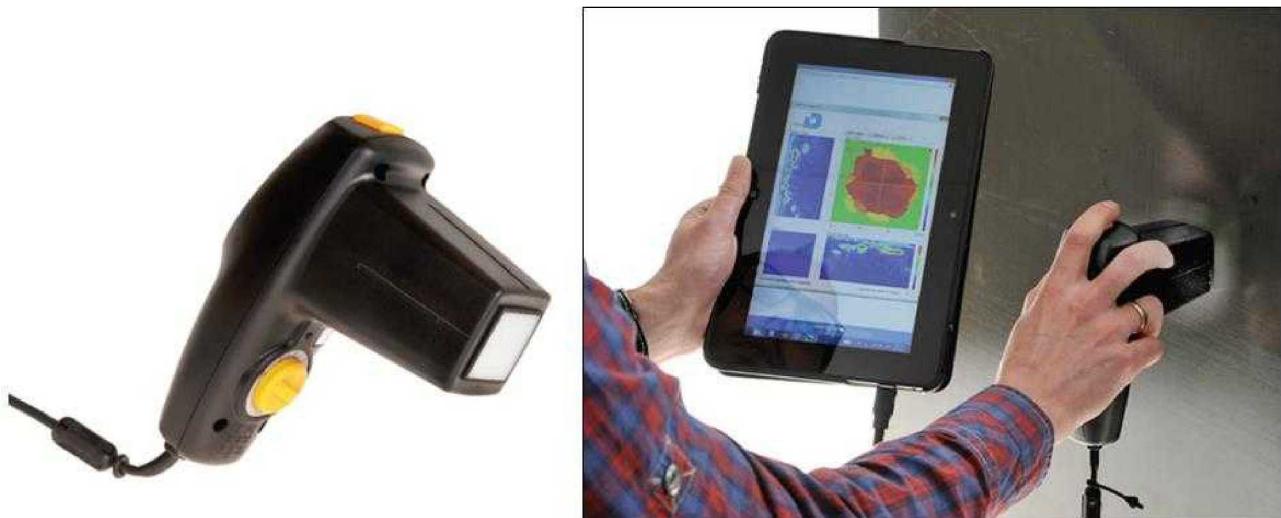
**Figure 6-60: DolphiTech DolphiCam Video-Based UT Device**

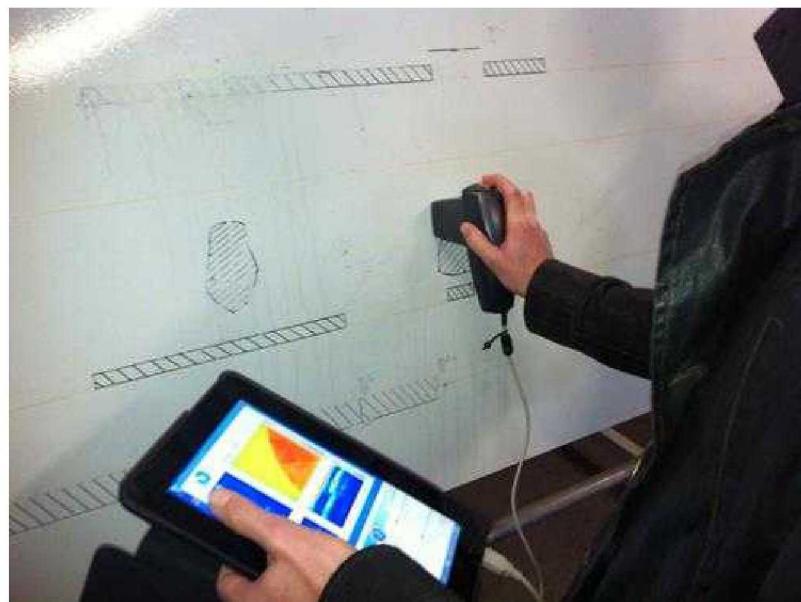
**Figure 6-61: Deployment of DolphiCam Video-Based UT System on Full-Scale Composite Panel – Image of Impact Damage on Screen**
