Fire-Induced Pressure Response and Failure Characterization of PCV/SCV/3013 Containers – Phase 1

Hector Mendoza, Walter Gill, Ray Sprinkle*, Alex Shefferman*, Victor G. Figueroa, and Scott Sanborn.

Prepared by
Sandia National Laboratories
Albuquerque, New Mexico 87185 and Livermore, California 94550
* Savannah River Nuclear Solutions, LLC, Savannah River Site, Aiken, SC

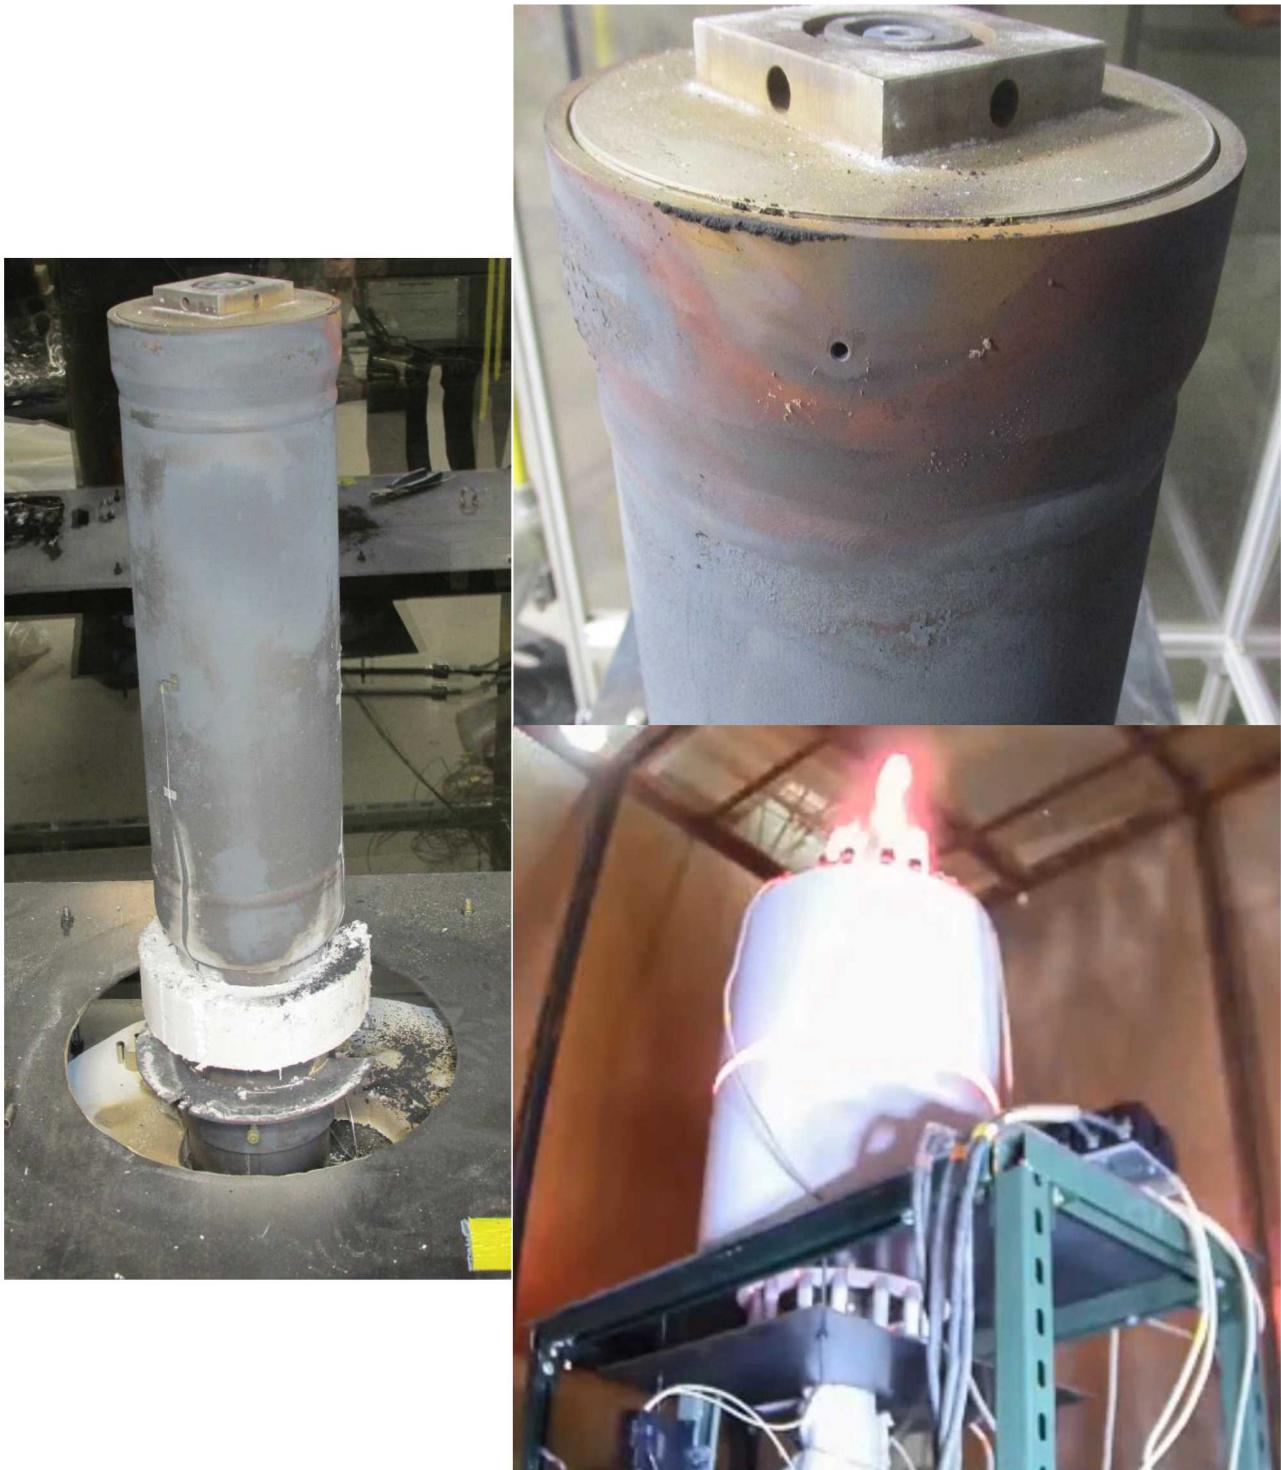
the pressure relief hole and prevent vessel rupture. Figure 13 shows how this did indeed happen and how Configuration 1 did not result in a ruptured vessel. Inspection of the pressure and temperature evolution of the configuration plotted in Figure 14 shows how the temperature rise around the PCV is immediately followed by the pressure rise inside the PCV. The pressure measurement shows how the PCV never experienced pressures above 500 psia. When examining the temperature profiles, the rise in temperature around the PCV was symmetrical, directly demonstrating that heating was symmetrical around this test unit. As noted in Section 2.3, a shroud temperature was not recorded through the MIDAS system. For the purposes of this report, a non NQA-1 shroud temperature is shown, which shows how the imposed heat was retained for approximately 20 minutes after seal failure.

A review of the test data indicates this container released as expected, by failure of the inner and outer O-rings and release of gas/particulate via the pressure relief hole located at the head end of the container (note the discoloration at the pressure relief hole location in Figure 13). The pressure inside the PCV initially reached approximately 438 psia at about 726 seconds into the test. At this point, the PCV relieved pressure over a period of about 13 seconds (initially at about 5 psi/sec then slowing to around 1 psi/sec) down to about 412 psia. At 739 seconds, the PCV began to re-pressurize until at 808 seconds (471 psia), the final pressure release occurred, at a rate of approximately 140 psi/sec. The peak (of three) radially spaced mid-height thermocouple readings at these three points was 655 °C at 726 seconds, 672 °C at 739 seconds, and 763 °C at 808 seconds. There is insufficient information to conclude what caused the re-pressurization after the initial pressure drop. However, the data indicates that all temperature readings were increasing over this time in accordance with the specified ASTM E1529 temperature/flux profile, thereby negating consideration of attributing the cause to variations in heater rod input by the Control Room Operator. Clearly, O-ring degradation at 726 seconds permitted leakage from the PCV. There is some conjecture that the softened O-rings plugged the leak to permit the PCV to again hold pressure for another 69 seconds, at which point O-ring degradation was sufficient to result in complete depressurization of the PCV. Nonetheless, it's clear that the PCV in Configuration 1 reached a peak pressure of 471 psia at 808 seconds into the PCV.

Figure 13. Configuration 1 Post-test PCV and Video Image Showing Flames During Test.

Finally, it is noted that the shroud temperatures dropped slightly at both times of pressure drop, then increased. Even though Configuration 1 shroud temperature measurements are not NQA-1 verifiable, the measurements are considered accurate as the phenomena (temporary shroud temperature drop at pressure release) is present in other test configurations. It is determined that the immediate temperature drop is due to the relatively cooler PCV internal gas impinging on the shroud and flowing around the shroud thermocouple positions during release. This only lasts until either the gas is fully expelled, or the gas ignites (see Figure 13).

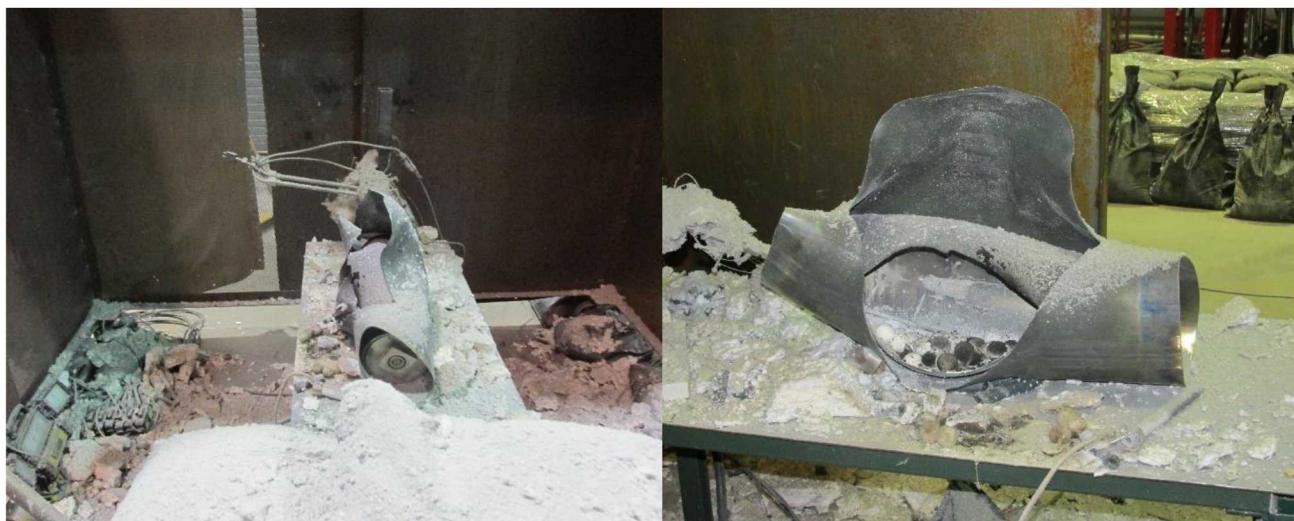
Figure 15 shows the remains of the Configuration 2 PCV, which shows how the configuration resulted in a catastrophically ruptured vessel. The remains indicate that the cooler O-ring region prevented degradation of the O-rings for Configuration 2 when compared to Configuration 1.

No post-test measurements were conducted for Configuration 2. It is clear from Figure 15 that a large portion of all parts of the payload, and the snorkel plate were ejected from the container.

Figure 15. Post-test PCV for Configuration 2.

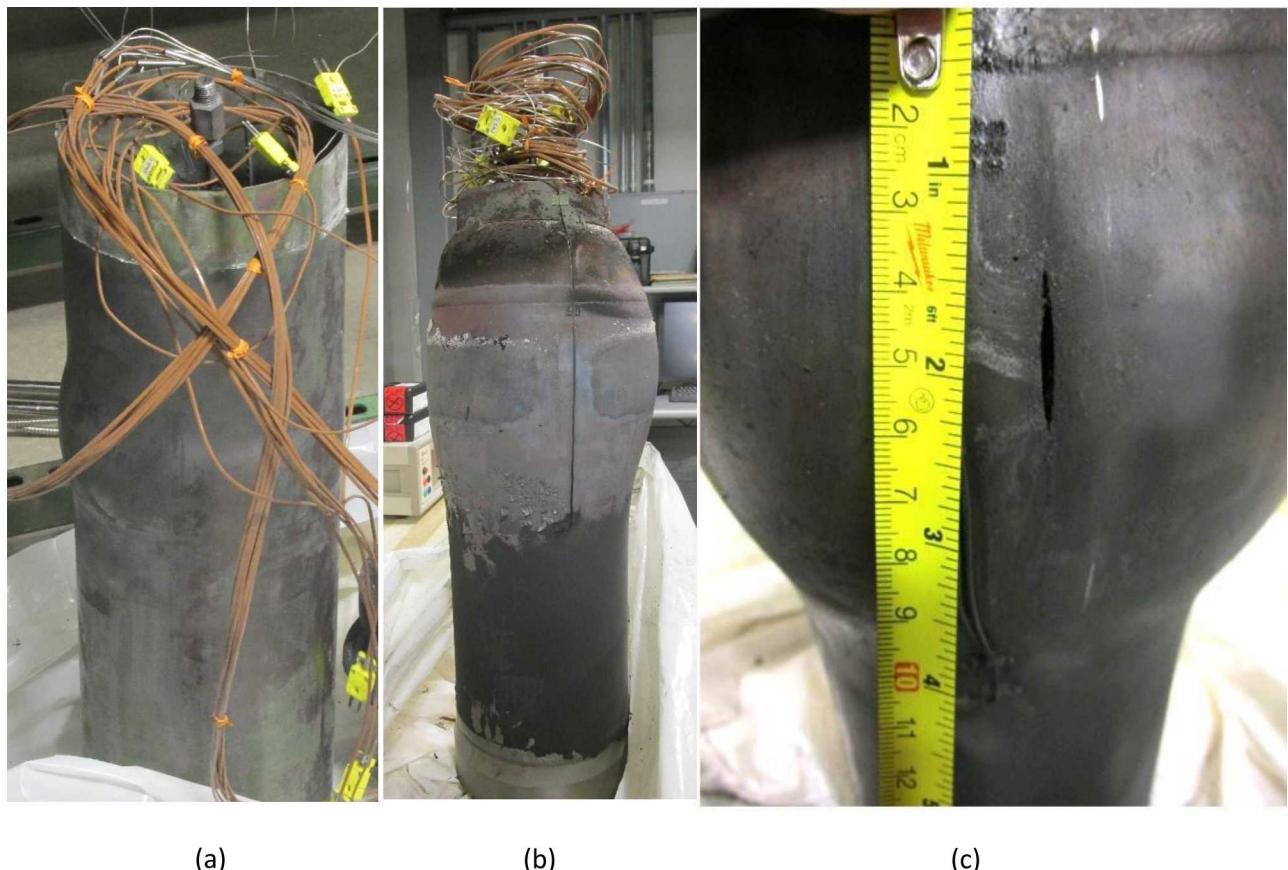
In Figure 17, it can be seen how the tested PCV for Configuration 3 bulged to the point of failure, resulting in a $\frac{3}{4}$ inch longitudinal fracture. This fracture location would suggest that, since the PCV was inverted, the internal contents served as a heat sink and helped obstruct heat transmission to the O-ring region inside the PCV. The swelling observed in Figure 17 was also large enough to cause the PCV to expand out to the shroud and deform it. The swelling was not radially uniform, but it did swell around the entire circumference of the PCV. As a result of that contact, it is uncertain whether the shroud prevented the PCV from expanding further to create a larger opening than the $\frac{3}{4}$ inch fracture observed. Similar to the test for Configuration 2, Figure 18 shows how the pressure inside the PCV steadily increased as the temperature rose until reaching a peak pressure of approximately 780 psia. While it is not fully known, perturbations in the pressure

Figure 17. Post-test PCV for Configuration 3. (a) shows the shroud bulging, (b) is a full view of the PCV, and (c) zooms in on the fracture experienced by the PCV.

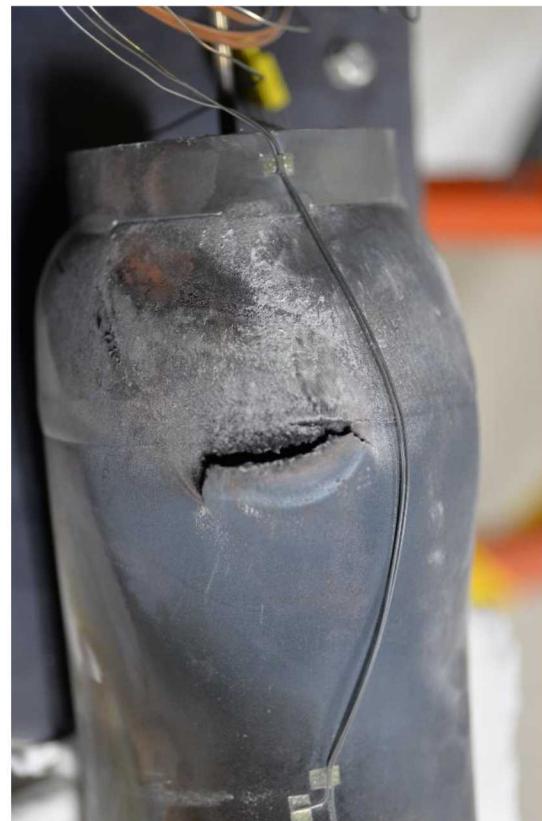
Figure 19 shows the resulting PCV for Configuration 4 at the end of the test. When visually compared to Configuration 3, the rupture experienced by the PCV in Configuration 4 was more severe. The plots in Figure 20 help explain why the rupture in Configuration 4 would be more severe than in Configuration 3. In this figure, it can be seen how the pressure almost reached 983 psia just before rupture, at which point the pressure immediately drops to atmospheric conditions. The higher pressure reached by Configuration 4 (when compared to Configuration 3) is attributed to the uneven heating. Note that the rupture in Configuration 3 (Figure 17) is a

longitudinal tear at the 0° position, likely along the vertical seam of the PCV and the rupture in Configuration 4 (Figure 19) is a radial tear along the bottom end weld, also at the 0° position. Figure 20 shows how the 0° position on the PCV experienced the highest temperature while the 120° and 240° positions saw lower temperatures. This is consistent with the description given in Section 2.4.4, where it was described how the heat shield covered the area between 60° and 300° , thus shielding the 120° and 240° positions. At the point of rupture, the three thermocouples were reading $964\text{ }^\circ\text{C}$, $791\text{ }^\circ\text{C}$, and $729\text{ }^\circ\text{C}$ for the 0° , 120° , and 240° positions, respectively.

Figure 19. Post-test PCV for Configuration 4. (a) is a full view of the PCV, and (b) zooms in on the rupture experienced by the PCV.

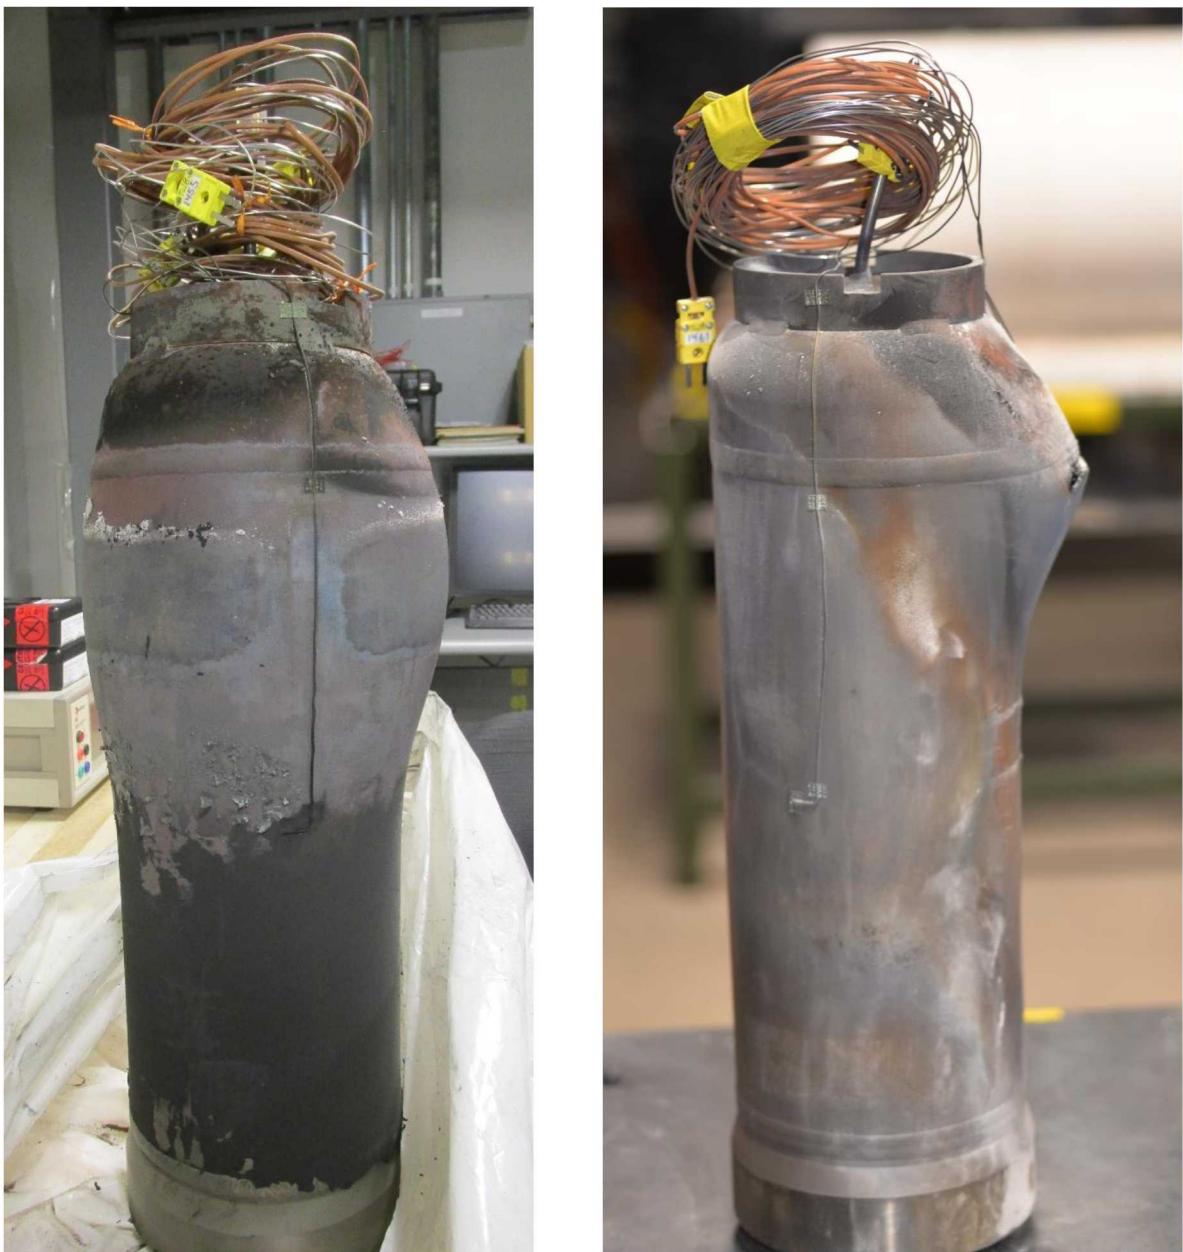
Figure 22. Comparison of PCV Swelling Between Configuration 3 (left) and Configuration 4 (right).

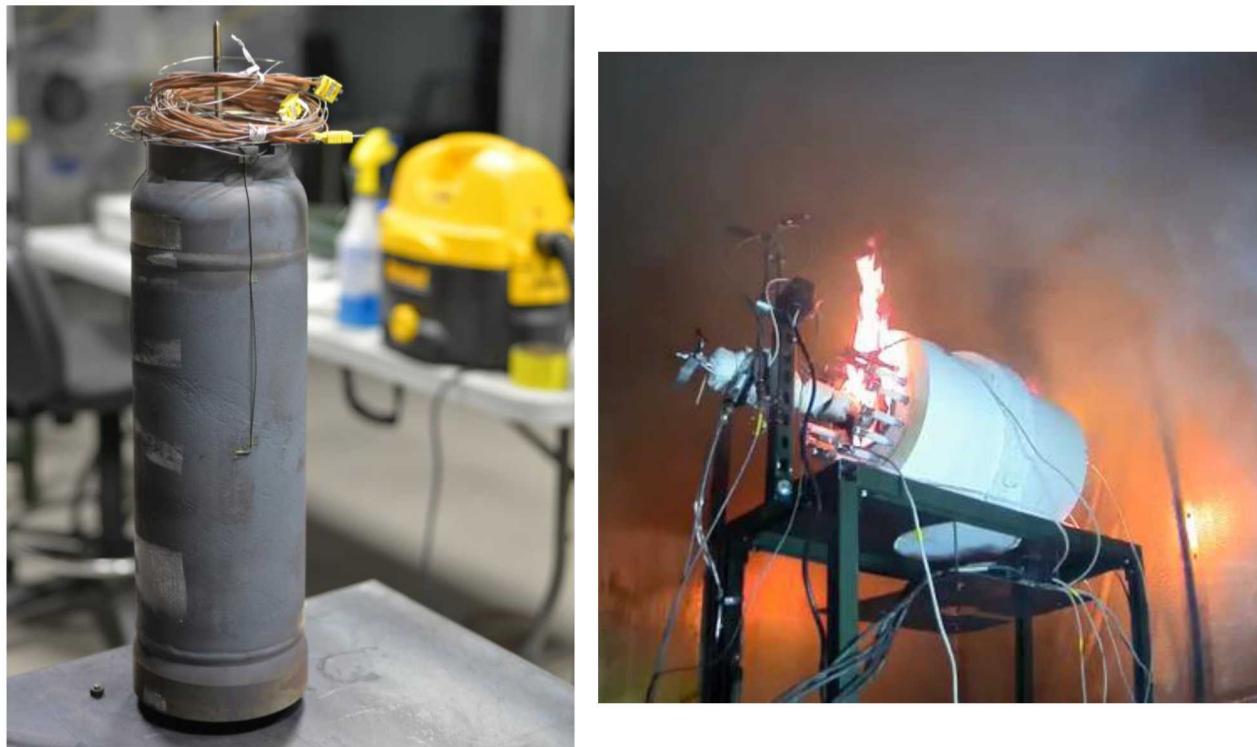
Figure 23 shows the resulting PCV after completion of the test on Configuration 5, where it can be seen that a rupture of the PCV did not occur even though some minor swelling was observed. Figure 24 shows the resulting temperature and pressure profiles for the test, and several differences can be noted when compared to Configuration 1. First, the pressure reached by the PCV was approximately 300 psi higher than what was experienced by the PCV in Configuration 1, reaching a pressure of about 780 psia. As with Configuration 1, but much less severe, a pressure drop occurred prior to final rupture. The pressure dropped slightly (about 3 psi) over a period of only 3 seconds as the mid-height sidewall temperature reached about 563°C and then continued to rise again. This could potentially indicate some minor O-ring degradation that released a little pressure then plugged itself to permit continued pressurization. The stainless-steel lid would serve as a heat sink for configuration 5 just as it did for Configuration 1. But for Configuration 5, the internal payload contents of the PCV would provide additional mass in the O-ring region to add additional heat absorption capacity. The effect of this is observed by the disparity in temperature between the thermocouples at the 0° position and the other two thermocouple positions, 120° and 240°. This disparity was as high as 220°C and can be seen in Figure 24. In the end, while the vessel did show some minor expansion along the wall, PCV rupture did not occur and pressure was released past the degraded O-rings. The release occurred at about 773 psia with the 0° thermocouple reading 913°C. Just like the test on Configuration 1, the imposed heat flux was kept on for about 20 minutes after seal failure to test if the vessel could re-pressurize. Figure 24 shows that this did not occur as can be seen by inspection of the pressure plot.

Figure 23. Configuration 5 Post-test PCV and Video Image Showing Flames During Test.
