SNL/CA East Avenue Vehicle-Pedestrian Accident (LLNL Property)

OCCURRENCE NA-SS-SNL-8000-2019-0017

Causal Analysis Report
Date: 1/7/2020

Causal Analysis Report

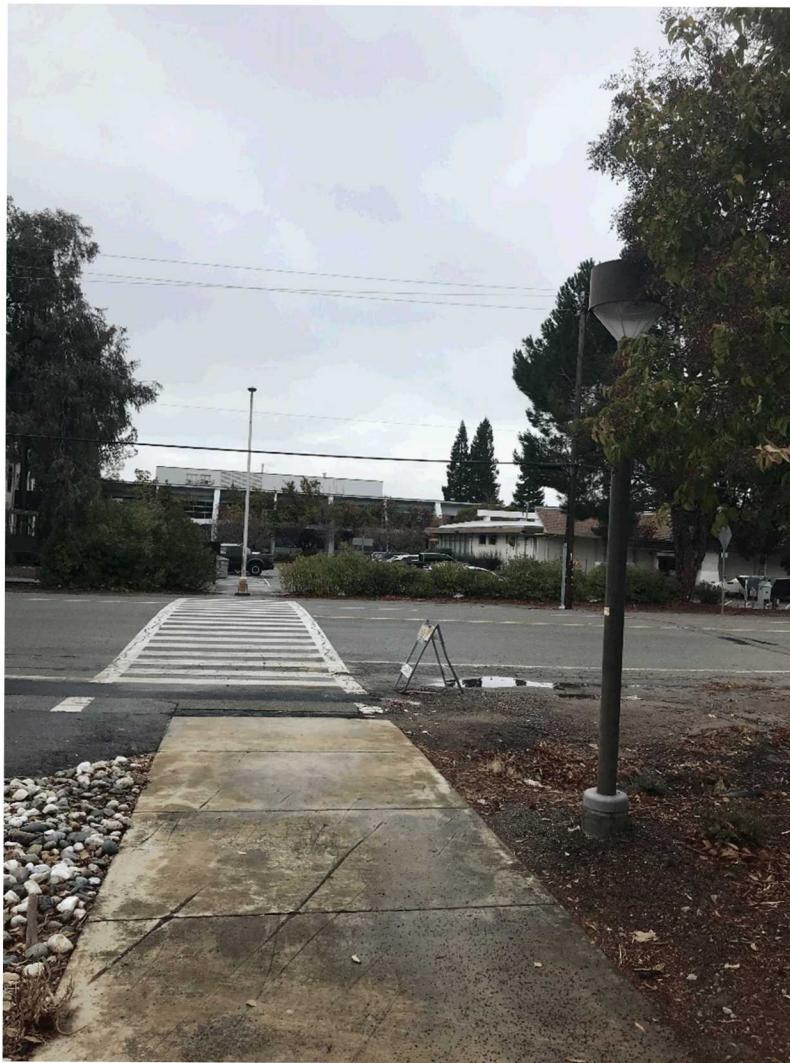
Figure 1. Photograph of crosswalk and light fixtures (facing north)

The roadway was wet, the sky was dark due to evening hours and cloud coverage, and the south side of the East Avenue roadway didn't have any dedicated street light illumination. A handful of vehicles used the road in either direction, but no other pedestrians were noted in the area at the time of the accident.

Roadway lighting along the LLNL-controlled East Avenue corridor is mixed. Westbound traffic (north side of the roadway) enjoys bright light from street lights designed to illuminate the roadway, but eastbound traffic (south side of the roadway) has no street lights designed for a similar purpose. The only lighting equipment along the south side of East Avenue are meant for walkway illumination or to point out parking lot entrances – not for vehicular traffic purposes. The crosswalk in question shared these lighting qualities: the north side of the crosswalk had a street light, while the south side didn't. Please refer to Figures 1 and 2 (below) for photographs of this crosswalk.

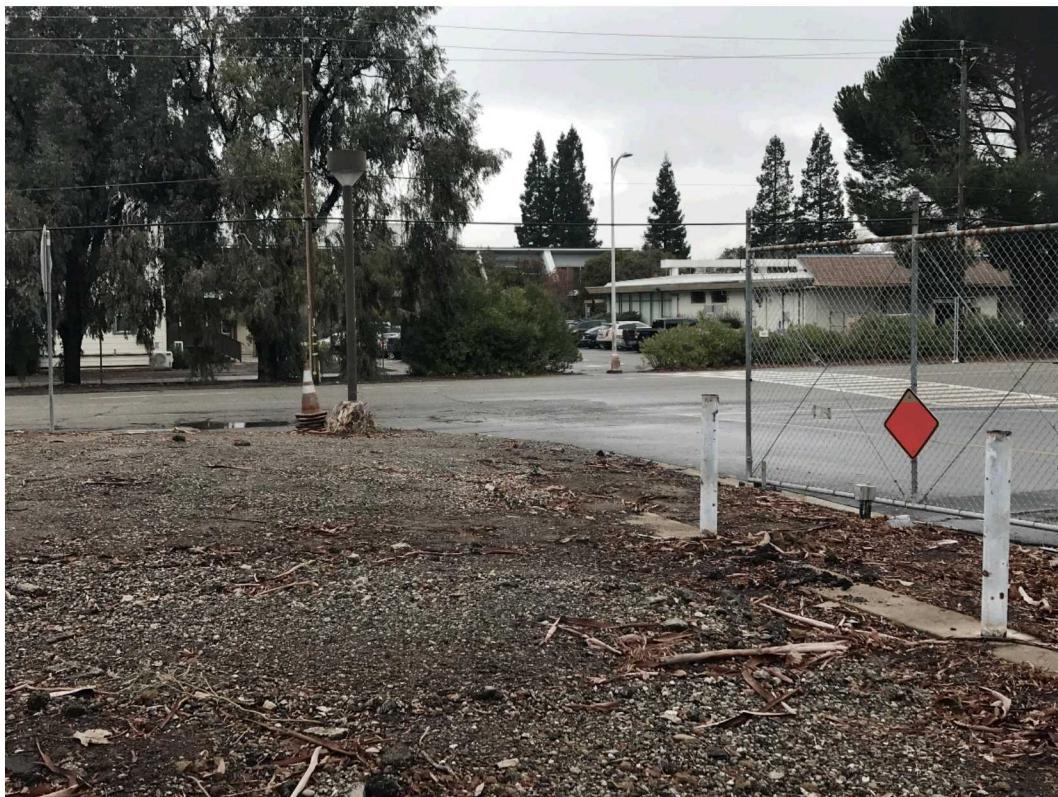
Figure 2. Photograph of intersection and light fixtures (facing northeast)

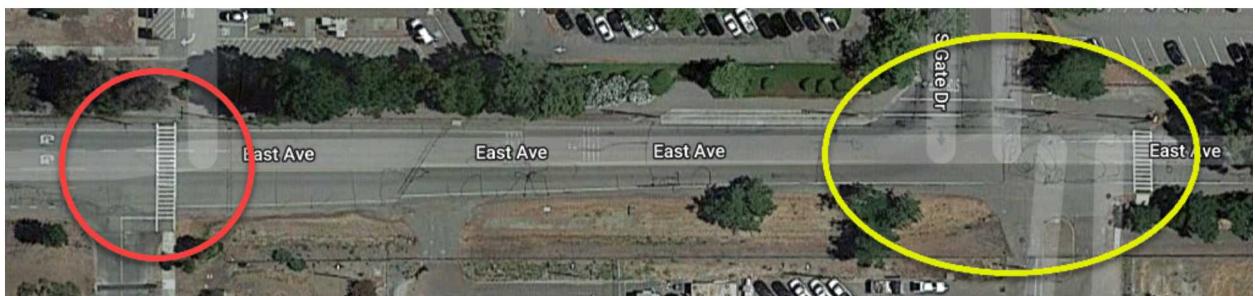
Figure 3. Portion of East Avenue. Red circle indicates area of accident (in front of Lima 1). Yellow circle indicates area diagramed in Livermore Police Department report #19-7338 (South Gate Drive to north, A Street to south).

Upon analyzing the incident, it was determined that the accident diagram included in the Livermore Police Department's report was inaccurate. The diagram appears to depict an intersection due east of the crosswalk area in question. Please refer to Figure 3 below for an aerial view of this discrepancy.

Other points of discussion involved the Livermore Police Department's report containing an inaccurate diagram of the incident location, and the fact that an injured employee who required hospitalization felt the need to drive home in a personal vehicle immediately after being discharged from the hospital.
