The critical microstructural conditions for void nucleation during ductile rupture: dislocation structures and vacancy condensation

Philip J. Noell, Julian E. C. Sabisch, Douglas L. Medlin, Jay D. Carroll, Brad L. Boyce

Void nucleation during ductile rupture

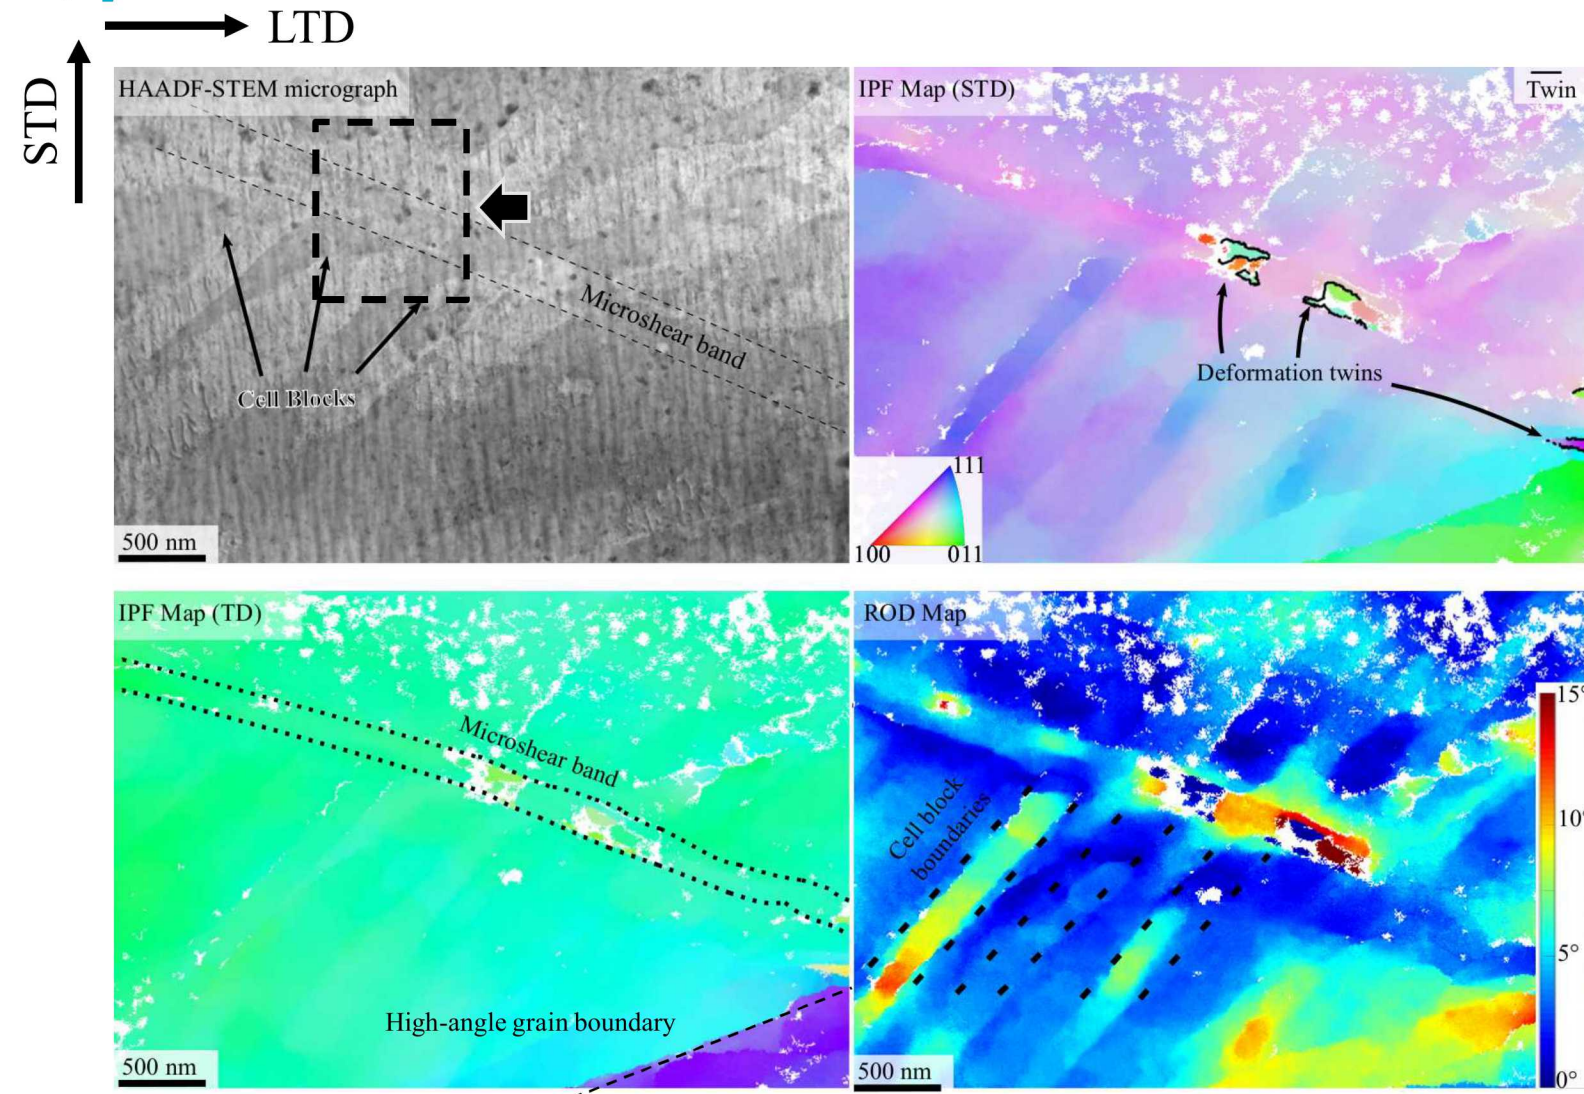
Deformation twins and microshear bands observed at the microscale
