FINAL TECHNICAL REPORT

Project Title: **Non-contact Current-Voltage (I-V) Tracer for Photovoltaics**

Recipient: Arizona State University
Photovoltaic Reliability Laboratory

Award Number: DE-EE-0008165 (PVRD2)

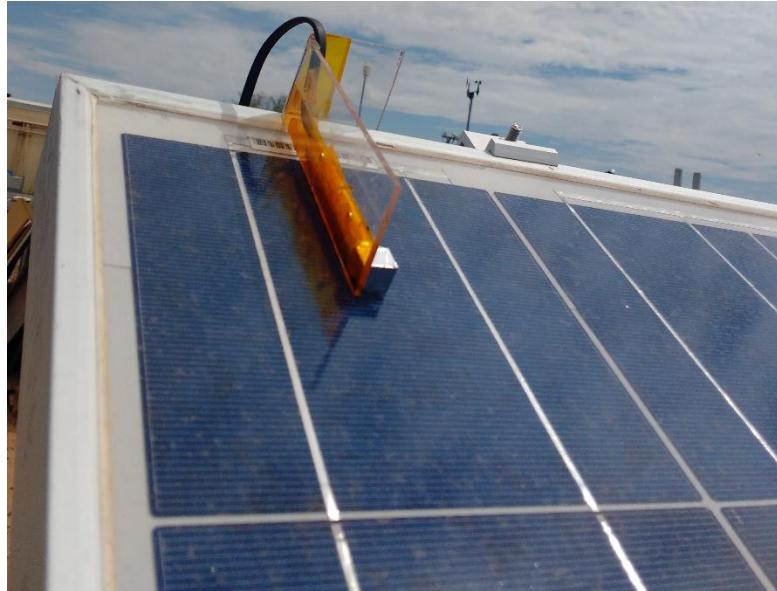
Figure 1-9: Probe (Trek 344) with Probe Holder

Probe holders: To hold the ESV probes firmly on the PV modules, probe holders were designed made of plexiglass, due to its transparency and bending ability. For the simultaneous measurement of voltages, the probe of Trek 344 ESV was attached on the front glass surface of the twentieth module (as shown in Figure 1-9) to measure the string voltage and the probe of Trek 565 ESV was attached on the front glass surface of the first module (as shown in Figure 1-10) to measure the voltage of the first module in the string.

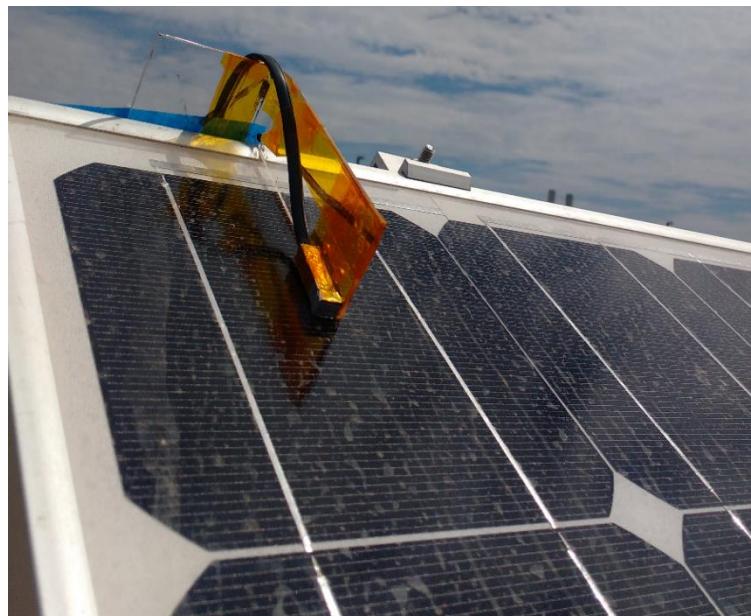
Figure 1-10: Probe (Trek 565) with Probe Holder

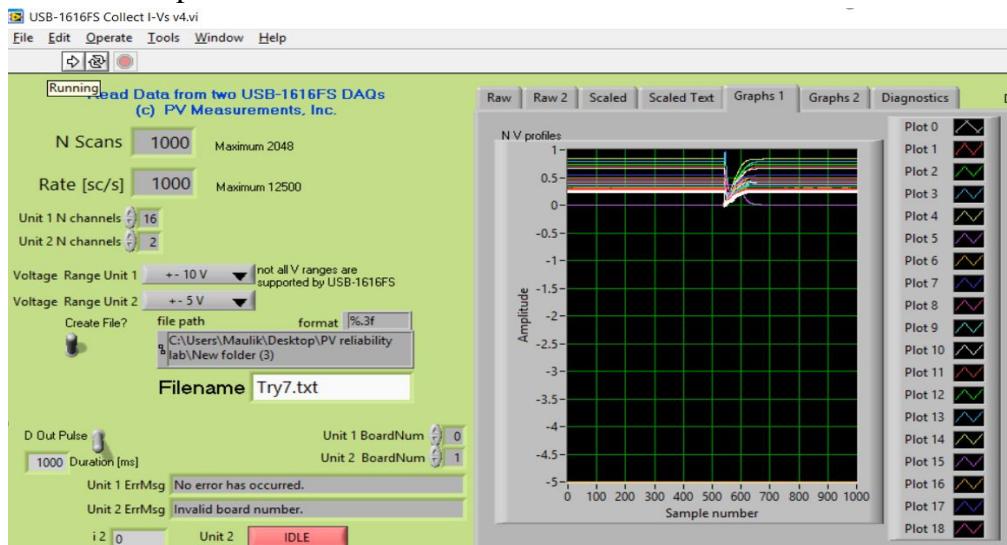
Figure 1-15: DAQ Software - Signal Vs Time response

Figure 1-15 shows the screenshot of the DAQ screenshot with signal versus time responses for 15 voltages and currents. The signal versus time data were saved to a .txt file which was used later to get IV and PV plots.

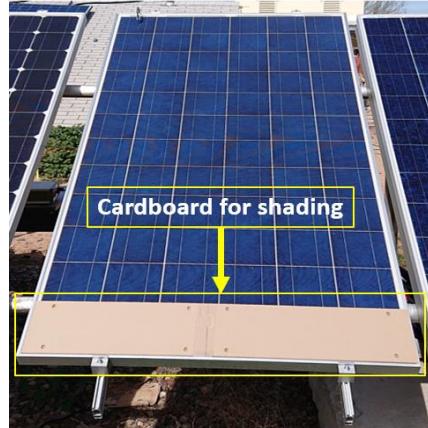
Figure 1-28: Experimental setup of shading experiments

Cardboard of dimension 38.3 ft * 7 ft was used to shade the PV module as shown in Figure 1-28 below.

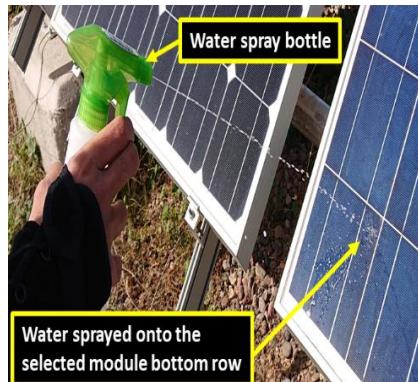
Figure 1-29: Soiling - Water sprayed

Water was sprayed onto the selected module for conducting soiling tests using a water spray bottle as shown in Figure 1-29 below.

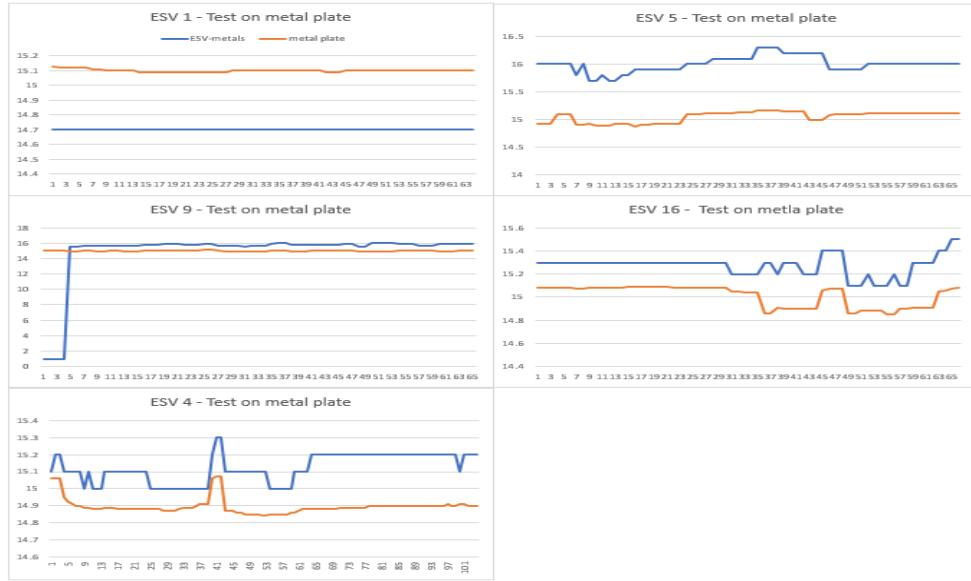
Figure 1-63: ESV drift - Metal plate

It is stable with metal plate based on the plots below (Figure 1-63). Variations we are seeing are mostly due to changes in the metal plate voltage. (i.e.) ESV follows whatever the metal plate voltage is. It does not change some time with respect to the metal, but 95% of the time it does if you look at the plot.

(X axis – Time (0.2s), Y -Axis – DC Voltage (V))

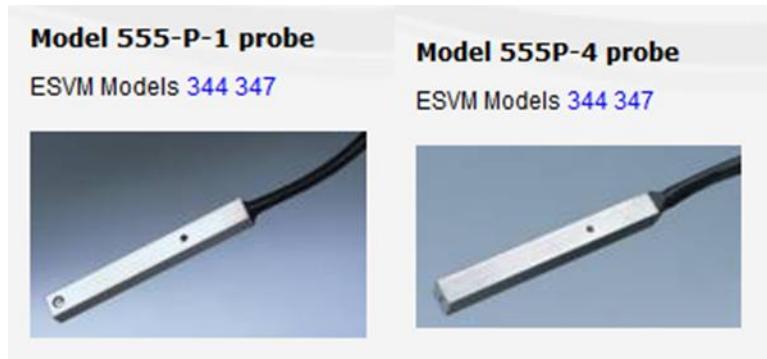
Figure 1-69: P1 Probe (2.56mm aperture diameter; side face) and P4 Probe (1.17mm aperture diameter; front face)

Decision to go ahead with the new probe was based on the intuition that the bigger sensor diameter would provide better results than the old probe (Model: 555-P-4). Model 555-P-1 probe has a sensor diameter of 2.56mm, whereas Model 555-P-4 probe has a sensor diameter of only 1.17mm (Figure 1-69). So, it is evident that Model 555-P-1 probe has a bigger sensor diameter than Model 555-P-4.

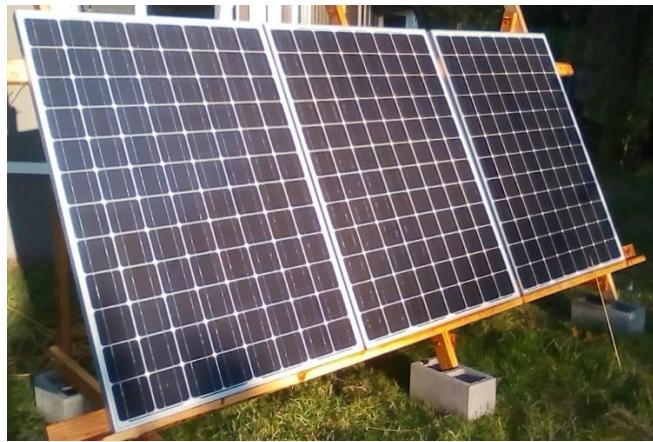
Figure 2-6: PVM 3- PV module string

PVM built a PV module rack from framing lumber and applied one layer of varnish to help it survive the upcoming rain and snow season. PV modules are now held to the rack with C clamps (Figure 2-6). To minimize risk of high voltage exposure to passing animals or

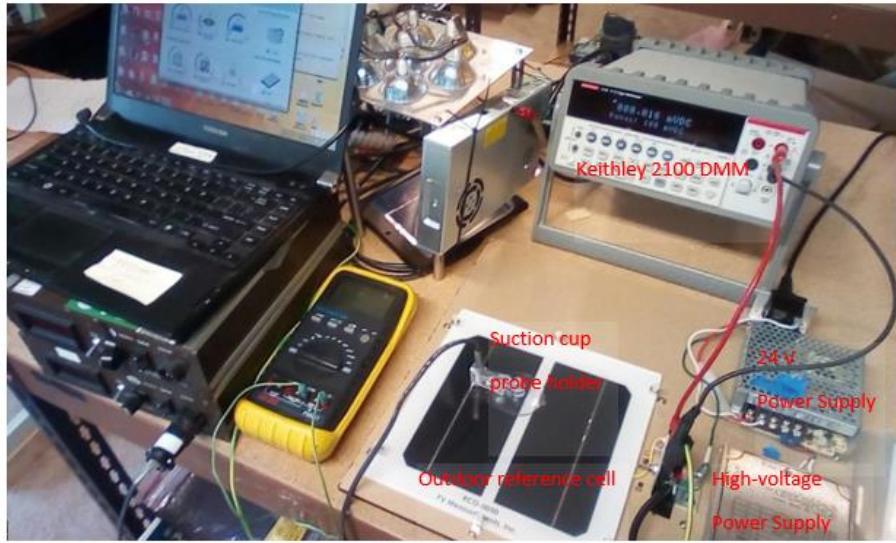
Figure 2-7: Calibration apparatus

PVM next built and utilized an apparatus (Figure 2-7) to calibrate the Probe - Controller - Signal Conditioning - DAQ system as a whole, according to the written procedure. This system uses a high-voltage power supply and an outdoor reference cell (RCO) to provide a known voltage to the probe. The probe affixes to the RCO as it would to a PV module. Its cable goes to its controller, which in turn provides its analog output signal to the I-V tester's signal conditioning

circuitry. That circuitry feeds the tester's DAQ which communicates its measurements to the calibration and testing software.

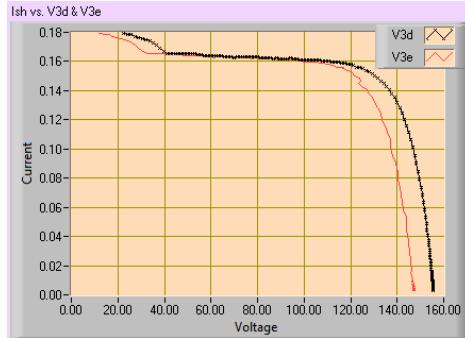
Figure 2-24: IV curves - Offset voltage at -30 Volts

As the sky darkened at the end of the day, the illumination also became more uniform, causing I-V curves to appear more ideal. Also, the offset voltage drifted less during a measurement. The next figure shows a measurement with a 50 ms period between points and offset voltage set at -30 volts (Figure 2-24):
