# Field-Aged Module Library Technical Update

Sandia National Laboratories

April 20, 2020

# DuraMAT Field-Aged Module Library

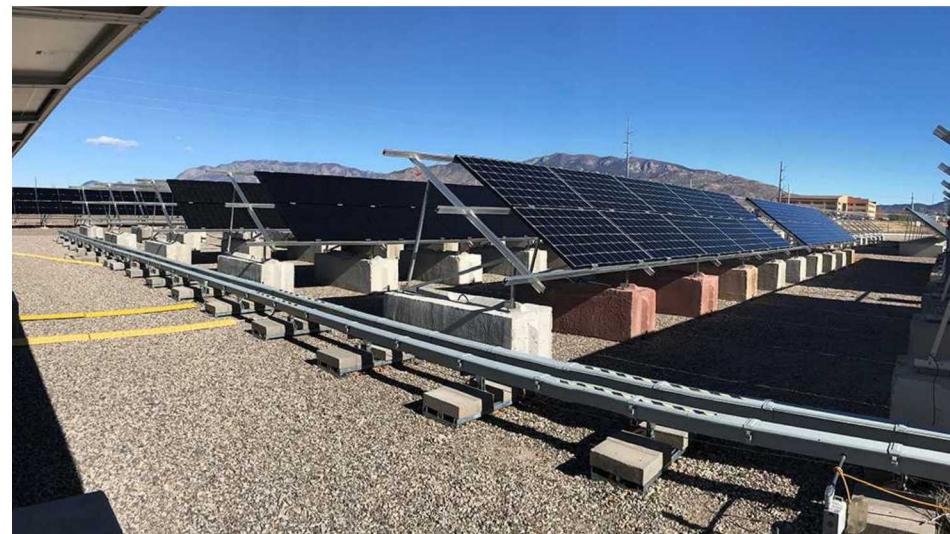
# Initial FT-IR Results

Manufacturer	Model	# mods	Backsheet Outer layer Material
Canadian Solar	CS6k300MS	10	PVDF (blended with PMMA)
QCells	Q.Peak-G4.1 300W	10	PET
Mission Solar	MSE300SQ5T	10	PET
Panasonic	N325SA16 325W	10	PET
LG	LG320N1K-A5	10	PET
Jinko	JKM260P-60	10	PVF

PVDF

PET

PVF

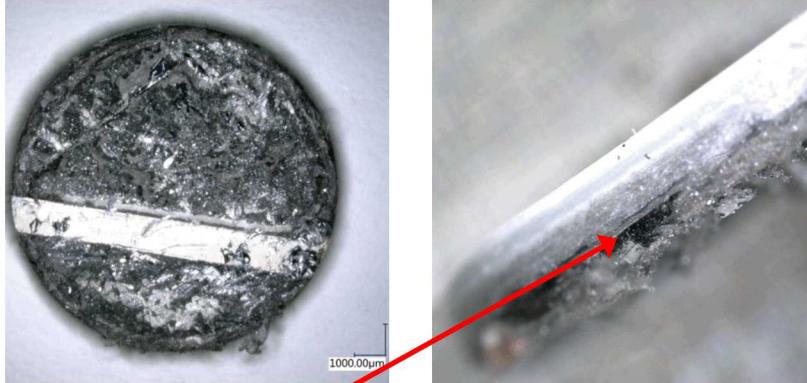
Mission Solar

Black inner layer, BS layer or encapsulant?  
Same seen on LG modules

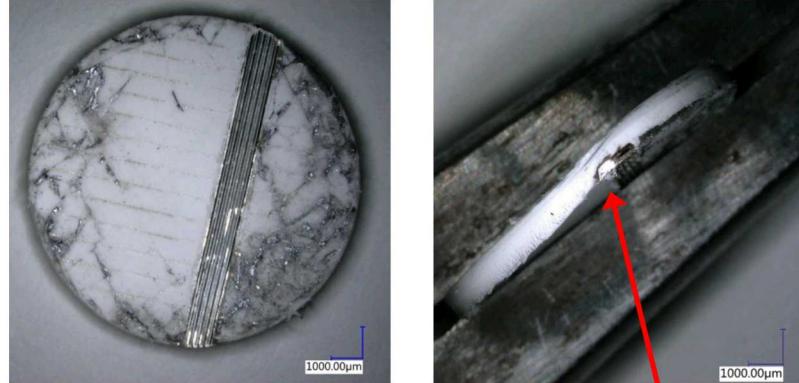
Panasonic

Extremely thin encapsulant layer  
Ribbon pressed deep into BS

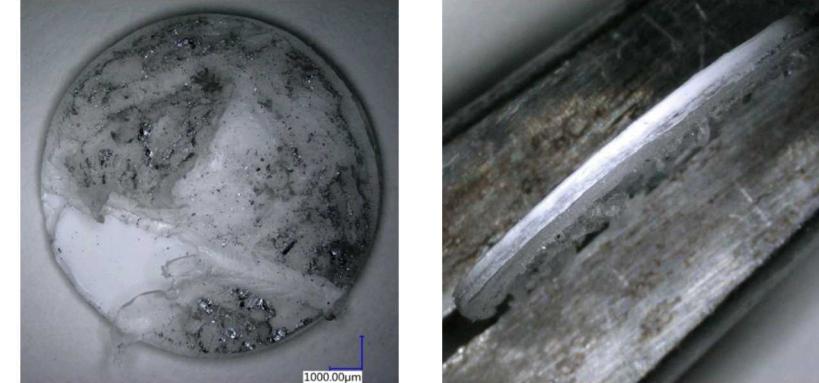
Q-Cells

Representative of remaining modules  
All white BS + distinct clear encapsulant

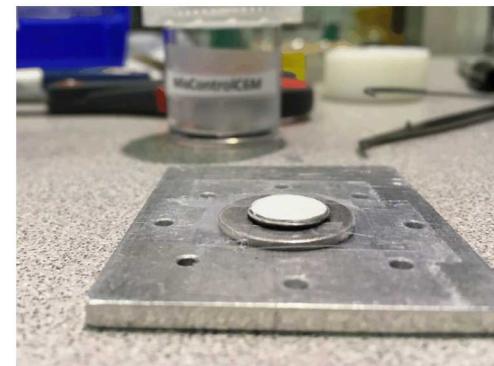
- Core samples were split to separate the back polymer layers from the cells
- Simultaneous small and wide-angle X-ray scattering conducted in transmission
- Motorized stage allowed quick collection from 6 locations top-to-bottom, 3 exposures each

Sample mounted w/ air side  
(BS) towards detectors

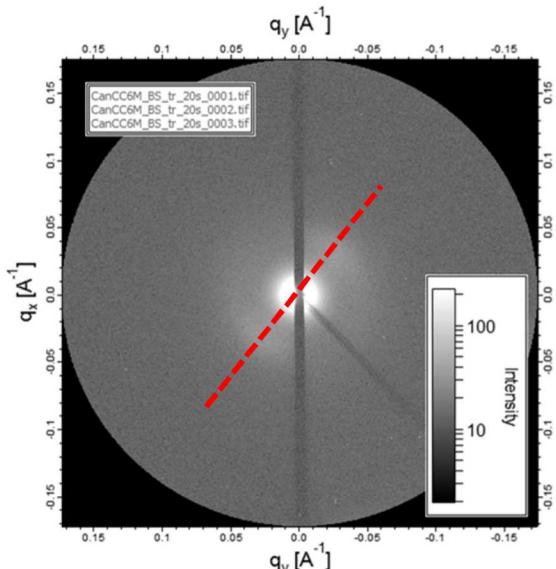
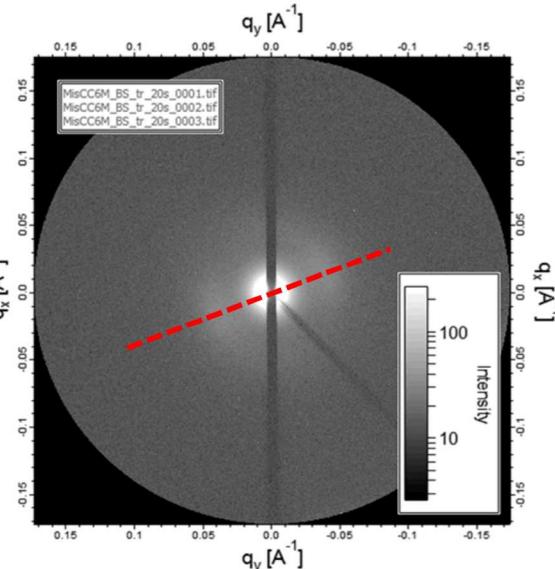
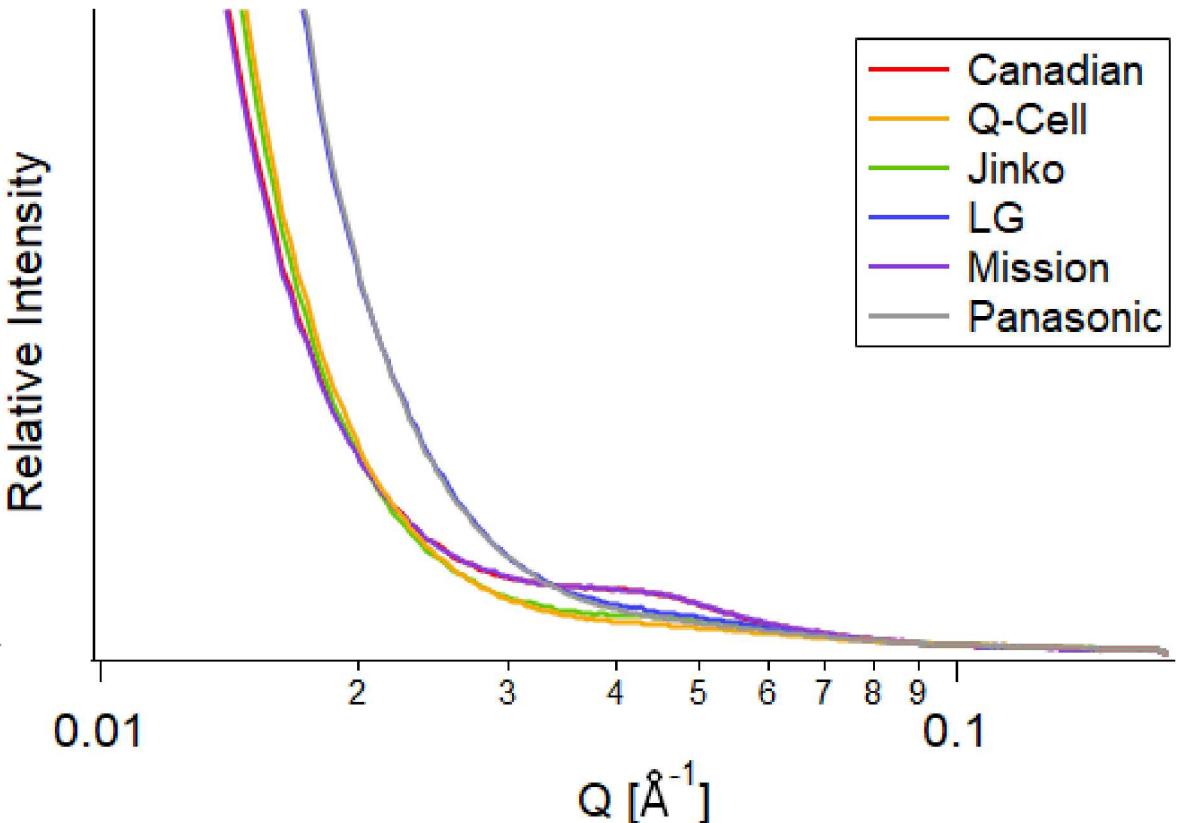
- Features in SAXS are produced from polycrystalline domains
- Canadian Solar and Mission Solar samples have anisotropic scattering due to alignment of domains along an axis

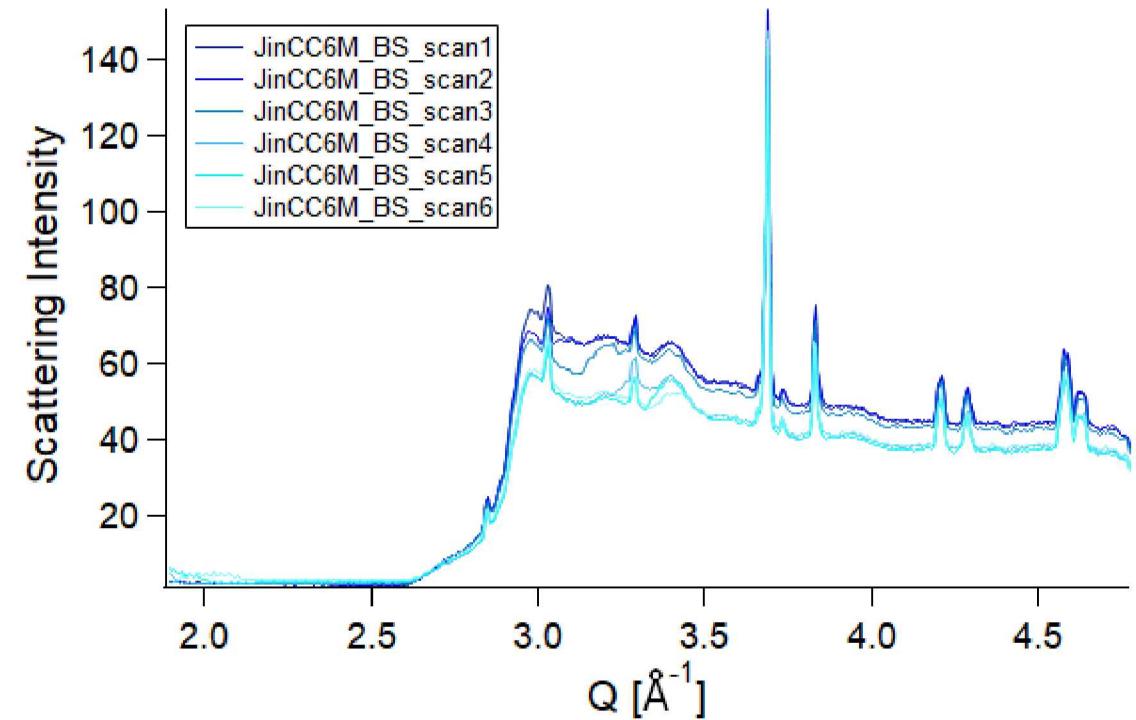
- Data shown for Jinko sample, very similar across all modules
- Sharp scattering peaks associated with  $\text{TiO}_2$  used as white pigment in backsheets

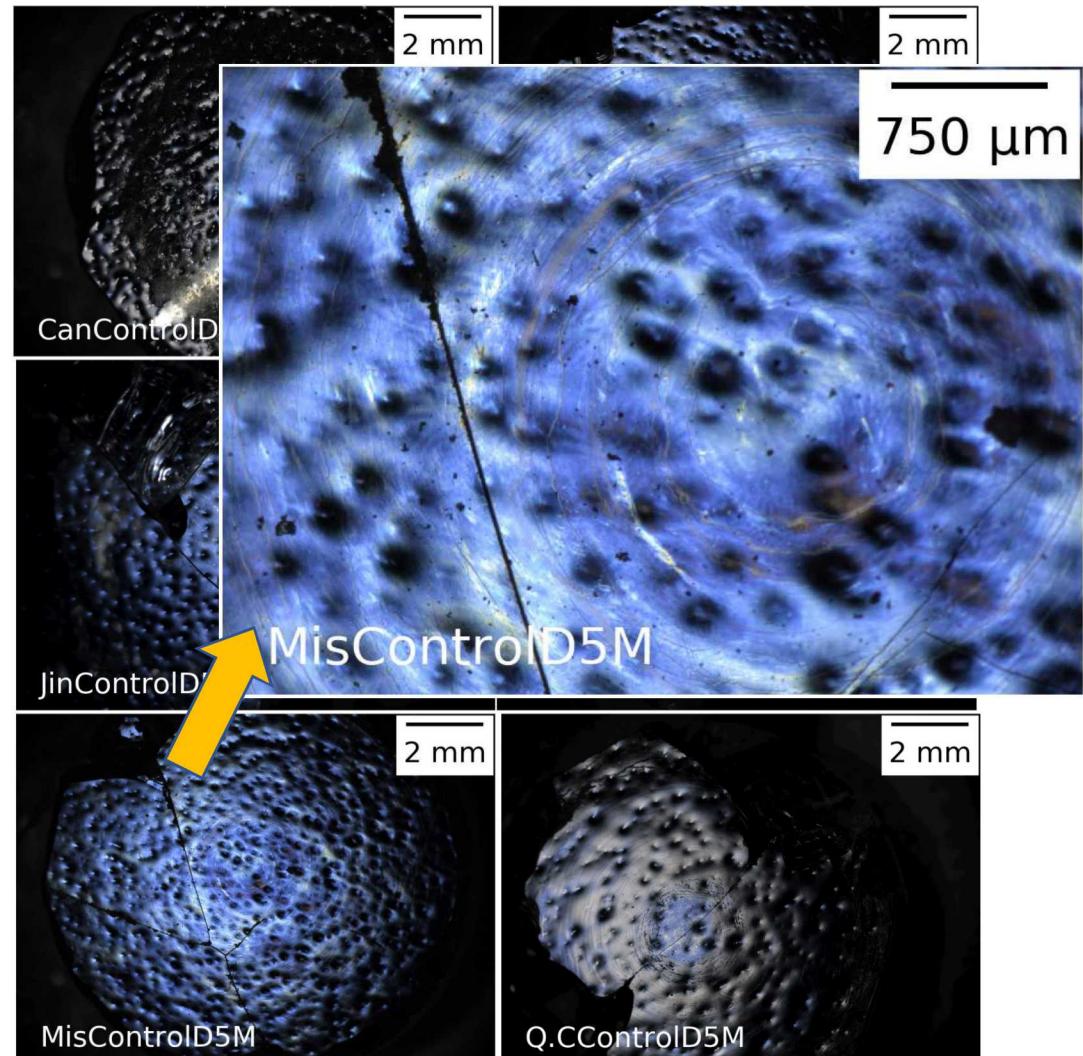
- Todd Karin (LBNL) requested core samples for analysis of ARCs
- Images are taken by imaging a white LED reflected from the top glass onto an RGB camera at ~10 degrees from normal incidence.
- Issue: all samples showed loss of coating in a circular pattern → damage occurring as core breaks loose

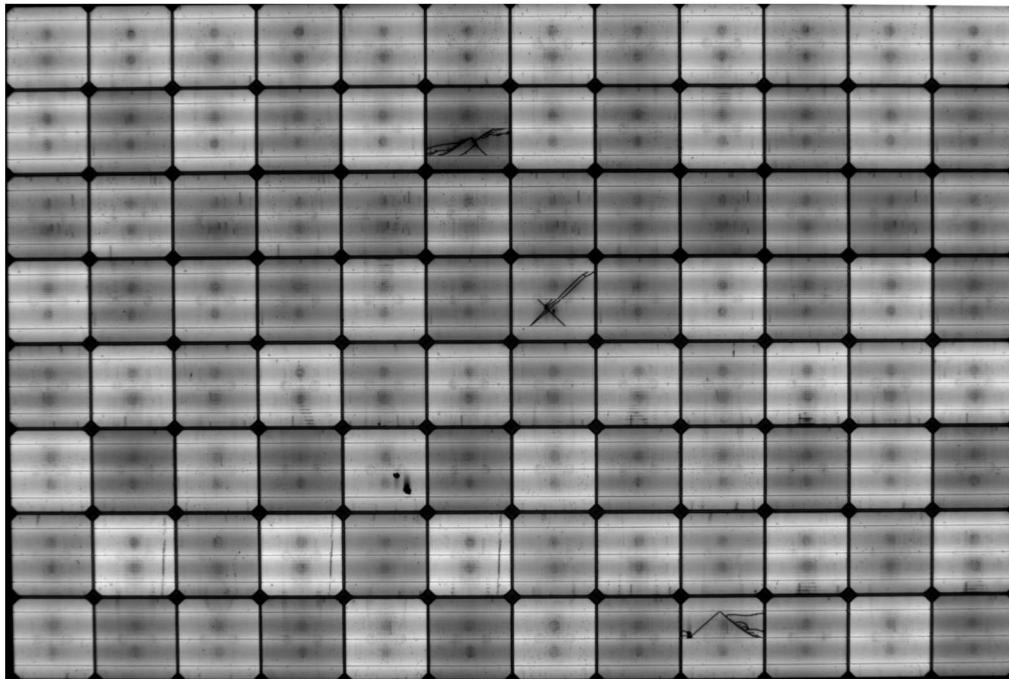
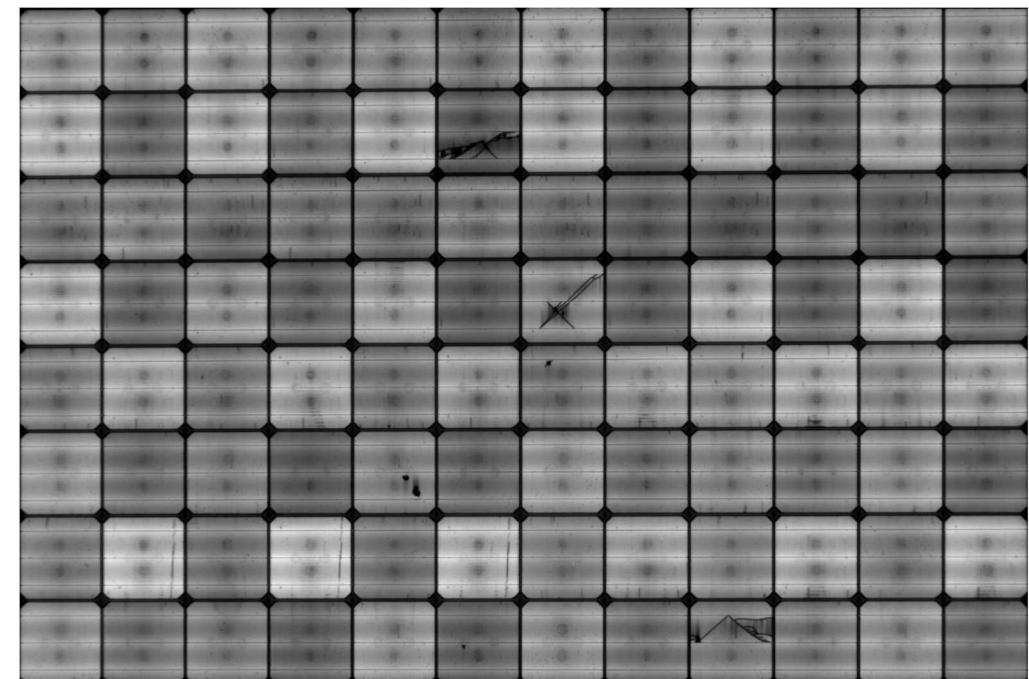
- EL imaging conducted on all modules after 1 Year in the field

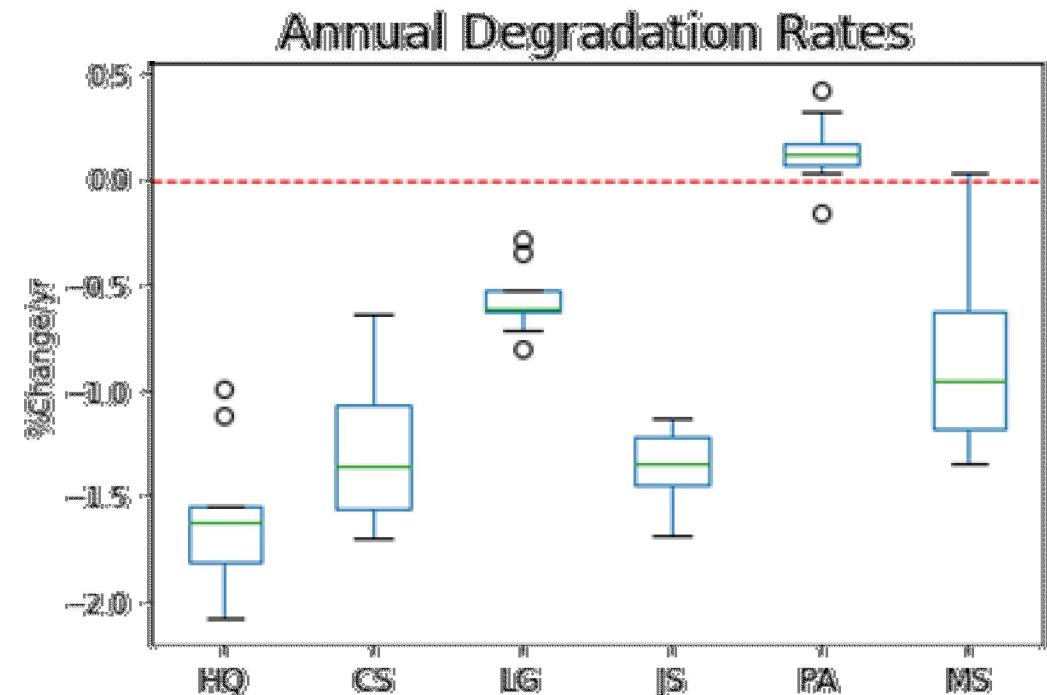
- Indoor light IV conducted on a Spire flash tester

Boxes: quartile 1 to quartile 3  
Error bars:  $1.5 \times (Q3 - Q1)$   
Circles: outliers
