Report Title: **SOFC Prototype System Test**

Type of Report: Final Technical Report

Report Prepared for: U. S. Department of Energy (DOE) – National Energy Technology Laboratory (NETL)

DOE Award No.: DE-FE0026199

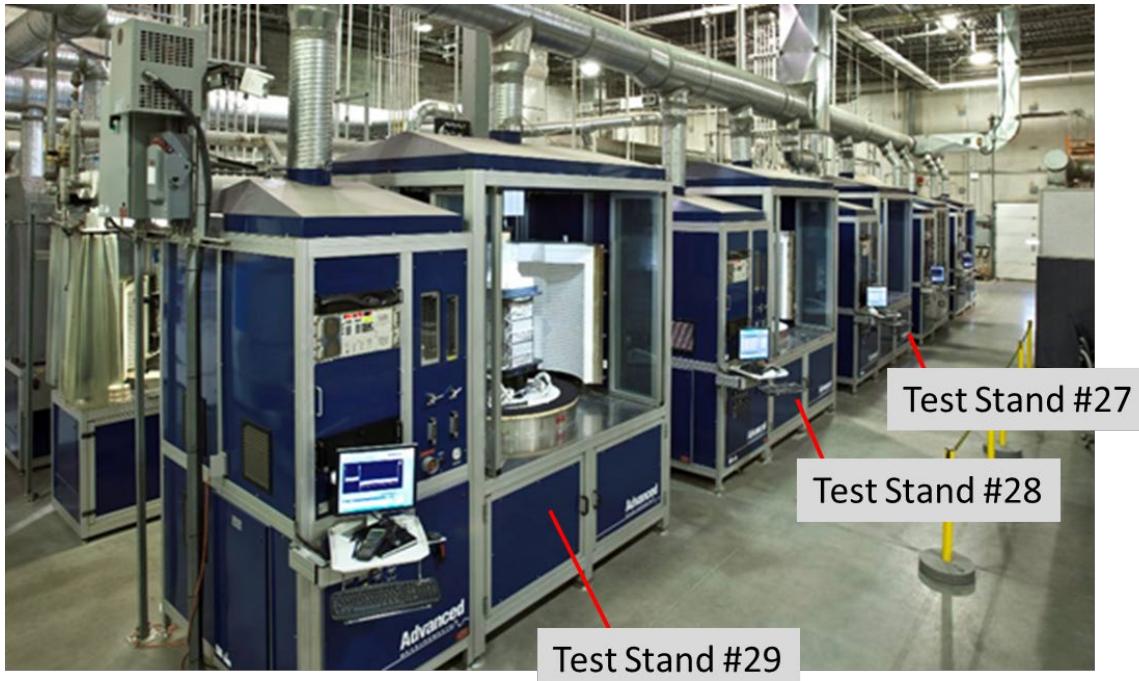
While in Test Stand 27 (for TC1 hold), the stack experienced humidifier pump communication errors at 1062 and 1615 hours. The humidifier pump adds water to a steam vessel which provides steam to the incoming fuel mix. Following the second interruption, the stack was shut down, cooled and physically moved to neighboring test stand #28 (see Figure 3-25). This was done to have both Test Stand 29 (lead) and Test Stand #27 (alternate) available for 120-cell stack conditioning and acceptance testing.

Figure 3-25. Tall (25 kW) Large Area Stack Test Stands

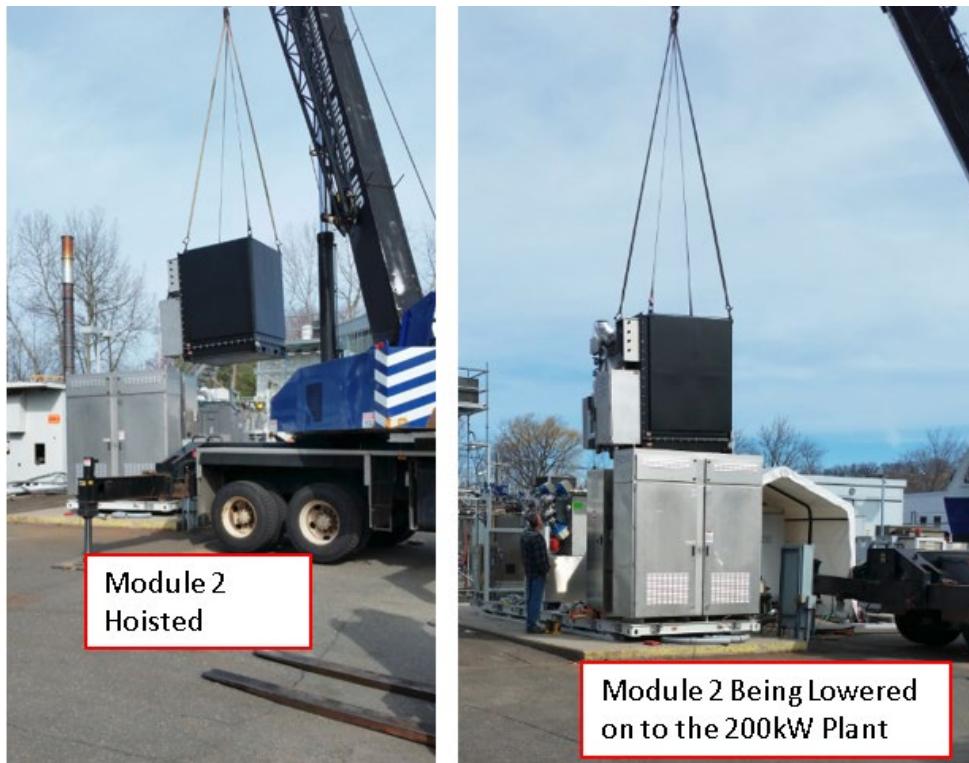
Figure 4-5 Module Power Black 2 (B) Integration

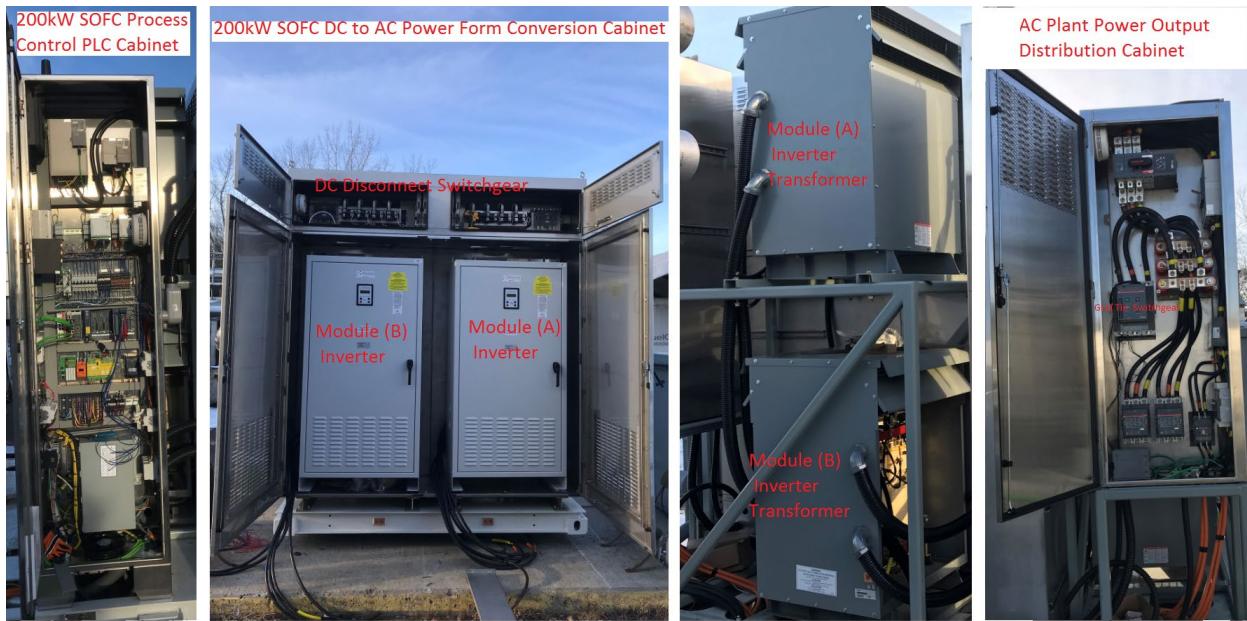
Figure 4-6 200kW Power Conditioning Unit

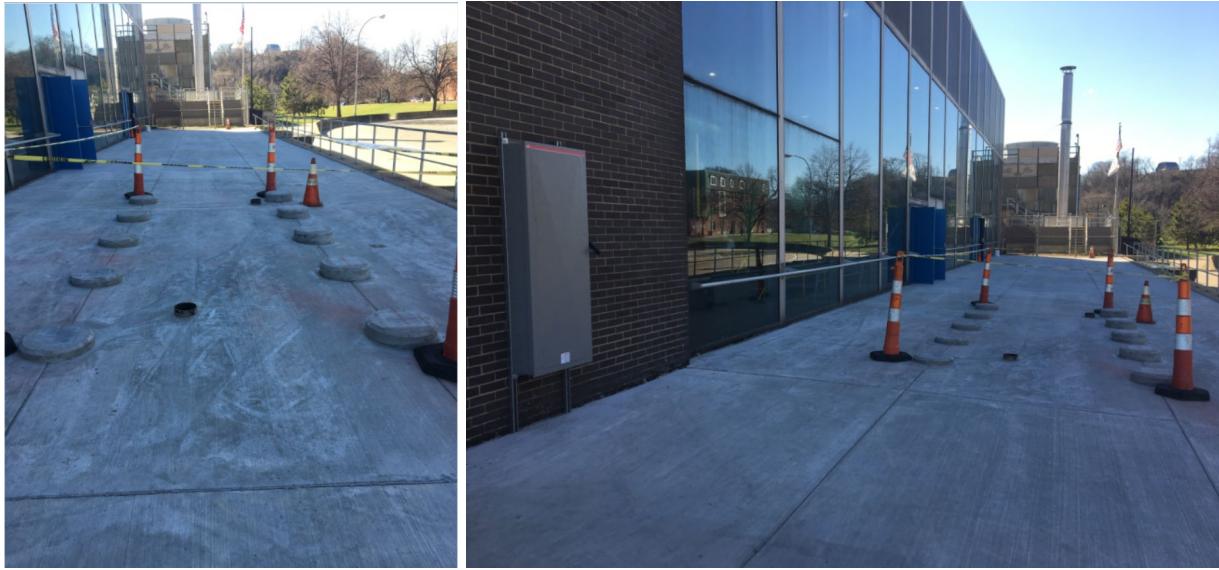
Figure 5-4 New Concrete Upper Deck, Fuel Cell Pier Supports & Pass Throughs
