Dispenser Reliability: Materials R&D

A Hydrogen Fueling Infrastructure Research and Station Technology (H2FIRST) Report

Nalini C. Menon
Ethan S. Hecht
Sandia National Laboratories

Technical Report
SAND2020-xxxx
December 2020

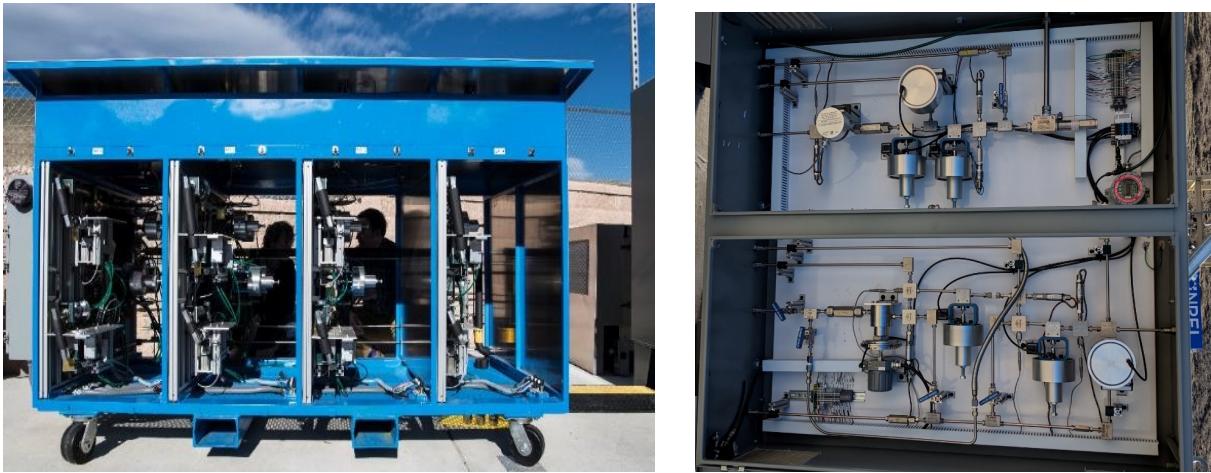
Figure 4. Photographs of the multi-test set-up with the devices under test (DUT) at NREL

Multiple units of the same type of component were procured from at least two different manufacturers per component type. Twenty-five units of each component per manufacturer were tested at each temperature in test loops designed for the purpose. A typical set-up is shown in Figure 2 and a schematic of multiple test set-ups is shown in Figure 3. Photographs of the multi-test set-up and the devices under test at NREL are shown in Figure 4.

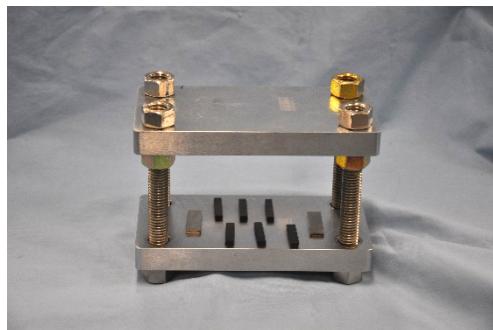
Figure 7. Compression set test set-up for elastomers. The black polymer specimens (center) are compressed to the thickness of the steel spacer bars on either side by lowering the top plate (currently raised for demonstration purposes)

Compression set provides information on the permanent deformation in elastomeric polymers during the application of a compressive force at a given temperature, % compression, and duration of compression. This permanent deformation can lead to a decrease in sealing force provided by the polymer, and ultimately leakage. When elastomers are exposed to hydrogen, free volume changes and weak interactions with hydrogen can either temporarily or permanently influence their compression set properties. Figure 7 shows the compression test set-up used for elastomers. Due to the limited number of specimens, typically only single measurements of each part were completed. After the starting thickness of each specimen is measured with a laser micrometer, the specimens were placed on the bottom plate of the compression set-up. A constant deflection to 75% of the starting thickness (25% compression), created by clamping down the top plate of the set-up and controlled by a steel spacer bar placed alongside the specimen, is exerted on the samples at a temperature of 110°C over a period of 22 hours (ASTM D 395 Method B). After removal from the

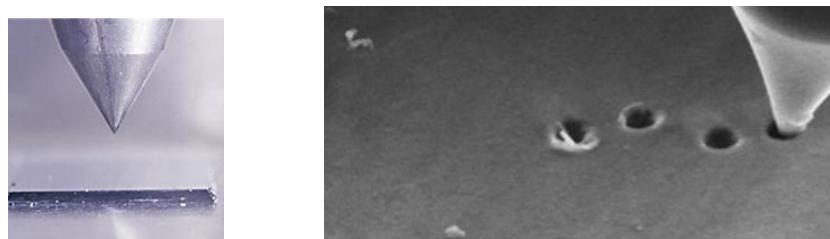
Figure 8. Nanoindentation conical tip being used to test hardness and elastic modulus of a surface

Nanoindentation is used to measure hardness, elastic modulus, and the coefficient of friction of rigid polymers. A 2- μm conical tip is used to either press against the surface to measure hardness and elastic modulus or to generate wear cycles on the surface of the sample. By applying a small oscillating force to the tip, the hardness and elastic modulus of the sample as a function of depth is measured. Wear cycles were performed in groups of 10 cycles (back and forth) covering a 5- μm length at a constant load of 25 μN . Five of these 10 cycles were grouped, and friction was calculated for each forward segment of a cycle. Surface texturization effects and their contribution were evaluated afterwards. This method is non-destructive and measures permanent changes in hardness of the material.
