Assessing Risk of Loss in Integrity of Sidewall of Cavern Located near Dome Edge

PA43G-1412 Byoung Yoon Park, Ph.D.

SAND2018-13823C

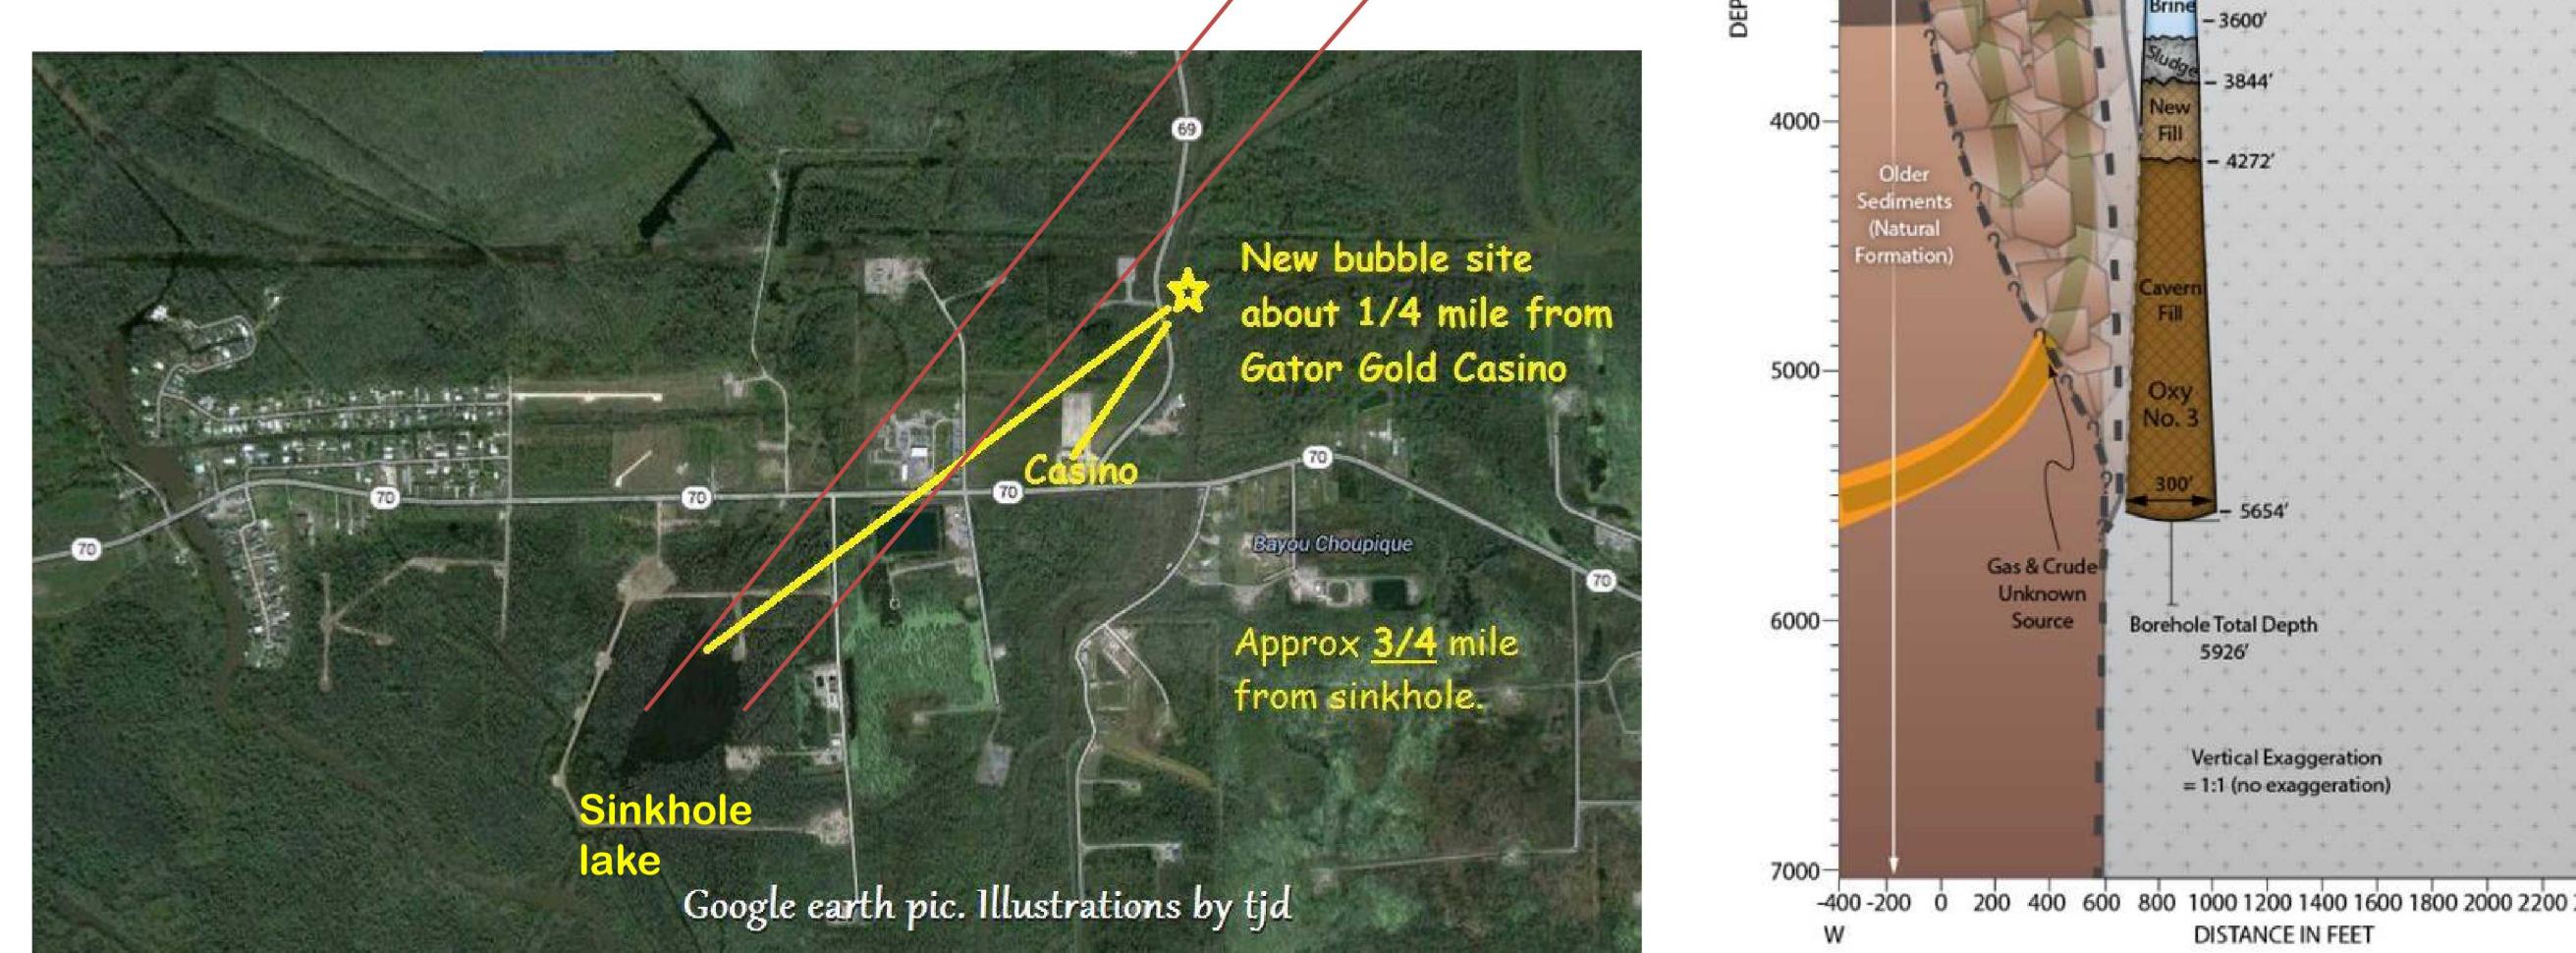
Fig.5. Photo of the sinkhole lake (left) and conceptual diagram of failure/collapse of sidewall of brine-mined Oxy No. 3 salt cavern in the Napoleonville salt dome. Formation of the Bayou Corne sinkhole occurred in August 2012 [LSU, 2013]
