## SANDIA REPORT

SAND2020-5906

# Mechanical testing of PH13-8Mo H950 Steel for Xue-Wierzbicki Fracture Criterion Determination at 20° C and -40° C

Philip J. Noell, Priya R. Pathare, Zachary Casias, Todd Huber, John Laing, Jay D. Carroll

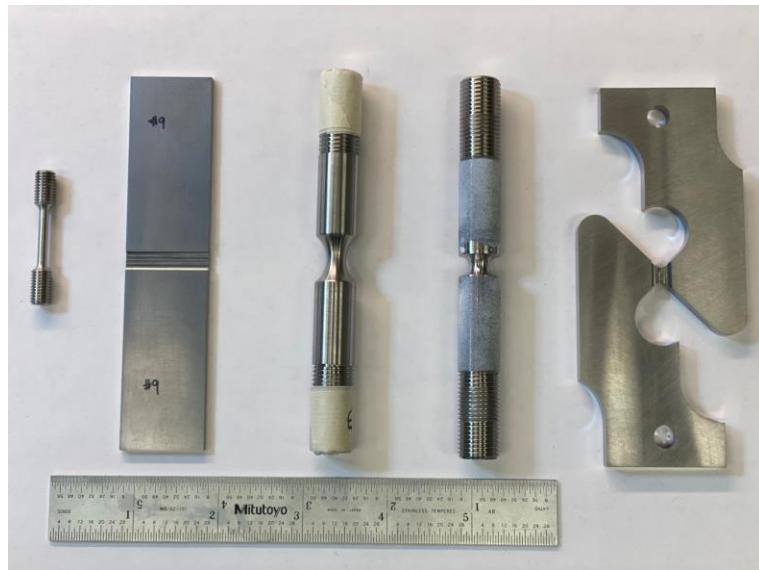
**Figure 1-1. Examples of all the test specimens investigated in this study, excepting compact tension specimens, are shown. The specimens are, left to right: R5, flat-groove, 9mm notch, 3mm notch, and shear specimens.**

These loading conditions can be accomplished by performing mechanical tests on specimens with different geometries. The four specimens used in this study to meet these conditions are pictured in **Figure 1-1**. The geometries of these specimens are identical to those described in reference [1]. Engineering drawings of all four specimens are provided in Appendix A. The average stress triaxiality ( $\eta$ ) and average lode parameter ( $\xi$ ) for each of these specimen designs are listed in **Table 1-1**. These values are all taken from calculations performed in reference [1]. The names of each specimen type are provided in **Table 1-1**. All specimen geometries were tested at both room temperature and at -40° C.

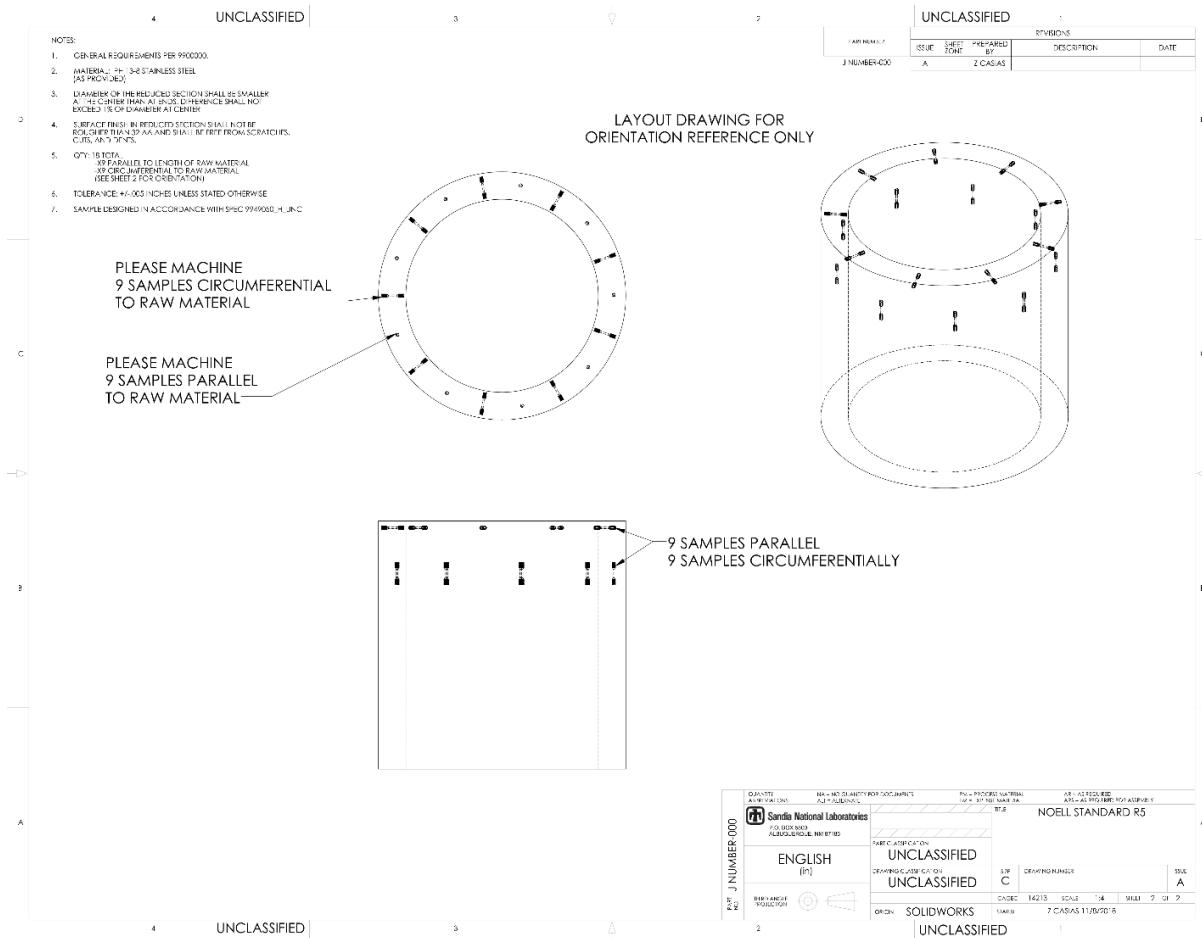
Figure 1-2. The layout of the specimens used in this study relative to the circumference and length of the cylinder from which they were extracted is shown. All specimens except the R5 radial specimen were extracted with the loading axis parallel to the length of this cylinder.

All four of the specimen types described in the previous paragraph were extracted from a cylinder of PH 13-8 SS parallel to the length of the cylinder. A reference layout drawing is provided in Appendix A. To determine if the mechanical properties of this material varied between the parallel and the radial direction (see **Figure 1-2** for definitions of these terms), 18 unnotched round bars were also extracted, half having the tensile direction (TD) parallel to the circumference of the cylinder and the other half having the TD parallel to the long axis of the cylinder. These bars met the specification for R5 tensile bars from ASTM specification E8-16 [2] and will be referred to as R5-radial and R5-parallel. The  $\eta$  and  $\xi$  values associated with this specimen geometry are also provided in **Table 1-1**. Both kinds of R5 specimens were tested at both room temperature and at -40° C.

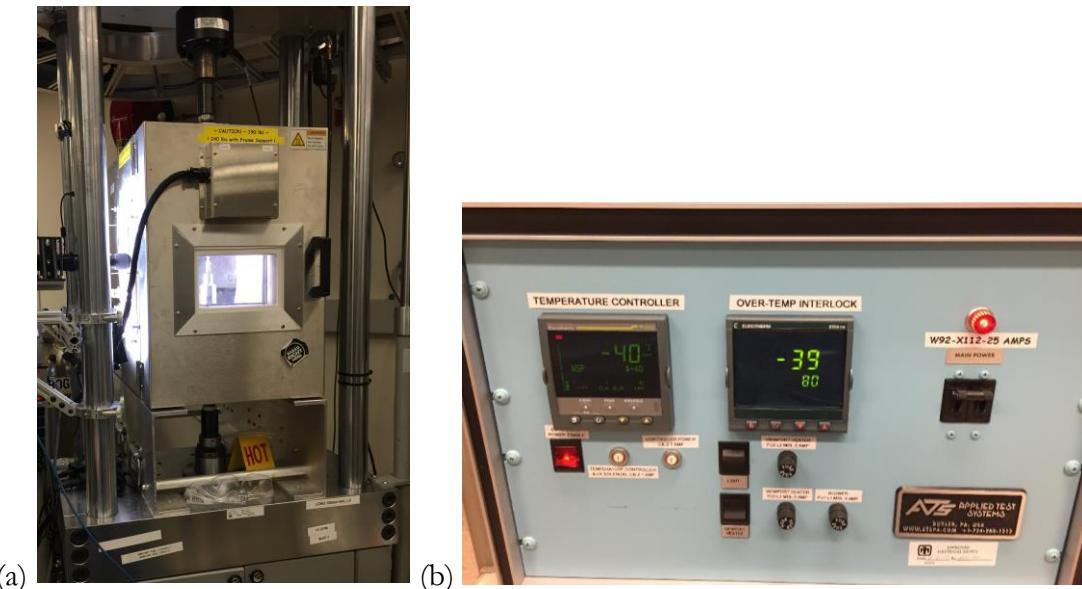
**Figure 2-1. Images of the load frame used to perform tensile testing (left) and the ATS temperature controller used to control the temperature within the test chamber (right) are shown.**

An environmental chamber attached to the load frame was used to perform testing at -40° C. Liquid nitrogen was pumped into the chamber and temperature was controlled using an Applied Test System™ temperature controller, see **Figure 2-1**. Samples were preloaded to a small amount of force and left to cool for 20-30 min. Actuator displacement was monitored until the displacement stabilized to assure that the load train had equilibrated to the oven temperature.

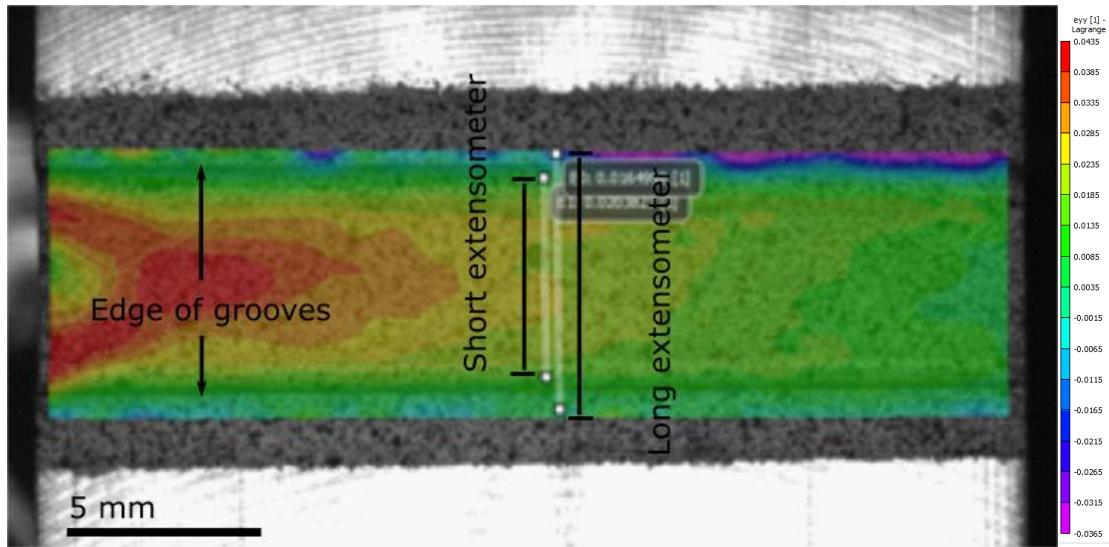
**Figure 2-6.** The locations of the two extensometers used to measure strain for the flat groove samples are shown overlaid on full-field strain data. Note the strain localization that can be seen on the left side of the sample (red “hotspot”). This was caused by misalignment of the grips and occurred in every specimen. This image was taken near failure.

As **Figure 2-6** shows, strain was not applied uniformly to the flat groove specimens. Misalignment of the pinch grips created a slight bending moment in the samples. Evidence of this can be seen in the elastic loading region of flat groove specimens, see *e.g.* Figure 3-26. Because of this, the strain at failure for all flat groove specimens was typically  $\approx 50\%$  greater on the left side of the sample as on the right side of the sample. Average strain at failure values reported in this study were made using extensometers positioned in the center of the sample. However, to assess the evolution of strain across the sample, plots of stress *versus* strain and force *versus* displacement include data from three extensometers at the three locations shown in Figure 2-7.

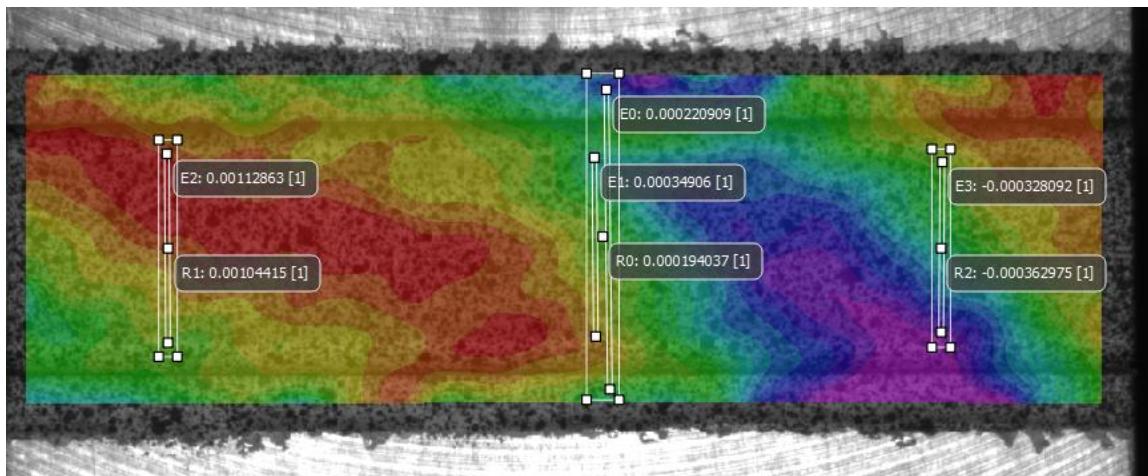
**Figure 2-7.** The locations of the three extensometers across the face of flat groove specimens used to make plots of stress versus strain and force versus displacement are shown. This image was taken in the elastic region failure.

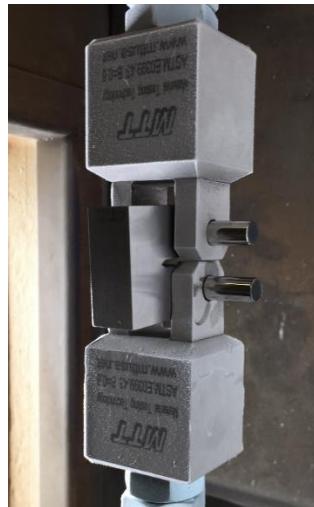
**Figure 2-14.** The setup for performing fracture toughness tests is shown.

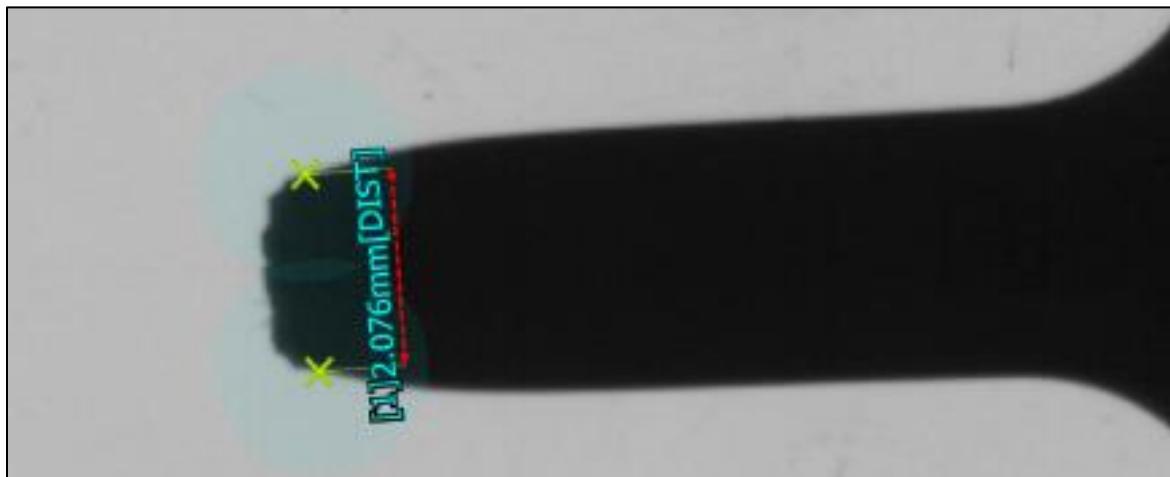
**Figure 2-15.** The method for measuring the diameter of fractured samples is illustrated for an R5 sample (Sample 11).

Reduction in area was measured for R5, 3mm, and 9mm notch samples. These measurements were made using a Keyence IM-6700 Image Dimension measuring system (SN: Y5151050011) with Keyence IM 6225T (SN: 3C519002) Imaging Head. The diameters of unbroken specimens were averaged to give an overall initial diameter. The gauge diameter of broken samples was measured as illustrated in **Figure 2-15**. Areas were calculated from these diameters for reduction in area measurements.

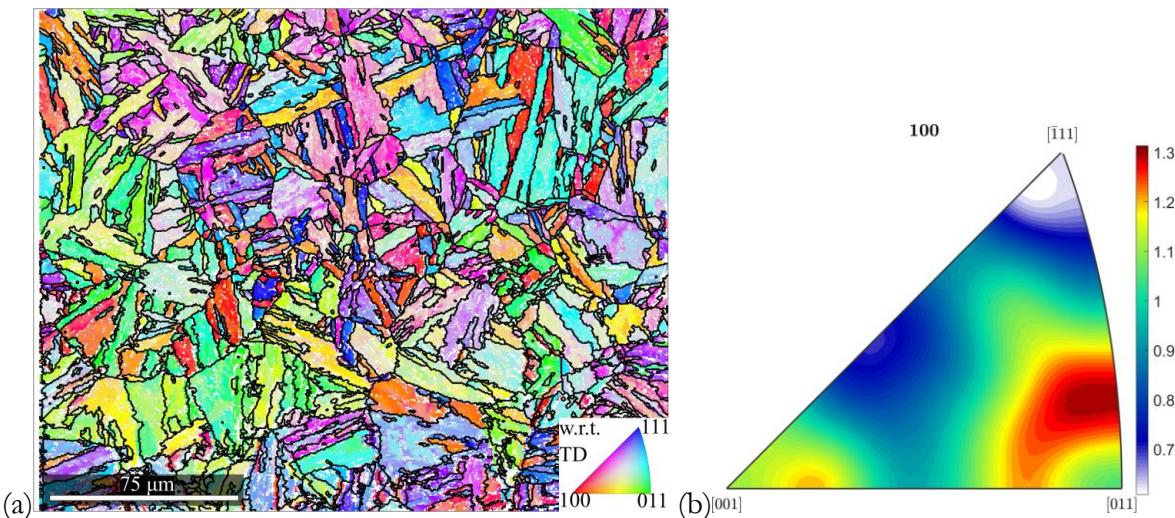
**Figure 3-1.** EBSD data from the grip region of an R5 radial specimen are plotted as an inverse pole figure (IPF) map colored with respect to the tensile direction and an IPF. High-angle ( $>5^\circ$ ) grain boundaries are colored black in (a). The IPF plots the texture of the material relative to the tensile direction of the R5 radial sample as multiples of random.

Electron backscatter diffraction (EBSD) data from the undeformed grip regions of R5 radial and R5 parallel samples are presented in **Figure 3-1.** and **Figure 3-2.** Because all samples except the R5 radial samples were extracted with their loading direction parallel to the length of the cylinder, the microstructure shown in **Figure 3-2** is considered representative of the undeformed microstructure of all other specimens. In each figure, the EBSD data are plotted as an inverse pole figure (IPF) map colored with respect to the tensile direction (TD) and as an IPF relative to the TD. High-angle grain boundaries, defined as boundaries greater than  $5^\circ$ , are colored black in the IPF maps. Grains appear acicular with the long axis randomly oriented. The texture in the radial direction was diffuse. A weak  $<111>$  fiber parallel to the TD was observed in the parallel sample, indicating that all samples except the R5 radial samples had a weak  $<111>$  fiber parallel to the loading direction.

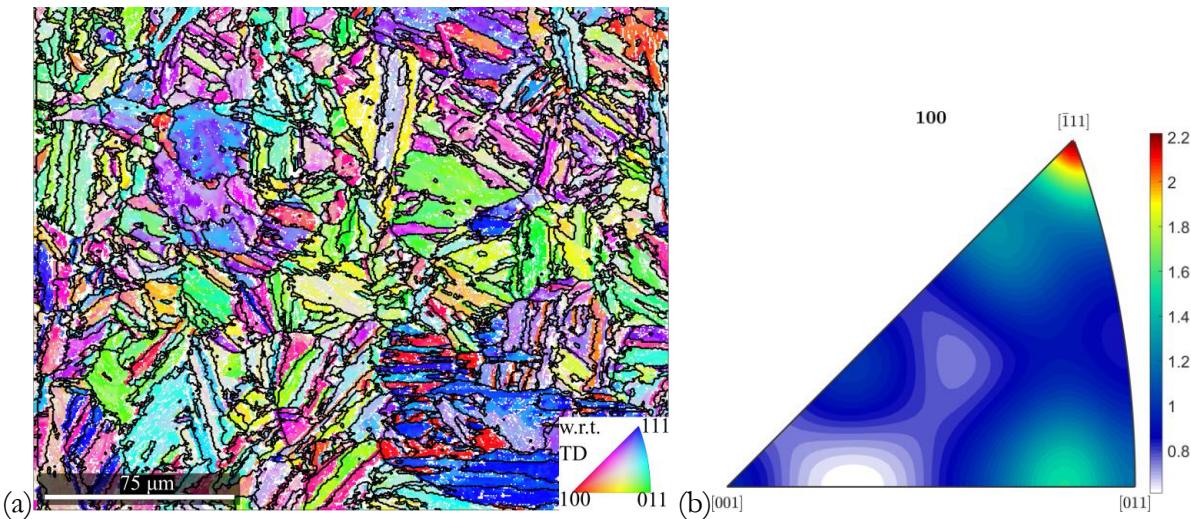
**Figure 3-2. EBSD data from the grip region of an R5 parallel specimen are plotted as an inverse pole figure (IPF) map colored with respect to the tensile direction and an IPF. High-angle ( $>5^\circ$ ) grain boundaries are colored black in (a). The IPF shows the texture of the material relative to the tensile direction of the R5 parallel sample as multiples of random.**

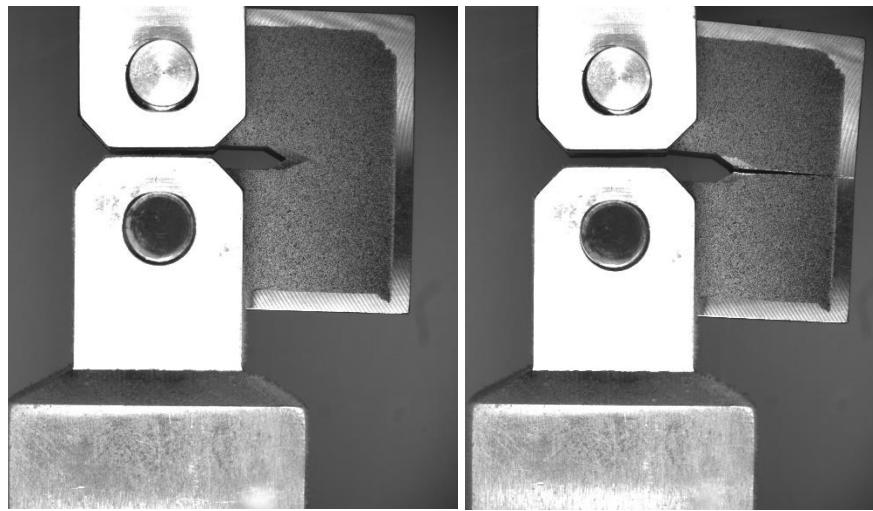
**Figure 3-3. Pre-test and post-test images showing failure location, CT, -40°C, Sample 03**

The testing temperature length of the precrack, maximum load held by the sample, and corresponding  $K_{IC}$  are provided for each of the 5 CT specimens tested. These measurements indicate that the fracture toughness of this material is significantly lower at  $-40^\circ C$  than at room temperature. The average  $K_{IC}$  at room temperature and  $-40^\circ C$  were 53.6 and 36.40  $MPa\sqrt{m}$ , respectively. Images of a CT specimen before and after failure are shown in **Figure 3-3**.

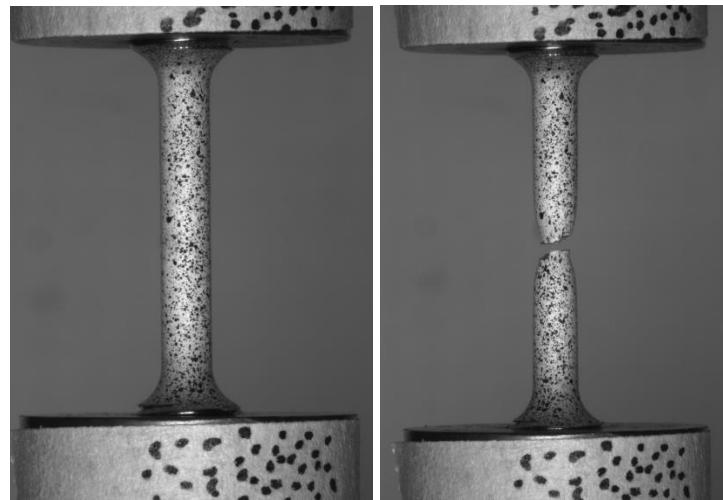
Figure 3-8. Pre-test and post-test images showing failure location, R5 Parallel, 22°C, Sample 07.

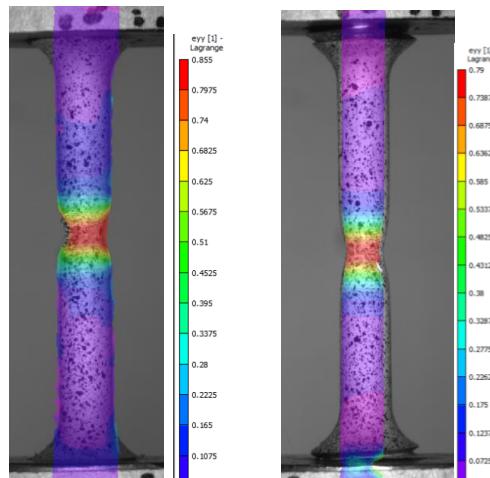
Figure 3-9. Final full field eyy strain measurements before failure for R5 samples tested at 22 °C, Sample 01 (Left) and -40°C, Sample 10 (Right). Strain localization in a neck can be seen for both samples. Note the different scales for strain, left: 85.5% to 0%, right: 80% to 0%.

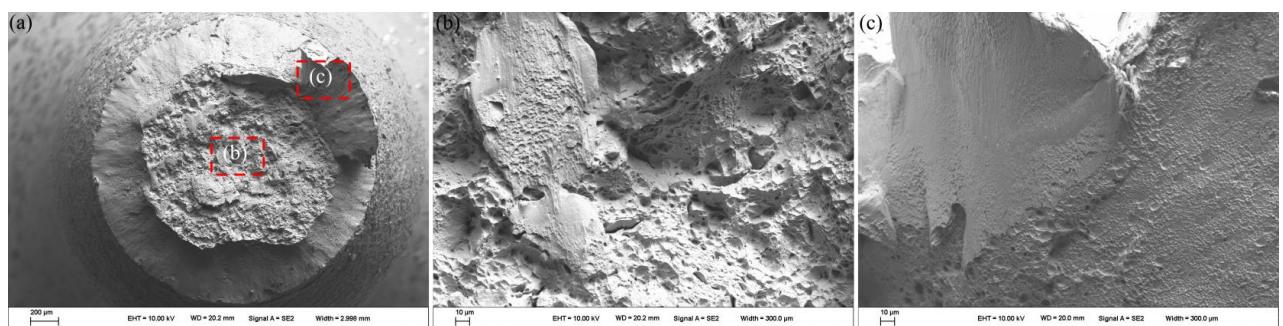
Figure 3-10. Secondary electron images of the fracture surface of a R5 radial sample tested at 22°C are provided. A low-magnitude image of the entire fracture surface is shown in (a). High-magnification images of the center (b) and shear lip (c) are also provided.

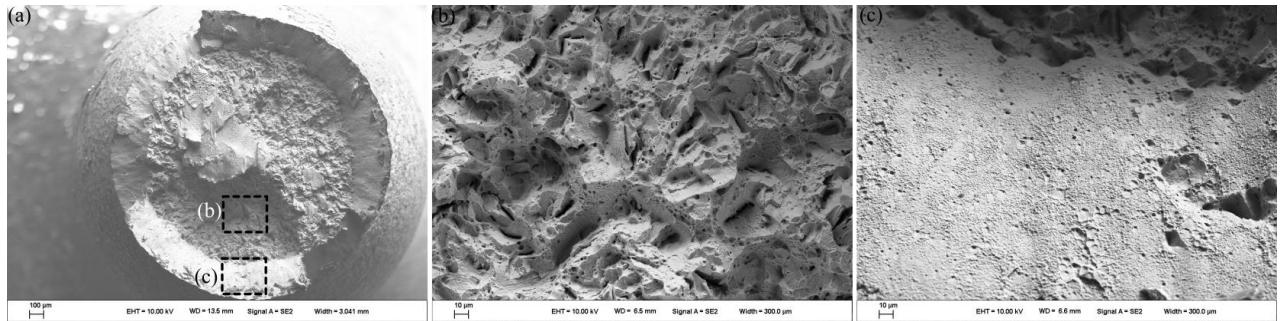
**Figure 3-11. Secondary electron images of the fracture surface of a R5 radial sample tested at -40C are provided. A low-magnitude image of the entire fracture surface is show in (a). High-magnification images of the center (b) and shear lip (c) are also provided.**

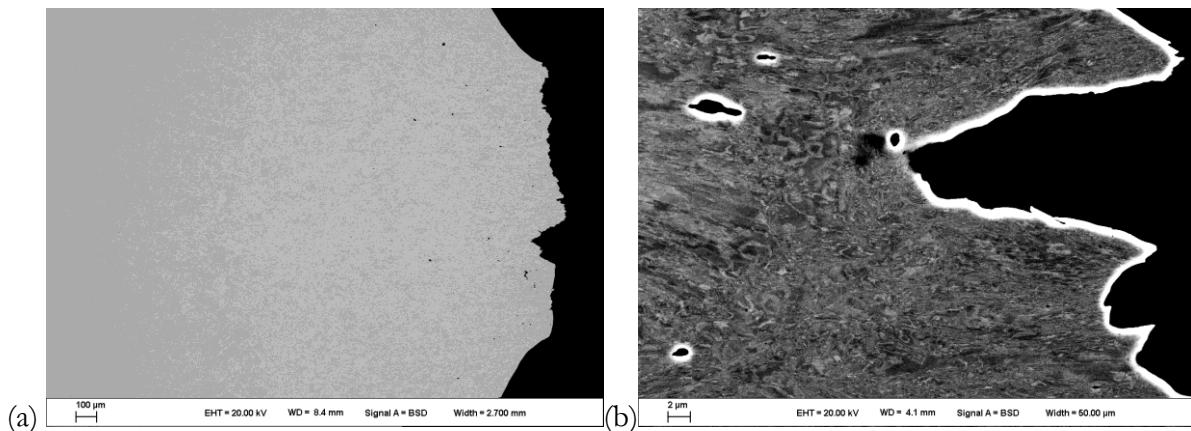
**Figure 3-12. ECCI images of a cross-sectioned R5 radial sample tested at 22C are provided. The fracture surface can be seen on the right side of both images. (a) shows a low magnification image (the image width is 2.7 mm) and (b) shows a high magnification image (the image width is 0.05 mm). Voids near the fracture surface can be seen in both images.**

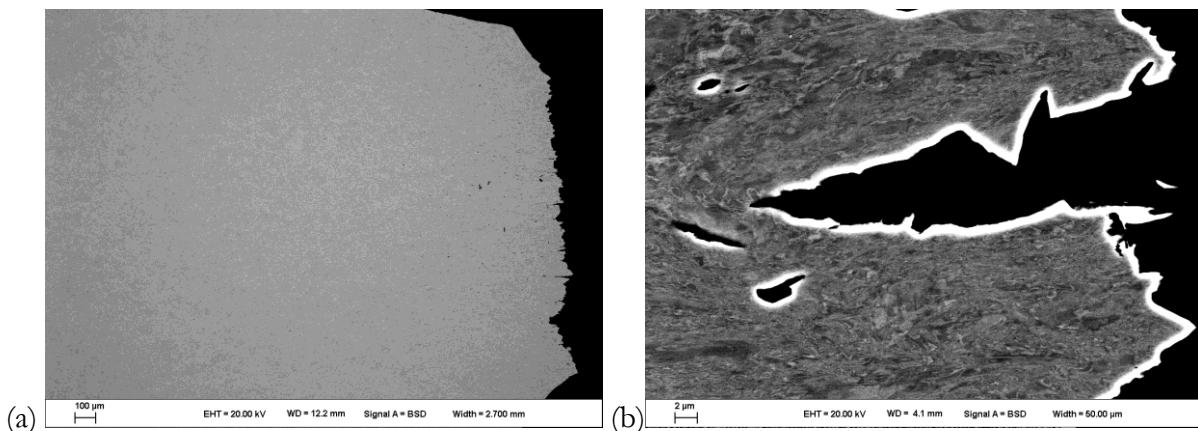
**Figure 3-13. ECCI images of a cross-sectioned R5 parallel sample tested at -40C are provided. The fracture surface can be seen on the right side of both images. (a) shows a low magnification image (the image width is 2.7 mm) and (b) shows a high magnification image (the image width is 0.05 mm). Voids near the fracture surface can be seen in both images.**

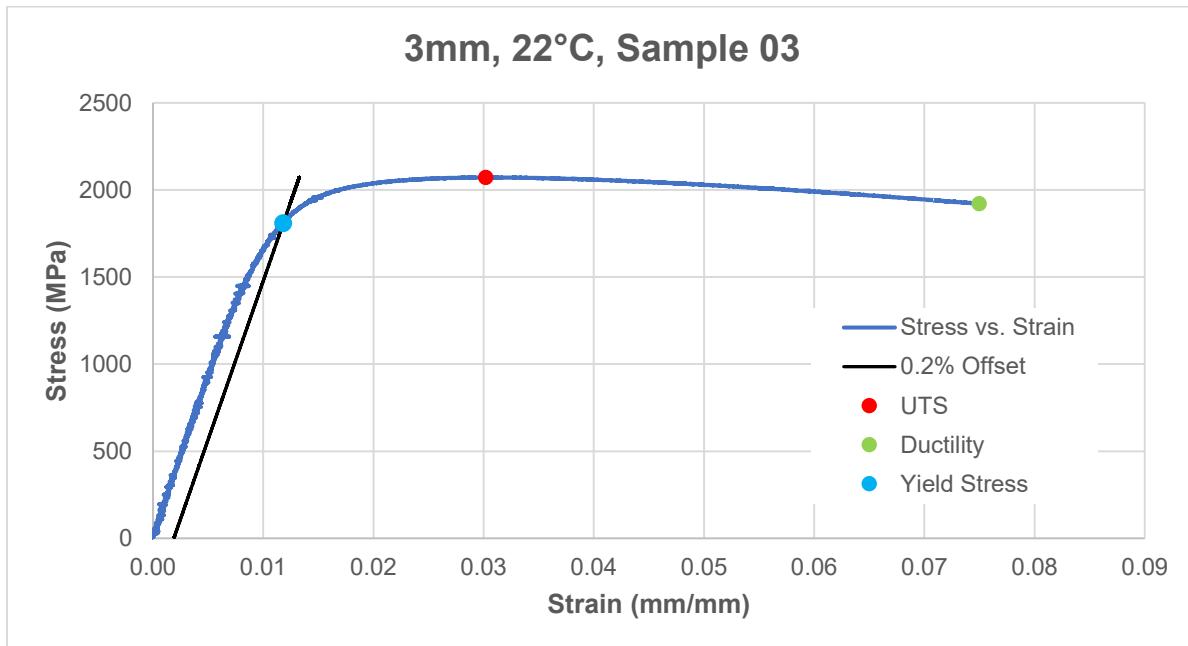
**Figure 3-14. Stress-strain curve, 3mm, 22°C, Sample 03.**

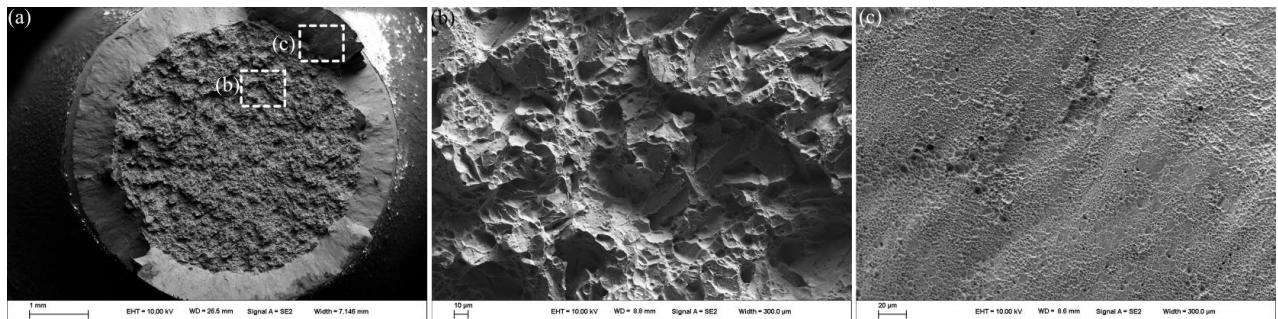
**Figure 3-16. Secondary electron images of the fracture surface of a 3mm-notched sample tested at 22C are provided. A low-magnitude image of the entire fracture surface is show in (a). High-magnification images of the center (b) and shear lip (c) are also provided.**

SEM images of fractured 3mm notched specimens tested at 22° C and -40° C are shown in Figure 3-16 and Figure 3-17. Optical images of the fracture surfaces of these specimens are provided in Appendix C. The fracture surface of 3mm notched samples tested at 22° C suggest ductile fracture. Specimens exhibited cup and cone fracture with ductile dimples in the center of the sample and shear dimples along the shear lip. Ductile dimples in these samples were similar to those observed in the center of R5 samples. While the fracture surfaces of samples tested at -40° C suggest ductile fracture at this temperature, several features are reminiscent of brittle failure. First, the shear lip on samples tested at -40° C was much smaller than that of samples tested at 22° C, compare Figure 3-16 and Figure 3-17. Second, facets reminiscent of transgranular fracture rather than dimples were seen in the center of the fracture surface of specimens tested at -40° C, as can be seen in the high magnification image provided in Figure 3-17.

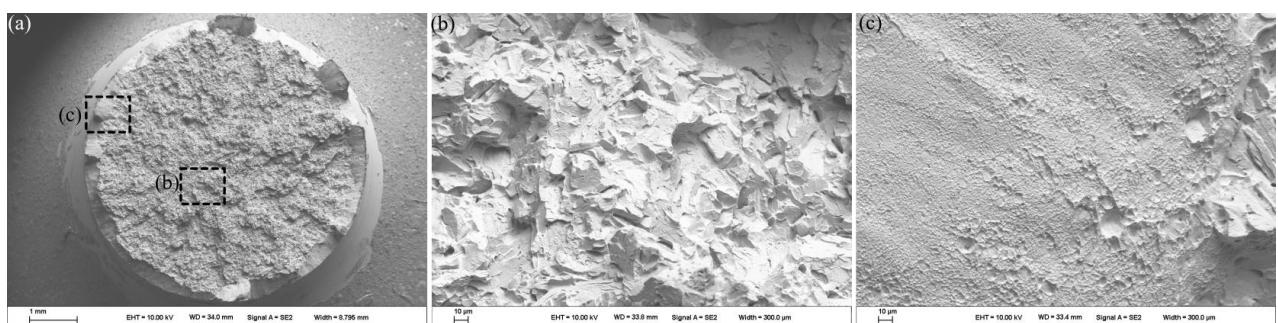
**Figure 3-17. Secondary electron images of the fracture surface of a 3mm-notched sample tested at -40C are provided. A low-magnitude image of the entire fracture surface is show in (a). High-magnification images of the center (b) and shear lip (c) are also provided.**

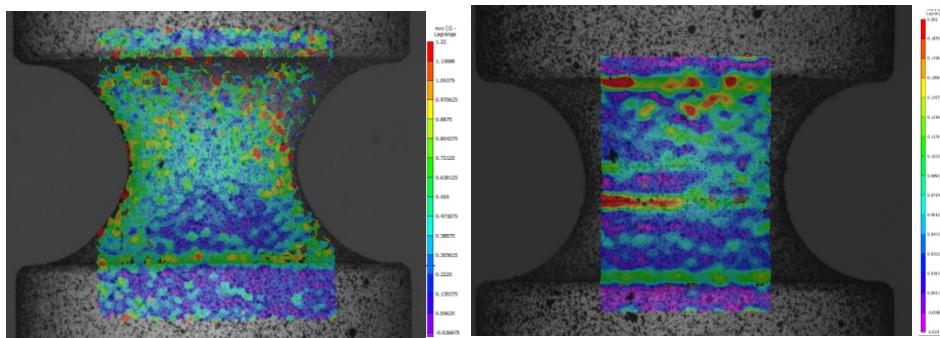
**Figure 3-19. Full field eyy measurements immediately before failure, 22°C, Sample 01 (left) and -40°C, Sample 04 (Right). Note the different scales for strain, left: 122% to 0%, right: 20% to 0%.**

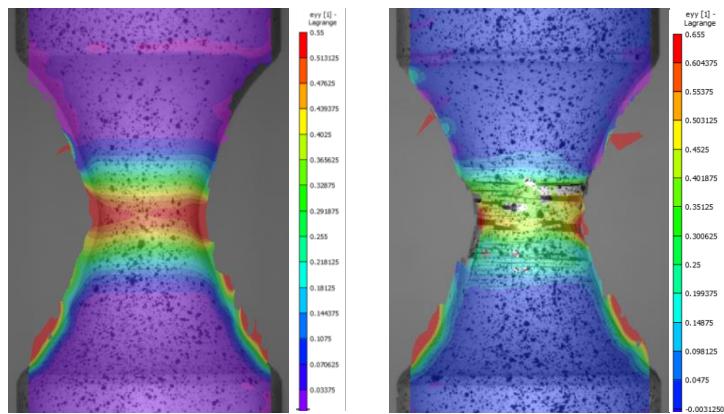
Figure 3-23. Full field strain (eyy) measurements for 9mm notch specimens immediately before failure, 22°C, Sample 01 (left) and -40°C, Sample 04 (Right). Note the different scales for strain, left: 122% to 0%, right: 20% to 0%. Paint chipping, likely caused by the cold temperature, can be seen for Sample 04. This created the elevated strain measurements (red areas) in full field strain measurements. The maximum strain in the center of the 9mm notch specimen tested at -40° C is  $\approx$ 45%. Note the different scales for strain, left: 55% to 0%, right: 65.5% to 0%.

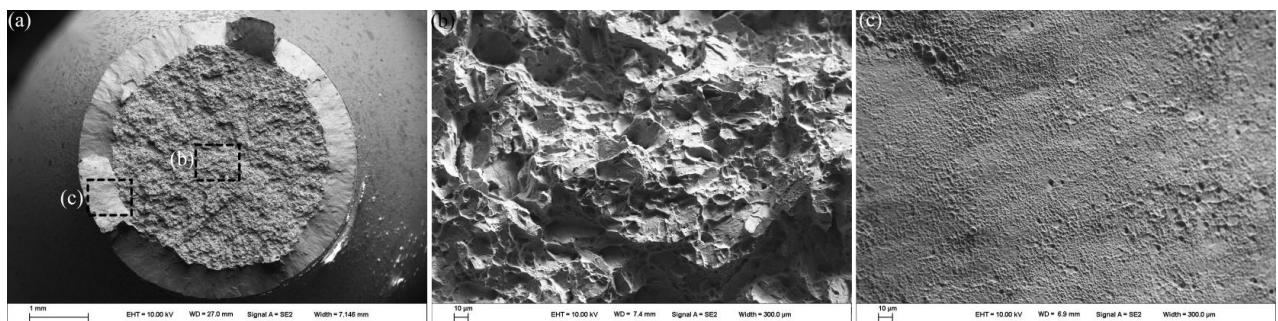
Figure 3-24. Secondary electron images of the fracture surface of a 9mm-notched sample tested at -40°C are provided. A low-magnitude image of the entire fracture surface is show in (a). High-magnification images of the center (b) and shear lip (c) are also provided.

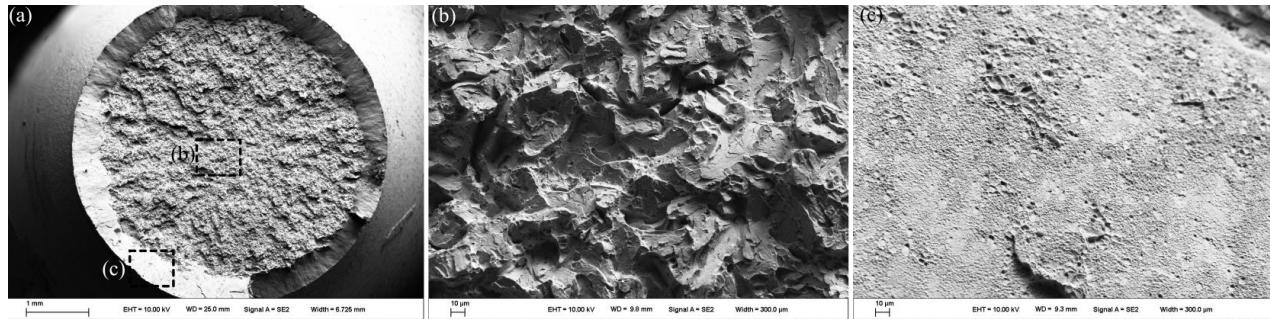
**Figure 3-25. Secondary electron images of the fracture surface of a 9mm-notched sample tested at -40°C are provided. A low-magnitude image of the entire fracture surface is show in (a). High-magnification images of the center (b) and shear lip (c) are also provided.**

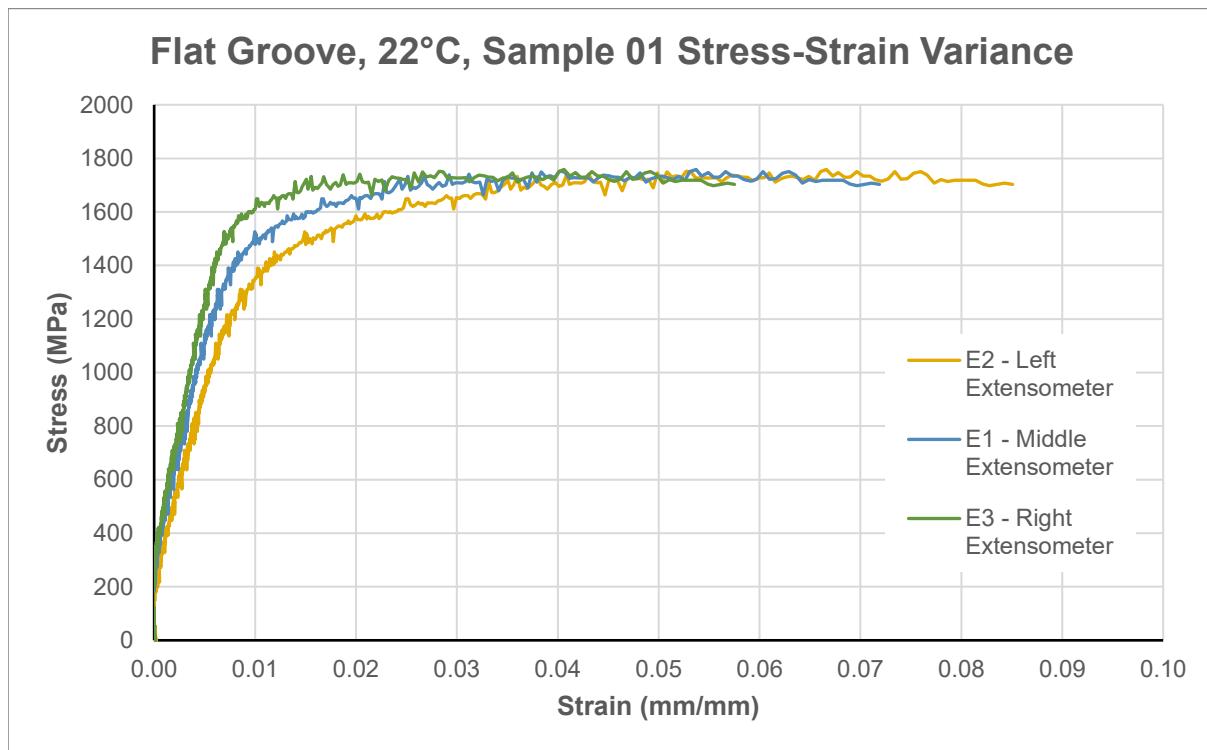
**Figure 3-27. The distribution of strain across the sample measured using the extensometers shown in Figure 2-7 are provided for Flat Groove sample, 22°C, Sample 01.**

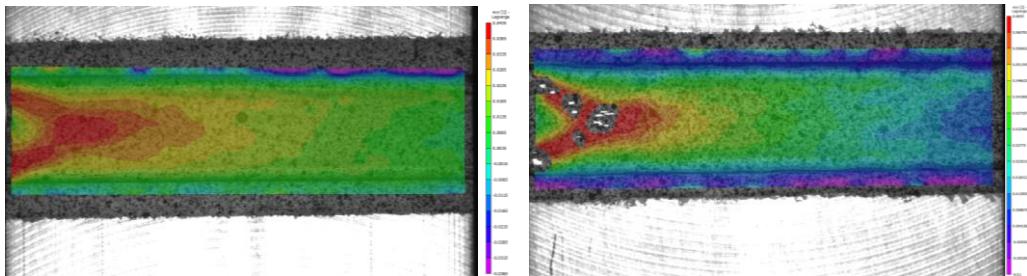
Figure 3-31. Full field strain (eyy) measurements for 9mm notch specimens immediately before failure, 22°C, Sample 01 (left) and -40°C, Sample 04 (Right). Paint chipped off Sample 04 because of the cold temperatures. Strain localizes on the left edge due to slight misalignment in the pinch grips. Note the different scales for strain, left: 4.4% to -3.7%, right: 6.6% to -1.0%. Negative strain measurements are from measurement noise.

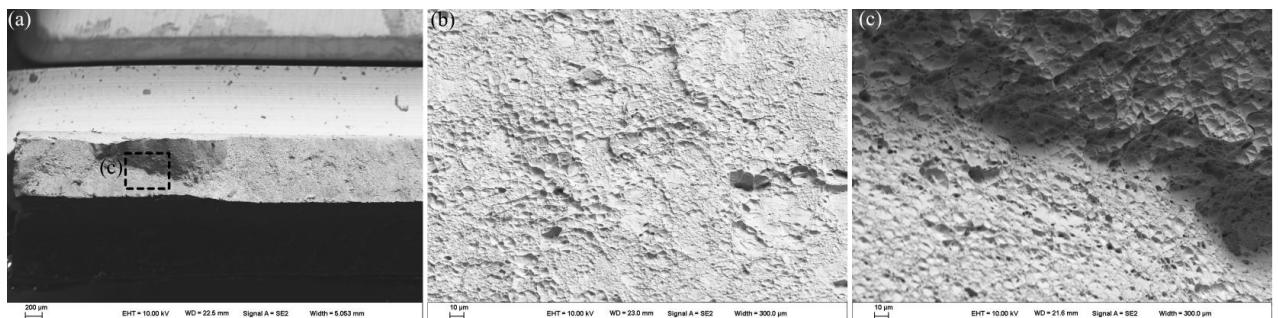
Figure 3-32. Secondary electron images of the fracture surface of a flat-grooved sample tested at 22°C are provided. A low-magnitude image of the left side of the fracture surface is shown in (a). A high-magnitude image of the center of the fracture surface is shown in (b). A high-magnification image of the left side of the fracture surface is shown in (c).

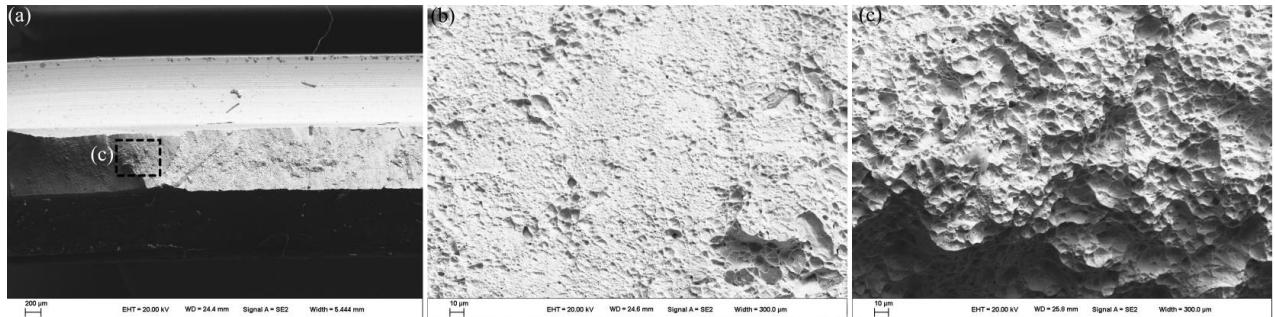
**Figure 3-33. Secondary electron images of the fracture surface of a flat-grooved sample tested at -40°C are provided. A low-magnitude image of the left side of the fracture surface is shown in (a). A high-magnification image of the center of the fracture surface is shown in (b). A high-magnification image of the left side of the fracture surface is shown in (c).**

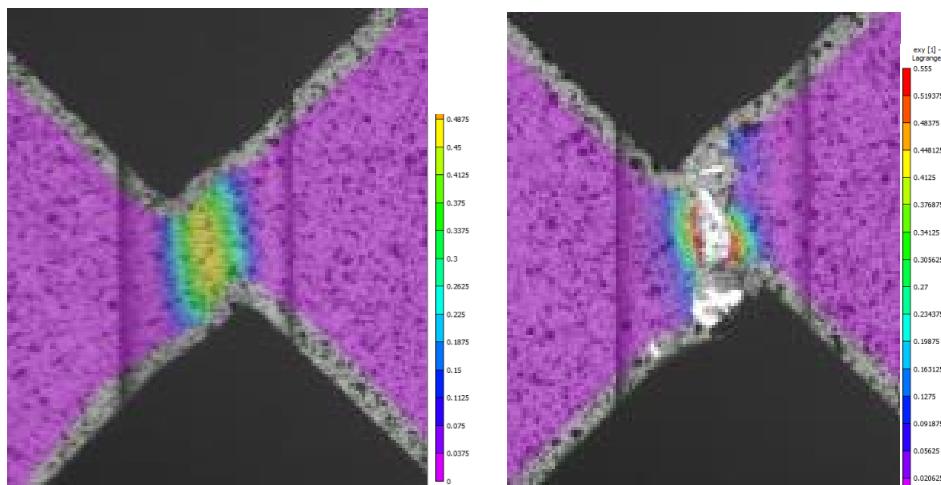
**Figure 3-39. Full field strain (exy) measurements for shear specimens immediately failure, 22°C, Sample 01 (left) and -40°C, Sample 06 (Right). Paint chipping in the center of the sample tested at -40° C prevented the shear strain in the center of the sample immediately before failure from being evaluated. Note the different scales for strain, left: 48.8% to 0%, right: 55.5% to 0%.**

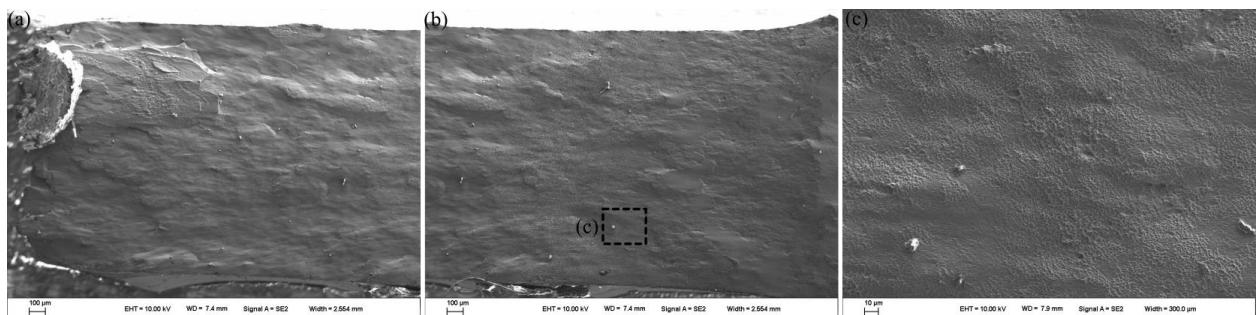
**Figure 3-40. Secondary electron images of the fracture surface of a shear sample tested at -40°C are provided. Low-magnitude images of the (a) left and (b) center of the fracture surface are shown. A high-magnification images of the center of the fracture surface is provided in (c).**

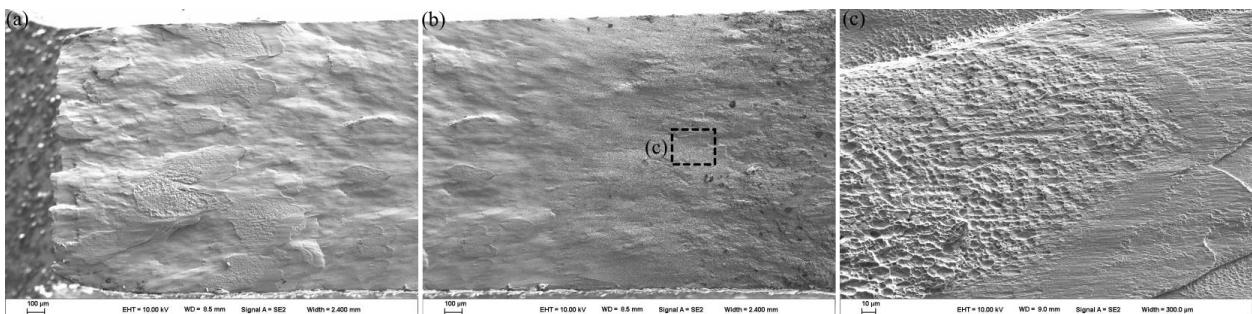
**Figure 3-41. Secondary electron images of the fracture surface of a shear sample tested at 22C are provided. Low-magnitude images of the (a) left and (b) center of the fracture surface are shown. A high-magnification images of the center of the fracture surface is provided in (c).**

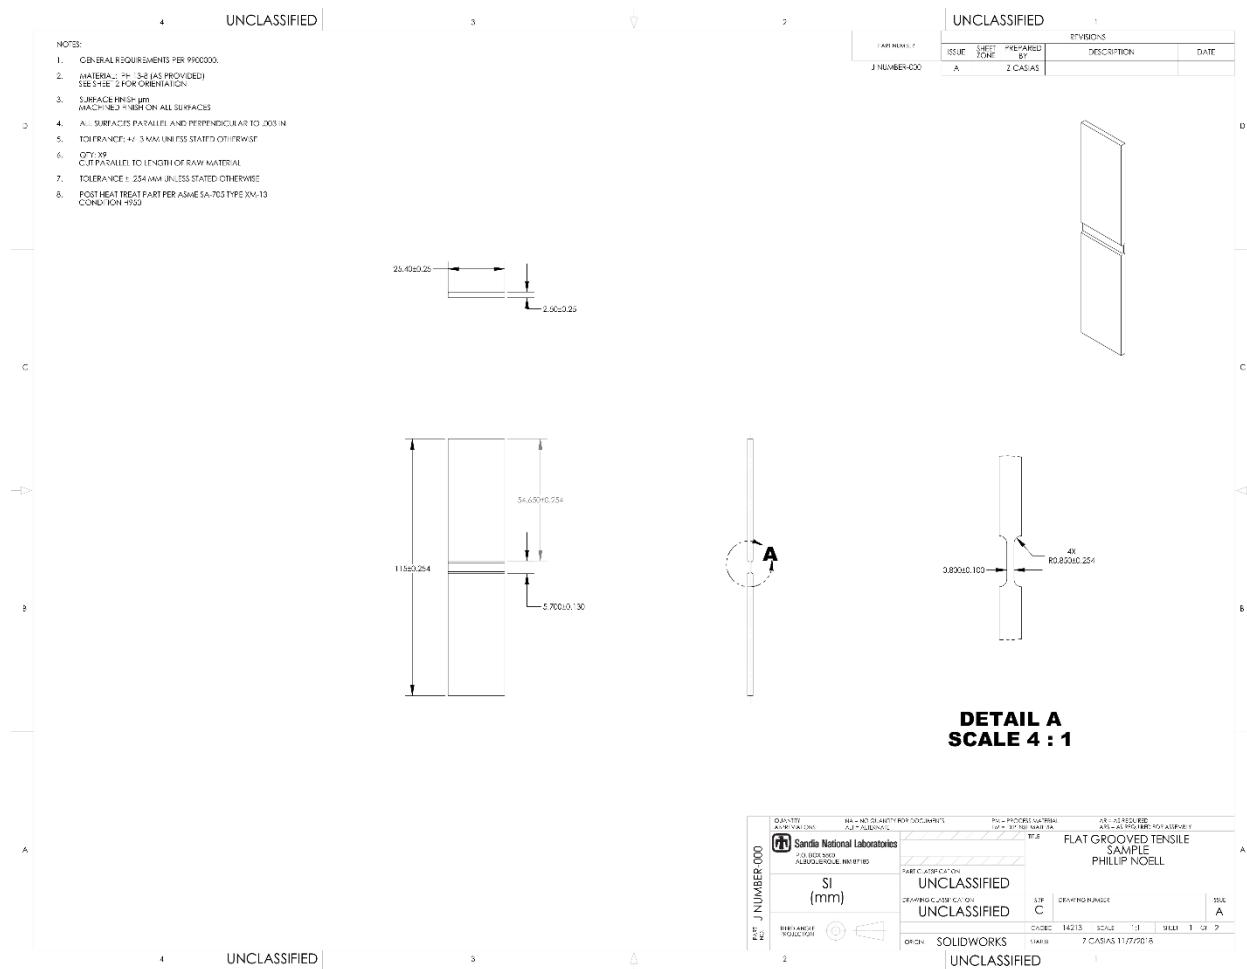
**Figure A-1.** The engineering drawing used for the flat-grooved plate specimen is shown.

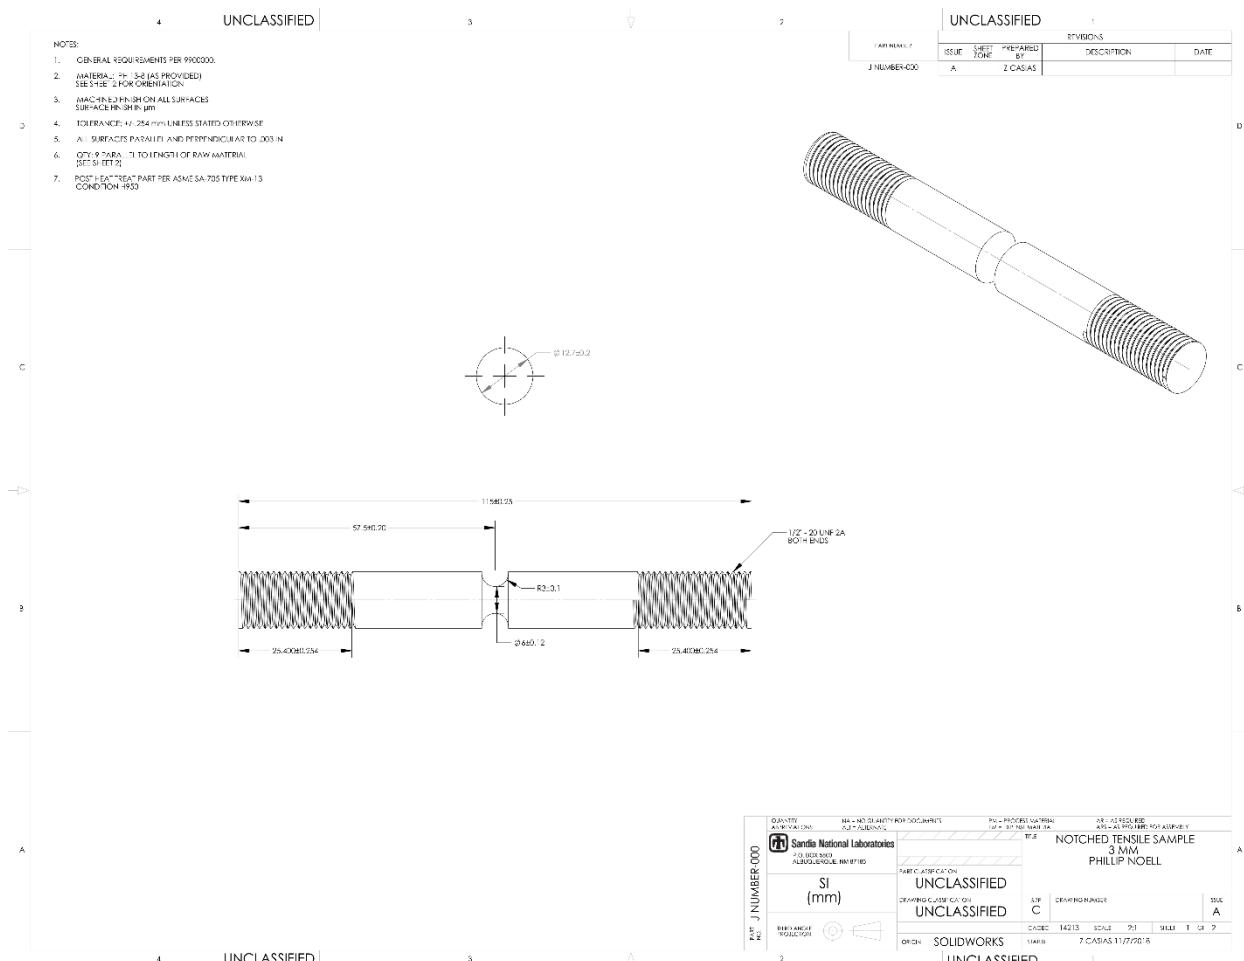
**Figure A-2.** The engineering drawing used for the 3 mm notched specimen is shown.

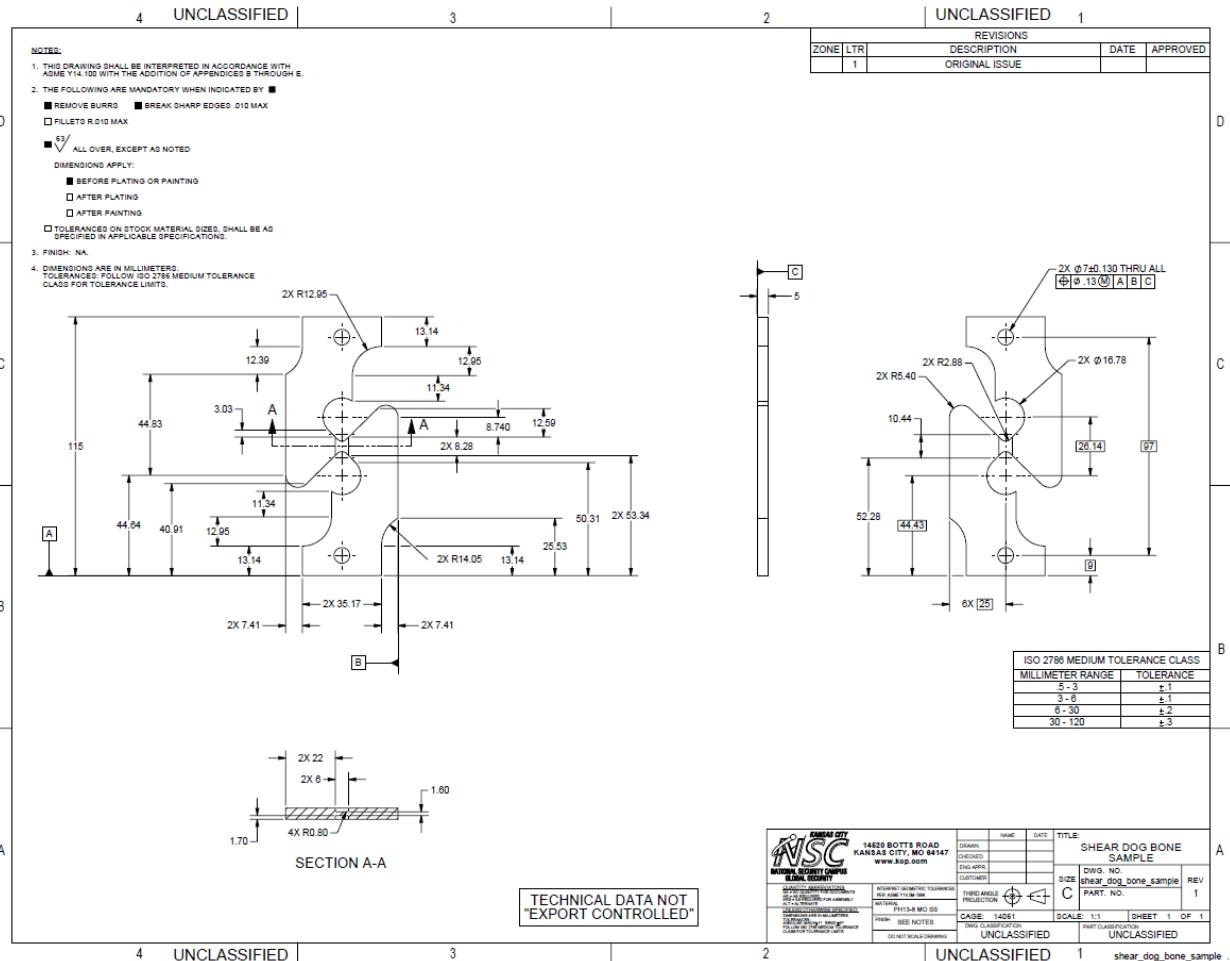
**Figure A-4.** The engineering drawing used for the shear specimen is shown.
