## SANDIA REPORT

SAND2020-5906

# Mechanical testing of PH13-8Mo H950 Steel for Xue-Wierzbicki Fracture Criterion Determination at 20° C and -40° C

Philip J. Noell, Priya R. Pathare, Zachary Casias, Todd Huber, John Laing, Jay D. Carroll

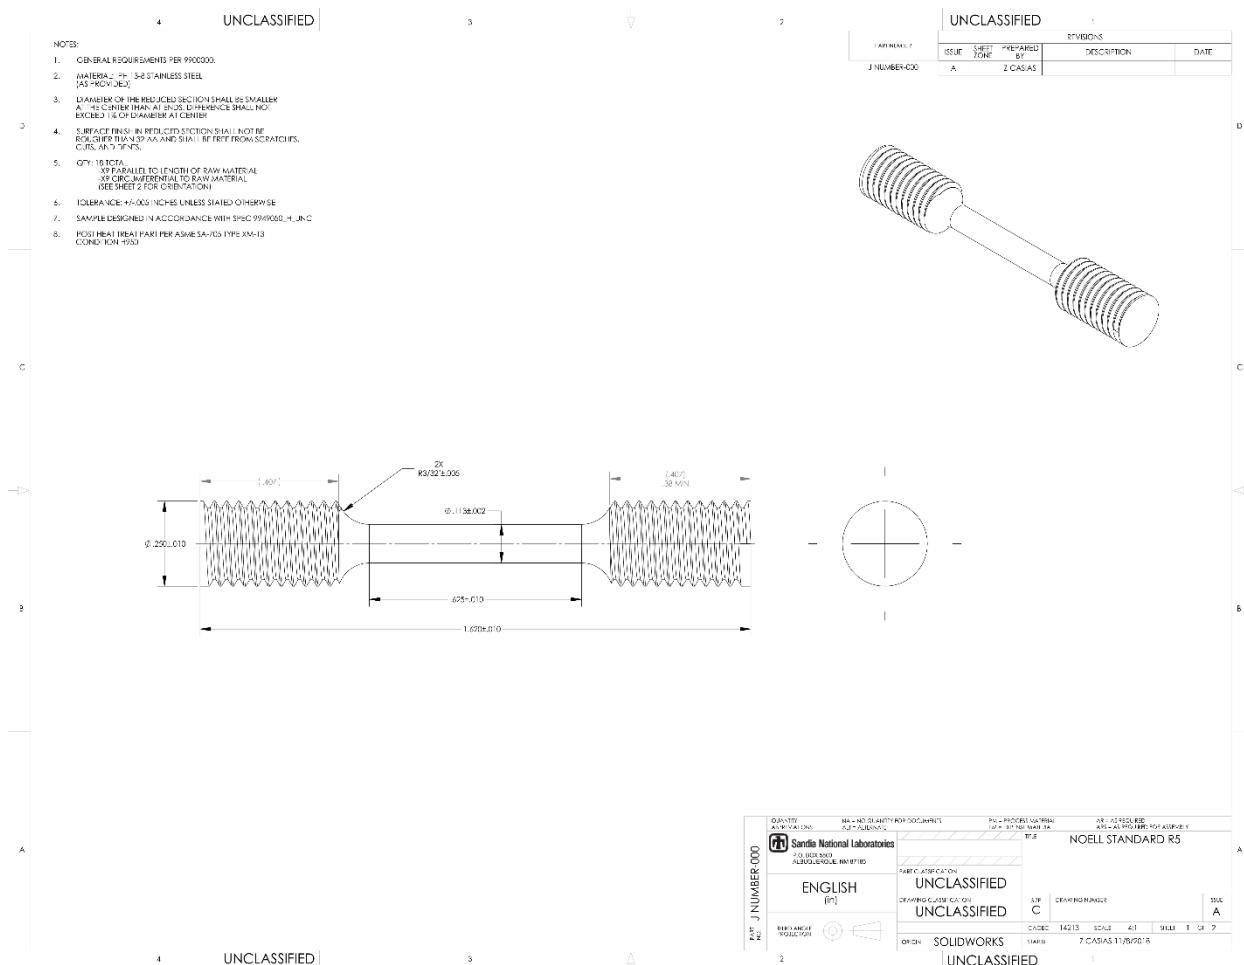
**Figure A-5.** The engineering drawing used for the R5 specimen is shown.

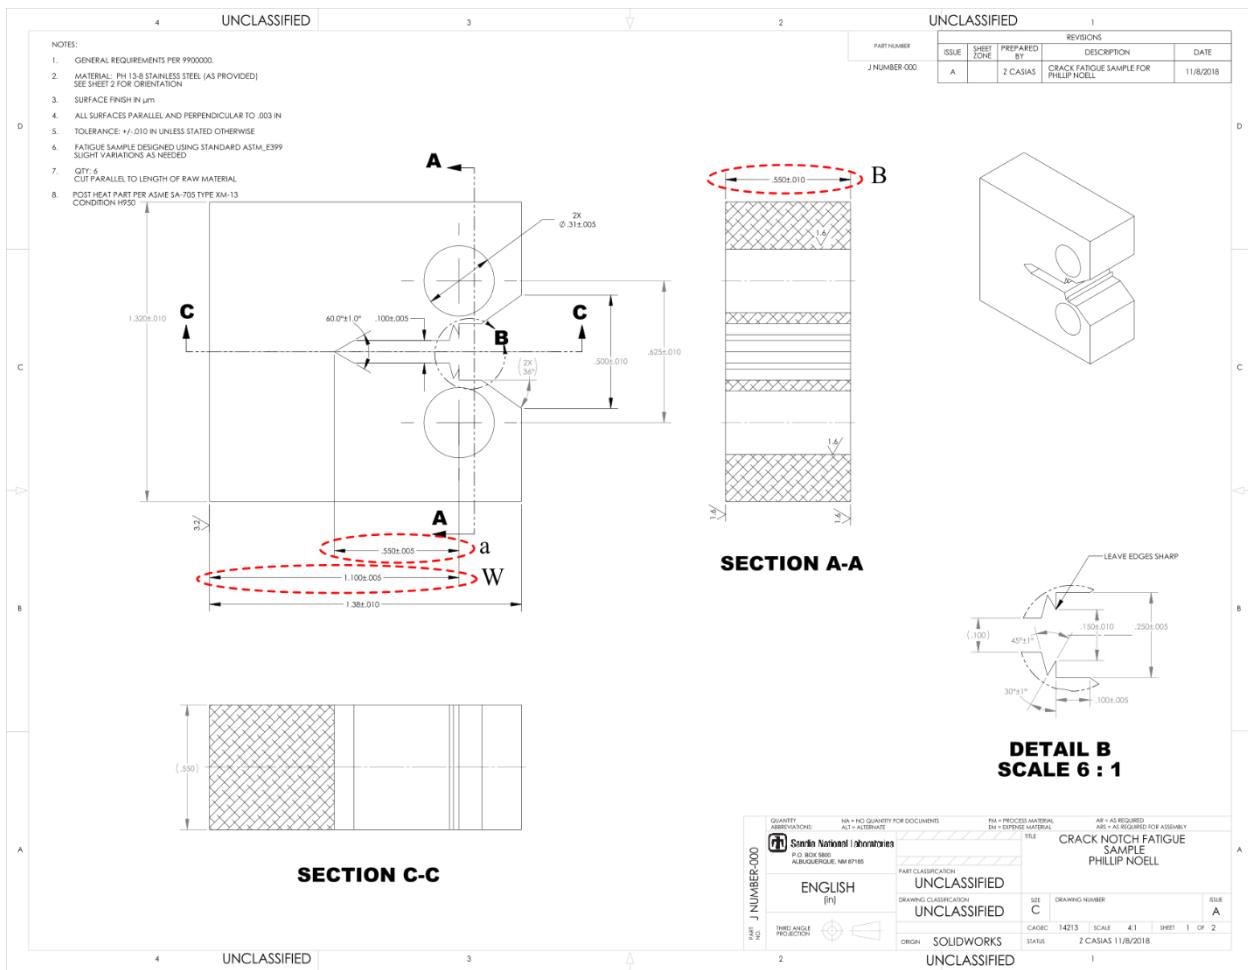
Figure A-6. The engineering drawing used for the compact tension specimen is shown.

To determine the fracture toughness of this material at both room temperature and at -40° C, compact tension (CT) specimens were also tested. Specimens were fabricated from the material in accordance with ASTM specification 399-17 [3]. An engineering drawing of this specimen type is provided in Appendix A.

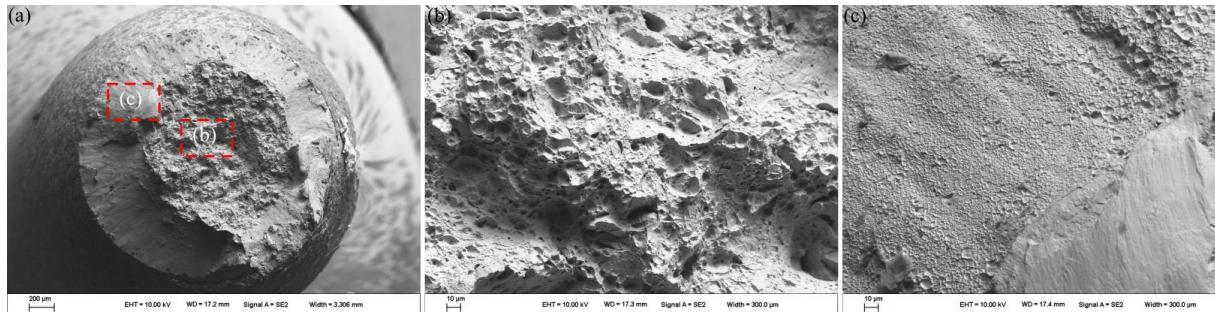
**Figure A-11.** Secondary electron images of the fracture surface of a R5 parallel sample tested at 22C are provided. A low-magnitude image of the entire fracture surface is show in (a). High-magnification images of the center (b) and shear lip (c) are also provided.

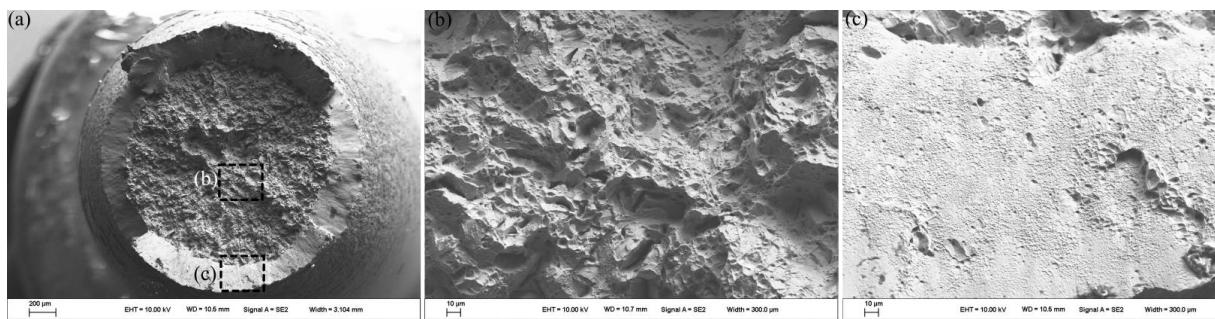
**Figure A-12.** Secondary electron images of the fracture surface of a R5 parallel sample tested at -40C are provided. A low-magnitude image of the entire fracture surface is show in (a). High-magnification images of the center (b) and shear lip (c) are also provided.

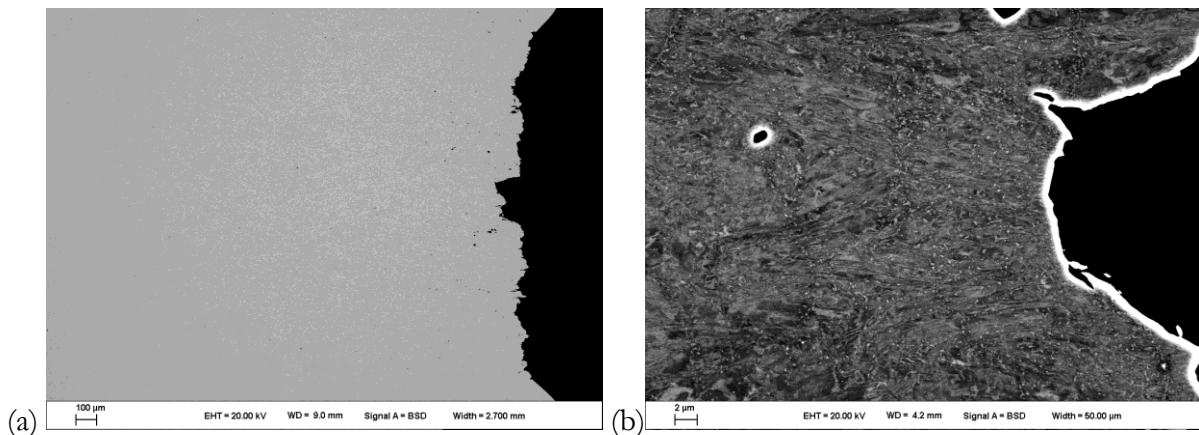
**Figure A-13.** ECCI images of a cross-sectioned R5 radial sample tested at -40C are provided. The fracture surface can be seen on the right side of both images. (a) shows a low magnification image (the image width is 2.7 mm) and (b) shows a high magnification image (the image width is 0.05 mm). Voids near the fracture surface can be seen in both images.

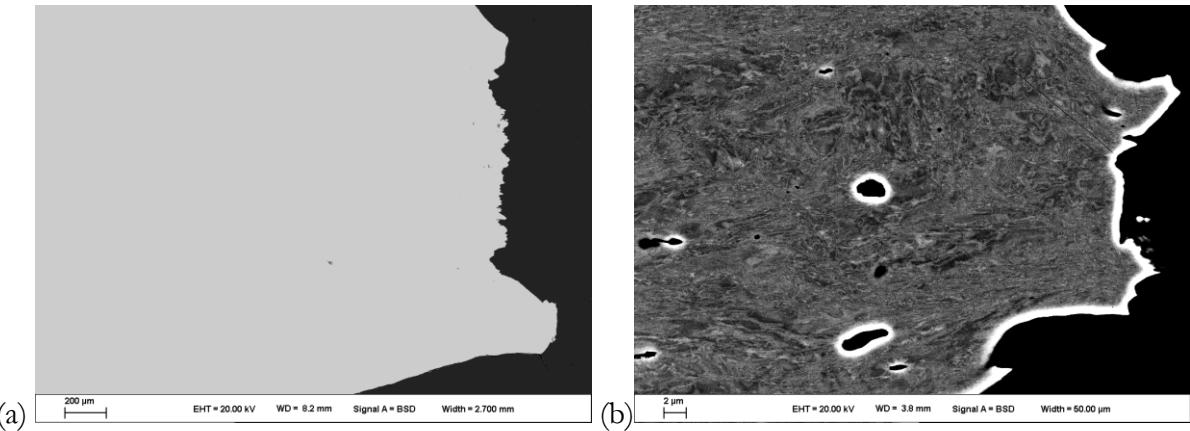
**Figure A-14.** ECCI images of a cross-sectioned R5 parallel sample tested at 22C are provided. The fracture surface can be seen on the right side of both images. (a) shows a low magnification image (the image width is 2.7 mm) and (b) shows a high magnification image (the image width is 0.05 mm). Voids near the fracture surface can be seen in both images.
