SAND2021-9854

Fire-Induced Pressure Response and Failure Characterization of PCV/SCV/3013 Containers – Phase 3

ABSTRACT

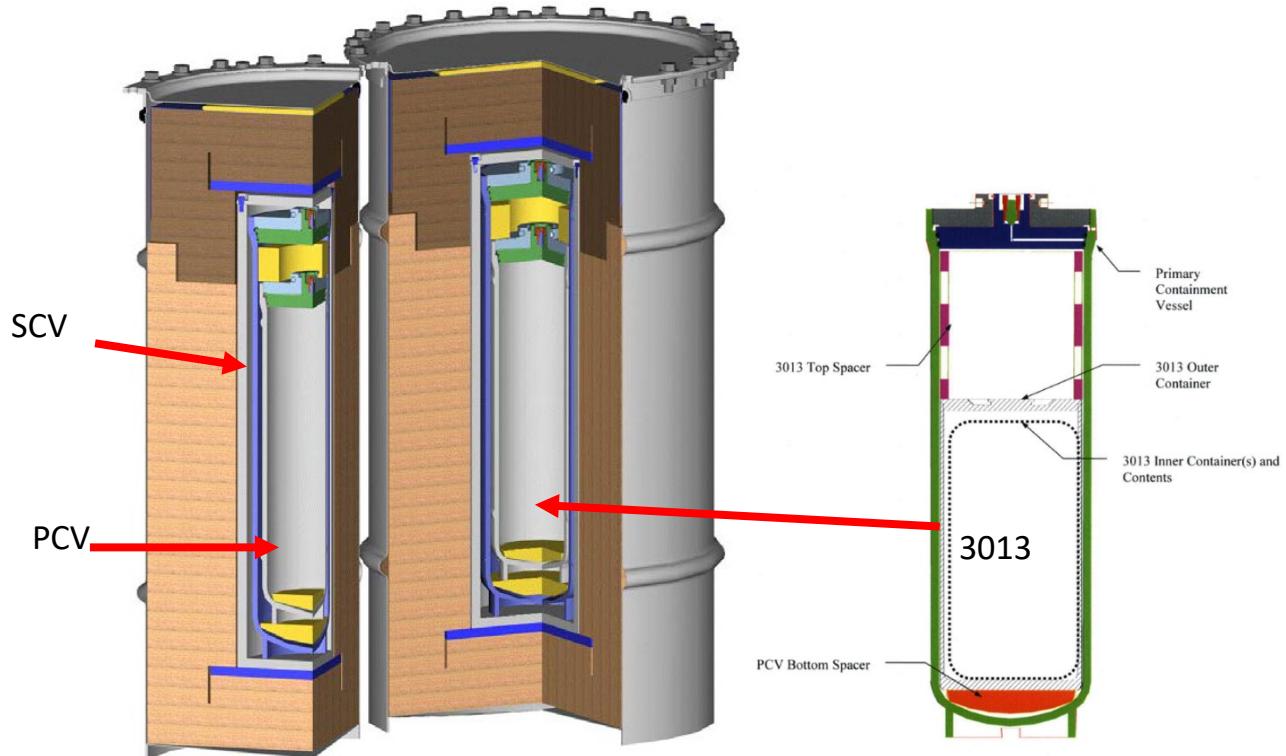
Figure 1-1. 9975 Package showing the 3013 container nested inside a primary containment vessel (PCV), which is nested inside a secondary containment vessel (SCV).

DOE 3013 containers are normally nested inside primary and secondary containment vessels (PCVs and SCVs, respectively) in 9975 shipping packages, as shown in Figure 1-1. 9975s provide substantial protection of inner contents within a fire. However, when removed from the 9975, the SCV and inner containers could produce high-pressure releases during direct fire events. The DOE 3013 container itself is a nested package of three containers that are used to store material. The 3013 assembly typically consists of: (1) a welded outer 3013 container, (2) a welded inner 3013 container, and (3) a vented inner-most container called the convenience can which contains the payload. The convenience can and inner container isolate the contents and assure that the outer container can be maintained free of material contamination during welding. The outer container provides a Safety Class pressure boundary to prevent release of any contents [2]. Two versions of the outer 3013 containers were considered in this test series that are distinguished by variations in their manufacturing process; a flow-formed outer container produced by Dynamic Flowform (the *ARIES Flowform Set Long Term Storage Assembly*, referred to as simply the “Flowform” version in the remainder of this report), and a machined outer 3013 container produced by Westinghouse Engineered Products Division (the *EPD Set 3013 Package Assembly*, referred to as simply the “EPD” version in the remainder of this report).

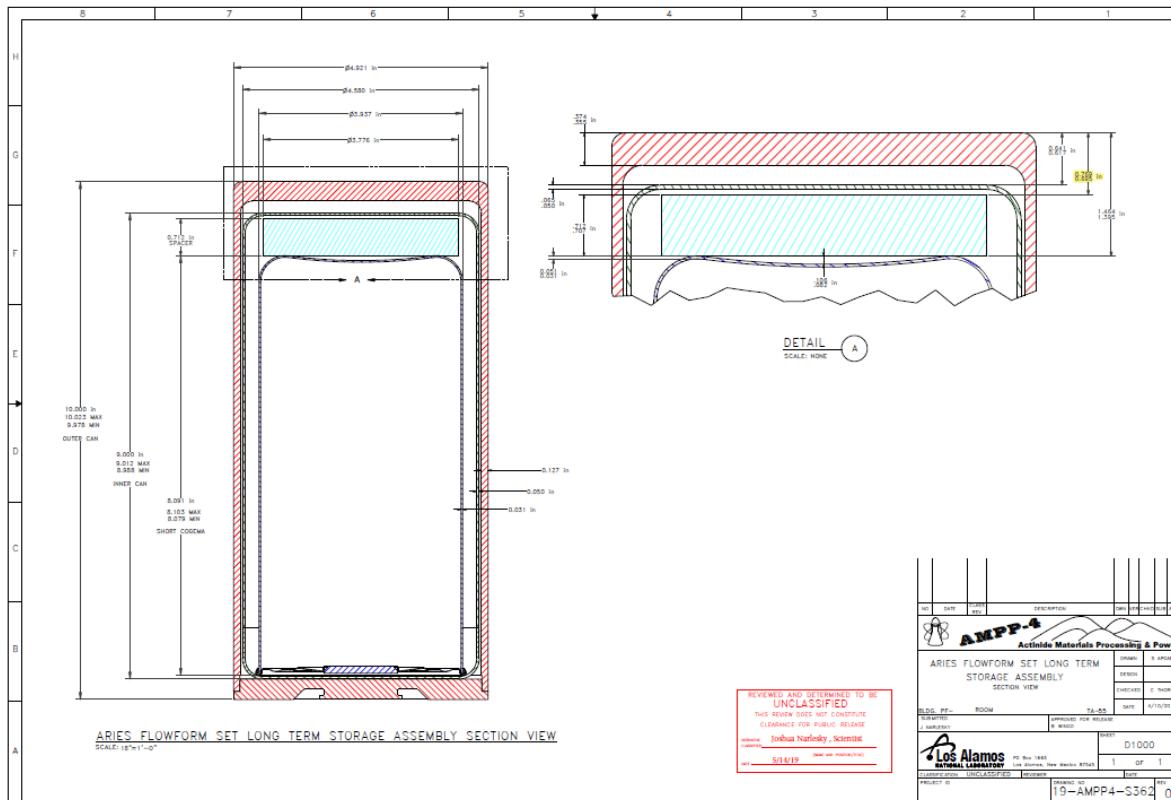
Figure 2-1. Cross-sectional drawing of the Flowform assembly version.

While the Flowform and EPD outer containers have roughly the same dimensions, tolerances, and minimum inner volume, the containers have structural variations due to their different manufacturing processes. In particular, the containers manufactured by the flow-form process have higher residual stresses and tensile strength due to the cold work manufacturing process [5]. Furthermore, the inner containers and convenience cans that complete the 3013 container-set also vary for each configuration. Cross-sectional drawings for the Flowform and EPD container sets are respectively captured in Figure 2-1 and Figure 2-2. The EPD set was completed with a Hanford Bagless Transfer Inner Container (BTIC) while the Flowform set was completed with an ARIES inner container. For the convenience can, the EPD set was completed with a Hanford Bagless Transfer Convenience Can (BTCC). The dimensions of this convenience can required a stainless-steel disk placed inside to conservatively minimize the unoccupied free volume given the payload amount considered in these studies (since pressurization is sensitive to free volume, free volume was minimized only to the point where bounding case was still captured) [5]. In the Flowform set, a shorter version of the Cogema convenience can was used, so an additional stainless-steel disk was placed externally, in between the convenience can and the inner container. It should be noted that, other than being required to be vented (allowing gas leakage), the design of the convenience can of each configuration is not specified by DOE-STD-3013, but it is required to be present. The convenience can inside the EPD set has a filtered vent that allows significant gas flow while the Cogema can inside the Flowform set is double-crimped (like a food can) but without an elastomeric seal, so while gas escapes the can, the flow rate is much lower than for the EPD convenience can. Although the inner container is required to be welded, it is not a Safety Class vessel, so it was decided that a hole would be drilled in the tested inner containers to simulate a failed container and to directly expose the outer container to the gases generated during the test. Ultimately, however, the vessel under test for this campaign was the outer container because; (1) it provides the pressure

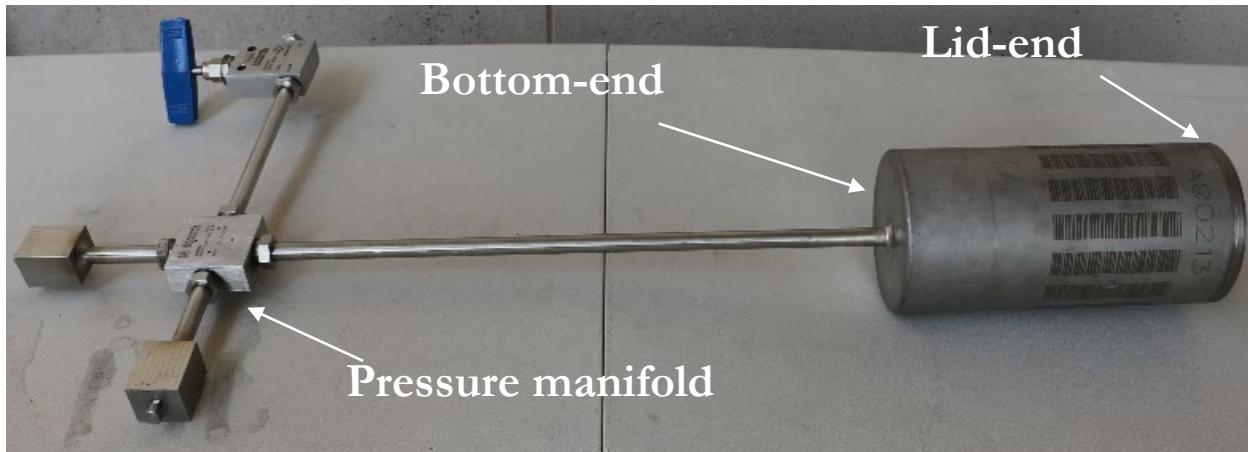
Figure 2-3. Typical tested 3013 container with welded pressure tap on bottom-end.

To measure the pressure response of the 3013 containers, the containers were modified and fitted with a pressure tap and manifold system on the bottom-end of the outer 3013 containers, as shown in Figure 2-3. The modification was performed at the Savannah River Site (SRS) under an NQA-1 program [9]. In both the ARIES and the EPD set, the pressure tap is a hole drilled through the outer and inner containers; the innermost convenience can was not punctured. The innermost can however, is considered vented so that pressurized gas can escape. A stainless-steel tube is welded to the tap on the outermost container and connects to the multiport stainless-steel block that in turn connects to the fill valve and two pressure transducer ports, forming the pressure manifold as shown in Figure 2-3. The manifold system allows installation of two pressure transducers on the corresponding ports to: (1) control the initial vessel pressure prior to heating and, (2) monitor the pressure buildup during heating. (See labeled diagram of manifold in Figure 7-5 of the Appendix). The third port on the manifold was connected to the fill valve that allowed adjustment of the pre-test internal pressure with added/removed helium. In case test day temperatures differed from the vessel preparation temperatures, this latter capability allowed adjustments that would guarantee that every test would initiate with ~ 8.1 psig inside the container. Helium leak tests were performed at SRNL after installing the pressure manifold but prior to shipping to SNL in order to ensure leak tightness [10].

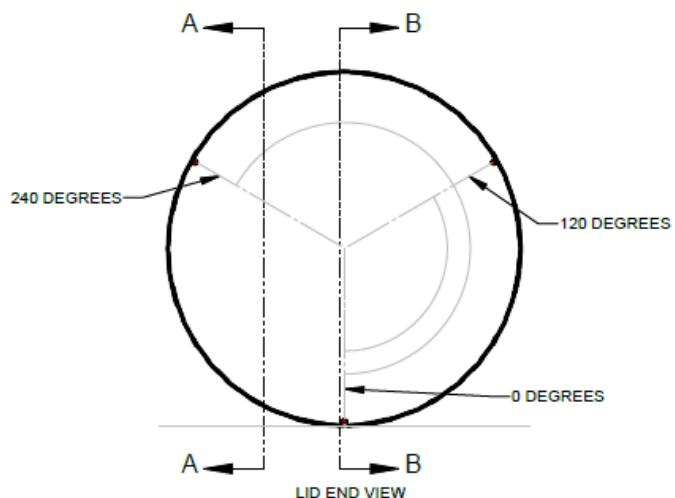
Figure 2-4. Angular reference points, looking into the lid-end of shroud. The 0 degrees reference point is where the vessel makes contact with the saddle.

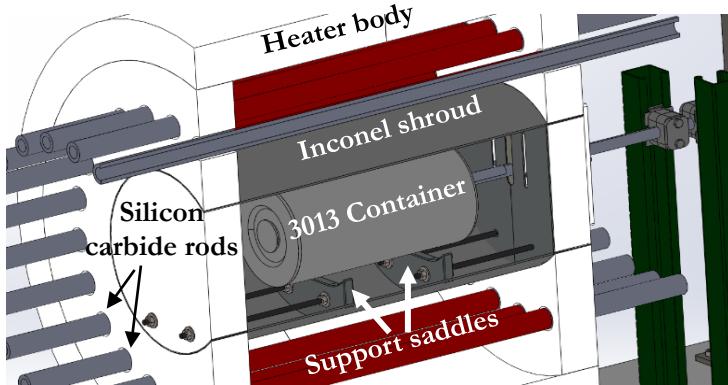
Figure 2-5. Heater configuration.

To address constraints (1) through (3), the heater was designed to sustain the test subject in a horizontal orientation with slots in the heater endcap insulation to allow routing for the pressure tap and TCs. Once installation of the vessel inside the heater assembly occurred, the slots were covered with flexible blanket insulation to minimize radiative and convective heat losses to the ambient but still permit movement of the pressure manifold. On the exterior of the heater, a support structure was designed to hold the manifold in place while simultaneously allowing movement in case of vessel swelling/rolling. Figure 2-6 illustrates these exterior design features in the setup, which shows how the manifold support was designed to allow movement and ensure that the pressure tap would not strain and result in an inadvertent failure point. By the same token, the diameter of the shroud was designed to be four inches larger than the outer diameter of the outer 3013 container in order to address constraint (4) and prevent obstruction of the vessel expansion by the shroud.

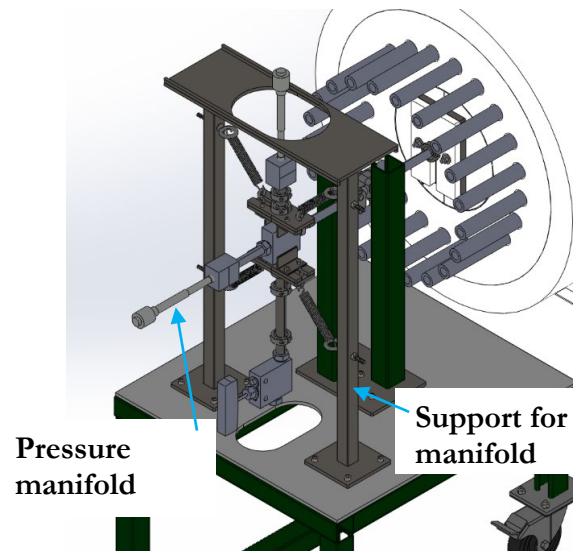
Figure 2-6. Pressure manifold support structure.

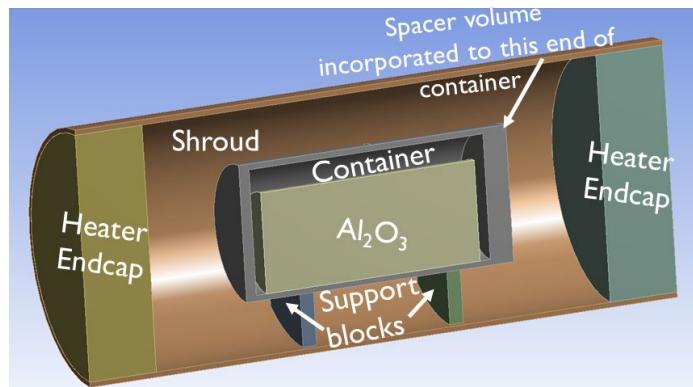
Figure 2-7. Cross-section of simplified model used for FEA thermal analysis

To address constraint (5), a thermal finite element analysis (FEA) was performed to analyze various design concepts for supporting the 3013 containers inside the heater. Various support systems were considered prior to modeling, but the designs with the support saddles (as shown in Figure 2-5) were the focus of the FEA work. Primarily, the model was created to ensure that any cold spots generated [on the contact points of the vessel with the support saddles] during the transient phase would not be so large as to have an unintentional adverse effect on the outcome of a test. The model was simulated using ANSYS 2019 R2, and it was simplified to only model the shroud, vessel, aluminum oxide payload, heater end caps, and support blocks. The vessel design was further simplified so that the masses of the three containers (outer, inner, and convenience can) and spacer were merged into one volume to avoid solution divergence resulting from thin materials with multiple contact resistances. Figure 2-7 illustrates the simplified FEA model. The simulated heat-up was based on the faster heating curve (ASTM-E1529, discussed in detail in next section) in order to capture a more conservative scenario. After performing a suite of steady and transient simulations, it became obvious that the period with the larger thermal gradients (located near the contact points between the vessel and support saddles) would be in the transient phase during the first 10 minutes of heating. Through some iterations on the radiative parameters, it also became apparent that

increasing the reflectivity of the heater endcaps and support blocks would benefit the transient phase. Ultimately, the chosen configuration was with two support saddles/blocks positioned two inches from the ends of the test vessel. Figure 2-8 shows contour plots along the bottom of the container for 10 minutes of simulation time when using an ASTM-E1529 heating profile. The larger gradients at the contact points (approximately two-inches from the ends) are observed near 5-6 minutes, after which thermal diffusion relaxes these gradients. This analysis supported the decision for the chosen configuration.

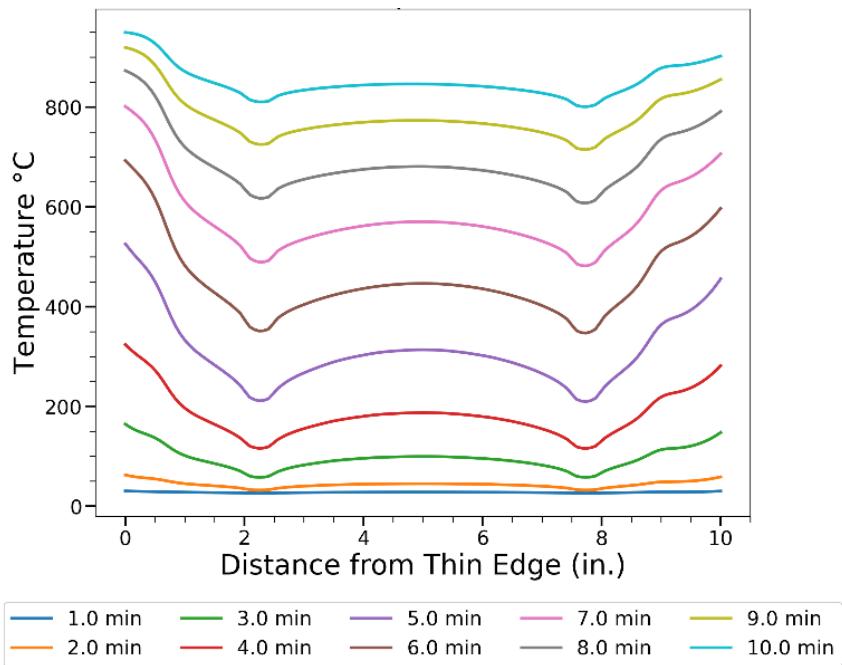
Figure 2-8. Transient temperature profiles along bottom of 3013 container as calculated from a thermal FEA model for the first 10 minutes of heat-up.

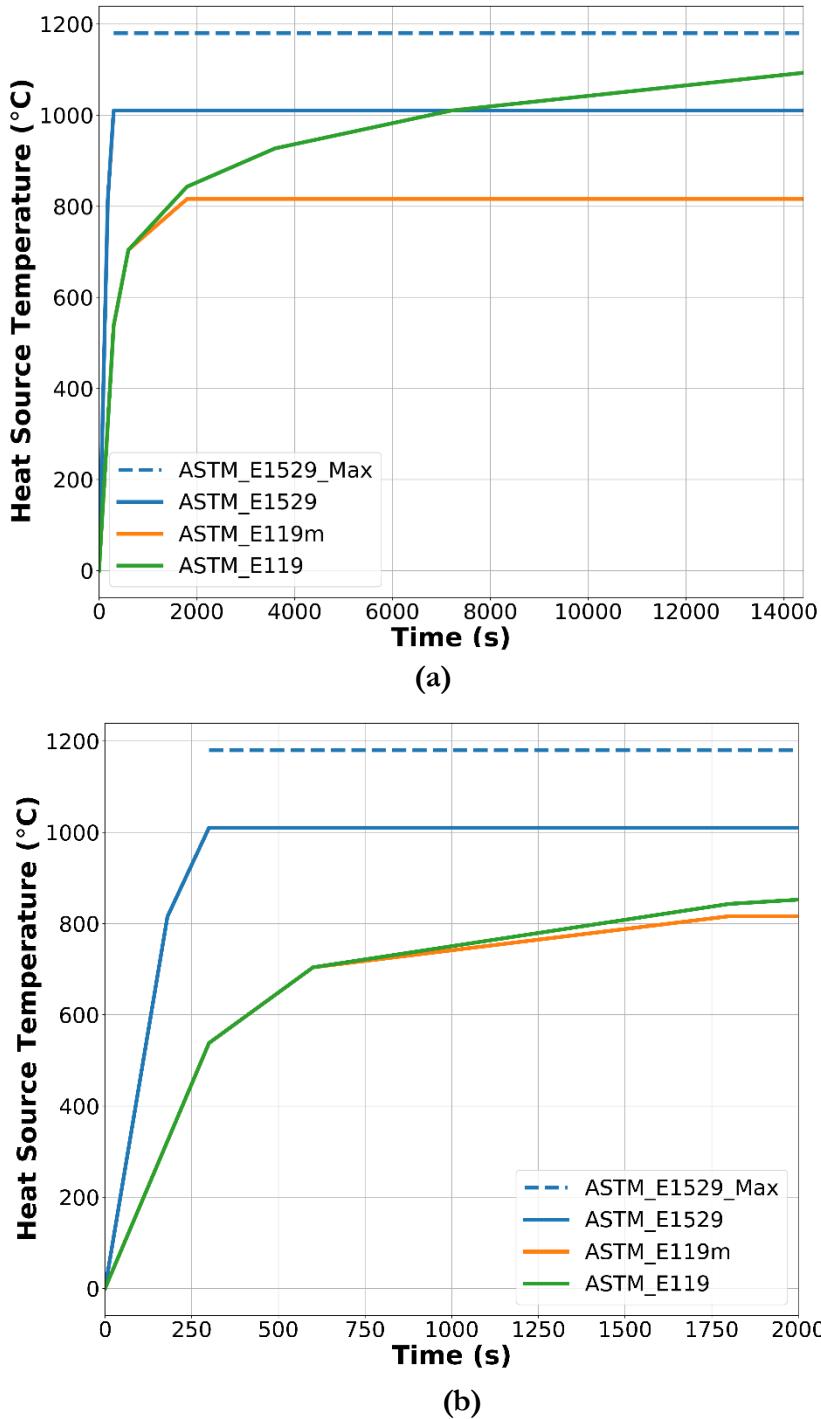
Figure 2-9. ASTM Heating Profiles. (a) Shows 4 hours of test time, (b) zooms in on 2000 seconds.

For the more aggressive thermal insult, the heating curve prescribed by ASTM-E1529 (*Standard Test Methods for Determining Effects of Large Hydrocarbon Pool Fires on Structural Members and Assemblies*) was chosen because it represents the bounding conditions for a 3013 container engulfed in a combustible liquid spill fire scenario [14]. With the ASTM-E1529, the heat source is required to reach 815°C by three minutes, 1010°C by 5 minutes, and shall remain between 1010°C and 1180°C

for the remainder of the test. The requirements on ASTM-E1529 also specify that a flux of $158 \text{ kW/m}^2 \pm 8 \text{ kW/m}^2$ shall be imposed on the test specimen within the first 5 minutes of test exposure and shall sustain there for the remainder of the test.

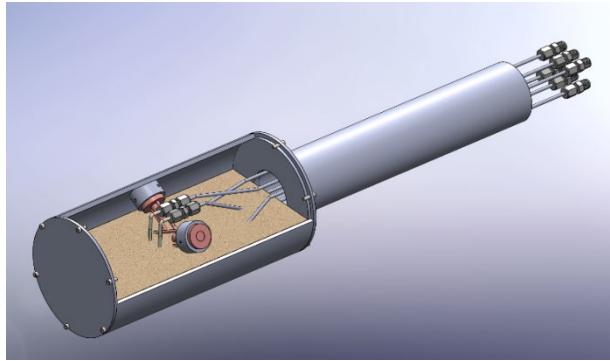
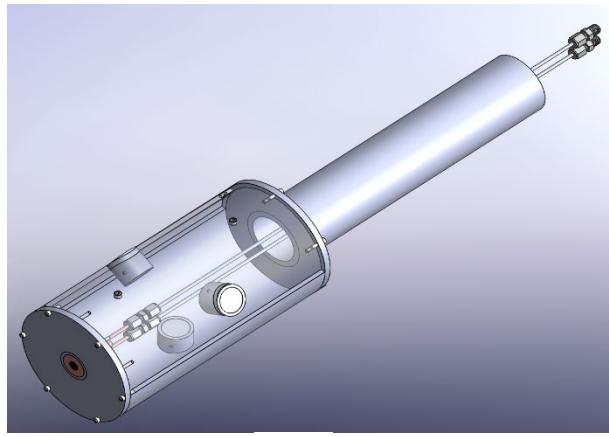
Figure 2-10. Calorimeter schematic.

The heat flux requirements of ASTM-E1529 required knowledge of the imposed heat flux on the test vessel for a given shroud temperature. Given the dimensions of the test subject, heat flux sensors would be difficult to incorporate into a radiant heat setup without affecting the heat flux imposed on vessels. A calorimeter was designed to correlate the imposed heat flux on the test specimen with the heat source temperature. To maintain representation, the geometry, materials, payload, and mass of the calorimeter were matched to that of the 3013 containers. Figure 2-10 illustrates sample isometric views of the calorimeter. Schmidt-Boelter heat flux sensors were placed on the walls of the calorimeter to correlate incident flux on the vessel with measured shroud temperatures. A payload was used to match that of the tested vessels, and a cross-section of the payload is depicted in Figure 2-10a as the shaded light-brown material filling the vessel. Figure 2-10b suppresses the payload to show how a second configuration was implemented with an additional sensor on the lid-end of the calorimeter to provide a reading for the heat flux received by the test unit at the ends. Mock tests were run on an un-instrumented calorimeter to define the transient heater power input required to produce the ASTM-E1529 temperature profile. Once the heater power was defined to produce the ASTM-E1529 temperature profile, an instrumented calorimeter was subsequently run. These latter calorimetry measurements assured that the heat flux criteria of ASTM-E1529 were met. Thorough details of the calorimeter are provided in *Correlating Incident Heat Flux and Source Temperature to Meet ASTM-E1529 Requirements for RAM Packaging Components Thermal Testing* [15].

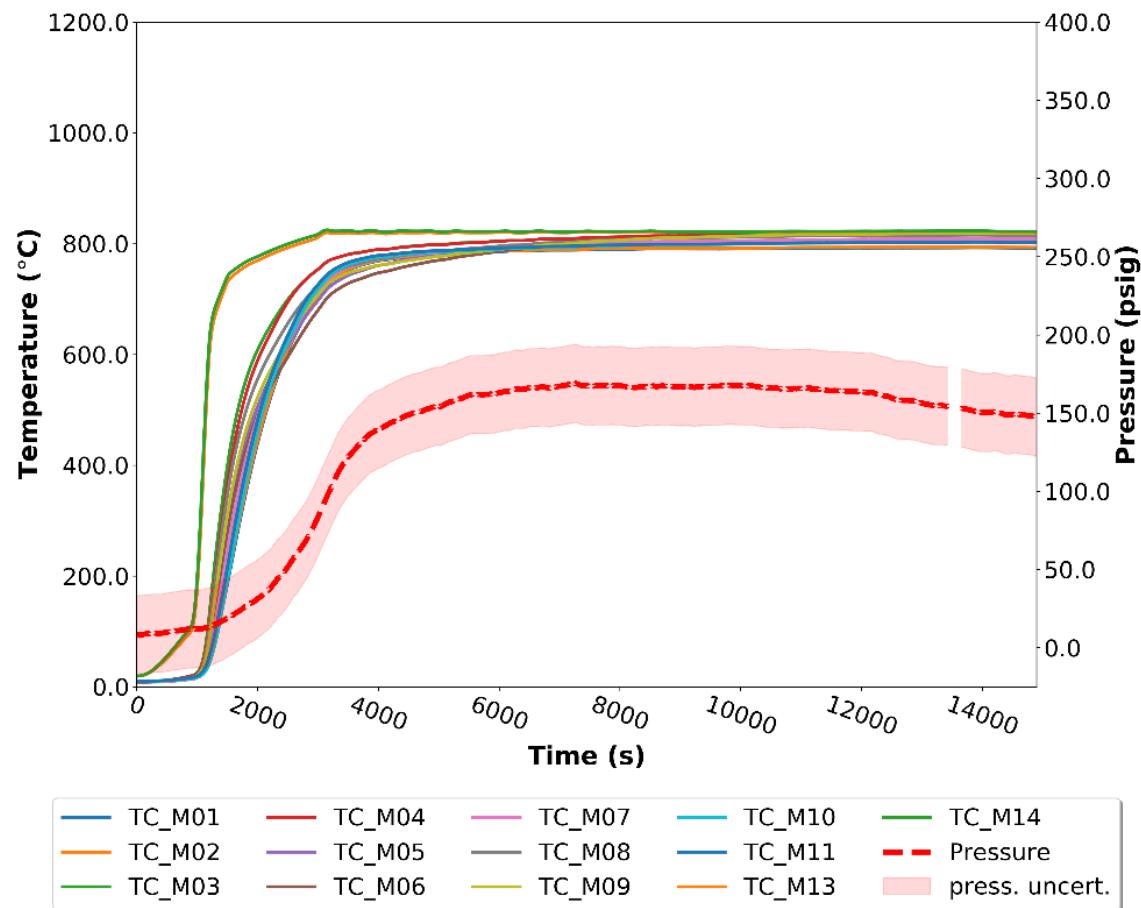
This test ran for the full four hours (Figure 4-1 shows a gap in the pressure reading, and this results from the MIDAS system having a max recording time of 3 hours and 45 minutes. The logging system thus has to restart to capture the full 4 hours of test time. The logging system takes a few minutes to restart, and this results in a short period of non-recorded data. This gap is seen in all tests that last the full test time). The peak pressurization observed in the outer container was 169±25 psig, but it was not significant enough to result in an obvious breach of the vessel. The post-test helium overspray test demonstrated no breach at less than 1.0×10^{-7} scc/s He. As discussed in Section 4, this pressure was lower than anticipated based on ideal gas expansion. The peak pressure experienced by the vessel was also observed before the end of the test. Figure 4-1 shows the vessel after test exposure from four angular positions (0°, 90°, 180°, and 270° in a clockwise direction), where it can be seen that no swelling or rupture of the vessel occurred (indicating that the reduced pressure observed was more likely to be as a result of (2) above). Mass loss was not registered for this vessel either. Due to these results significantly deviating from expectations based on ideal gas expansion, it was decided that the subsequent 8 vessels would be tested using the more aggressive ASTM-E1529 heating profile.

Figure 4-1. Temperature and pressure for Sequence 1.

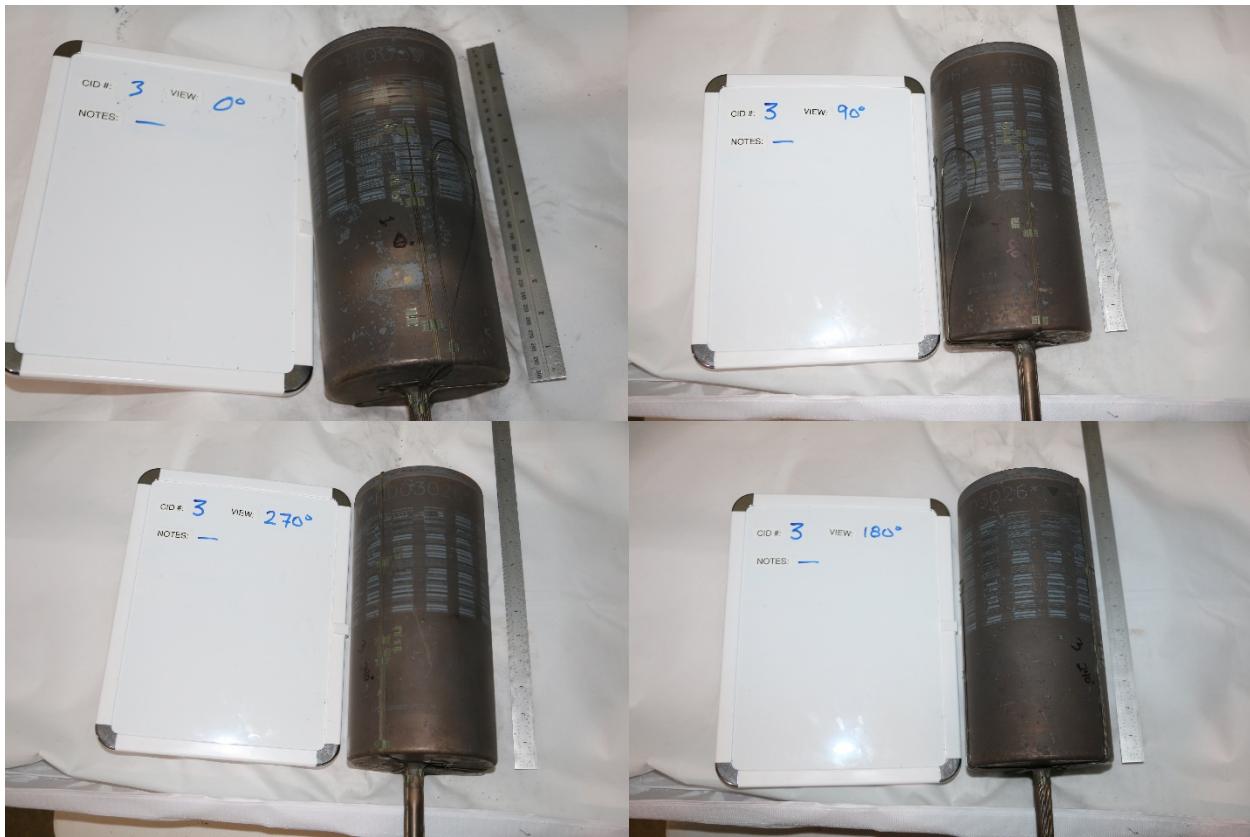
Figure 4-2. Post-test conditions of test vessel for Sequence 1. Angle positions refer to the visible portion of the vessel (see Figure 2-4). Angular positions, in clockwise direction, starting from upper left quadrant: 0°, 90°, 180°, and 270°.

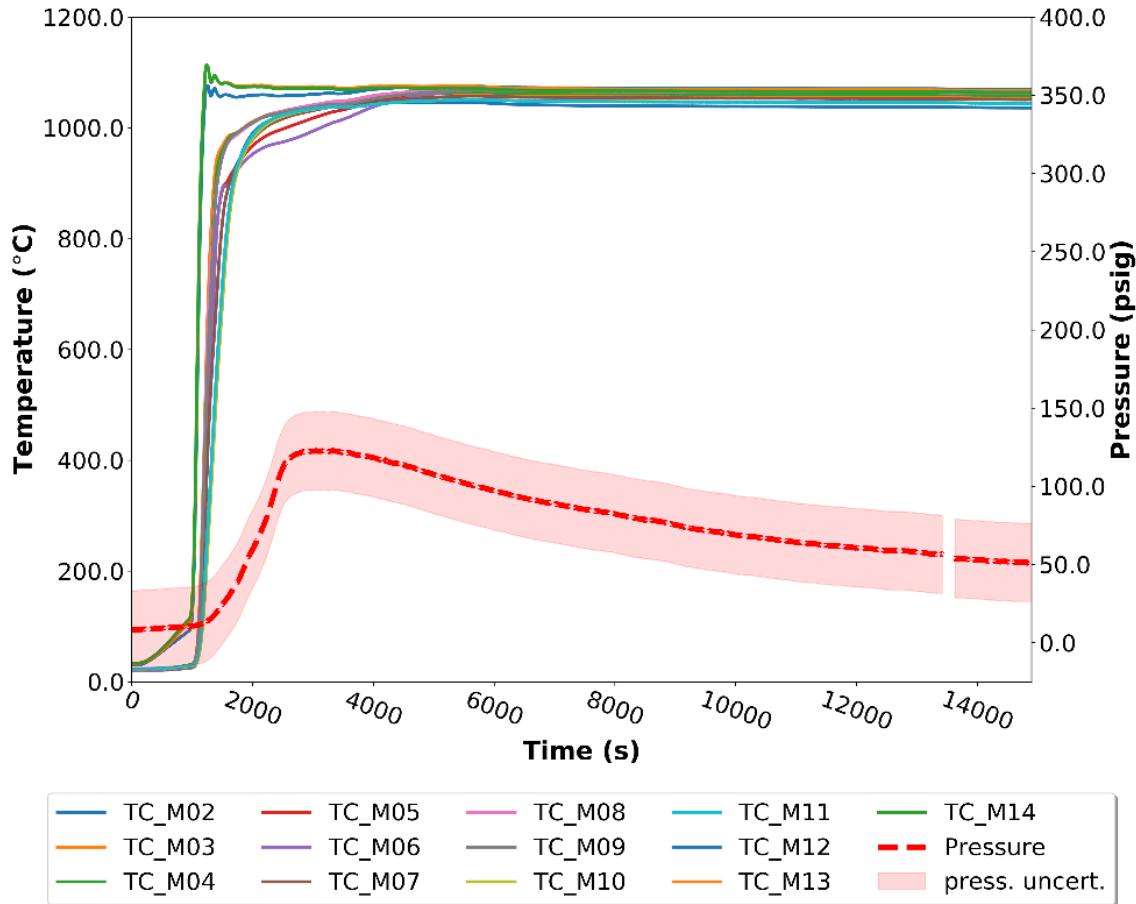
The thermal range and temperature profiles of Figure 4-3 show how the heating profile of Sequence 2 differed from Sequence 1 and was specific to ASTM-E1529. The sharp ramp rate and higher peak temperatures unique to ASTM-E1529 can be similarly noticed in Sequences 2 through 9, and it is therefore only mentioned here to avoid repetition. While heating was faster with this profile, the peak pressure observed by this vessel was lower than Sequence 1, at 123 ± 50 psi. However, two key observations can be noticed when looking at the pressure profile for the entire test time: (1) the peak occurred almost 4,000 seconds sooner than Sequence 1, and (2) it can be seen how the pressure slowly but consistently dropped throughout the test after experiencing this peak pressure early on. This drop wasn't a sudden pressure drop to be considered a rupture, so the test persisted for the full four hours. However, the pressure did drop down to approximately 52 ± 25 psig by the end of the test. Post-test vessel inspections found the vessel to have some swelling with deformation near the lid area (see Figure 4-5). To verify whether a breach was observed by the vessel, a post-test helium leak test was performed by SNL to check for breach points, and the container demonstrated no

Figure 4-3. Temperature and pressure for Sequence 2.

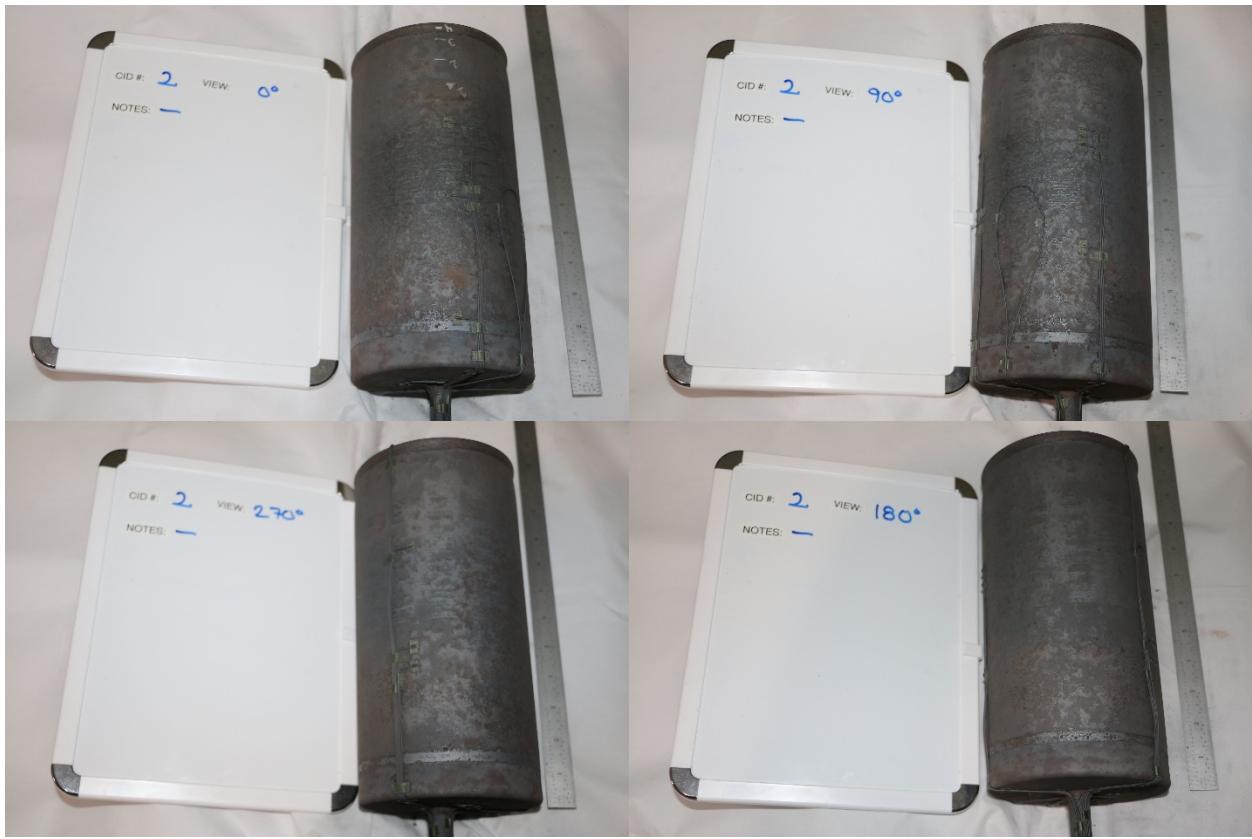
breach at less than 1.0×10^{-7} scc/s He. As discussed in Section 4, the observed decrease in pressure is likely the result of hydrogen gas, which is generated when moisture reacts with the stainless steel, permeating through the container wall at elevated temperature [16]. In addition, the vessel did experience some visible swelling that would be partially responsible for a pressure drop, but quantifying the exact volume increase as a result of the deformation was beyond the scope of these tests. Approximate measurements showed the vessel increased ~ 1.25 cm in length and $\sim .05$ cm diameter at the sites of maximum deformation.

Figure 4-4. Post-test conditions of Sequence 2. Angle positions refer to the visible portion of the vessel (see Figure 2-4). Angular positions, in clockwise direction, starting from upper left quadrant: 0°, 90°, 180°, and 270°.

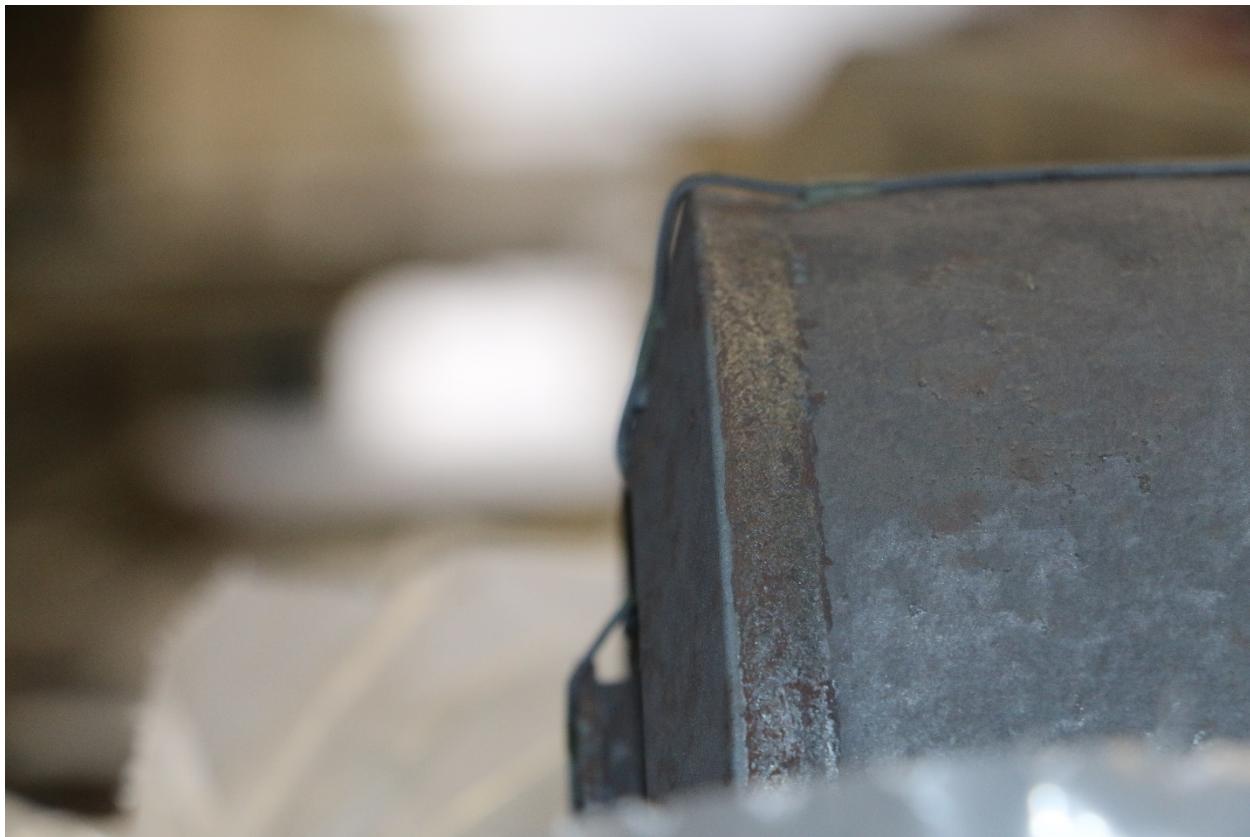
Figure 4-5. Deformation around lid region of vessel in Sequence 2.

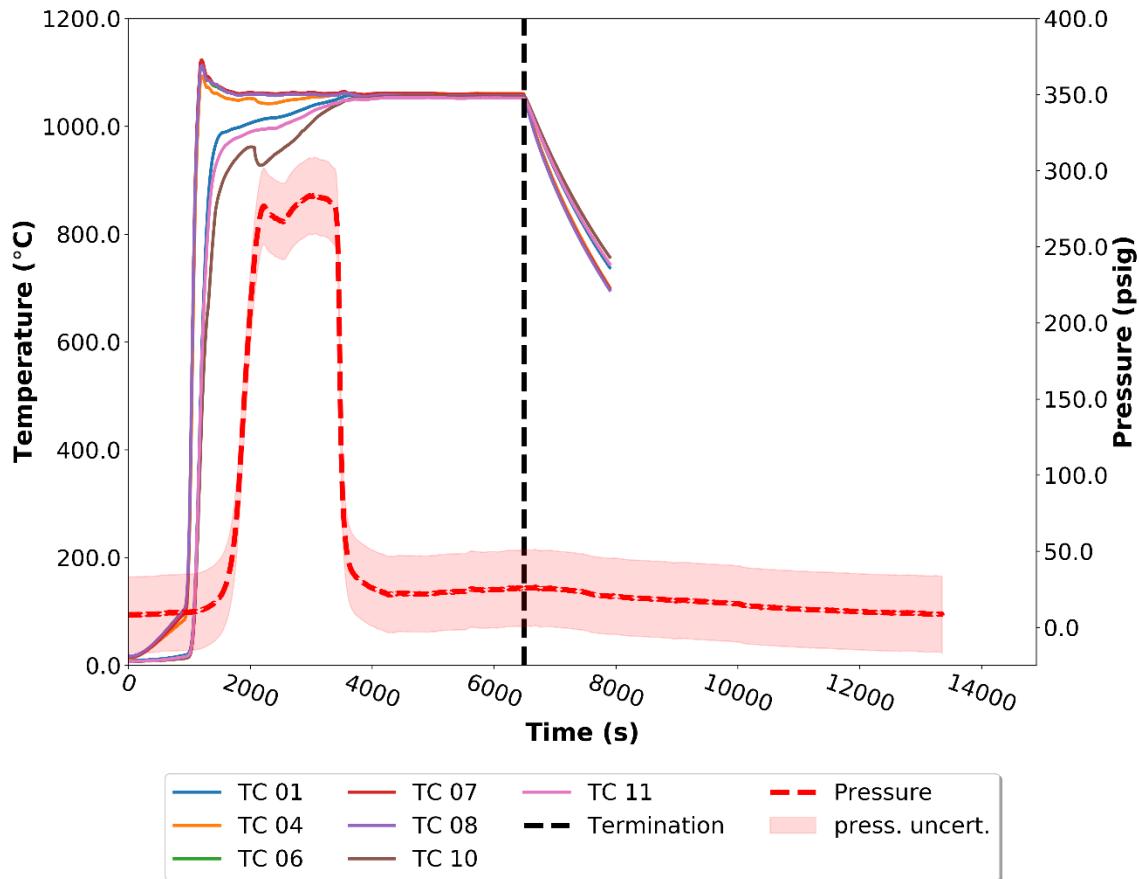
The payload in the vessel of this third test was similar to the second test in the amount of moisture present, but it differed with the inclusion of salts. The thermal response was similar to that of Sequence 2, which was expected given the same heating profile. The pressure response, however, was significantly different. First, the peak pressure observed in this test was much larger, reaching 284 ± 25 psig near 3100 seconds. Then, just before reaching 4000 seconds, the vessel was breached as noted by the sudden drop in pressure. Considering that the primary difference between Sequence 2 and Sequence 3 was the added salt content in the payload, as discussed in Section 4, the added salt

was deduced to result in larger pressurization than for water alone. Heating in this test was allowed to continue for 6450 seconds, at which point the test was terminated. Post-test leak checks identified a breach to be near the 180° position at the lid weld on the vessel (see red mark in Figure 4-7, 180° image), and the measured mass loss for the vessel in this test was ~ 13 grams.

Figure 4-6. Temperature and pressure for Sequence 3.

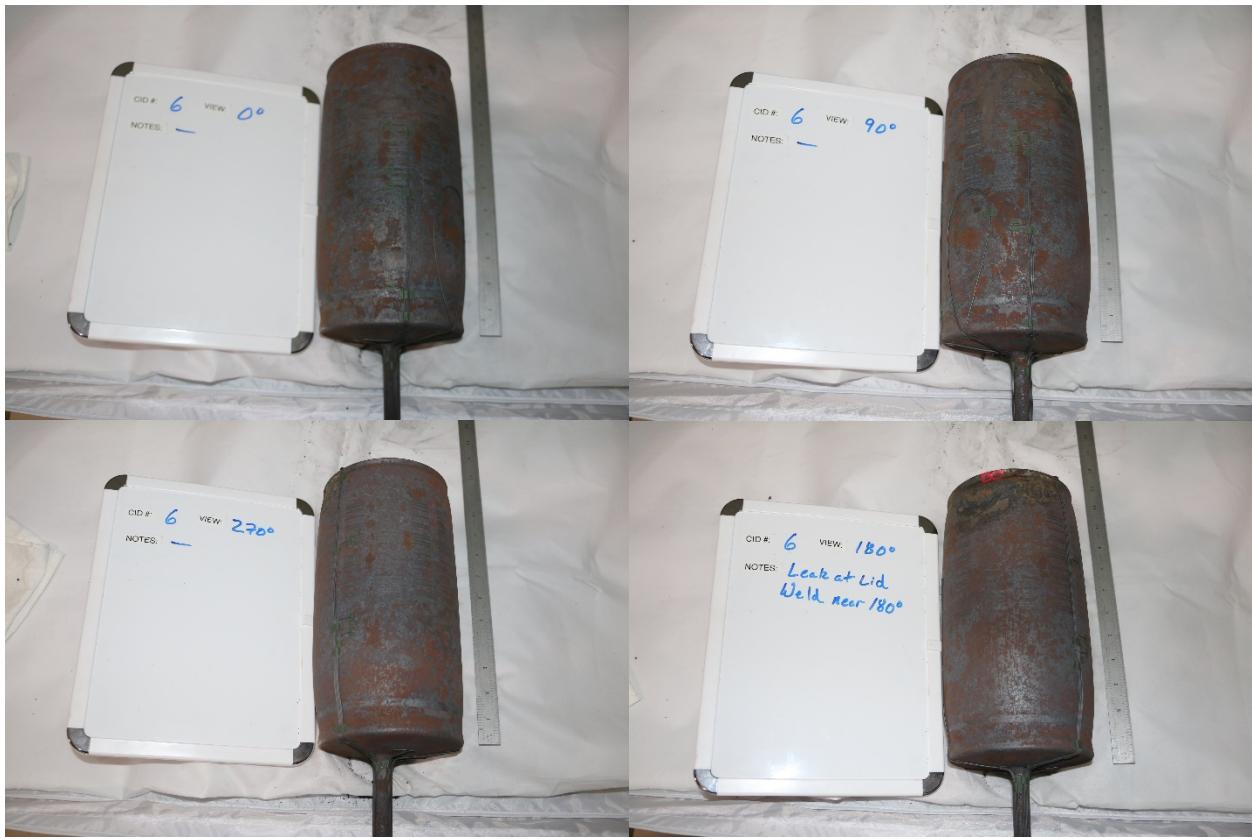
Figure 4-7. Post-test conditions of test vessel for Sequence 3. Angle positions refer to the visible portion of the vessel (see Figure 2-4). Angular positions, in clockwise direction, starting from upper left quadrant: 0°, 90°, 180°, and 270°.

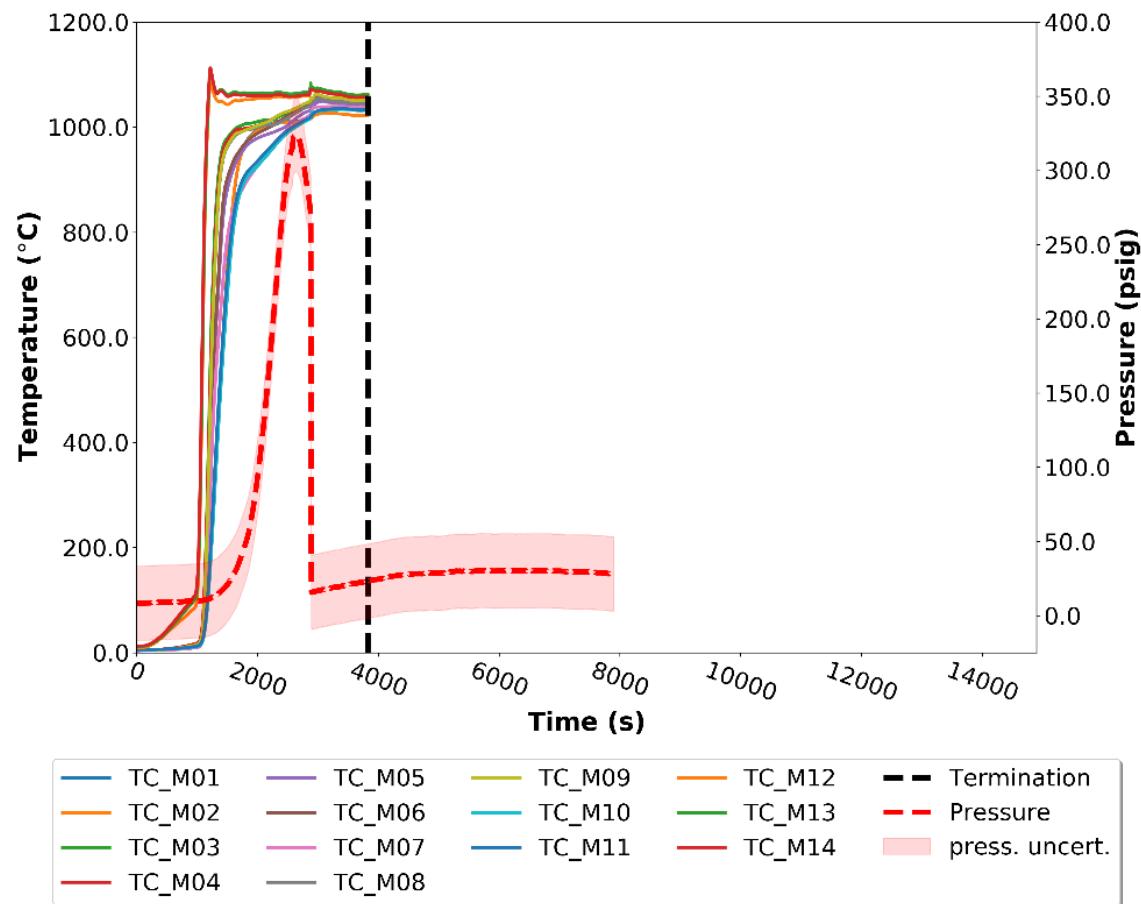
Figure 4-8 shows how the Flowform configuration responded differently from the EPD configuration when comparing to Figure 4-3 (Sequence 2). Specifically, Sequence 4 experienced a much larger pressurization and an obvious breach (abrupt depressurization) when compared to Sequence 2. The peak pressurization in Sequence 4 was 324 ± 25 psig at 2630 seconds, which is just over 200 psi \pm 50 above the peak pressure experienced by the vessel in Sequence 2. Then, just before 2900 seconds into the test, a breach was observed by the vessel as noted by the sudden pressure drop in the figure. Figure 4-10 shows how the expelled gases ignited with the incident heat just after the vessel was breached. This flame is indicative of reactions occurring within the payload before the breach that possibly led to the generation of combustible gases (such as hydrogen) produced from the heat-up of the payload. Since the payloads were nearly identical between Sequence 2 and Sequence 4, the different results suggest that the manufacturing process and differences between the inner container and convenience container designs significantly influences the mechanical response of the 3013 container in a fire accident scenario. The test was allowed to continue until 3780 seconds, at which point power to the heaters was terminated. Post-test leak checks identified the vessel breach to be near the 100° point in the axial center of the vessel (see red mark in Figure 4-9, 180° image), and the measured mass loss for the vessel was ~ 48 grams. Approximate measurements to capture swelling of the vessel showed the vessel increased ~ 1.85 cm in length and ~ 3.9 cm in diameter at the sites of maximum deformation.

Figure 4-8. Temperature and pressure for Sequence 4.

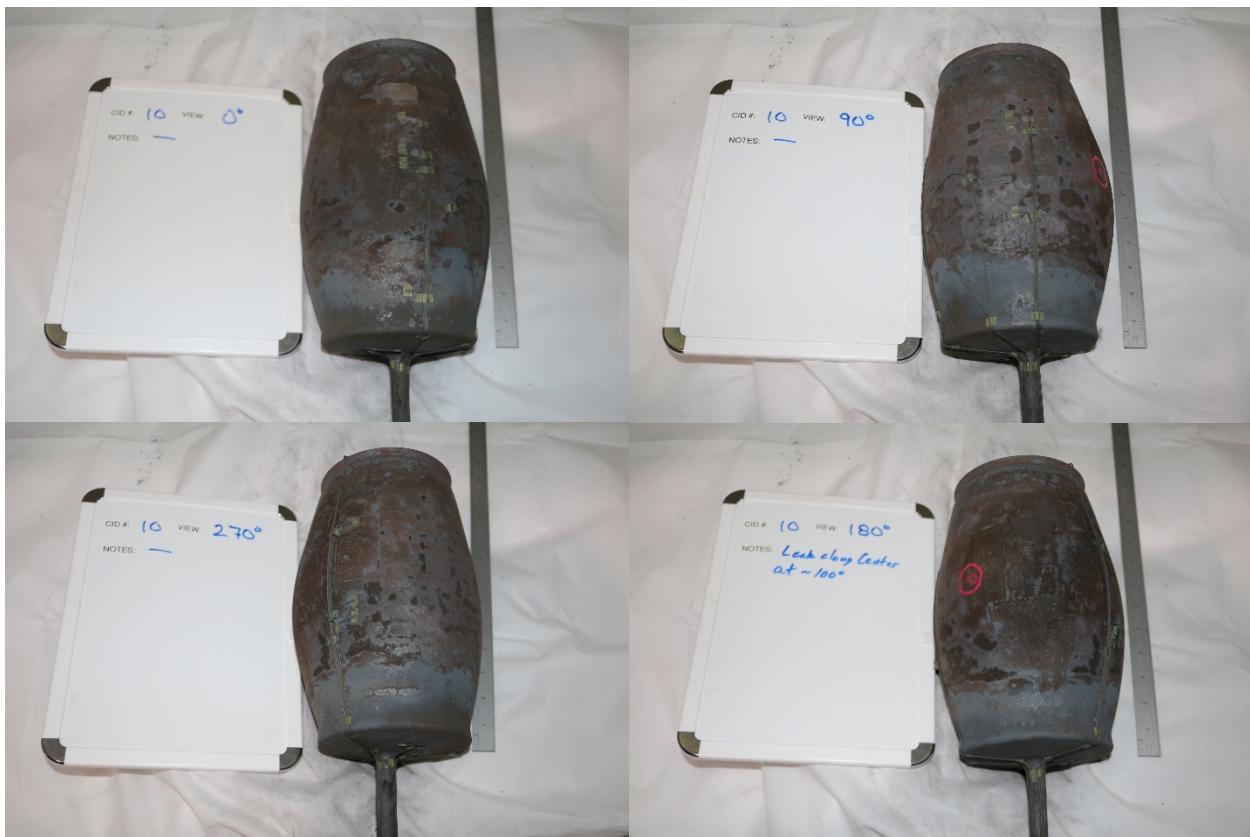
Figure 4-9. Post-test conditions of test vessel for Sequence 4. Angle positions refer to the visible portion of the vessel (see Figure 2-4). Angular positions, in clockwise direction, starting from upper left quadrant: 0°, 90°, 180°, and 270°.

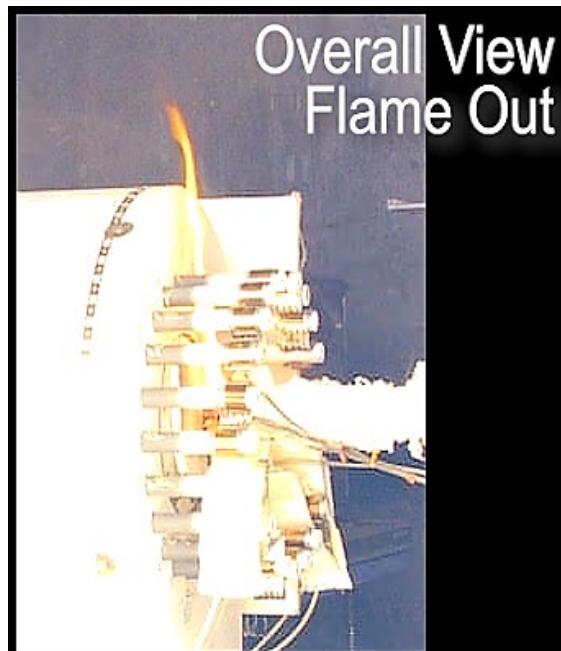
Figure 4-10. Exterior view of Sequence 4 during test, immediately after vessel was breached.

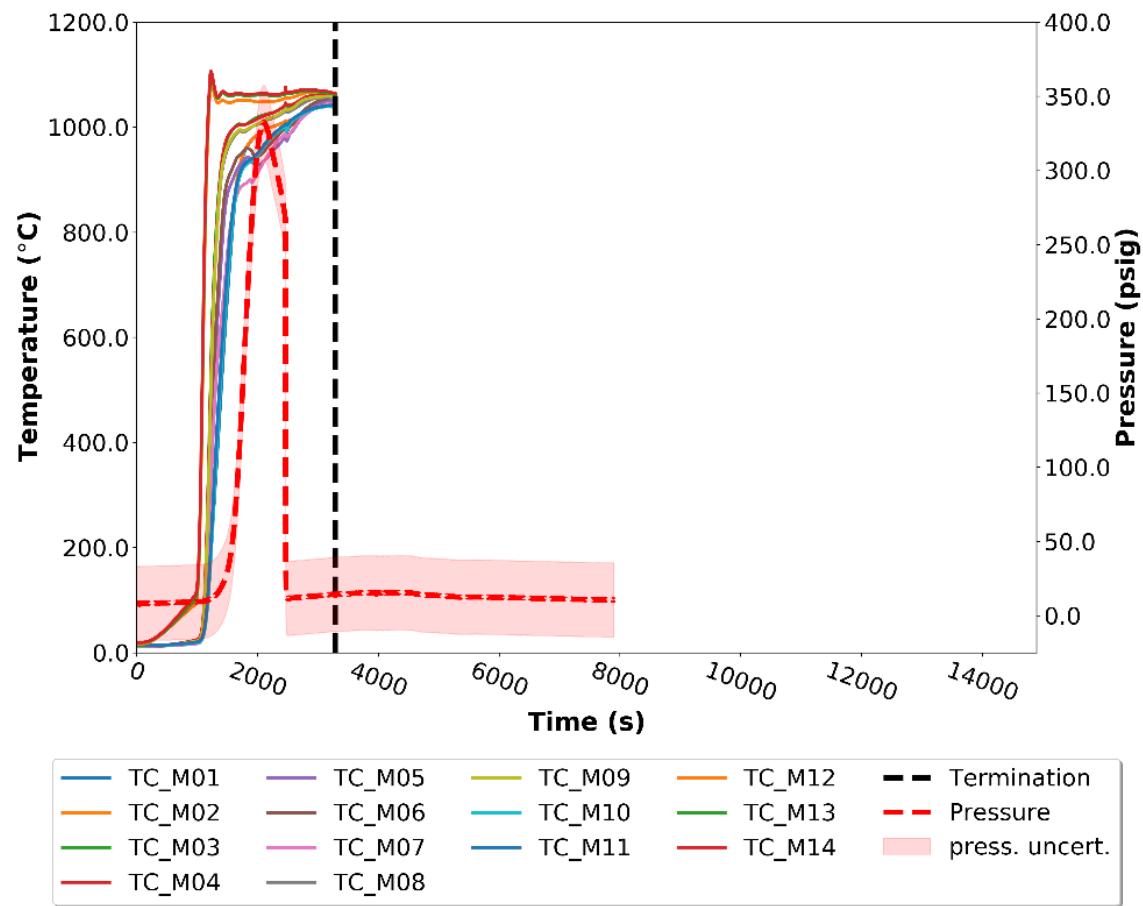
Compared to Sequence 4, when salt was absent in the payload, the peak pressure experienced by Sequence 5 was approximately 10 ± 50 psi higher with an observed peak pressure of 332 ± 25 psig near 2100 seconds. Compared to Sequence 3, where the payload was the same but with the EPD vessel configuration, Sequence 5 saw a pressurization that was approximately 50 ± 50 psi higher. Like the comparison between Sequence 2 and Sequence 4, the different outcomes between Sequence 5 and Sequence 3 support the argument that the manufacturing process and differences between the internal containers influence the mechanical response of the outer 3013 containers in a fire accident scenario. At approximately 2460 seconds, a breach was experienced by the vessel as noted by the sudden pressure drop in Figure 4-11. Figure 4-12 reveals how the vessel significantly deformed as a result of the test, and Figure 4-13 shows how the expelled gases ignited with the incident heat just after the vessel was breached, similar to Sequence 4. This test was allowed to continue until 3240 seconds, at which point power to the heater was terminated. Post-test leak checks identified the vessel breach to be near the 200° position about six inches from the bottom of the unit (see red mark in Figure 4-12, 180° image), and the measured mass loss for the vessel was ~ 5 grams.

Figure 4-11. Temperature and pressure for Sequence 5.
