SAND2021-9854

Fire-Induced Pressure Response and Failure Characterization of PCV/SCV/3013 Containers – Phase 3

ABSTRACT

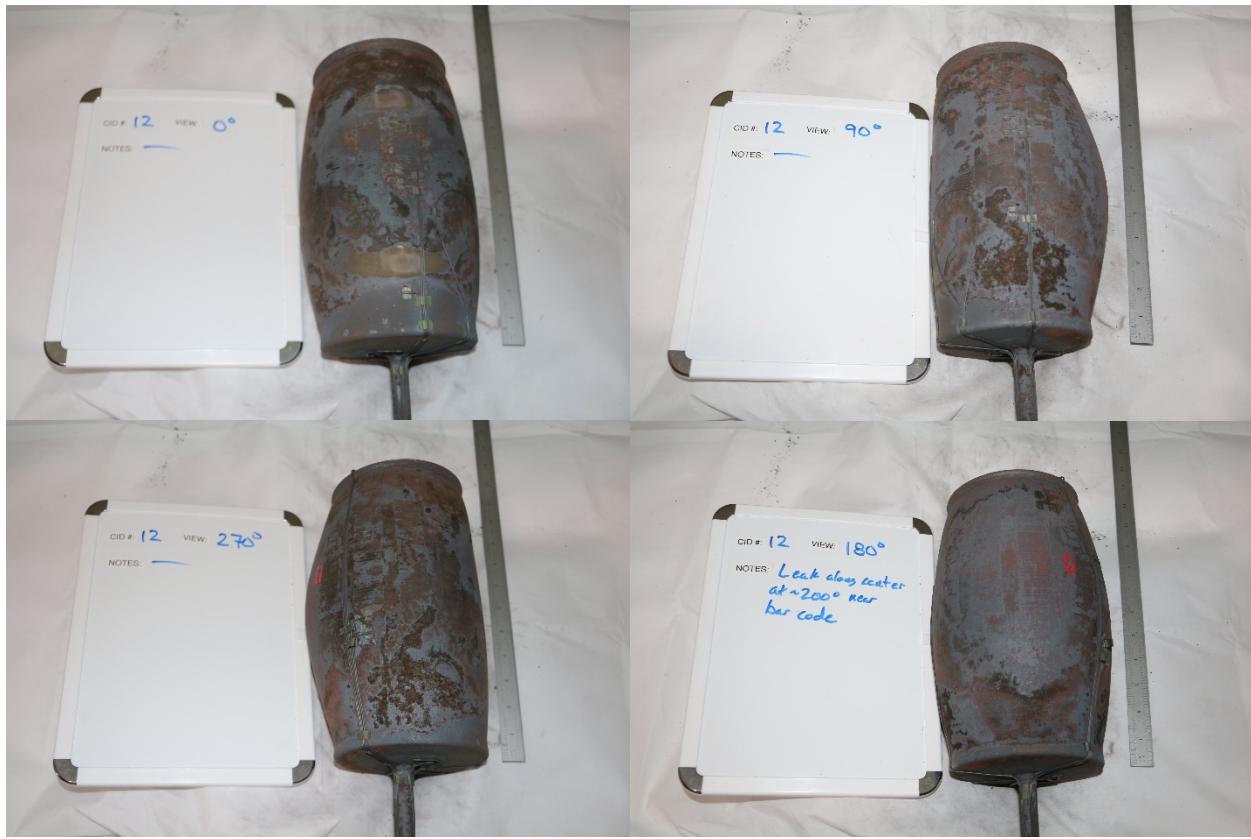
Approximate measurements to capture swelling of the vessel showed the vessel increased ~ 1.8 cm in length and ~ 3.0 cm in diameter at the sites of maximum deformation.

Figure 4-12. Post-test conditions of test vessel for Sequence 5. Angle positions refer to the visible portion of the vessel (see Figure 2-4). Angular positions, in clockwise direction, starting from upper left quadrant: 0°, 90°, 180°, and 270°.

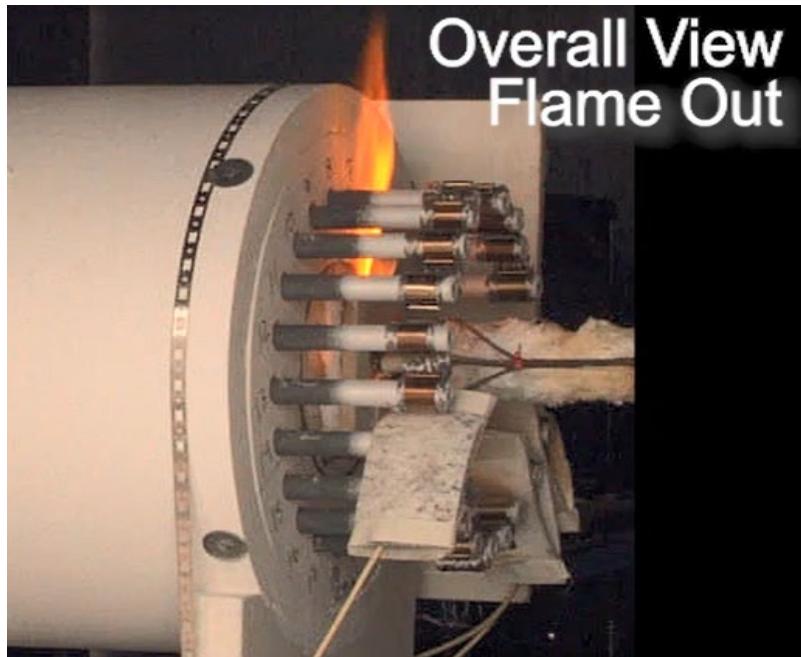
Figure 4-13. Exterior view of Sequence 5 during test, immediately after vessel was breached.

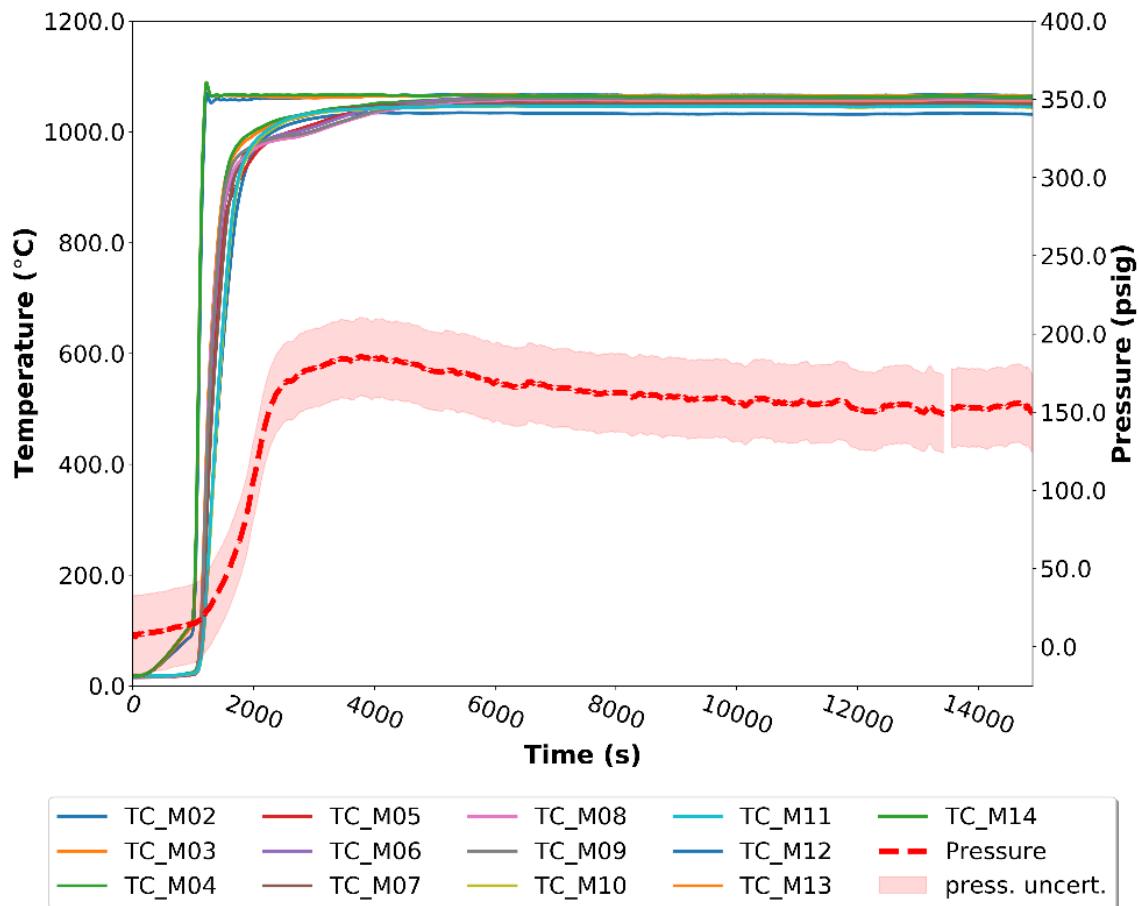
Figure 4-14 shows how the vessel response was similar to Sequence 2, where the test conditions were comparable except for the payload instead including 12 g of H_2O . The peak pressurization in Sequence 6, however, was larger than Sequence 2 despite the lower moisture. At 3789 seconds, the vessel experienced the peak pressure of 186 ± 25 psig, which is $\sim 63 \pm 50$ psi over the peak pressure experienced by Sequence 2 despite the lower moisture in CID-4. SNL performed pre- and post-test calibration checks on the transducers to investigate any unexpected anomalies that could have led to the higher pressure reading in Sequence 6. The operating conditions of the data acquisition system were verified along with temperatures near the pressure transducers to check for unexpected drift. None of the checks that SNL performed indicated that anything went wrong with the test or the data acquisition process to have skewed the data.

Figure 4-14. Temperature and pressure for Sequence 6.

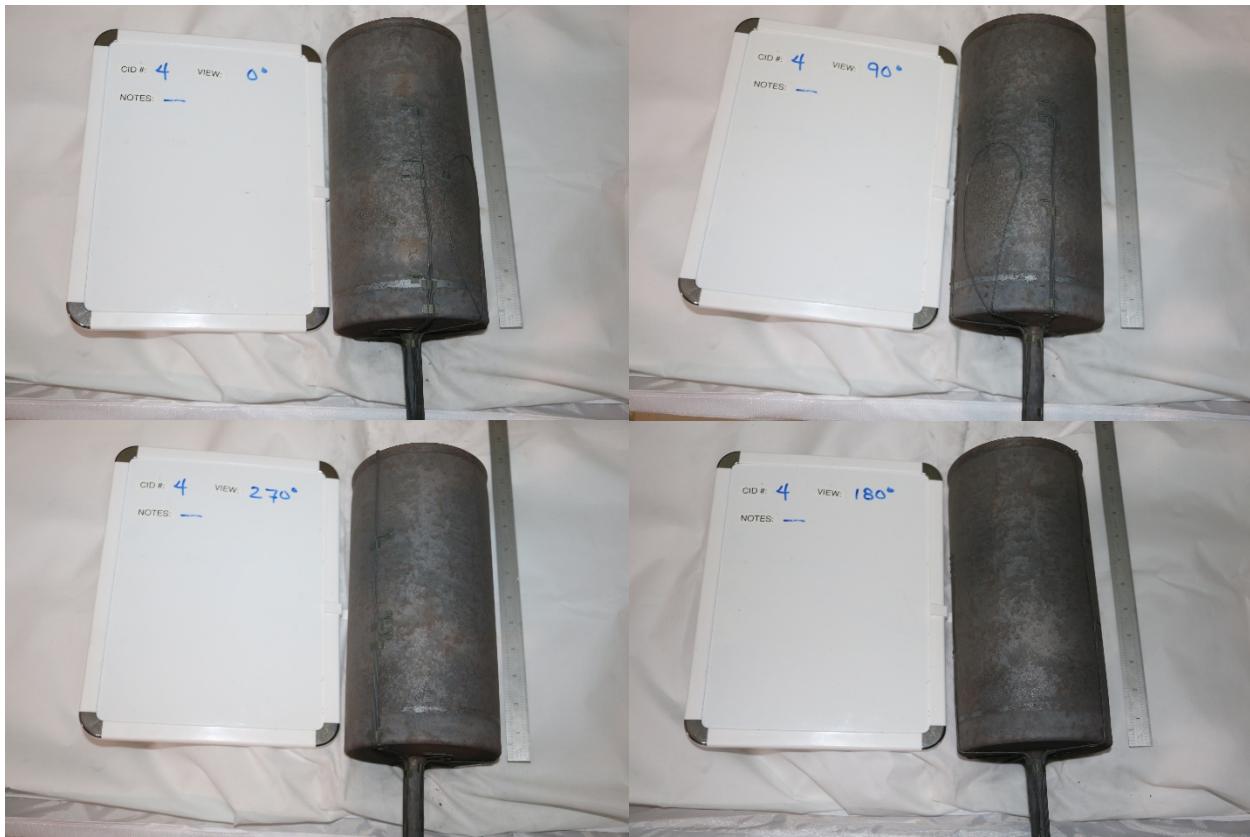
volume increase resulting from the deformation was not measured for this vessel either, so pressure loss from volume expansion alone could not be isolated. Deformed vessel dimensions were not measured for this vessel.

Figure 4-15. Post-test conditions of test vessel for Sequence 6. Angle positions refer to the visible portion of the vessel (see Figure 2-4). Angular positions, in clockwise direction, starting from upper left quadrant: 0°, 90°, 180°, and 270°.

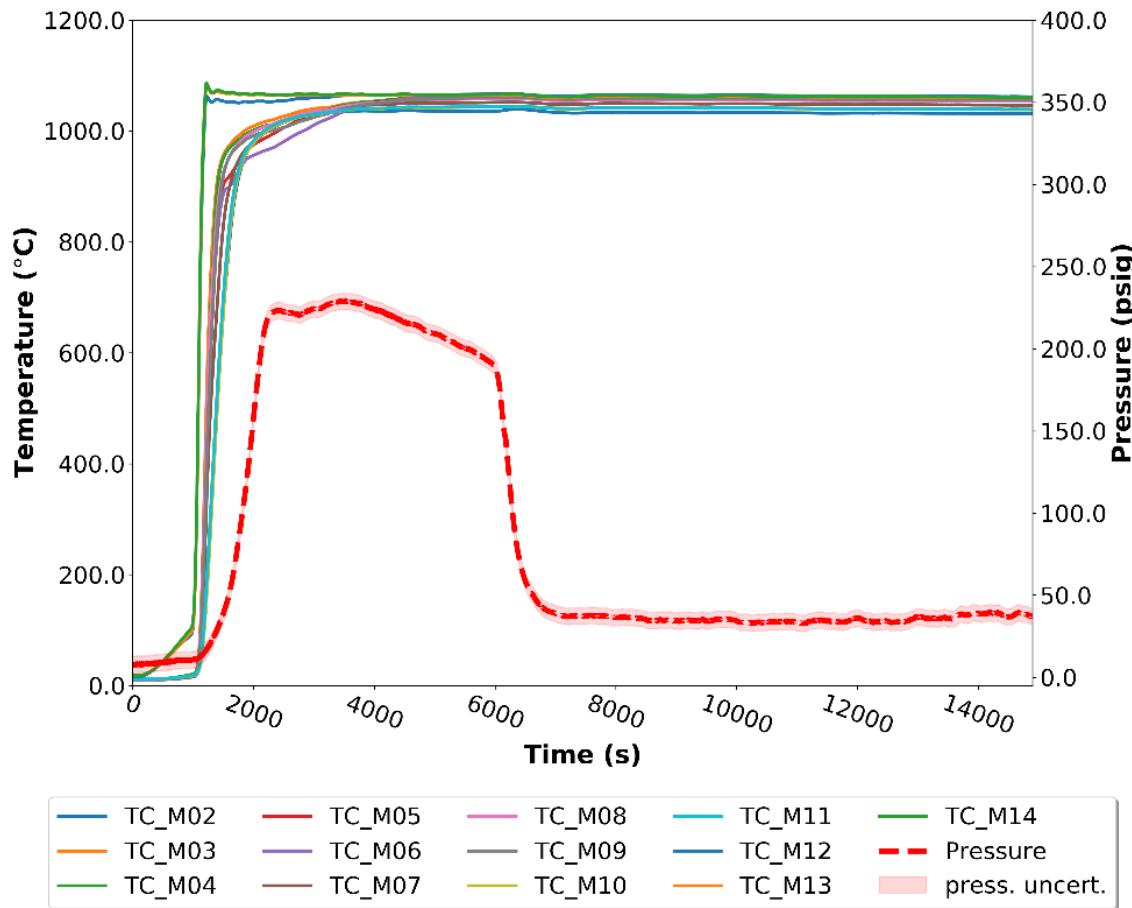
Figure 4-16 shows how the vessel response in this test compared to Sequence 3 and Sequence 6. Peak pressurization of Sequence 7 was 229 ± 5 psig at 3430 seconds, which was 43 ± 30 psi higher than Sequence 6 but 55 ± 30 psig lower than Sequence 3. While sudden but not as abrupt as Sequence 3, the pressure dropped at ~ 6050 seconds in a manner indicative of a breach. However, this test also ran for the full four hours because the pressure did not drop to near ambient as the previous container failures had (Sequences 3, 4, and 5), and there was a possibility that the pressure drop was not a breach. Post-test leak checks showed that a breach was detected at the 300° position along the lid weld, which is captured in the 300° image of Figure 4-17. While post-test volume change was not measured, visual inspection of Figure 4-17 also shows significant deformation when compared to Sequence 6 and comparable deformation when compared to Sequence 3. Unlike Sequences 3 and 6, however, no mass loss was detected in Sequence 7. Approximate measurements to capture swelling of this vessel showed the vessel increased ~ 2.4 cm in length and ~ 0.7 cm in diameter at the sites of maximum deformation.

Figure 4-16. Temperature and pressure for Sequence 7. Shaded region around pressure is instrument uncertainty

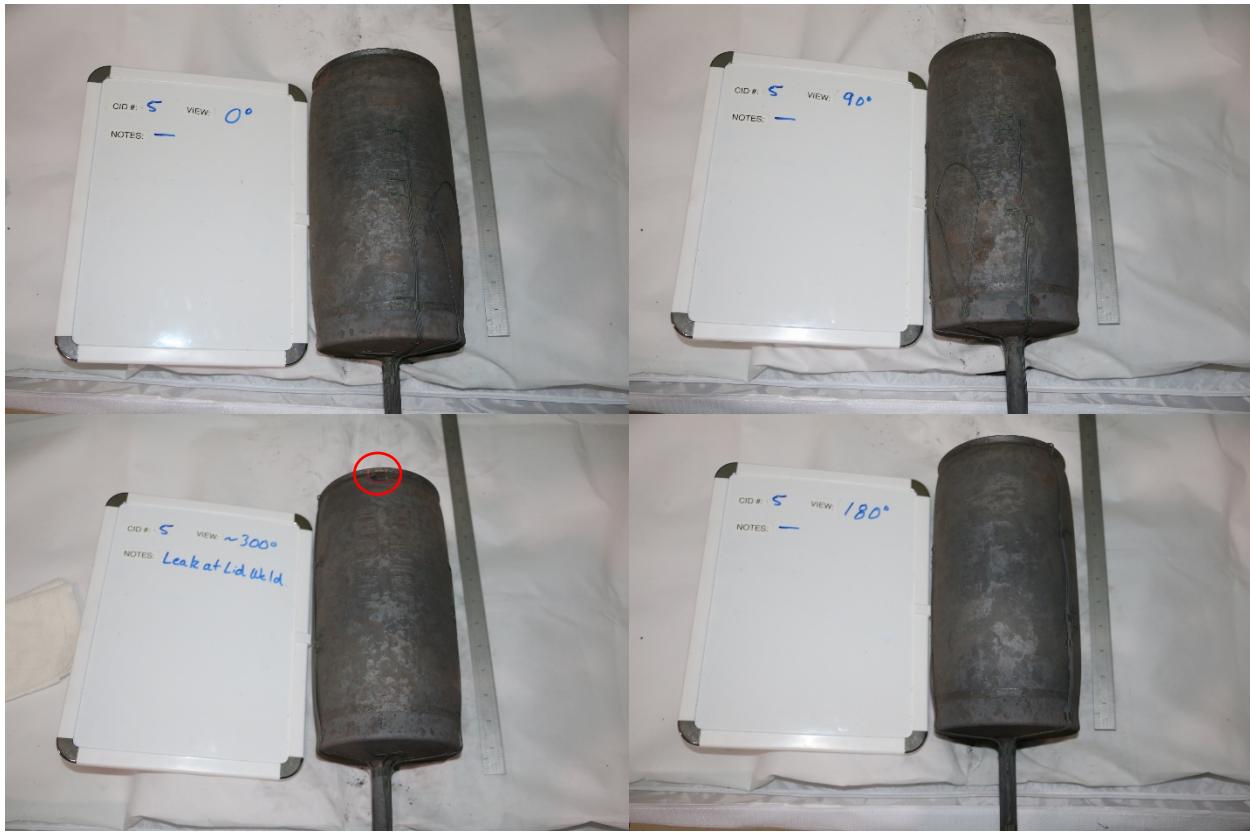
Figure 4-17. Post-test conditions of test vessel for Sequence 7. Angle positions refer to the visible portion of the vessel (see Figure 2-4). Angular positions, in clockwise direction, starting from upper left quadrant: 0°, 90°, 180°, and 300°.

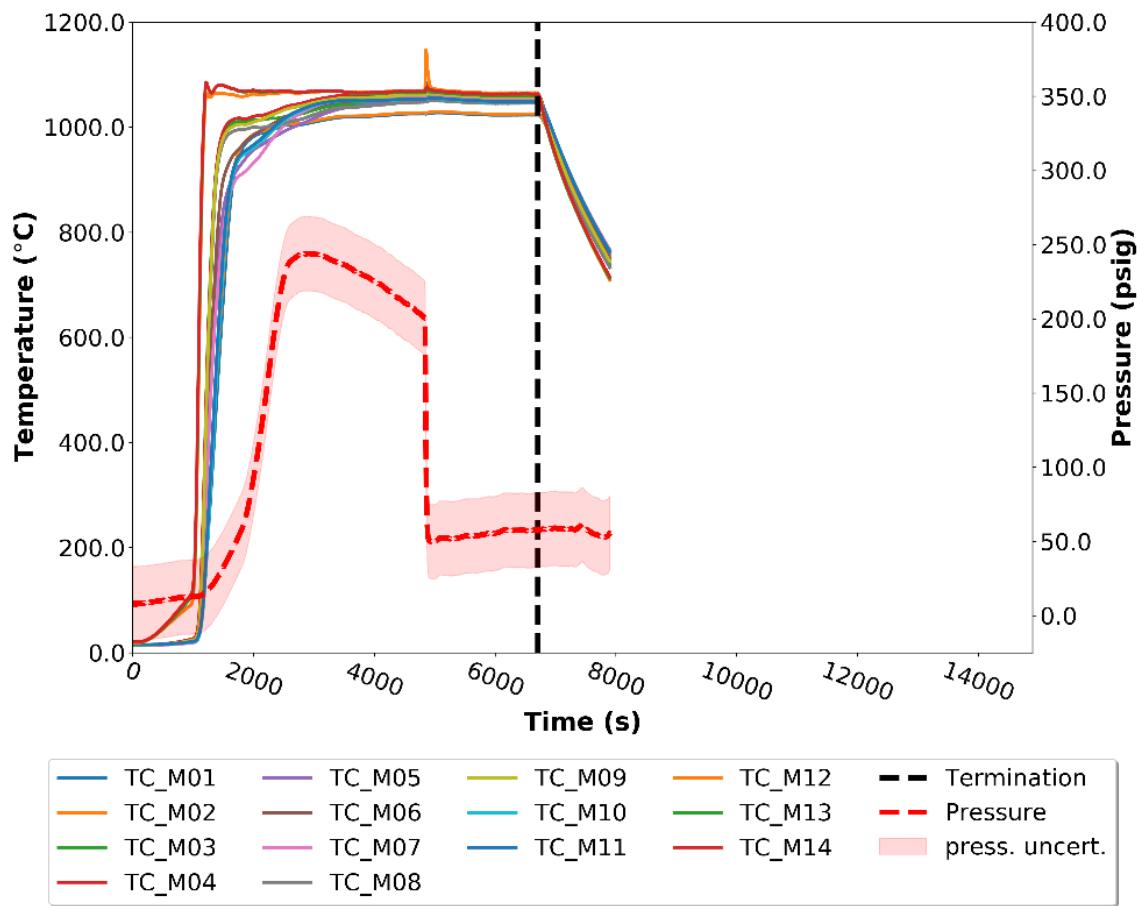
Figure 4-18. Temperature and pressure for Sequence 8.

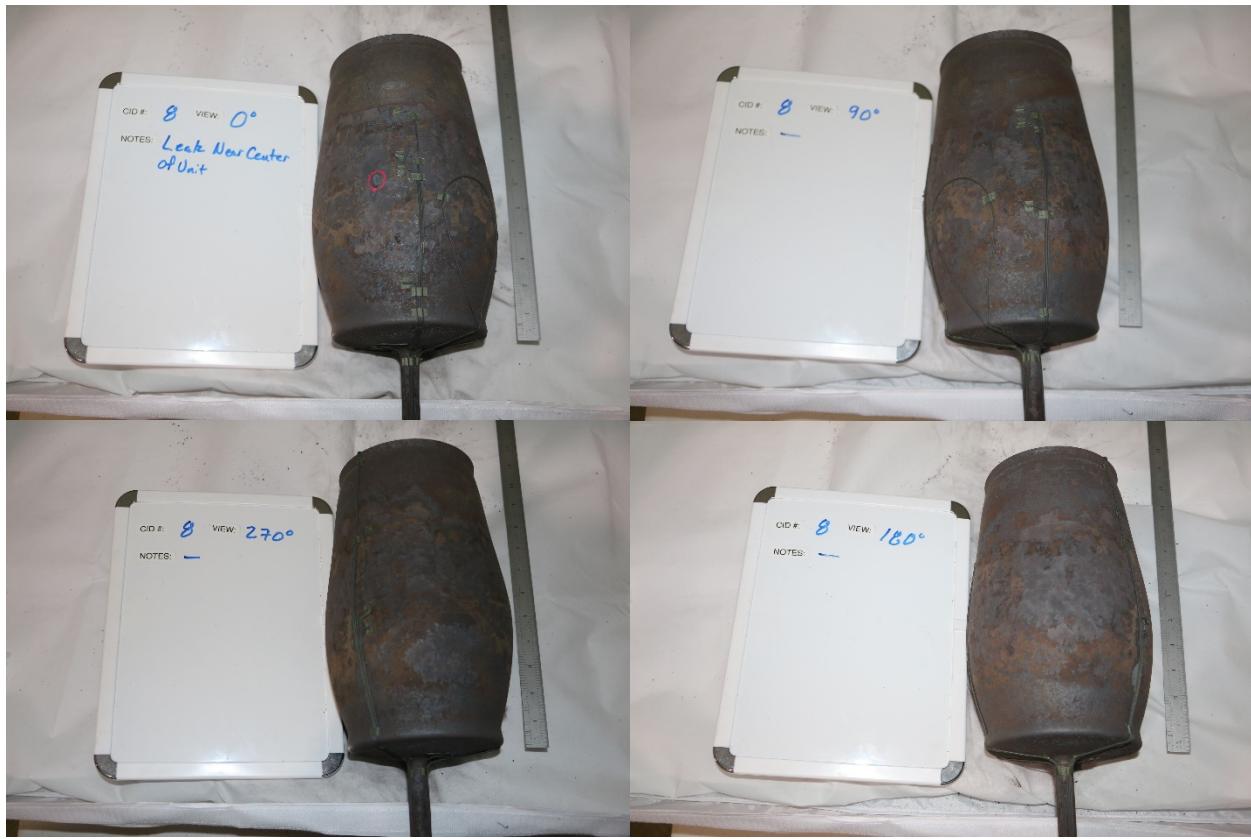
compared to Sequence 4. A mass loss of 10 g showed that the Flowform container in Sequence 8 lost less mass than the EPD equivalent (Sequence 6) and the Flowform version having comparable composition but higher moisture (Sequence 4). Approximate measurements to capture swelling of the vessel showed the vessel increased ~ 2.0 cm in length and ~ 3.25 cm in diameter at the sites of maximum deformation.

Figure 4-19. Post-test conditions of test vessel for Sequence 8. Angle positions refer to the visible portion of the vessel (see Figure 2-4). Angular positions, in clockwise direction, starting from upper left quadrant: 0°, 90°, 180°, and 270°.

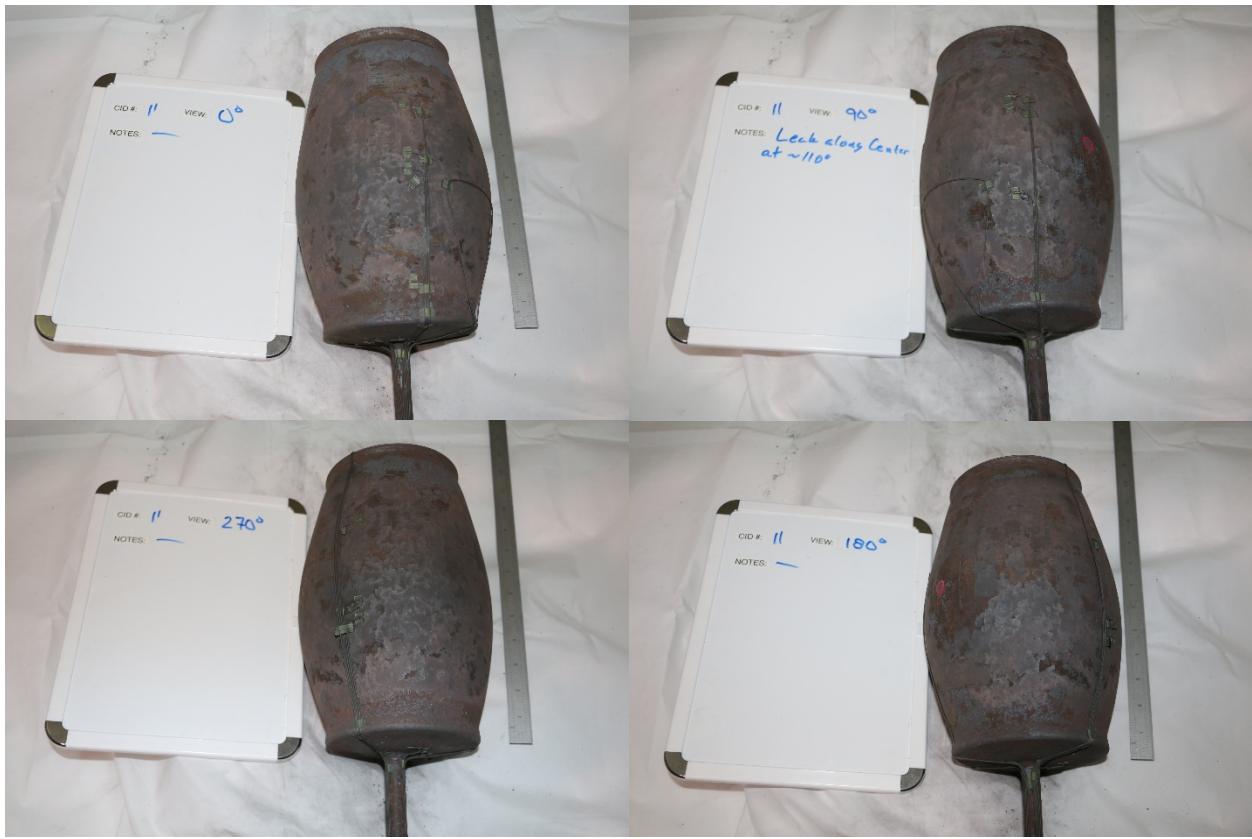
Figure 4-21. Post-test conditions of test vessel for Sequence 9. Angle positions refer to the visible portion of the vessel (see Figure 2-4). Angular positions, in clockwise direction, starting from upper left quadrant: 0°, 90°, 180°, and 270°.

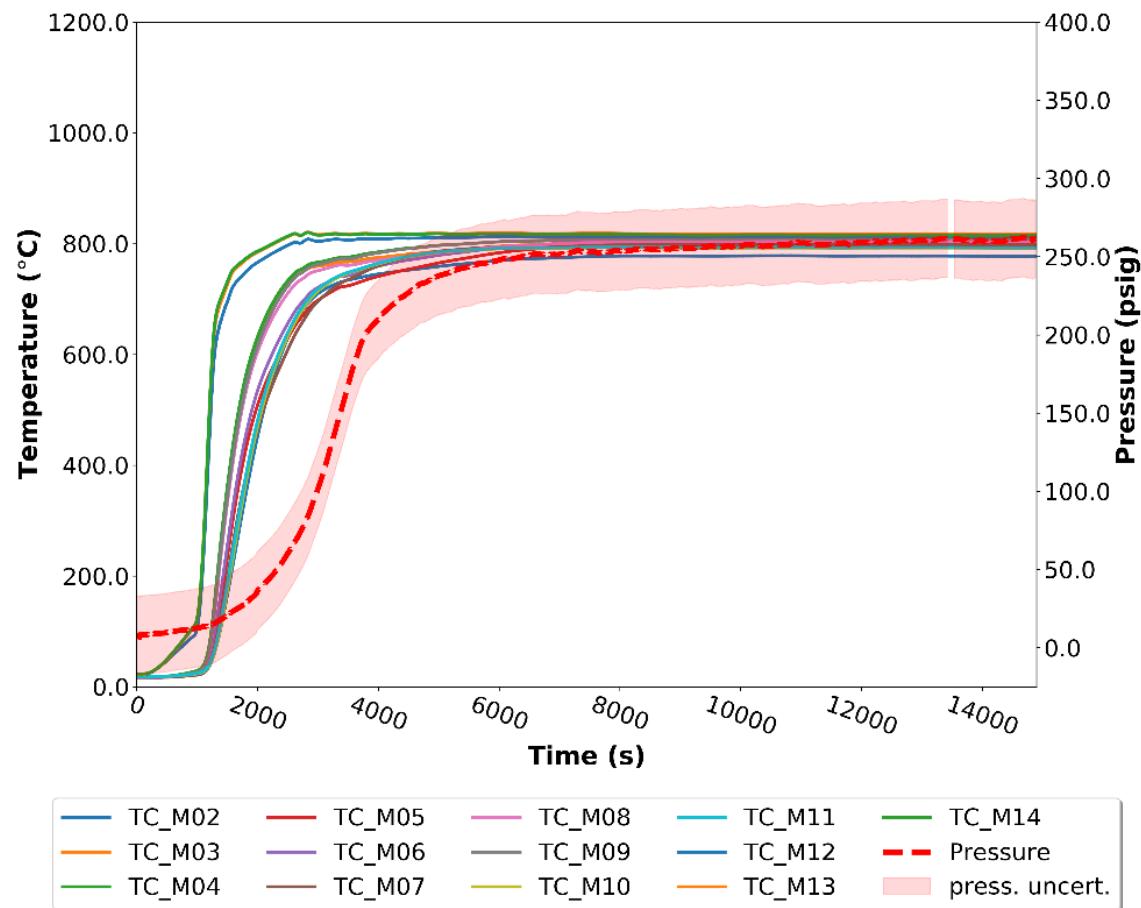
Figure 4-22 shows how the vessel response had some similarities to Sequence 1. Peak pressurization of Sequence 10 was 262 ± 25 psig, and this occurred at the end of the four-hour criterion as the pressure was still slowly but steadily rising at that point. Sequence 1 had a similar pressure response, except that there was a slow pressure decline by the end of the test and peak pressurization was only at 169 ± 25 psig. This higher pressurization occurred despite the higher moisture content in Sequence 1, but it was consistent with prior tests revealing that the Flowform version of the outer container generally experienced larger pressurizations under comparable conditions. Compared to Sequence 8, which was an identical vessel but tested with the ASTM-E1529 heating profile, Sequence 10 saw a peak pressure that was 18 ± 50 psig higher. When making comparisons, however, it should be noted that this peak pressurization in Sequence 10 was experienced at the end of the test and with no noticeable breach (unlike Sequence 8 that experienced a peak pressure and breach relatively early in the test). Due to the pressure profile being observed to continue increasing at the end of the test, post-test leak checks were not performed. Similar to Sequence 1, Figure 4-23 shows how no visible deformation was noticed for the vessel in Sequence 10 after test exposure. Interestingly, a mass gain of 8 grams was recorded for the vessel in Sequence 10. This increase in mass could have resulted from debris collected on the bottom of the shroud since it was added as part of the post-test mass (see Figure 4-24). Collection of this debris was initiated in Sequence 2, so any debris collected in Sequence 1 was not considered and therefore cannot be compared. However, since Sequence 1 recorded zero mass loss, any debris added would have similarly resulted in a net mass gain. With regards to swelling and similar to the vessel in Sequence 1, minimal deformation was recorded in the vessel for Sequence 10. Approximate measurements to capture swelling of the vessel showed that the vessel increased ~ 0.02 cm in length and ~ 0.1 cm in diameter at the sites of maximum deformation.

Figure 4-22. Temperature and pressure for Sequence 10.

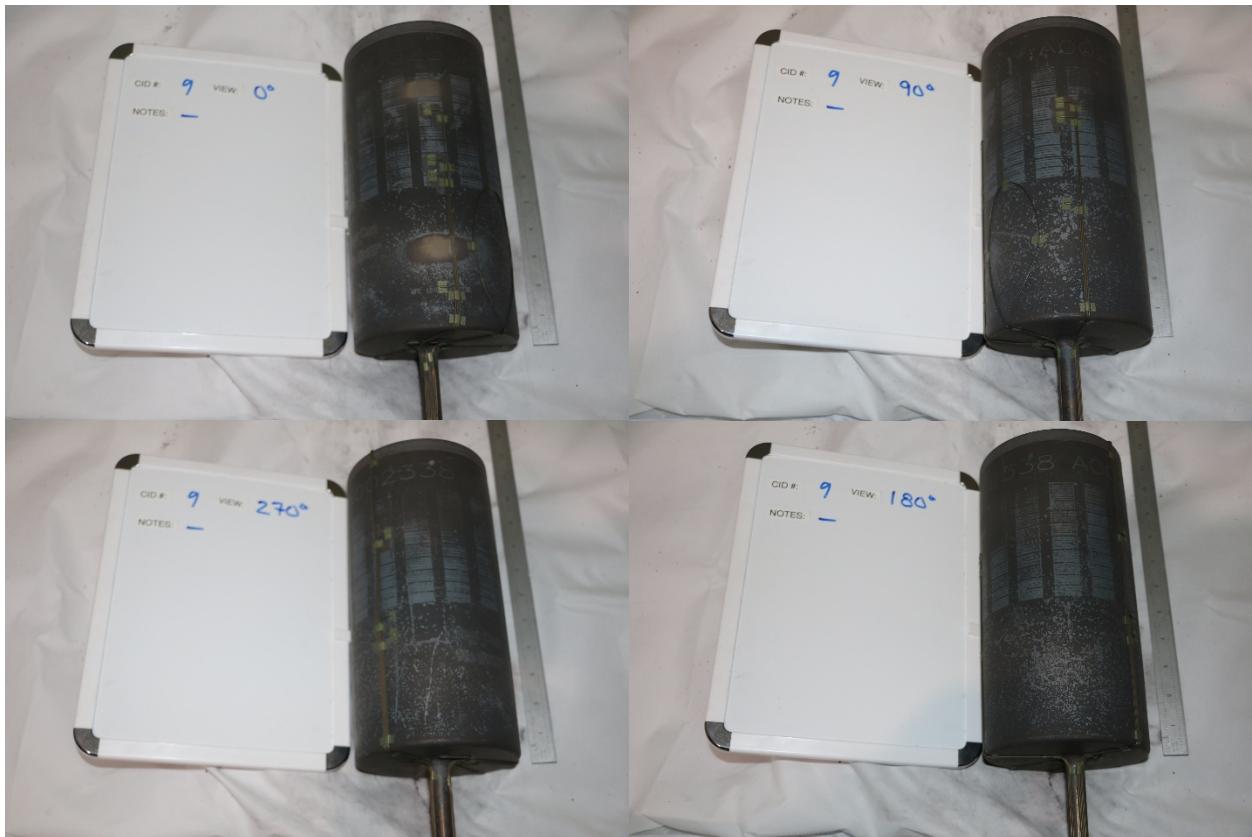
Figure 4-23. Post-test conditions of test vessel for Sequence 10. Angle positions refer to the visible portion of the vessel (see Figure 2-4). Angular positions, in clockwise direction, starting from upper left quadrant: 0°, 90°, 180°, and 270°.

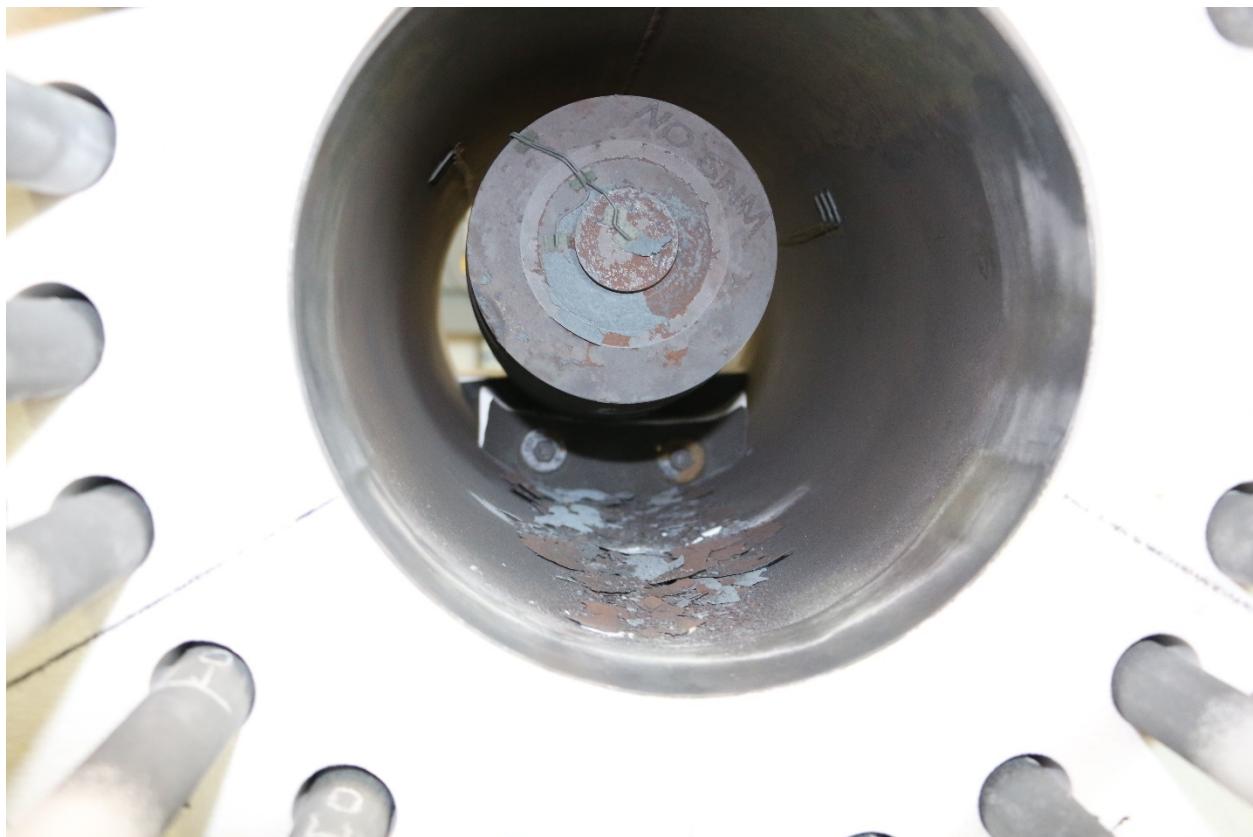
Figure 4-24. Post-test image of Sequence 10 showing debris from shroud collected at the bottom of the shroud.

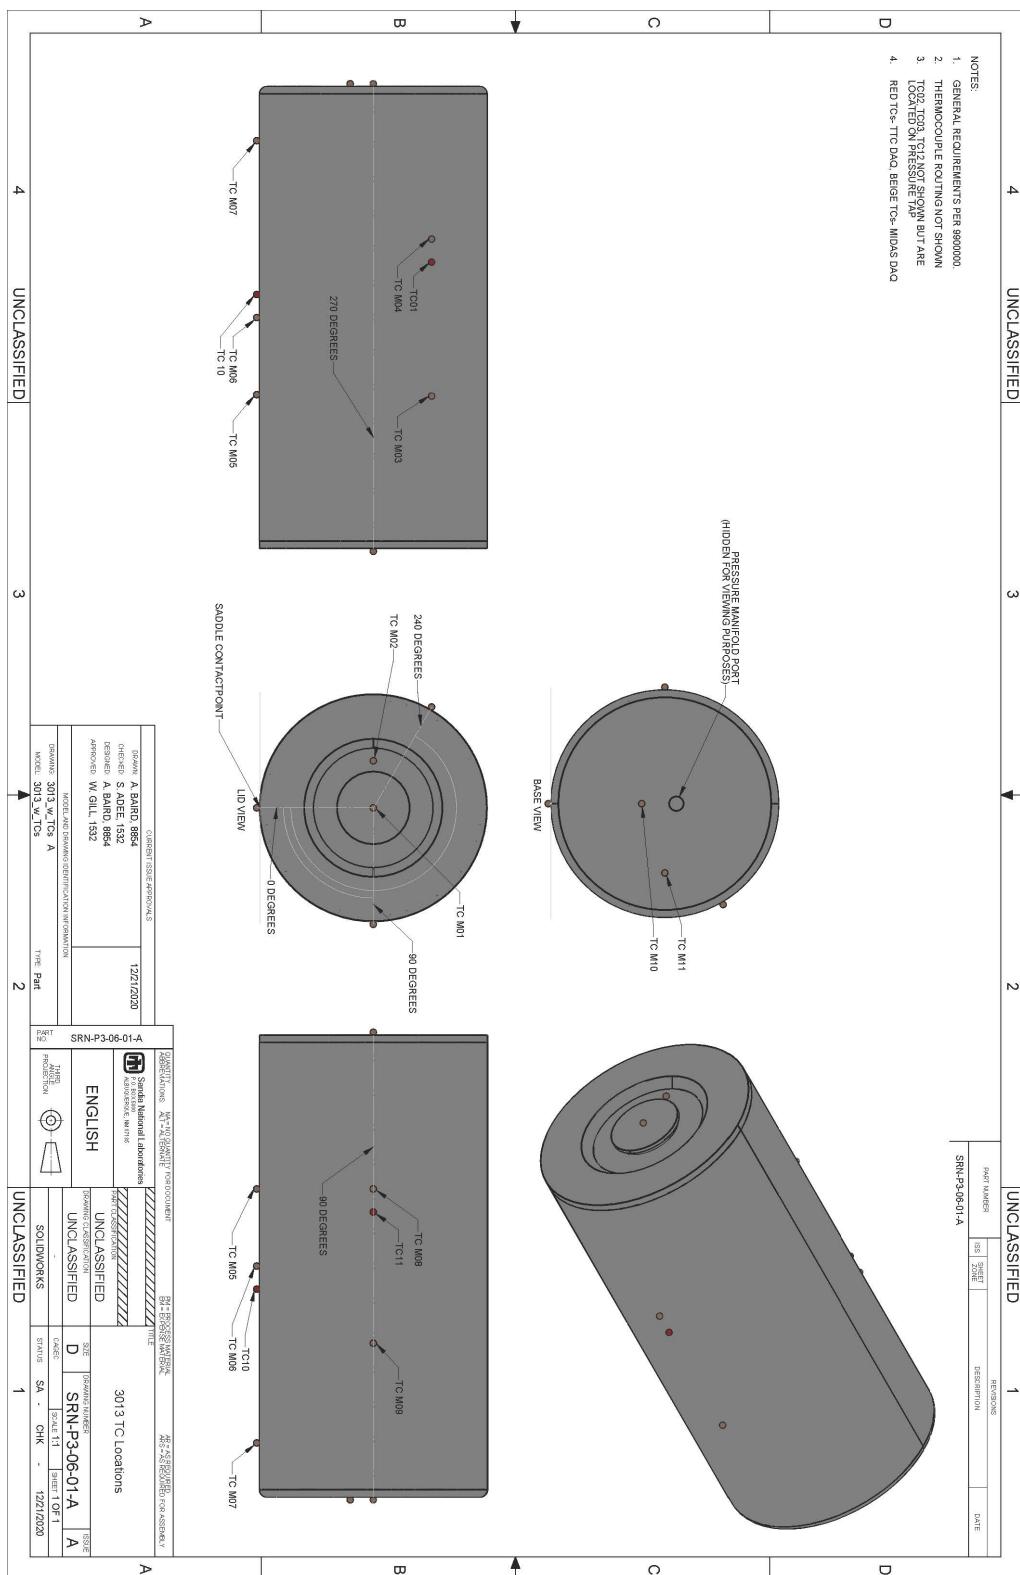
Figure 7-3. TC Locations on Vessel.

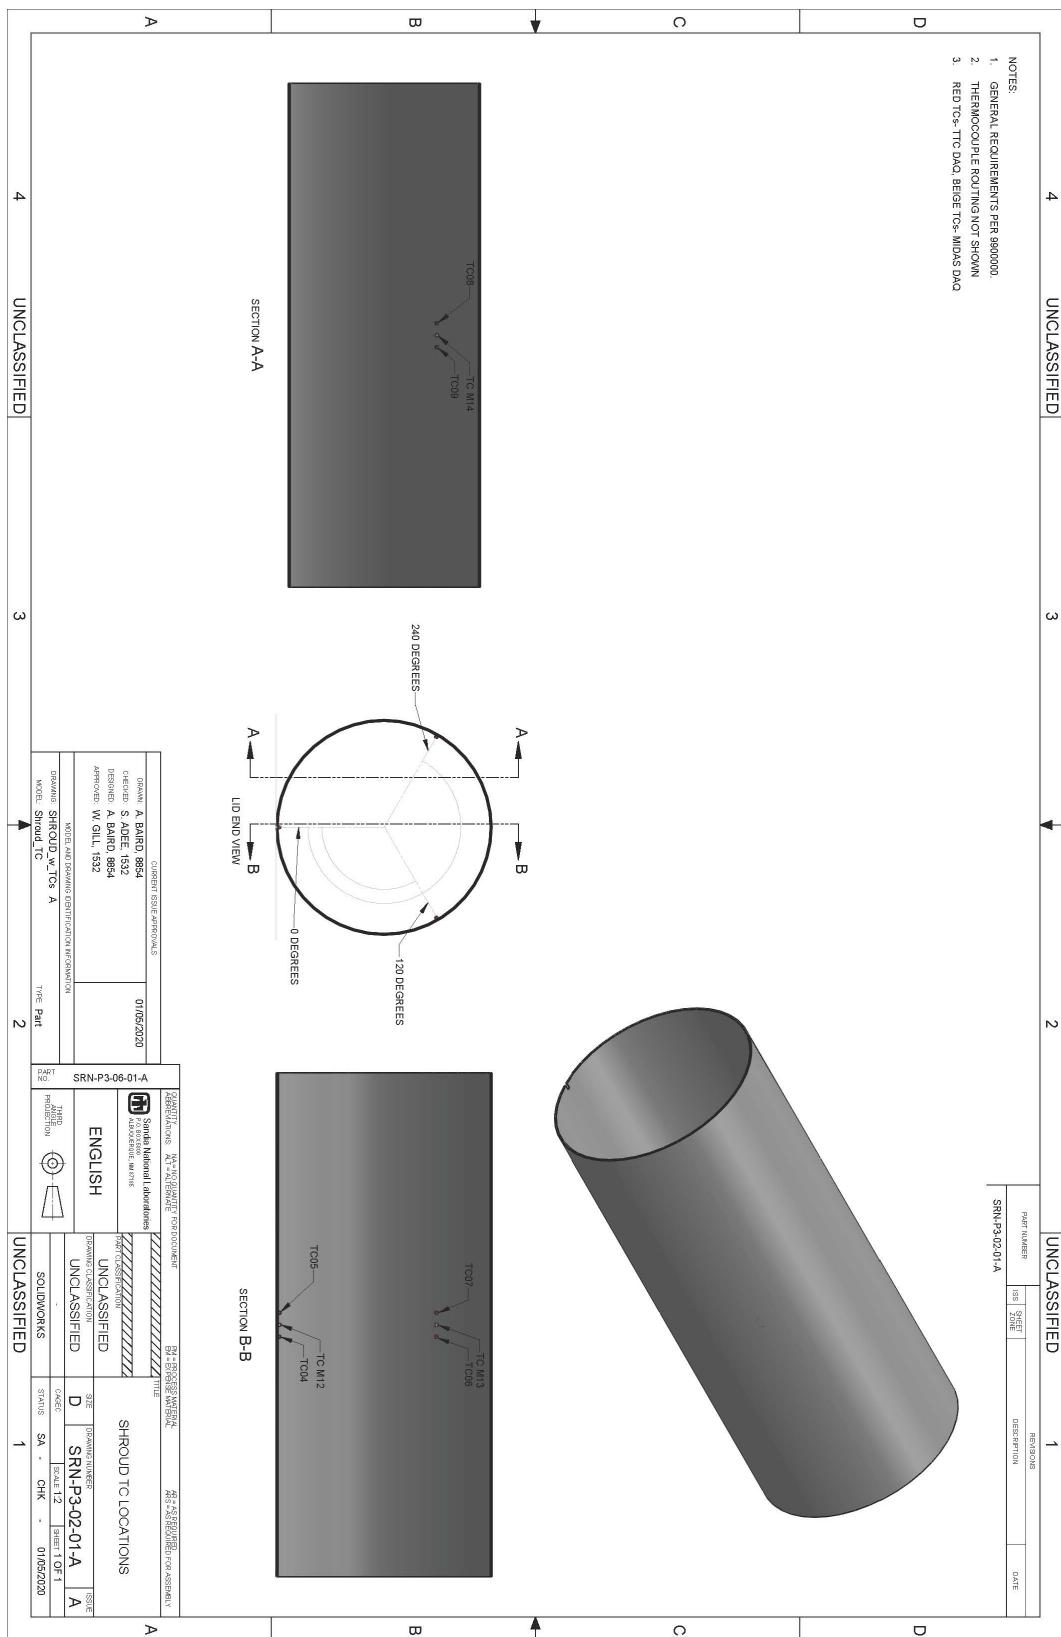
Figure 7-4. TC Locations on Shroud.

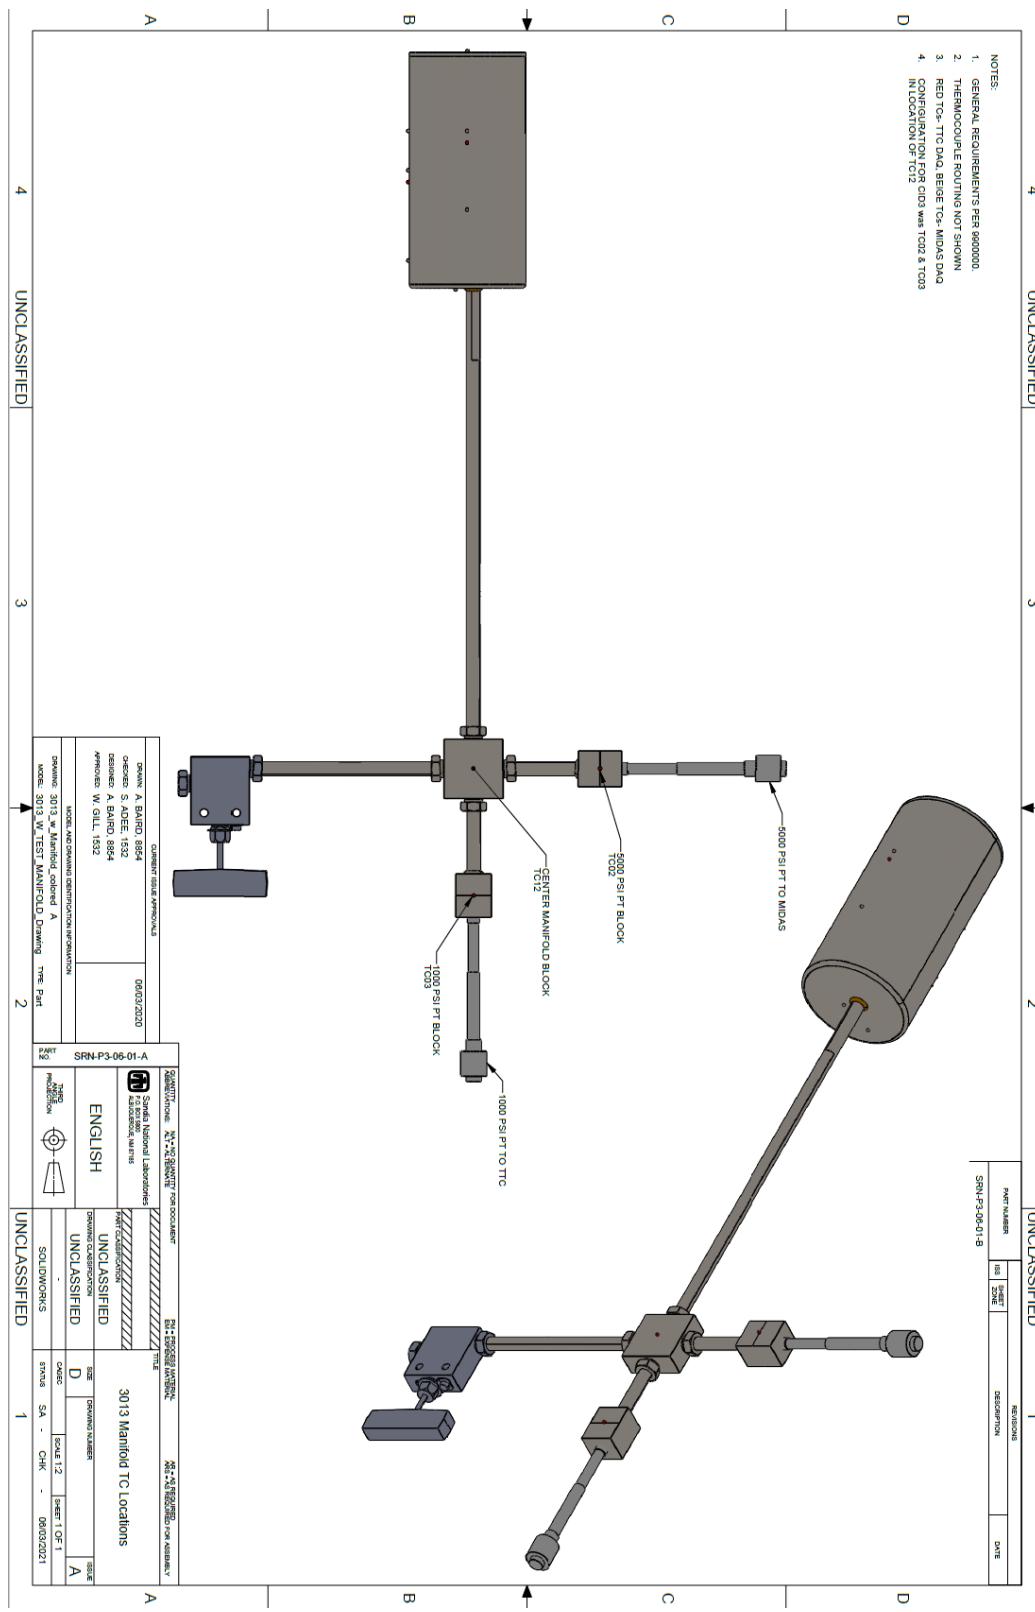
Figure 7-5. TCs on pressure manifold.
