Benchmark Study of the Accident at Fukushima (BSAF) Overview

R.O. Gauntt

Severe Accident Analysis Department, Sandia National Laboratories

CSARP/MCAP Meeting, Bethesda MD

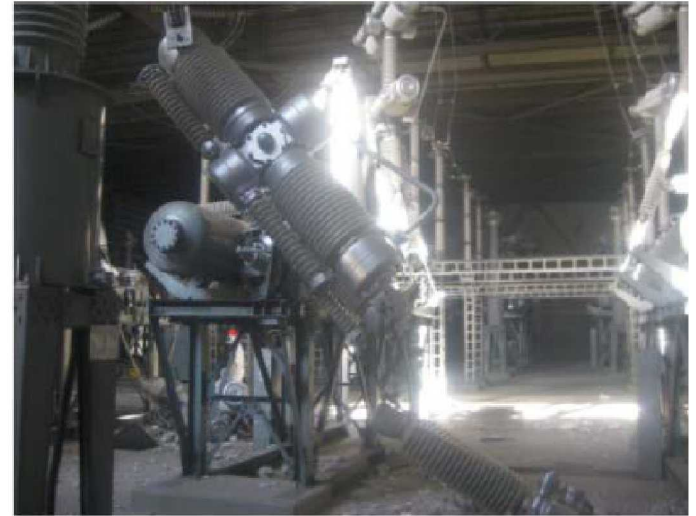
Circuit Breaker damaged

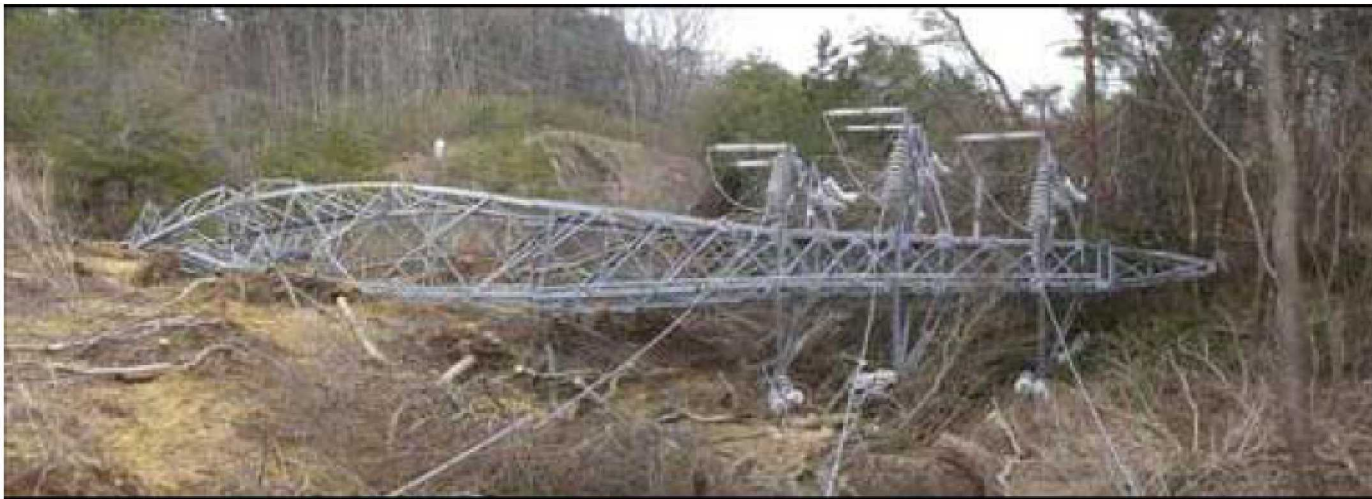
Collapsed tower

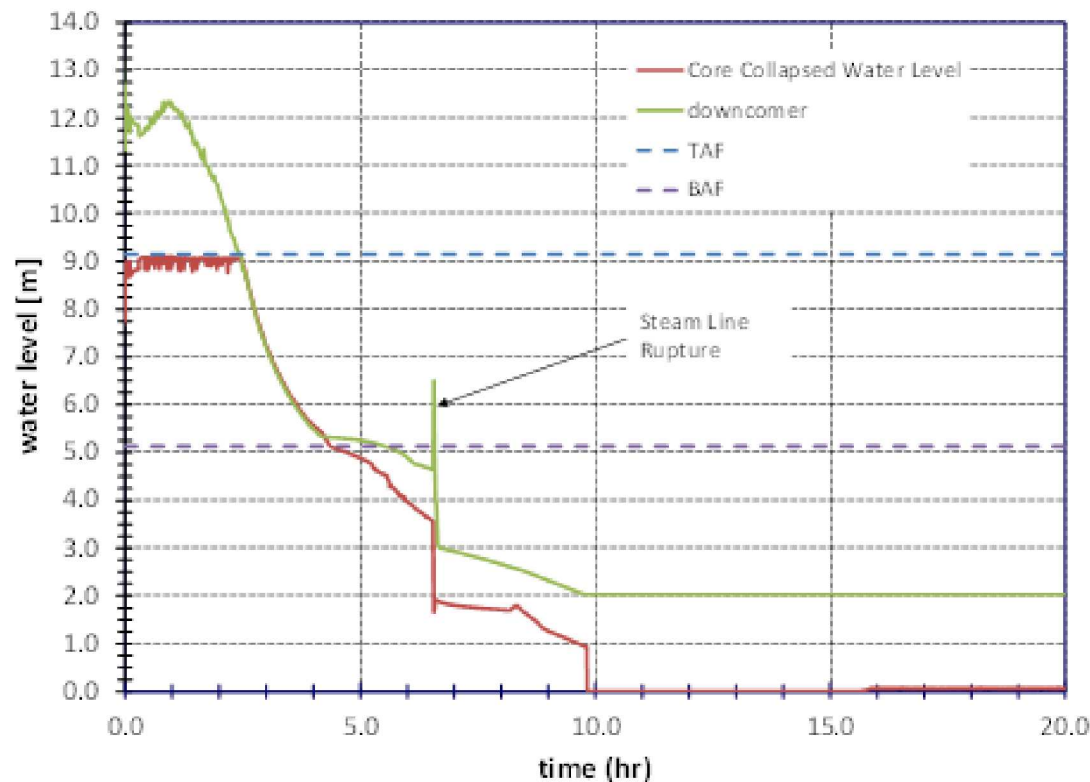
Vessel Water Boil-Down in Unit-1

■ MELCOR Code predictions

- Fuel uncovered at 3 hr
- Core damage and H_2 generation by 4 hr
- Steam line rupture at 6.5 hr
- Reactor Vessel dry at 10 hr
- Reactor Vessel melt-through between 12 and 14 hr

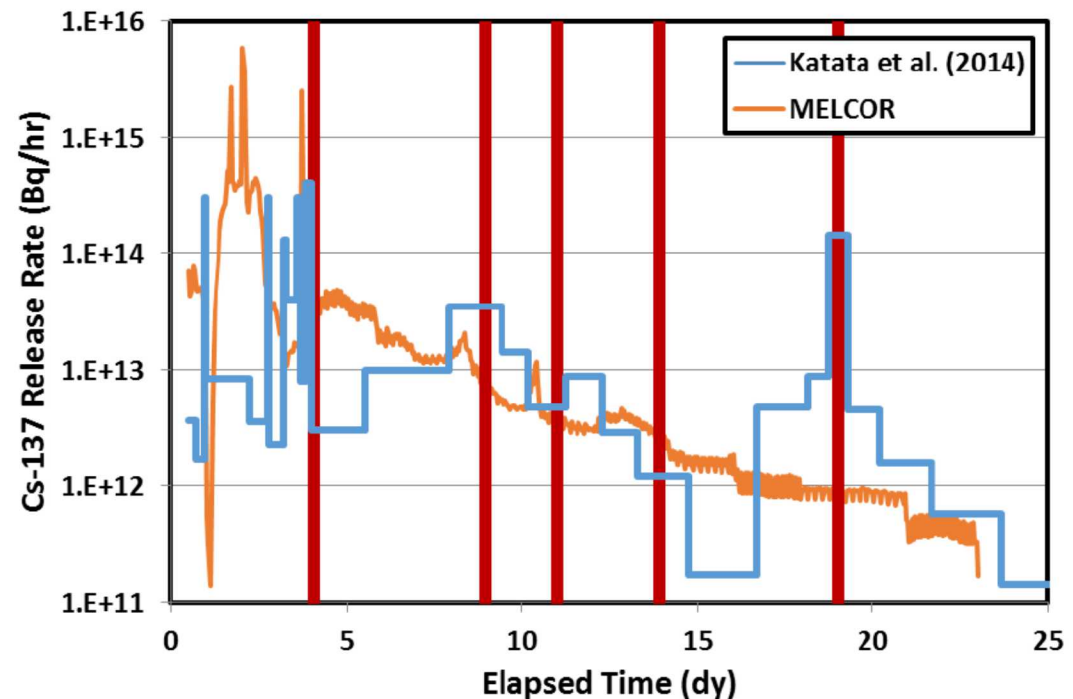
Extending Calculations – Why 3 Weeks?

- Significant releases well past initial BSAF Phase I simulations
 - Phase I extended to 6 days
- Large predicted Unit 2 releases to the NW after day 9
- Key times when wind blows to NW (vertical redlines on plot)
 - 98 hours (4.1 dy), March 15
 - 215 hours (9 dy), March 20
 - 264 hours (11 dy), March 22
 - 334 hours (13.9 dy), March 24
 - 456 hours (19 dy), March 30
