Pit-to-Crack Transition in Stress Corrosion Cracking of Type 304 Stainless Steels Under Marine Exposure Conditions

MS&T 2020 11/2/20-11/6/20

Practical Background of Investigating SCC of Stainless Steels

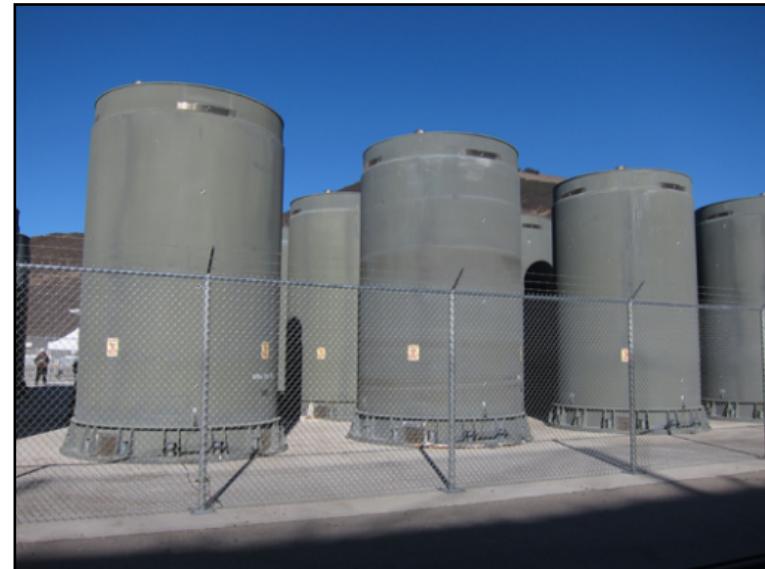
Canisters in overpacks may develop a Cl- rich brine on the surface

- Develops from accumulated dust that deliquesces on surface
- Sea salt responsible for chloride presence

Brines form in droplets on the surface when the RH and T on the surface exceeds the deliquescence RH of a particular salt
