Temperature Effects on Fracture Thresholds of Hydrogen Precharged Stainless Steel Welds

Joe Ronevich, Chris San Marchi, Dorian Balch

PVP2017-65603

ASME 2017 Pressure Vessels & Piping Conference

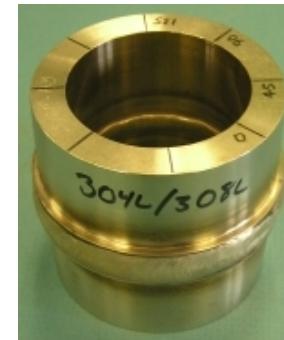
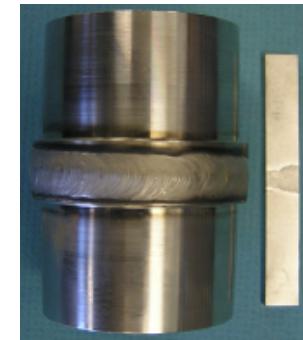
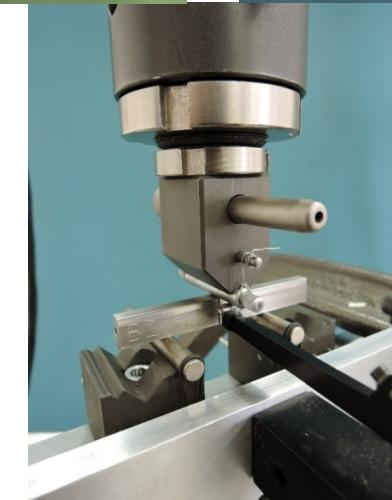
- Extracted 3-point bend bars from forged gas tungsten arc welded (GTAW) rings
 - 304L
 - 316L
 - XM-11 (21Cr-6Ni-9Mn)
 - All welded with 308L filler metal
- Machined notch centered in weld
- Thermal precharge with H₂
 - 300°C for 16+ days at 138 MPa
- Elastic-Plastic Fracture (J-R curves) tests of welds at 223 K and 293 K
 - Liquid Nitrogen chilled environmental chamber
- Extract mini-tensile specimens from weld region for testing at 223 K and 293 K

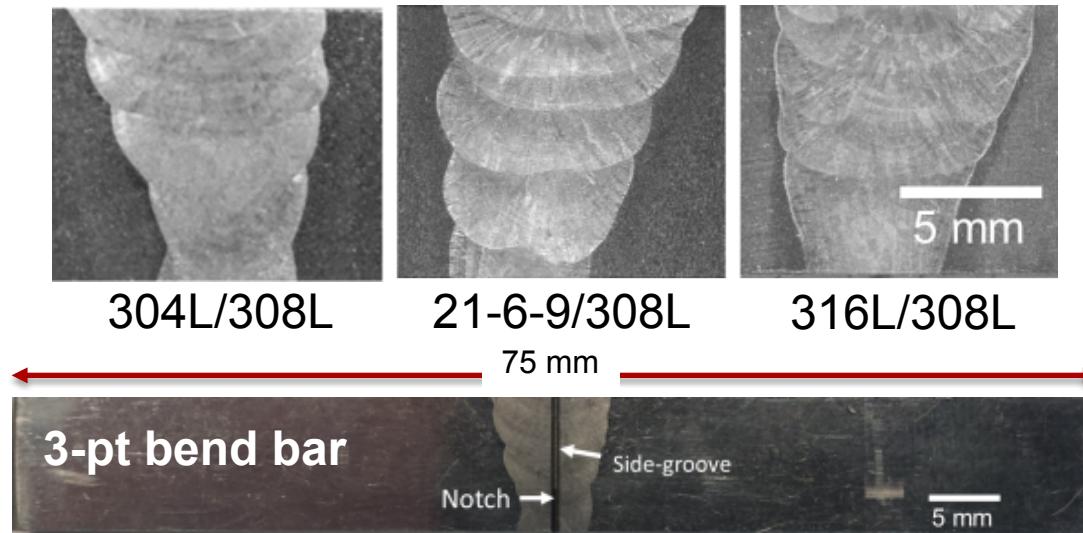
Materials: Forged Austenitic Stainless Steel Gas Tungsten Arc Welds

- Forgings were welded using same 308L filler metal

- J-grooves / Square-groove weld joint to permit testing in FZ or HAZ

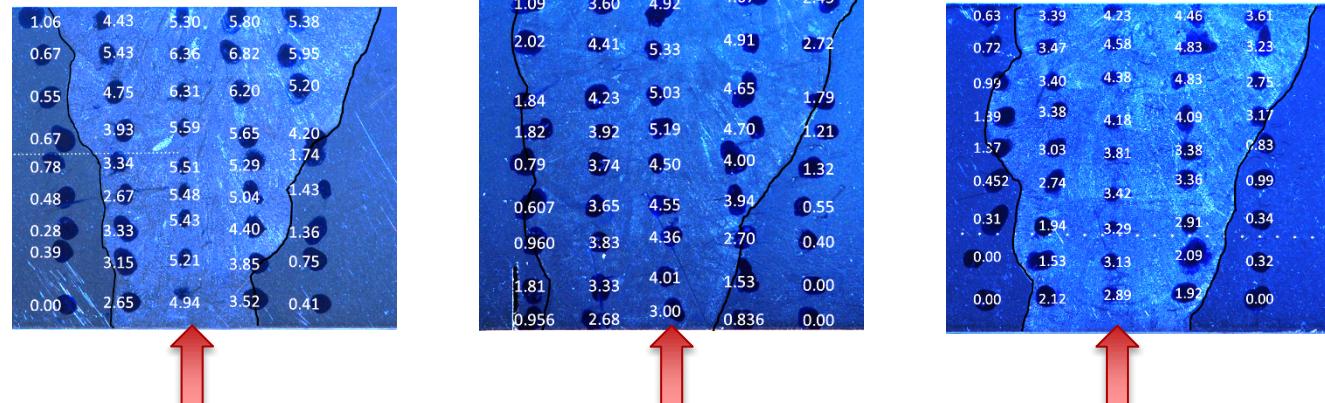
Ferrite content varied among welds fabricated with same filler metal

- Feritscope® was used to measure ferrite content in grid-like pattern

- Desirable to have primary δ -ferrite in order to prevent solidification cracking
- Despite same filler metal, dilution of 308L filler metal resulted in differences in ferrite content

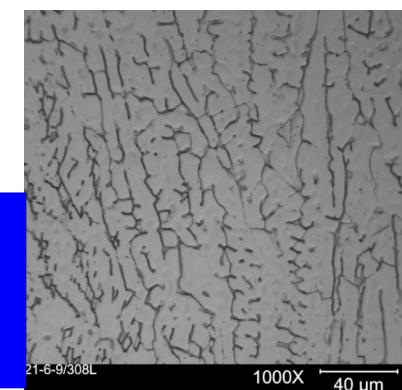
δ -ferrite: black γ : grey

It is known that ferrite contributes to lower fracture toughness by acting as enhanced diffusion pathway, crack nucleation/coalescence site

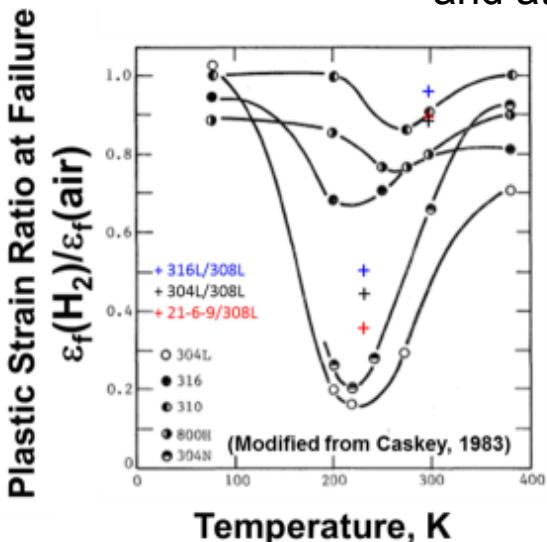
In Hydrogen Precharged Welds

- Total Elongation decreased 3-11% at 293 K
- Total Elongation decreased 50-64% at 223 K
- Similar behavior to other 300 series stainless steels showing enhanced degradation at ~ 220 K

Hydrogen induced ductility loss was exacerbated at low temperatures

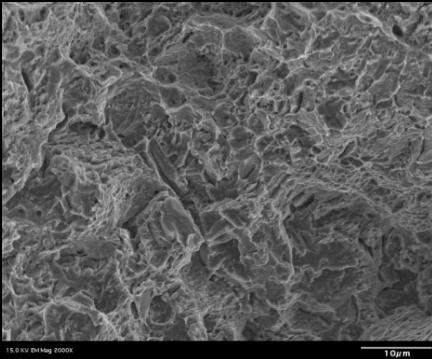
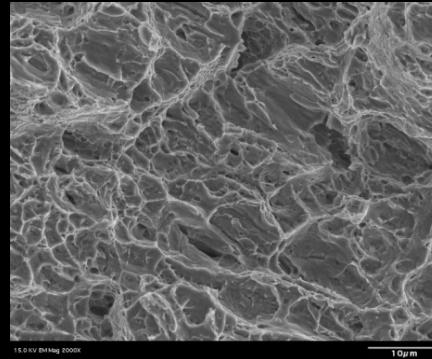
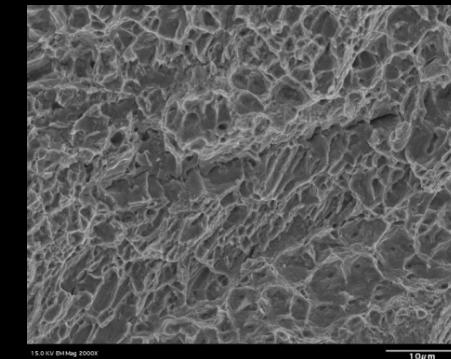
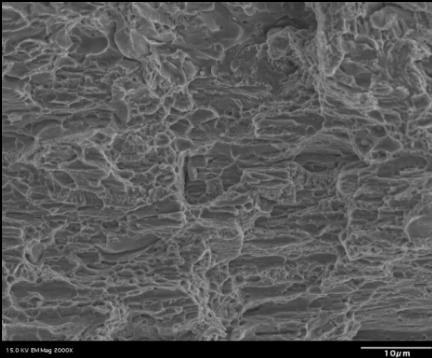
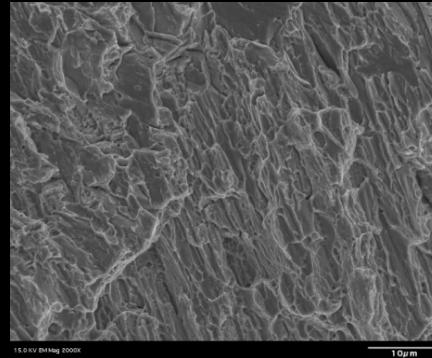
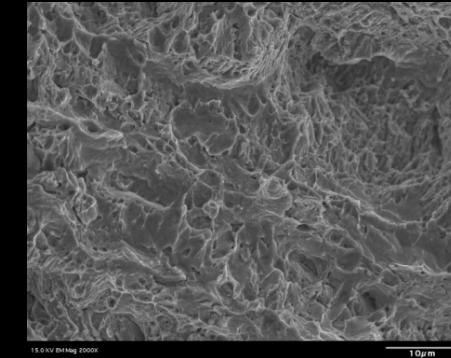
Greater microvoid coalescence in 293 K tests compared to 223 K weld tensile tests

Greater loss in ductility at low temperature results in more brittle fracture features

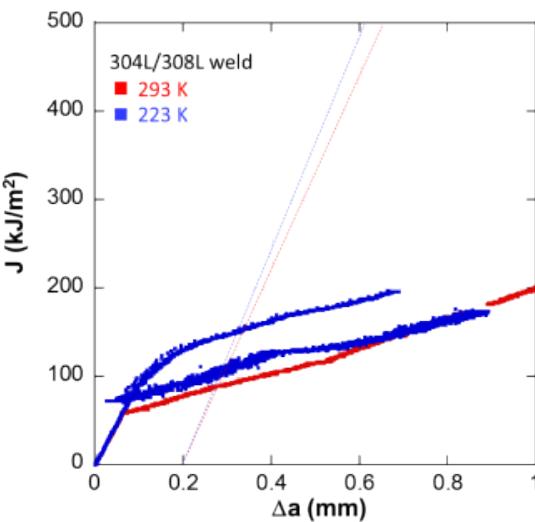
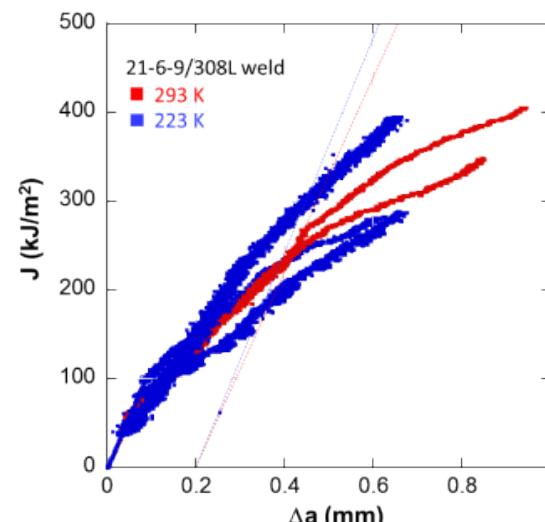
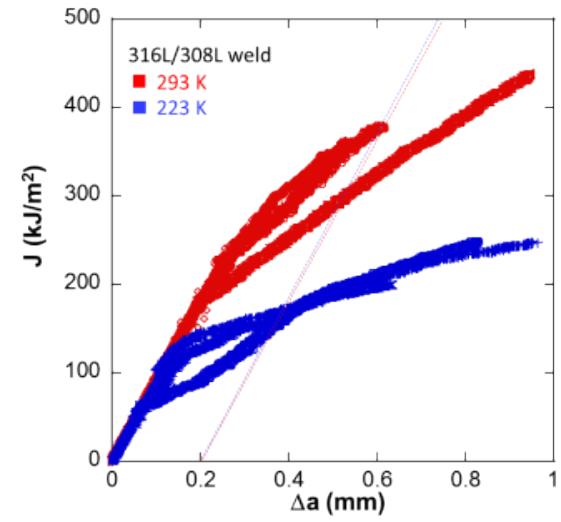
Fracture Threshold (J-R curves) measured on hydrogen-precharged at 293 K and 223 K

Test rate 0.02 mm/min
(0.1 MPa m^{1/2}/s)

- In non-charged condition, negligible crack extension observed
- 304L/308L weld exhibited lowest fracture thresholds of three welds
- 316L/308L weld exhibited significant degradation at low temperature

Temperature dependence only observed in
316L/308L weld fracture behavior

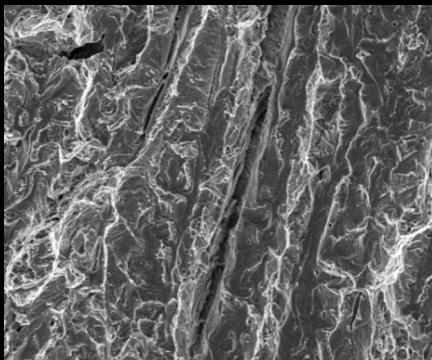
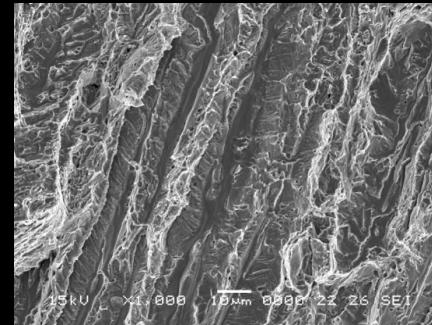
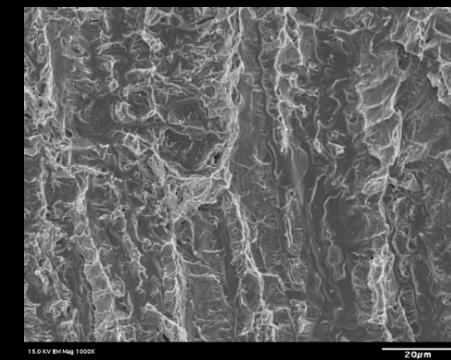
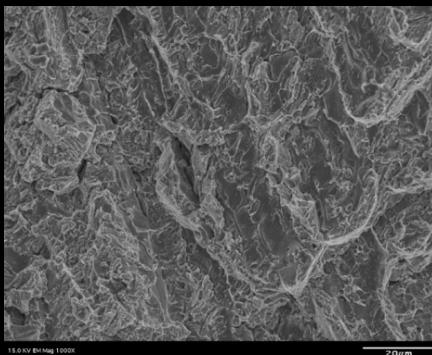
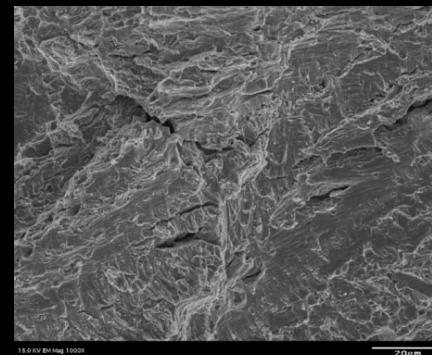
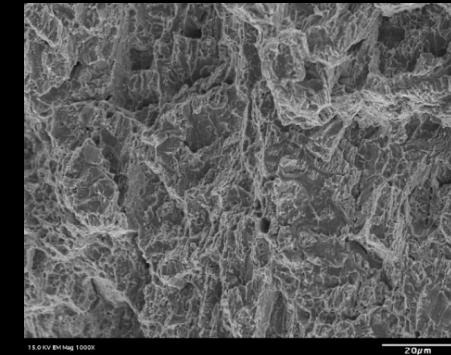
Fracture tests fractography revealed distinct differences at 293 K and 223 K

- At 293 K, dendritic structure was visible on weld fracture surfaces
 - Clear that dendritic ferrite participated in crack nucleation & growth
- At 223 K, dendritic structure mostly absent

Differences in fracture surface features suggests ferrite participates differently in fracture at low temperature

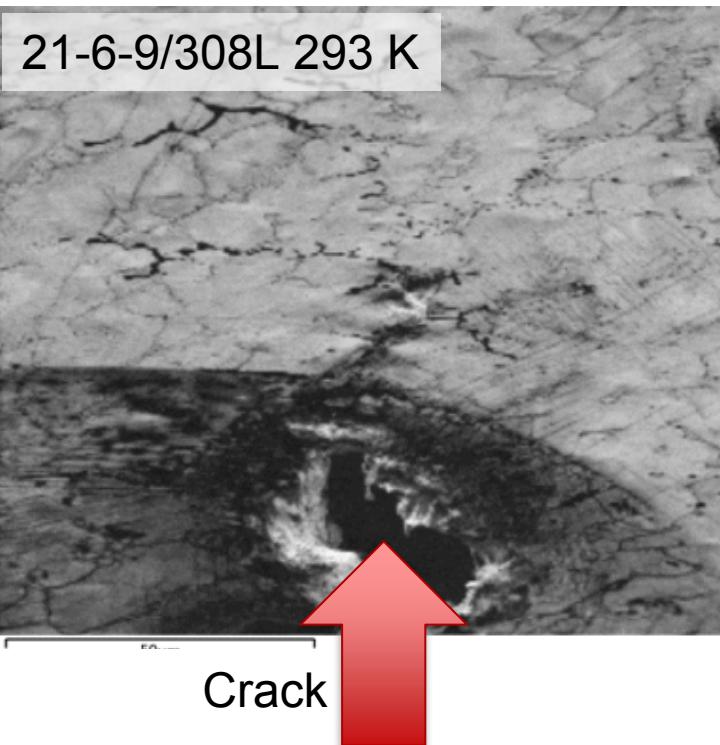
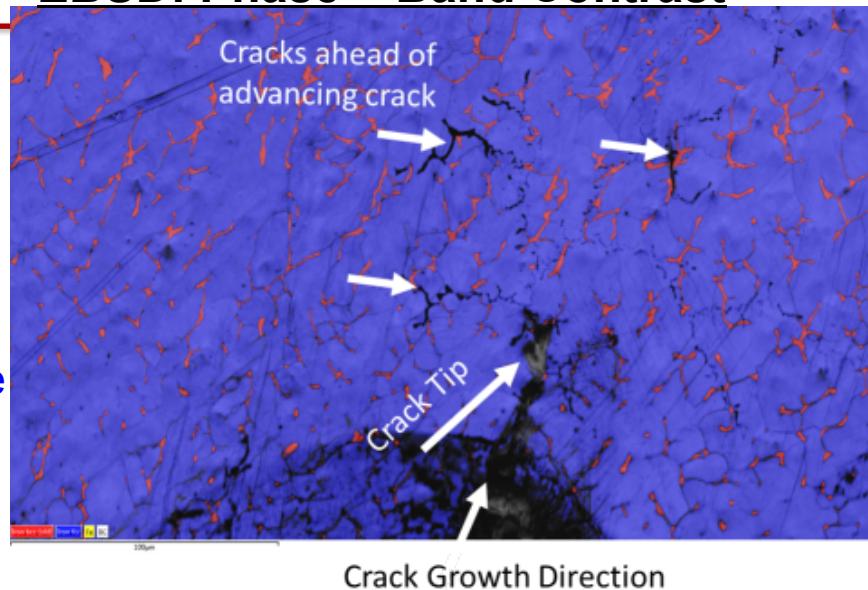
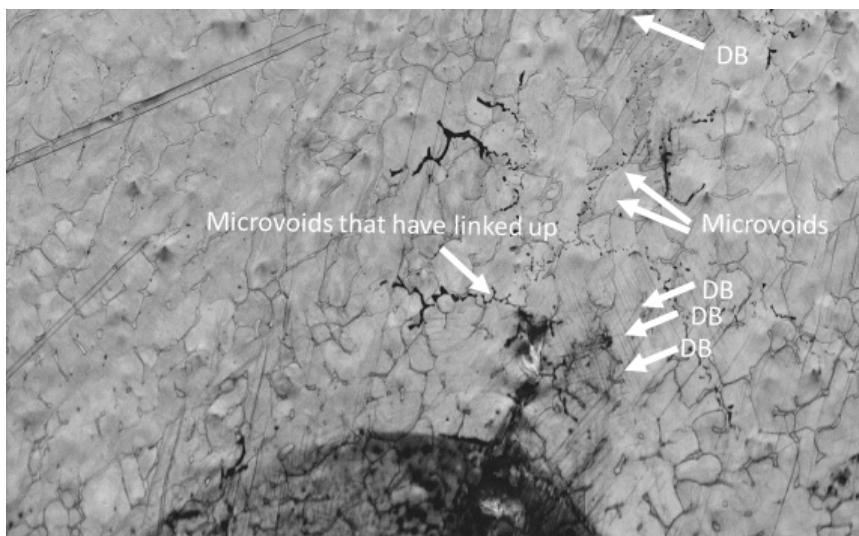
Deformation structures ahead of crack tip at 293K

EBSD: Phase + Band Contrast

Ferrite: red
Austenite: blue

EBSD: Band Contrast

- Damage occurs as voids which link up to form microcracks.
- Deformation bands (DB) appear ahead of advancing crack
- Damage located at or near ferrite

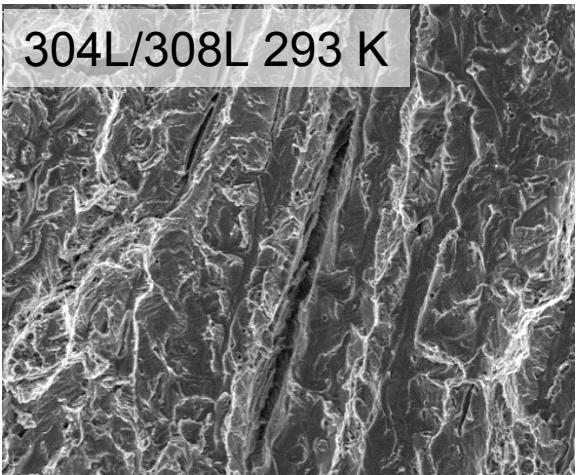
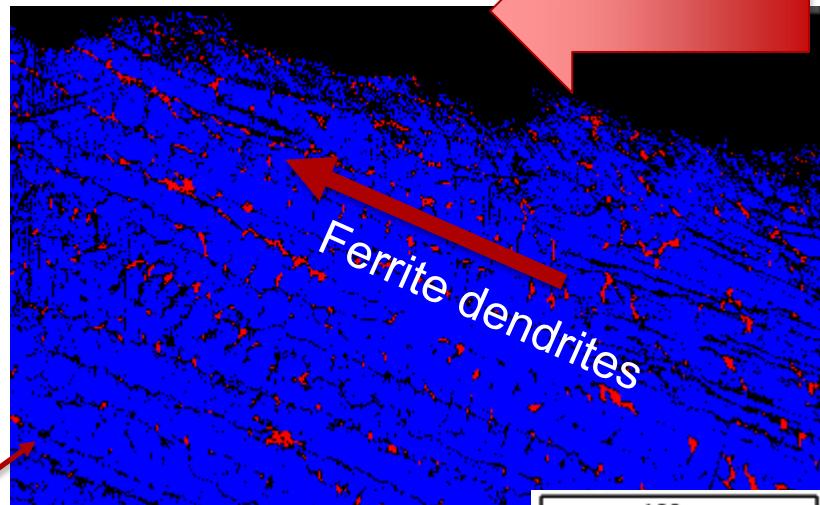
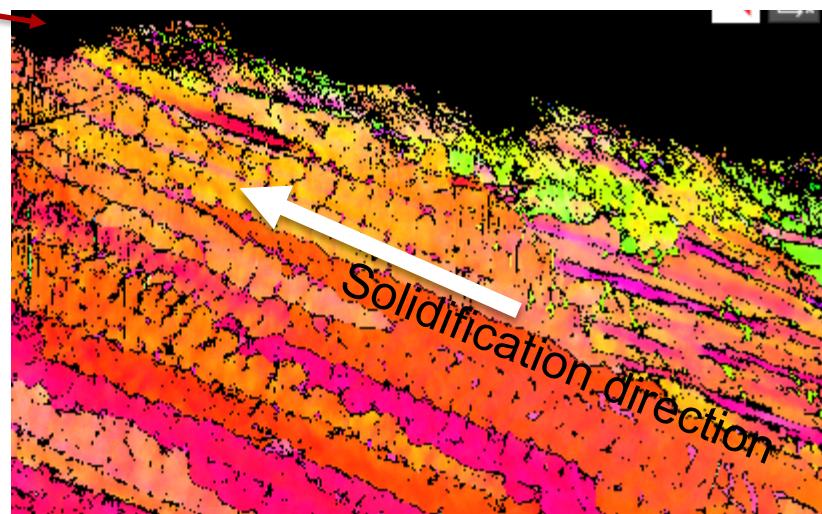
Deformation structures below fracture surface at 293K

Ferrite: red
Austenite: blue

EBSD: Phase
IPF

Crack Growth Direction

- Fracture path follows dendritic structures
- Ferrite appears to be predominant pathway.

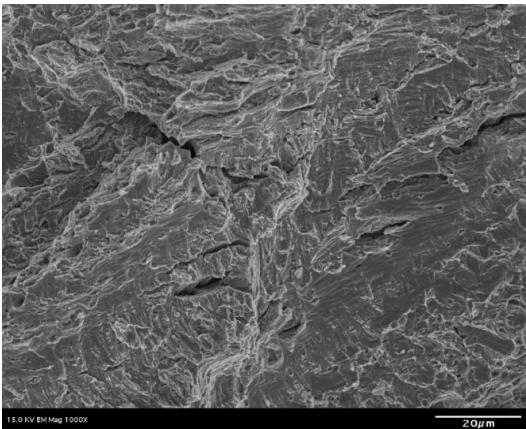
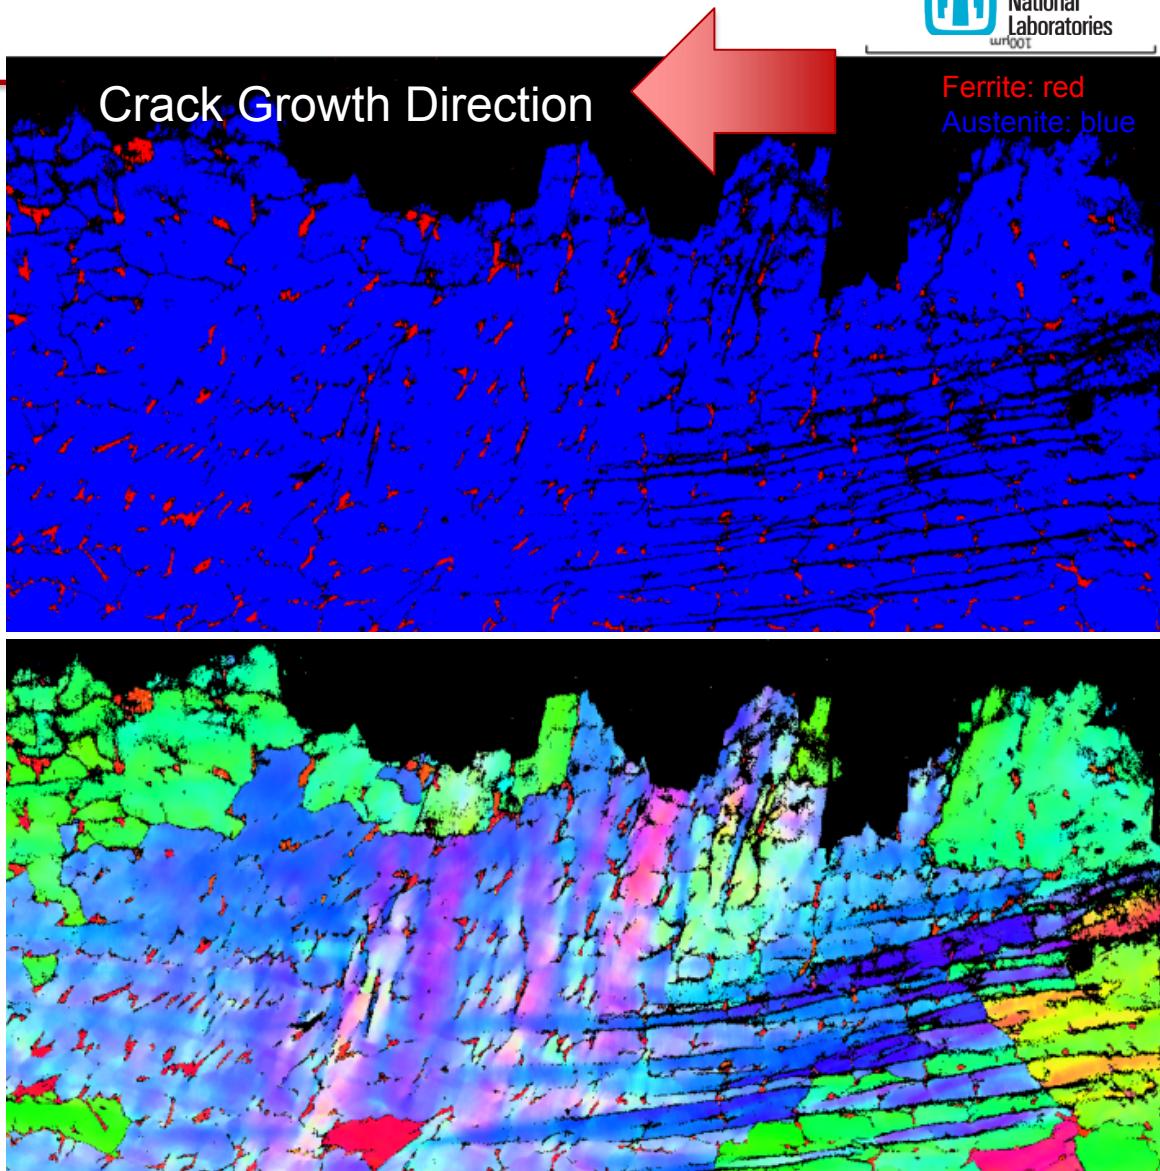
21-6-9/308L 223 K

Deformation structure below fracture surface at 223 K

- Dendritic features are absent on fracture surface
- Crack profile is more tortuous, e.g. does not follow solidification dendrites

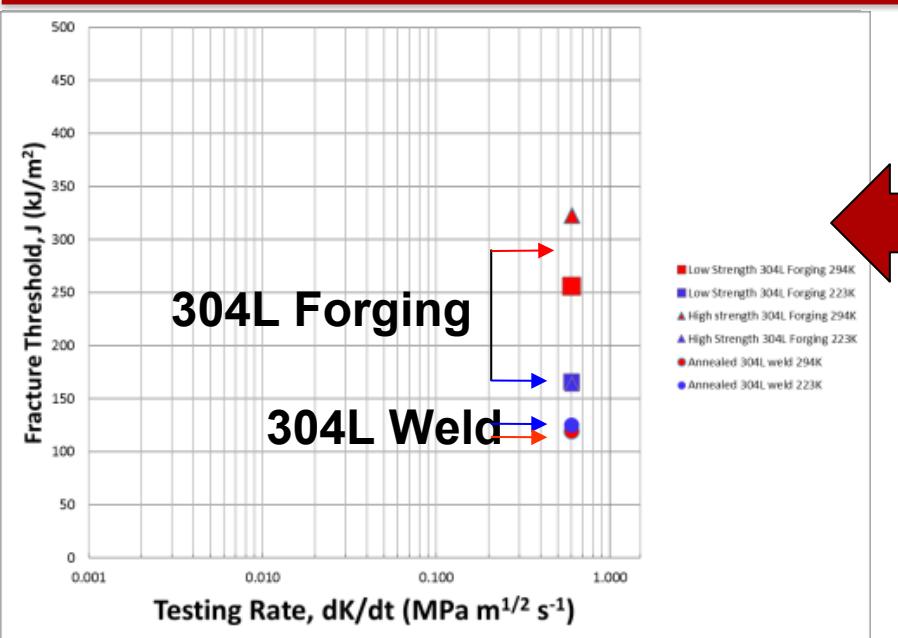
Temperature Effects on forgings vs welds

- 304L Forgings exhibited temperature effects
 - **Low T = lower toughness**
- Annealed 304L/308L welds → No temp effects

Jackson et al (2012,2016)

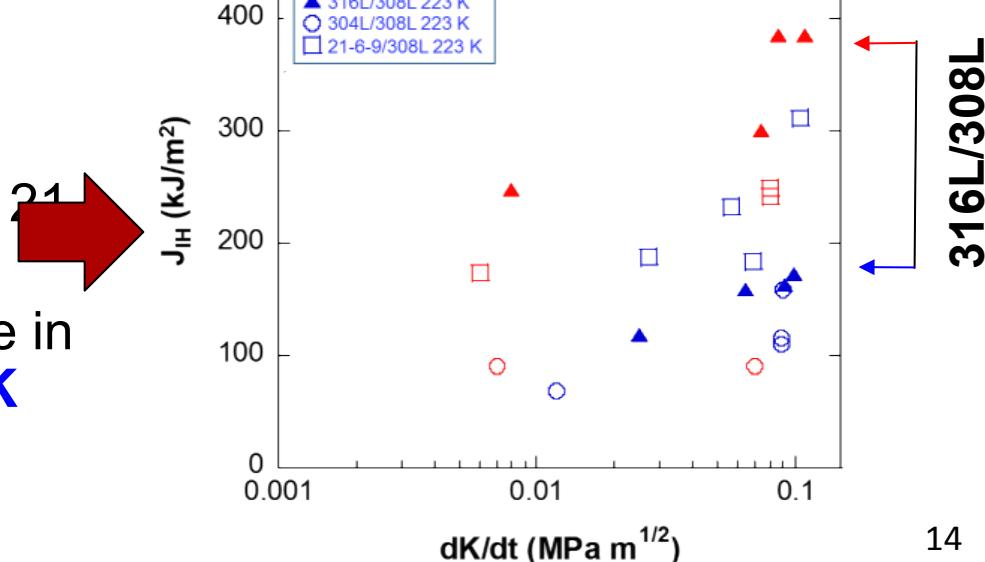
- Minimal temperature effects on fracture toughness for 304L and -6-9 welds
- 316L welds → Over 50% decrease in toughness for 316L welds at **223 K**
- Similar rate dependence at both temperatures

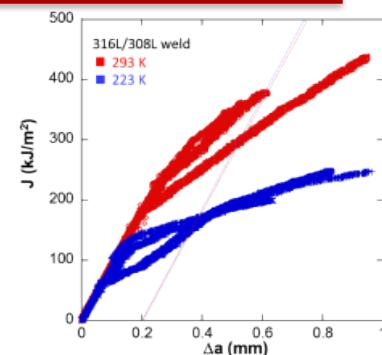
Low Temperature can exacerbate slip planarity

316L/308L weld exhibited enhanced degradation at low temperature

- Low temperature reduces SFE and enhances planar slip
- High Ni-content promoted cross slip at 293K
 - At 223 K, deformation may transition into planar slip accounting for large reduction in toughness

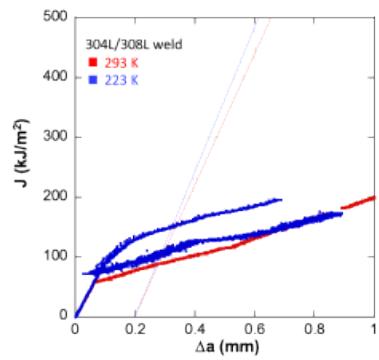
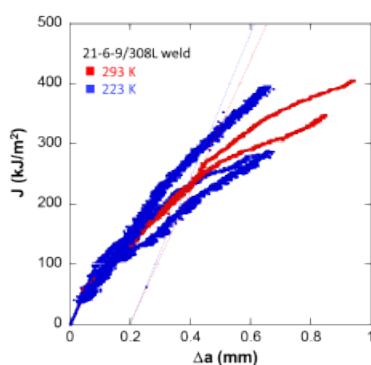
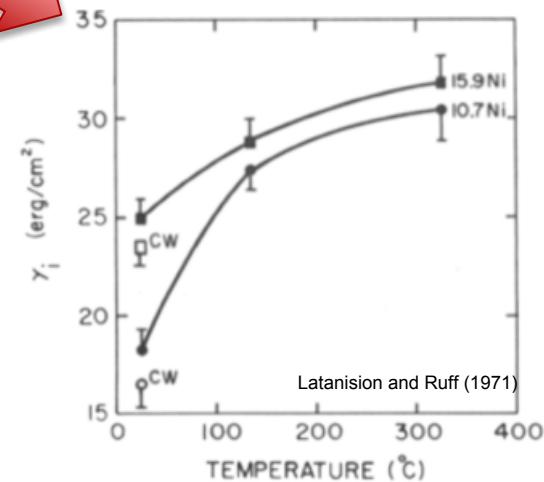
304L/308L and 21-6-9/308L welds contain lower Ni-content and therefore may already exhibit a significant amount of planar slip at 293 K

- Therefore less sensitive to temperature when tested at 223 K.

Composition, Temperature, and hydrogen can influence deformation mechanisms
