# Multi-Parameter Optical Fiber Sensor for Simultaneous Corrosion and Humidity Monitoring

C2021-16909

Presented to CORROSION 2021 Virtual Conference & Expo

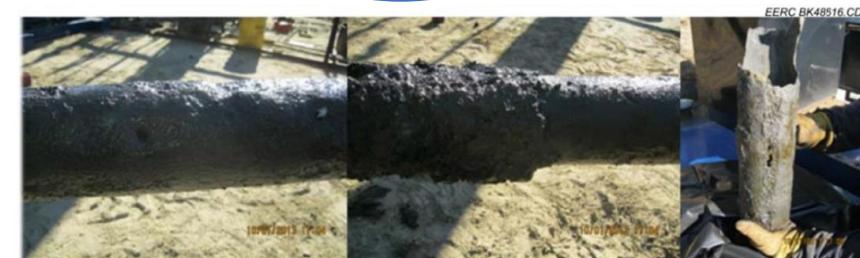
Corroded production casing pipe sample from downhole

(University of North Dakota Energy & Environmental Research Center)

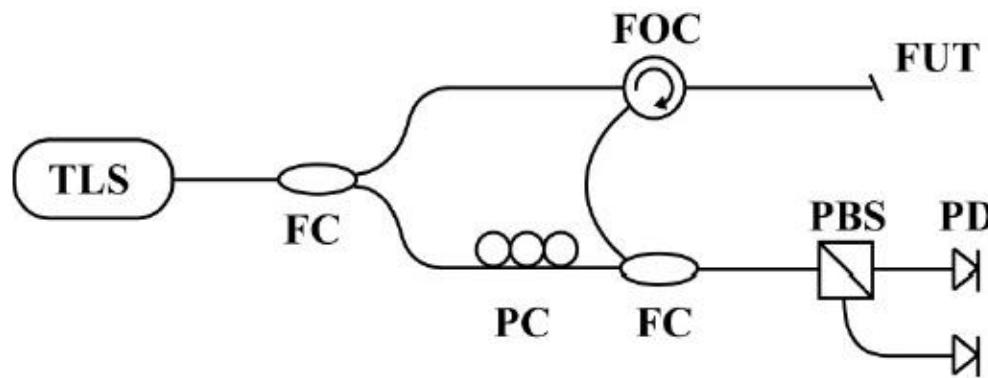
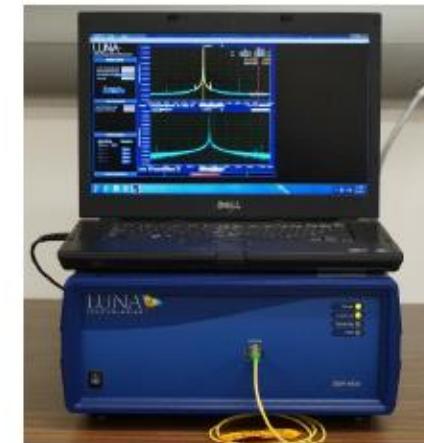
- This instrument measures the Rayleigh backscattering from the fiber-under-test (FUT).
- Provides spatially distributed measurements along the fiber with location and sensing information.

Figure 1 – LUNA OBR 4600 distributed interrogator LEFT: internal components (TLS: tunable laser source, FC: fiber coupler, FOC: fiber optic circulator, PC: polarization controller, PBS: polarizing beamsplitter, PD: photodiode); RIGHT: photo of instrument.

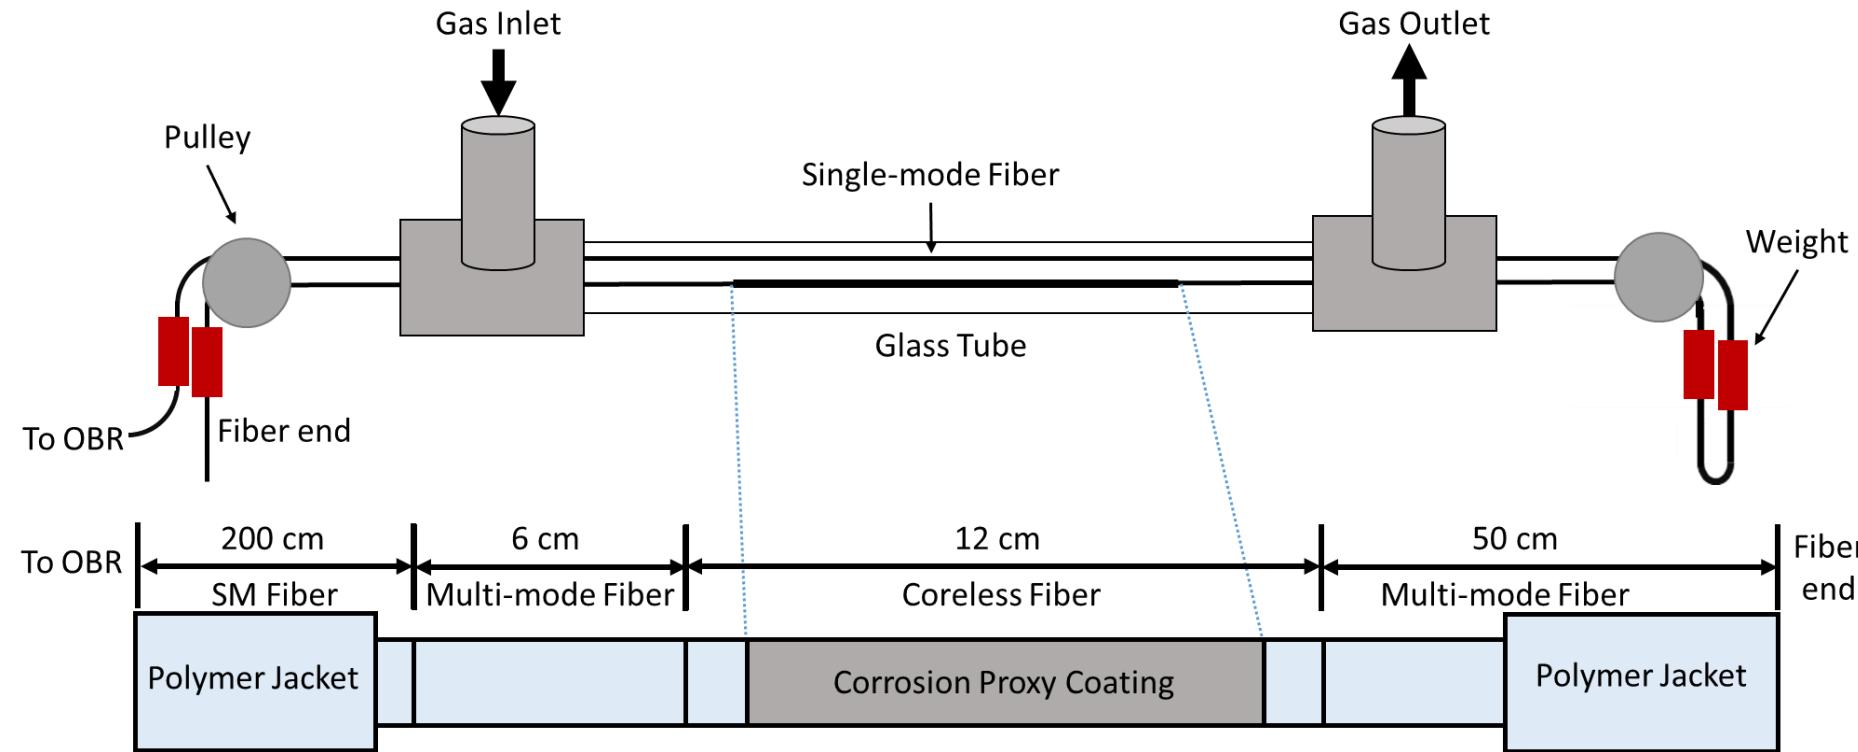
**Schematic diagram of the spliced optical fiber sensor configuration and the experimental setup for distributed measurements in a glass tube.**

- The multi-parameter sensor was prepared by combining a corrosion sensor and a water sensor, which were then connected to and interrogated by an OBR. Corrosion was detected from light intensity changes associated with the corrosion proxy metallic coatings, and changes in water/humidity were monitored based on the water-induced strain changes along the optical fiber.

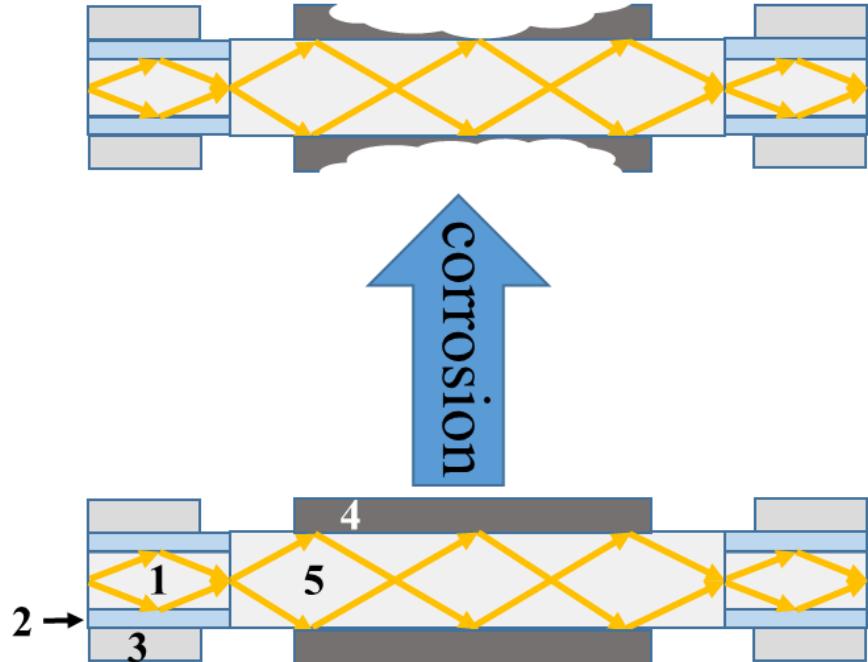
1—multi-mode fiber core; 2—cladding;  
3—polymer jacket; 4—coated metallic  
film; 5—coreless optical fiber.

- The metallic thin film leads to broadband light absorption in the evanescent field, which occurs at the interface between the optical fiber and the thin film along the fiber.
- As the metallic film gets thinner, the light absorption of the film decreases; therefore, the light transmission increases through the optical fiber.

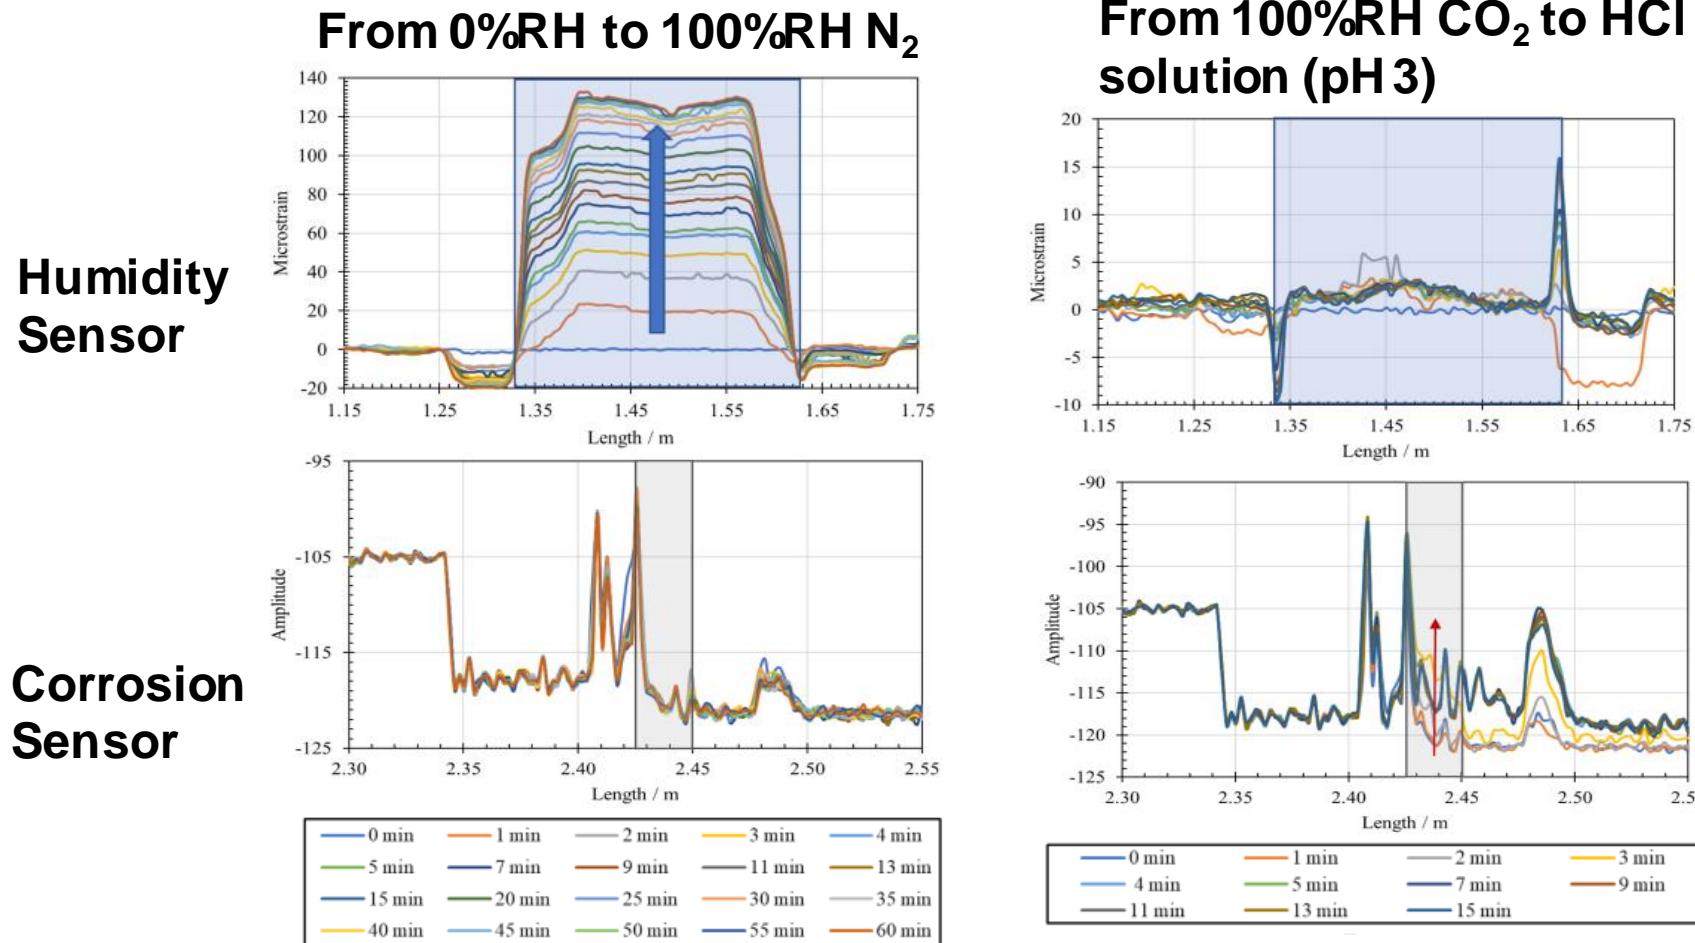
- Humidity increased strain by  $\sim 125 \mu\epsilon$  due to water-induced swelling of optical fiber polymer jacket.
- Corrosion increased the backscattered light intensity in the X65 thin film coated location.

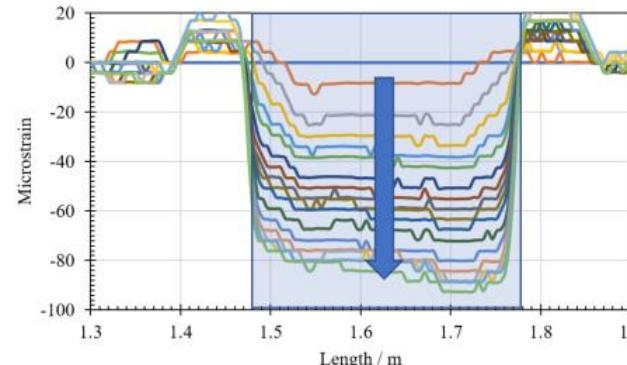
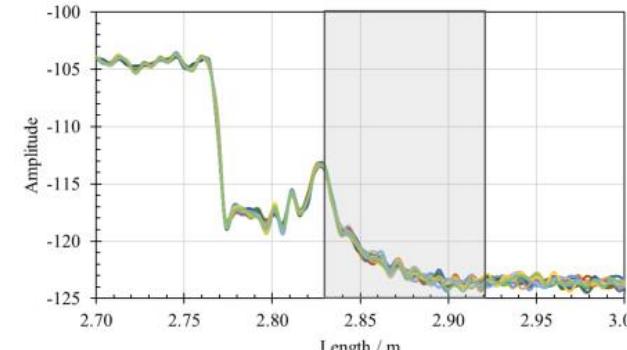
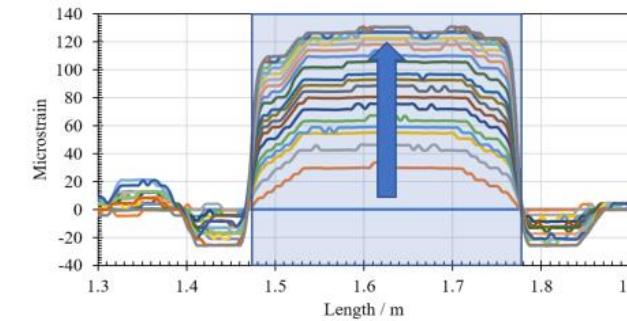
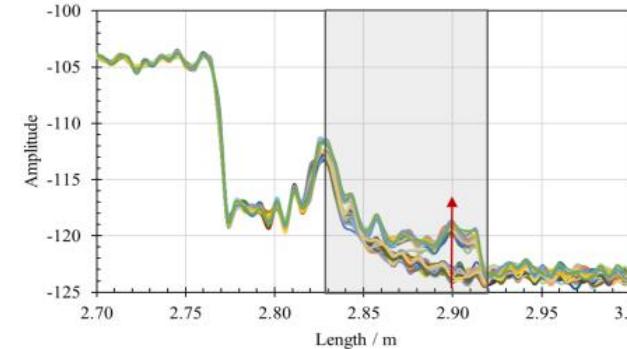
- Corrosion proxy sensor doesn't have cross-sensitivity to humidity.
- Wet CO<sub>2</sub>-caused localized corrosion was monitored as only a few locations of the Fe coating showed an increase in the backscattered light intensity.

- The corrosion proxy sensor didn't show cross-sensitivity to humidity variation.
- After the wet  $\text{CO}_2$  corrosion, localized corrosion was monitored through the non-uniform increase in the backscattered light intensity at a few locations along the optical fiber. This is representative of localized corrosion in natural gas pipelines.

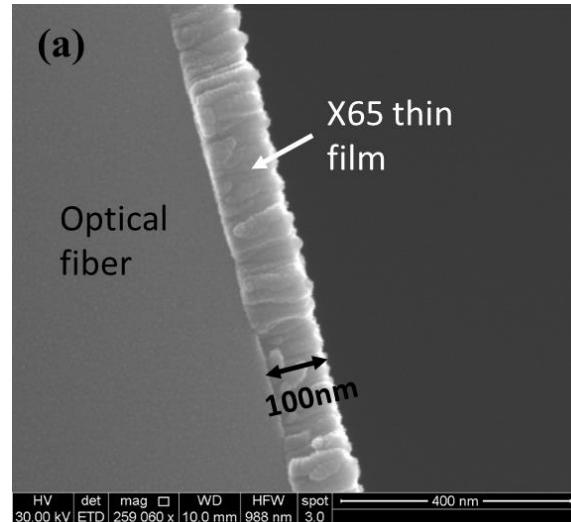
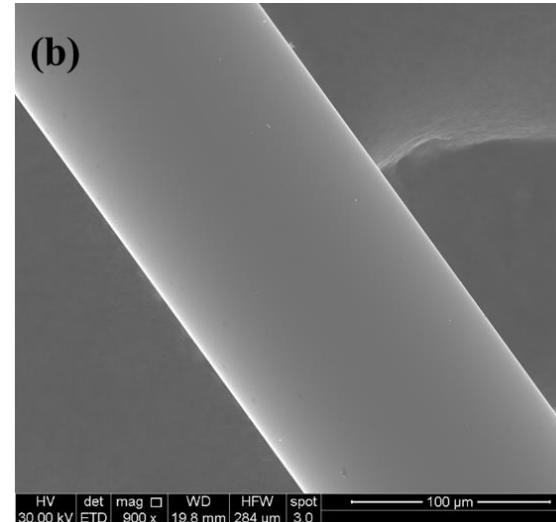
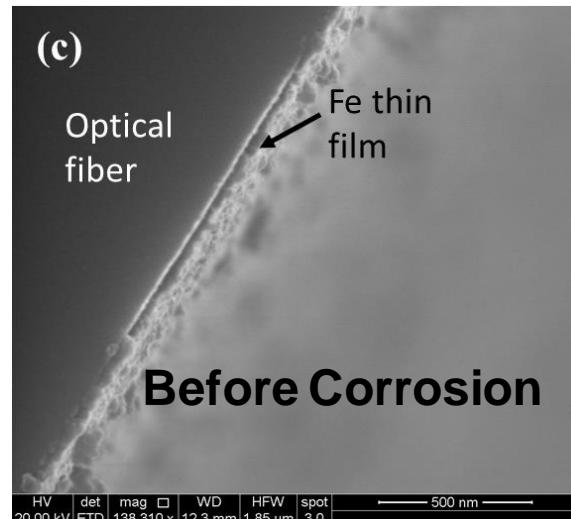
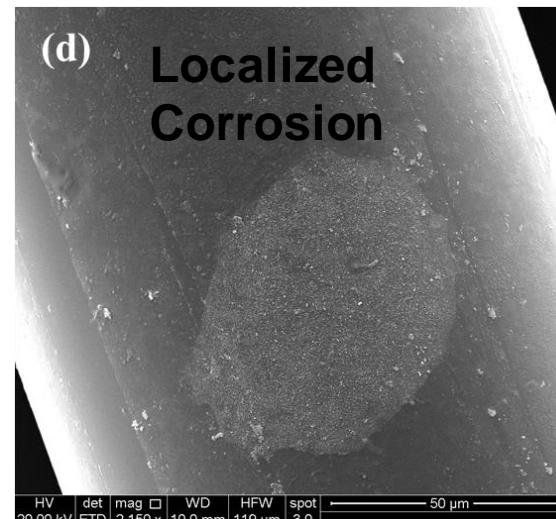
## X65 Carbon Steel Thin Film

- SEM results confirm localized corrosion of the Fe thin film after corrosion in wet  $\text{CO}_2$  gas. The XPS results indicate the formation of iron carbonate on the surface of the Fe thin film after wet  $\text{CO}_2$  corrosion.

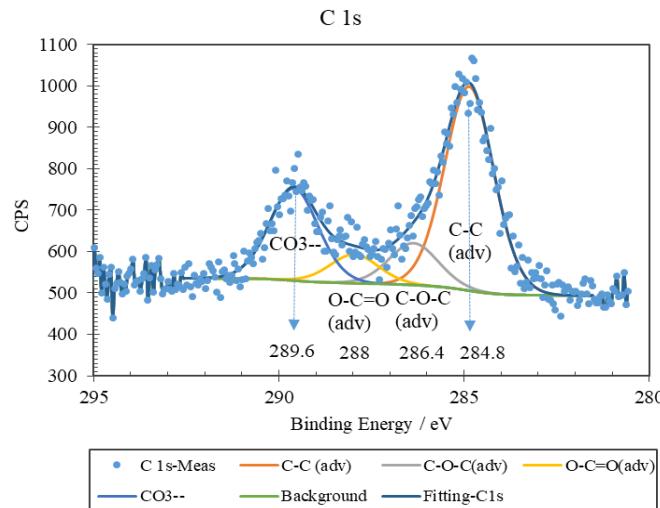
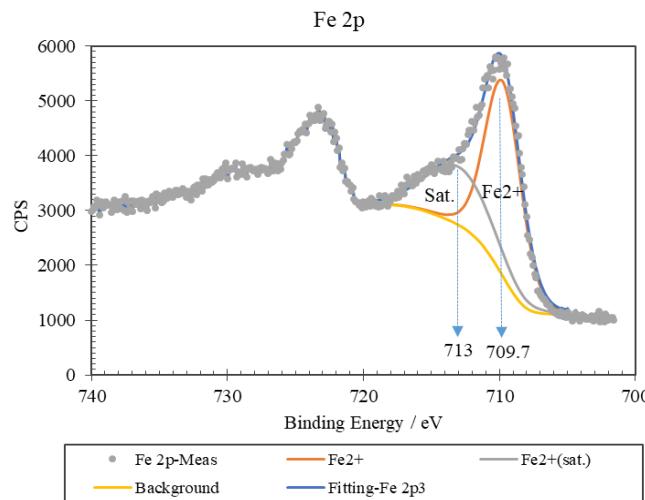
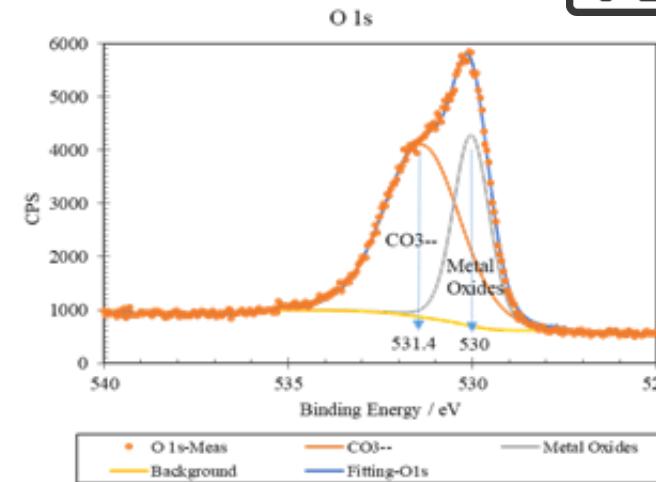
**XPS-determined chemical composition of Fe thin film after exposure in wet CO<sub>2</sub> gas after 1 min ion sputtering (2 KeV).**

- A carbonate (CO<sub>3</sub><sup>2-</sup>) peak was found in the C 1s and O 1s XPS spectra, indicating the formation of iron carbonate (FeCO<sub>3</sub>) as a corrosion product.
- The Fe 2p3/2 spectrum contains an Fe(II) satellite, consistent with the oxidation of Fe to FeCO<sub>3</sub>.
