Metallic Coating Enabled Optical Fiber Sensor for Distributed Corrosion Monitoring

SPIE Paper 11739-13

*Presented to SPIE Defense + Commercial Sensing Digital Forum
April 12-16, 2021*

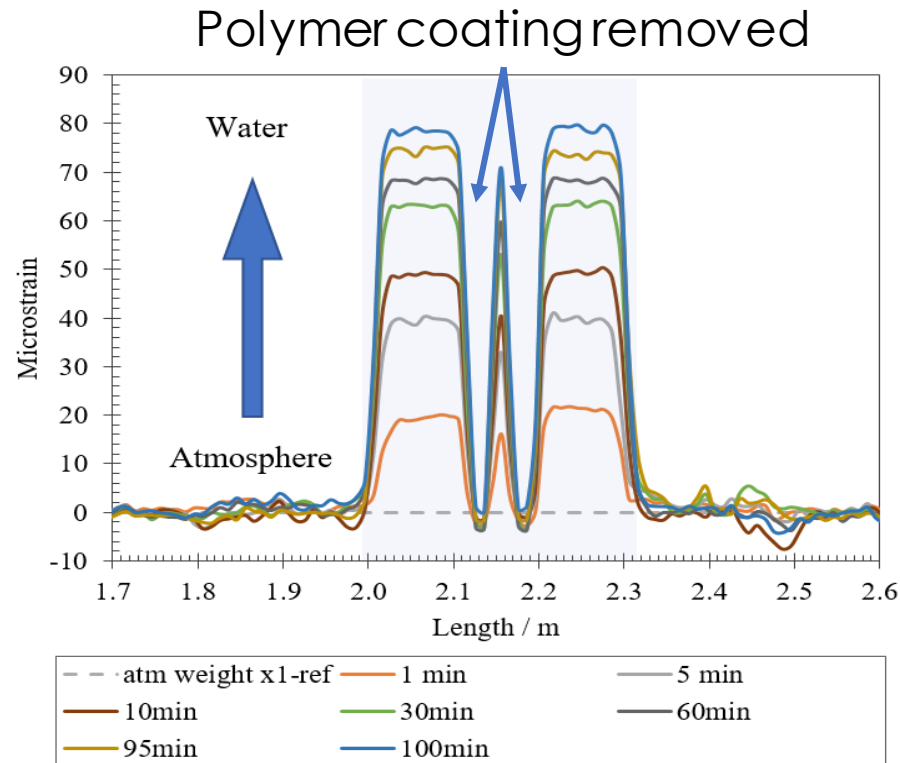
- The intrinsic hygroscopic polymer jacket coating of SMF-28Ultra serves as the water sensing layer due to expansion/swelling from water absorption.
- Reversible humidity sensing and linear correlation between humidity levels and strain along the fiber at room temperature.

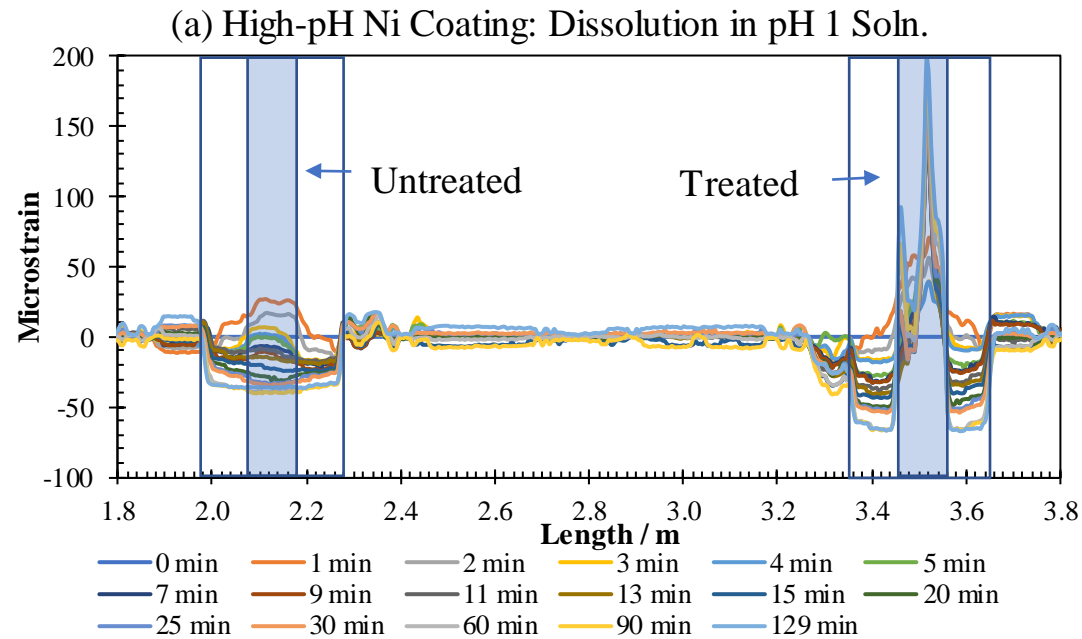
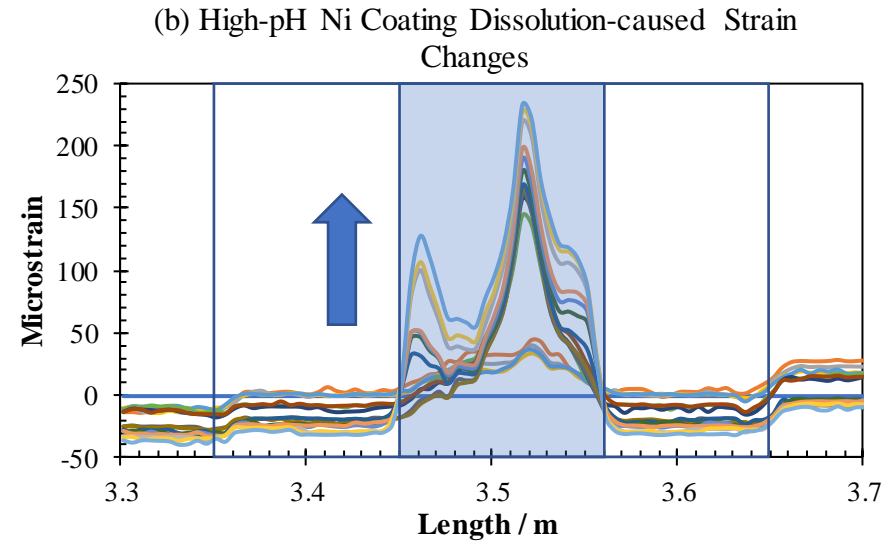
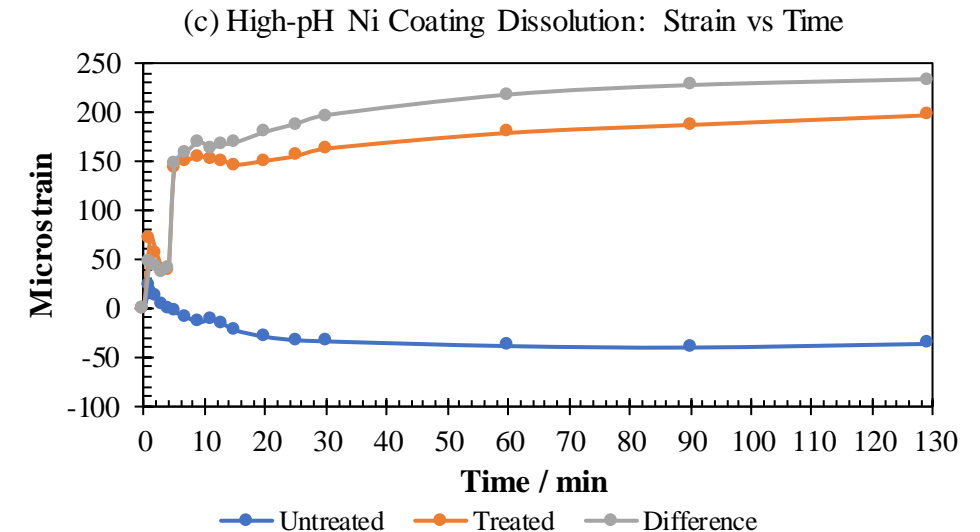
Treated subtracted
by Untreated

- After plating, high-pH Ni coating was exposed to pH 1 HCl soln.
- **Untreated section:** at room temperature (RT), strain showed a minimal decrease to $-36 \mu\epsilon$.
- **Treated section:** strain increased up to $233 \mu\epsilon$ due to Ni dissolution. Two preferable dissolution locations, corresponding to Ni deposition strains.

- High-pH Ni plating had a faster deposition rate and induced negative strains, and the dissolution induced positive strains in the corresponding coating locations.

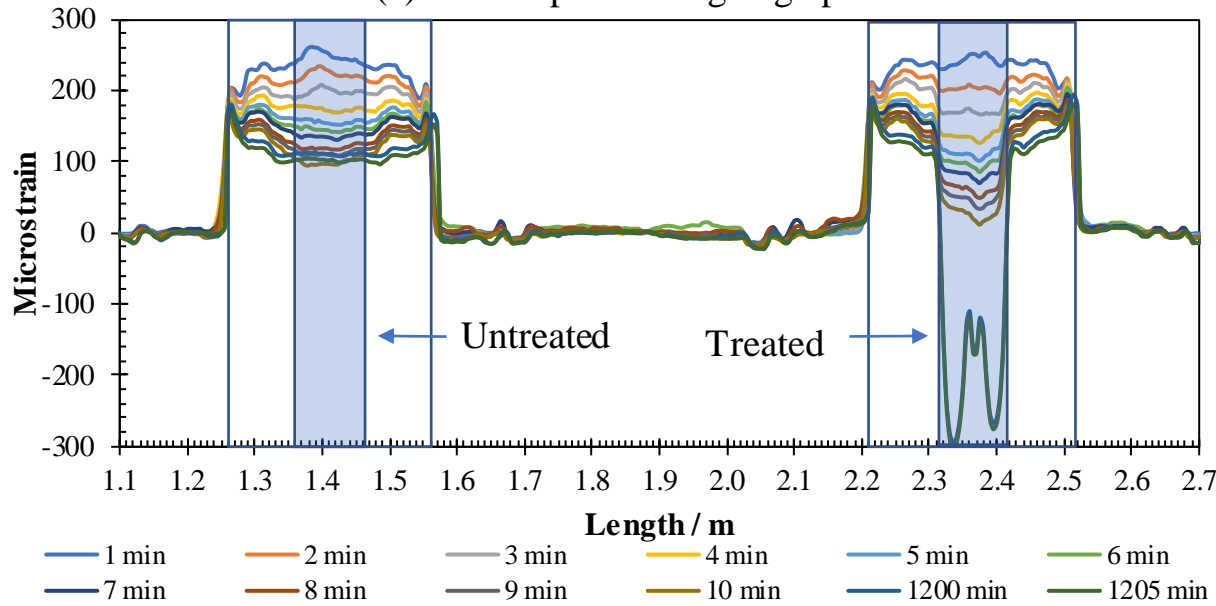
(a) Two-step Ni Plating-High pH

- Two-step Ni plating: Low-pH plating solution for 6 min to deposit the initial layer; then high-pH plating solution with a faster plating rate.
- **Untreated section:** strain increased due to $\sim 50^\circ\text{C}$ Ni plating solution and water-induced swelling; then decreased as the solution cooled down (no heating).
- **Treated section:** strain decreased comparatively due to high-pH Ni plating. 10 min: $-88\ \mu\epsilon$; 20 hr: $-407\ \mu\epsilon$.

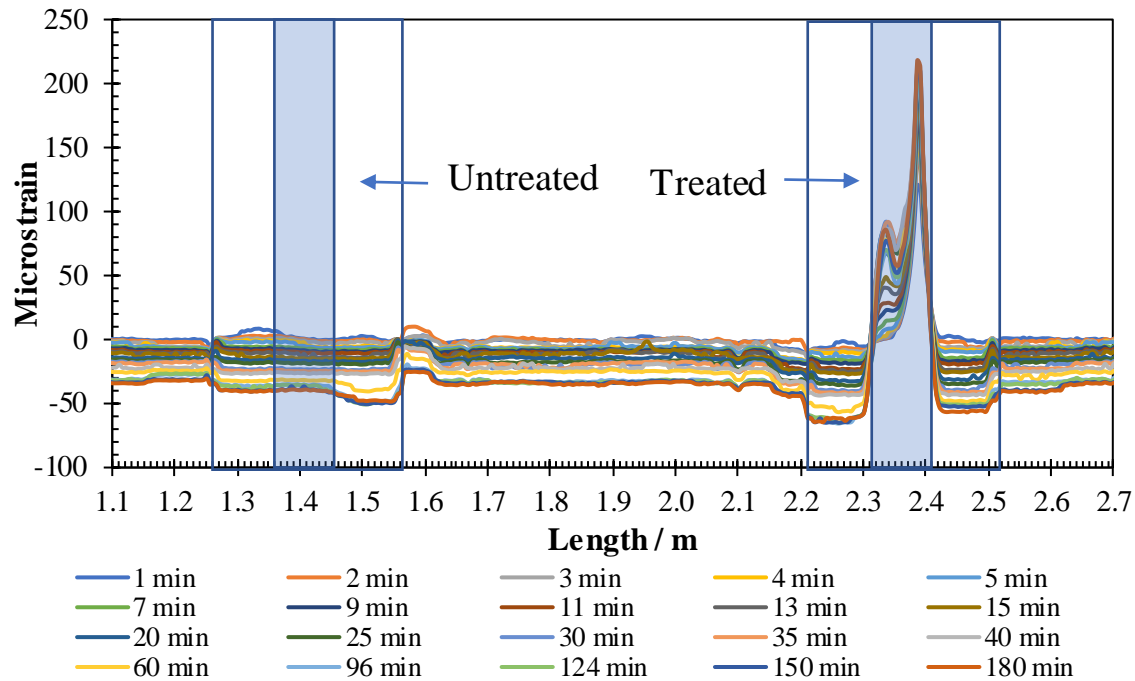
(a) Two-step Ni Coating: Dissolution in pH 1.5 Soln.

- After plating, two-step Ni coating was exposed to pH 1.5 HCl soln.
- **Untreated section:** at RT, strain showed minimal changes.
- **Treated section:** strain increased comparatively up to $\sim 260 \mu\epsilon$ due to Ni dissolution. Two preferable dissolution locations, corresponding to Ni deposition strains.

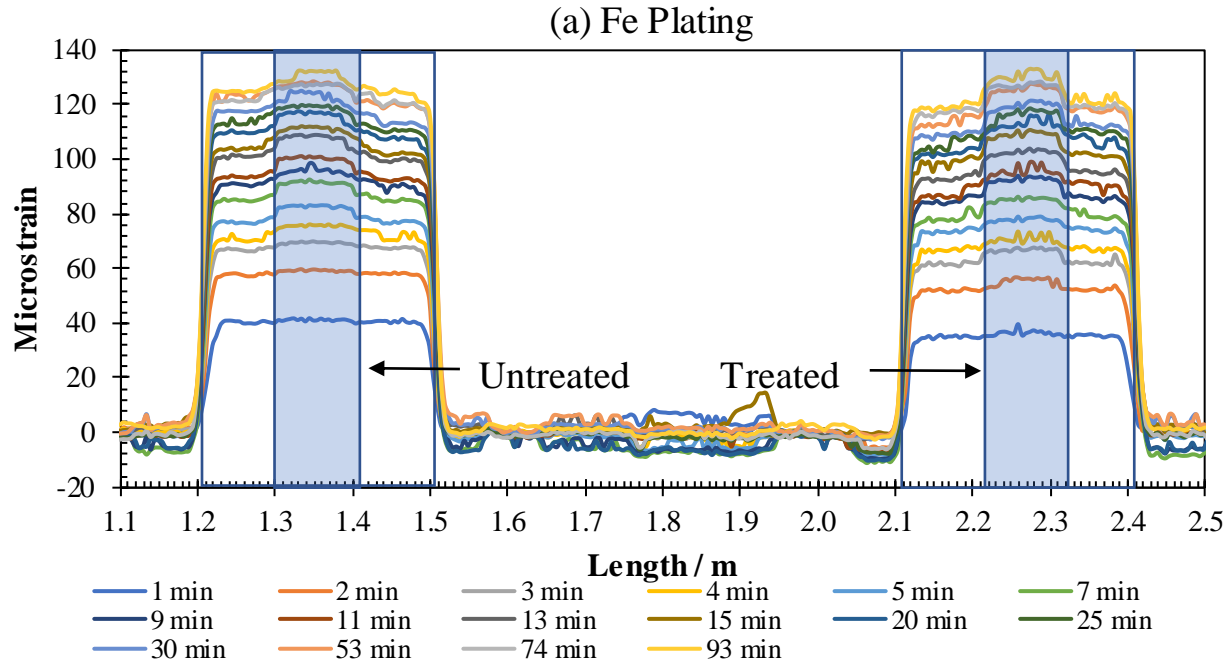
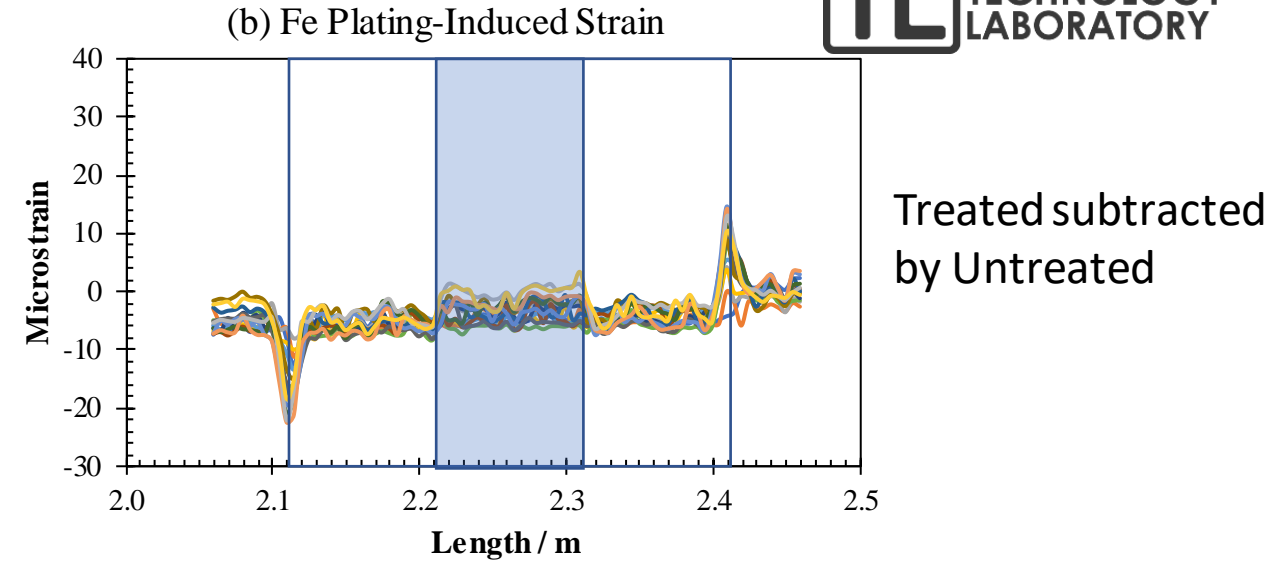
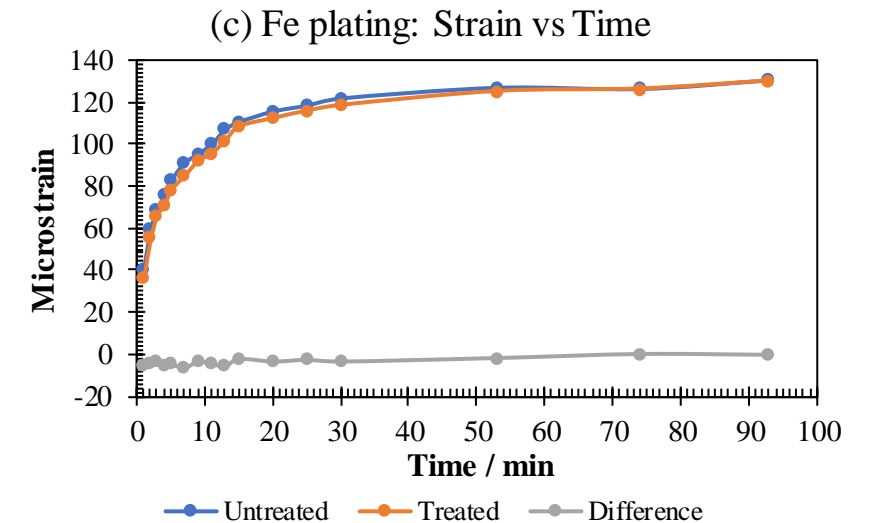
Fe Plating Induced Negligible Strains

- **Untreated section:** at RT, strain increased due to water-induced swelling.
- **Treated section:** strain increased similarly to the untreated section, leading to minimal strains (near-zero) due to Fe plating.

- Low-pH Ni plating and Fe plating had a relative slow and smooth coating, which induced minimal strains.
- Two-step Ni plating includes low-pH plating to deposit an initial layer and then high-pH plating with a faster deposition rate. The high-pH Ni plating induced negative strains.
