Sandia
National
Laboratories

SAND2021-2457C

Disinfectant corrosivity with shipboard HY80 steel

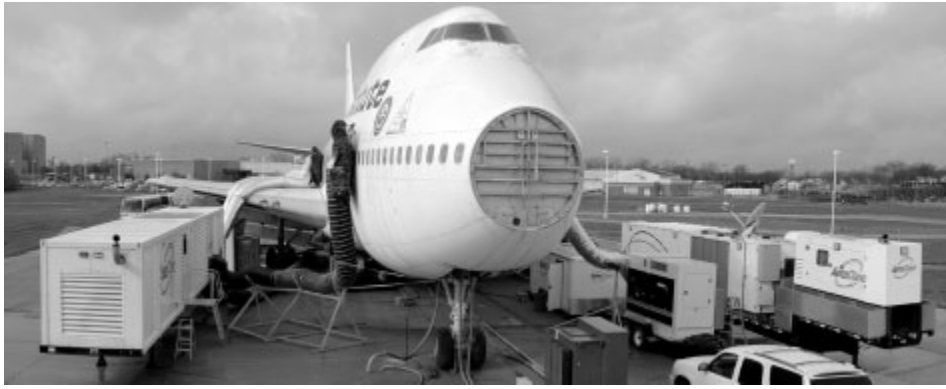
Demonstration of decontamination of entire wide body airliner cabin using VHP.

Application of some disinfectants (hydrogen peroxide based) is done through vaporization of the solution, such as **vaporized hydrogen peroxide (VHP)**.

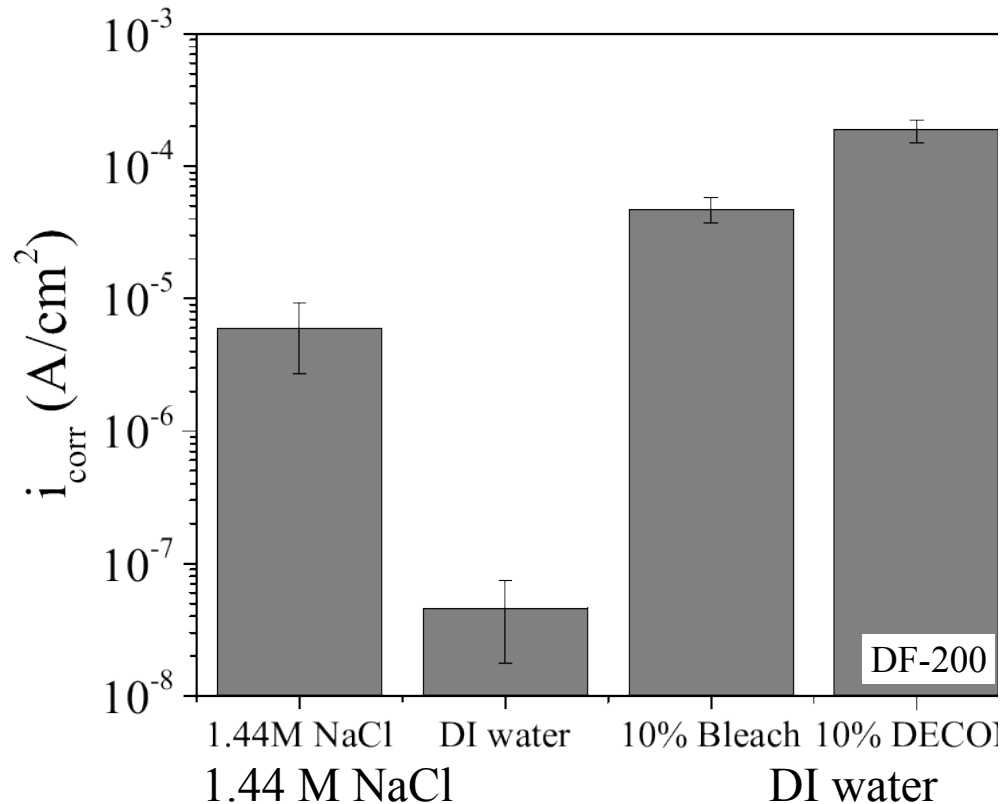
Observations after 1 hour immersion electrochemical tests

1. The **corrosion rates** of HY80 steel when immersed for an hour in 10% Bleach and 10% DF-200 disinfectants **are similar**.
2. The corrosion rate caused by the NaCl solution was **~1 order of magnitude less** than the disinfectants after 1 hour immersion.
3. Deionized water caused the smallest corrosion rate.

$$\text{Corrosion rate} \propto \frac{1}{R_p} \propto i_{corr}$$

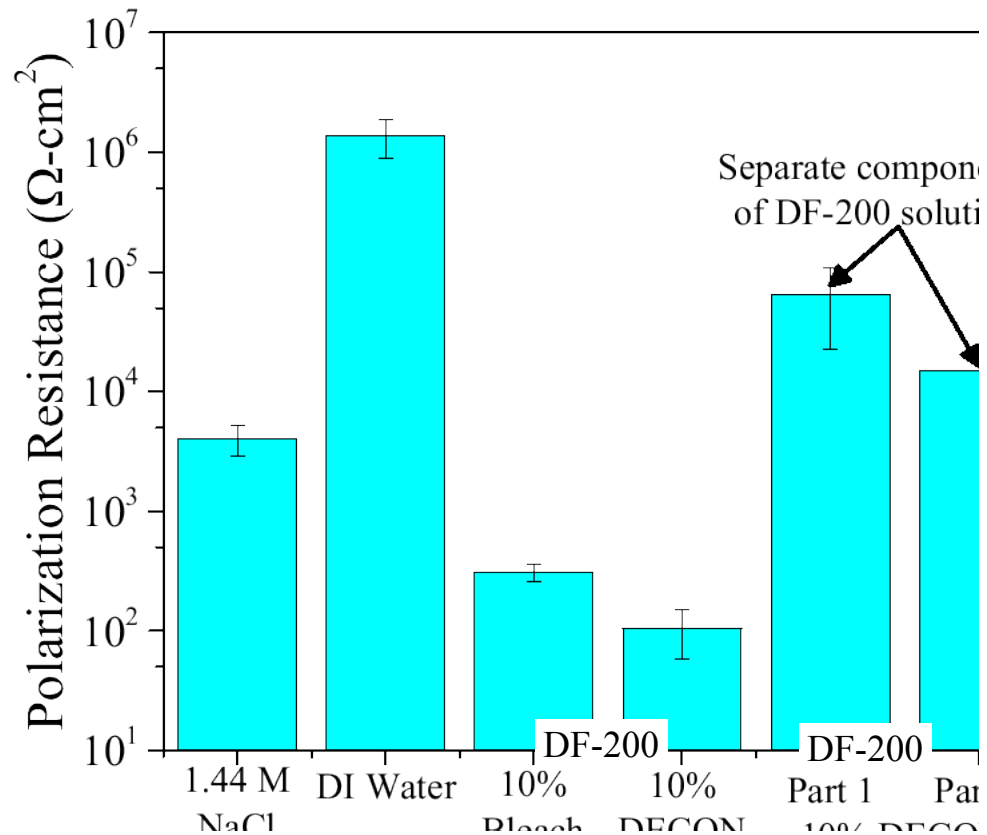
Observations after 1 hour immersion electrochemical tests

$$\text{Corrosion rate} \propto \frac{1}{R_p} \propto i_{corr}$$

1. The corrosion rate determined by **polarization resistance (R_p)** corresponds to i_{corr} values.
2. Samples were immersed in the separate parts of the DF-200 solution:
 - Part 1 – Detergents.
 - Part 2 – Hydrogen peroxide.
 - The corrosion rate caused by **part 1** was 2 orders of magnitude less than the combined solution.
 - The corrosion rate caused by **part 2** was ~ 2 orders of magnitude less than the combined solution.
 - This rate diminished over time but corrosion product was prevalent on the surface.

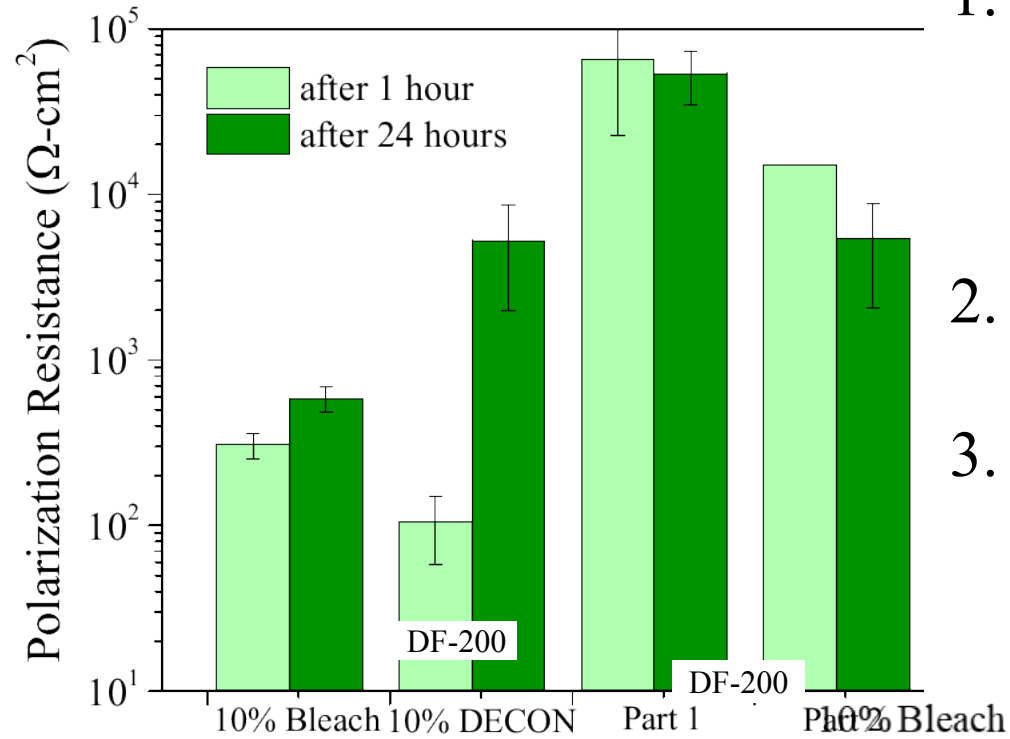
Observations after 1 and 24 hours immersion tests

1. After 24 hours, the samples immersed in DF-200 saw **~2 orders of magnitude reduction** in corrosion rate (This is caused by the concentration of H_2O_2 diminishing with time – result was somewhat expected).
2. After 24 hours, the samples immersed in bleach saw **minimal change in corrosion rate**.
3. The Part 1 and Part 2 of DF-200 both exhibited lower corrosion rates at all times than 10% DF-200 with all parts.

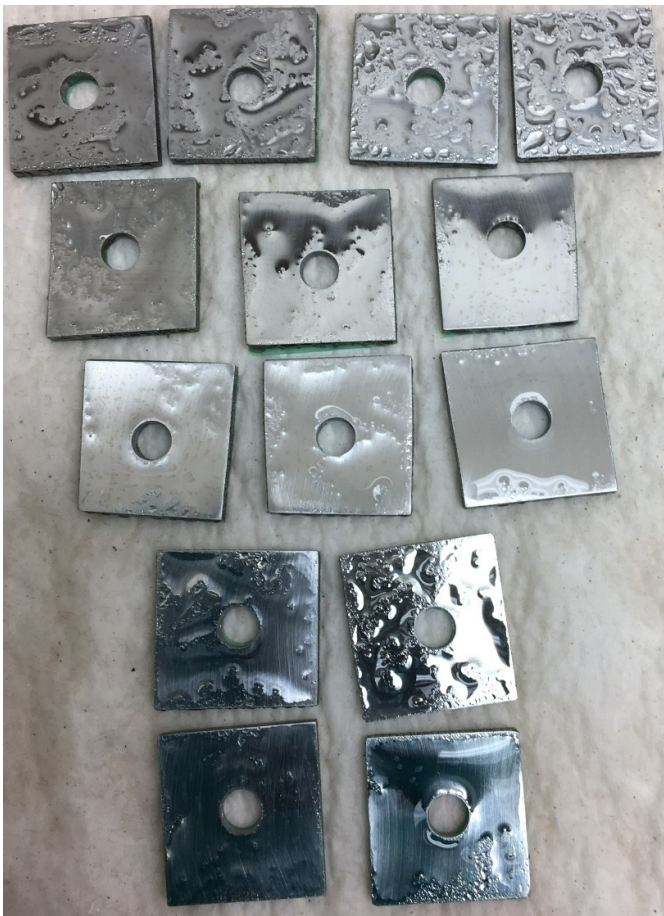
Disinfectants sprayed onto HY80 samples after grinding to 400 grit finish.

Samples are laid out in hood

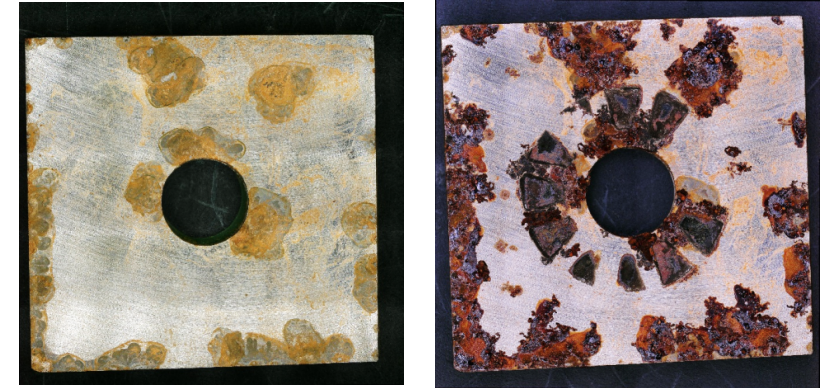
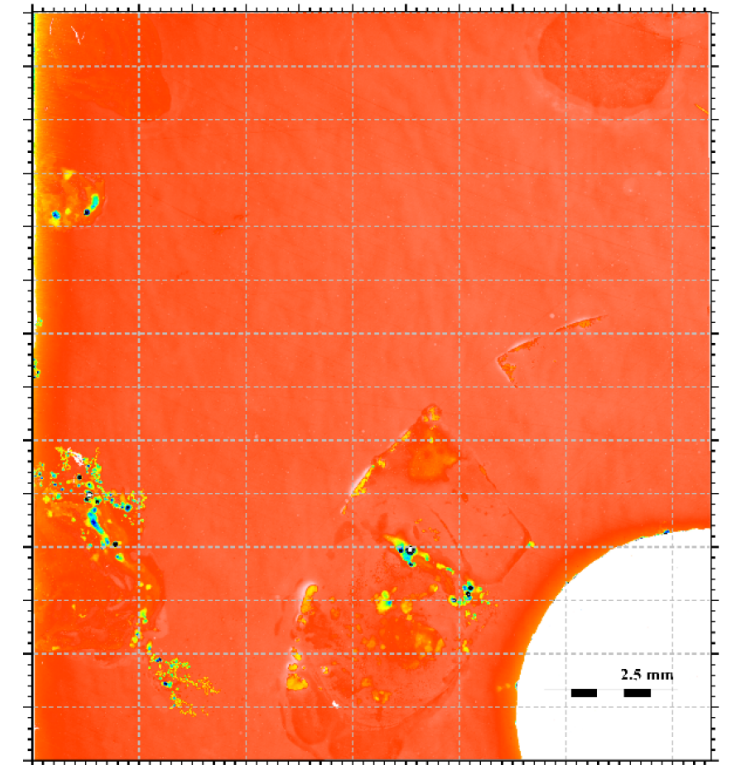
10% DF-200-no rinse
After disinfectant After humidity test

- Similar damage morphology, coverage, and mass loss to samples with NaCl.
- Corrosion damaged caused by the full concentration DF-200 samples covered less area than the 10% dilute samples, however this corrosion tended to be more localized, penetrating deeper.

Prior to the humidity test - The corrosion that occurred around the edge of the samples, in particular for the DF-200 solution, was likely caused by a meniscus/droplet edge effect coupled with the oxidizing intensity of hydrogen peroxide. These edge regions become the main areas of corrosion initiation and are accelerated with an oxidizer.
