SAND2021-6179C

Casing Deformation at the Big Hill SPR Site

Barry L. Roberts – Sandia National Labs

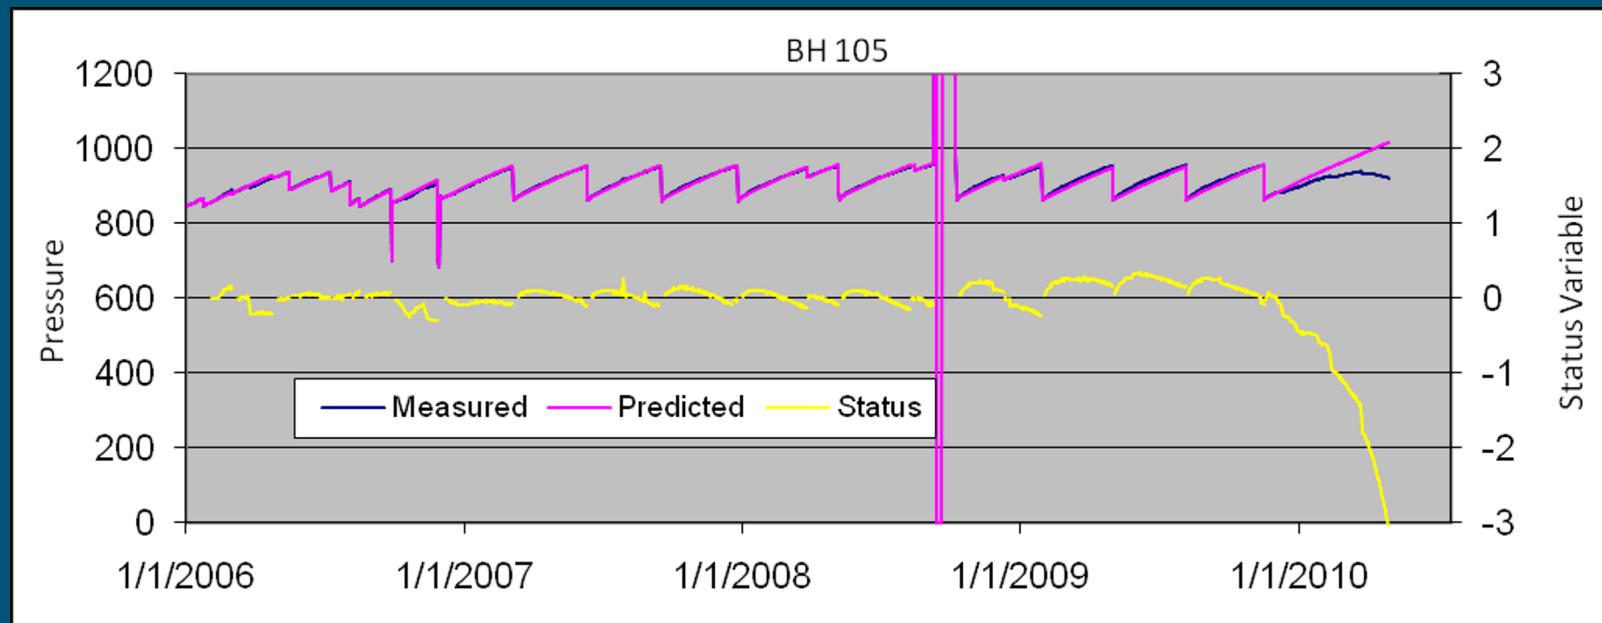
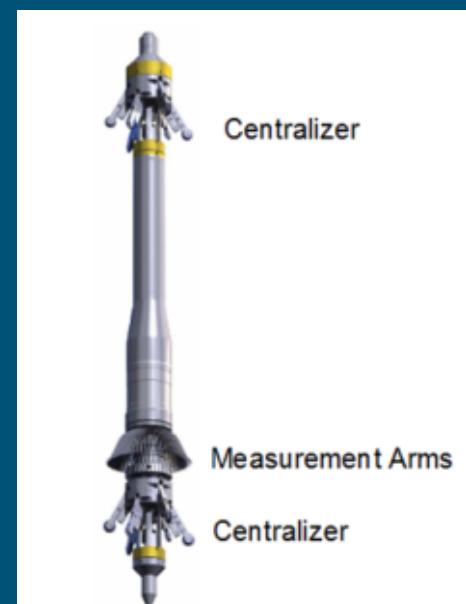
Recognition of Well Integrity Issues at Big Hill

- 2009 - Recognition of loss of pressure integrity for BH-105B and BH-109B
- Wells subsequently remediated via liner installation
- Multi-Arm Caliper (MAC) Surveys of SPR wells started in 2010

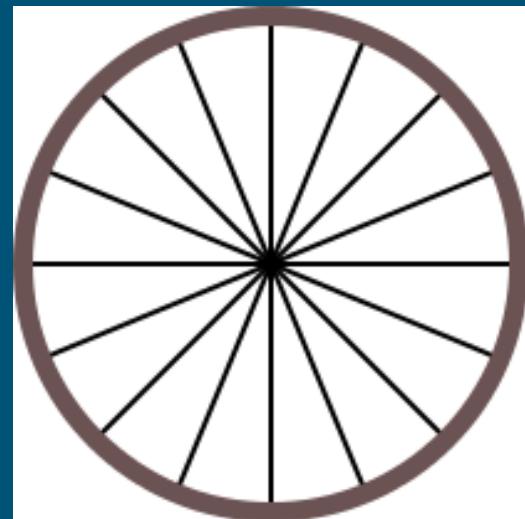
Nearly Circular Cross Section

Diameter values nearly equal
Low Cv values

$$C_v = \frac{\sigma}{\mu}$$

Investigations show that the coefficient of variation – Cv – of the diameter values provides a robust indicator of casing deformation suitable for differing well configurations

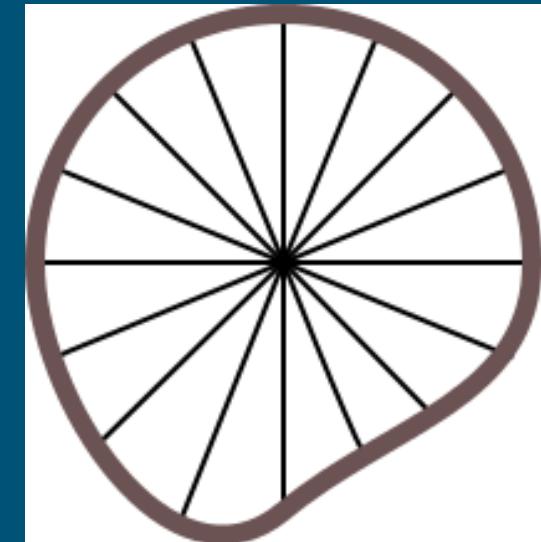
Deformed Cross Section

Diameter values vary significantly
Higher Cv values

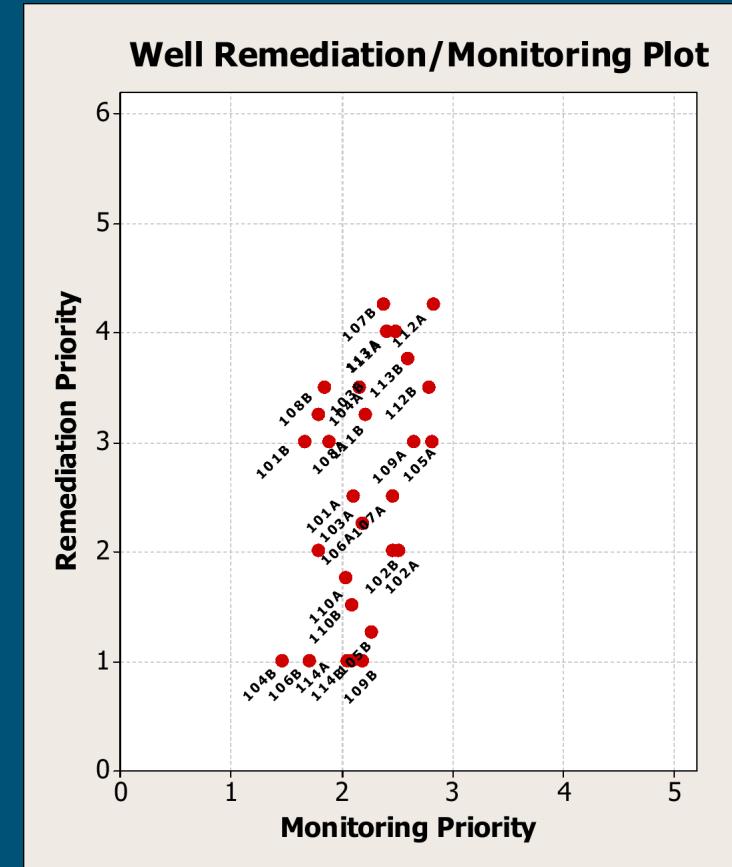
Grading Data Tabulation

- Well grading framework developed for SPR
- Considers geology, simulation results, cavern geometry, well history, etc.
- Main driving components are MAC survey data and pressure history

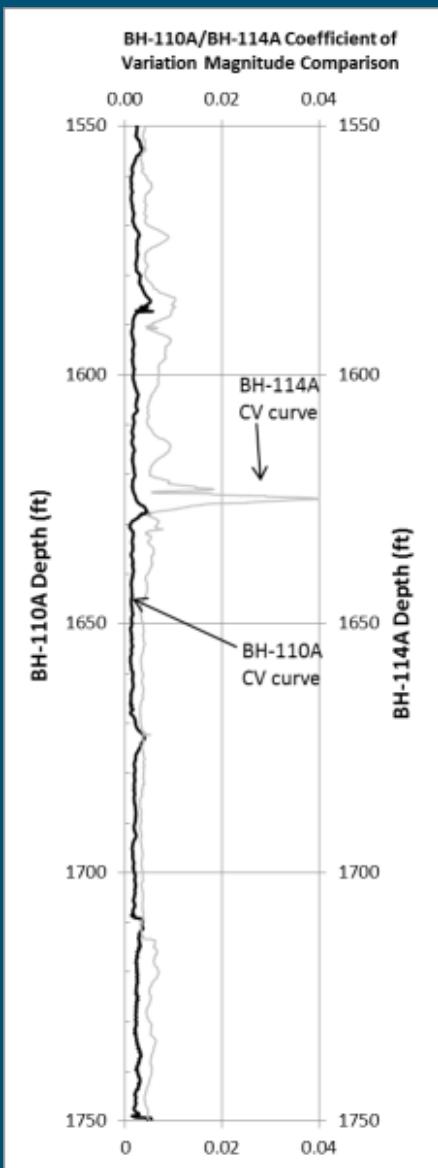
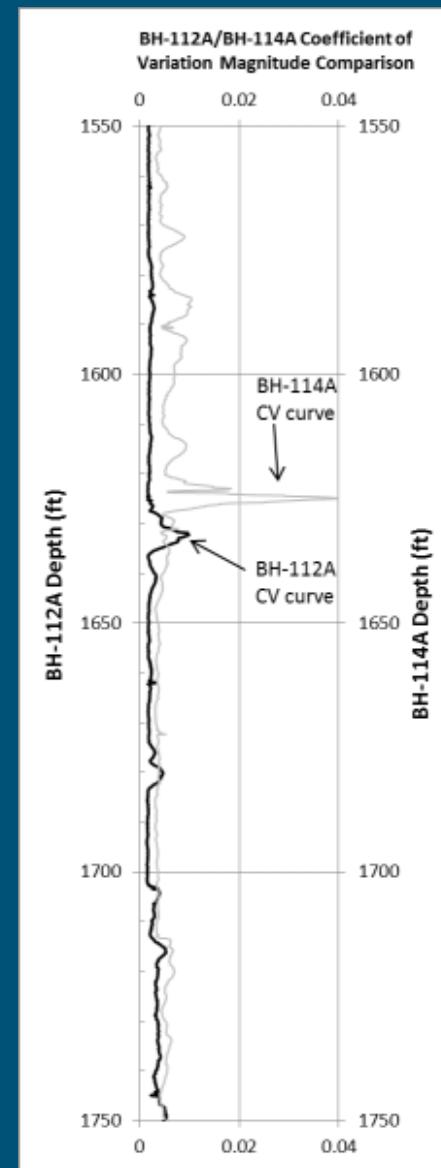
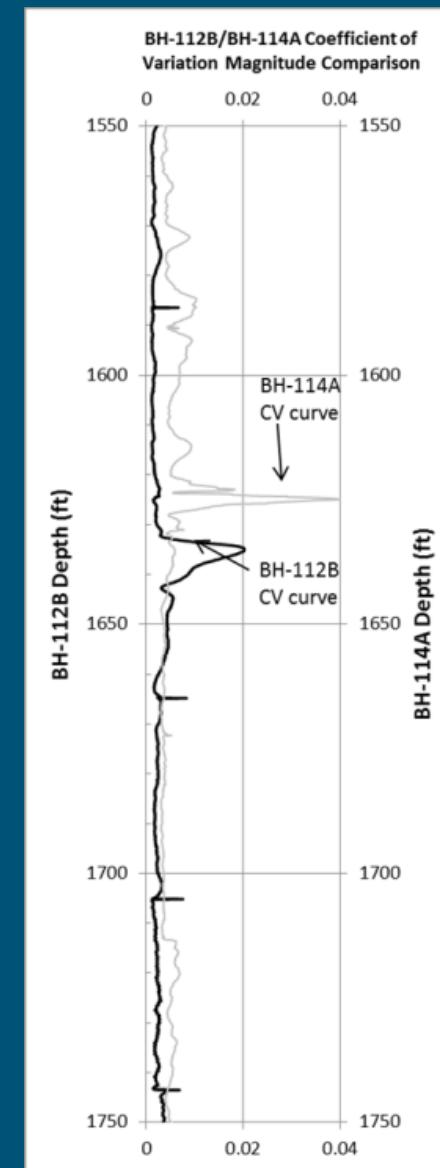
Summary Plots

Cv Values Allows for Well-to-Well Comparisons

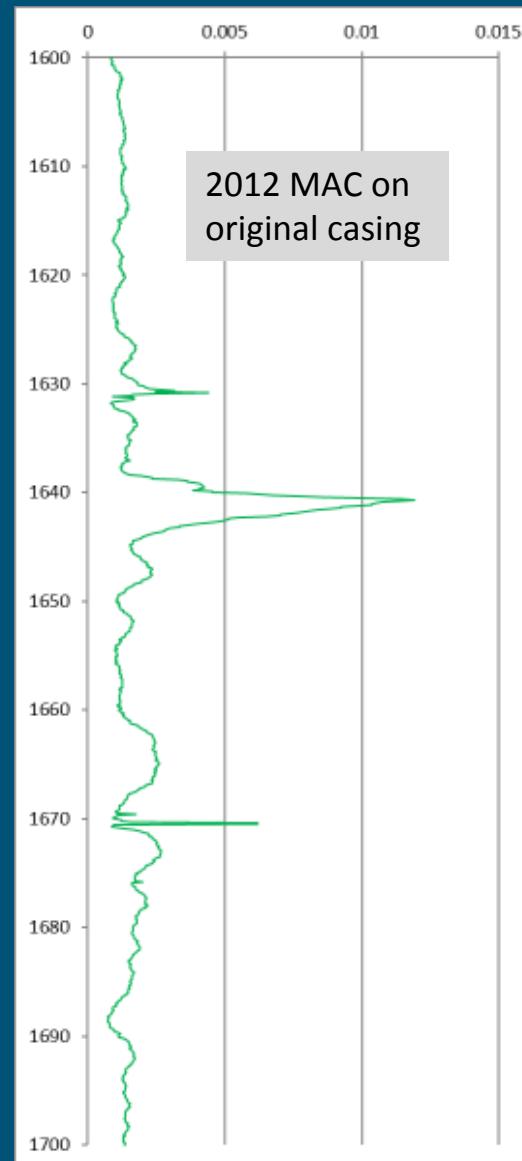
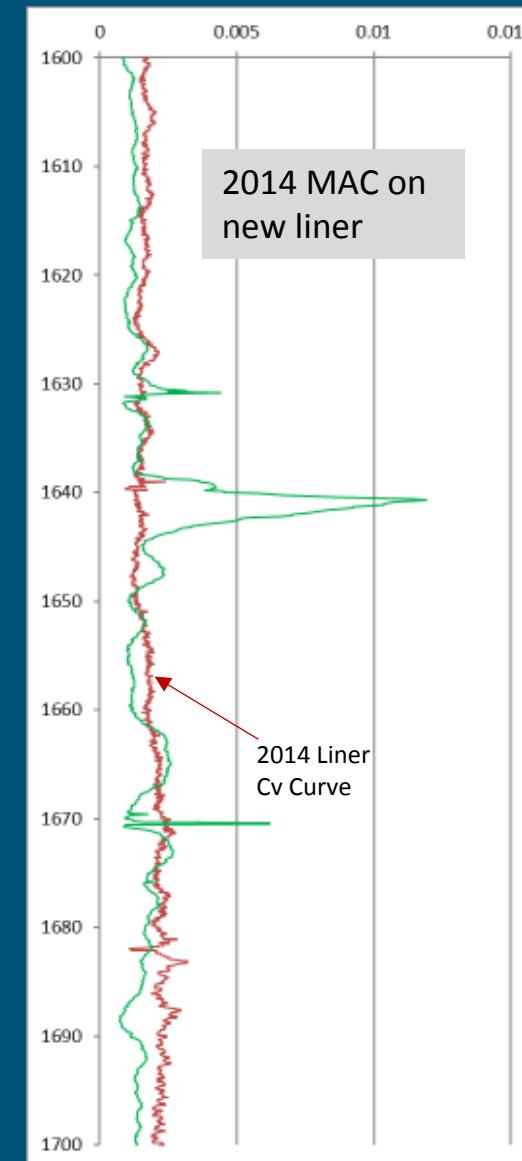
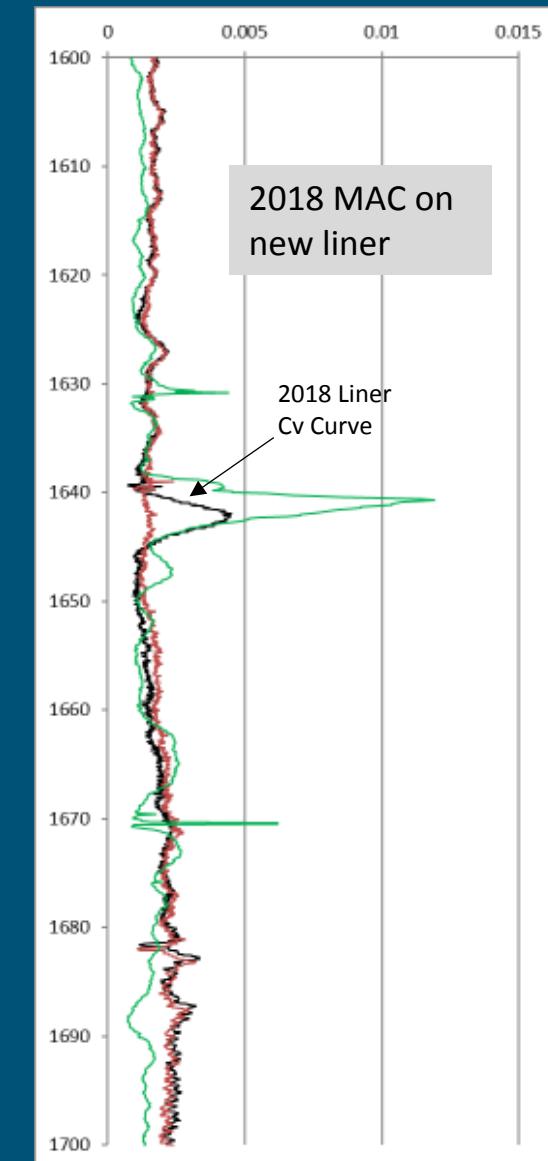
BH-103B
Cv Values
through
time

Cv Values Provide Basis for Time-Dependent Analysis

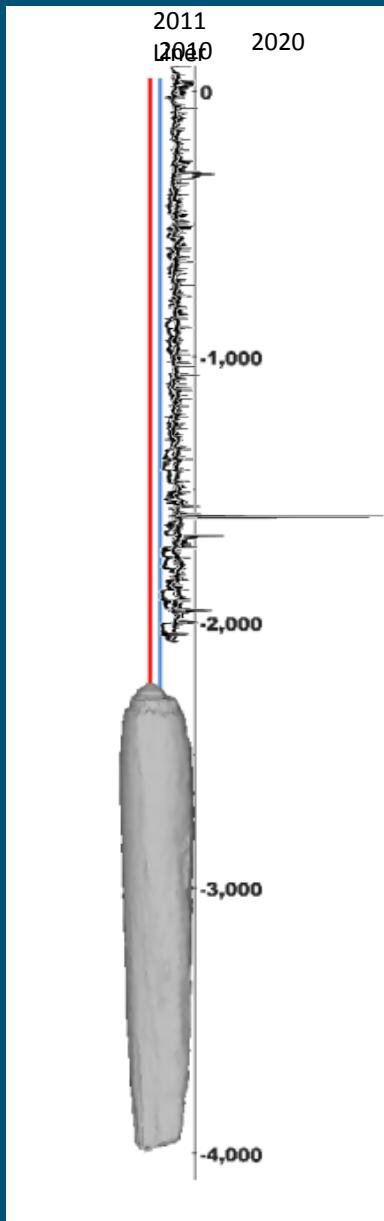
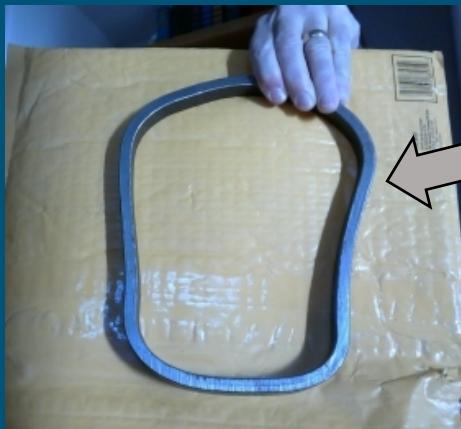
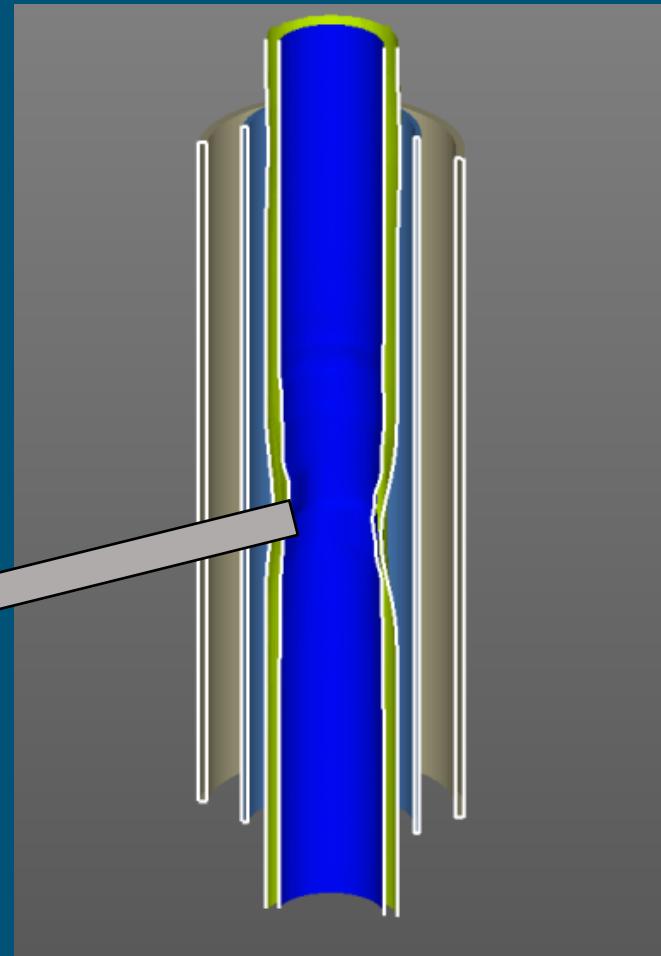
BH-105B Case Study

- BH-105B completed in Dec. 1984
- 2010 MAC shows significant casing deformation
- 2011 new well liner cemented in place
- 2020 evidence of deformation of the brine string
- MAC survey of the brine string indicated it deformed
- 2020 removal of the brine string and MAC survey of the liner showed severe deformation
- Geologic forces had deformed:
 - 20" outer casing
 - 13.375" original inner casing
 - 10.75" liner
 - 8.625" hanging string

27 years
9 years

- Remediation of the deformed casings is necessary to assure cavern integrity
- Historic liner installation remediations have demonstrated that liners may succumb to geologic forces within 10-11 years requiring further remediation

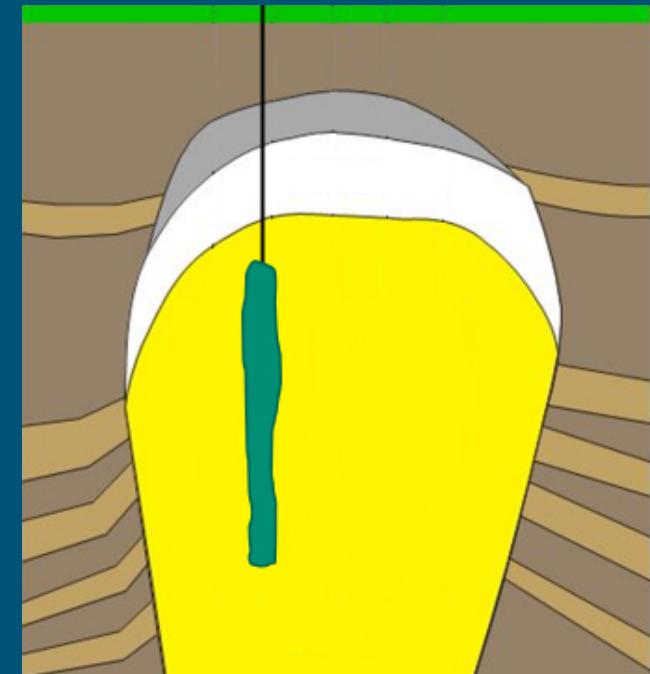
Why is this Happening?

- Severe, rapid casing deformation at the salt-caprock interface is limited to the Big Hill SPR site.
- What is different about the Big Hill site?
- Cavern operations are similar, caverns have desirable shape
- Wells have well designed completions
- Each dome has unique geology
- Site nominal caprock thicknesses
 - Bayou Choctaw 200 – 300 feet
 - Bryan Mound 400 – 200 feet
 - West Hackberry 350 – 400 feet
 - Big Hill 850 – 1300 feet

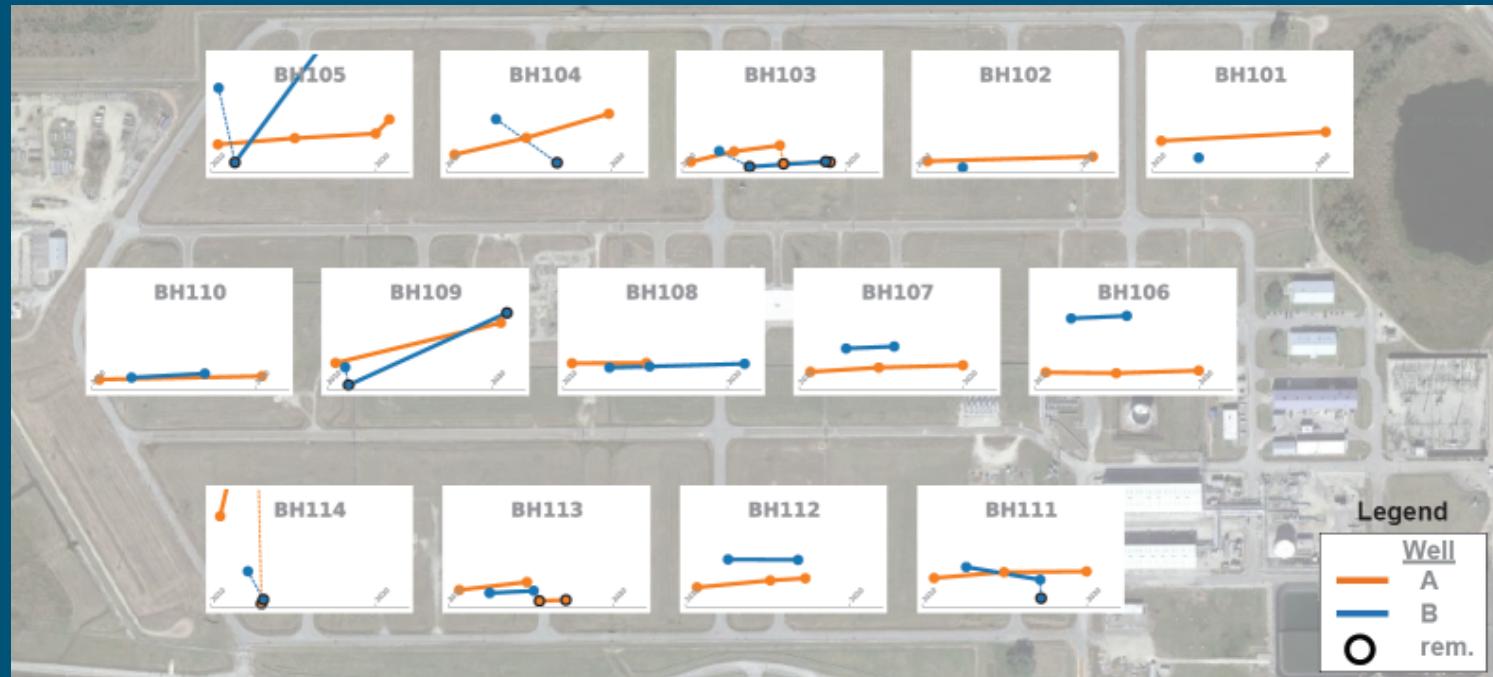
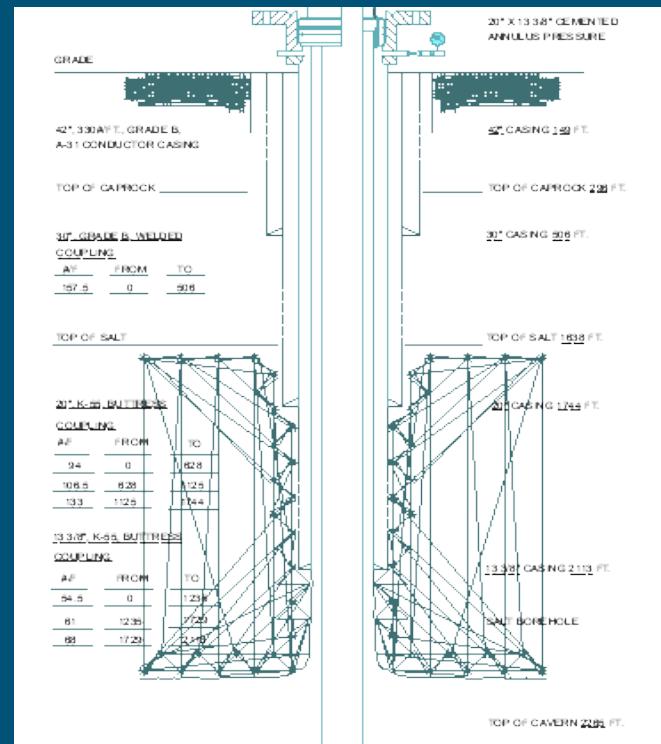
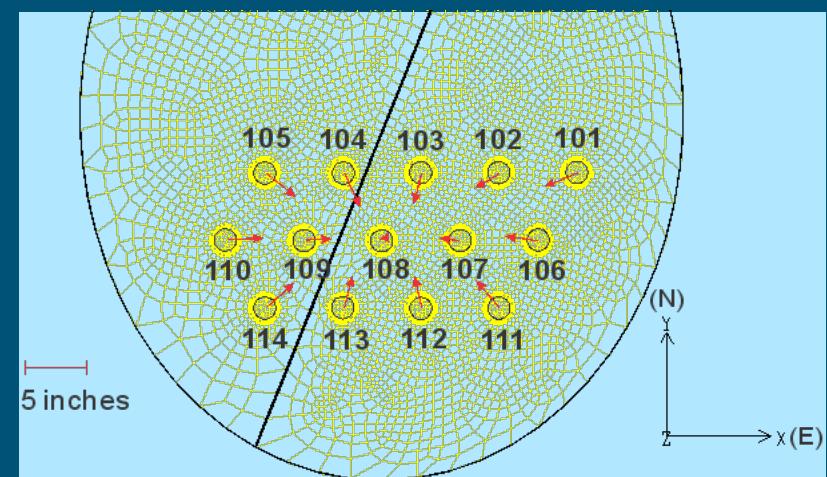
Why is this Happening? Is there a spatial pattern?

- Deformation is always at the salt-caprock interface
- Deformation occurs over a narrow vertical interval
- Greatest level of deformation typical on western side of site
- No clear correlation to surface subsidence
- Some correlation to results from geomechanical modeling
- Maybe associated with different salt spines?
