1 **Enhanced Crevice Corrosion of Stainless Steel 316 by Degradation of Cr-containing Hollandite**  
2 **Crevice Former**

14 This study explores the corrosion interactions between stainless steel 316 (SS316), a candidate nuclear  
15 waste canister material, and Cr-containing hollandite ( $\text{Ba}_{1.15}\text{Cr}_{2.3}\text{Ti}_{5.7}\text{O}_{16}$ ), a model ceramic nuclear waste  
16 form. The two materials were corroded in close proximity in 0.6 M NaCl solution at 90 °C for 28 days.  
17 Severe crevice corrosion was observed on the stainless steel surface after the corrosion experiment, which  
18 is likely associated with the rapid accumulation of  $\text{Cr}^{3+}$  cations originating from both SS316 and the Cr-  
19 containing hollandite. The enhanced corrosion of SS316 by the corrosion products of hollandite is  
20 quantitatively explained using a classical crevice corrosion model.

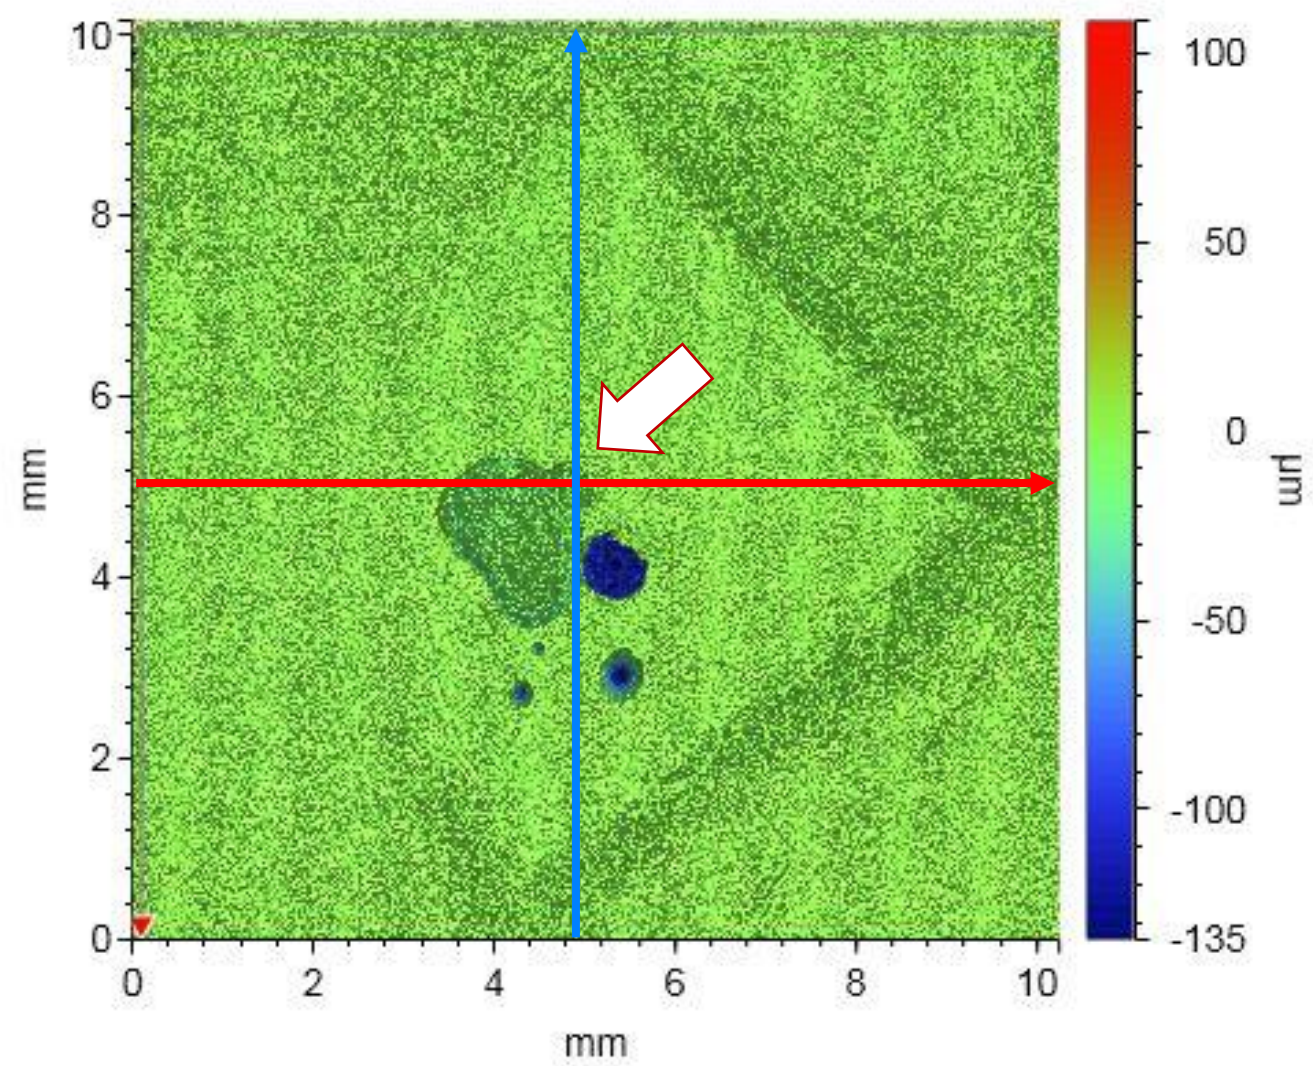
180 To illuminate the initiation site of crevice corrosion, the SS specimen corroded with Cr-Hol was also  
181 subjected to surface topological analysis via optical profilometry. As shown in **Fig. 2**, large and localized  
182 damage was identified in several regions inside the crevice. The largest and deepest pit was found near the  
183 center of the crevice. This pit has a diameter of  $\sim 700 \mu\text{m}$  and a depth of  $\sim 135 \mu\text{m}$  and was connected to a

565 **Figure 2.** Surface topography of the stainless steel 316 after corroding with the Cr-containing hollandite in  
566 0.6 M NaCl at 90 °C for 28 days. The white arrow indicates the initiation site of the crevice corrosion.

184 large crevice damage located in its west direction (**Figs. 1b** and **2**). Additionally, some smaller pits were  
185 observed near the edge of the crevice. These observations indicate that there were probably more than one  
186 initiation sites of localized corrosion. The detail corrosion mechanism will be discussed in a following  
187 section.

405 As shown in **Fig. 2**, several locally damaged areas were observed inside the crevice of the SS, indicating  
406 the presence of multiple initiation sites of pitting or crevice corrosion. The presence of multiple isolated  
407 pits near the crevice center is consistent with the observations from Oldfield and Sutton[51], particularly at

418 The depth profiles shown in **Fig. 2** shows that the extent of crevice corrosion increases from the center  
419 toward the south and west directions. In a study by Lillard et al., crevice corrosion of alloy 625 was found  
420 to initiate in the center and propagate toward the mouth.[52] The authors also reported that the depth of the  
421 crevice damage increased from the center to the active front, which is similar to the crevice damage  
422 observed in this study. Based on this analysis, it is inferred that the crevice corrosion observed in the current  
423 study may also have initiated near the center of the crevice as indicated by the white arrow in **Fig. 2**. As the  
424 active front moved toward the crevice mouth in the south and west directions, the depth of the crevice  
425 damage increased from several  $\mu\text{m}$  to tens of  $\mu\text{m}$ . It is worth noting that localized corrosion did not initiate

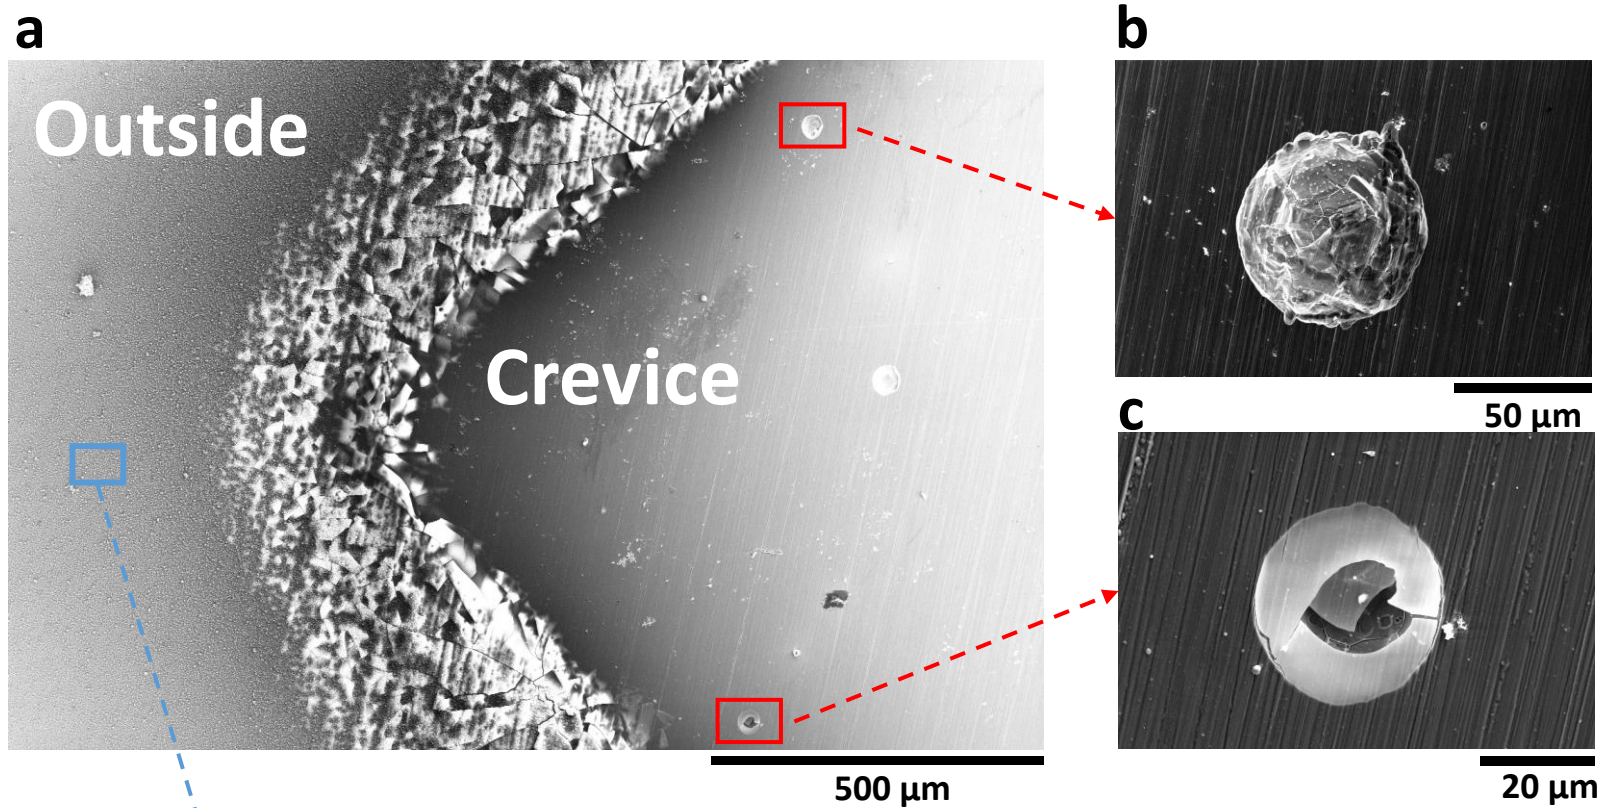
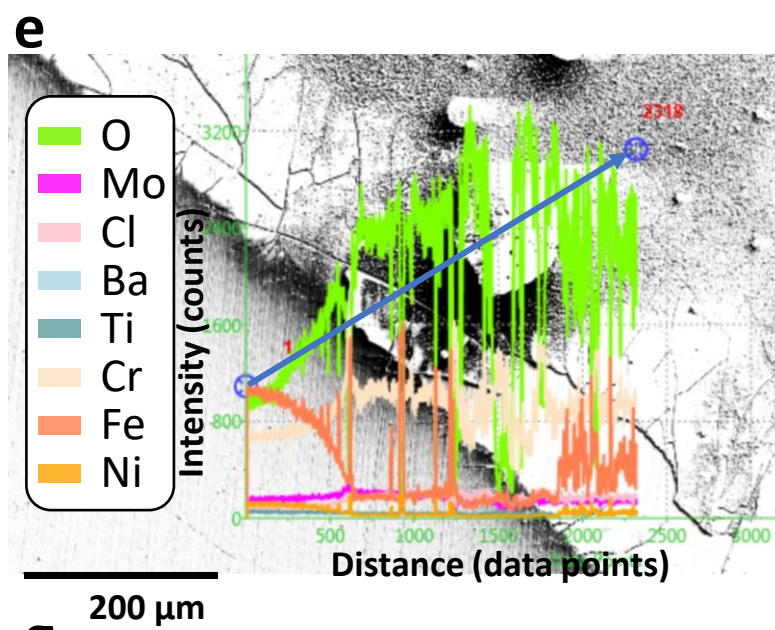
188 The boundary of the contact area was further examined with SEM. As shown in **Fig. 3a**, a large amount of  
189 corrosion products was found along the border of the contact area. Pits with diameter on the order of tens  
190 of  $\mu\text{m}$  were identified near the crevice mouth. Pits without (**Fig. 3b**) and with (**Fig. 3c**) a pit cover (a remnant  
191 of the passive film) were both identified. A magnified view of the crevice boundary is provided in **Fig. 3d**.  
192 In this image, the region to the bottom left was inside the crevice, while the top right was outside the crevice.  
193 As shown in **Figs. 3a** and **3d**, numerous cracks, likely formed during sample dehydration in the SEM  
194 chamber, exist in the layer of corrosion products built up near the crevice mouth. In certain areas, this thick  
195 layer of corrosion products partially detached from the surface, exposing the pristine SS substrate (**Fig. 3d**).

196 An EDS line scan (along the dark blue arrow in **Fig. 3e**) was performed across the border of the crevice,  
197 revealing that the corrosion products accumulating along the boundary are enriched in Cr, so are likely Cr  
198 oxides or hydroxides. In this area, the concentration of Cr is consistently higher than Fe, except for the  
199 cracked regions where the metal substrate was exposed. At the end of the line scan, the concentration of Fe  
200 increased to a level similar to that of Cr, suggesting that the Cr-rich precipitation surrounding the crevice  
201 boundary originated from the local crevice solution. In an area far away from the crevice that was exposed  
202 to the bulk solution during the corrosion test and does not contain dark-colored corrosion products, a large  
203 amount of granular corrosion products exists (**Fig. 3f-g**). An EDS map collected from this area suggests

567 **Figure 3.** Surface characterization of the stainless steel 316 after corroding with the Cr-containing  
568 hollandite in 0.6 M NaCl at 90 °C for 28 days. Scanning electron microscopy image showing **a)** the  
569 boundary of the crevice area, **b)** pits near the crevice mouth without a pit cover, **c)** pits near the crevice  
570 mouth with a partially collapsed pit cover, **d-e)** boundary of the crevice area with corrosion products  
571 partially detached from the metal substrate. Energy dispersive spectroscopy line scan profiles (dark blue  
572 arrow) are overlaid on top of the image. The scale bar for d and e is the same. **f)** an area that was  
573 exposed to the bulk solution during corrosion. **g)** an enlarged view of a random area selected from **f).**

441 center, smaller pits with diameters on the order of tens of  $\mu\text{m}$  were also identified near the crevice mouth  
 442 (**Figs. 3a-c**), probably also because of the lower ohmic potential drop in this area. In comparison, localized  
 443 corrosion damage only exists near the mouth of the crevice for SS corroded near I-APT[18] or glass[16,  
 444 17]. The mechanism accounting for these different corrosion morphologies will be explained below.

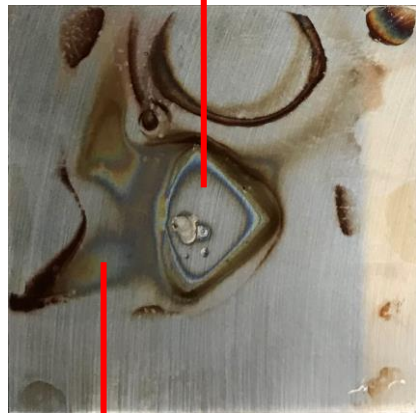
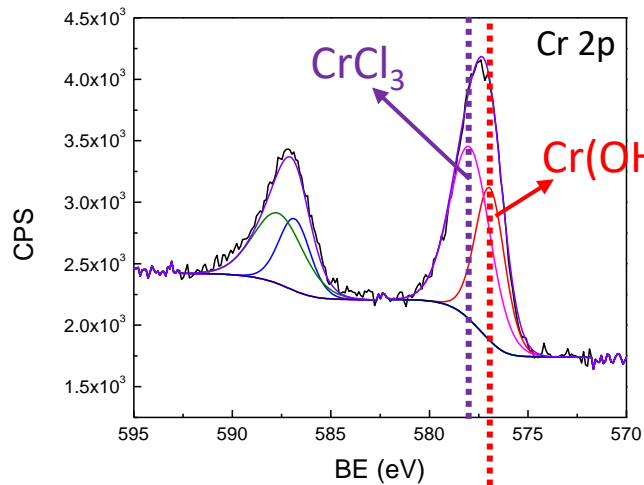
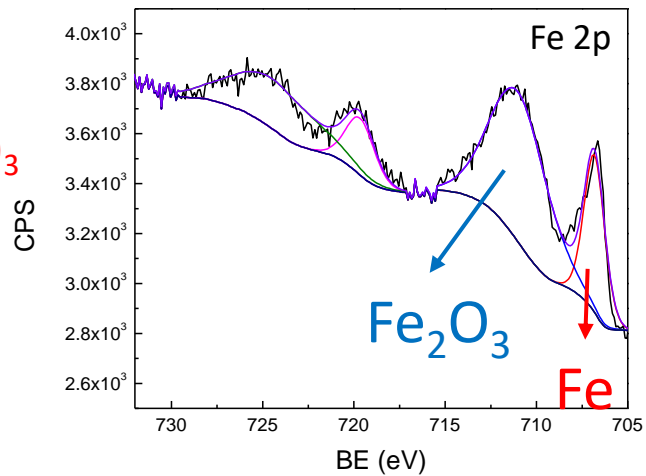
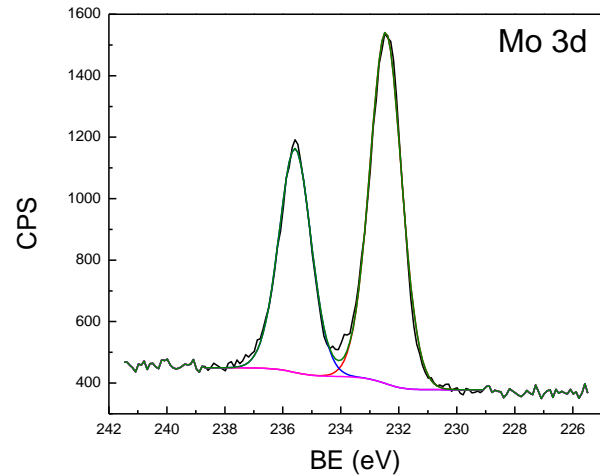
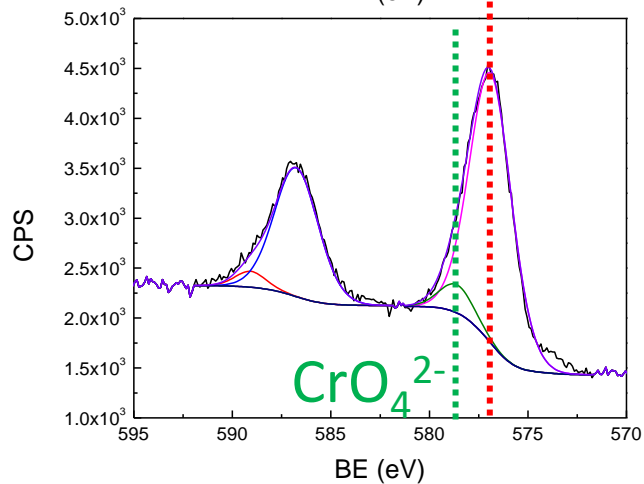
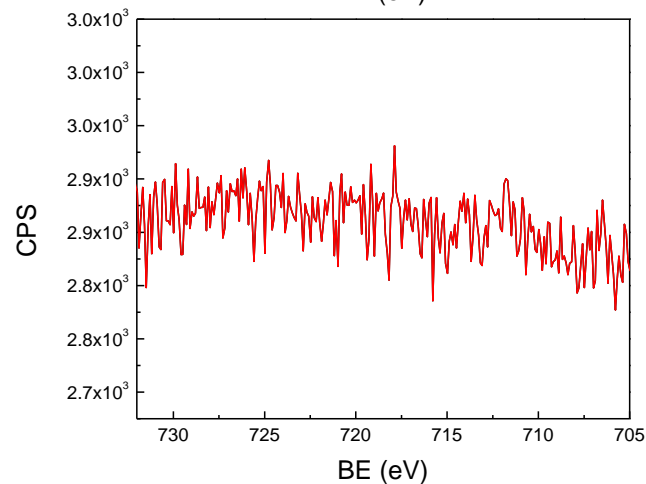
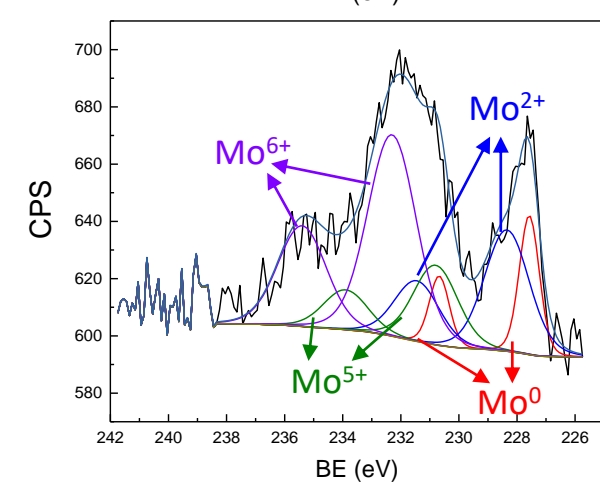
583 **Figure 6.** Macrograph and X-ray photoelectron spectroscopy spectra for the stainless steel 316 after  
584 corroding with the Cr-containing hollandite in 0.6 M NaCl at 90 °C for 28 days.

214 As shown in **Fig. 1a**, severe localized corrosion was found on the SS surface after 28 days of corrosion with  
215 Cr-Hol. To illuminate the underlying corrosion mechanism, the chemical composition of the SS surface  
216 was further explored with XPS. Areas inside and outside the crevice as illustrated in **Fig. 6** were subjected

228 For the area inside the crevice, both metallic Fe and Fe<sub>2</sub>O<sub>3</sub> species were identified in the Fe 2p 3/2 core  
229 level spectrum. In comparison, no Fe signal was detected in the area exposed to the bulk solution during  
230 corrosion. This suggests that the SS substrate in the dark-color area was covered by a thick layer of  
231 corrosion products that does not contain Fe. Note that this area is not the same as the one examined with  
232 EDS mapping (**Fig. 4**), which does not contain the dark-color corrosion products. Combining the  
233 observations of SEM and XPS, it is clear that the dark-color corrosion products shown in **Fig. 1a** are  
234 primarily Cr oxides and/or hydroxides.

505 XPS analysis of the SS sample corroded near Cr-Hol (**Fig. 6**) suggests that the oxidation state of Mo is  
506 higher in the area located inside the crevice than the area outside, suggesting the formation of less soluble  
507  $\text{MoO}_3$  inside the crevice. The higher oxidation state of Mo observed inside the crevice might be associated  
508 with the oxidation of Mo to multiple valent states, but only the least soluble corrosion product remained  
509 inside the highly acidic crevice space. The observation of  $\text{MoO}_3$  inside the crevice for the current study is  
510 consistent with the SS corroded near a PTFE crevice former in a similar environment (0.6 M NaCl solution,  
511 90 °C) for the same period of time.[18] When SS corroded near an iodine containing apatite ( $\text{Pb}_{9.85}(\text{VO}_4)_6\text{I}_{1.7}$ ,  
512 hereafter referred to as I-APT), however, the oxidation state of Mo inside the crevice was low, similar to
