Sandia
National
Laboratories

Microanalysis of Cd Whiskers on Cd Plated Long-Term Used Hardware

August 5, 2021

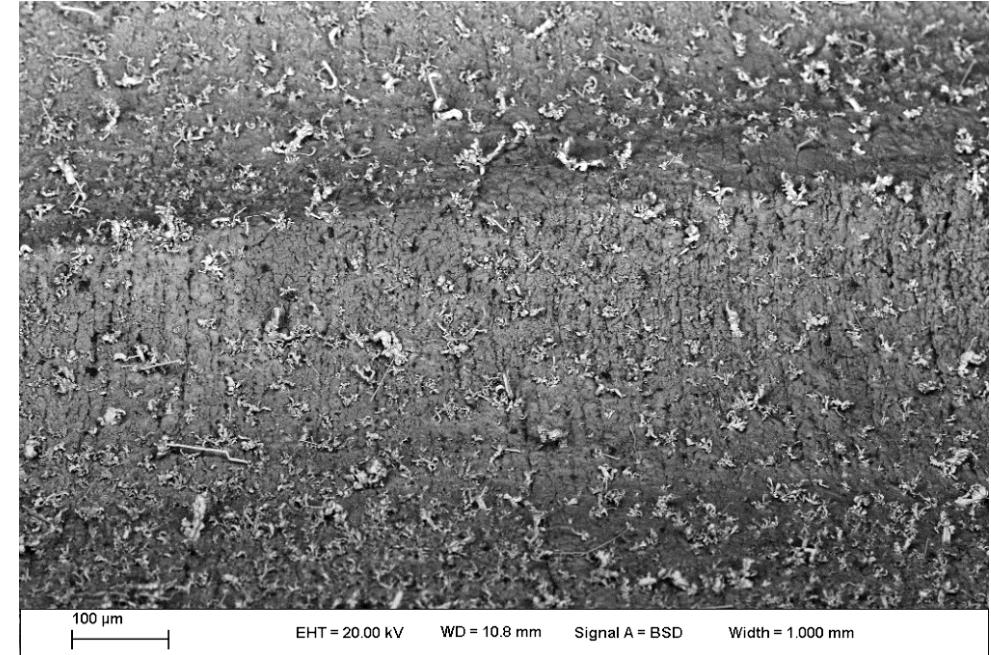
SEM SE Image of Cd whiskers on cap screw threads

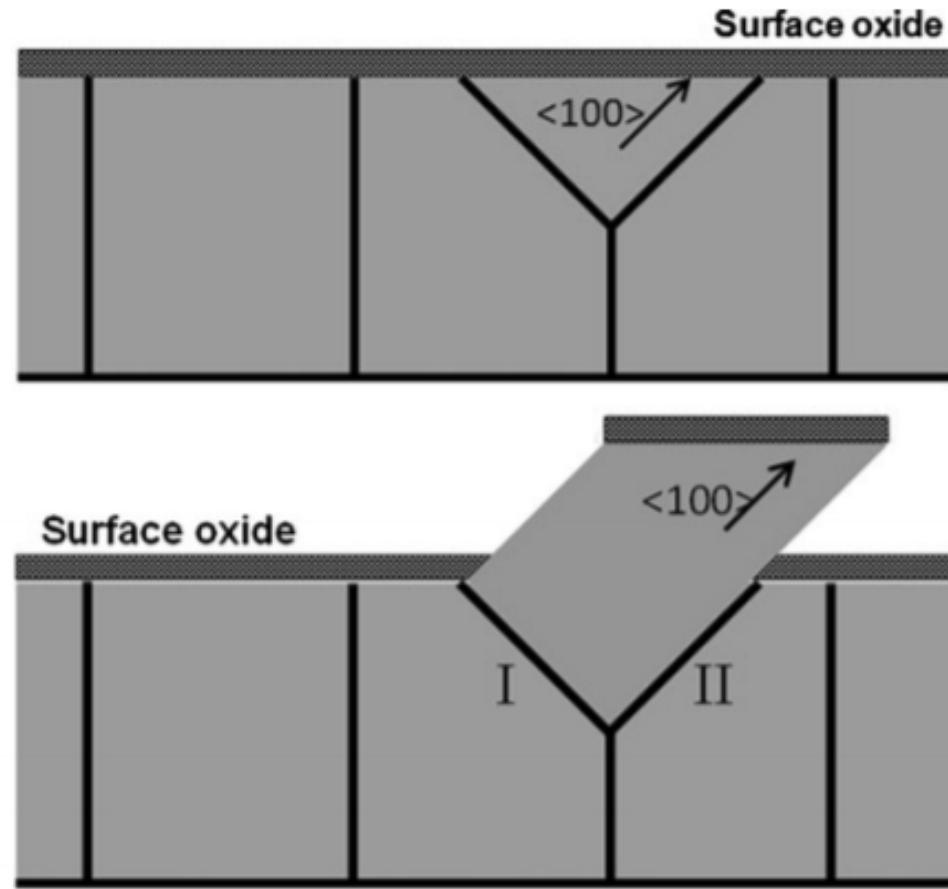
Oblique grain boundaries at the base of a whisker in an otherwise columnar Sn plating
[Susan et al. Met Trans A, 2013]

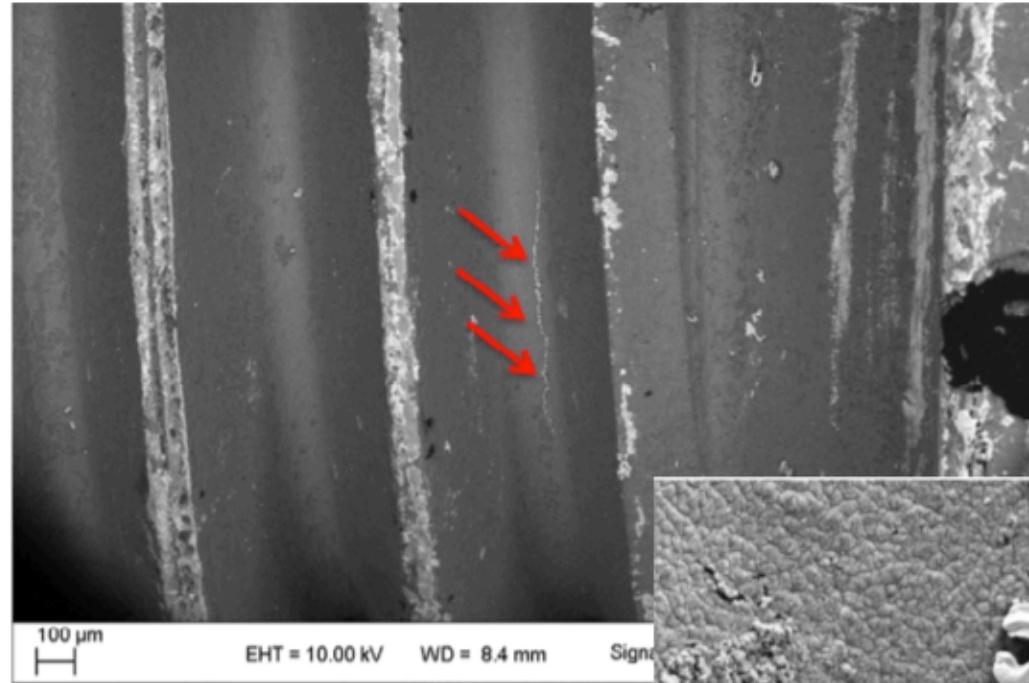
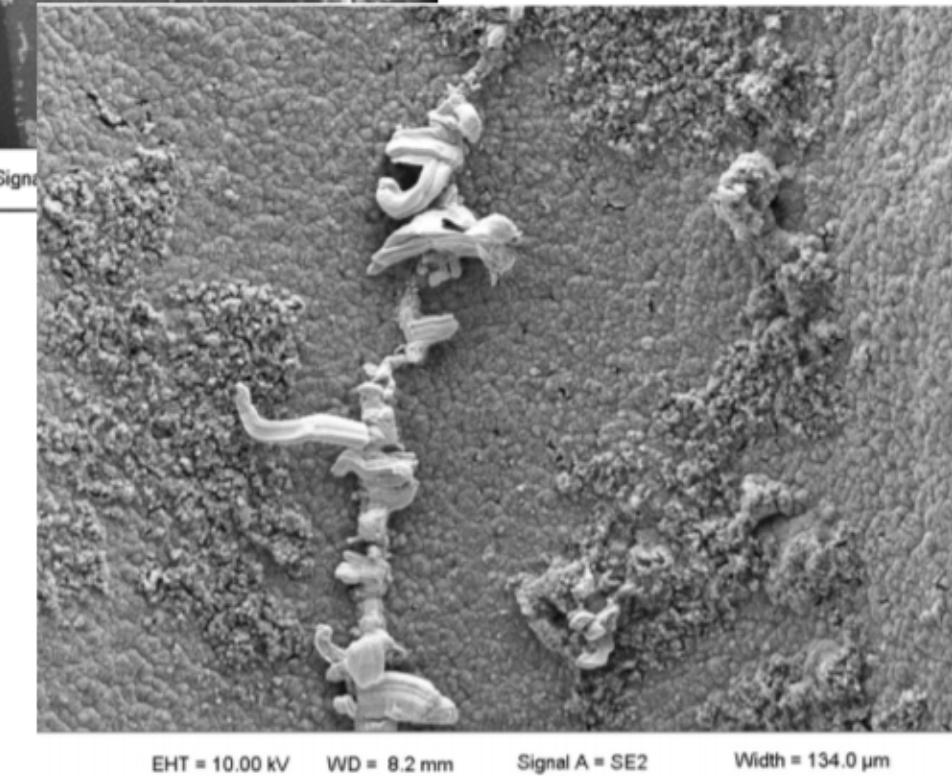
- Observed during an unrelated fastener failure analysis
- Cd whiskers were found growing from a crack in the thread root
- Hardware of indeterminate age found in tool boxes also contain Cd whiskers

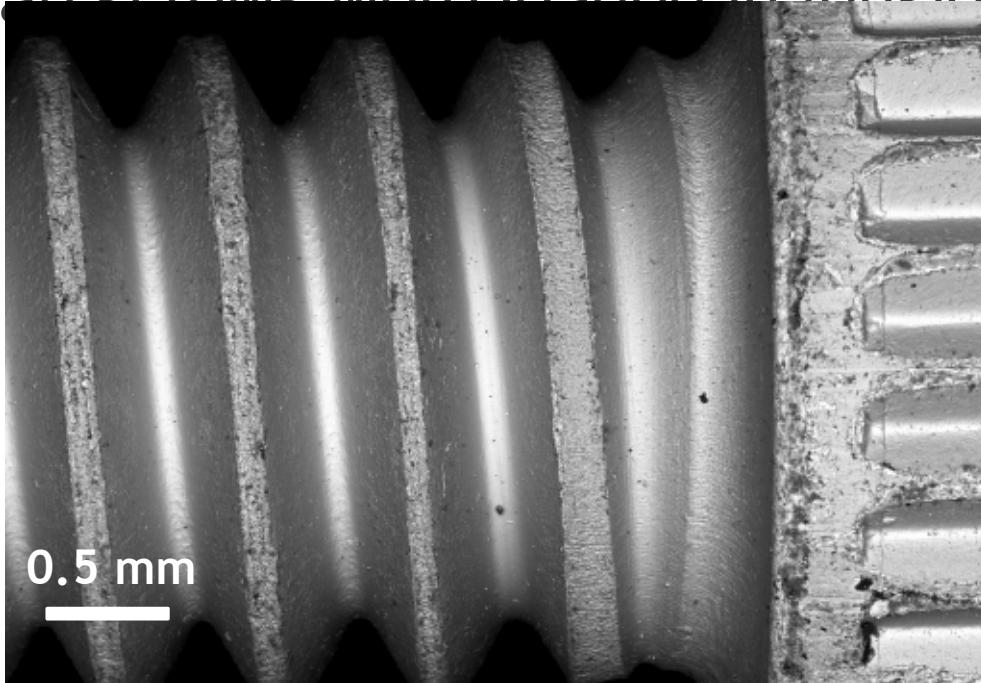
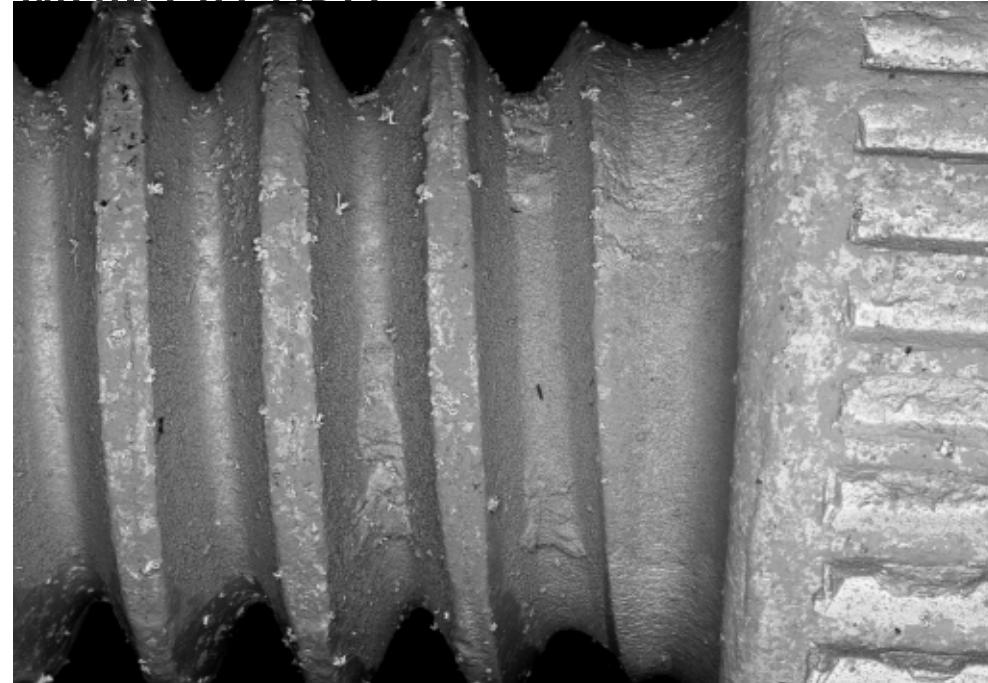
- Backscatter (BSE) SEM images of
 - [Left Image] an uncontaminated cap screw showing a smooth appearance with very little wear and debris
 - [Right Image] a contaminated cap screw showing uneven contamination (low Z), increased wear (high Z) on the head and threads
- Cap screws were loaded in tension while in use

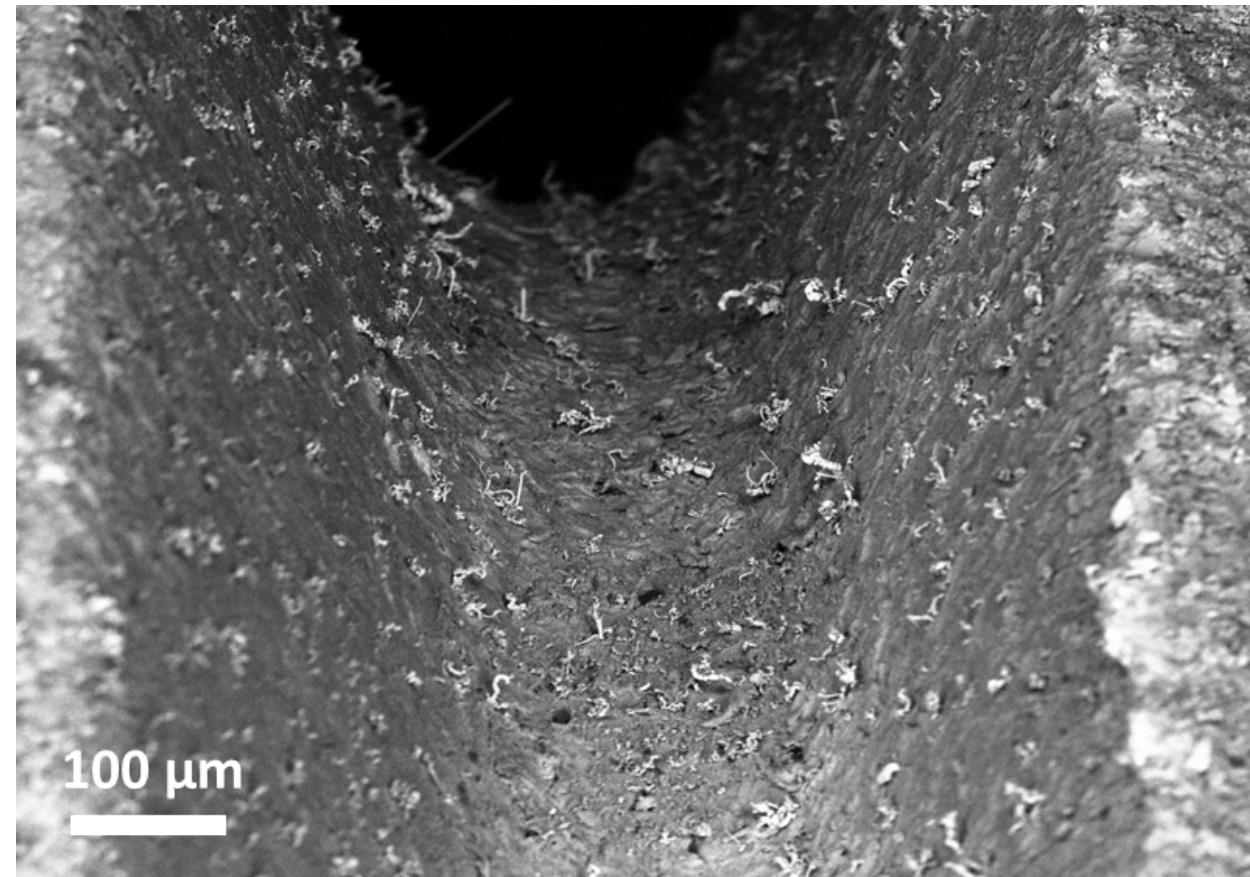
SEM BSE image of a thread root (left)

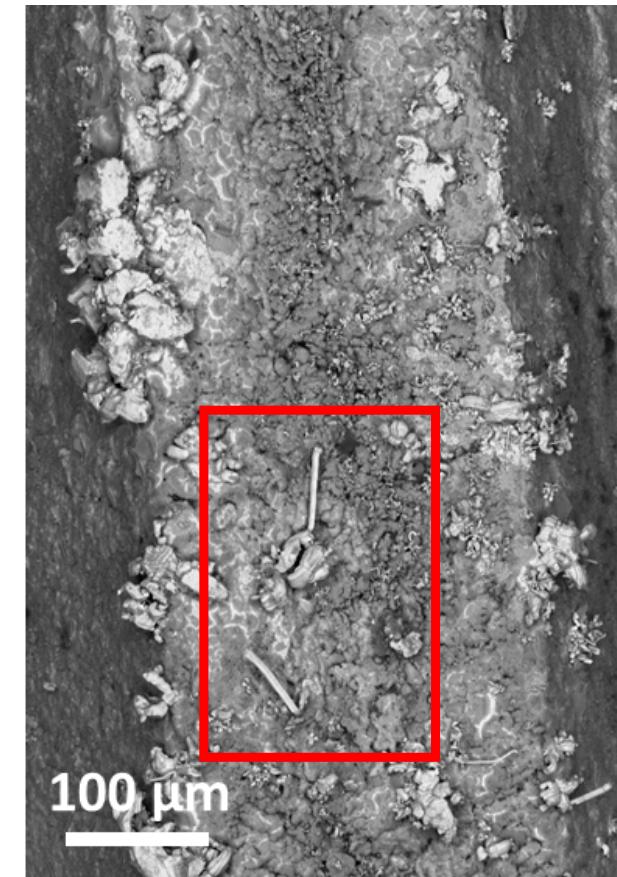
SEM BSE image on the crest of a thread (right) with a box indicating where long, straight whiskers have grown

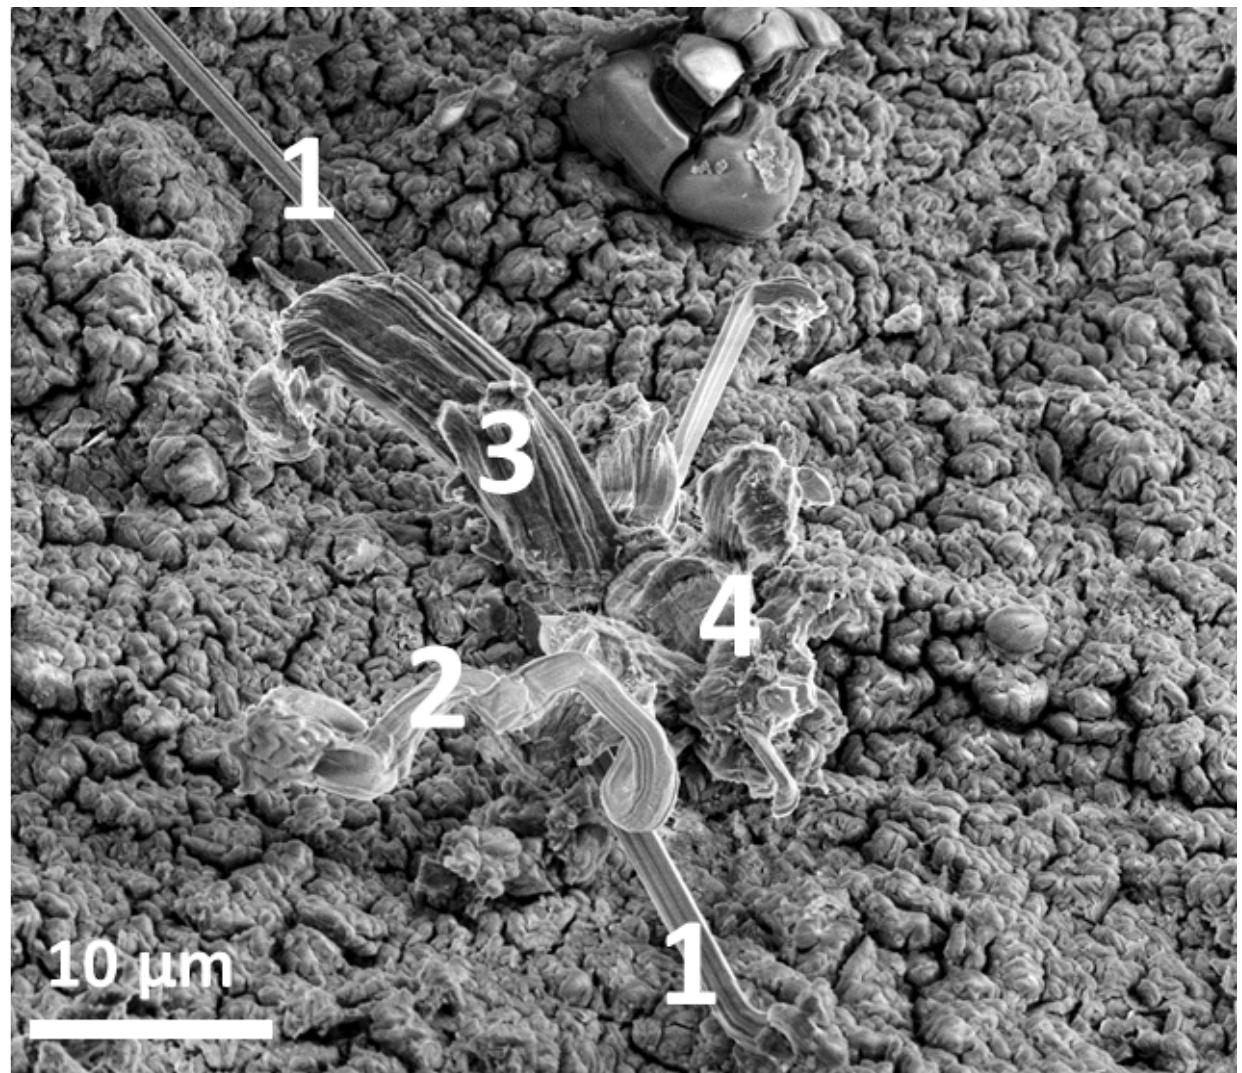
SE image of an agglomerate with several different Cd morphologies

1. Straight and/or kinked whiskers
 - High aspect ratio
 - Single crystal
2. Curly whiskers
3. “Multi-stranded” whiskers (possibly)
4. Hillocks/Nodules
 - Low aspect ratio

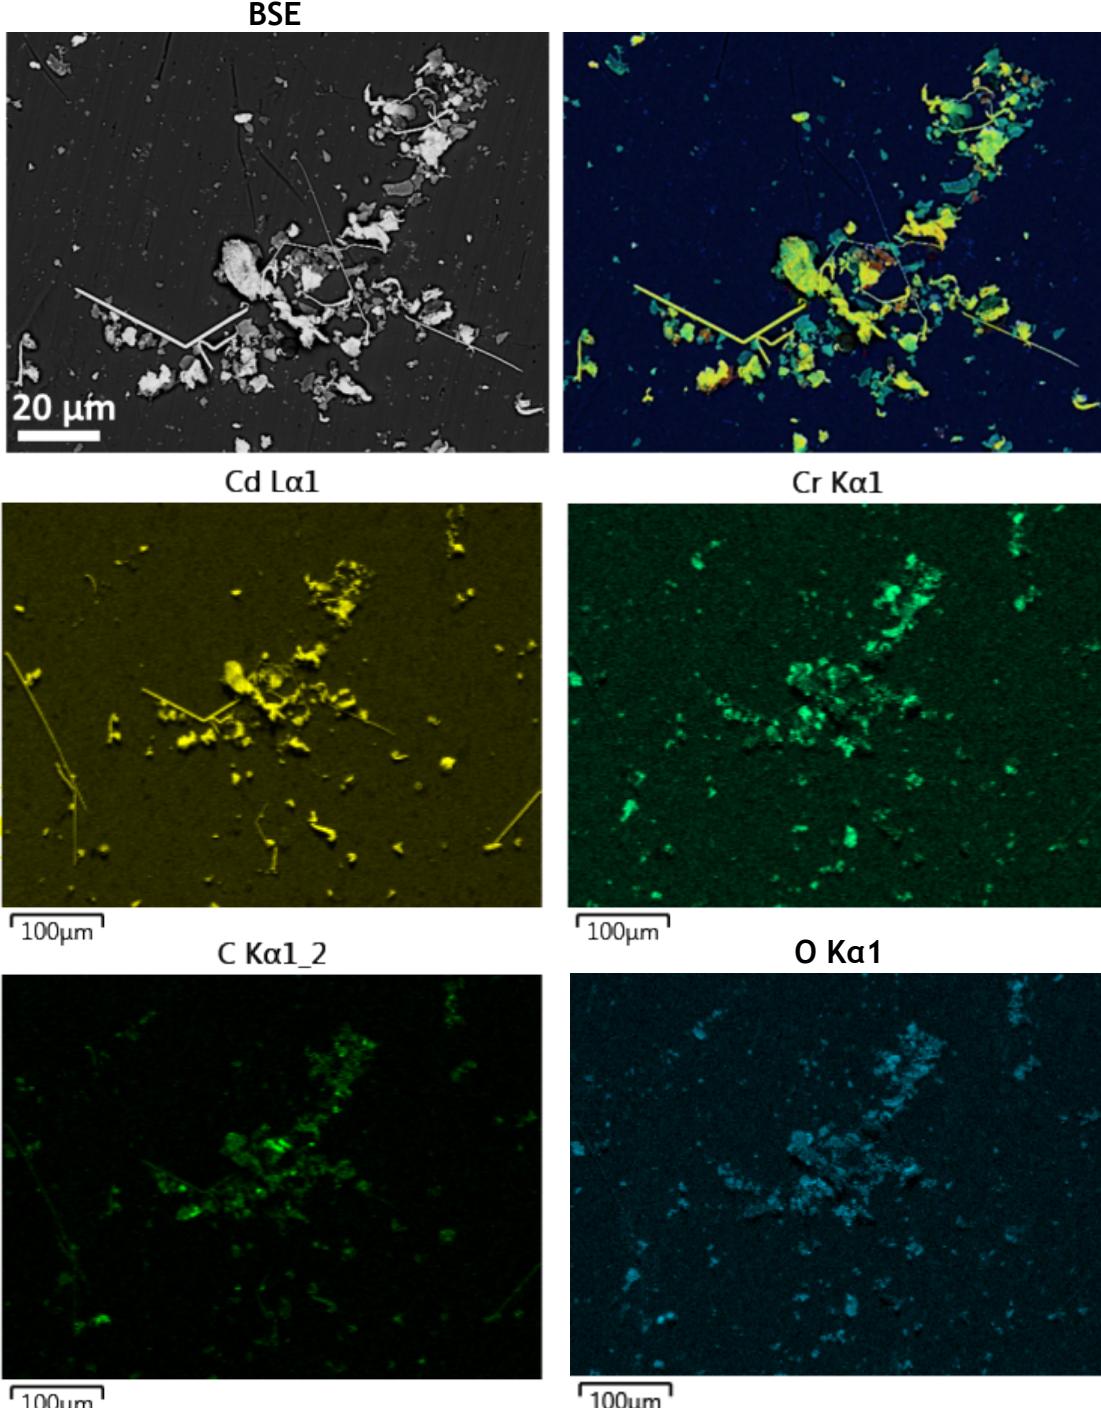
- Energy dispersive spectroscopy (EDS)
 - Most dense concentration of whiskers were found on most visibly contaminated cap screws
 - Pure cadmium (yellow) and chromate (teal) were found as well as possible organic contamination, cadmium oxide and/or cadmium carbonate from environmental contamination.
 - Debris morphology and composition appear to vary between hardware sets
 - Possibly from different environmental exposures.

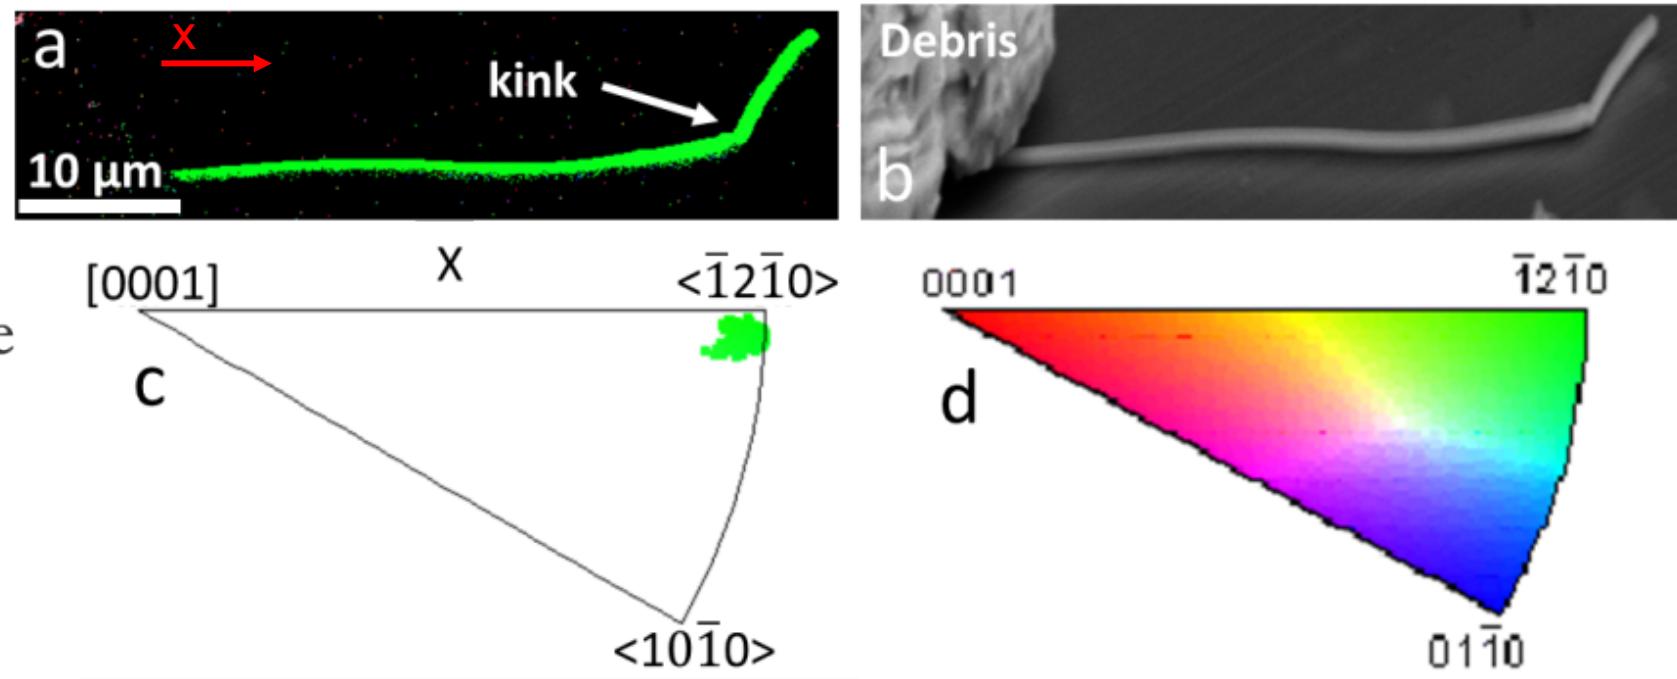
The kink of a whisker studied in detail

- (a) EBSD IPF X map
- (b) secondary SEM image
- (c) IPF of the whisker showing a single crystal with a $\langle\bar{1}2\bar{1}0\rangle$ type growth direction
- (d) the IPF map orientation color key

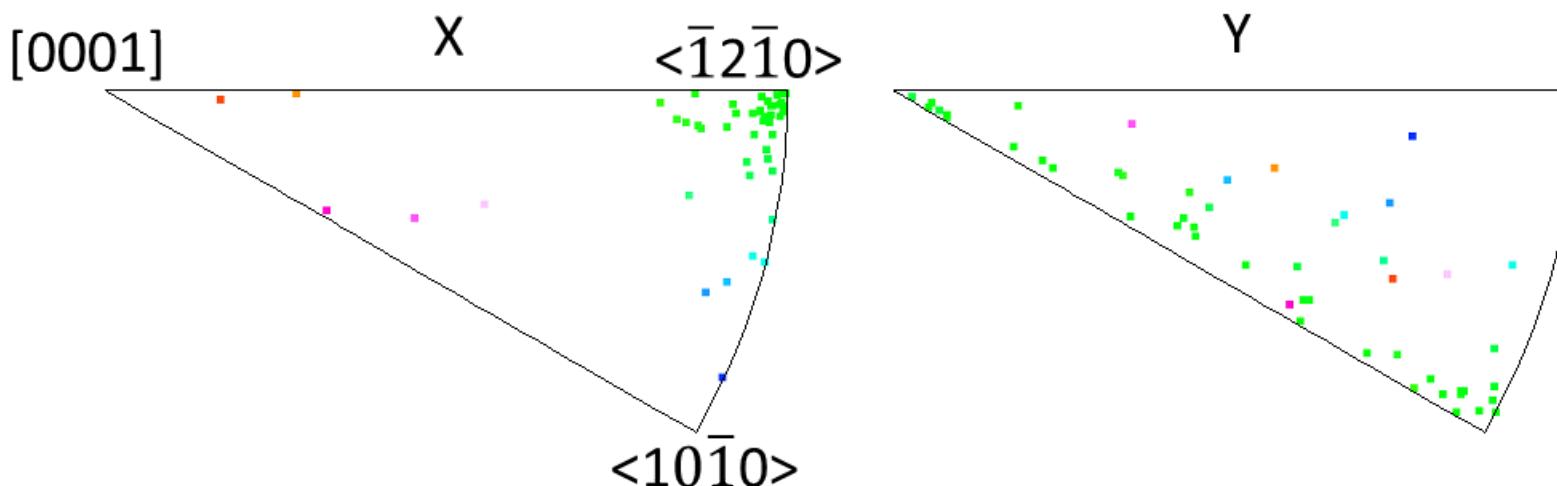
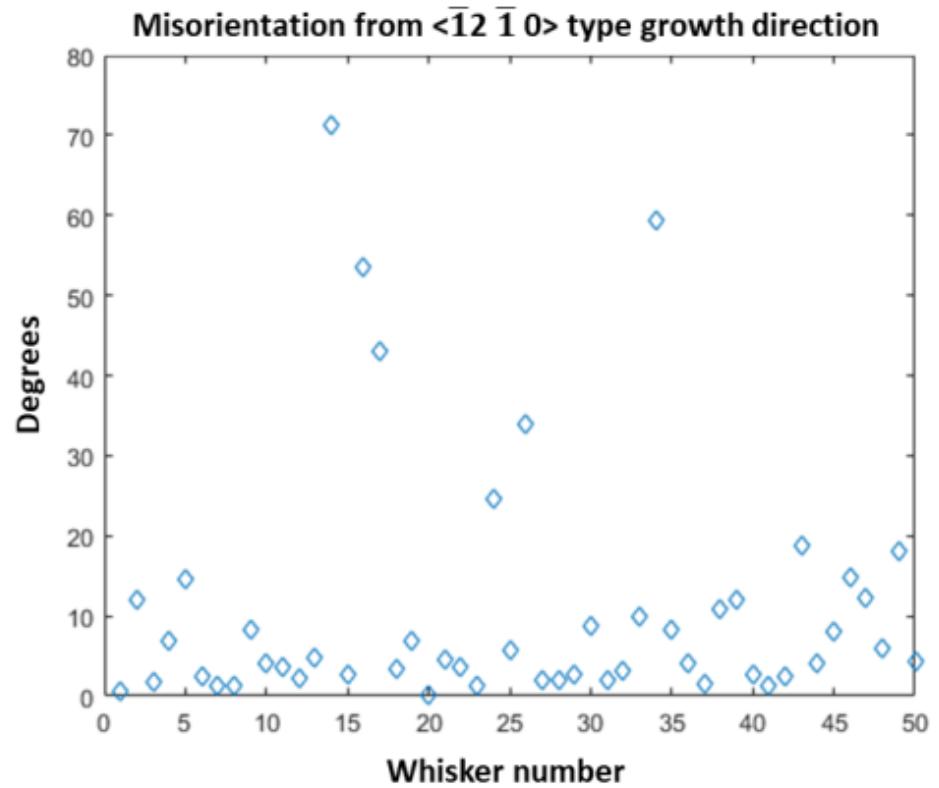
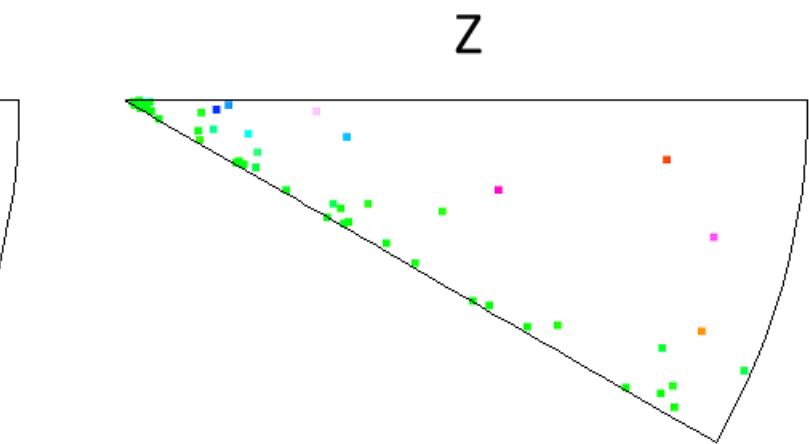
- 50 straight, x-oriented, whiskers were compiled into one pole figure
- 80% were within 15° of a $\langle\bar{1}2\bar{1}0\rangle$ type growth direction
- 20% grew in directions other than the $\{\bar{1}2\bar{1}0\}$ type
 - less favorable growth directions are possible
- Perhaps only if the plating stress is very high in these locations (i.e. there exists a very high thermodynamic driving force)
- Sn has been shown to grow in a variety of directions including $\langle100\rangle$, $\langle210\rangle$, $\langle001\rangle$, $\langle101\rangle$, and $\langle110\rangle$

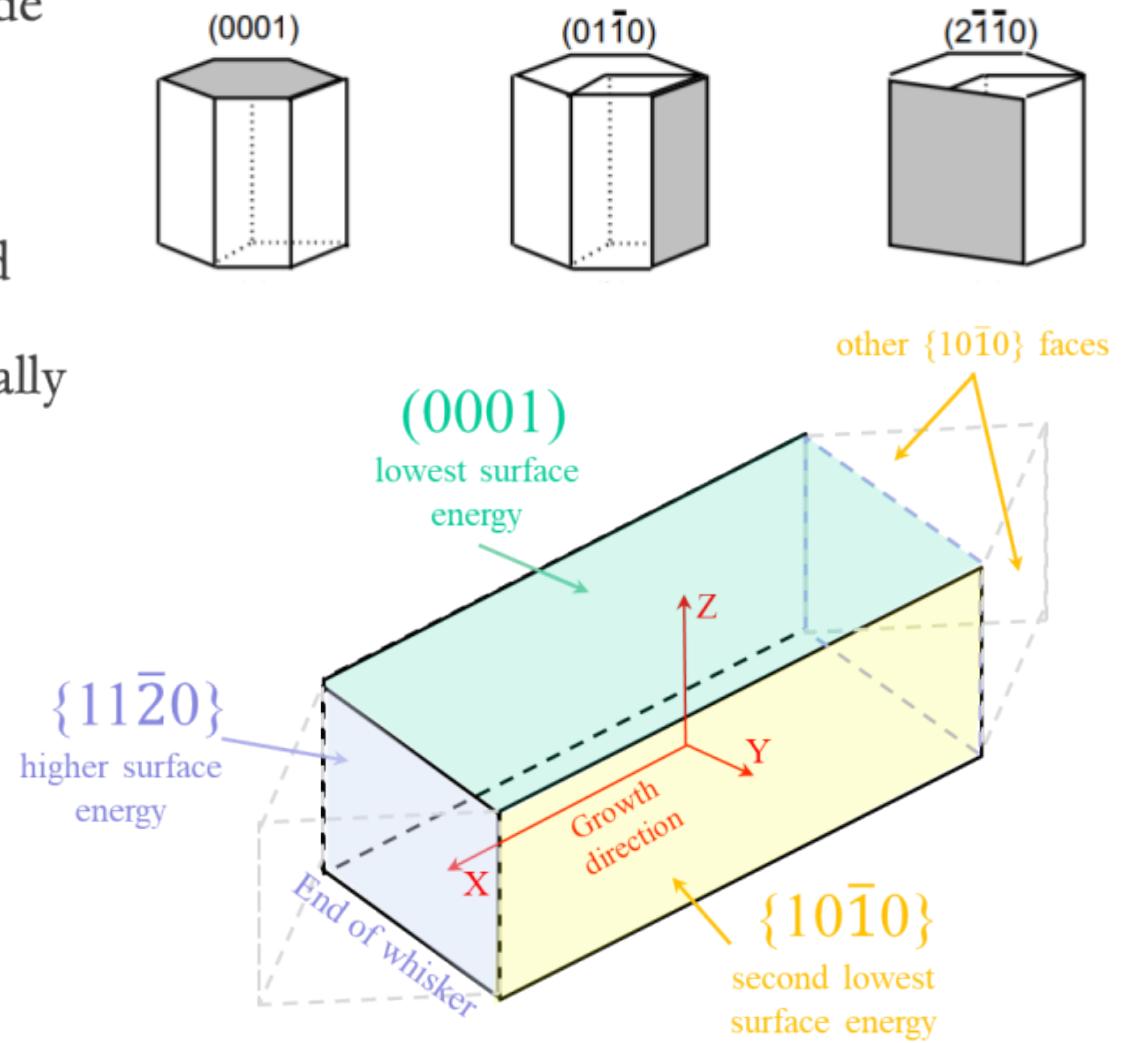
- Growth direction sets the whisker side faces
 - Energetically optimized with (0001) and $\{10\bar{1}0\}$ side faces!
- This data shows that Cd whiskers grow to minimize their surface energy.
 - Gibbs free energy minimization by stress relief and energetically stable whiskers
 - This crystal growth optimization is more energetically consequential for anisotropic materials like Sn, Cd, and Zn
 - Cd and Zn have high c/a ratio which results in unideal atomic packing and anisotropic properties.
 - As the c/a ratio increases, the formation of low energy planes becomes more important

Material	(0001)	$\{10\bar{1}0\}$ type	$\{\bar{1}2\bar{1}0\}$ type
Be (c/a=1.568)	1.00	1.00	1.00
Ideal (c/a=1.633)	1.00	1.06	1.20
Cd (c/a=1.886)	1.00	1.50	1.95

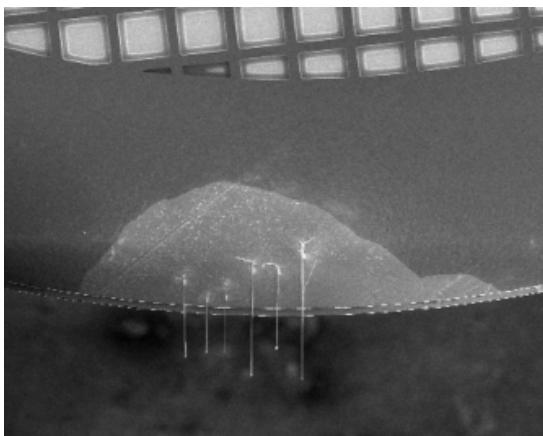
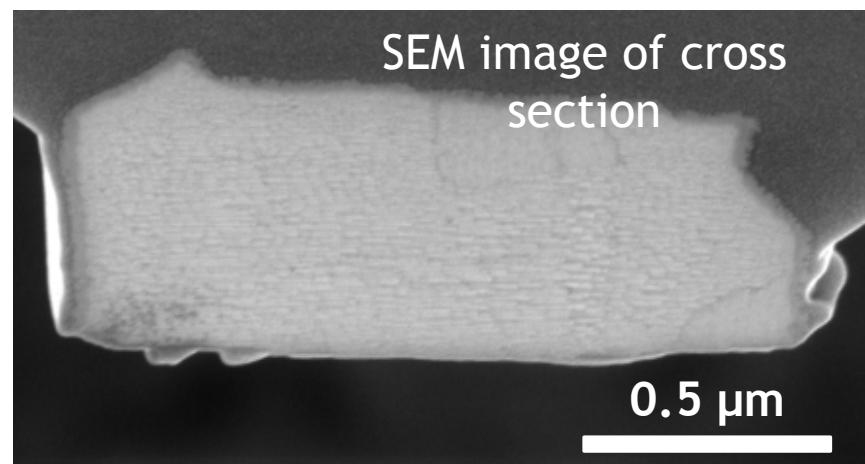
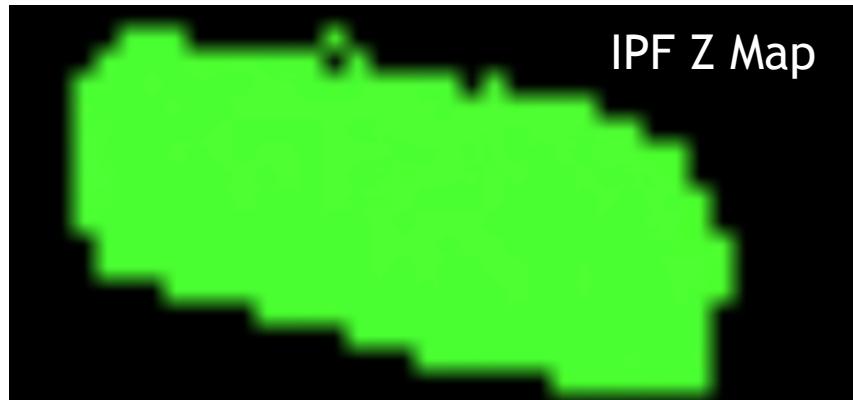
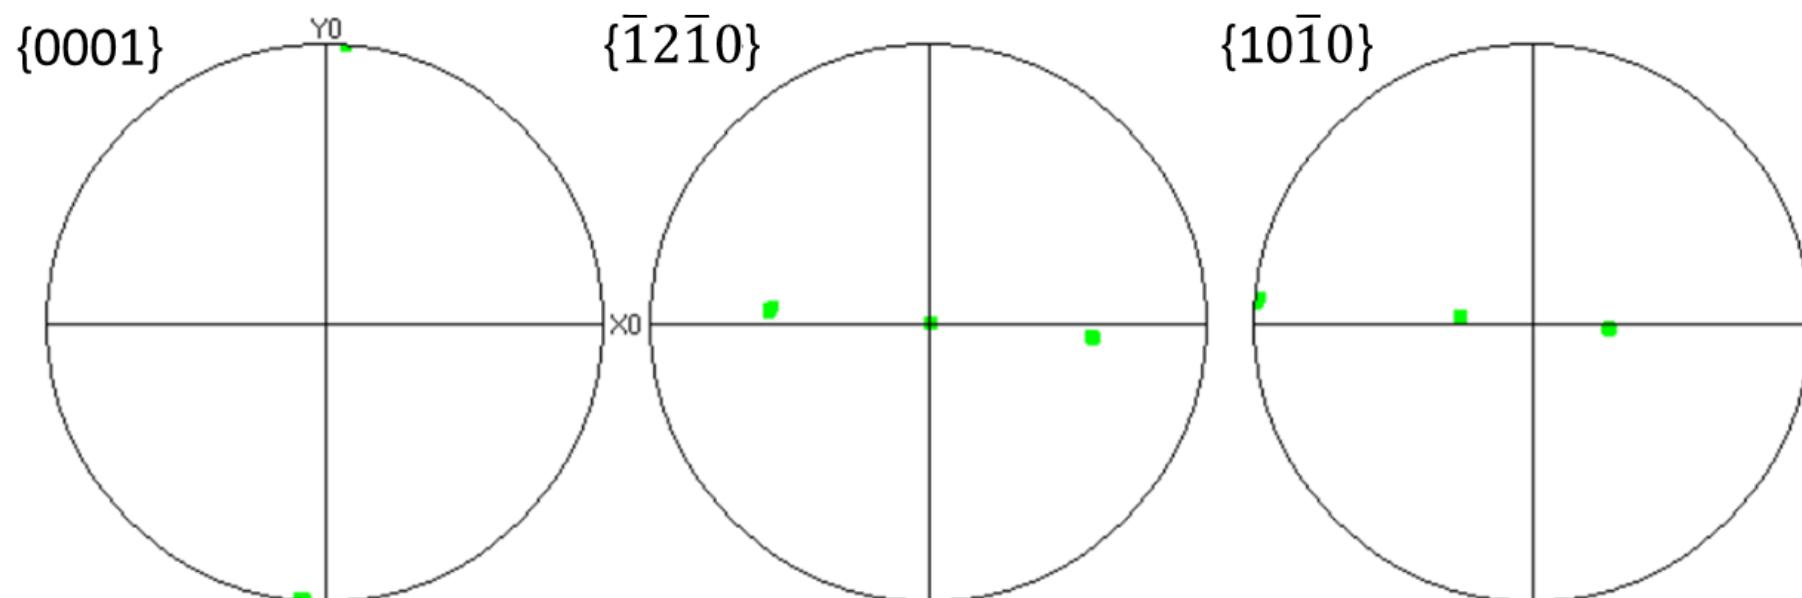
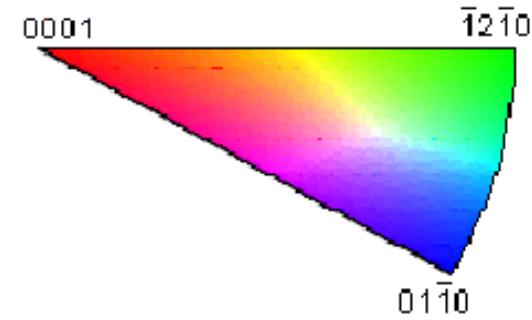
- Focused ion beam (FIB) cross section on end of whisker and EBSD to determine growth direction and side faces
- Does this energy optimization actually happen?
- ~50% of surface area of five $\langle\bar{1}2\bar{1}0\rangle$ type whiskers
- 87% of surface area of “nearly ideal” whisker

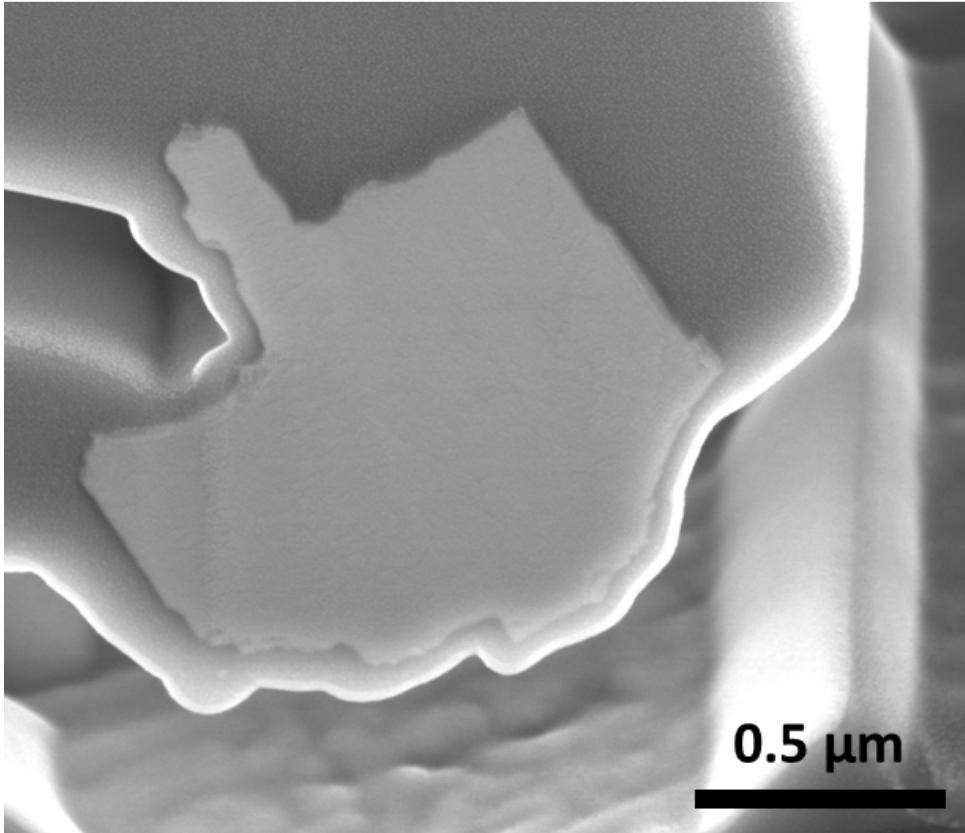
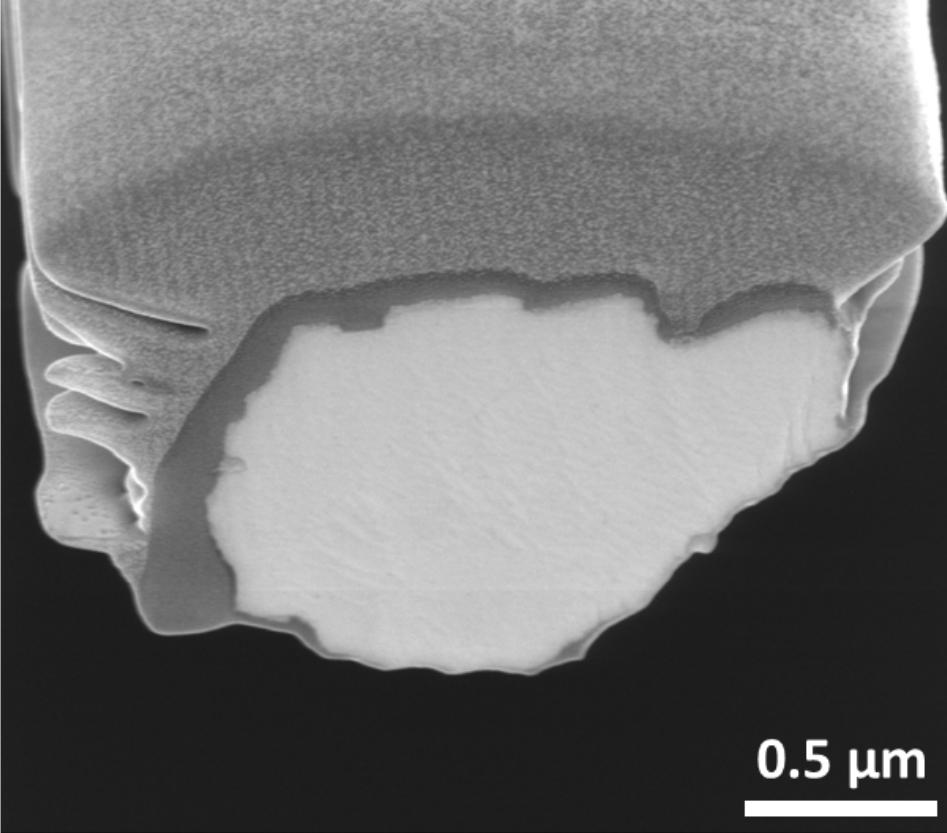
With a high driving force to reduce stress in plating, whiskers of all shapes and sizes can form

- Are influenced by plating (voids, grain shape, etc.)
