Cyclic Bend Over Sheave Performance of A Steel Tension Member Belt for Wave Energy Conversion

14th European Wave and Tidal Energy Conference (EWTEC 2021)
5 – 9 September 2021

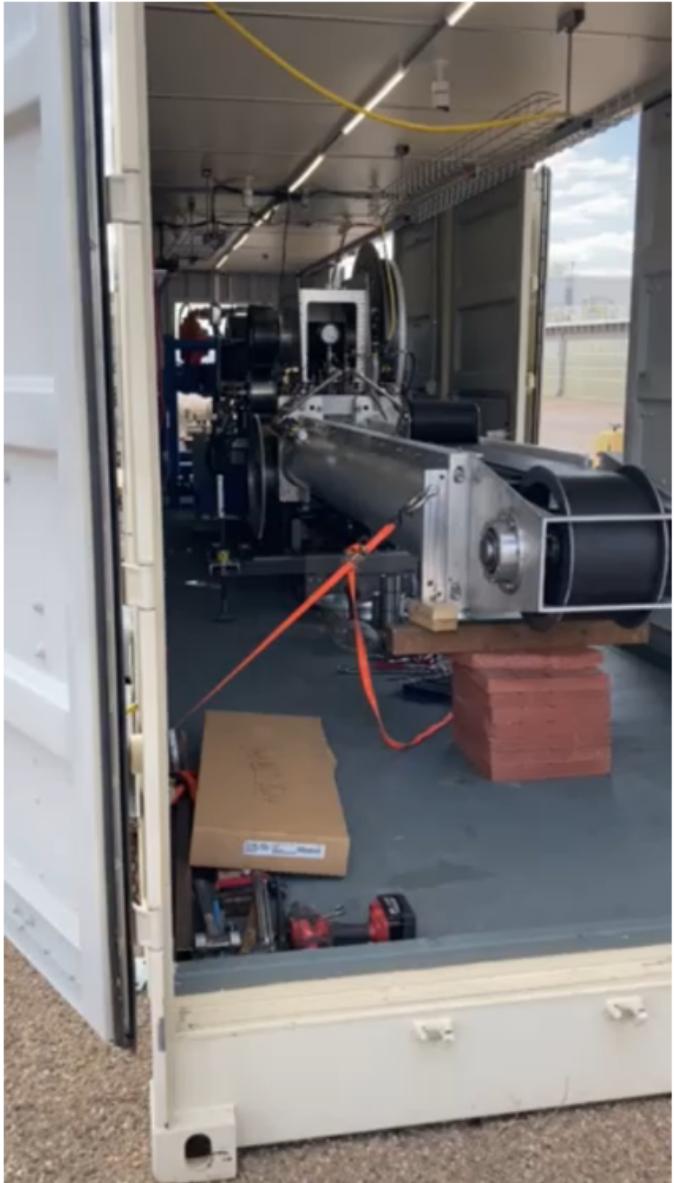
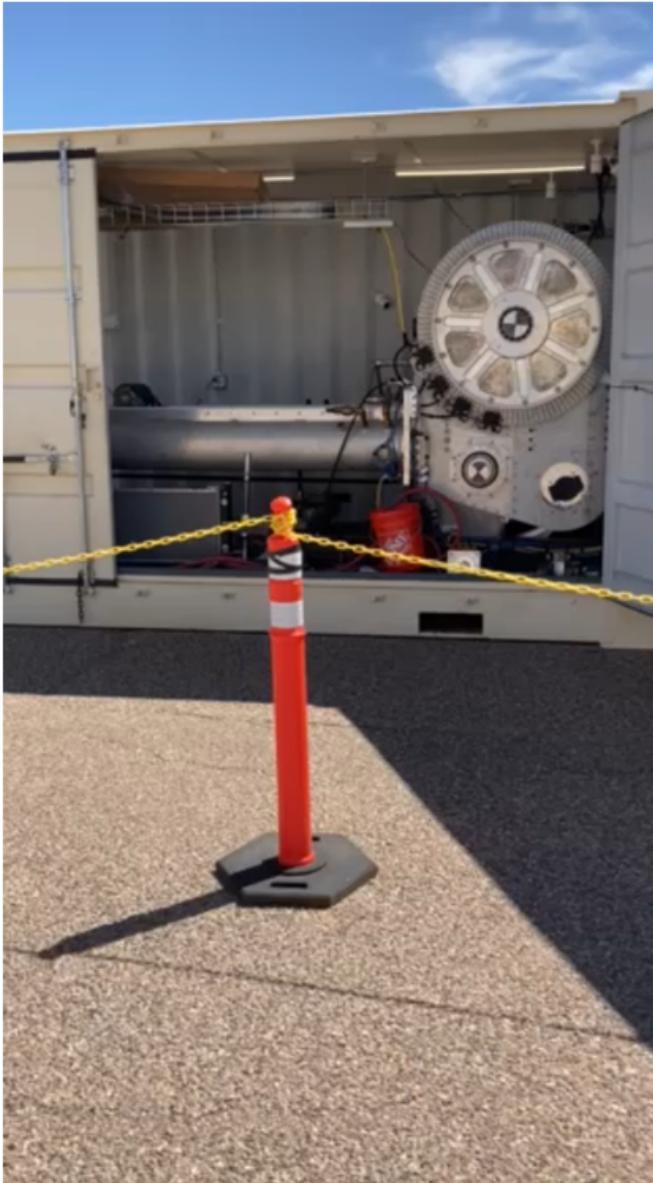
AquaHarmonics PTO testing (with belt), at Sandia Wave Energy Power Take-Off (SWEPT) Lab

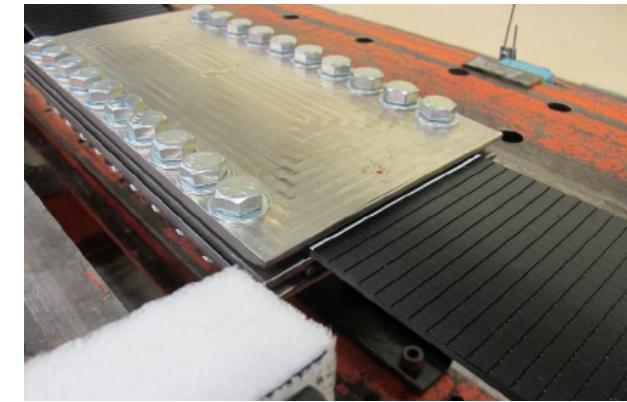
Belt termination

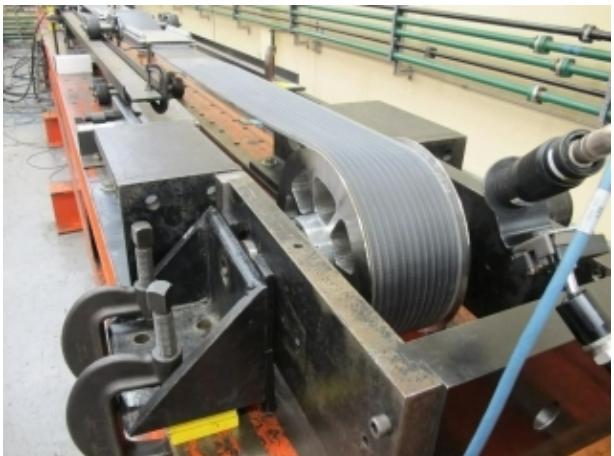
Drive drum and IR temperature sensor

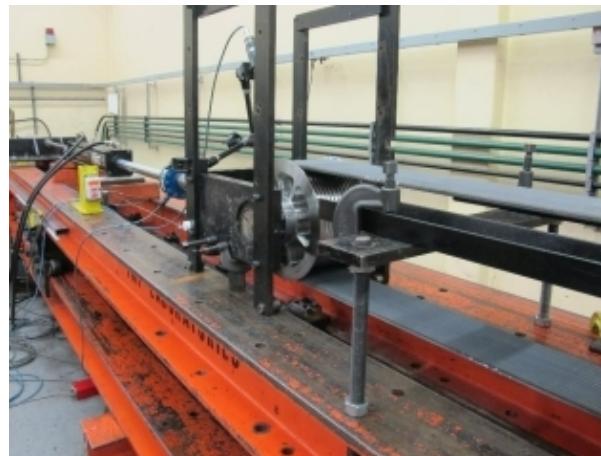
Tensioning drum clevis assembly attached to load cell and hydraulic tensioning cylinder

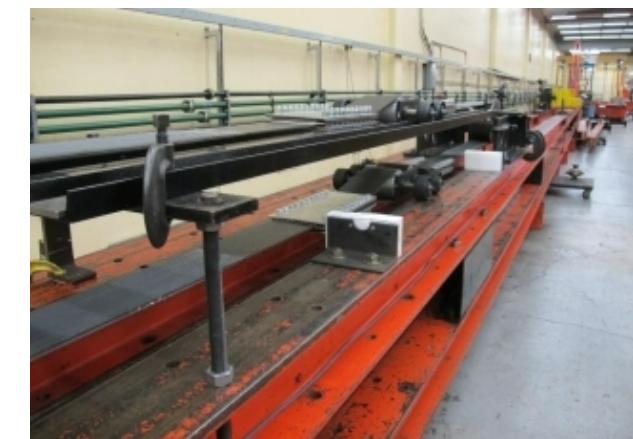
Belt samples attached to termination support trolleys.

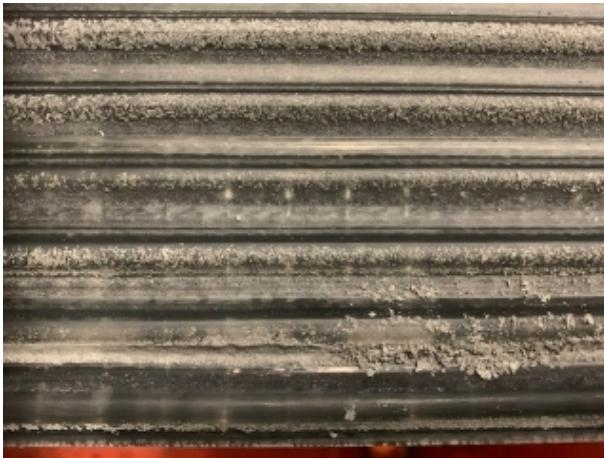
Accumulated powder residue thought to be worn polyurethane debris

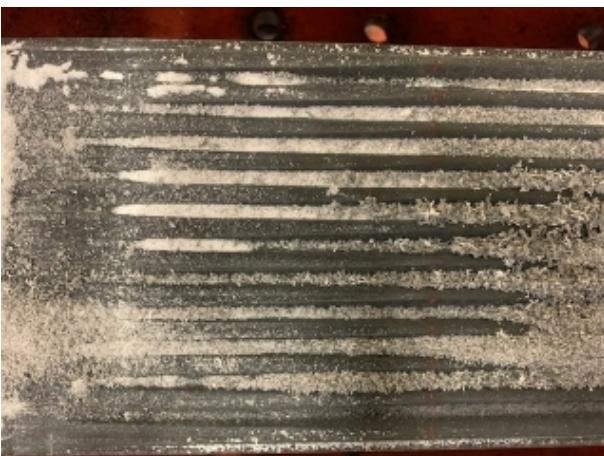
Belt wear residue at 847,612 machine cycles

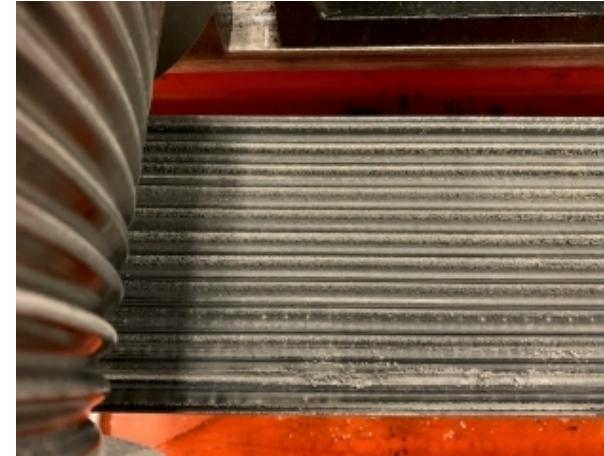
Drive belt wear in double bend zone after 750,962 cycles. Greatest wear on the near edge of the belt.

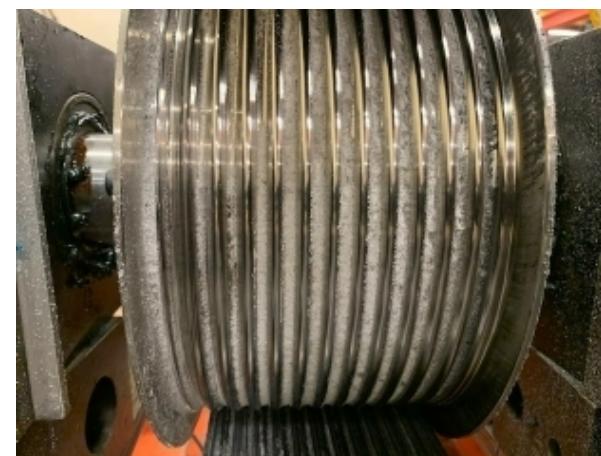
Belt wear debris in drum grooves at 847,612 machine cycles.

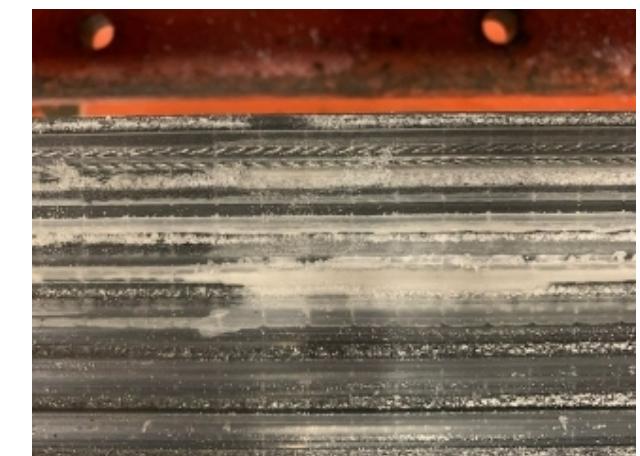
Exposed steel cables at 847,612 machine cycles

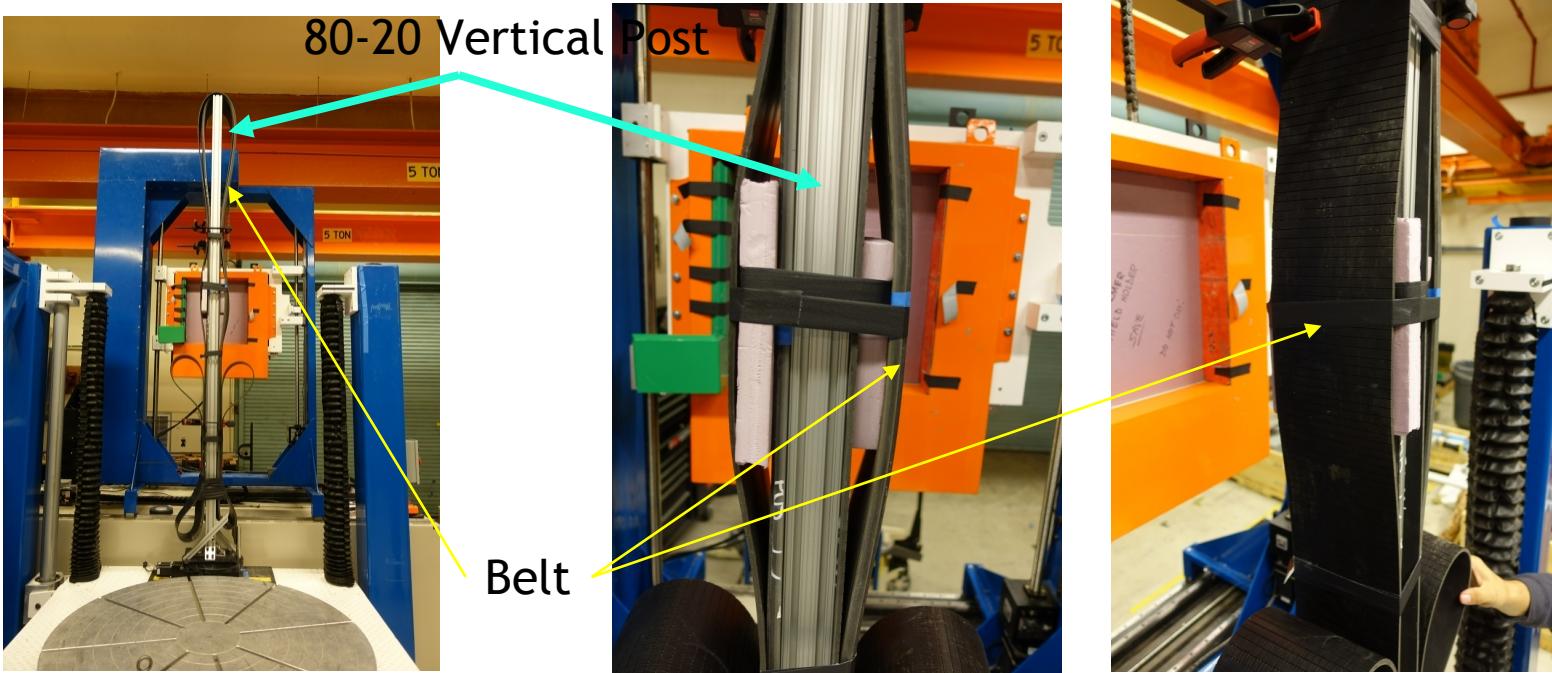
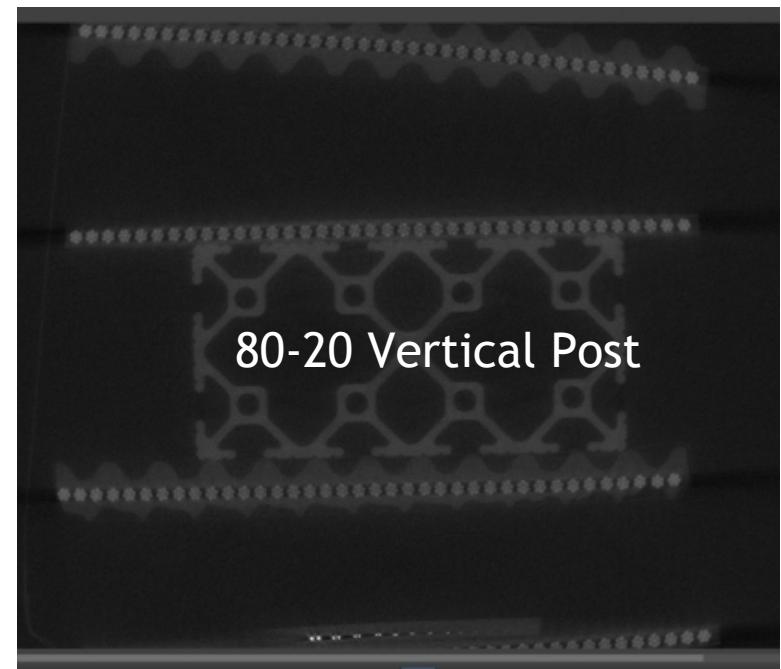
The belts were scanned using the below equipment and parameters:

- Varex M9A Linear Accelerator in the 6 MeV Mode
- Perkin-Elmer 1611 AP Flat Panel Detector in 1 x 1 mode
- Multi Axis Galil Motion Control System
- North Star Imaging eFx DR Acquisition Software
- Volume Graphics Reconstruction and Analysis Software
- Image J Image Processing software for AVI production

- Final Effective Pixel Size of 92 μm
- 1500 Projections
- 4 Frame Average
- 4 hours 12 min scan duration
- .5 Frames Per Second with a 50ms delay between steps

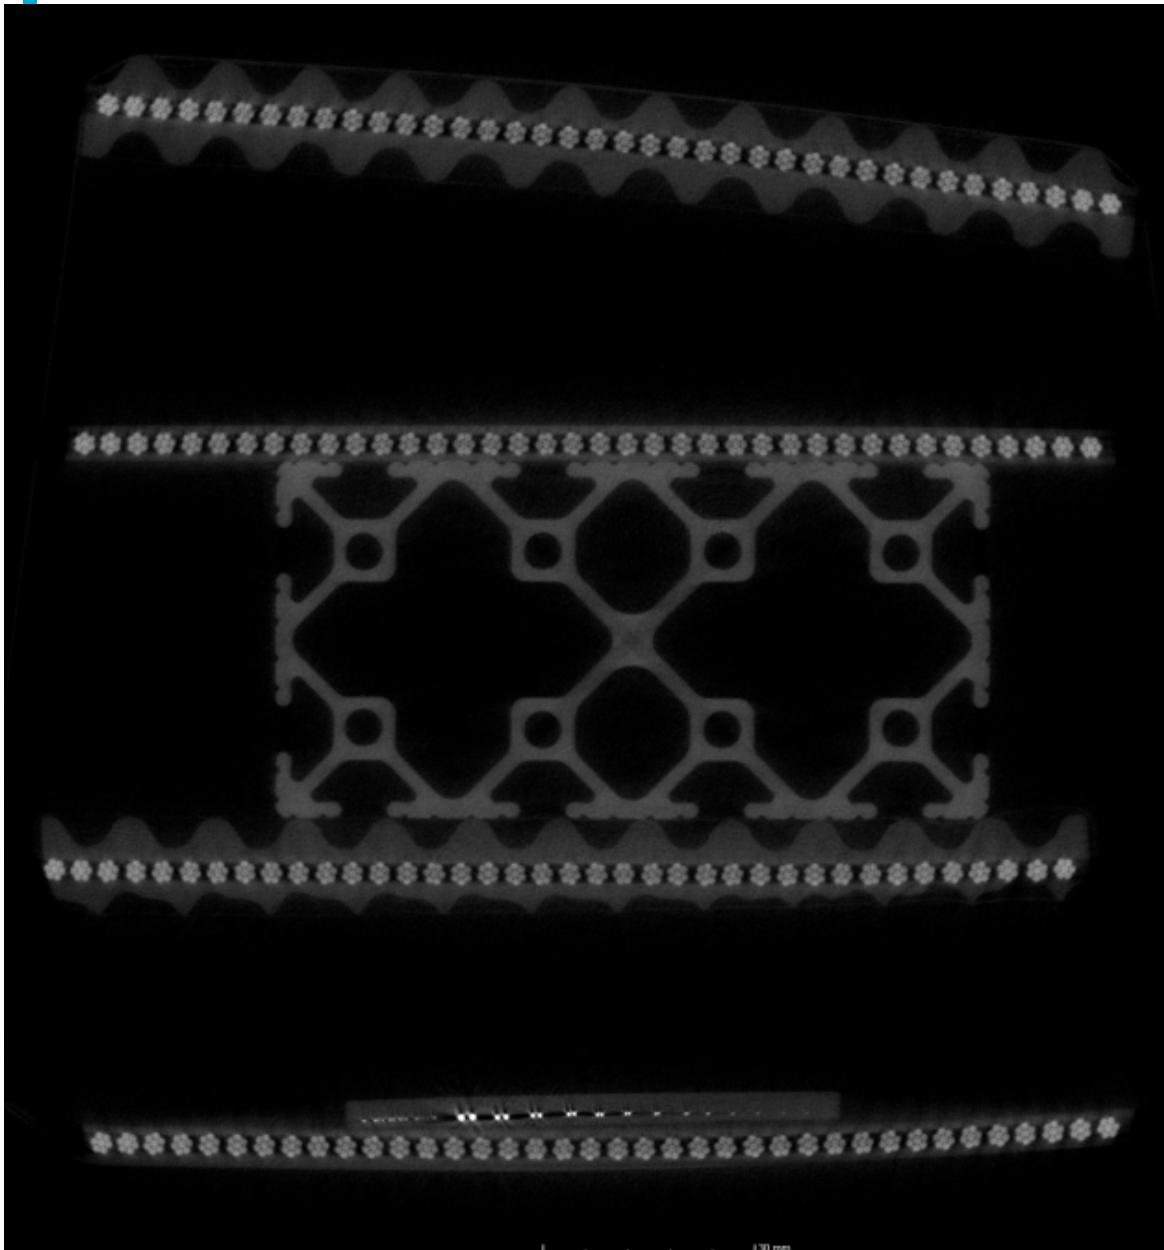
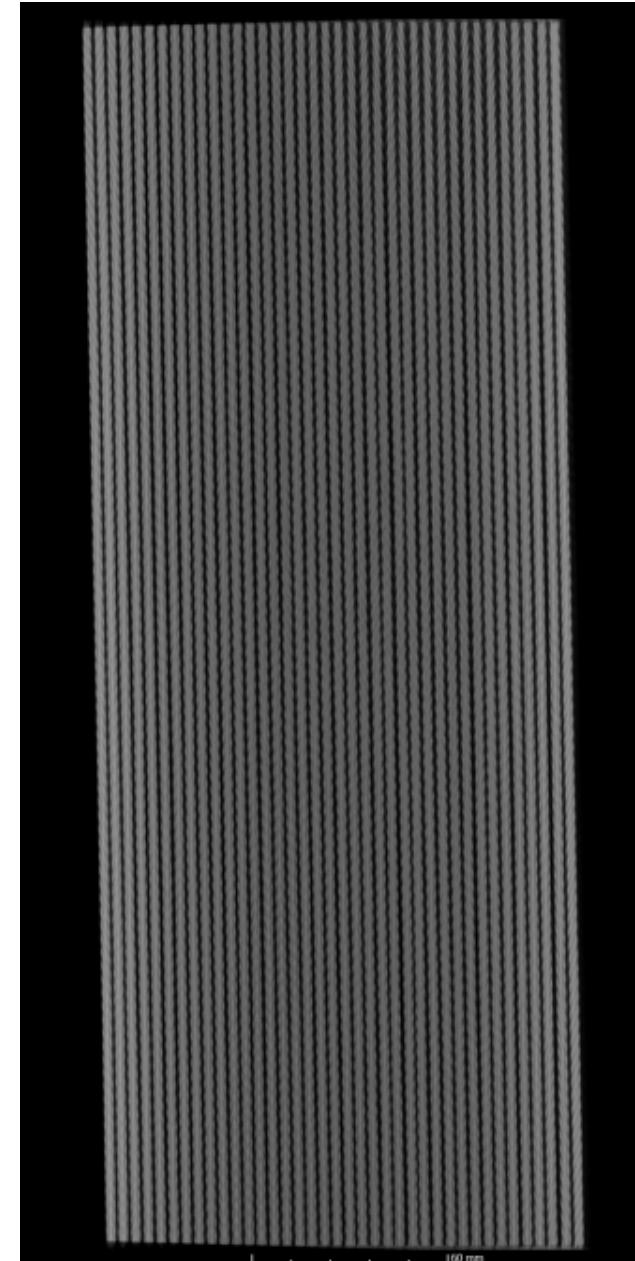
NDT Results

The overall quality of the scan provides the ability to evaluate the wire rope clearly.

Potential issues such as birdcaging, broken strands, and other defects could be observed if present.
