**DESERT RESEARCH INSTITUTE  
CULTURAL RESOURCES REPORT SR092921-1-MIT  
PROJECT NO. 2113MIT**

**AN ARCHITECTURAL SURVEY OF THE REECO MAINTENANCE COMPOUND,  
AREA 6, NEVADA NATIONAL SECURITY SITE, NYE COUNTY, NEVADA**

**April 2022**

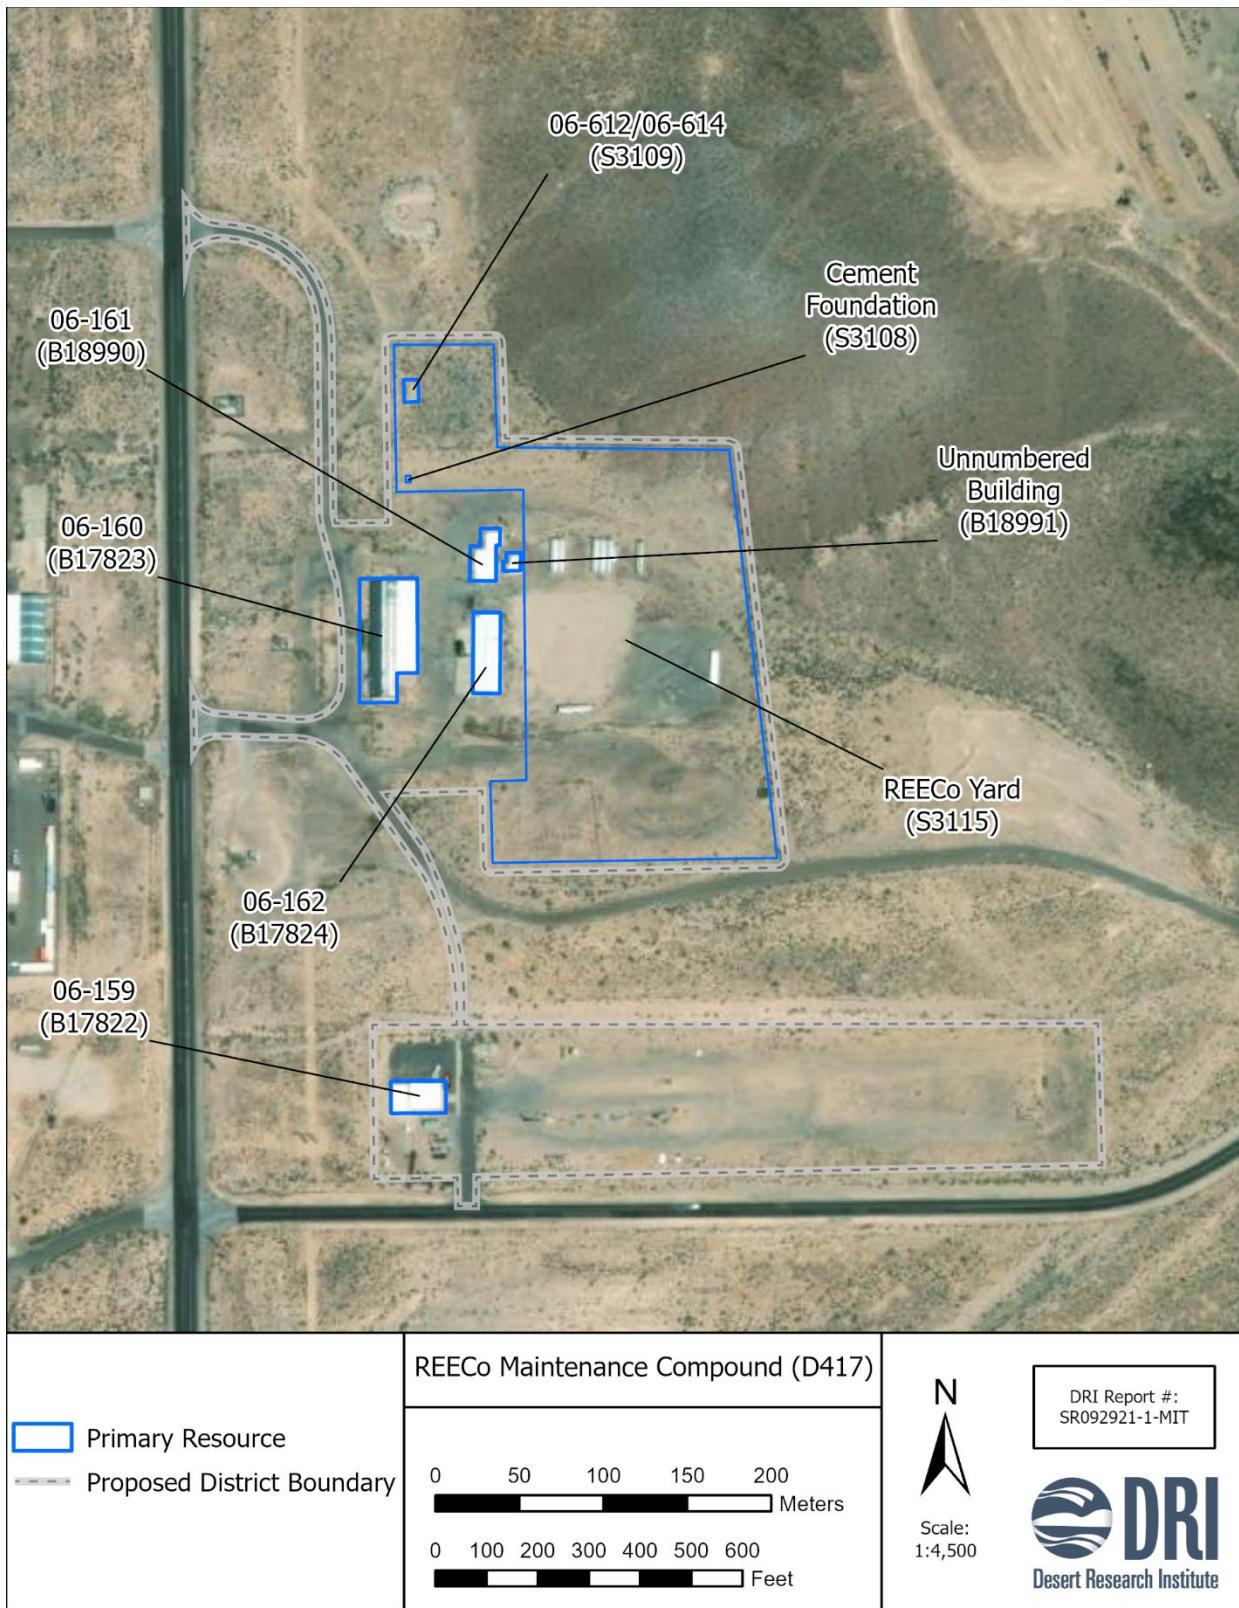
Figure 2. Proposed REECo Maintenance Compound Historic District.

Figure 2 shows the REECO Maintenance Compound Historic District and its boundary, as proposed. The boundary follows the fences that bound both the larger, northern compound and the smaller, southern compound. These two compound polygons are connected by a boundary that follows the edges of a two-track road that permits access across the open space between them. In addition, the boundary follows the edges of asphalt roadways that lie outside of both compound fences and permit access via Mercury Highway for the northern compound and 6-01 Road for the southern compound.

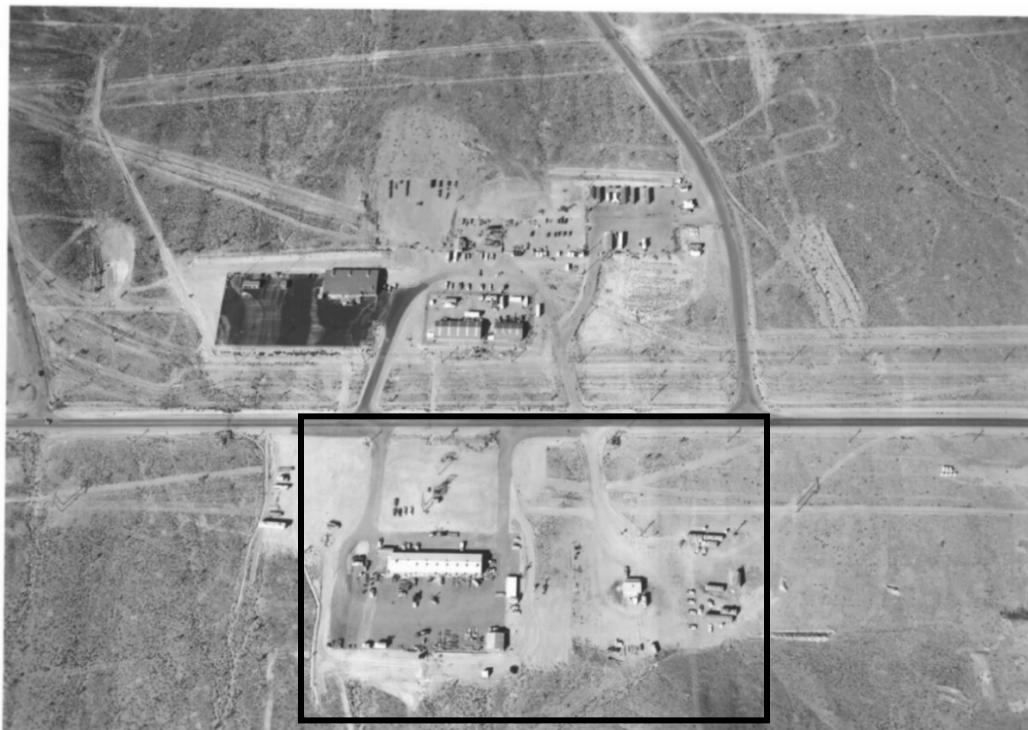
Figure 4. REECo Maintenance Compound in 1967. North is to the right (REECo 1982: Photo No. 2574-10).

The REECo Maintenance Compound expanded late in the 1970s. Records indicate that by 1979, the compound included a second large warehouse, Building 06-162, in addition to the two original warehouses and the lumber shed (Holmes & Narver 1979a). This building is located 50 feet east of the original warehouse, Building 06-160, on the existing terraced pad and separated from it by an asphalt drive. At that time, the new warehouse contained a paint shop, with spray paint and paint storage areas; a carpentry shop; a steam water shop; and other supporting offices (Holmes & Narver 1977). Two other permanent structures were also added, an electrical shop, Building 06-612/06-614, and an undesignated storage shed on the east side of Building 06-161. The yard was substantially enlarged to approximately 300 × 600 feet and nonpermanent facilities included a loading ramp, gas bottle storage, fuel storage, and trailer storage. The spatial layout of the compound continued to follow the initial format: buildings clustered to the west with a rectangular yard immediately to the east.

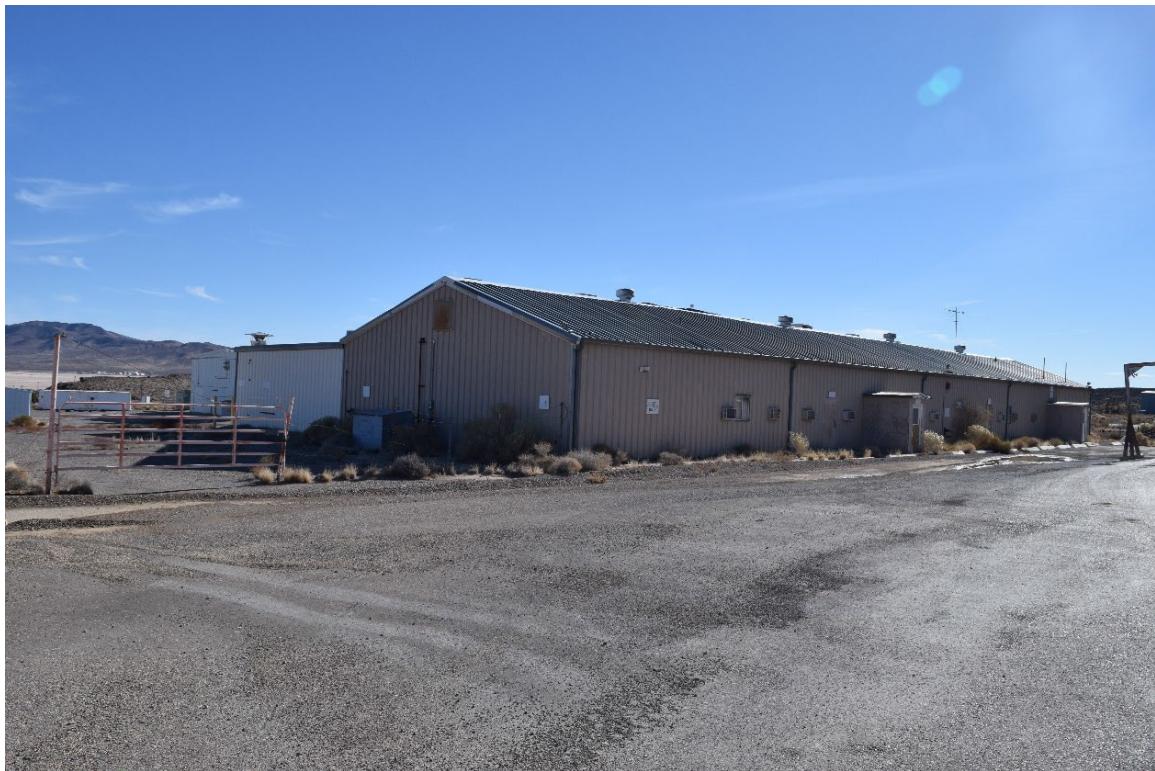
Constructed in 1967, this prefabricated warehouse was a maintenance shop that housed a variety of general contracting trades, such as carpentry, painting, ironworking, electrical, plumbing, and sheet metal working (Figure 5). It is the largest and most visible structure in the northern compound, is oriented north-south, and parallels Mercury Highway. Similar in form to the other buildings, it is rectangular and made of corrugated metal siding with a side gabled roof. It was designed with the interior divided into work bays, with the carpentry and paint shops enclosed by metal panel walls, and the other bays divided by chain-link fence. A row of small offices ran along the west side of the building, which also included space for laborers, and served as the main entry into the building. There are no accessory resources associated with it. The building is still in its original location.

Figure 5. NNSS Building 06-160, facing southeast (2113MIT\_0025, DRI 2018).

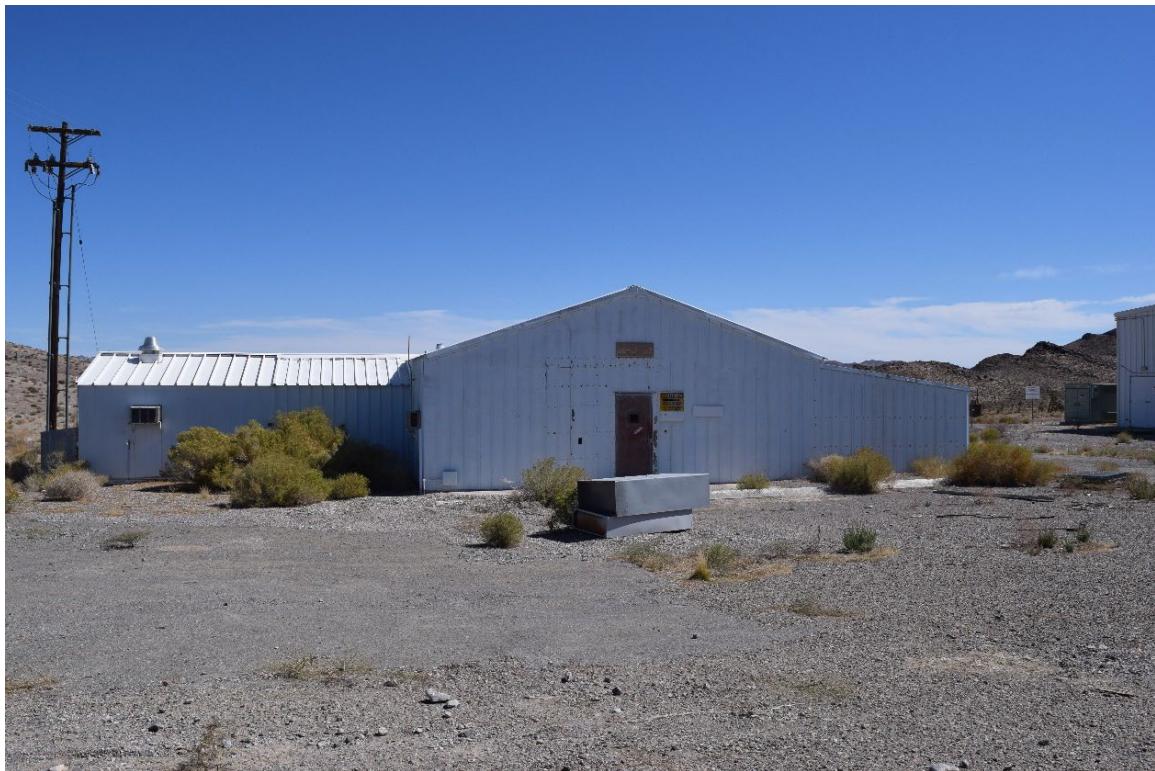
Figure 6. NNSS Building 06-161, facing east (2113MIT\_0013, DRI 2021).

There are two accessory resources associated with it: an iron scaffolding that allows access to the outside HVAC device (AR1) and an electrical transformer and panel (AR2). Because both of these accessory resources appear to be recent additions, they are recommended as noncontributing resources to the primary resource.

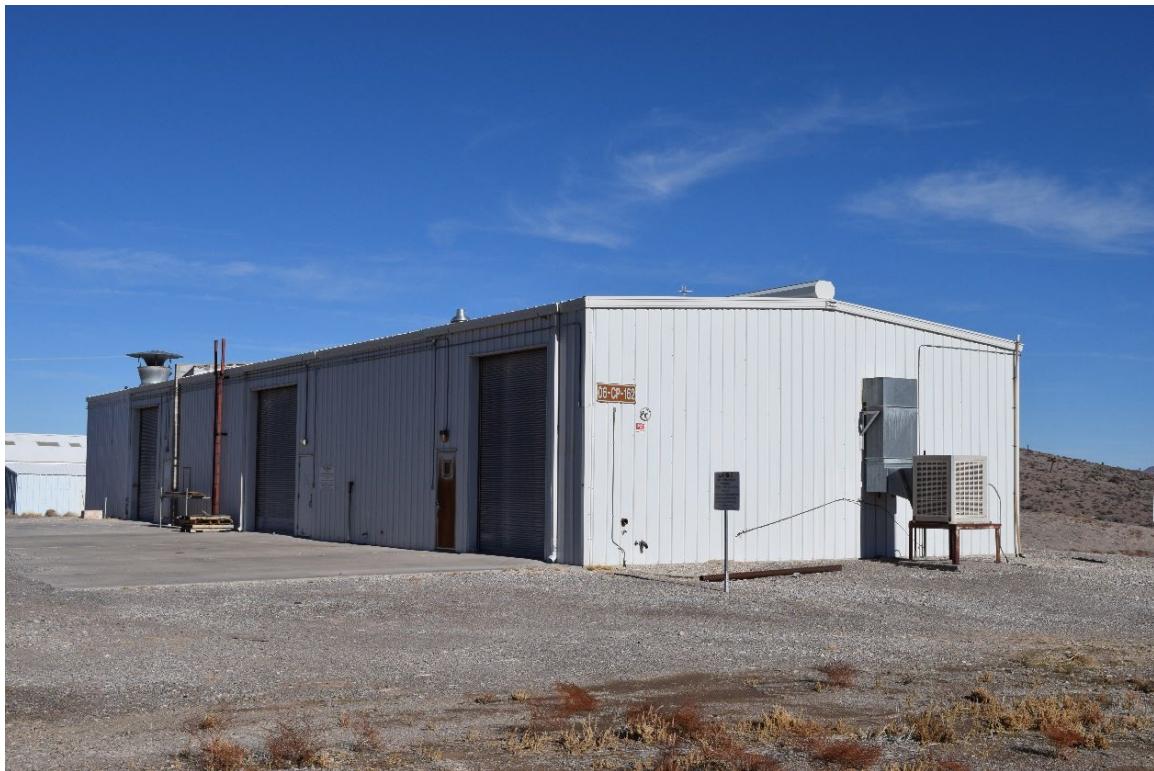
This prefabricated warehouse was constructed in 1979 and designed as shop space for carpentry, paint, and pipe fitting trades and associated offices (Figure 7). It is located immediately east of and parallel to Building 06-160. Each of the separate shops are accessed both by pedestrian doors and roll-up doors on the west side. A mezzanine with office space, restrooms, and a break room is located in the southern third of the building. Construction drawings indicate that the warehouse was made of vertical and horizontal steel framing covered with corrugated metal panels on the roof and walls. A concrete block firewall serves as a partition dividing the space devoted to painting services from the remainder of the building. The building has been altered with the installation of several HVAC components (ducts, hoods, and ground-mounted evaporative cooling units), two large louvered vents, and a dust filtration system, among other alterations. There are no accessory resources associated with this primary resource.

Figure 7. NNSS Building 06-162, facing northeast (2113MIT\_0028, DRI 2018).

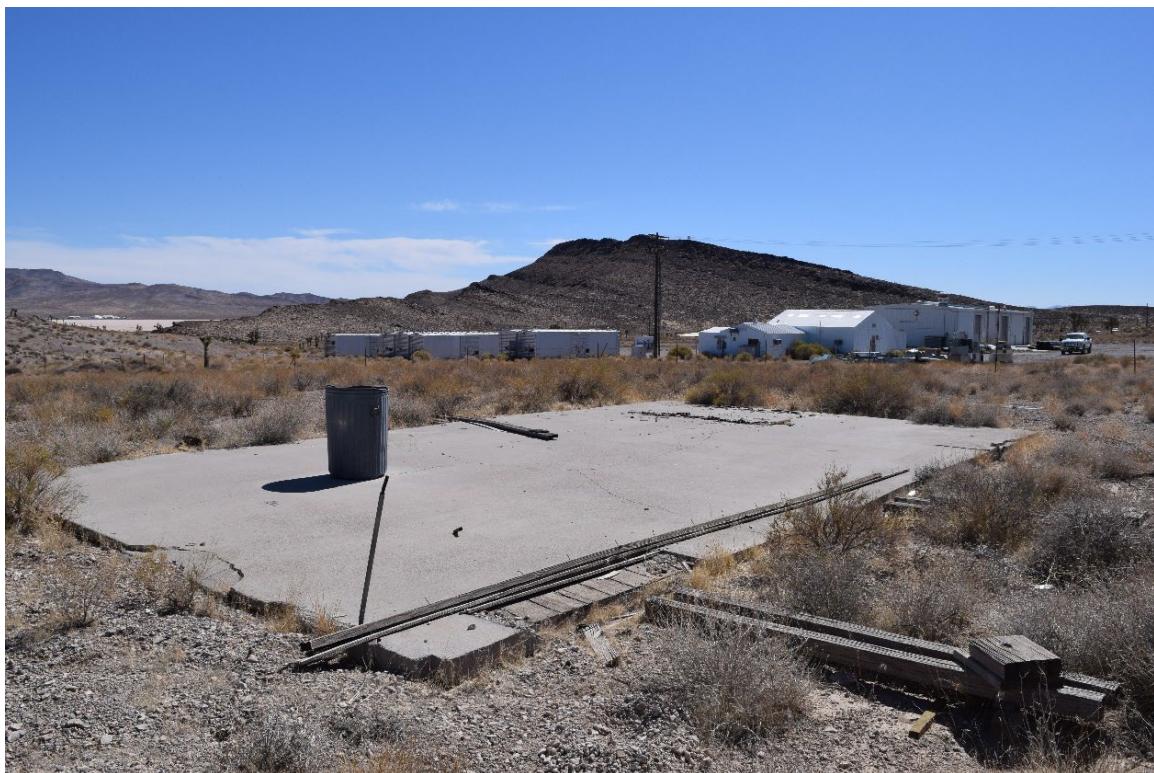
Figure 8. NNSS Building 06-612/614 foundation, facing southeast (2113MIT\_0011, DRI 2021).

Building 06-612/06-614, used throughout the period of significance as an electrical shop, appears to have been one of the original buildings constructed for the compound in 1967 (Figure 8). It would continue to be used in the same manner throughout much of the period of significance. However, engineering drawings show that the building had been demolished by 1992, leaving only the concrete foundation pad strewn with artifacts. The foundation is rectangular, measures 35 feet north-south × 20 feet east-west and

is raised 3 inches above the surrounding terrain. It apparently had a single pedestrian door located on its west side, as indicated by a wooden sill. Square post emplacements are evident around the perimeter of the foundation. Milled lumber, nails, and various other small metal objects are strewn throughout the area. The only accessory resource is an electrical panel (AR1) located west of the foundation.

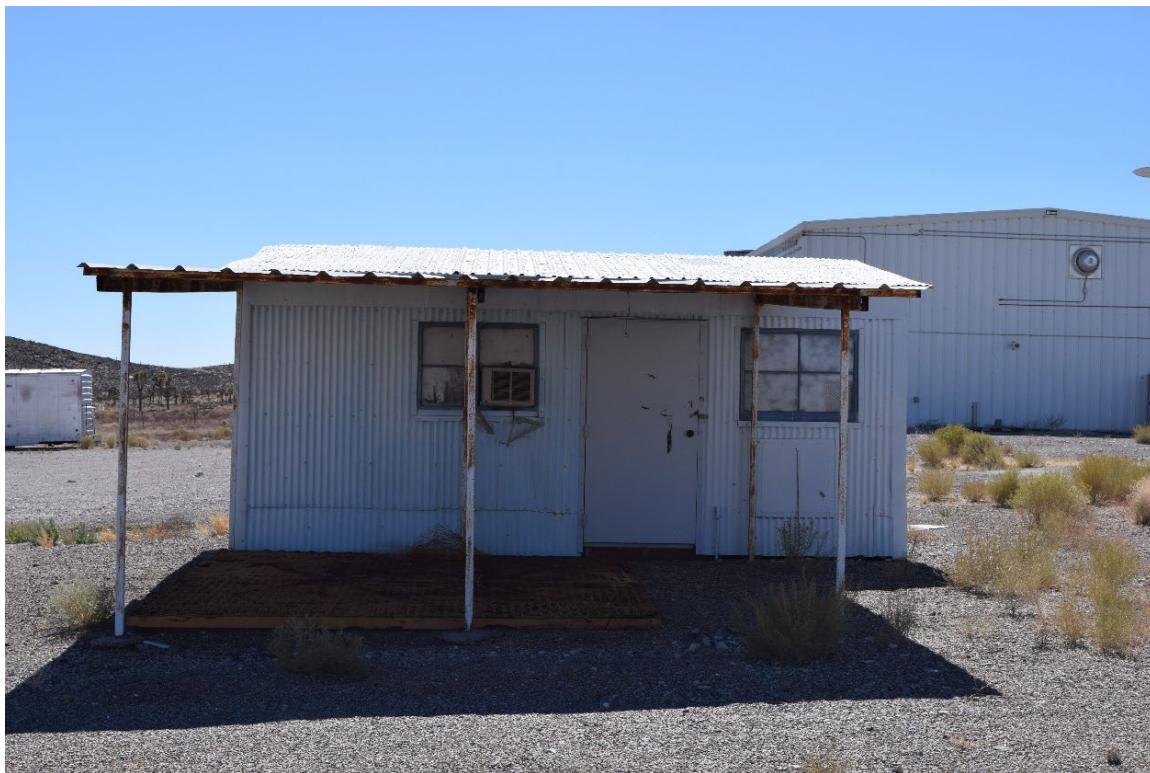
Figure 9. Unnumbered building, facing south (2113MIT\_0018, 2021).

This unnumbered building was likely constructed during the 1960s, based on its overall style and similarity to Building 06-161 (Figure 9). It may have served as a specialized trade shop or have been used for storage. Unfortunately, the archival review did not reveal either its date of construction or any information to indicate its function. It is a simple rectangular shed made of corrugated metal siding and roof. There is a single pedestrian door facing north with two metal-framed, fixed-glass, four-lite windows, one on either side of the door. One of the lower lites in the east (left) window has been replaced by an air conditioning unit. An awning extends off the entry and there is a metal grate underneath it that serves as a floor. There are no accessory resources associated with this resource.

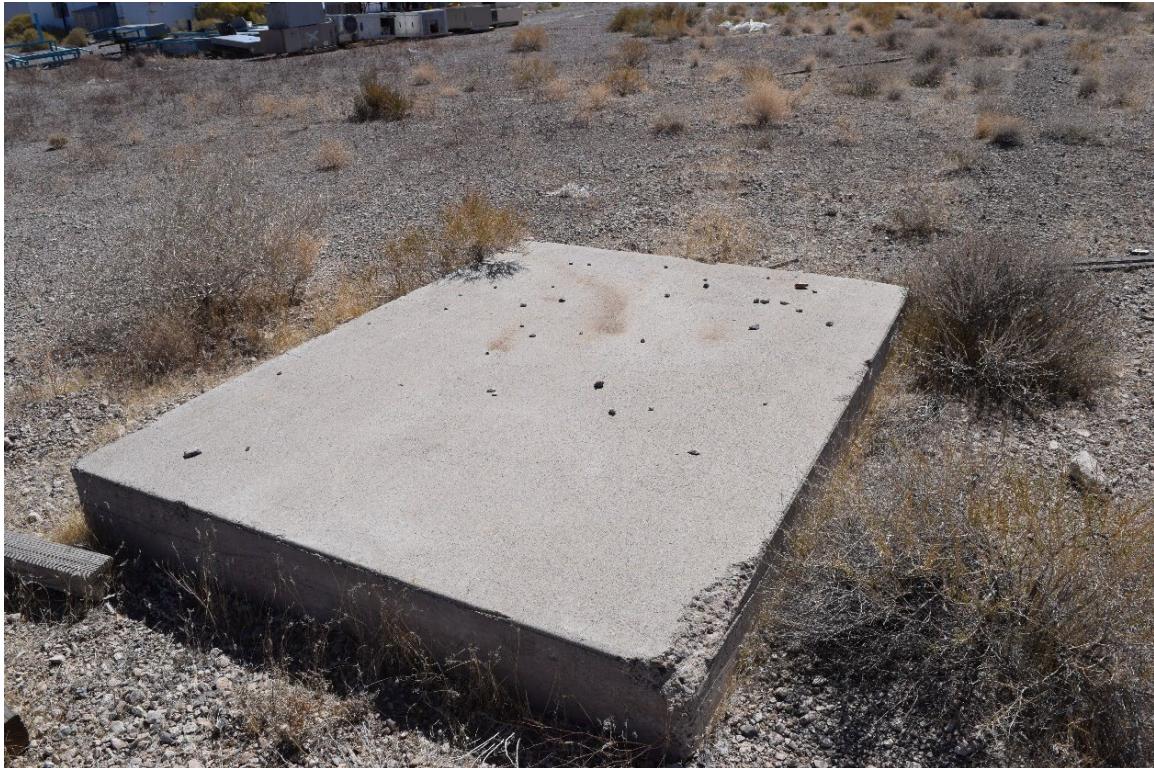
Figure 10. Unnumbered foundation, facing southeast (2113MIT\_0030, DRI 2021).

This resource is a small concrete foundation (Figure 10). The archival review did not reveal either the date it was made or any information to indicate its function. It is rectangular, measures 8 feet north-south × 6 feet east-west and is raised approximately 8 inches above the surrounding surface. It appears to be 1 foot thick. No artifacts appear in direct association with it nor are there any accessory resources.

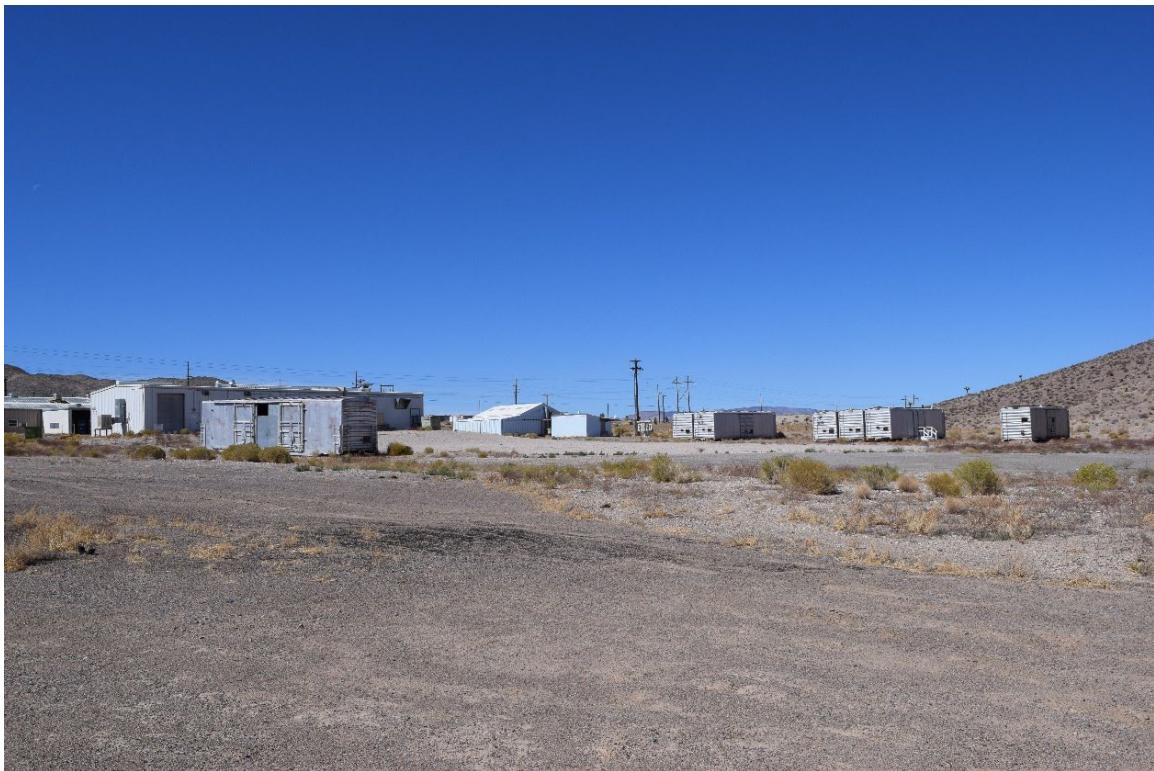
The northern compound parking and storage yard was developed during the initial stage of the facility (Figure 11). The archival review indicates that its size changed over time, as well as the number and variety of items within it.

The original 1967 maintenance compound consisted of three buildings, including Building 06-160 (REECo 1967). A generalized yard or open area was located immediately behind Building 06-160 and measured 150 feet north-south × 70 feet east-west. It was demarcated by a T-post and four-strand barbed wire fence that had three gates, one immediately north and another immediately south of Building 06-160, as well one that allowed access directly into the yard from its southwest corner.

After the construction of Building 06-162 in 1979, the yard fronted it and had grown considerably in size to measure 600 feet north-south × 275 feet east-west (Holmes & Narver 1979a). This does not include an open area on the compound's northwest corner that could have been used as an extension of the yard. An engineering drawing of the Area 6 CP and vicinity shows that the yard was used for "maintenance parking and storage," "gas bottle storage," and "trailer storage" and multiple trailers and/or portable structures were depicted in the yard (Holmes & Narver 1979). From 1985 to 1992, the size of the yard and what was contained in it remained much the same (Holmes & Narver 1985; Raytheon Services Nevada 1992). Its current size and configuration, along with the demarcating fence is approximately the same as it was in 1979. Moreover, the three gate locations depicted in the 1967 REECO engineering

Figure 11. Northern compound parking lot and storage yard, facing northwest (2113MIT\_0002, DRI 2021).

drawing still allow access into the compound. What may well be the original T-post and barbed wire fence remains around most of the yard.

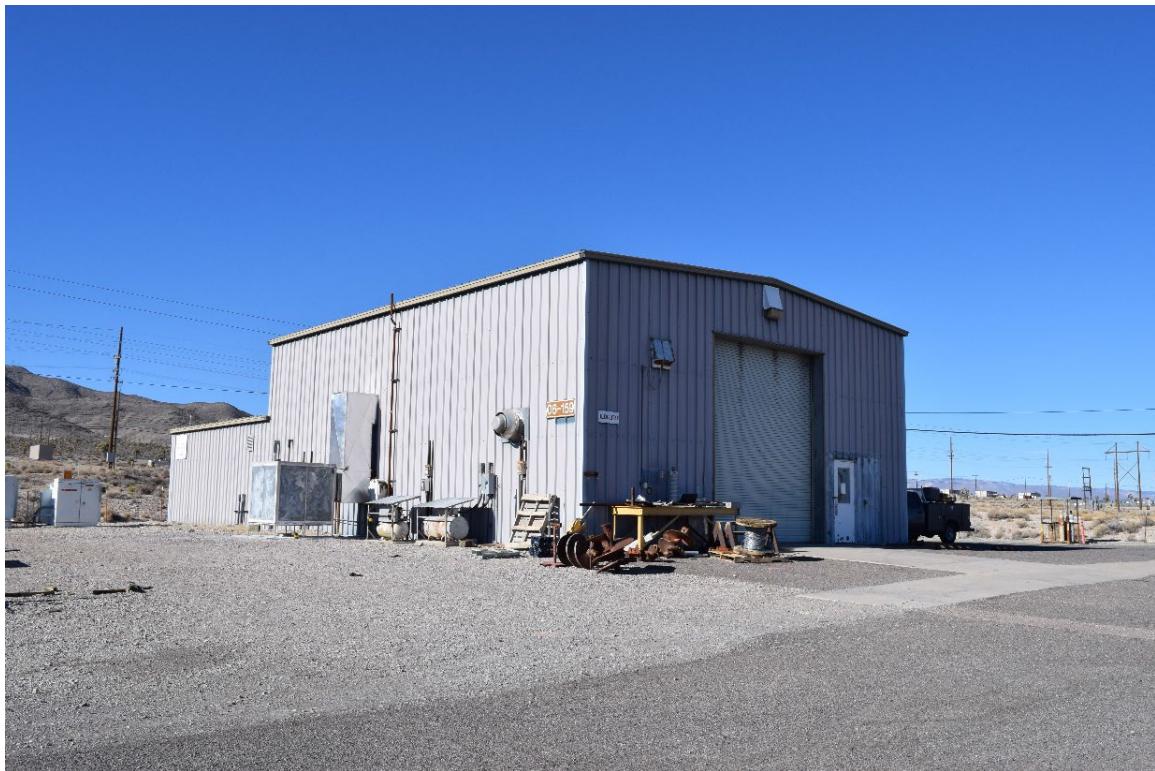
This structure is a simple, utilitarian warehouse that was built in 1980 and housed a power shop (Figure 12). It is located approximately 600 feet south of the northern compound and composes, along with a yard and boundary fence, what is referred to in this report as the smaller, southern compound. Engineering drawings show that the largest portion of the building consisted of a main work bay and a smaller welding bay. A smaller building section to the west contained offices, locker and rest rooms, a storeroom, and a small work bay. The building is accessed by a metal roll-up door and a single pedestrian door on its east side. A second pedestrian door, located on the north side of the building, also provides access from a parking lot into the main work bay. The west and south sides of the building have no doors or windows, although the south side has numerous electrical junction boxes, power lines, a louvered vent, and a large turbine vent. Two compressors, sitting on pads, are visible near the southeast corner of the building.

Figure 12. NNSS Building 06-159, facing northwest (2113MIT\_0029, DRI 2018).

There is only one accessory resource associated with this building. It is a large, fenced, graded yard immediately east of the building (AR1). The yard is rectangular in shape and over time its length expanded to the east while maintaining the same width north-south.

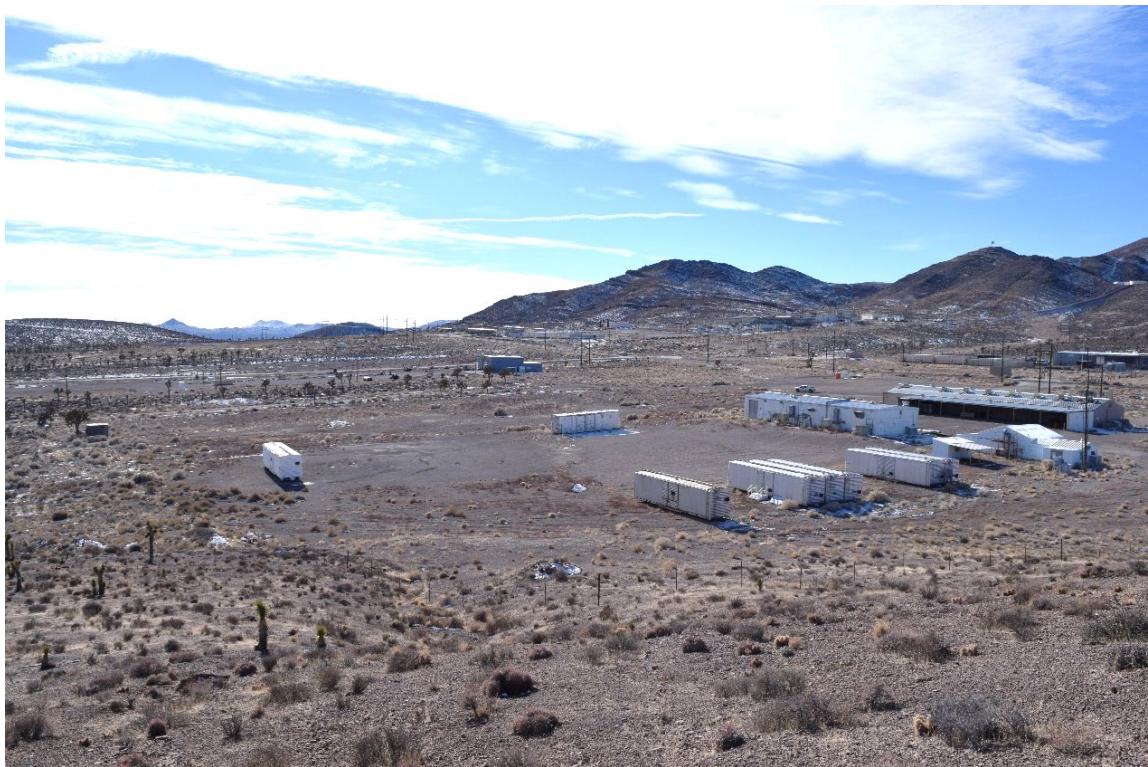
Photo 1. Boundary overview from the northeast edge of the REECo Maintenance Compound, view to southwest. Photo 2113MIT-0003.

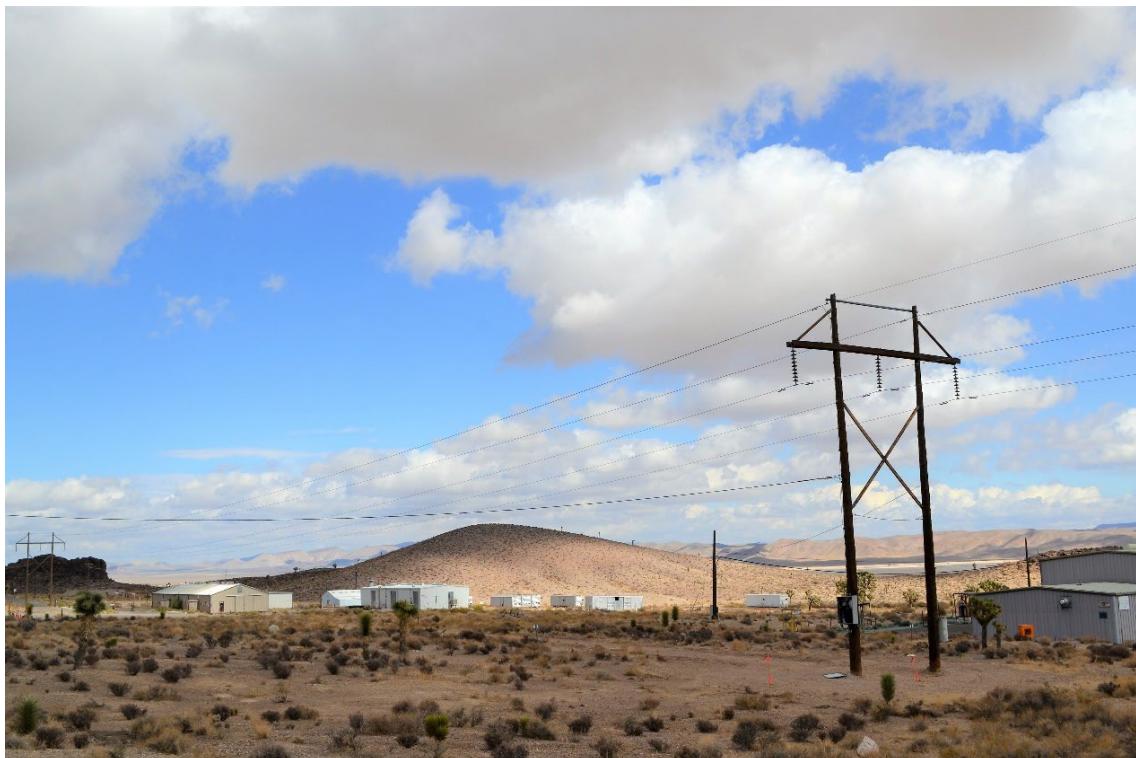
Photo 2. Boundary overview from the southwest edge of the REECo Maintenance Compound, view to northeast. Photo 2113MIT\_0010.

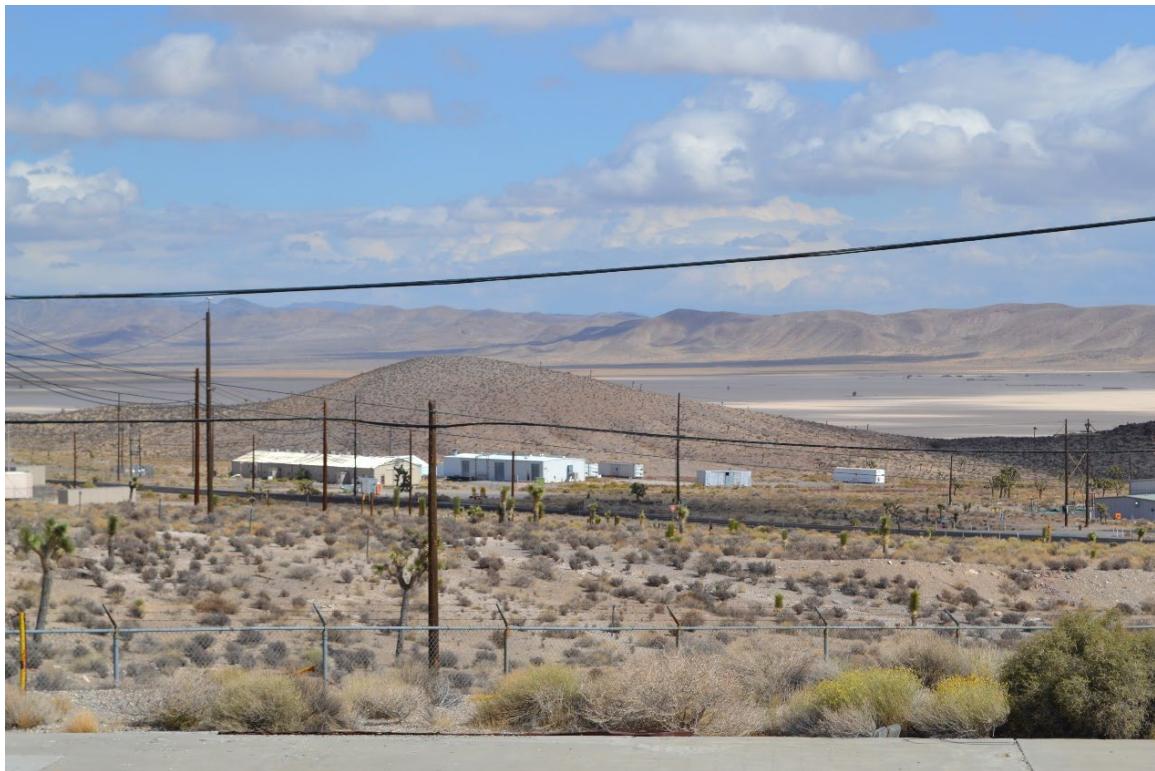
Photo 3. Western boundary of REECo Maintenance Compound; note Mercury Highway mid-ground and Yucca Flat in background, view to east-northeast. Photo 2113MIT\_0009.

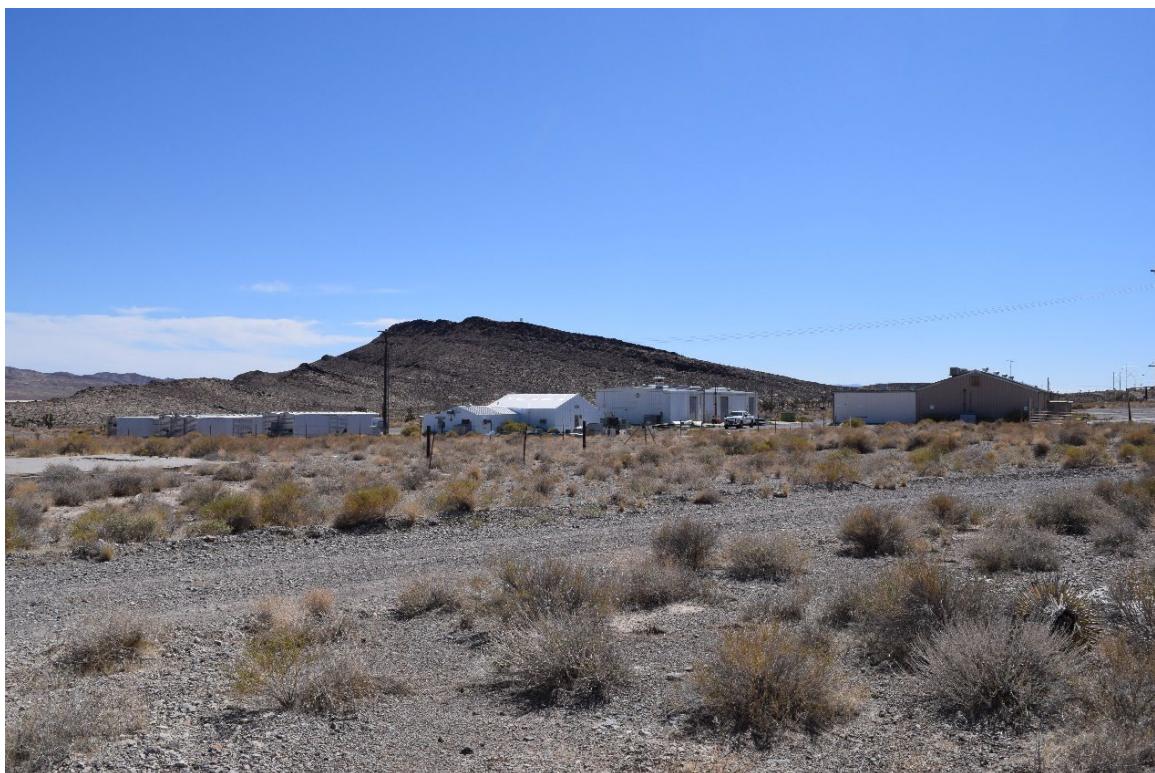
Photo 4. Western boundary of REECo Maintenance Compound from northwest corner; note fence posts in mid-ground, view to southeast. Photo 2113MIT\_0001.

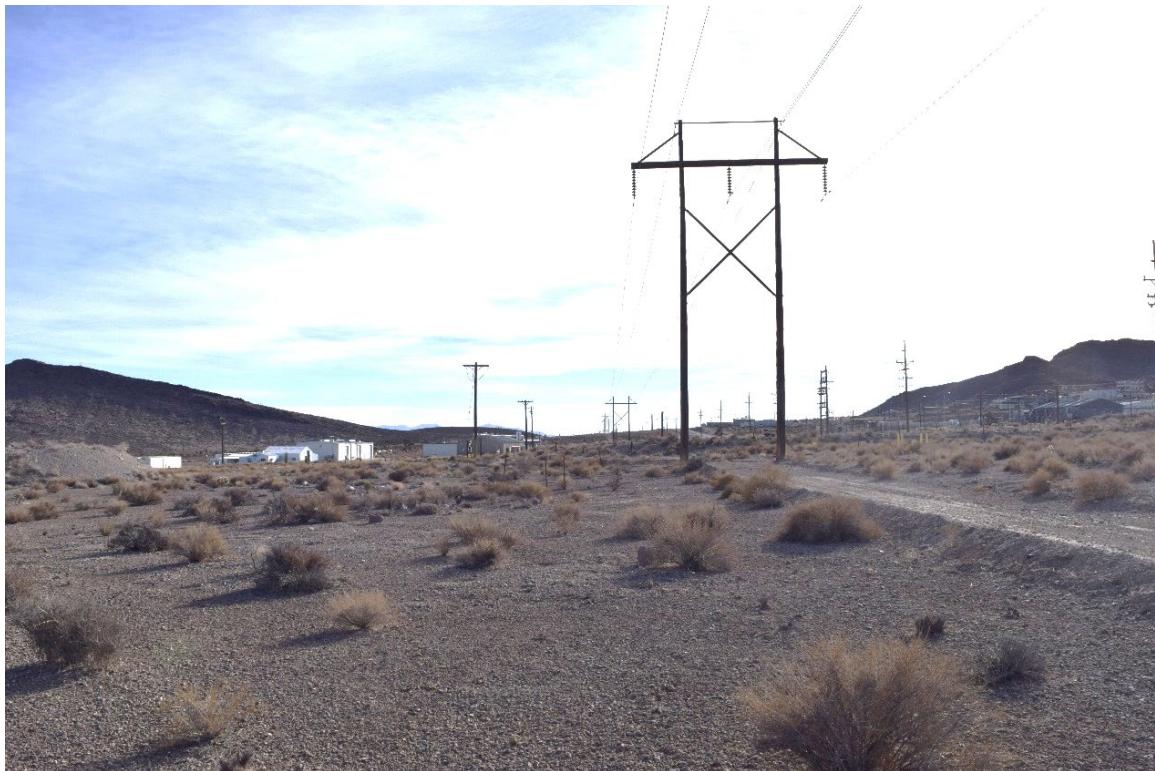
Photo 5. Northeastern boundary of REECo Maintenance Compound, view to south. Photo 2113MIT\_0004.

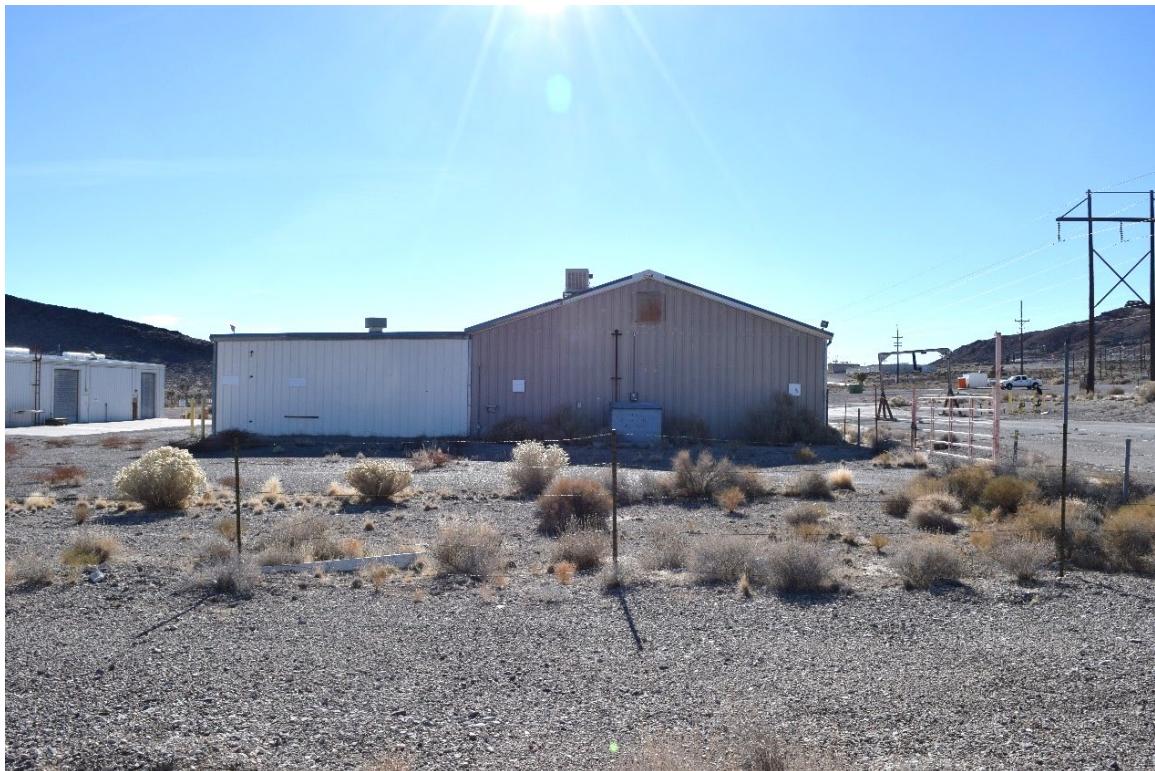
Photo 6. Boundary defined by fence line north of Building 06-160, view to south. Photo 2113MIT\_0005.

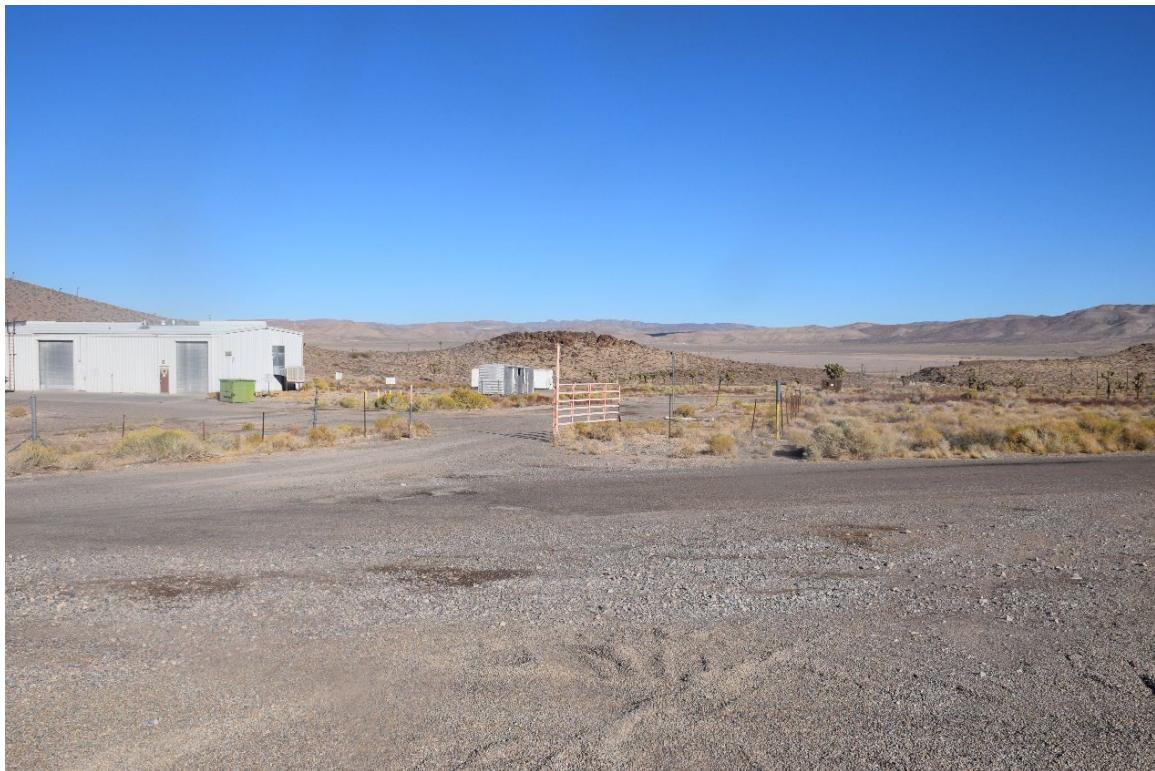
Photo 7. Western boundary defined by west fence line and entrance gate, view to east. Photo 2113MIT\_0008.

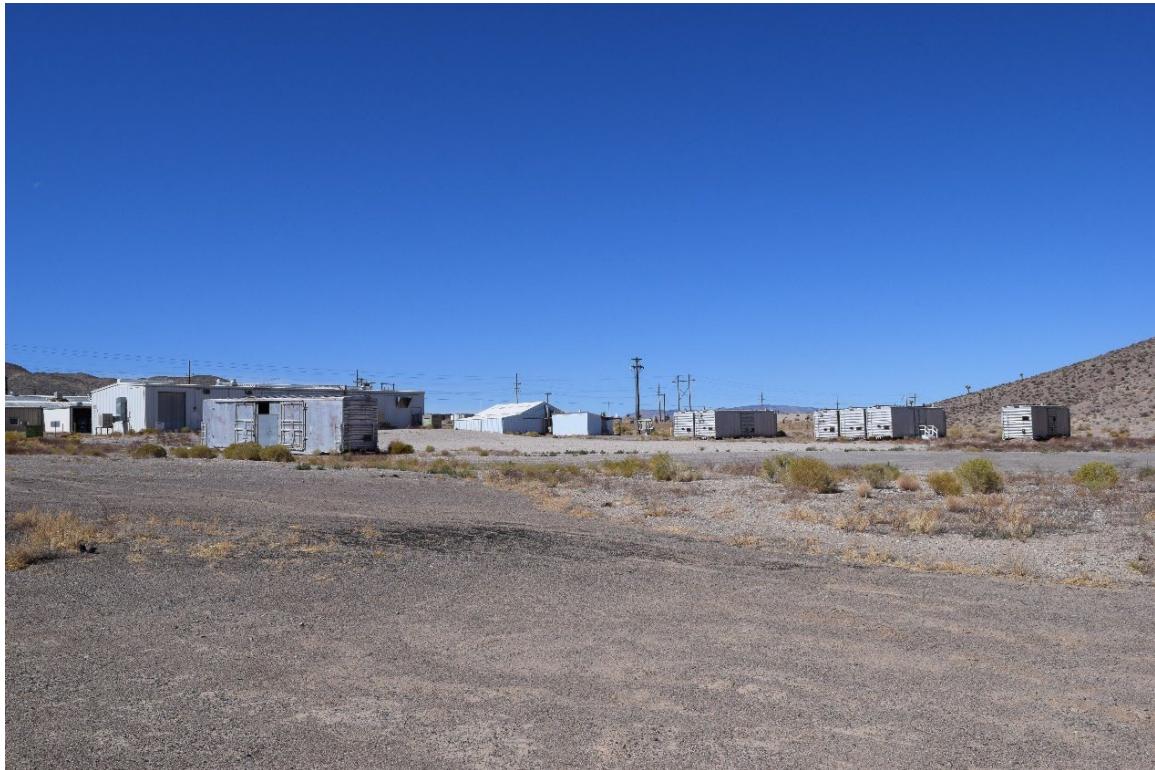
Photo 8. Eastern boundary from fence line, looking into yard and parking area of northern compound, view to northwest. Photo 2113MIT\_0002.

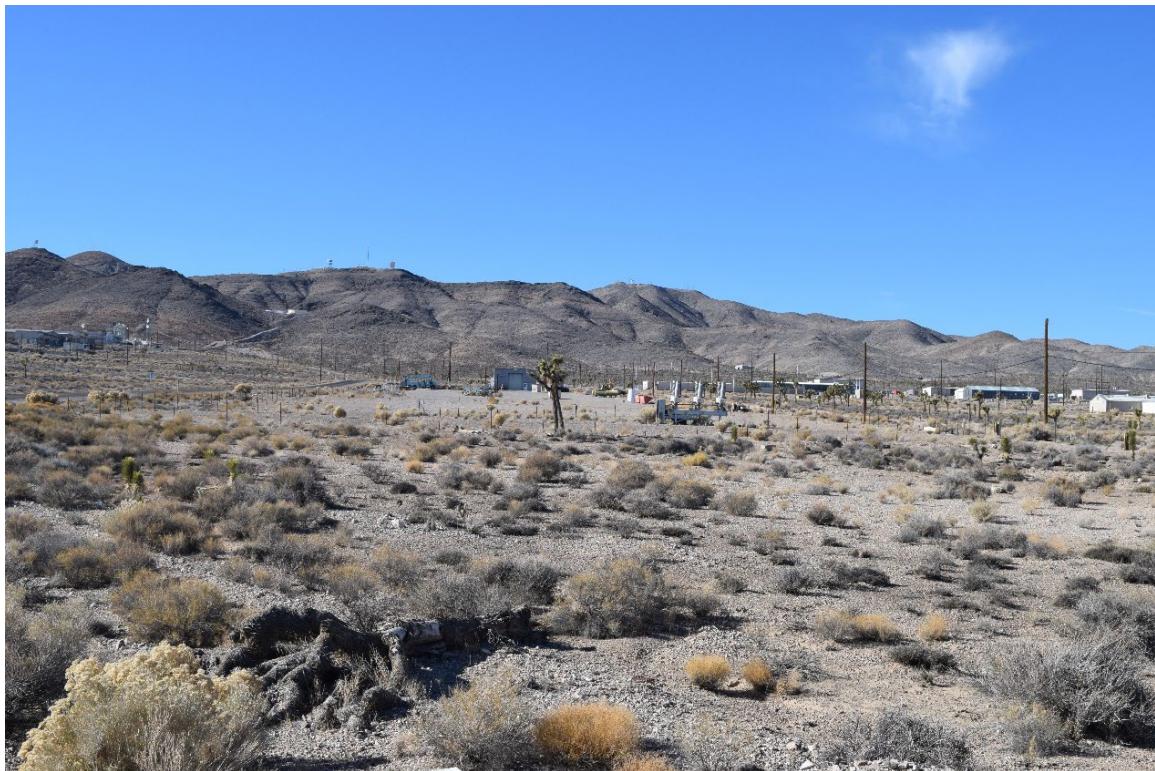
Photo 9. Eastern and southern boundaries of REECo Maintenance Compound, defined by fence line, view to west. Photo 2113MIT\_0006.

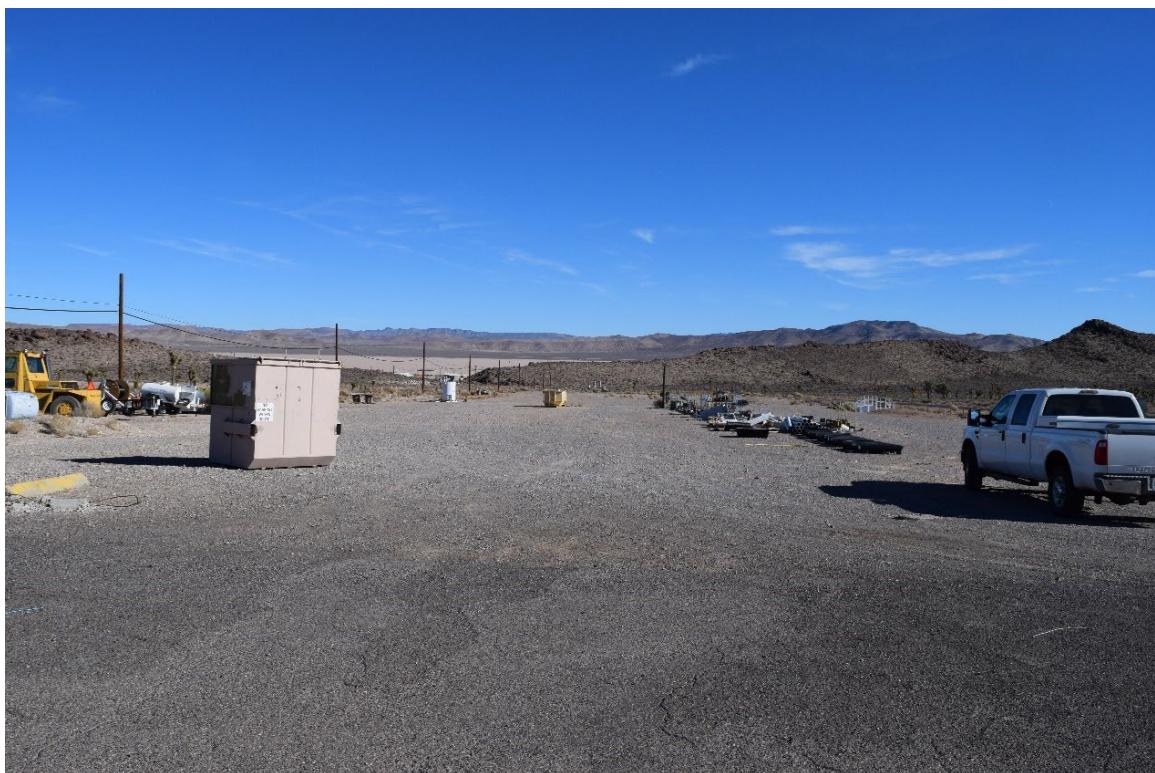
Photo 10. Eastern and southern boundaries of REECo Maintenance Compound, defined by fence line to right and in background, view to east. Photo 2113MIT\_0007.

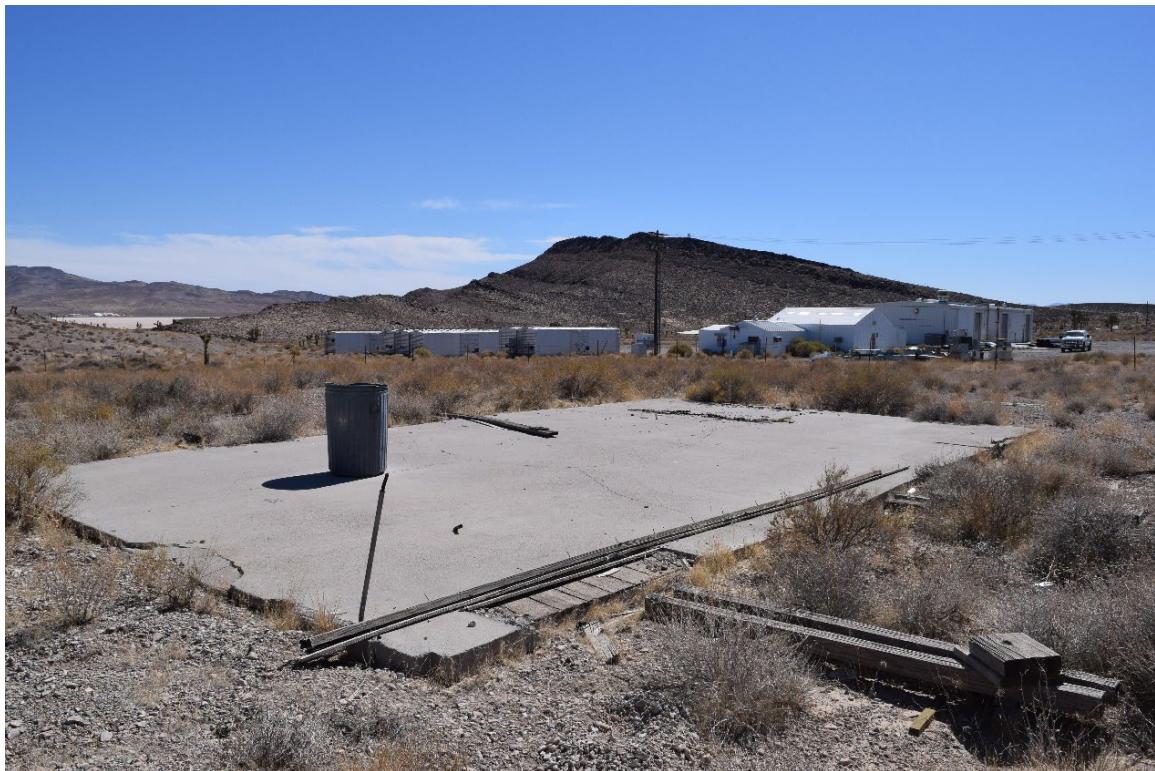
Photo 11. Foundation of Building 06-612/06-614 at northwest extent of REECo Maintenance Compound, view to southeast. Photo 2113MIT\_0011.
