**DESERT RESEARCH INSTITUTE  
CULTURAL RESOURCES REPORT SR092921-1-MIT  
PROJECT NO. 2113MIT**

**AN ARCHITECTURAL SURVEY OF THE REECO MAINTENANCE COMPOUND,  
AREA 6, NEVADA NATIONAL SECURITY SITE, NYE COUNTY, NEVADA**

**April 2022**

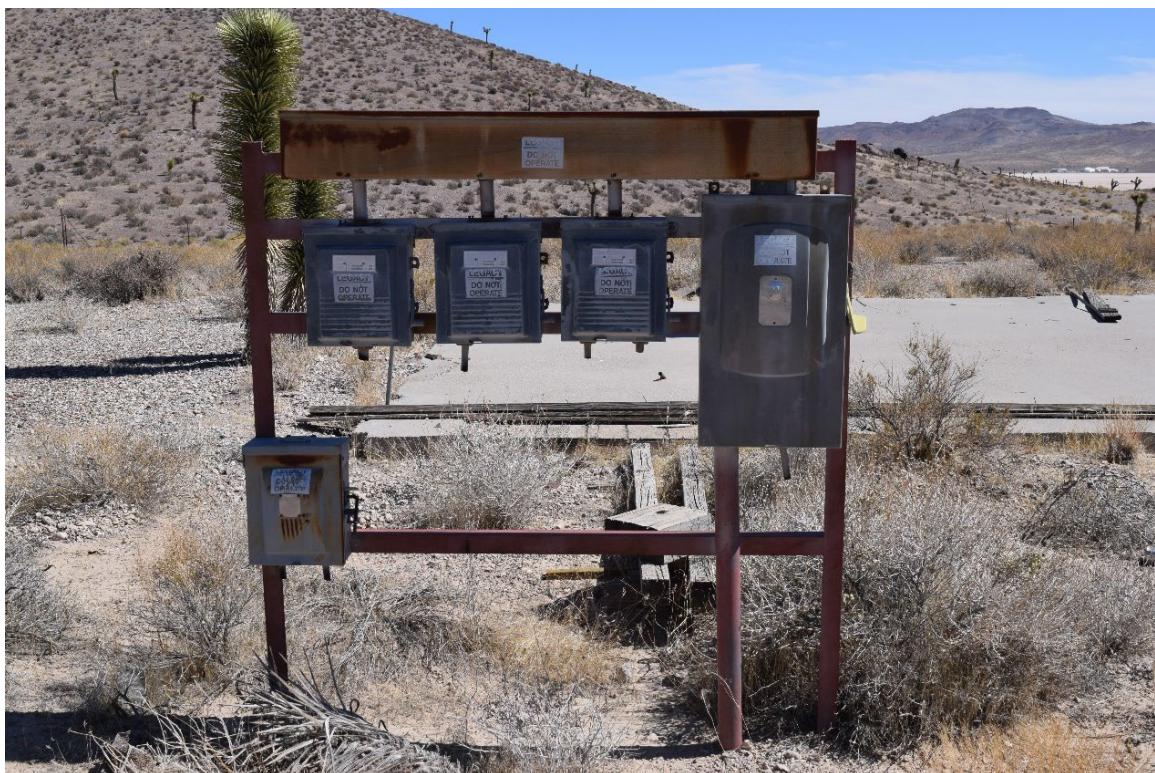
Photo 12. Electric box at Building 06-612/06-614, view to east. Photo 2113MIT\_0012.

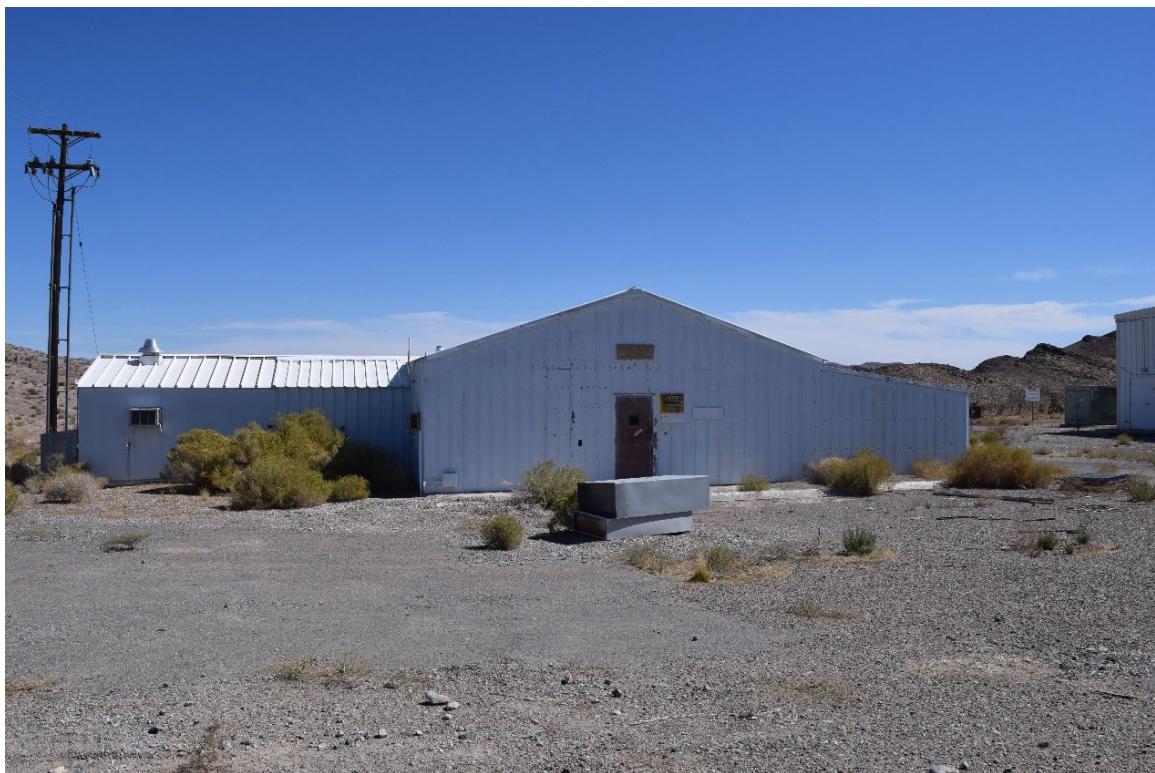
Photo 13. West elevation of Building 06-161, view to east. Photo 2113MIT\_0013.

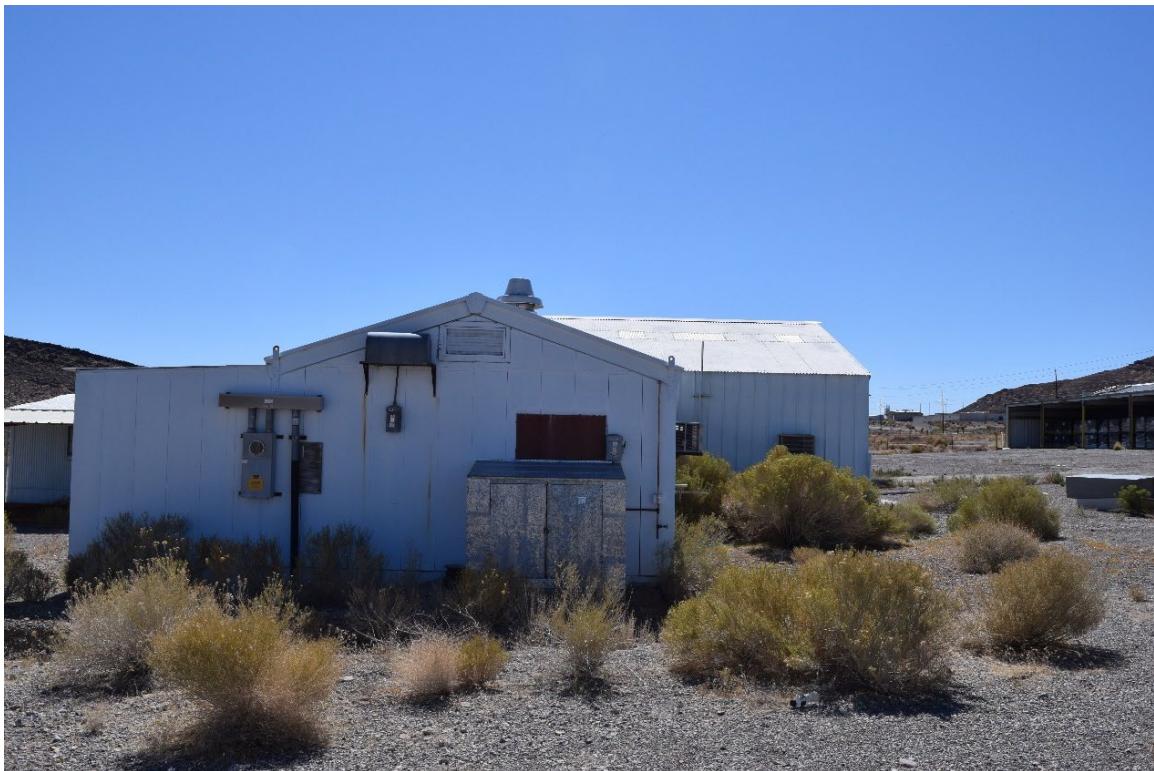
Photo 15. North elevation of Building 06-161 with utility panels and attached box, view to south. Photo 2113MIT\_0015.

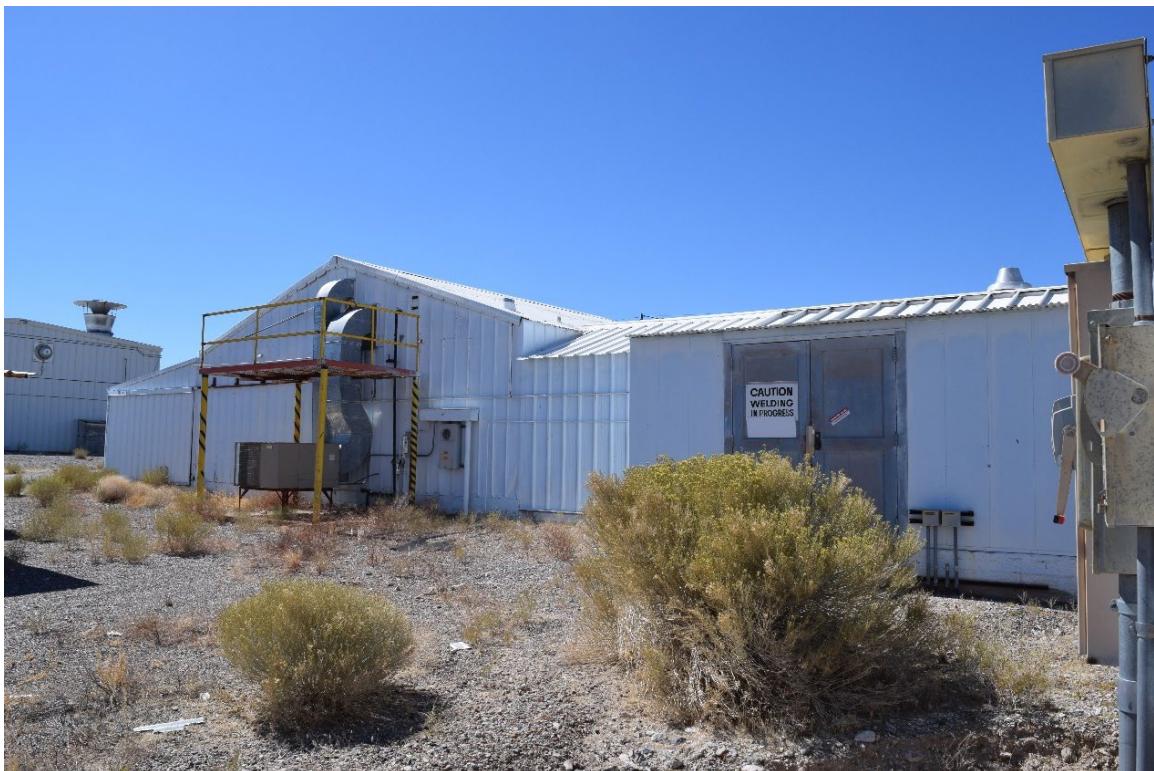
Photo 16. West elevation of Building 06-161 with HVAC scaffolding and electrical panel at far right, view to southwest. Photo 2113MIT\_0016.

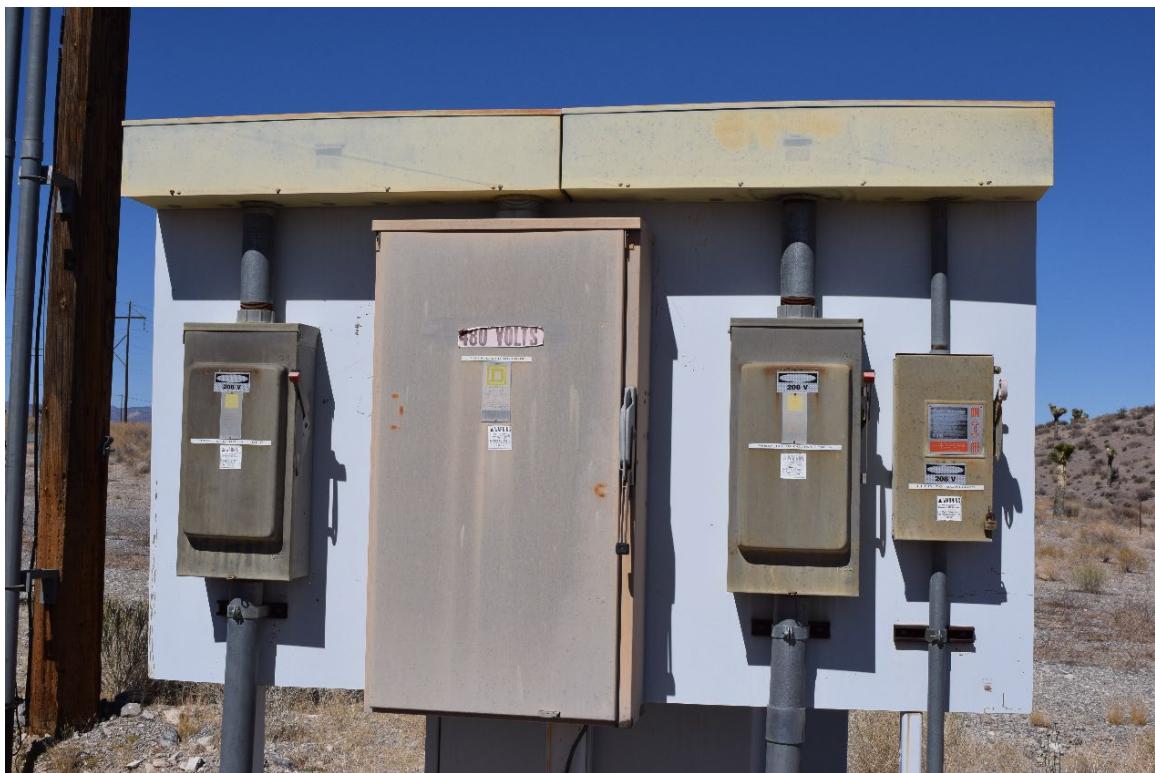
Photo 17. Close-up of electrical panel outside of Building 06-161, view to north. Photo 2113MIT\_0021.

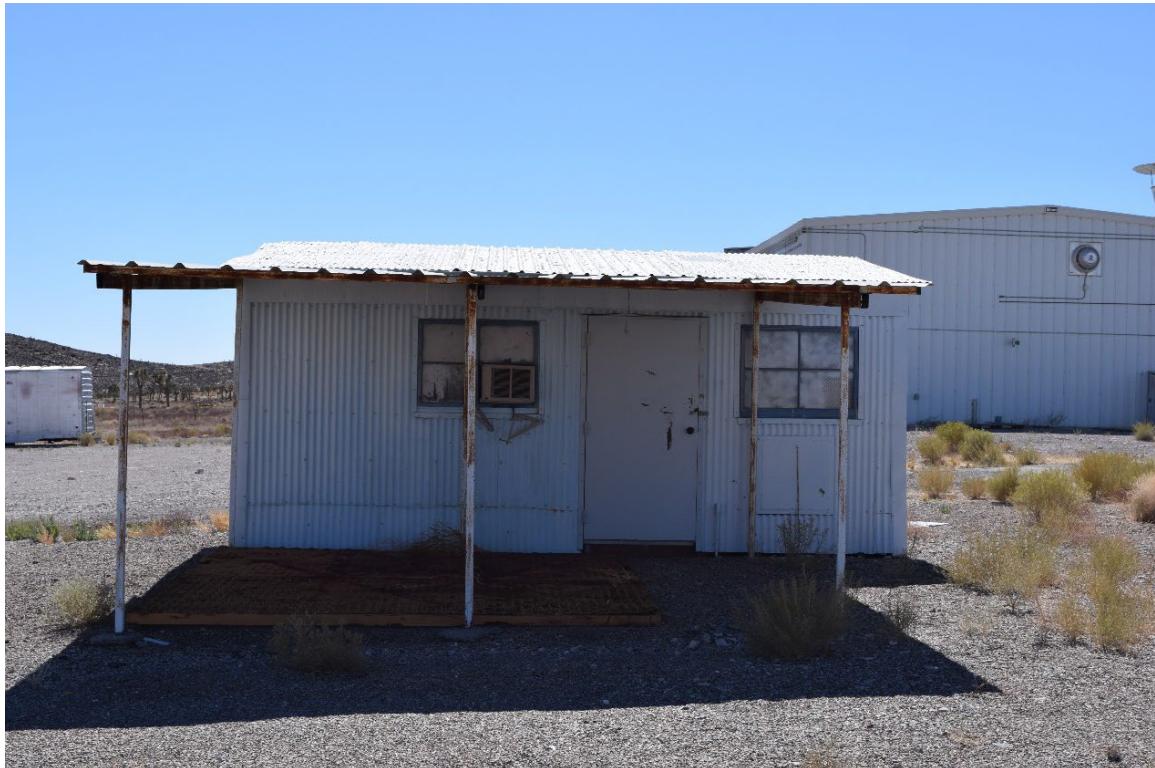
Photo 18. North elevation of unnumbered building with shade and patio area, view to south. Photo 2113MIT\_0017.

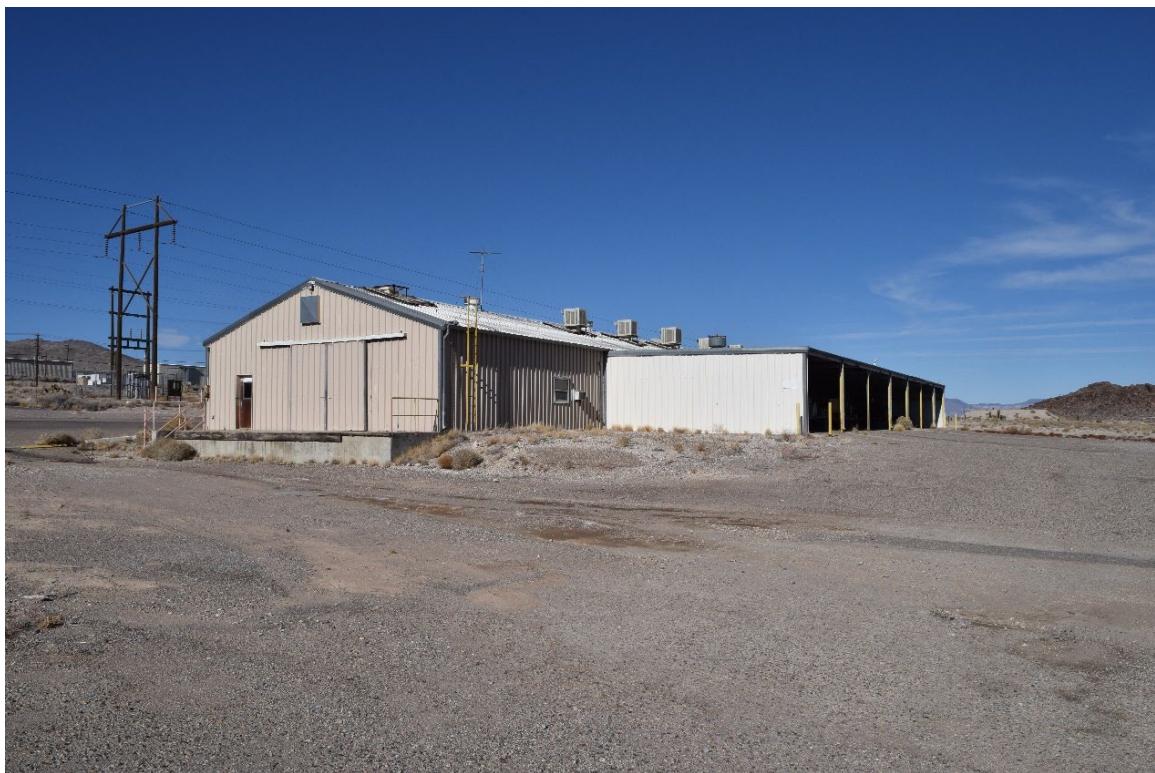
Photo 19. South and east elevations of Building 06-160, view to north-northwest. Photo 2113MIT\_0023.

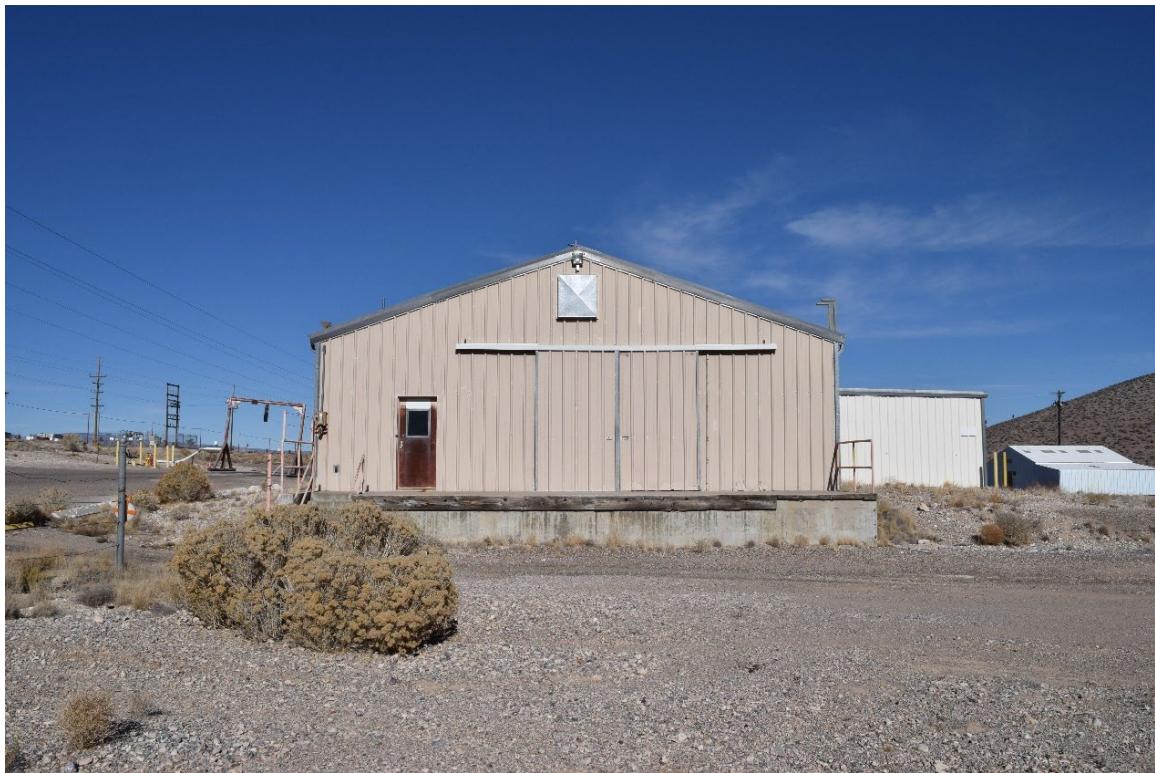
Photo 20. Loading platform on south elevation of Building 06-160, view to north. Photo 2113MIT\_0022.

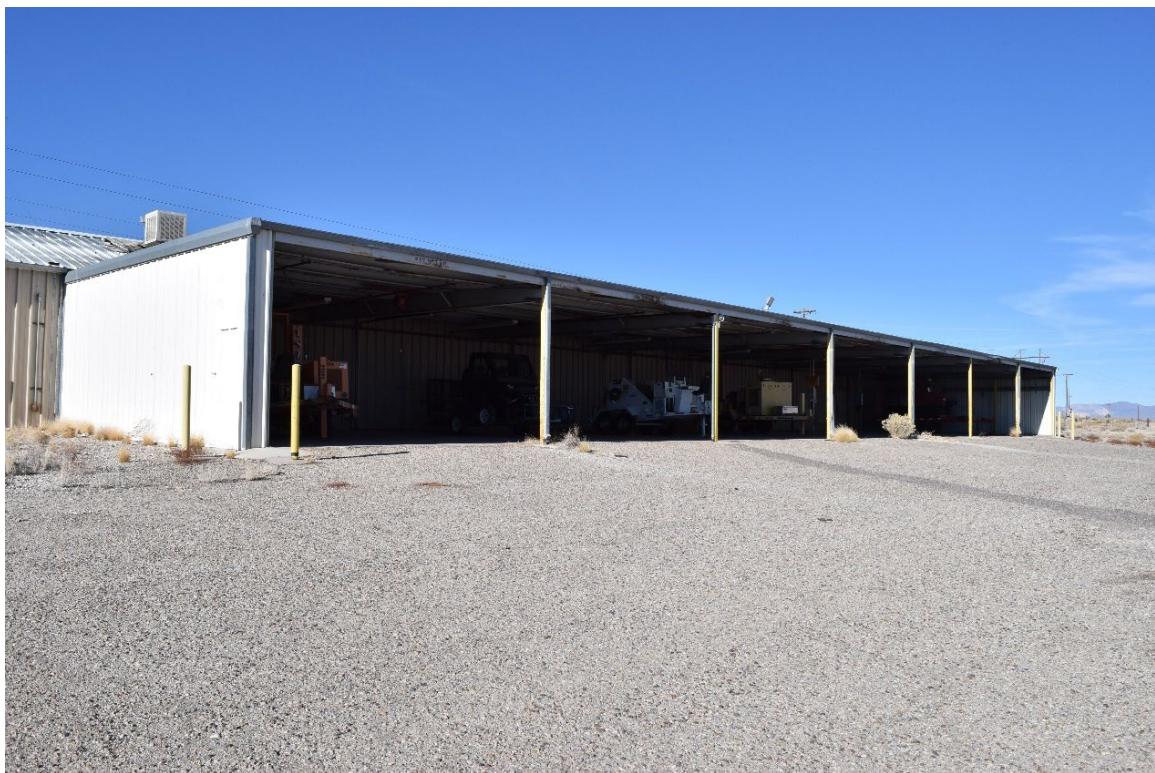
Photo 21. East elevation of Building 06-160 into open bays, view to northwest. Photo 2113MIT\_0024.

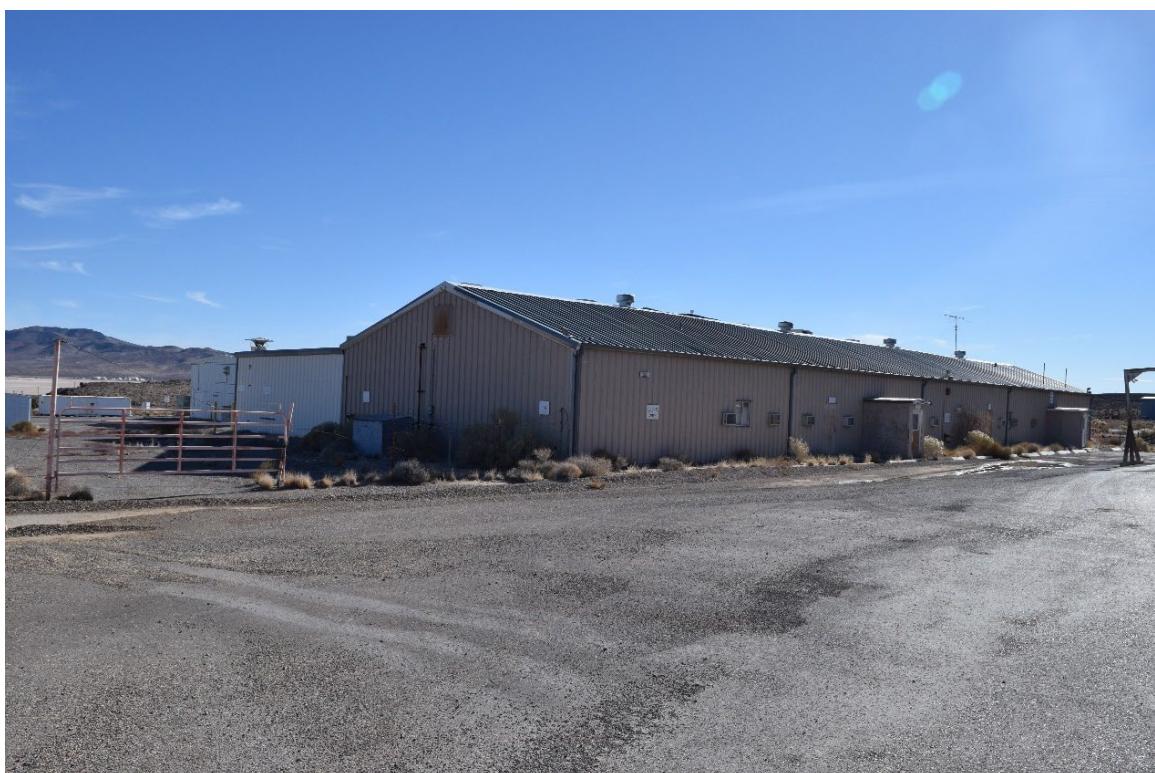
Photo 22. North and west elevations of Building 06-160, view to southeast. Photo 2113MIT-0025.

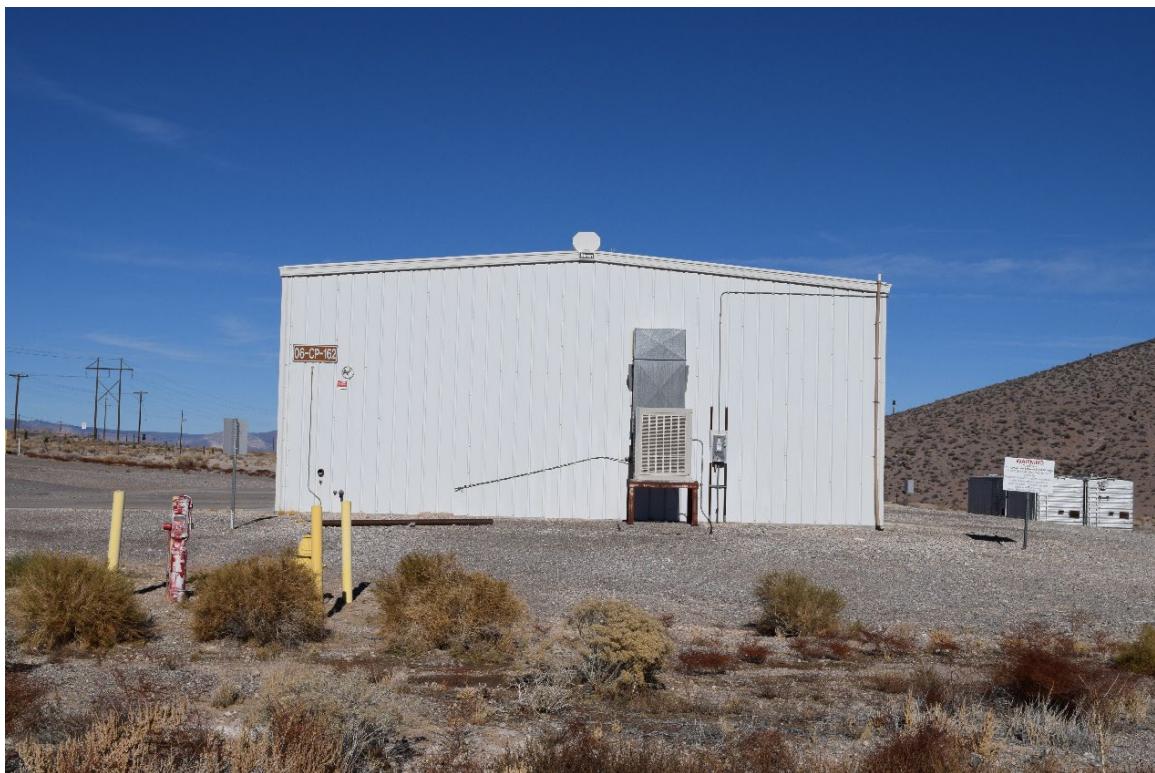
Photo 23. South elevation of Building 06-162, view to north. Photo 2113MIT\_0027.

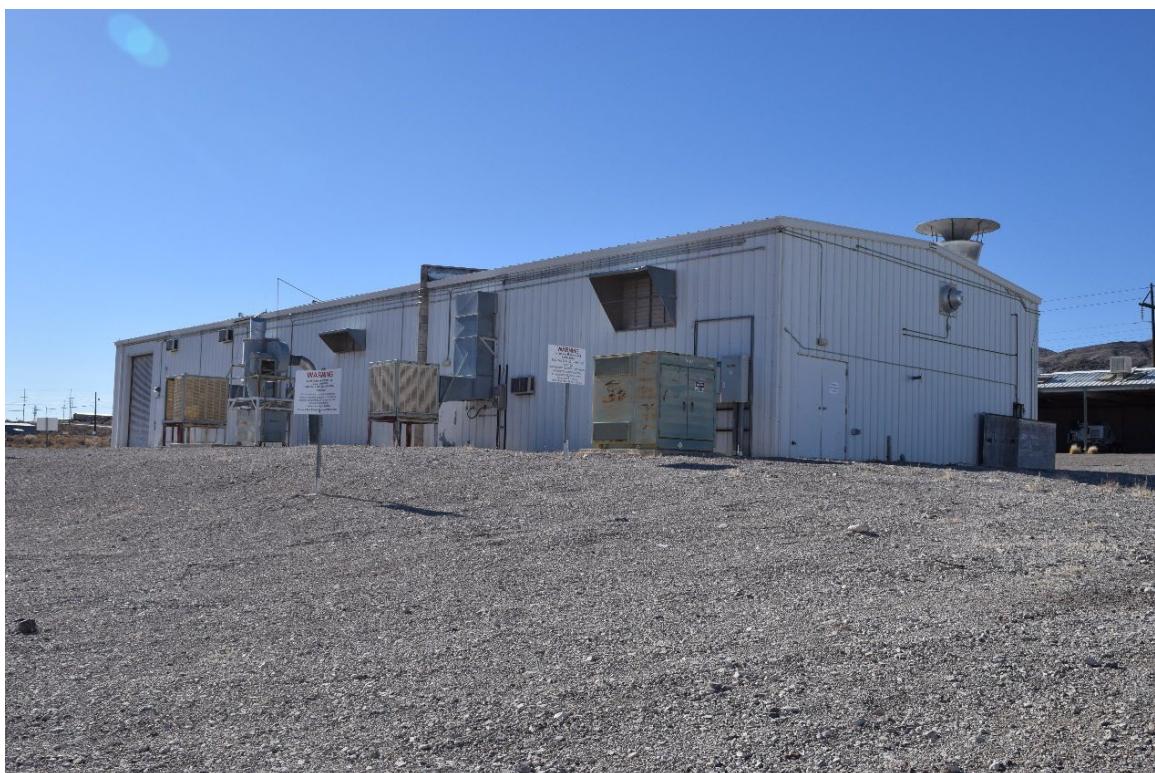
Photo 24. North and east elevations of Building 06-162, view to southwest. Photo 2113MIT\_0026.

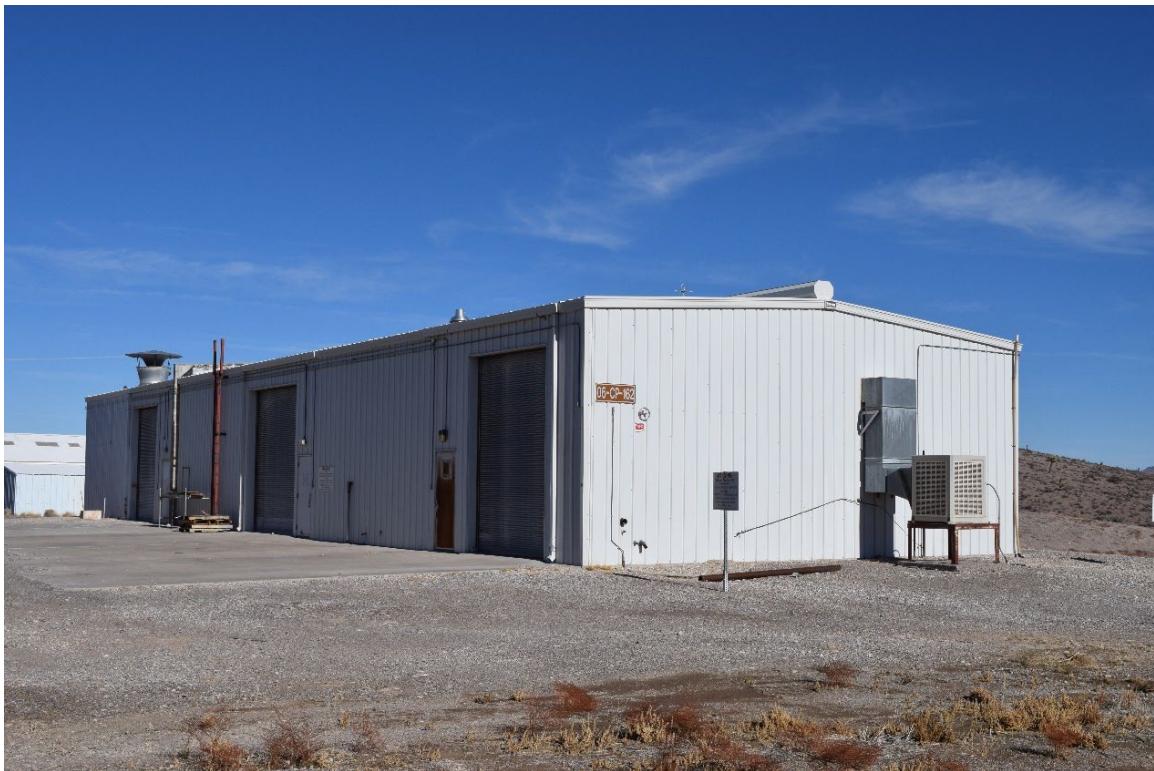
Photo 25. South and west elevations of Building 06-162 showing building sign, view to north-northeast. Photo 2113MIT\_0028.

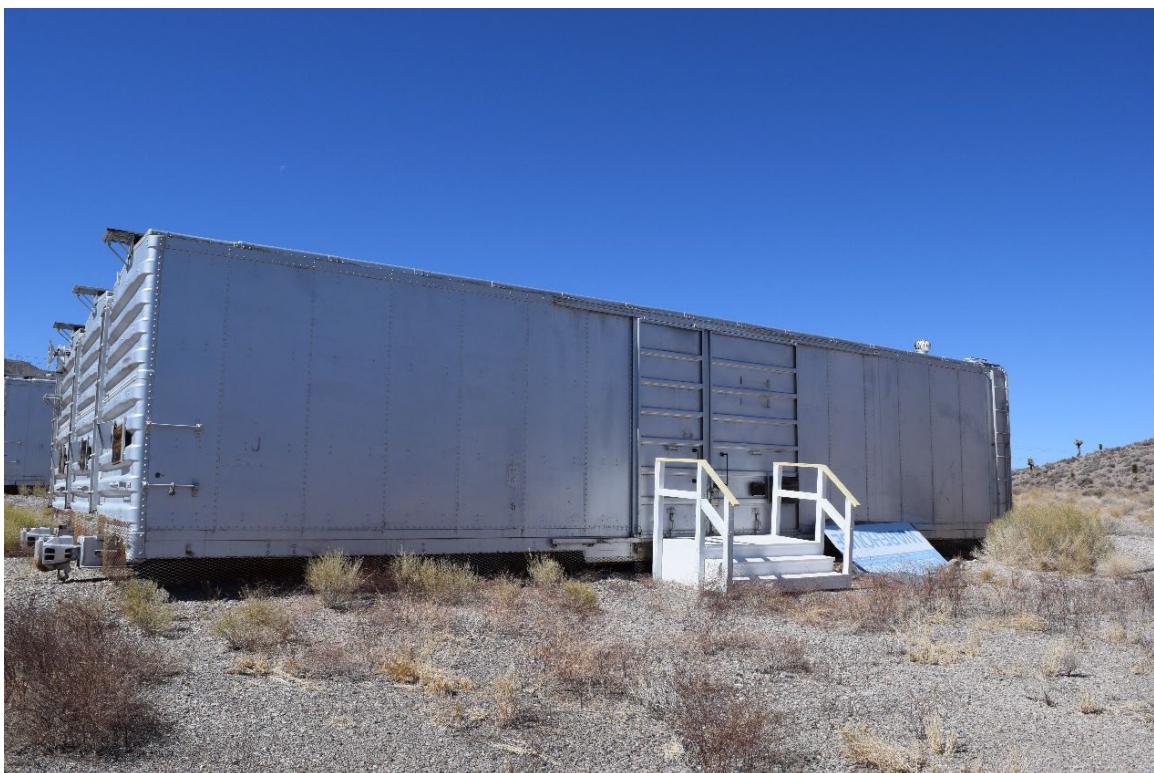
Photo 26. East elevation of Railroad Box Cars Nos. 202004, 202005, and 202006, with Los Alamos National Laboratory signs on right, view to west. Photo 2113MIT\_0018.

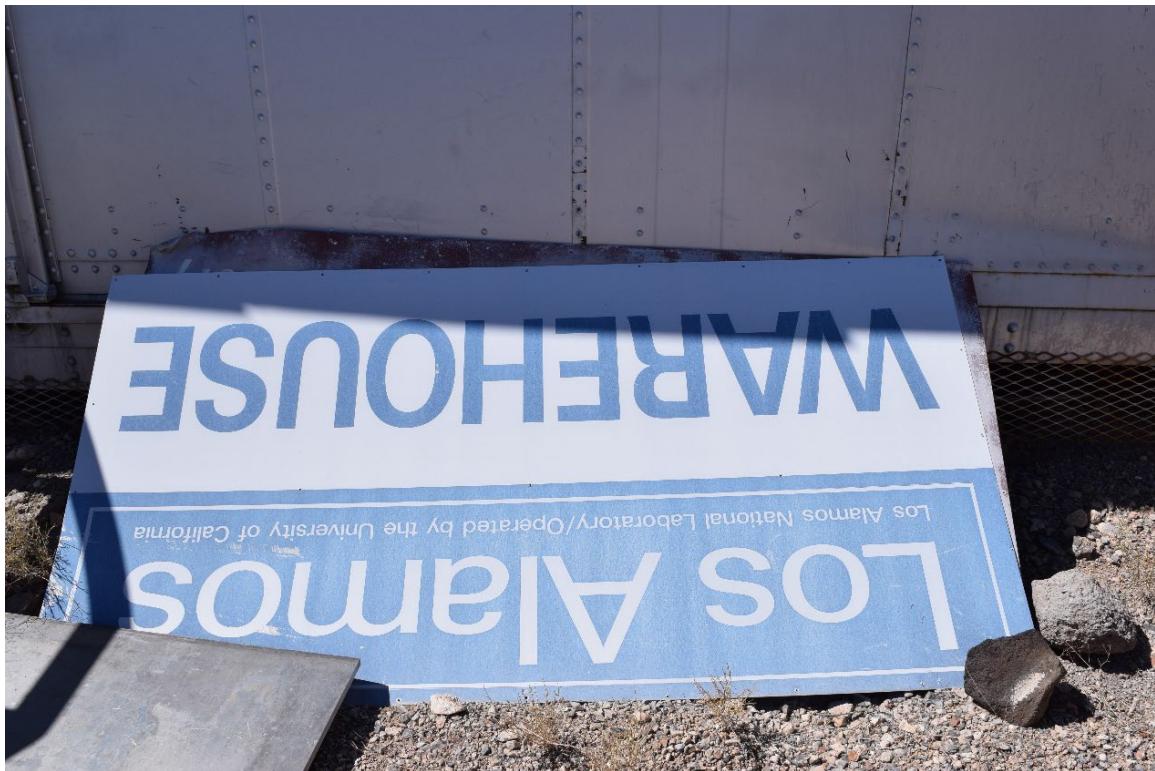
Photo 27. Close-up of discarded Los Alamos National Laboratory signs, view is down. Photo 2113MIT\_0019.

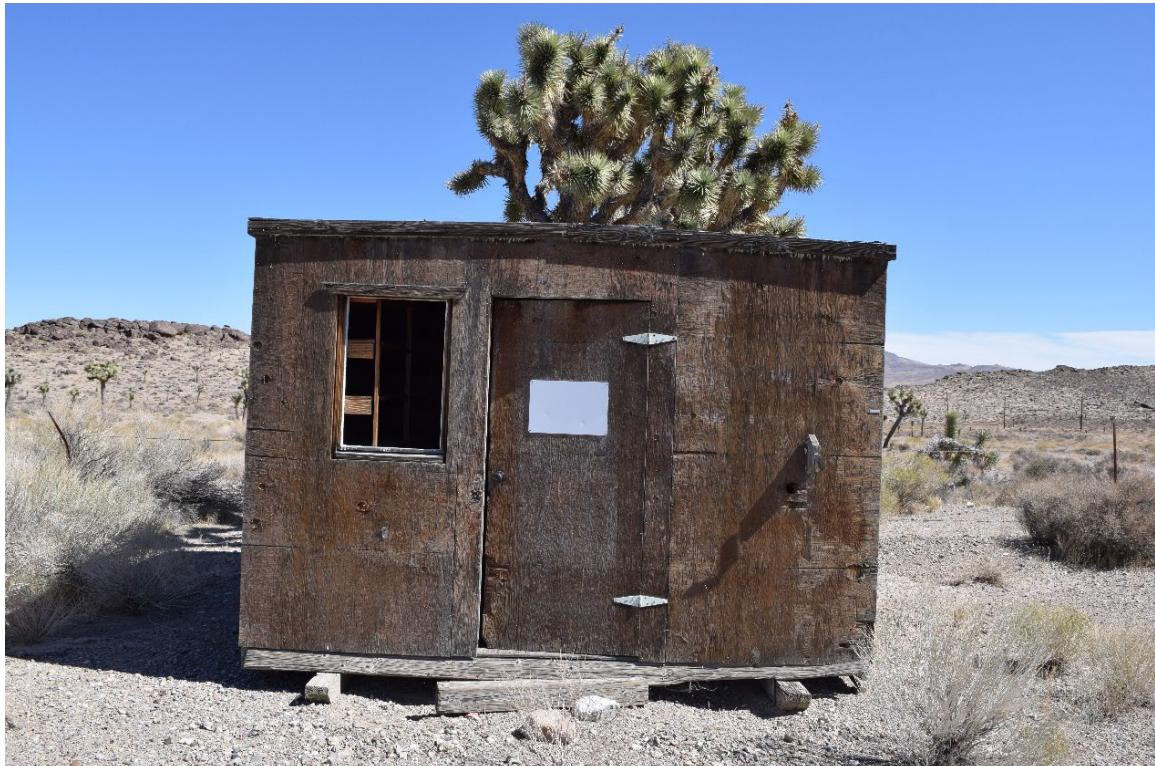
Photo 28. West elevation of portable brockhouse in front of eastern fence line boundary, view to east. Photo 2113MIT\_0020.

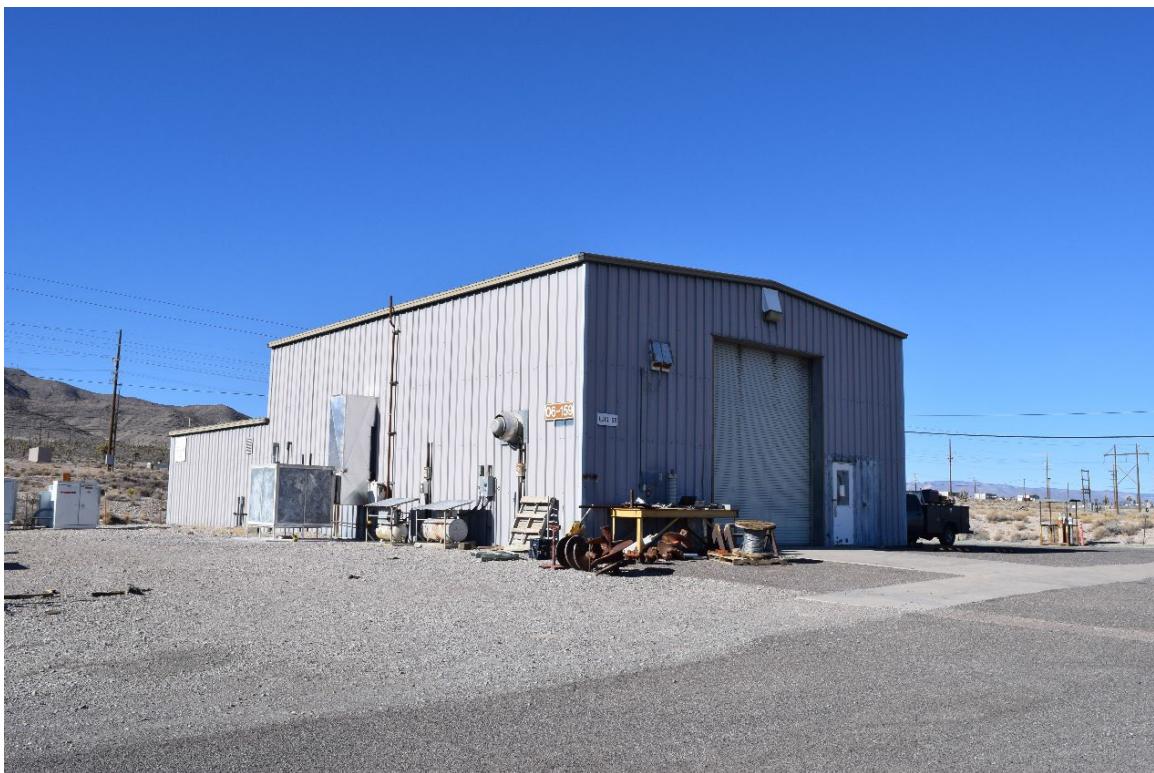
Photo 29. South and east elevations of building 06-159, view to northwest. Photo 2113MIT\_0029.

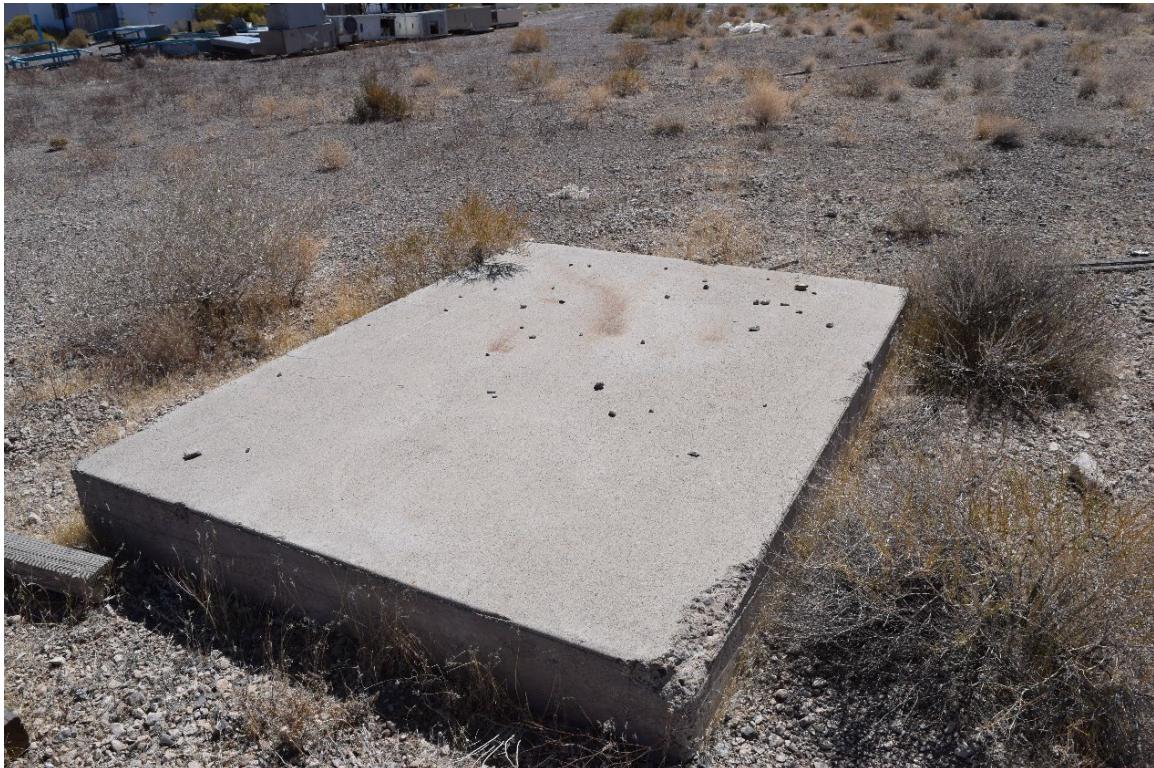
This resource is a small concrete foundation (Figure 10). The archival review did not reveal either the date it was made or any information to indicate its function. It is rectangular, measures 8 feet north-south × 6 feet east-west and is raised approximately 8 inches above the surrounding surface. It appears to be 1 foot thick. No artifacts appear in direct association with it nor are there any accessory resources.

Photo 30. Functionally unknown concrete foundation, view to south-southeast. Photo 2113MIT\_0030.

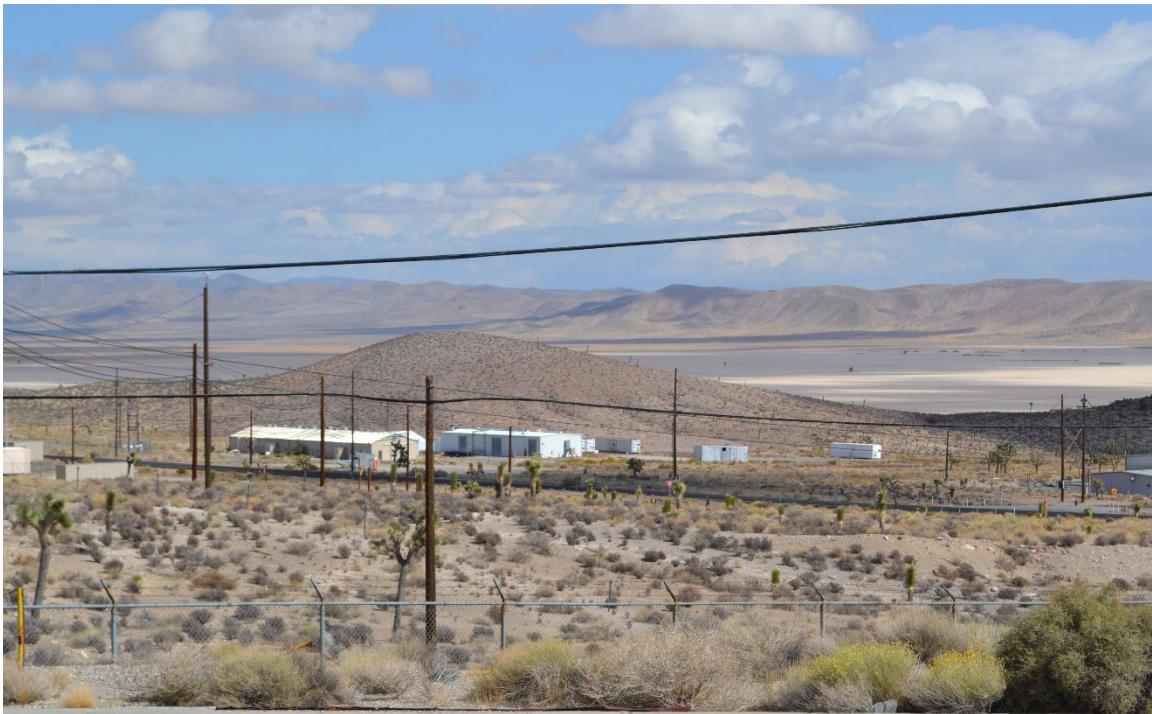
Overview of REECo Maintenance Compound with building concentration to left and B17822 to right (TM 2021\_7555).

Elevation: N/A      Direction facing: Northeast      Photographer: T. Menocal      Date: 10/28/2021

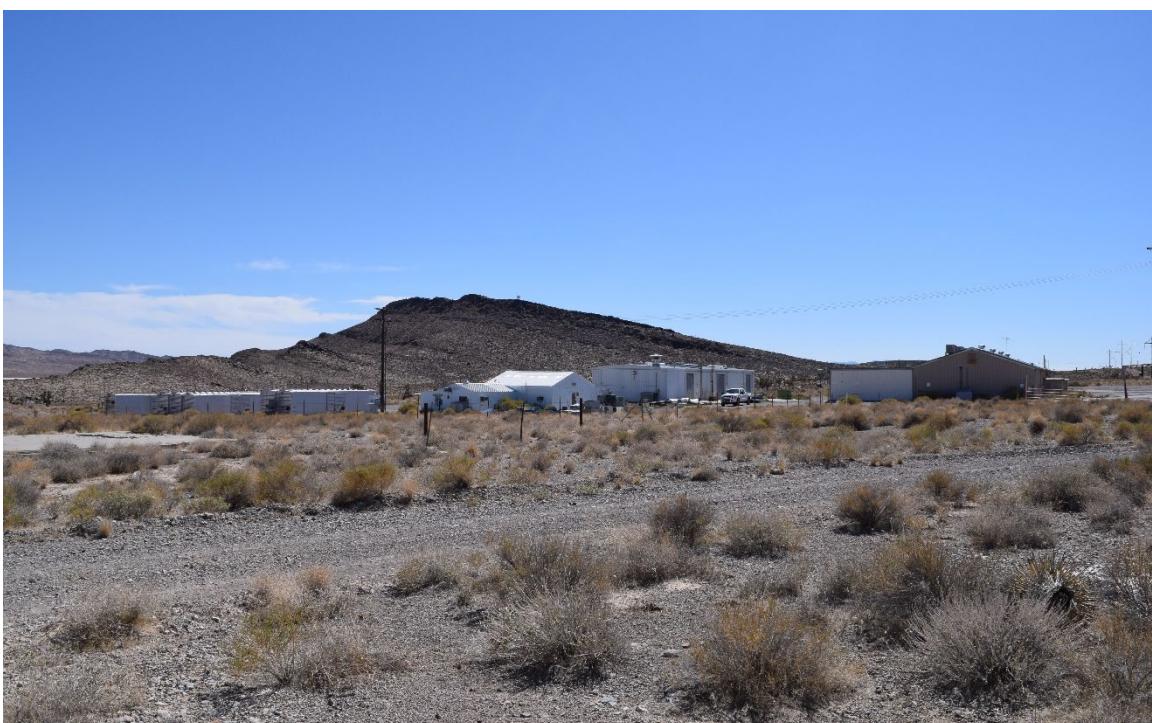
Overview of REECo Maintenance Compound from northwest perimeter into building concentration (DP 2021\_0021).

Elevation: N/A      Direction facing: Southeast      Photographer: D. Person      Date: 09/29/2021

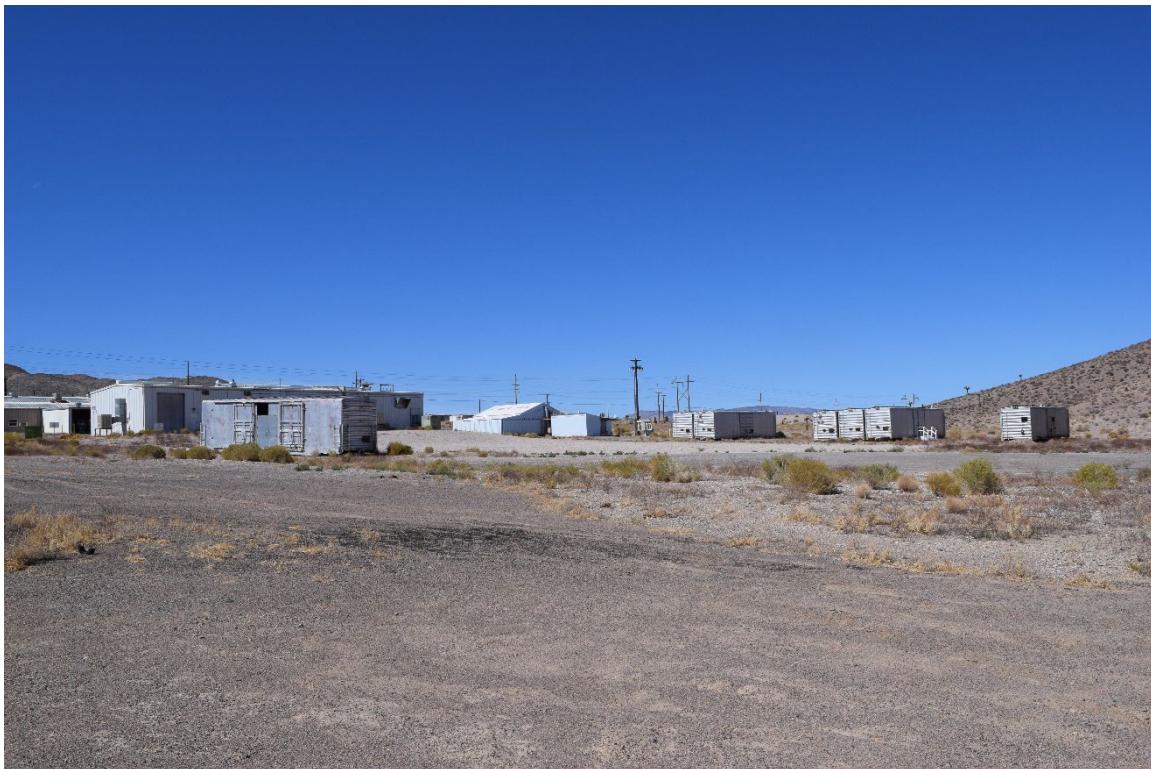
Overview of the REECo Maintenance Compound primary yard from the southeast perimeter (DP 2021\_0041).

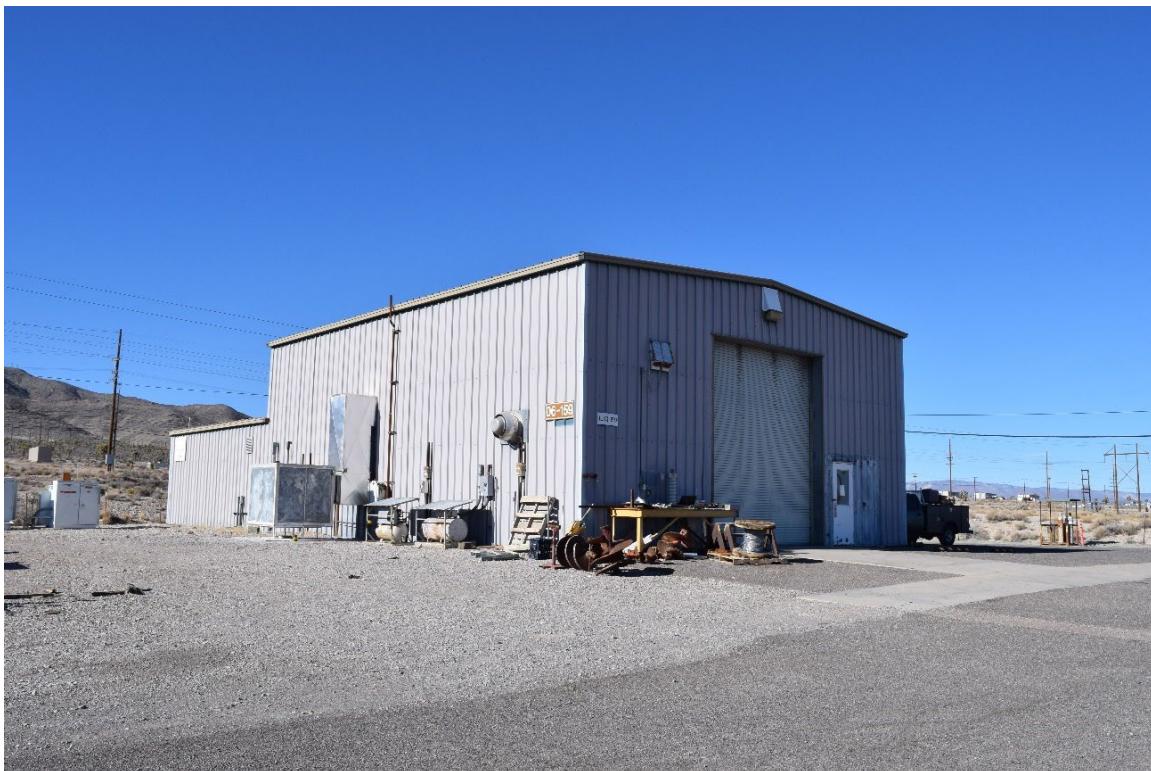
View of Building 06-159 (SHPO Resource # B17822) (DSC\_0232\_PR)

Elevation: South and East

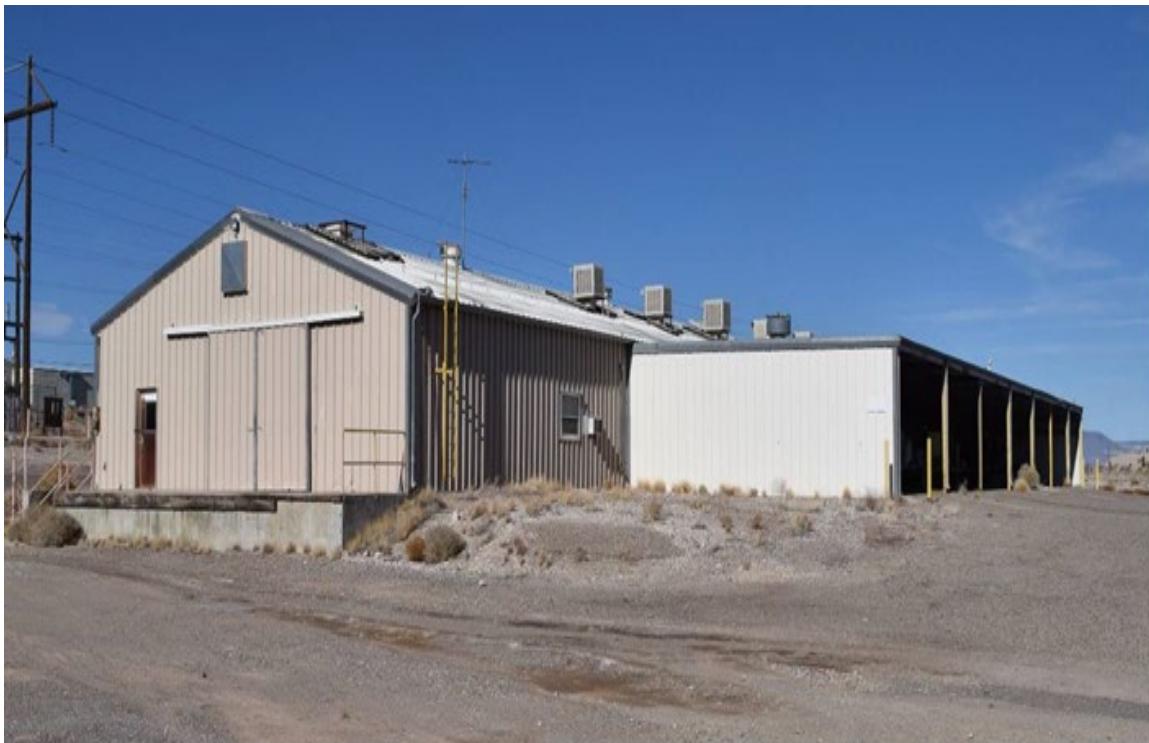
View of Building No. 06-160 (SHPO Resource # B17823) (TM 2018).

Elevation: South and East

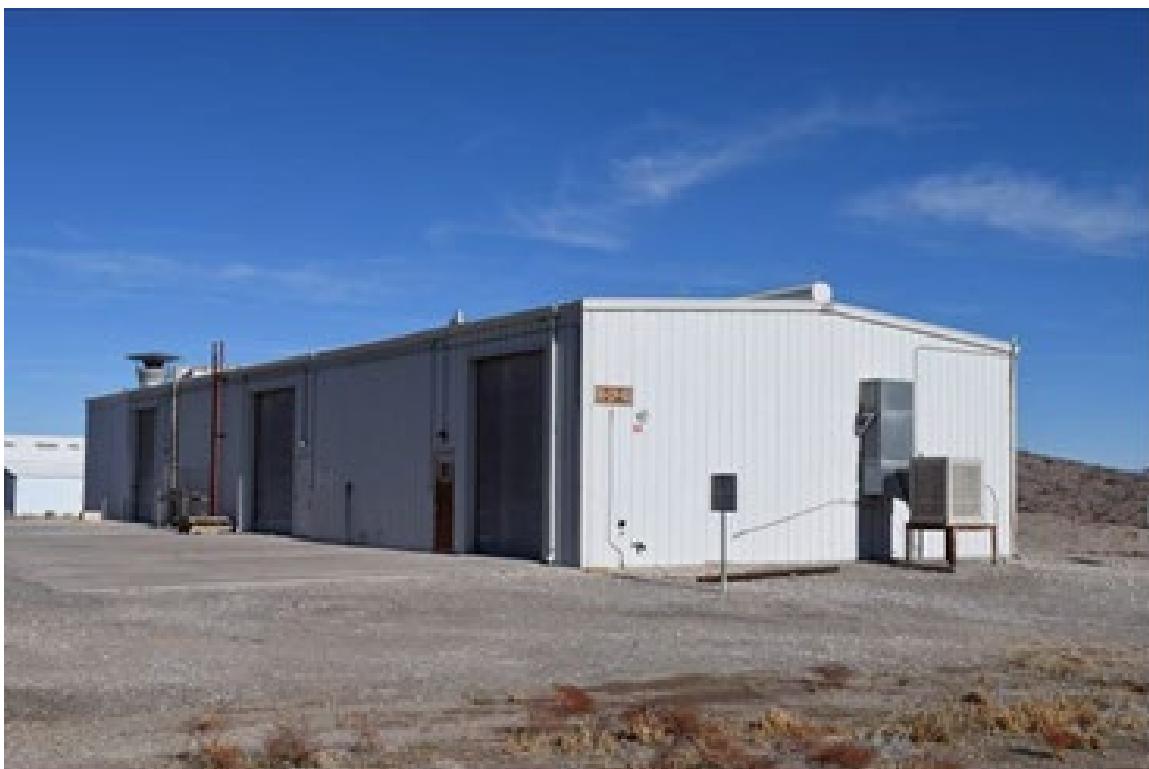
View of Building No. 06-162 (SHPO Resource # 17824) (TM 2018).

Elevation: South and West

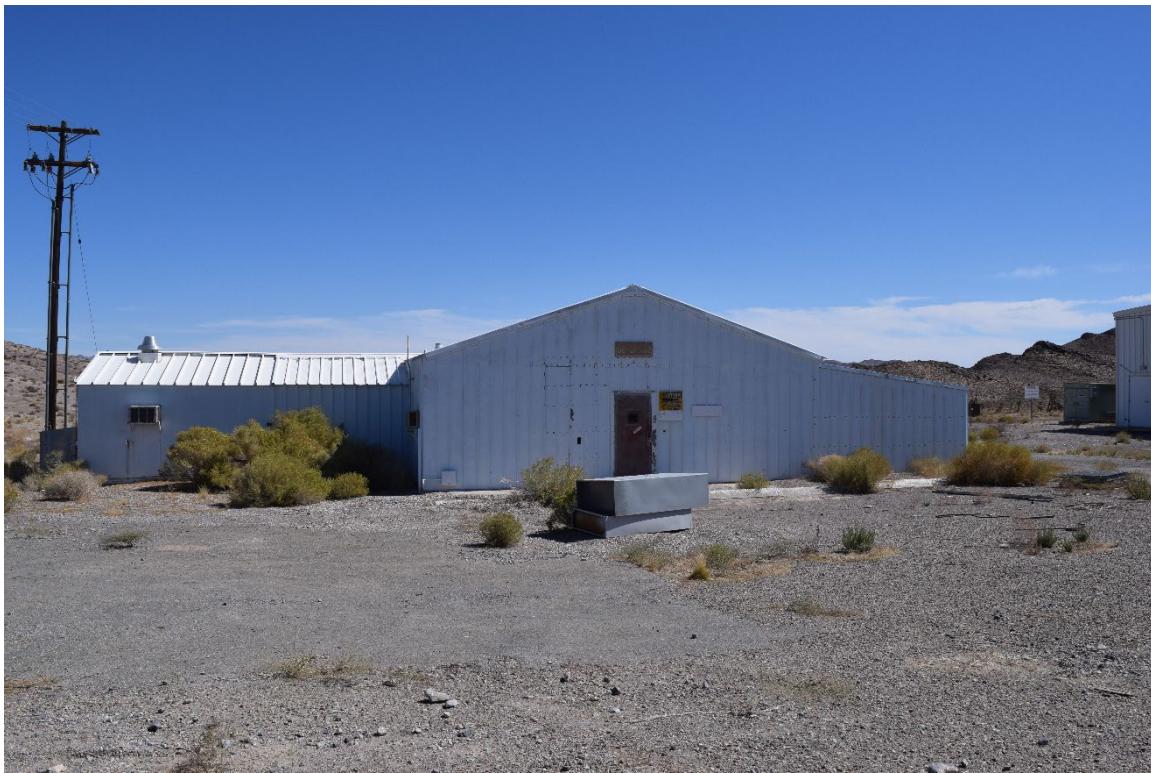
View of Building No. 06-161 (SHPO Resource # B18990) (DP 2021\_0023).
