**DESERT RESEARCH INSTITUTE  
CULTURAL RESOURCES REPORT SR092921-1-MIT  
PROJECT NO. 2113MIT**

**AN ARCHITECTURAL SURVEY OF THE REECO MAINTENANCE COMPOUND,  
AREA 6, NEVADA NATIONAL SECURITY SITE, NYE COUNTY, NEVADA**

**April 2022**

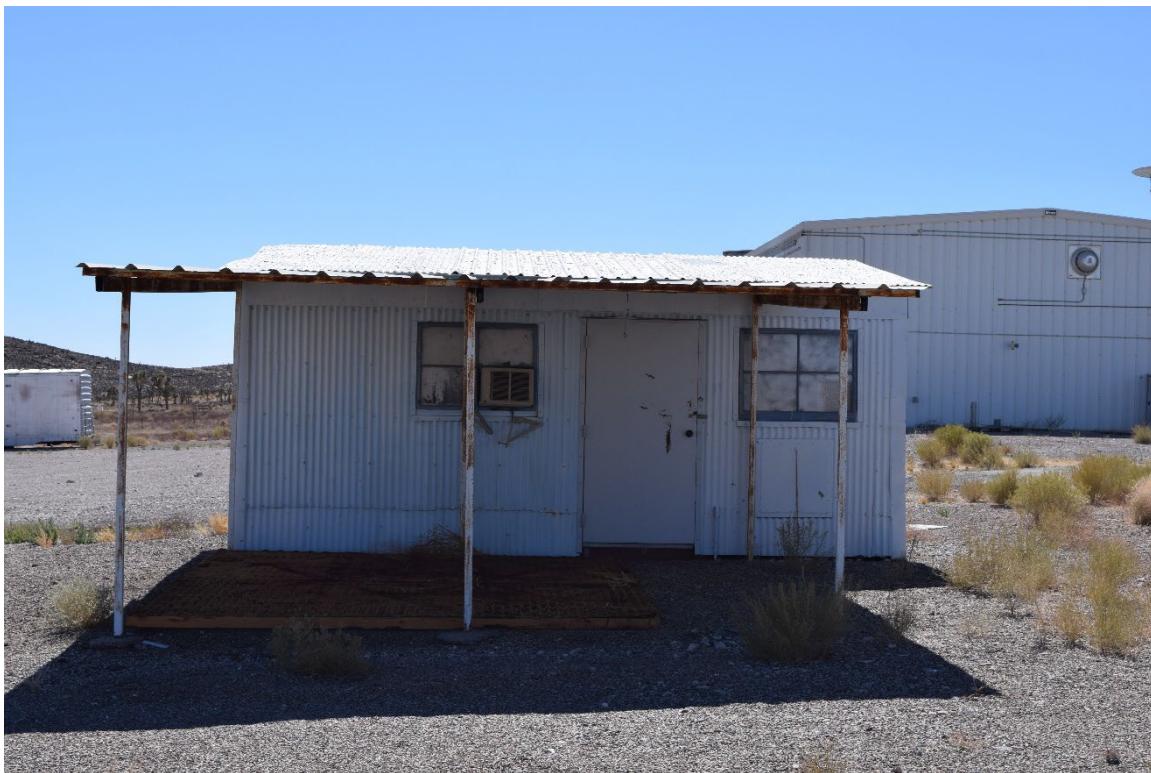
View of unnumbered building located east of Building No. 06-161 (SHPO Resource # B18991) (DP 2021\_0031).

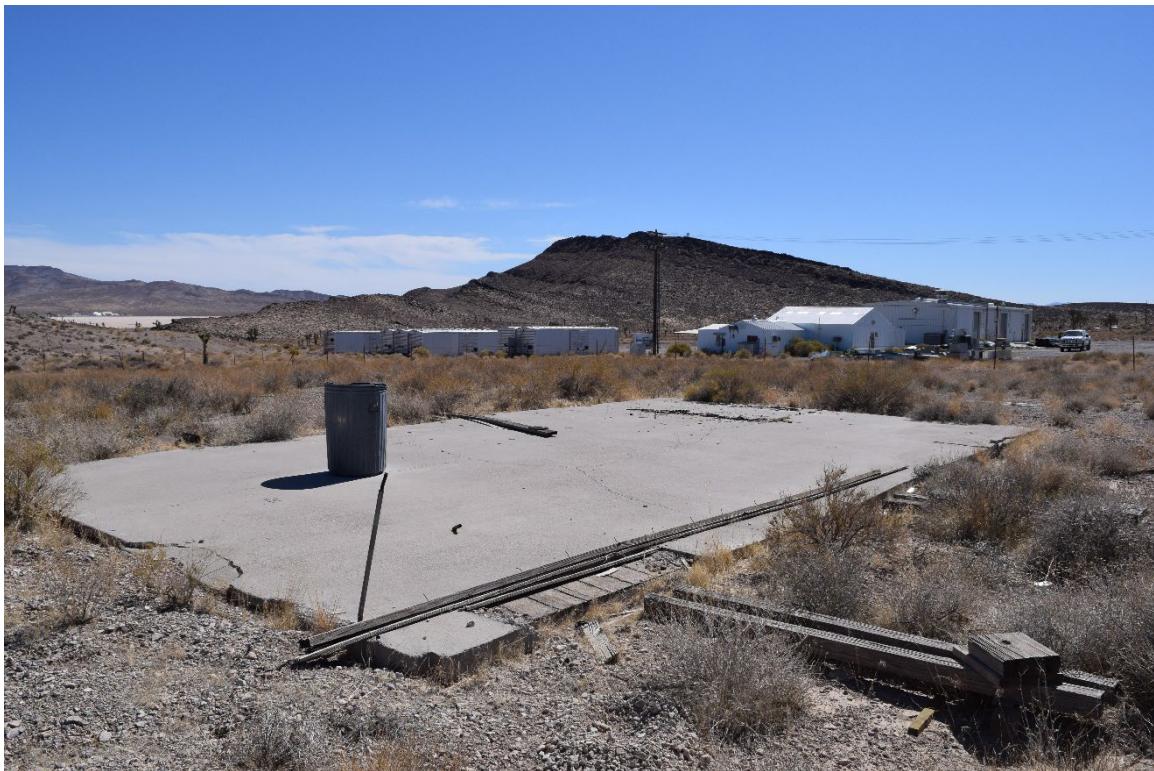
Cement foundation for Building No. 06-612 / 06-614 (SHPO Resource # S3109) (DP 2021\_0019).  
Elevation: N/A      Direction facing: Southeast      Photographer: D. Person      Date: 09/29/2021

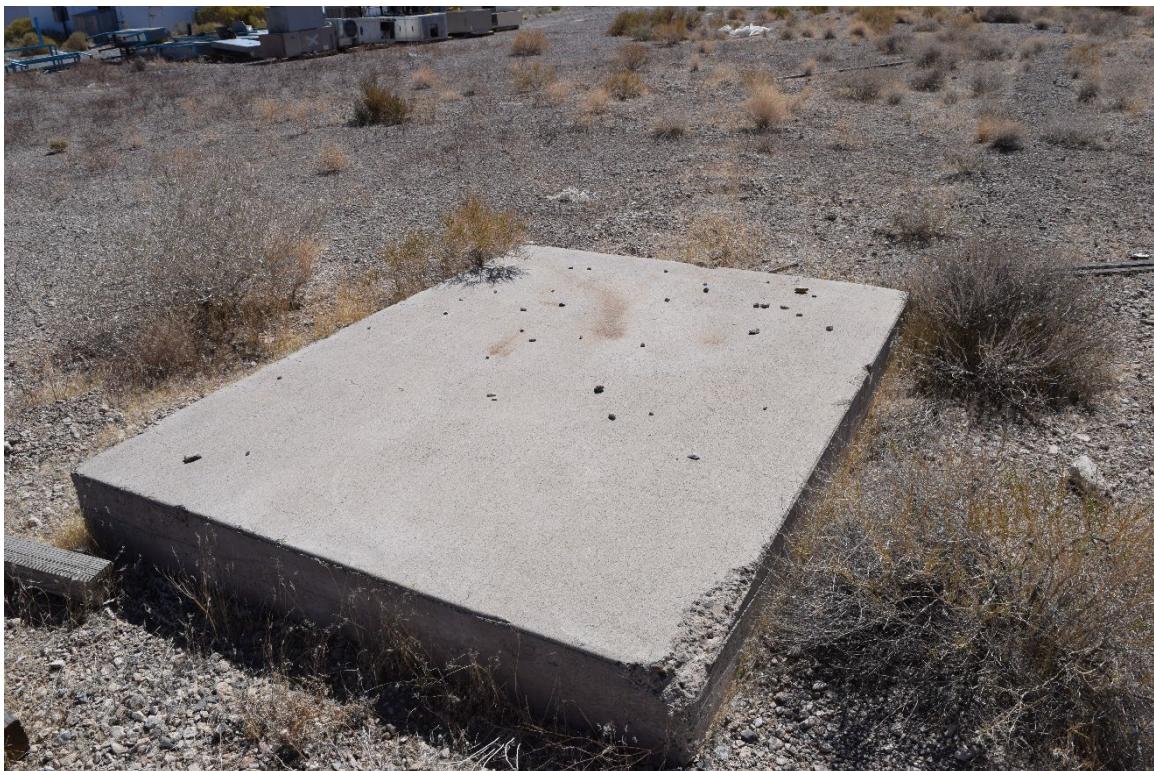
Cement foundation of unknown function (SHPO Resource # S3108) (DP 2021\_0022).  
Elevation: N/A      Direction facing: Southeast      Photographer: D. Person      Date: 09/29/2021

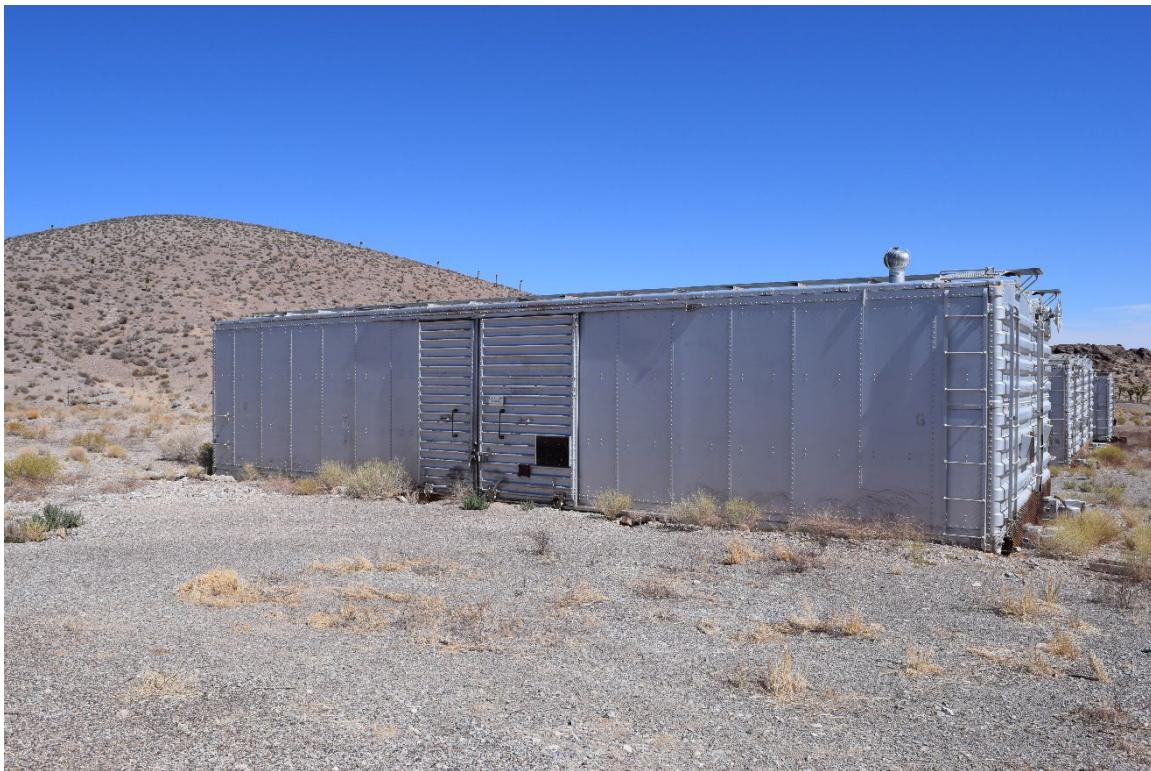
Railroad boxcars stored in yard (SHPO Resource # S3115 AR1) (DP 2021\_0032).

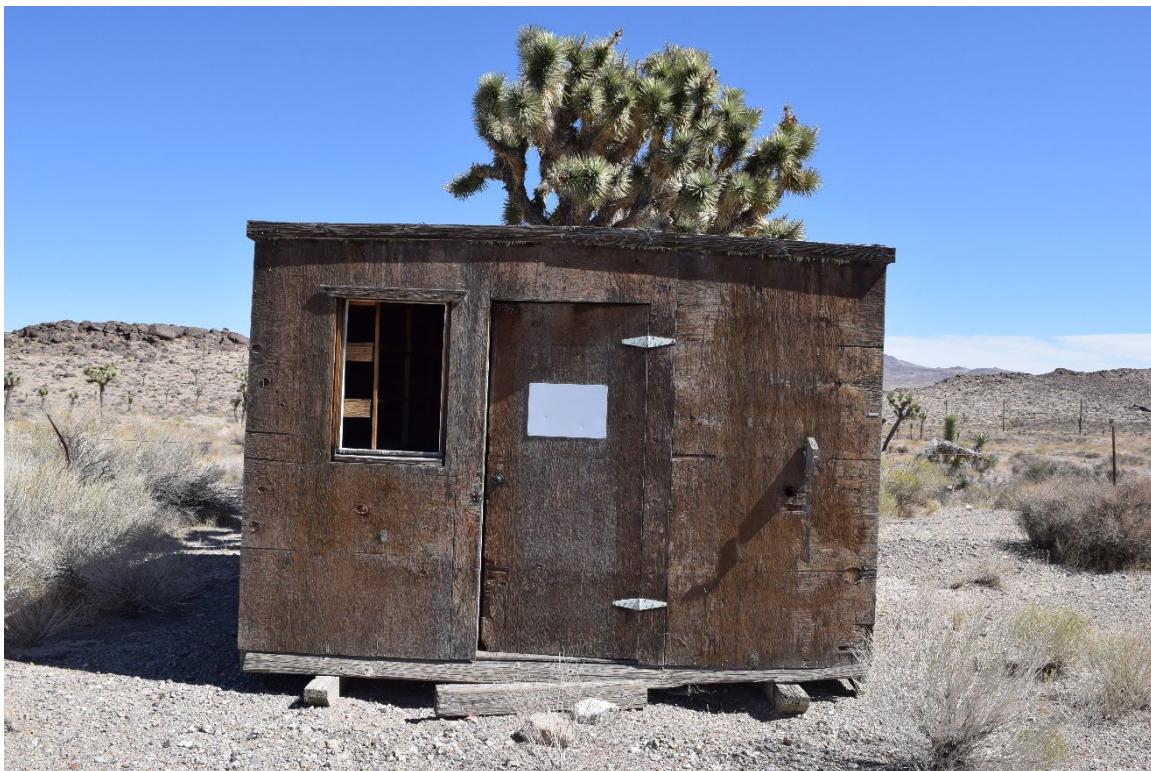
Dilapidated brockhouse at southeastern perimeter of yard (SHPO Resource # S3115, AR6 (DP 2021\_0038)).  
Elevation: N/A      Direction facing: East      Photographer: D. Person      Date: 09/29/2021

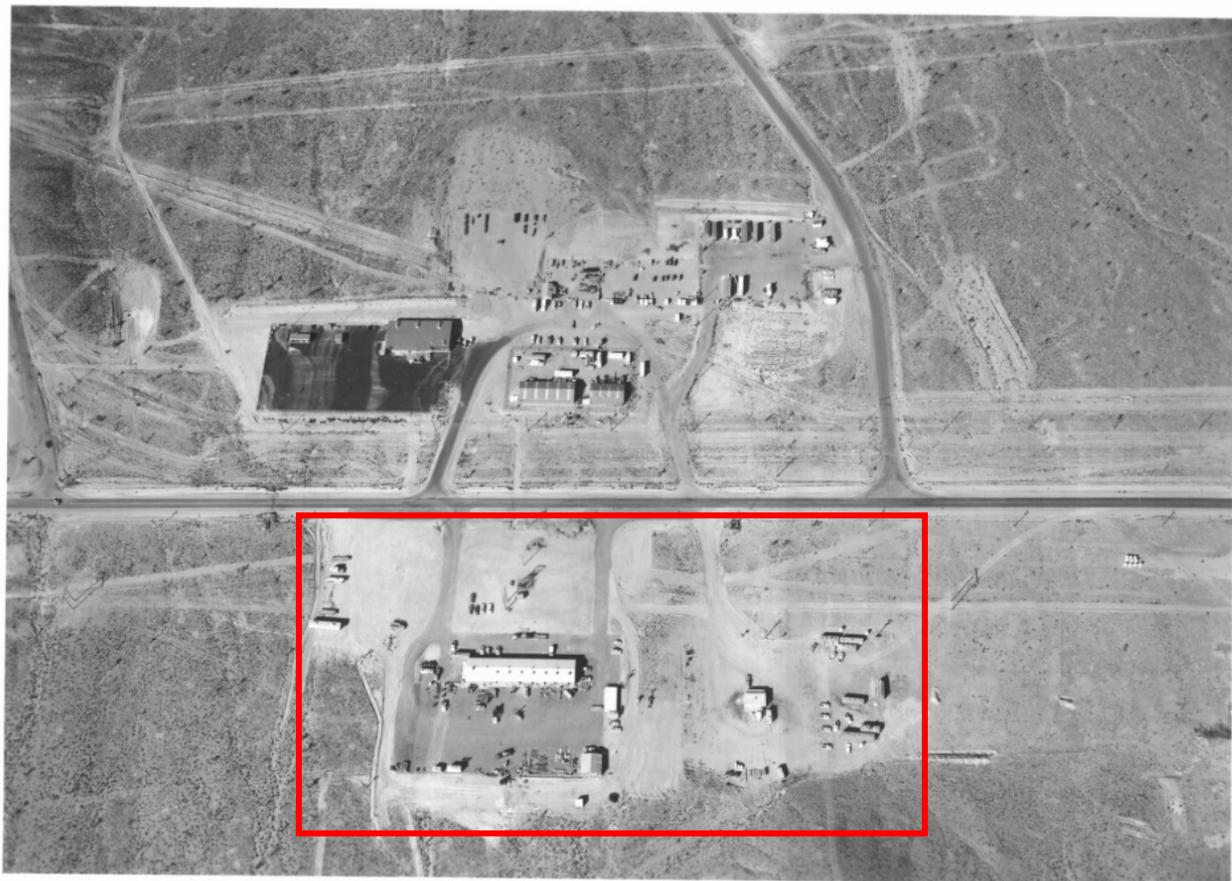
REECo Maintenance Compound in 1967, Photo No. 2574-10 (REECo 1982).

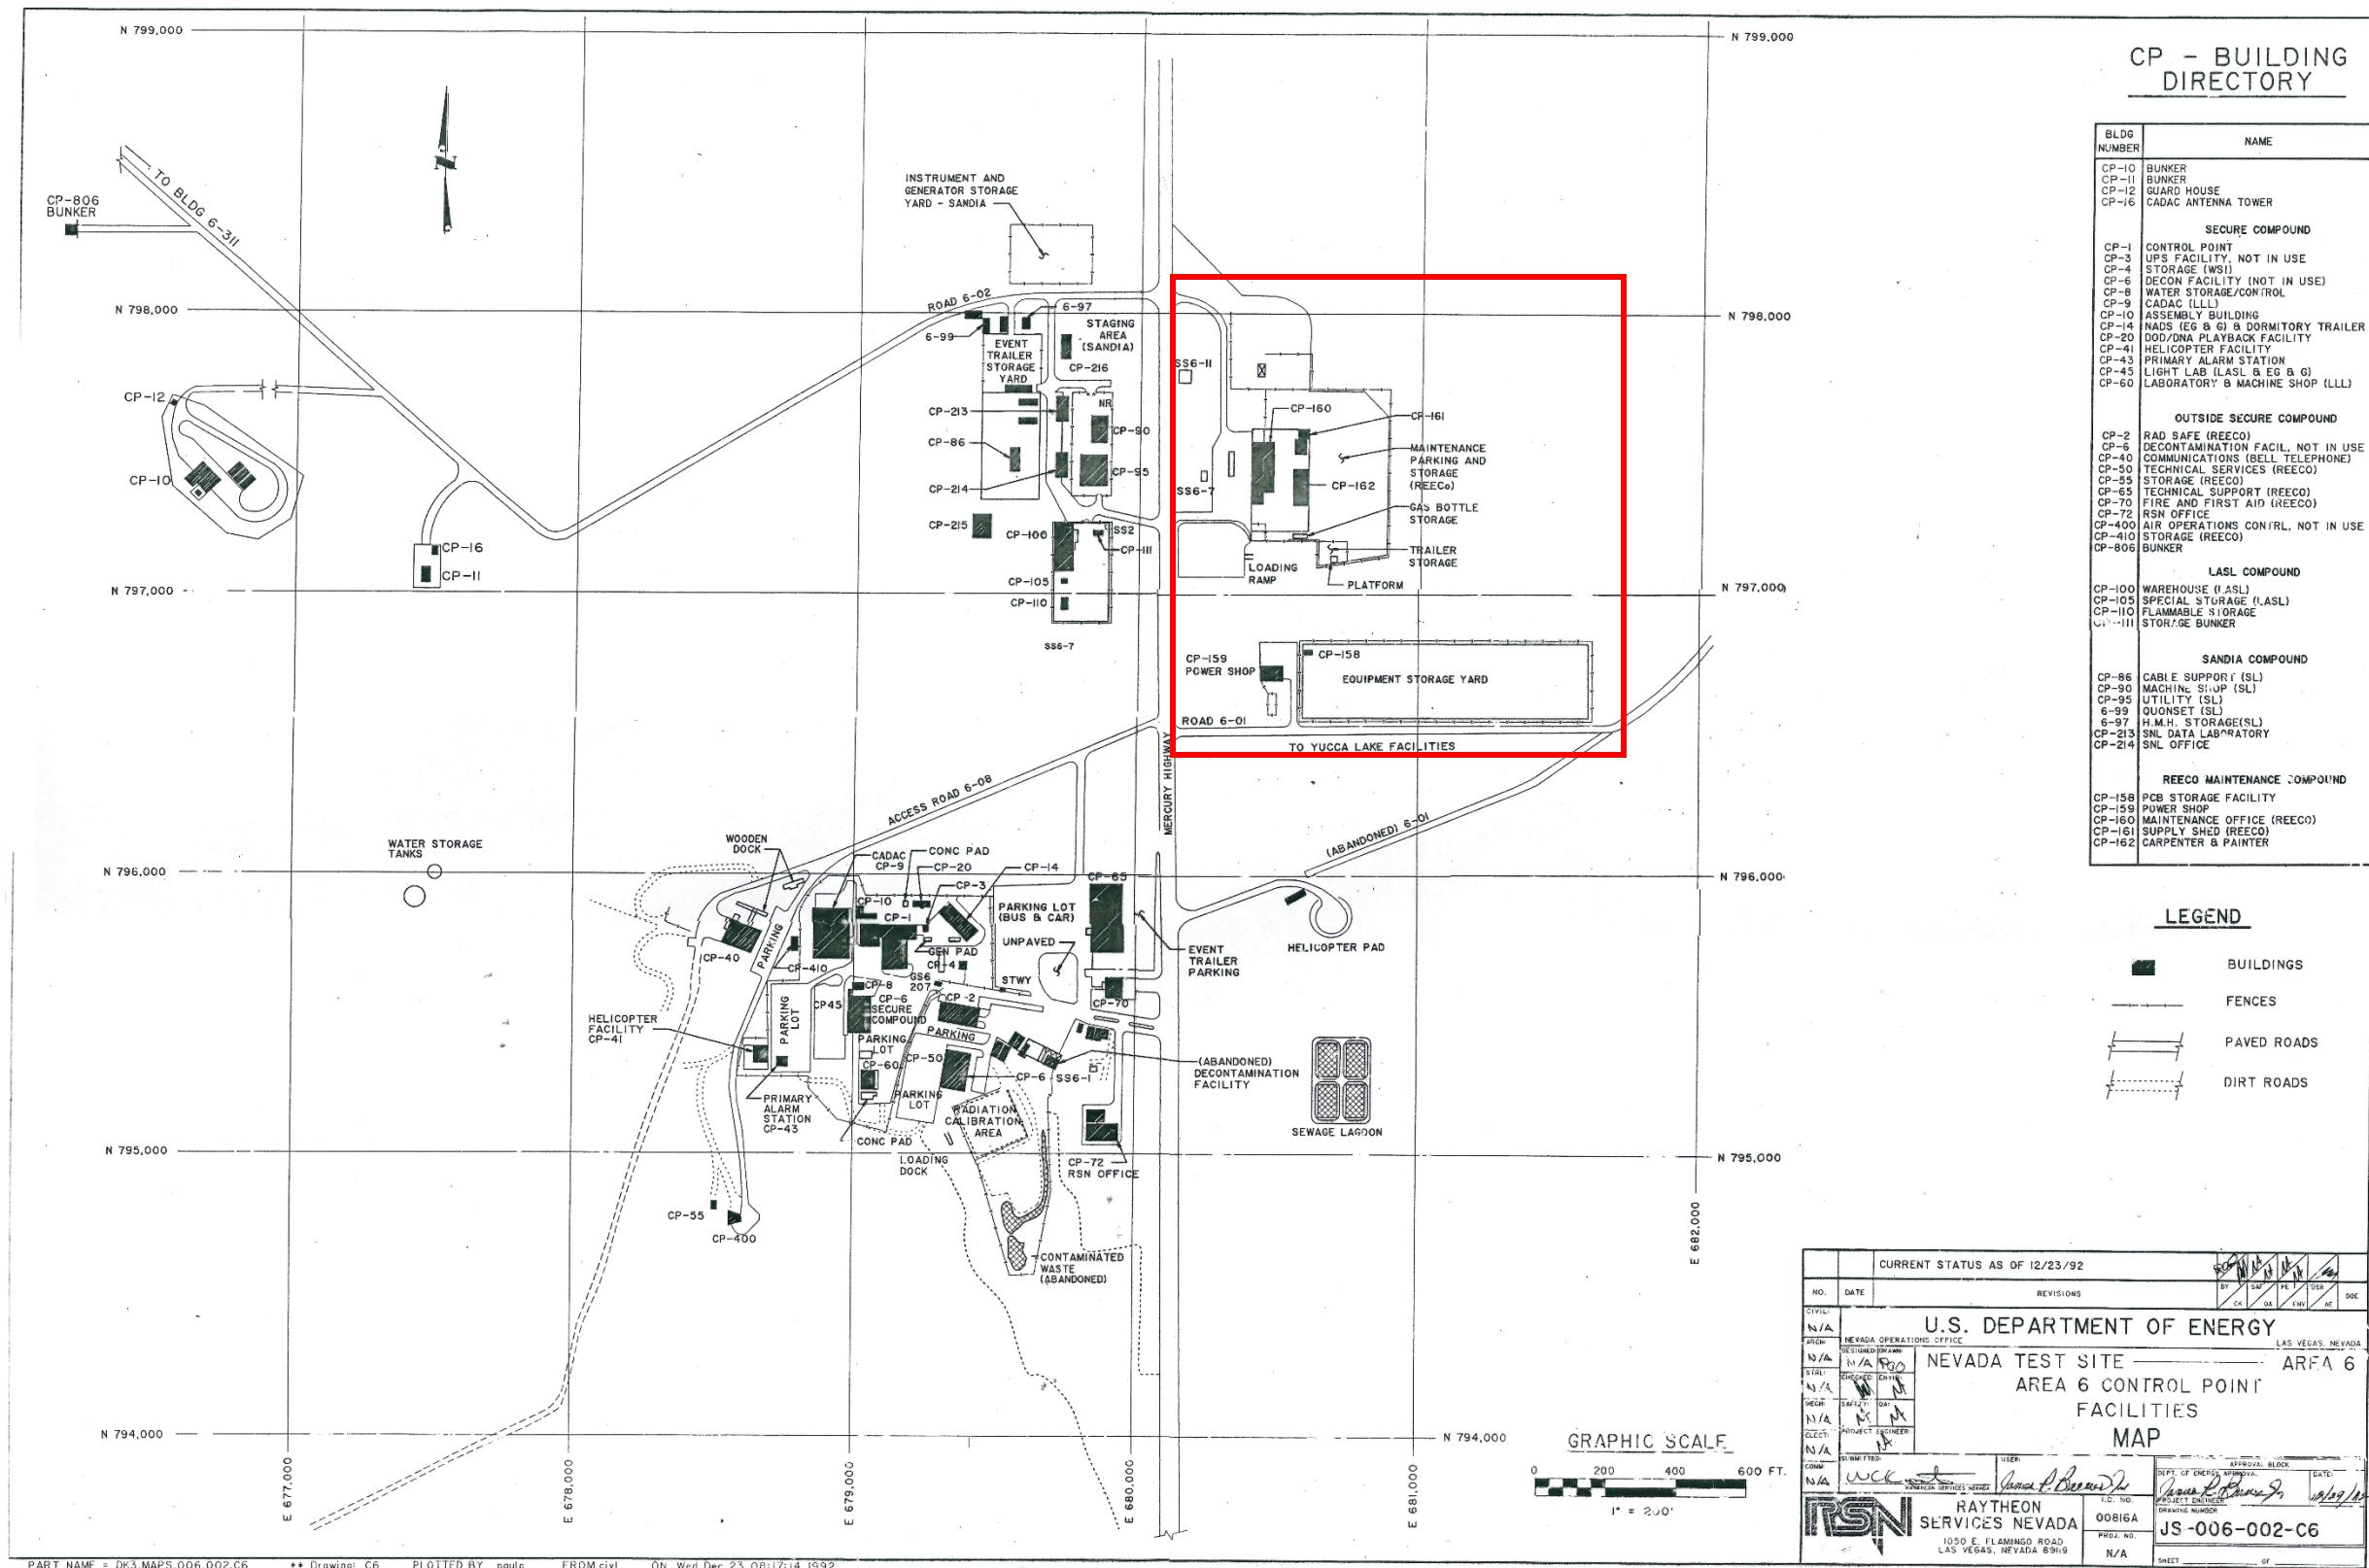
Historic site plan for REECO Maintenance Compound in 1992 at the end of the Period of Significance. Source: Raytheon Services Nevada, 1992.

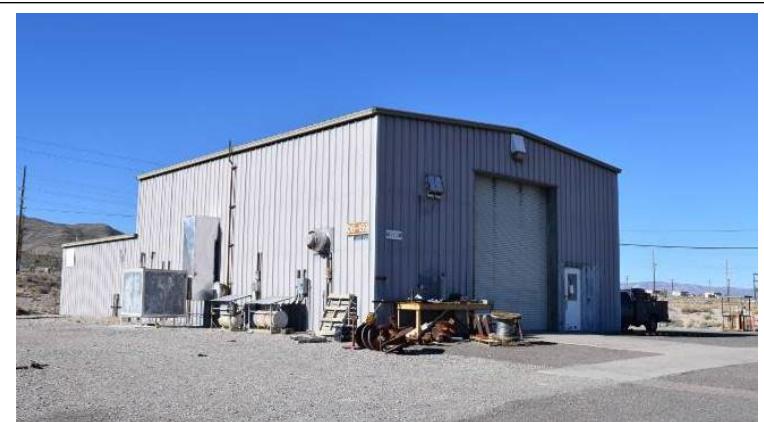
South and east side of Building B17822. View west (DRI 2018). Note roll up and pedestrian door, and large metal air duct on south side of building.

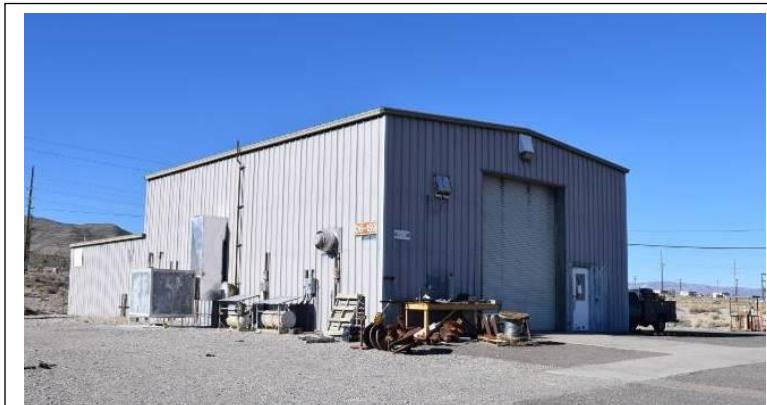
Condition of Resource(s)
Good <input checked="" type="checkbox"/> Fair <input type="checkbox"/> Poor <input type="checkbox"/>
Explanation: Building appears to be in good condition with no visible issues.

South and east side of Building B17822. View west (2018). Note roll up and pedestrian door, and large metal air duct on south side of building.

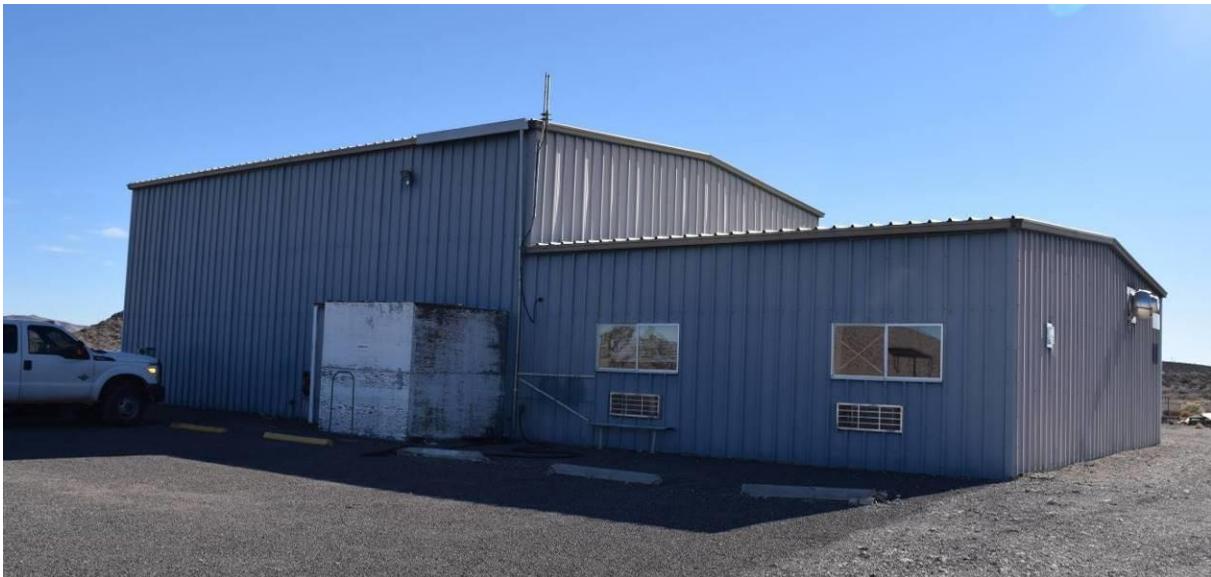
Elevation: North      Direction facing: Southwest      Photographer: Menocal      Date: 12/13/2018  
North side of B17822, looking southeast. Note different heights of sections, sliding windows, and pedestrian door cover at mid-point of building.

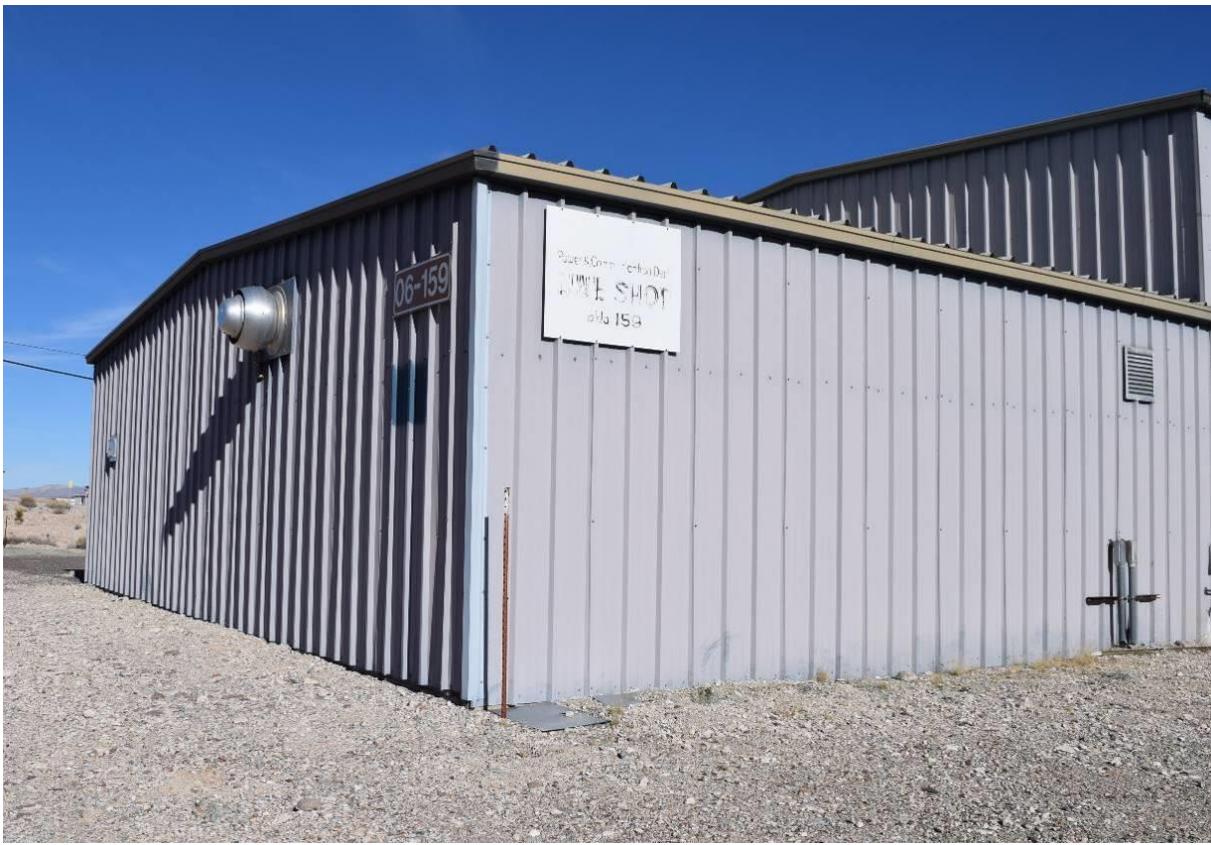
Elevations: South, West      Direction facing: Northeast      Photographer: Menocal      Date: 12/13/2018  
Southwest corner of building. Note signs, vent (on western end) and metals panels on walls and roof.

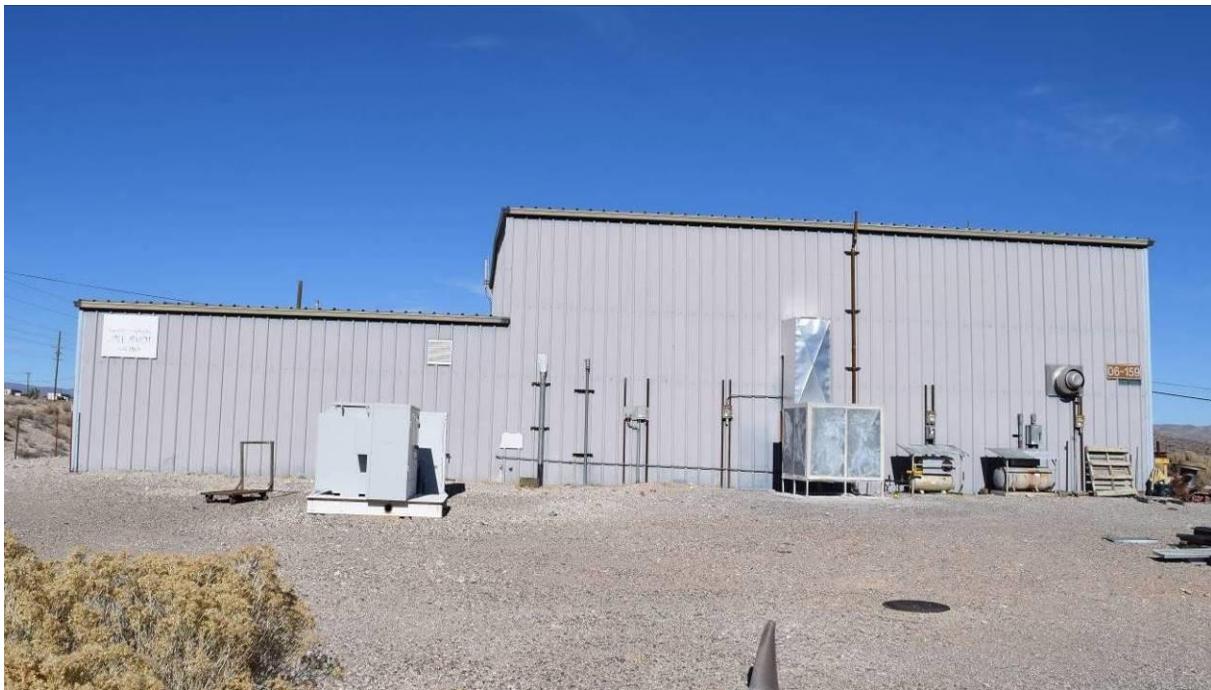
Elevation: South      Direction facing: North      Photographer: Menocal      Date: 12/13/2018  
South side of B17822, looking north. Note different heights of sections, and HVAC system and compressors.

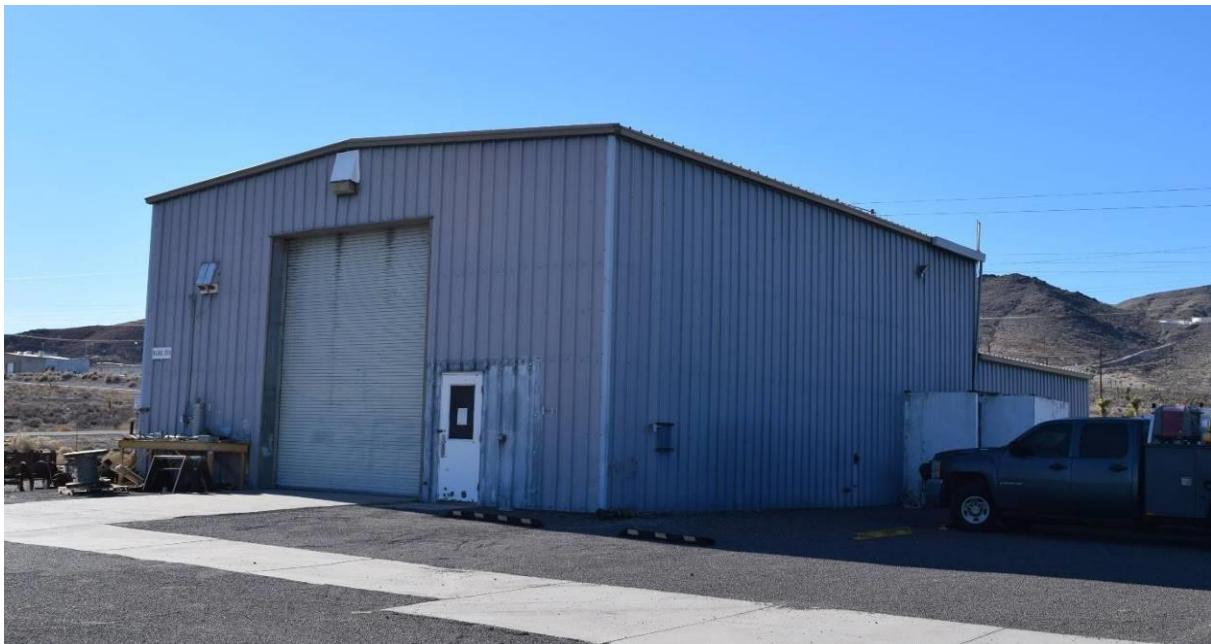
Elevations: East, North      Direction facing: West      Photographer: Menocal      Date: 12/13/2018  
Northeast corner of building. Note doors on east side of building, and enclosed door area on north side.

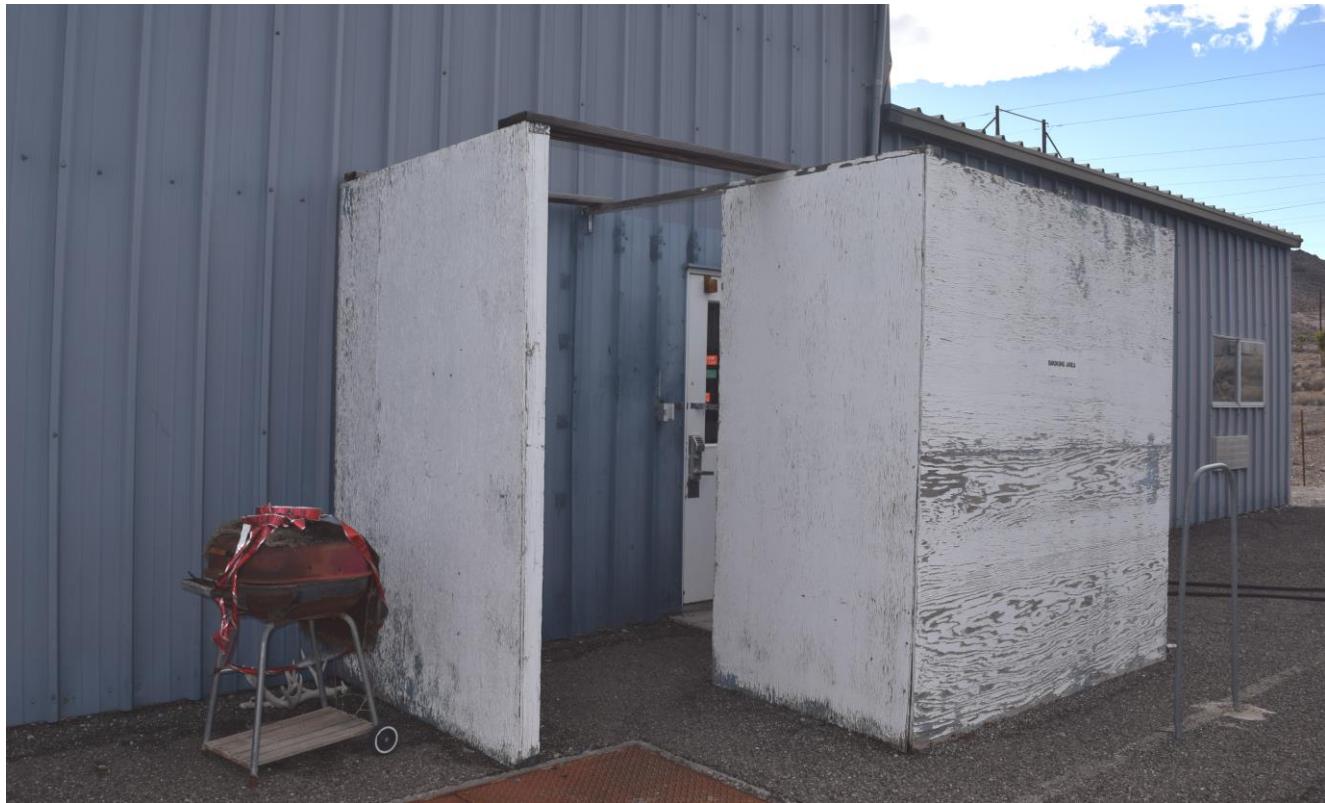
North side of B17822 showings plywood enclosure around door.

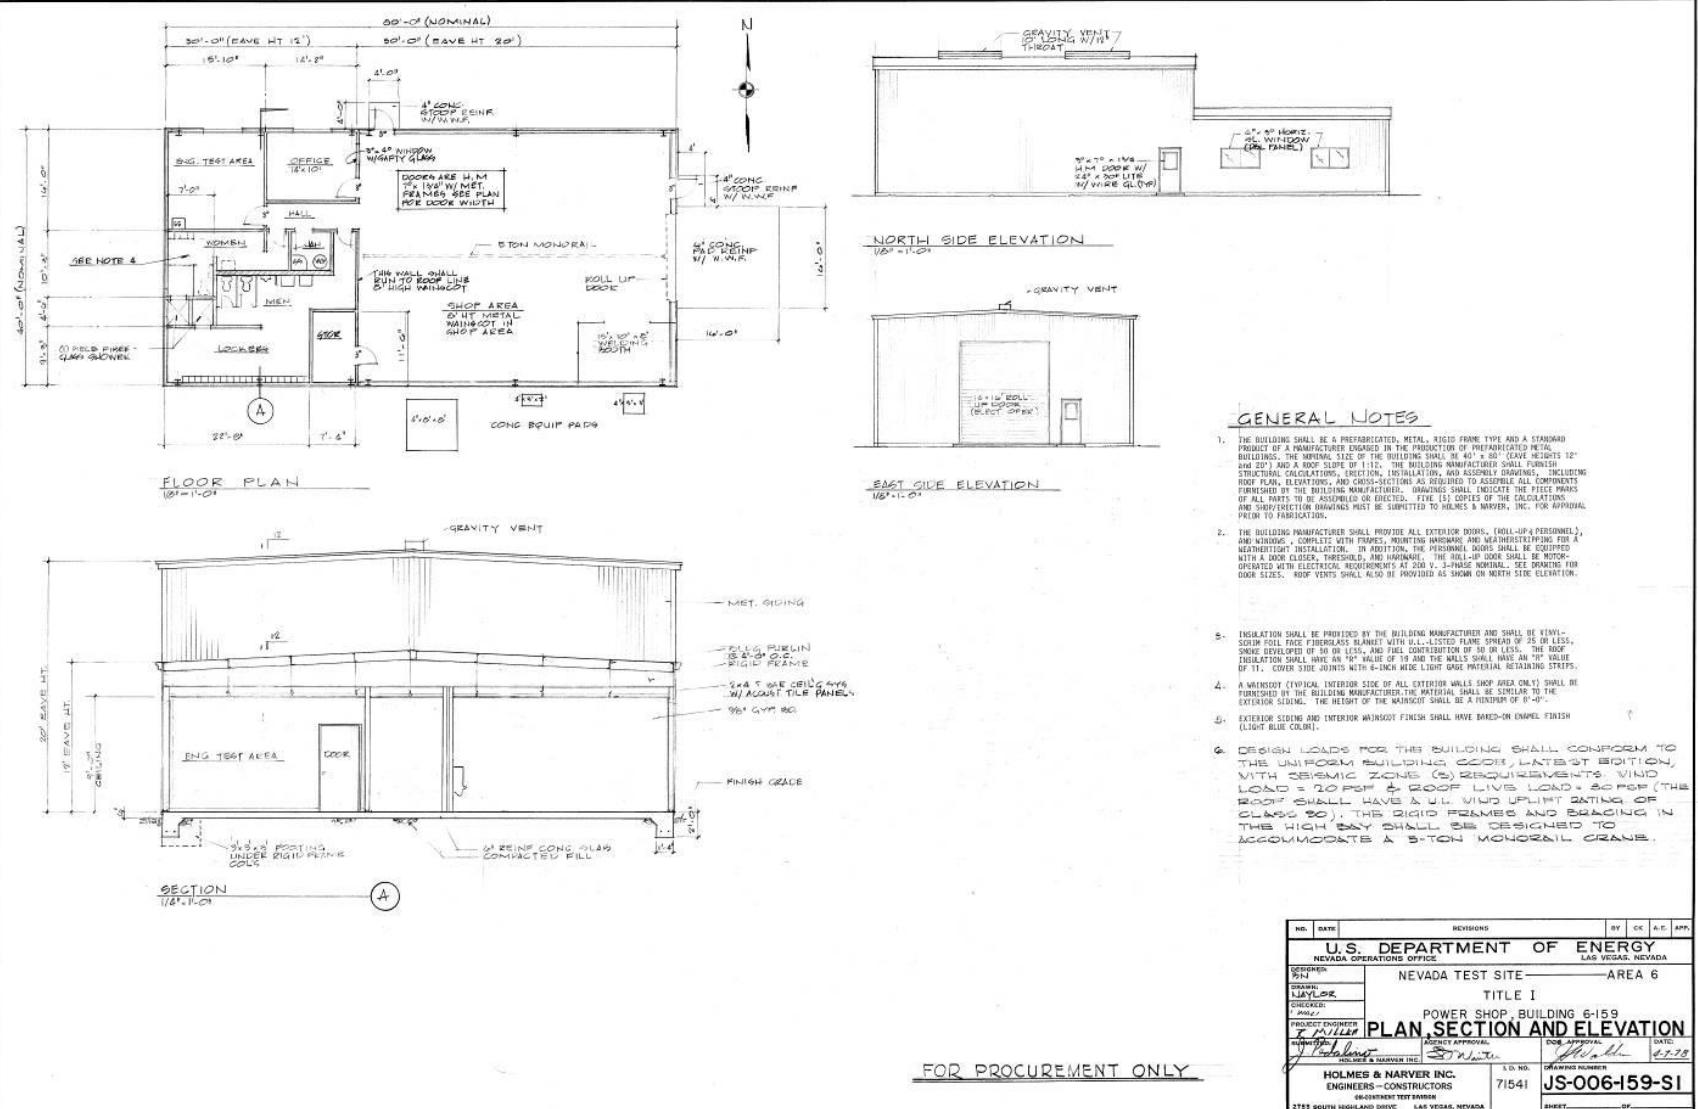
Historical construction plan for B17822 showing exterior elevations and floorplan. Source: Holmes and Narver, Inc. 1978.

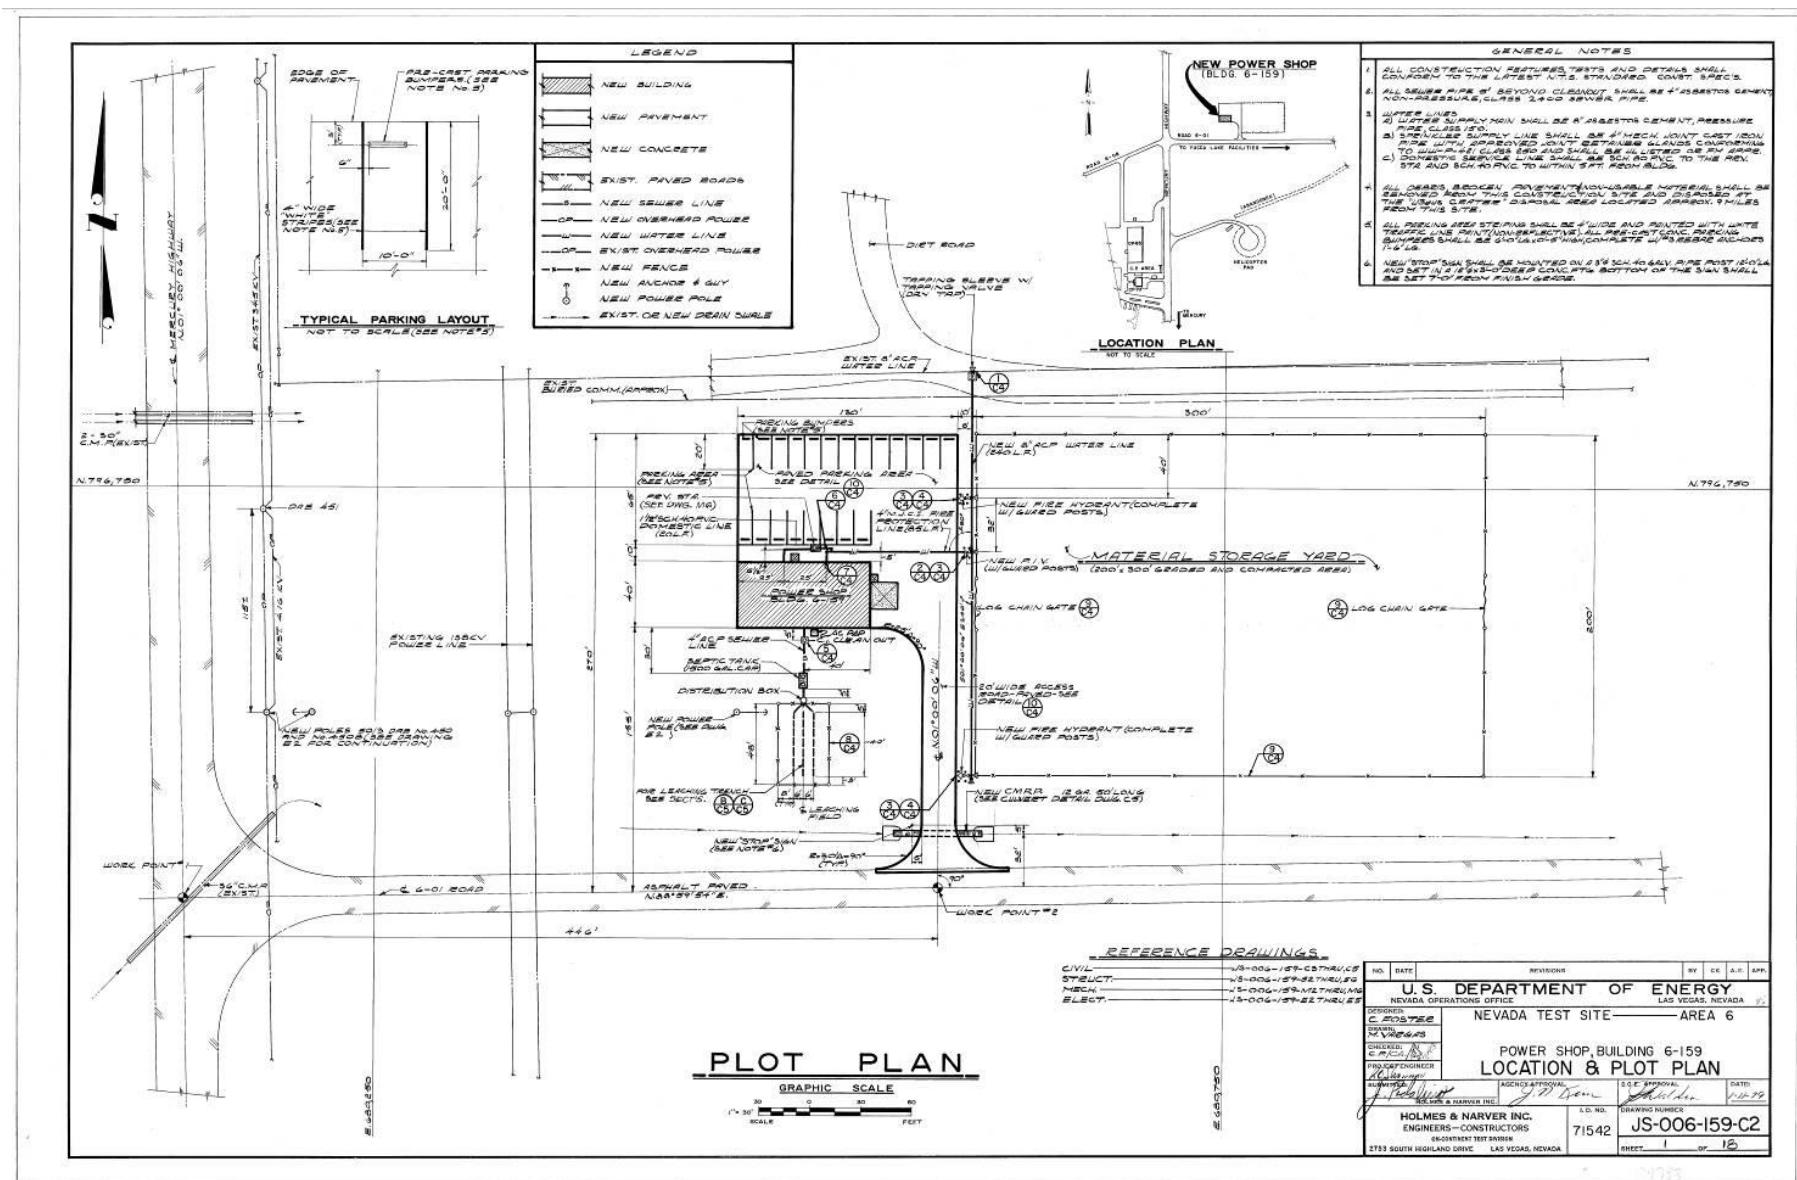
Historical construction plan for B17822 showing site plan and storage yard (AR1). Source: Holmes and Narver, Inc. 1979.

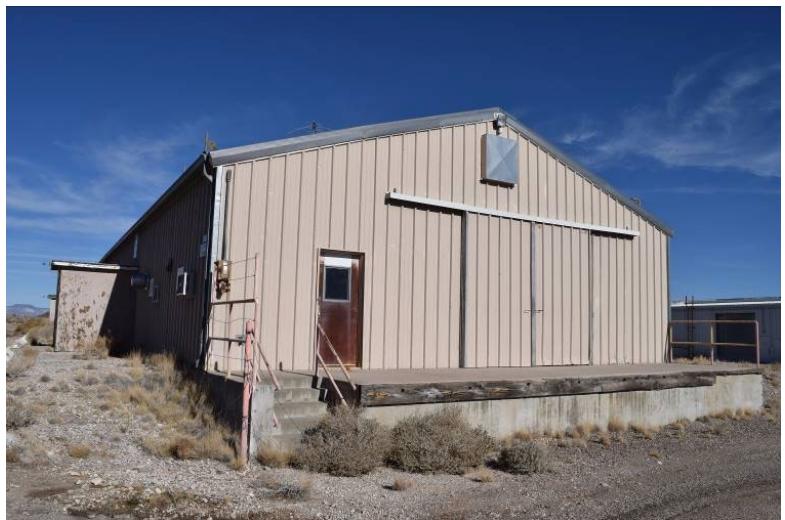
South end of B17823, view is north (DRI 2018).

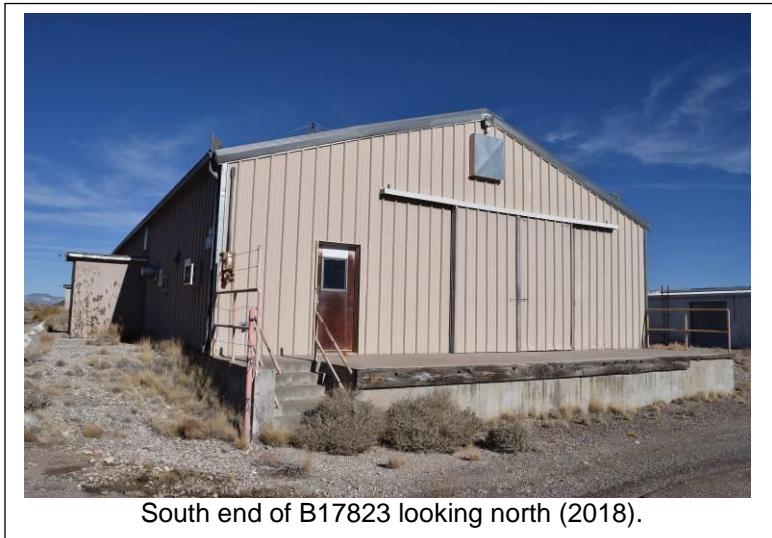
South end of B17823 looking north (2018).

Explanation: Building appears to be in fair condition with no major visible issues.

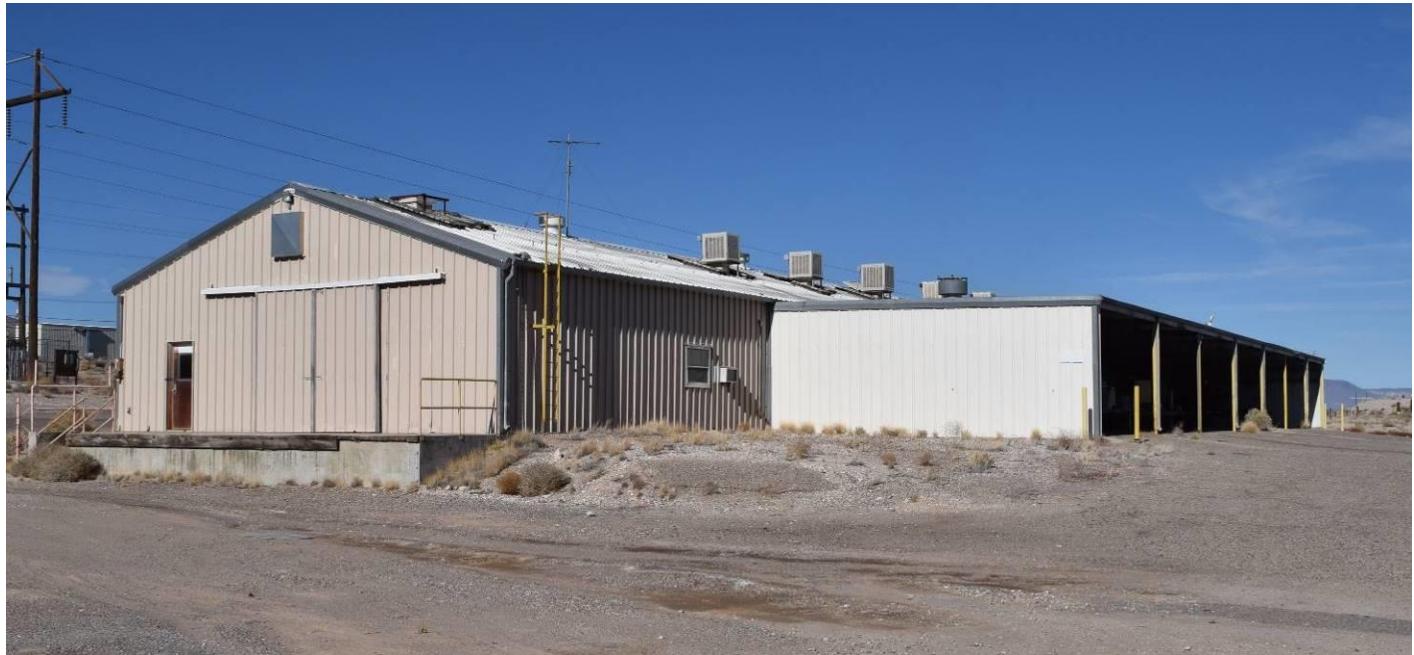
Southeast corner of B17823. Note canopy on east side of building, roof mounted HVAC units, metal siding and roofing, and former loading dock.

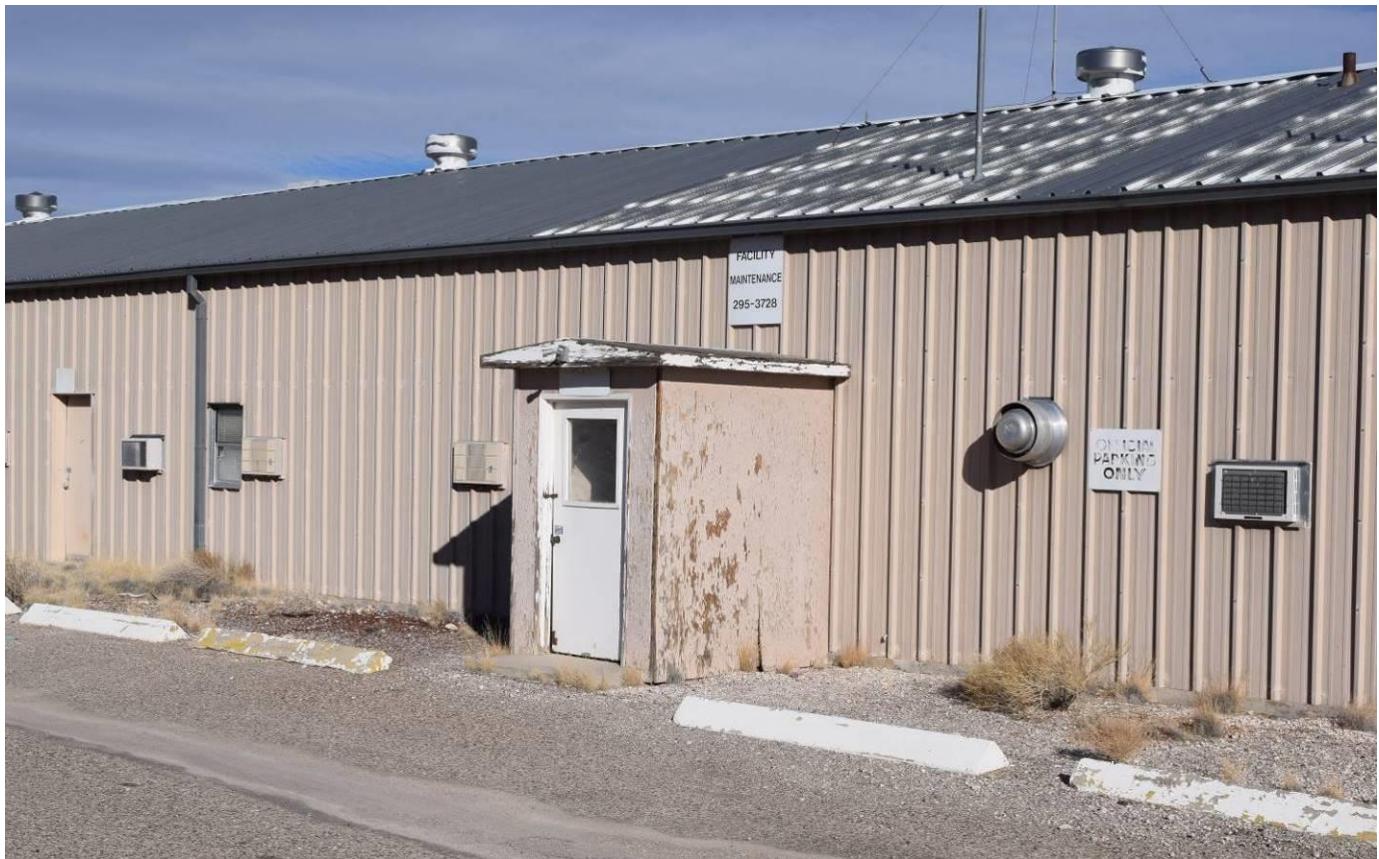
West side of B17823. Note the plywood enclosures on the two pedestrian doors, and the HVAC units set into the walls.

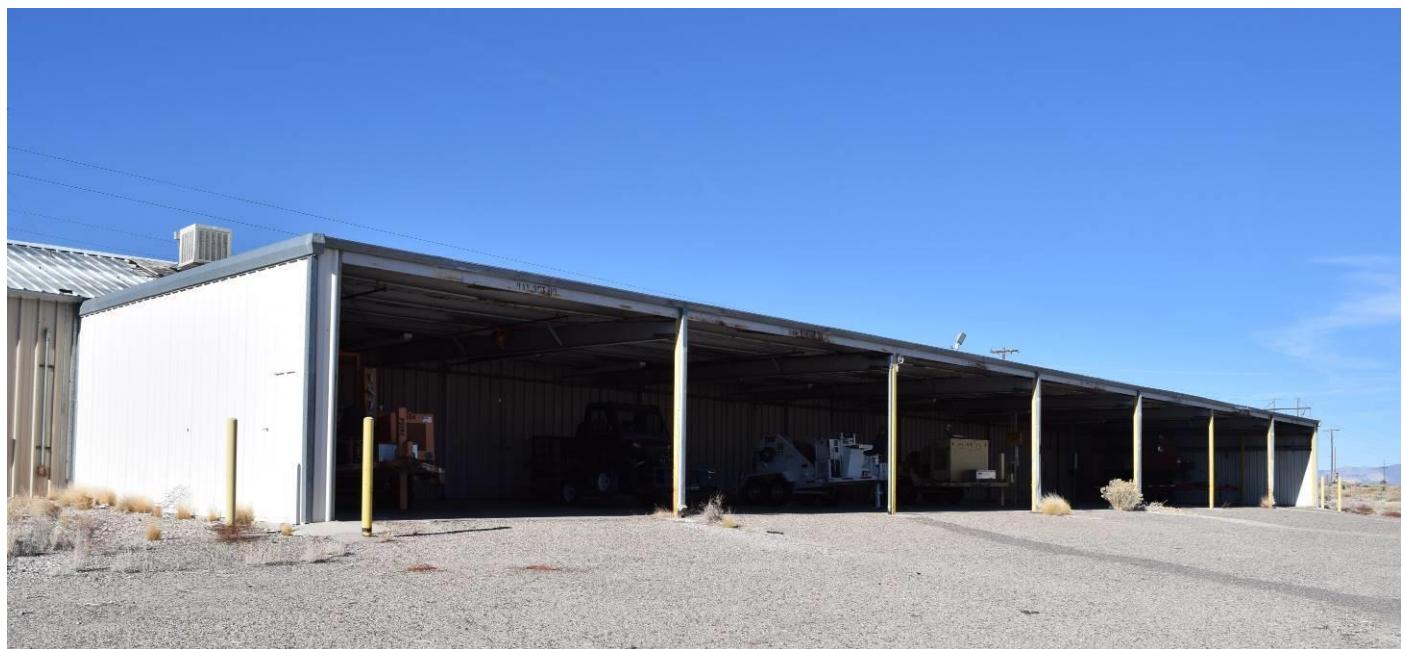
Southeast corner of canopy on B17823.
