**DESERT RESEARCH INSTITUTE  
CULTURAL RESOURCES REPORT SR092921-1-MIT  
PROJECT NO. 2113MIT**

**AN ARCHITECTURAL SURVEY OF THE REECO MAINTENANCE COMPOUND,  
AREA 6, NEVADA NATIONAL SECURITY SITE, NYE COUNTY, NEVADA**

**April 2022**

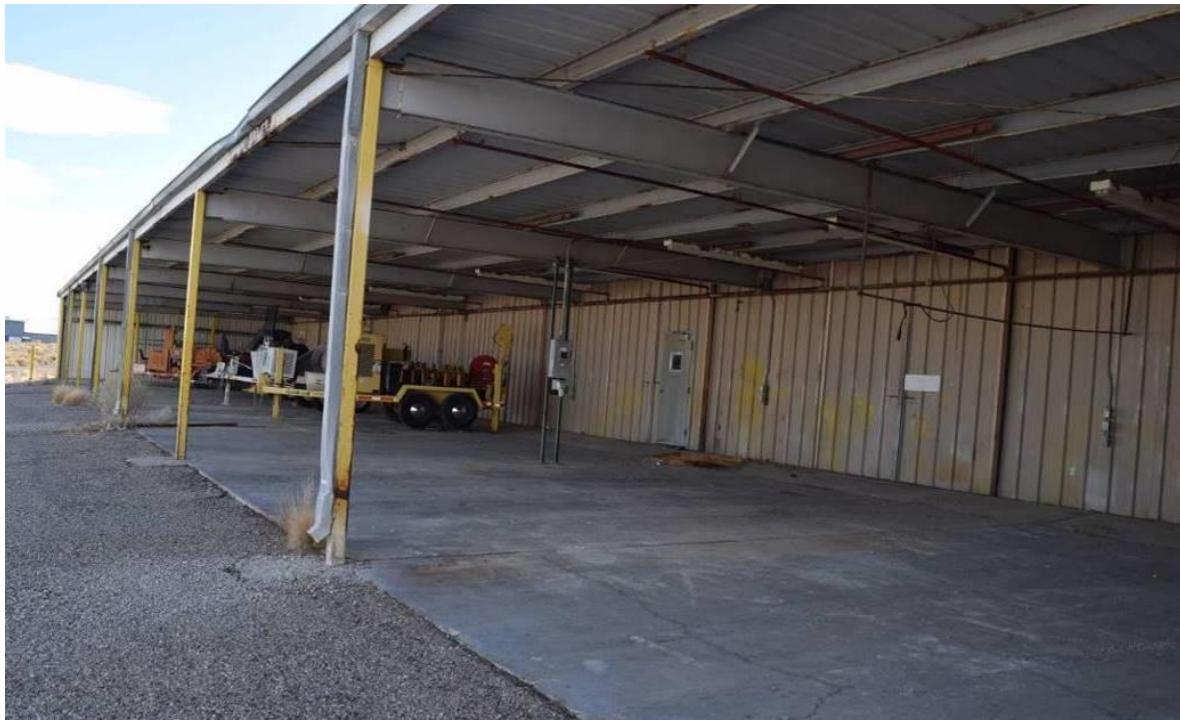
Interior of canopy on east side of B17823. Note steel framework, former sliding doors, and corrugated panels.

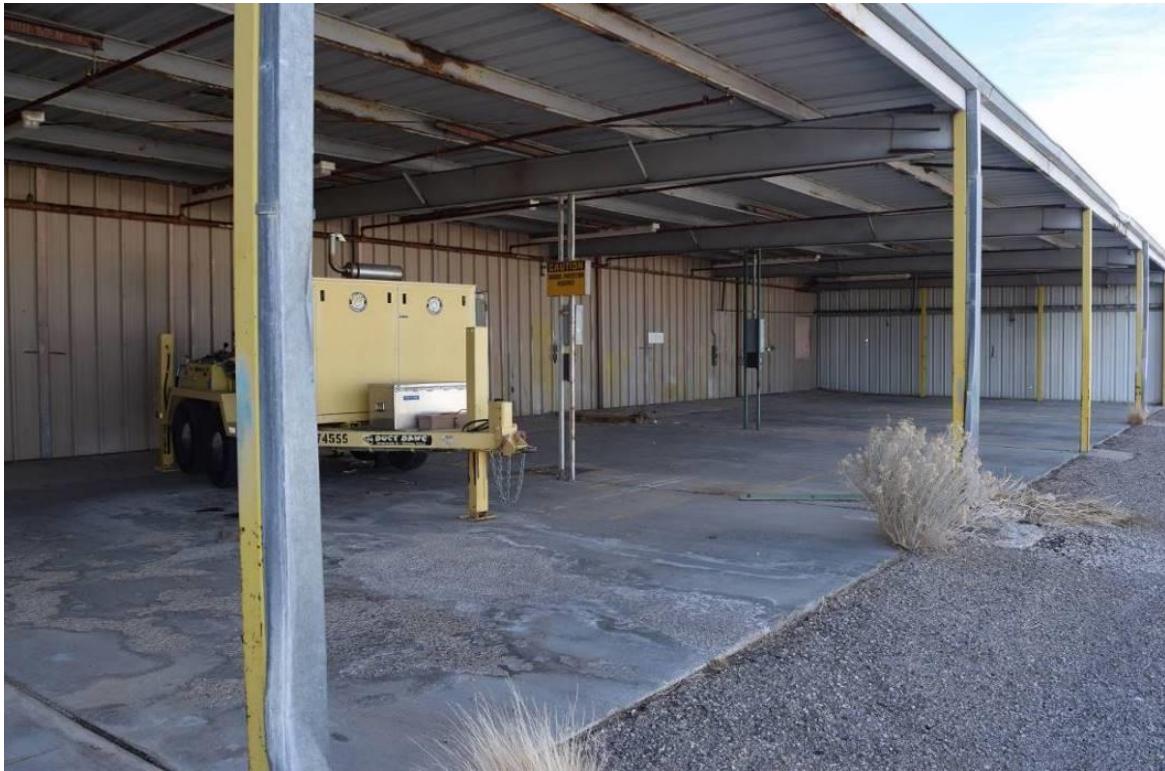
Interior of canopy on east side of B17823. Note steel framework and former sliding doors.

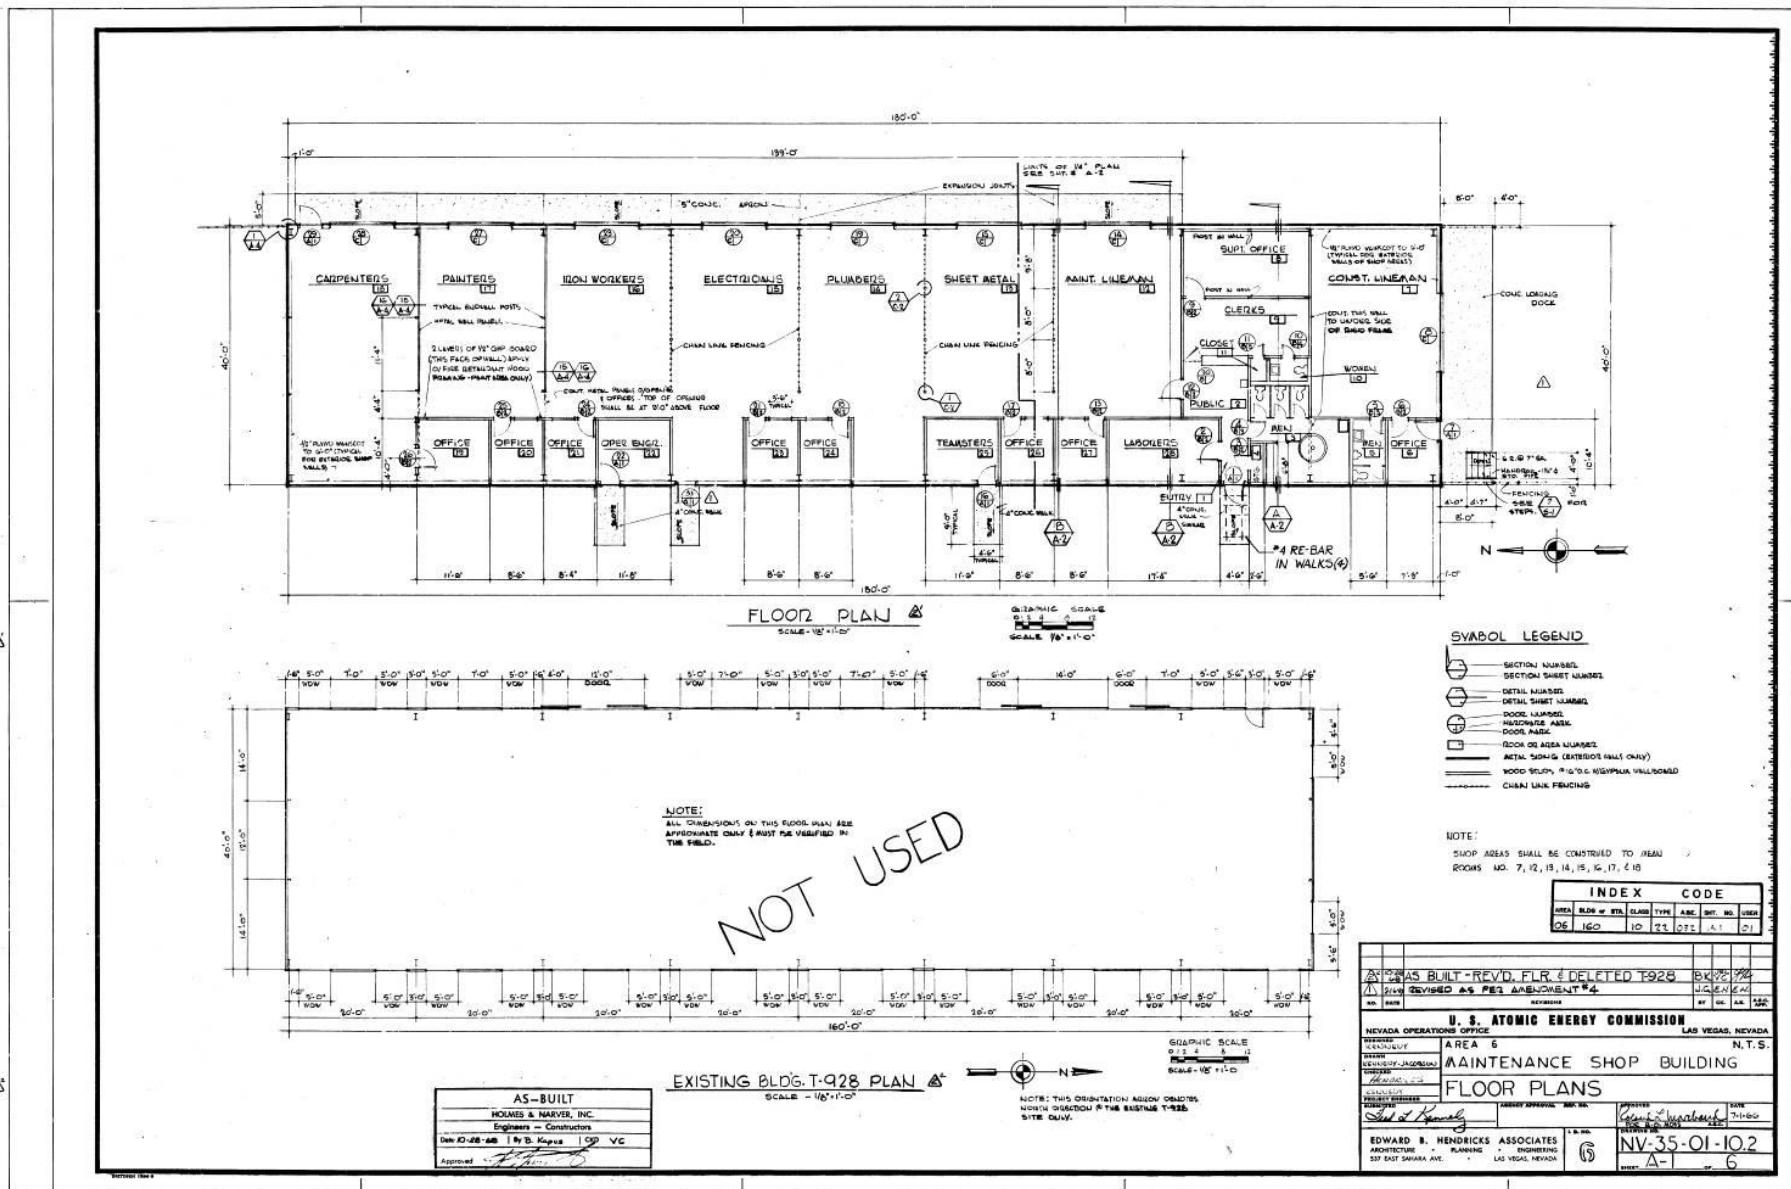
Historical construction plan for B17823 showing building floor plan. Source: Hendricks 1966a.

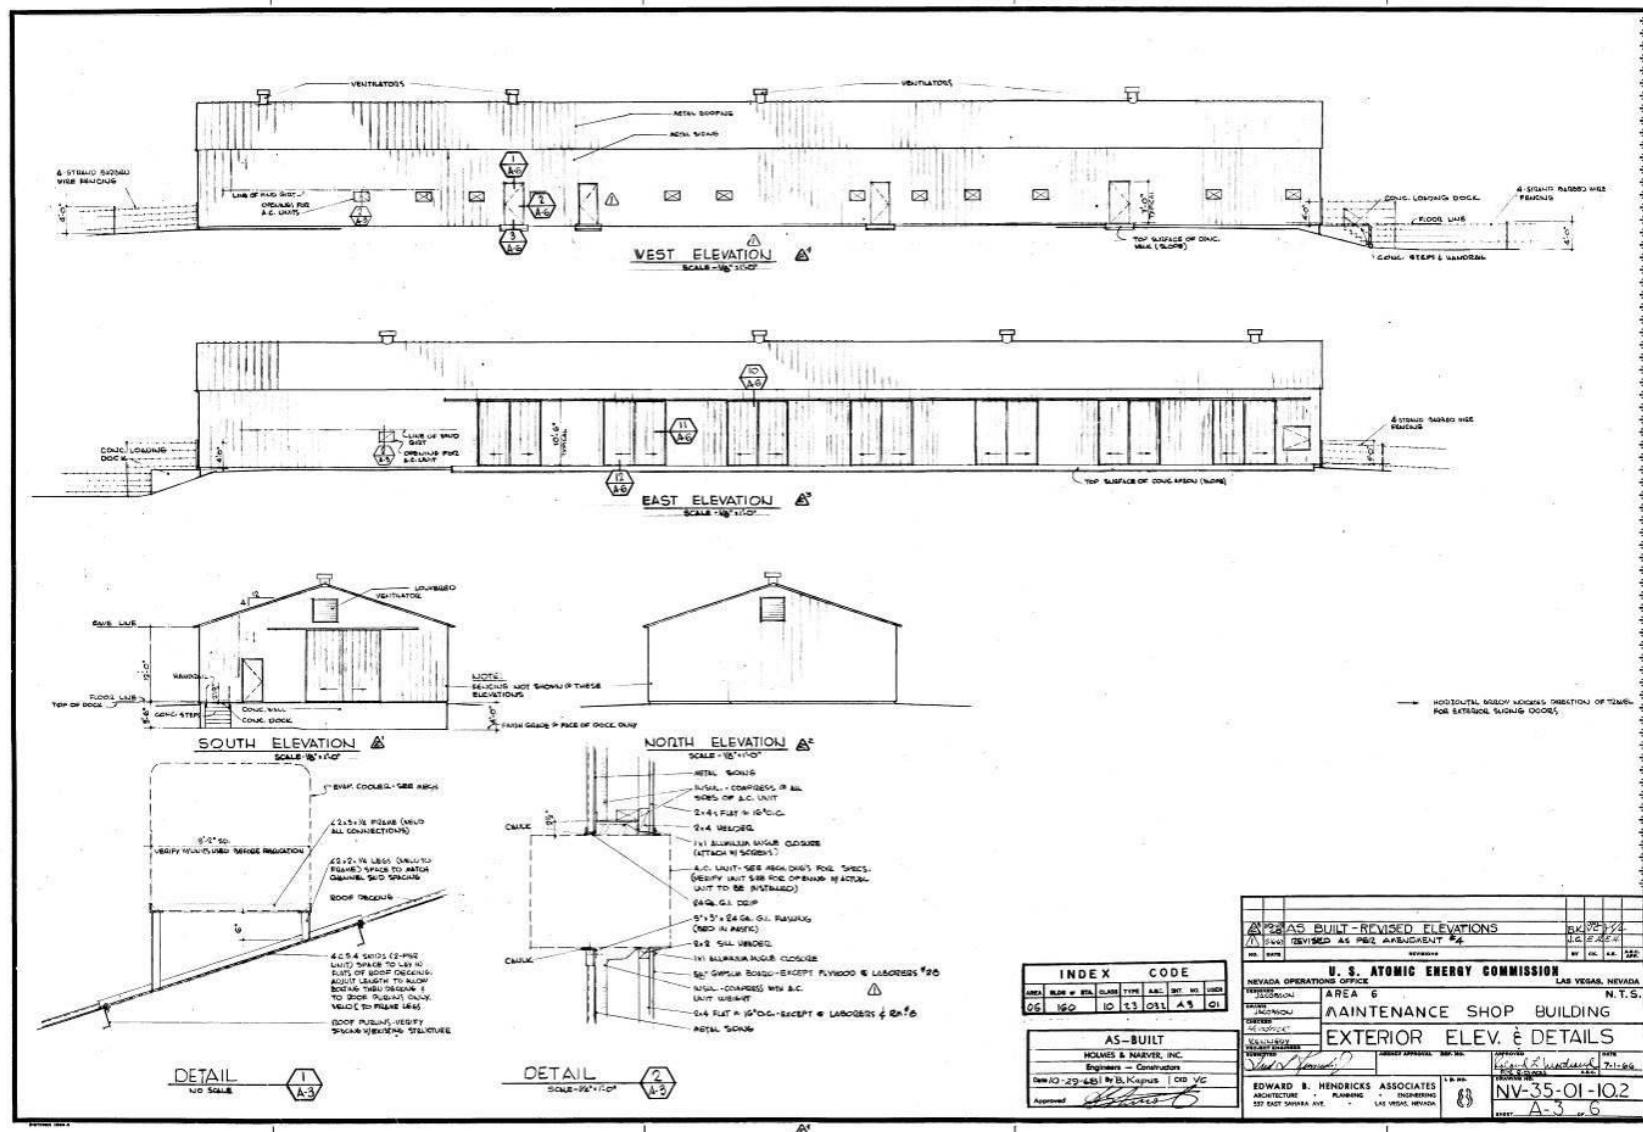
Historical construction plan for B17823 showing exterior elevations. Source: Hendricks 1966b.

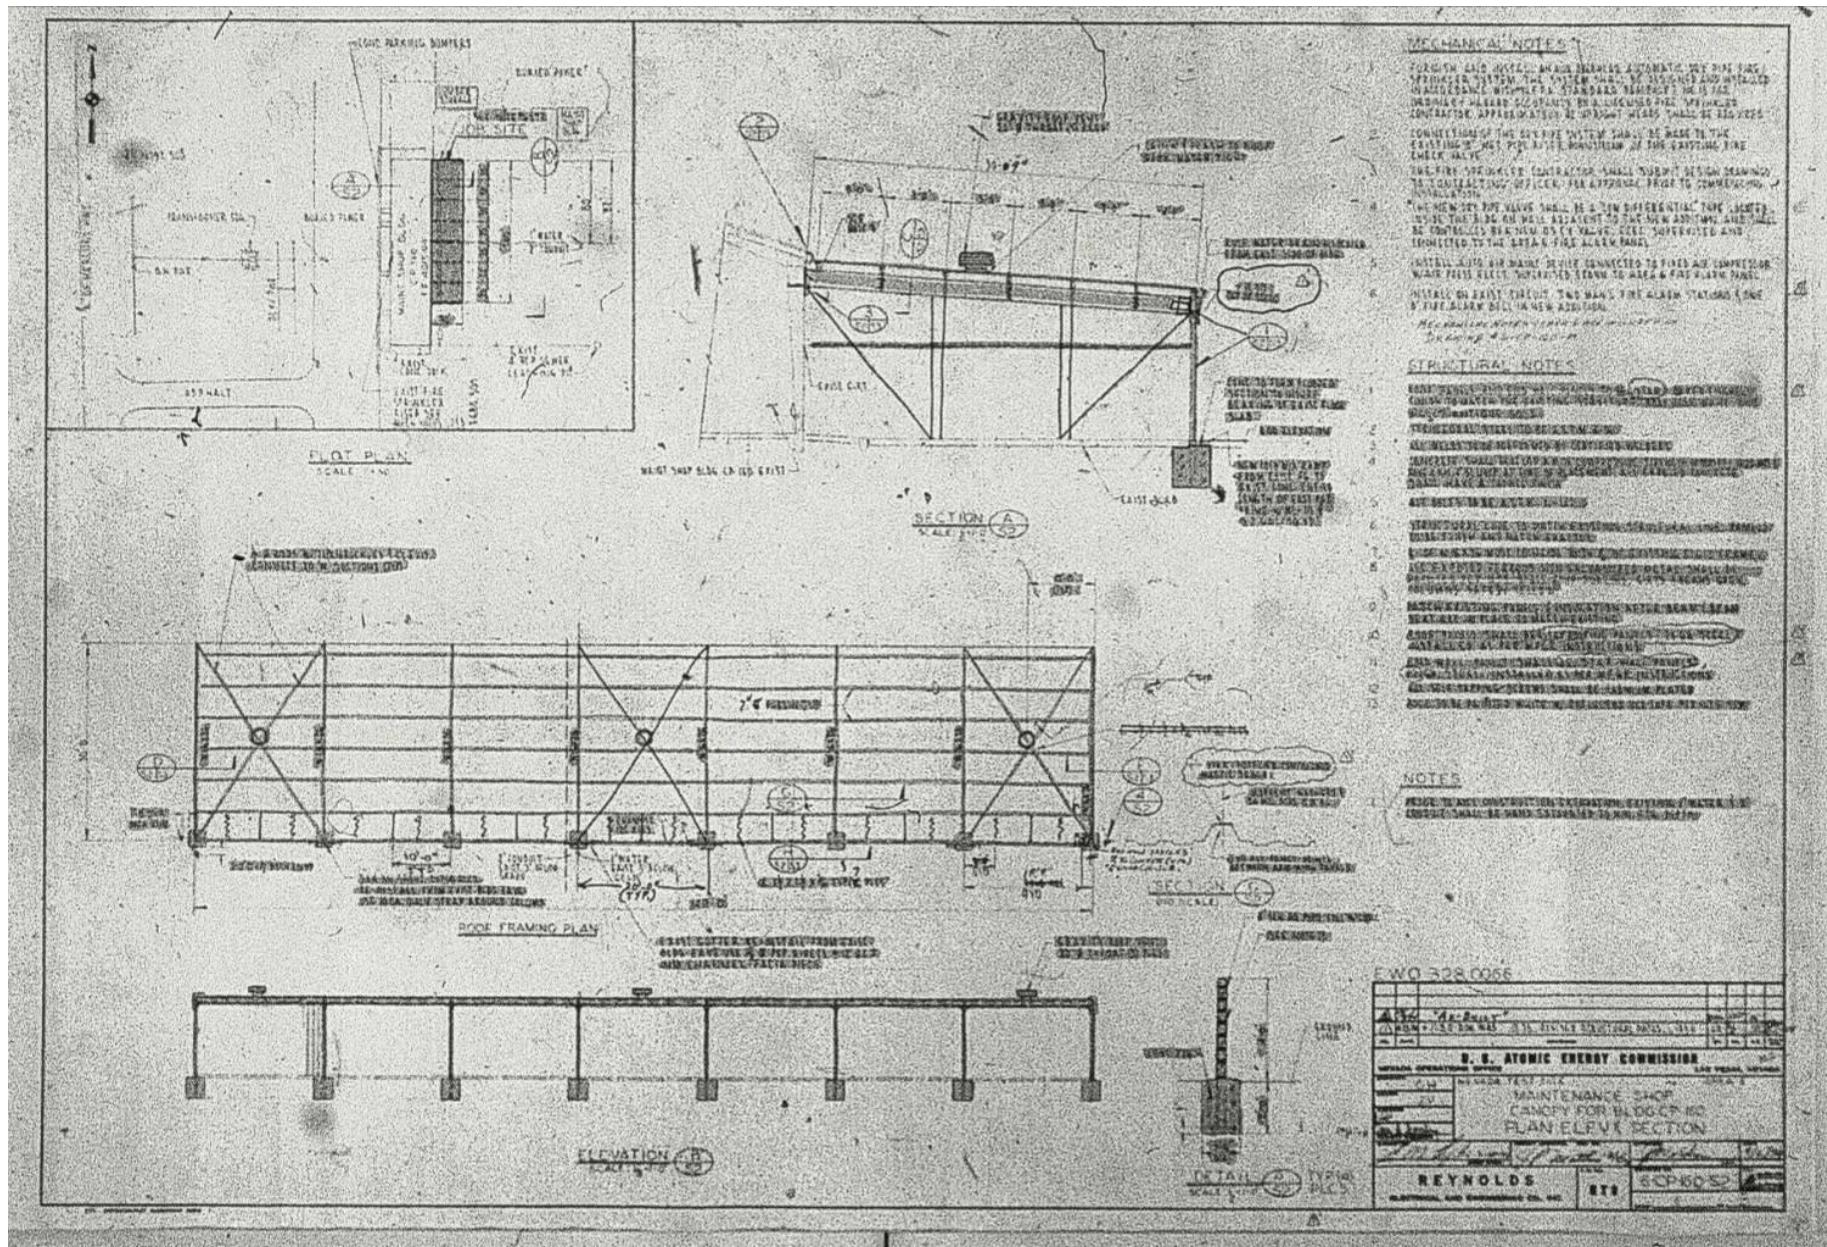
Historical construction plans for canopy built onto east side of B17823. Source: REECO n.d.

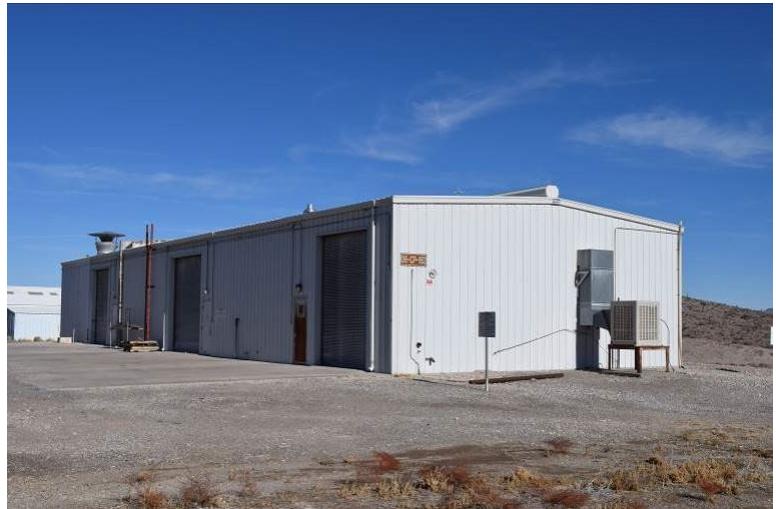
South and west elevations of B17824, view is northeast  
(DRI 2018).

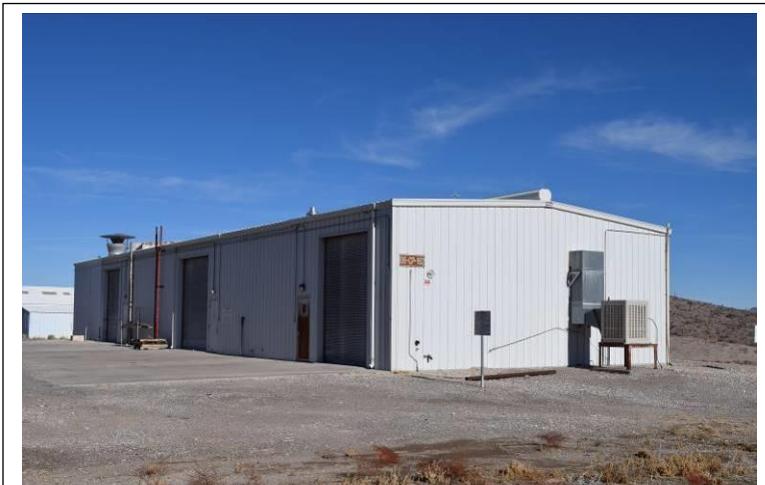
View of B17824 looking northeast (2018).

Condition of Resource(s)?		
Good <input checked="" type="checkbox"/>	Fair <input type="checkbox"/>	Poor <input type="checkbox"/>
Explanation: Building appears to be in good condition with no visible issues.

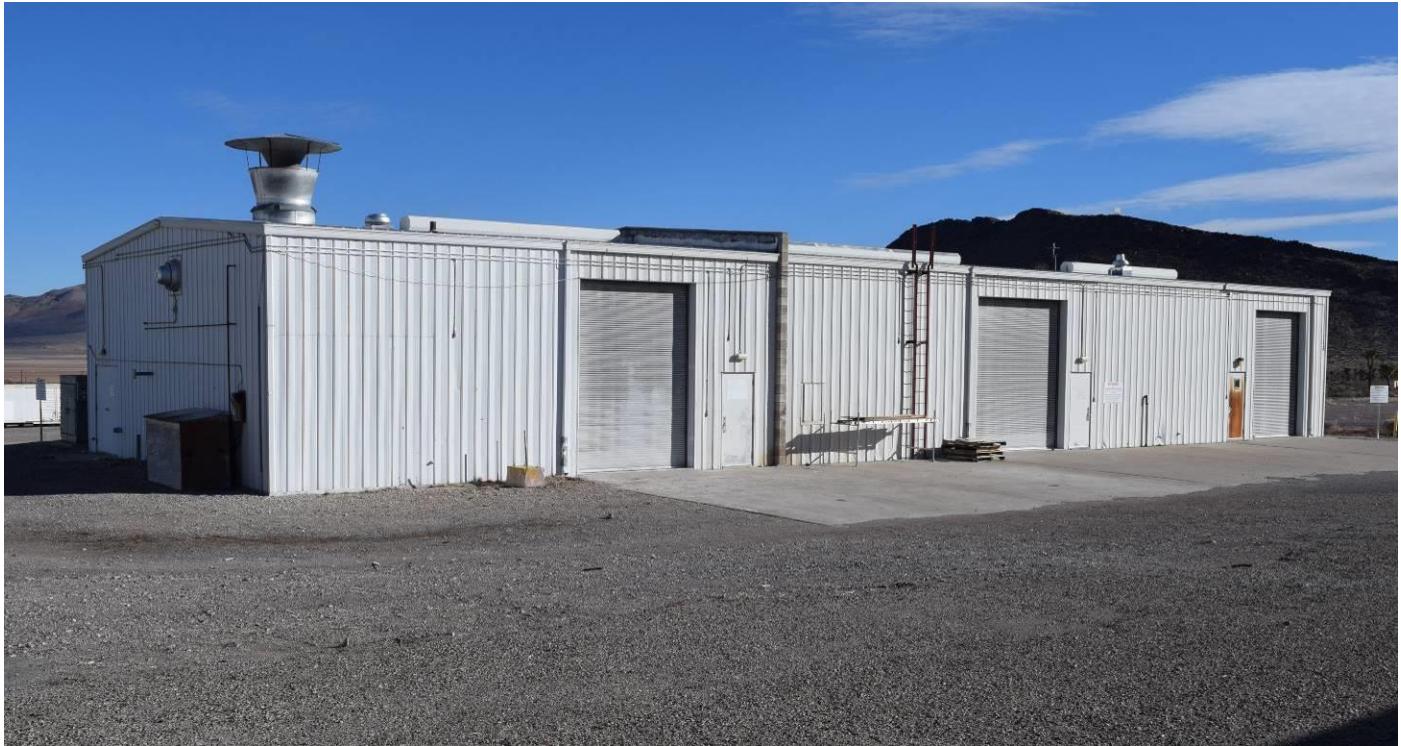
Northwest corner of B17824. Note roll-up and pedestrian doors, corrugated metal siding and roofing, large vent in roof over paint shop, and block firewall extending out from roof and wall line near roll-up door on left side of photo.

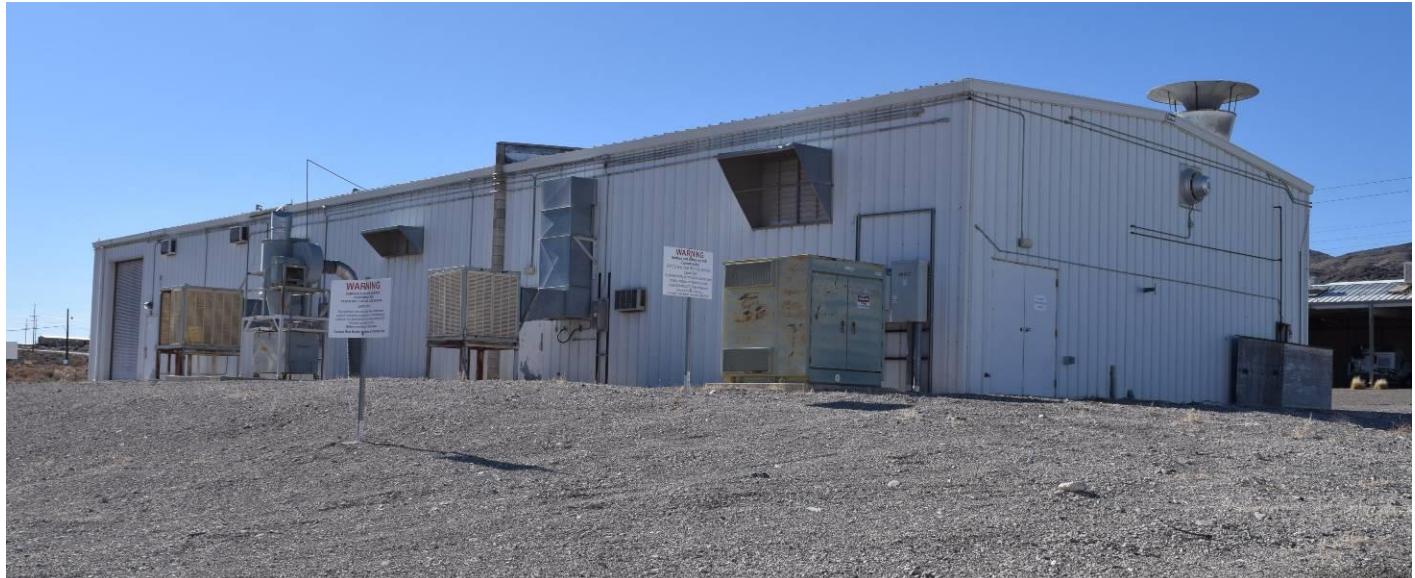
Northeast corner of B17824. Note roll-up door near southeast corner, large vent in roof over paint shop, vents, HVAC units, and block firewall extending out from roof and wall line near the HVAC system in middle of photo.

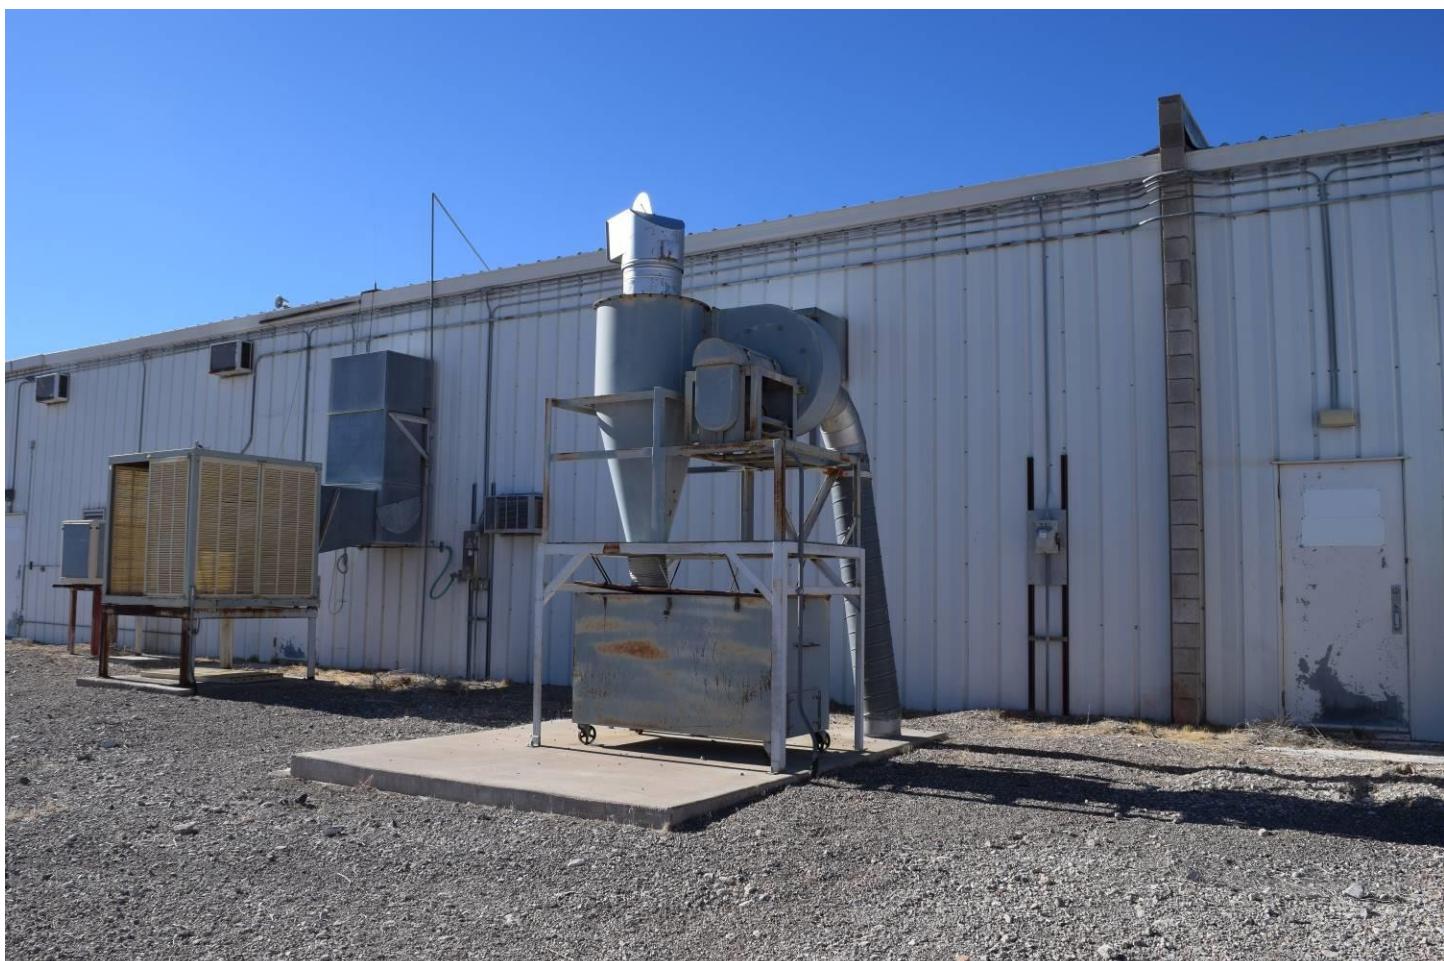
Southeast corner of B17824. Note roll-up door near southeast corner, vents and HVAC units, and block firewall extending out from roof and wall line near the HVAC system in middle of photo. Corner of B17823 is in background.

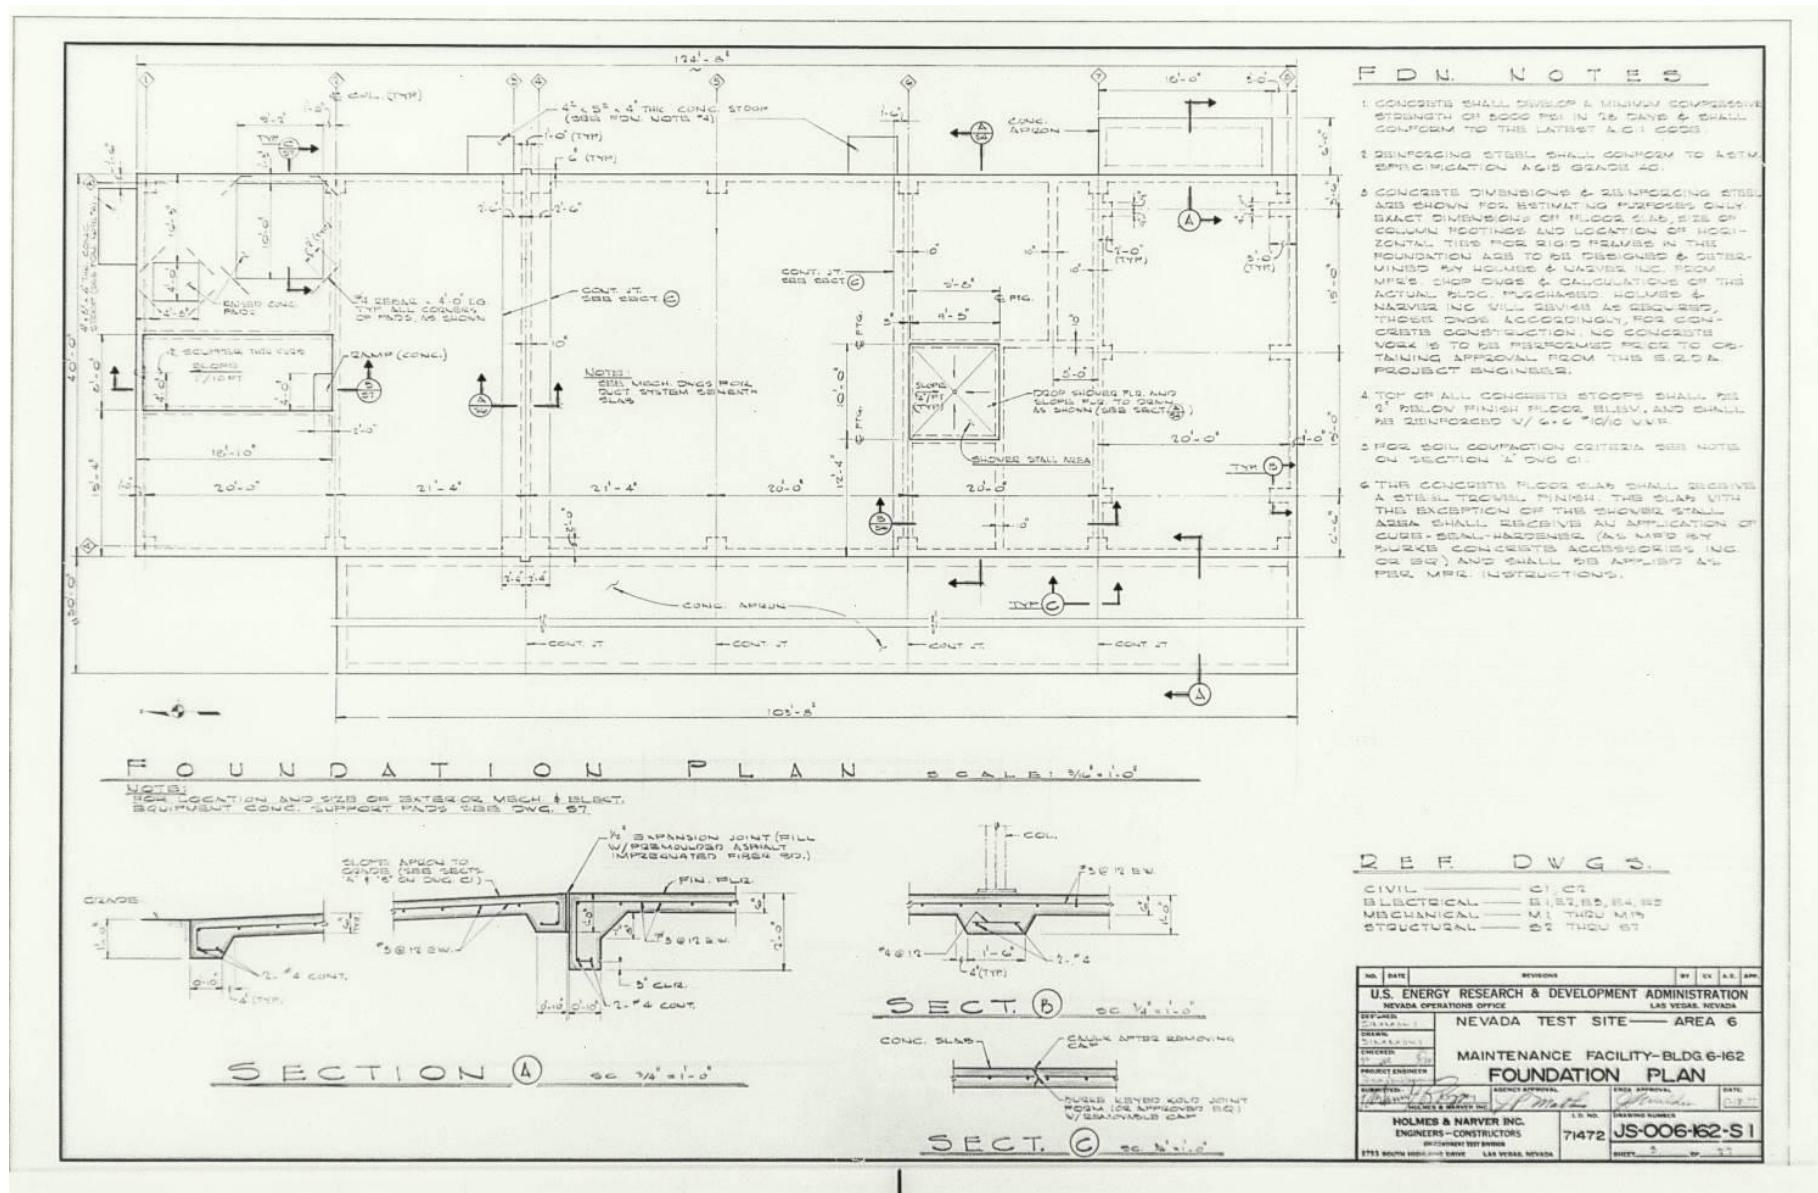
East side of B17824, showing HVAC units, large dust filtration system, and block firewall extending out from roof and wall.

Historic construction plan for B17824 showing building foundation plan. Source: Holmes and Narver, Inc. 1977a.

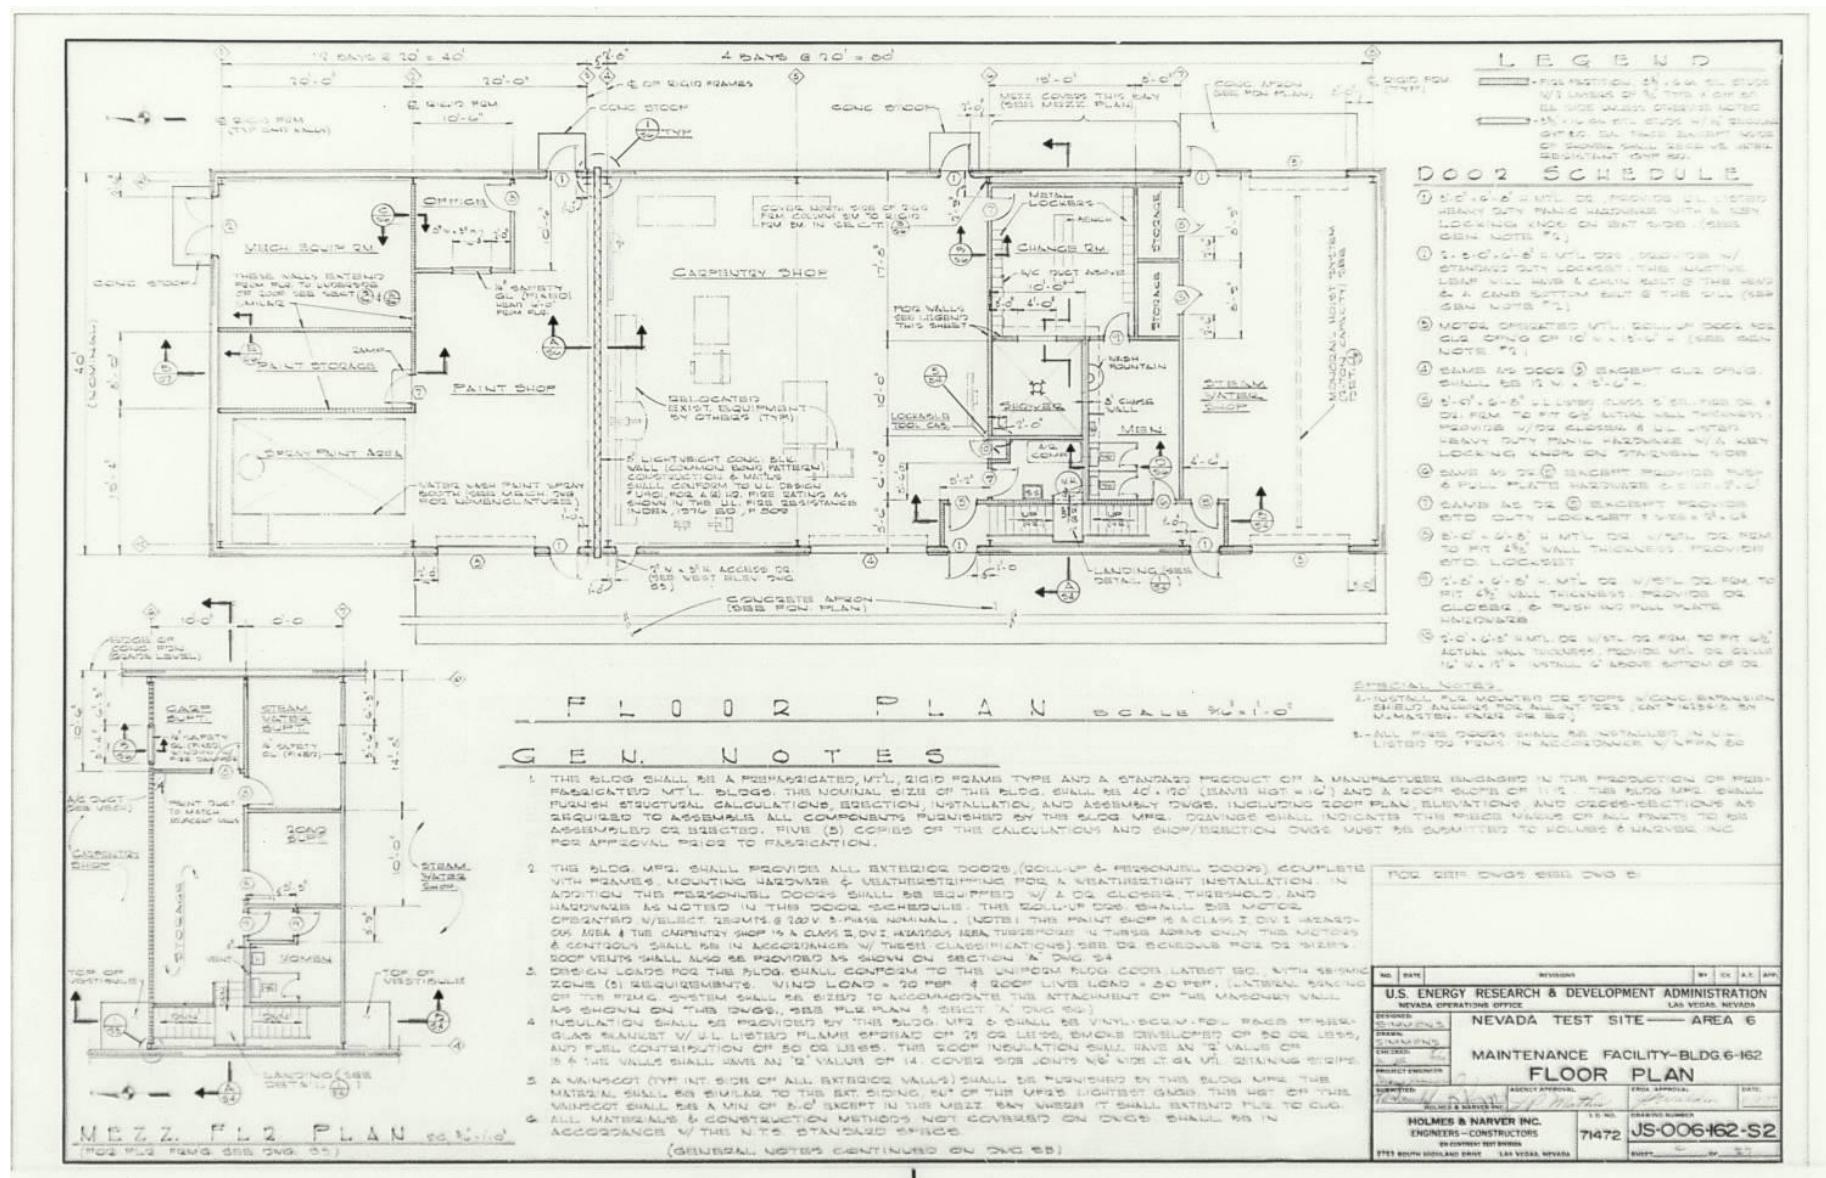
Historic construction plan for B17824 showing building floor plan. Source: Holmes and Narver, Inc. 1977b.

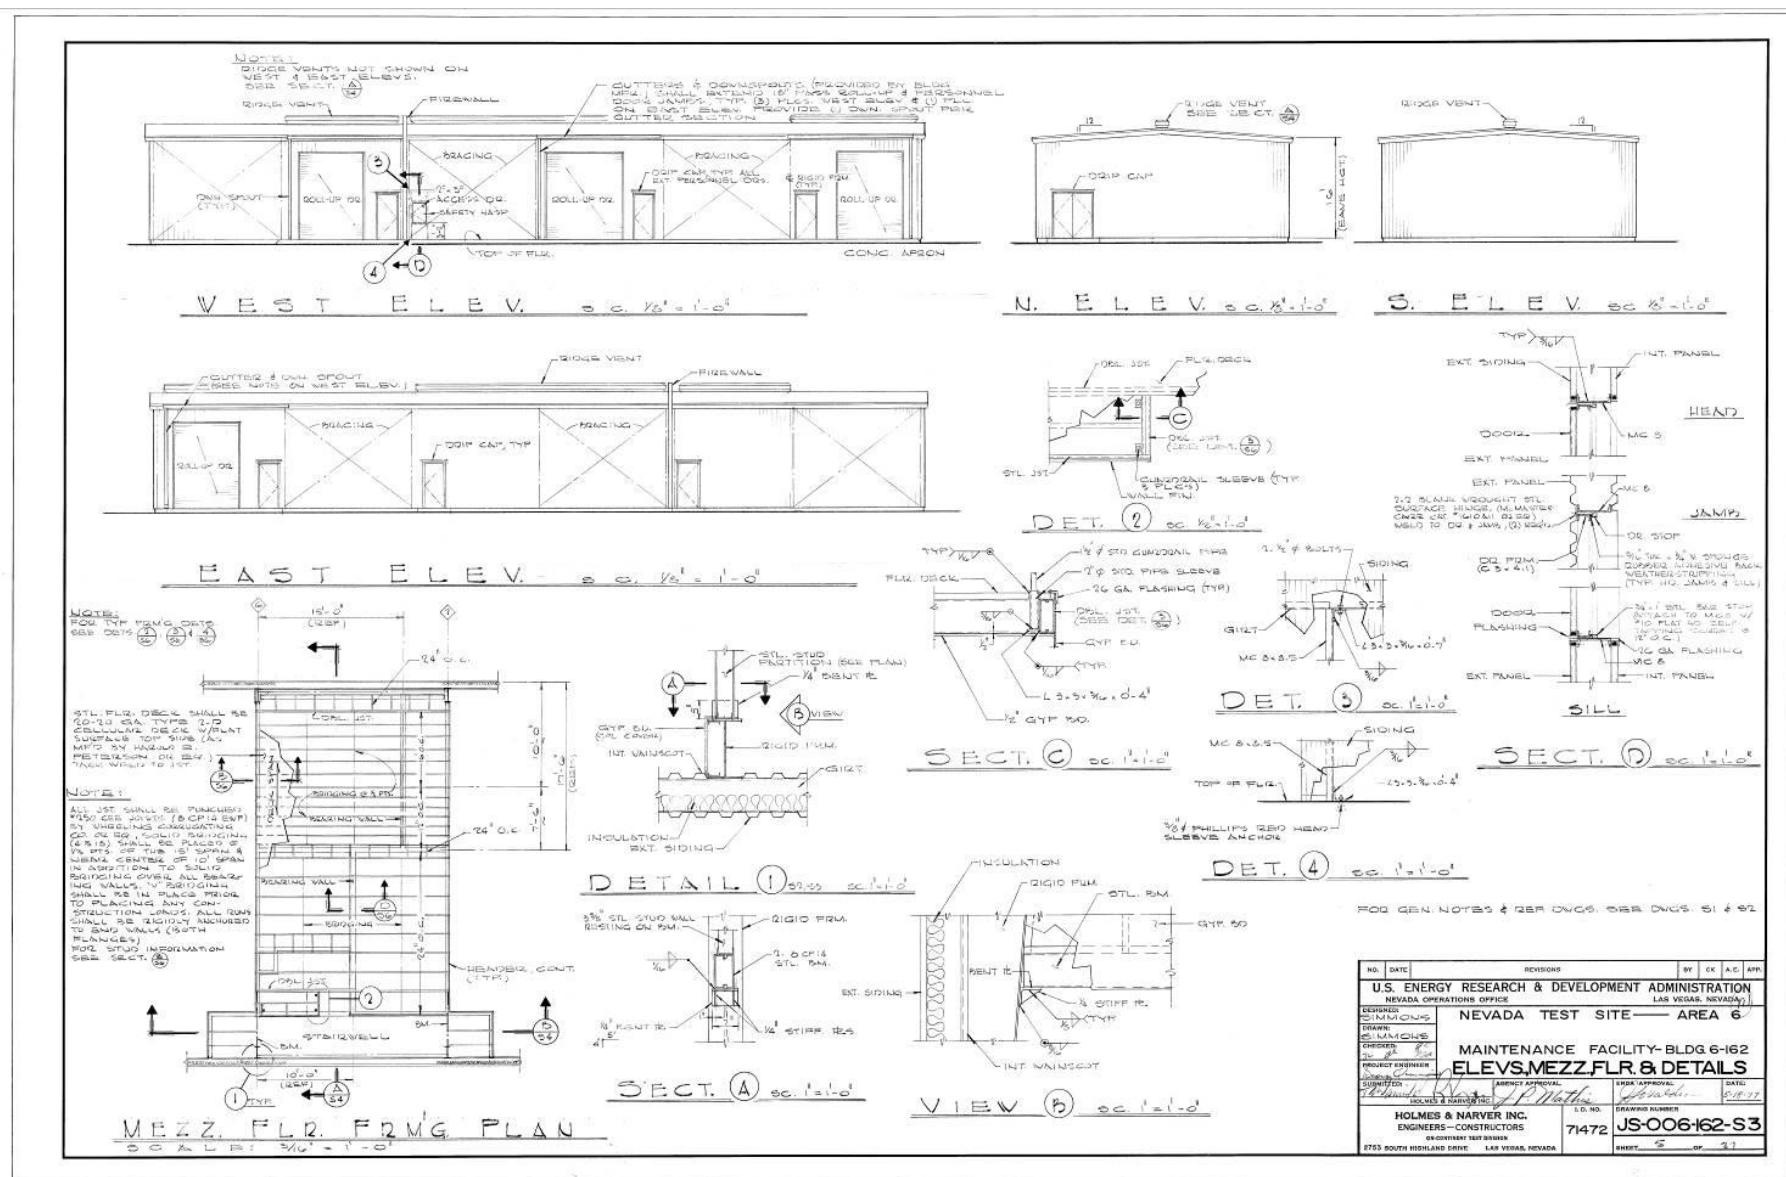
Historic construction plan for B17824 showing elevations. Source: Holmes and Narver, Inc. 1977c.

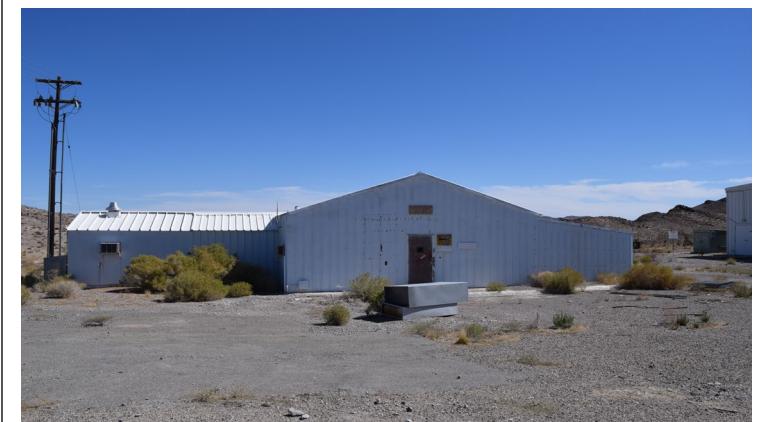
Condition of Resource(s)?
Good <input type="checkbox"/> Fair <input checked="" type="checkbox"/> Poor <input type="checkbox"/>
Explanation: Exterior shows low levels of rust and paint loss.

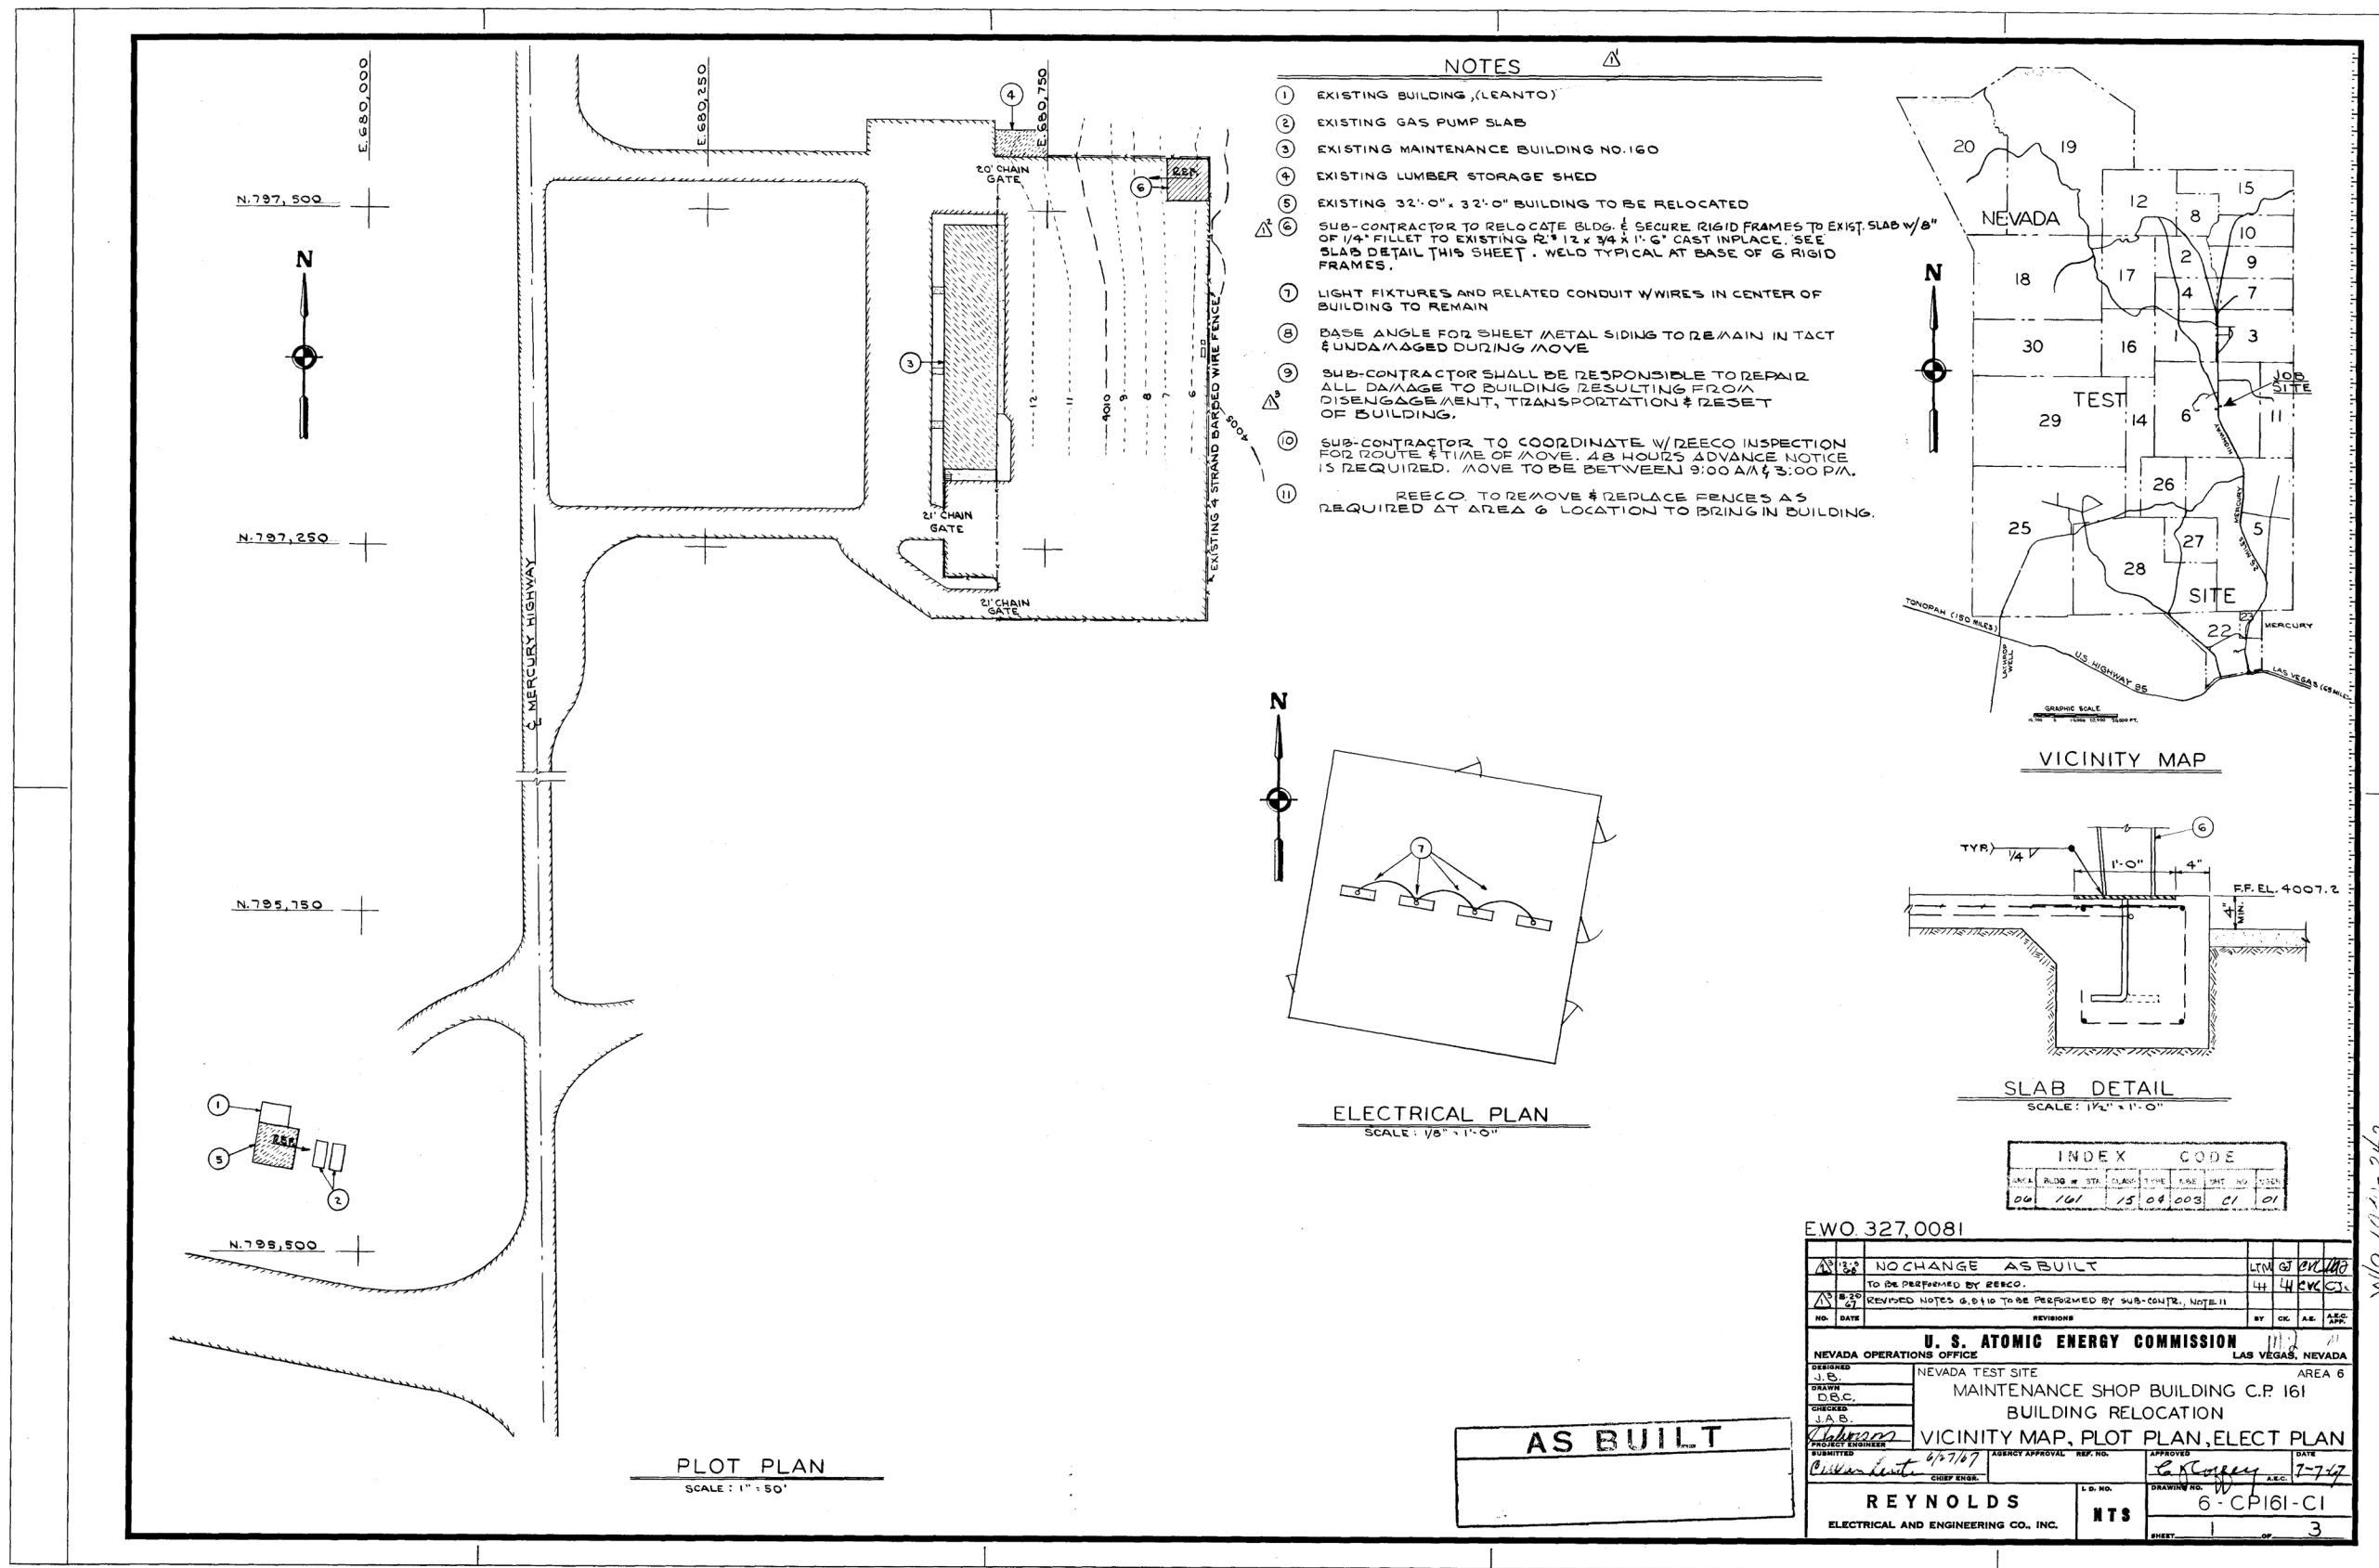
Historical "AS BUILT" relocation plan for Building 06-161 showing its original location and relocation plot in the REECo Maintenance Compound. Source: Reynolds Electrical and Engineering Company, Inc. 1967.  
Nevada SHPO – ARA Form Page 11
