**DESERT RESEARCH INSTITUTE  
CULTURAL RESOURCES REPORT SR092921-1-MIT  
PROJECT NO. 2113MIT**

**AN ARCHITECTURAL SURVEY OF THE REECO MAINTENANCE COMPOUND,  
AREA 6, NEVADA NATIONAL SECURITY SITE, NYE COUNTY, NEVADA**

**April 2022**

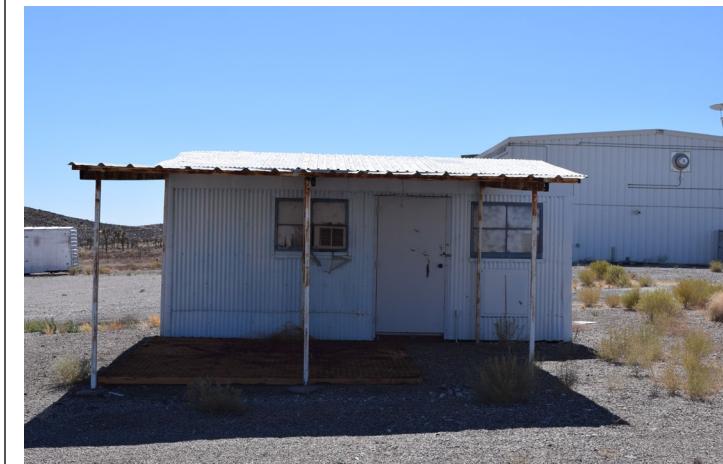
Condition of Resource(s)?
Good <input type="checkbox"/> Fair <input checked="" type="checkbox"/> Poor <input type="checkbox"/>
Explanation: Metal exterior walls and components exhibit a moderate level of rust and paint loss.

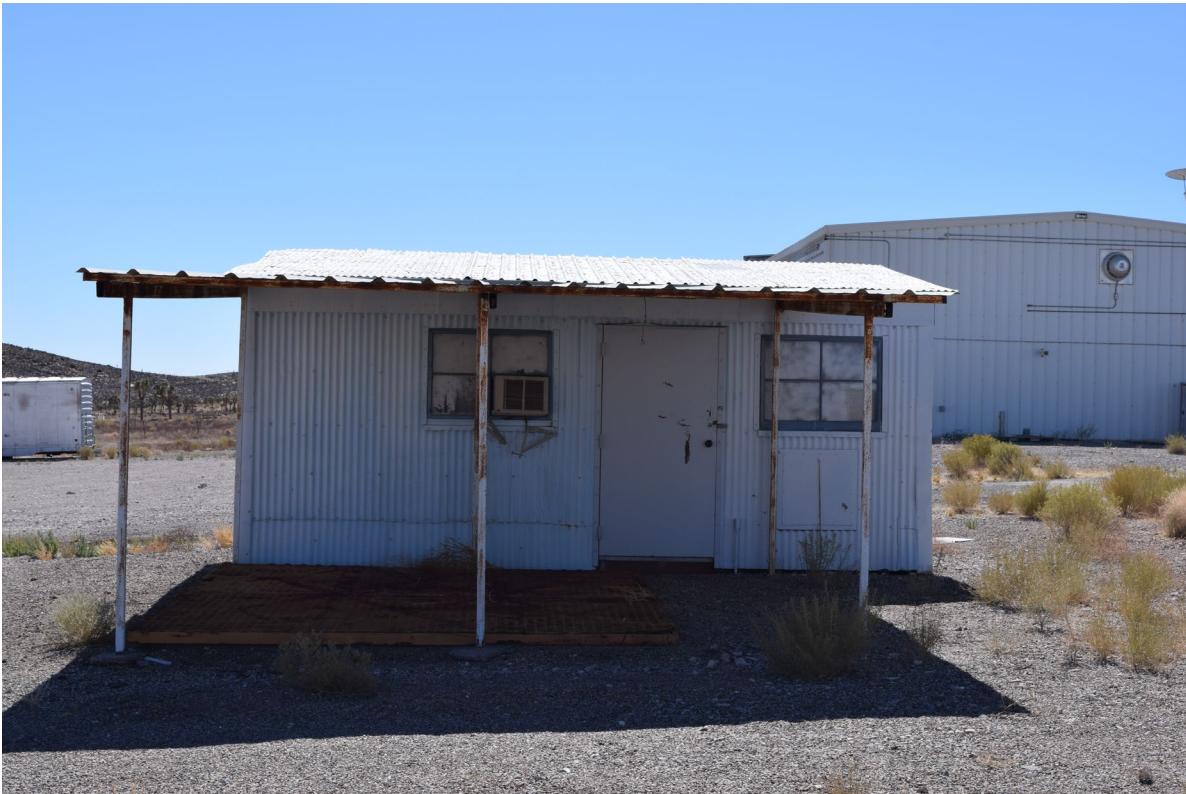
Elevation: North

Direction facing: South

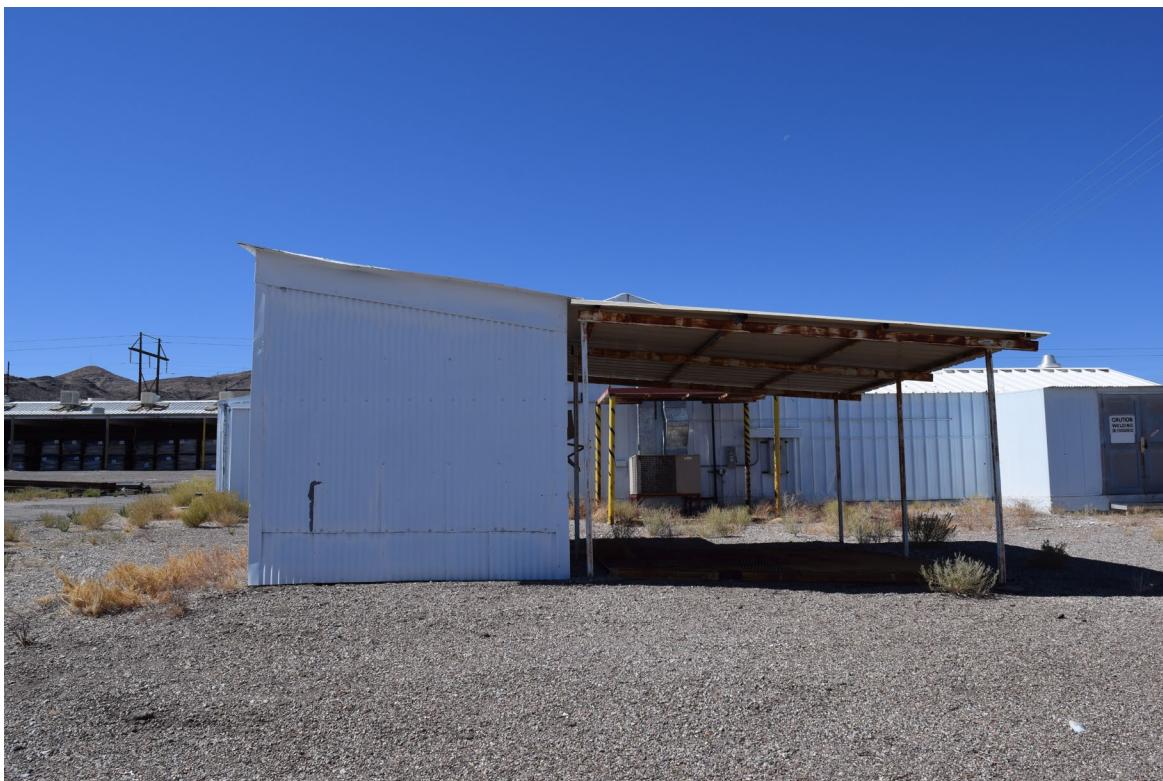
Elevation: East

Direction facing: West

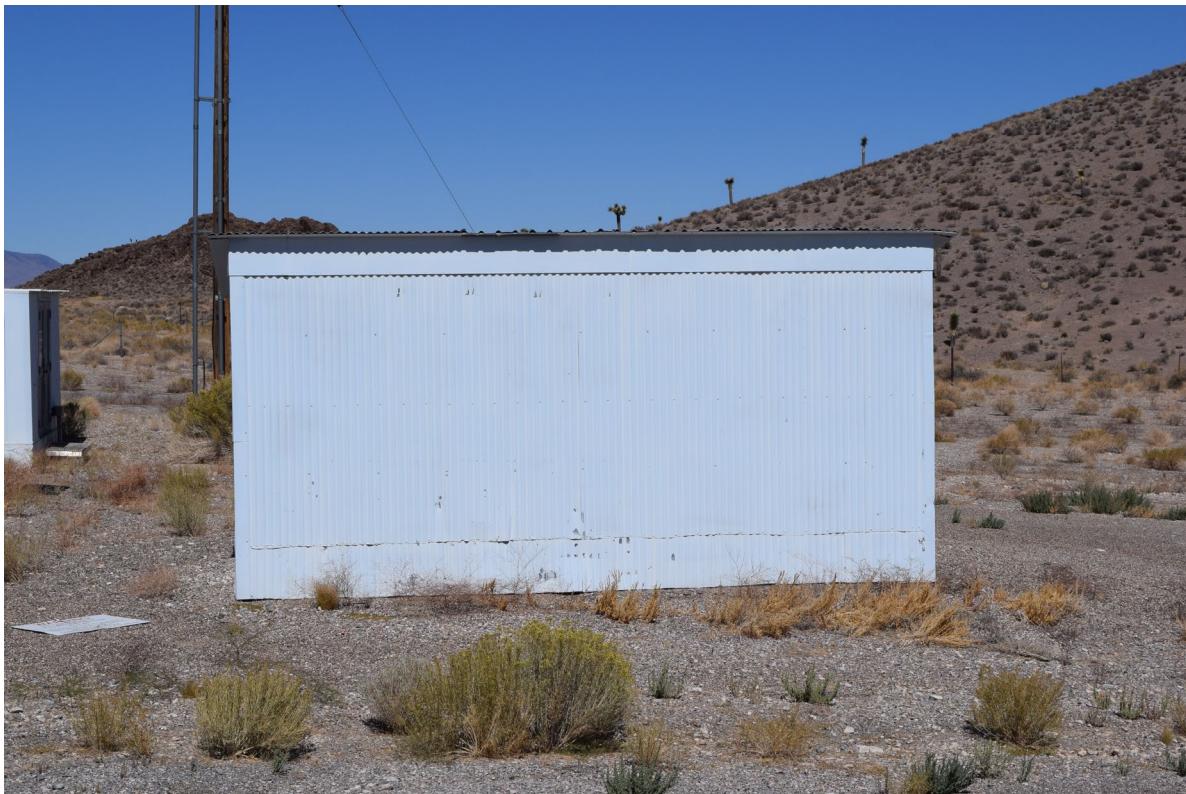
Elevation: South

Direction facing: North

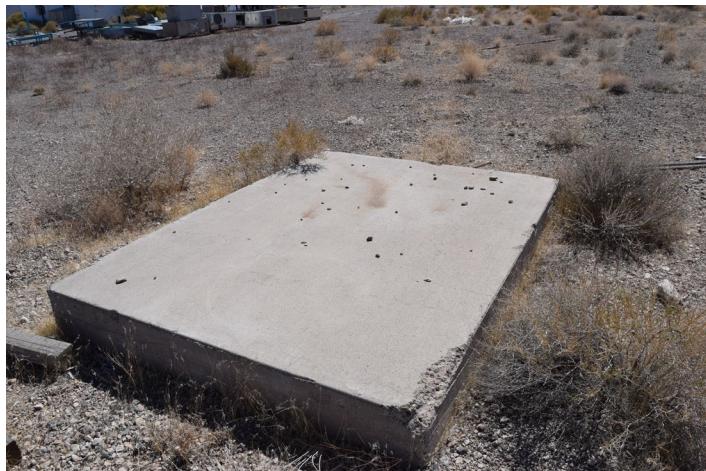
Condition of Resource(s)?
Good <input type="checkbox"/> Fair <input type="checkbox"/> Poor <input checked="" type="checkbox"/>
Explanation: The building has been removed and only the foundation remains.

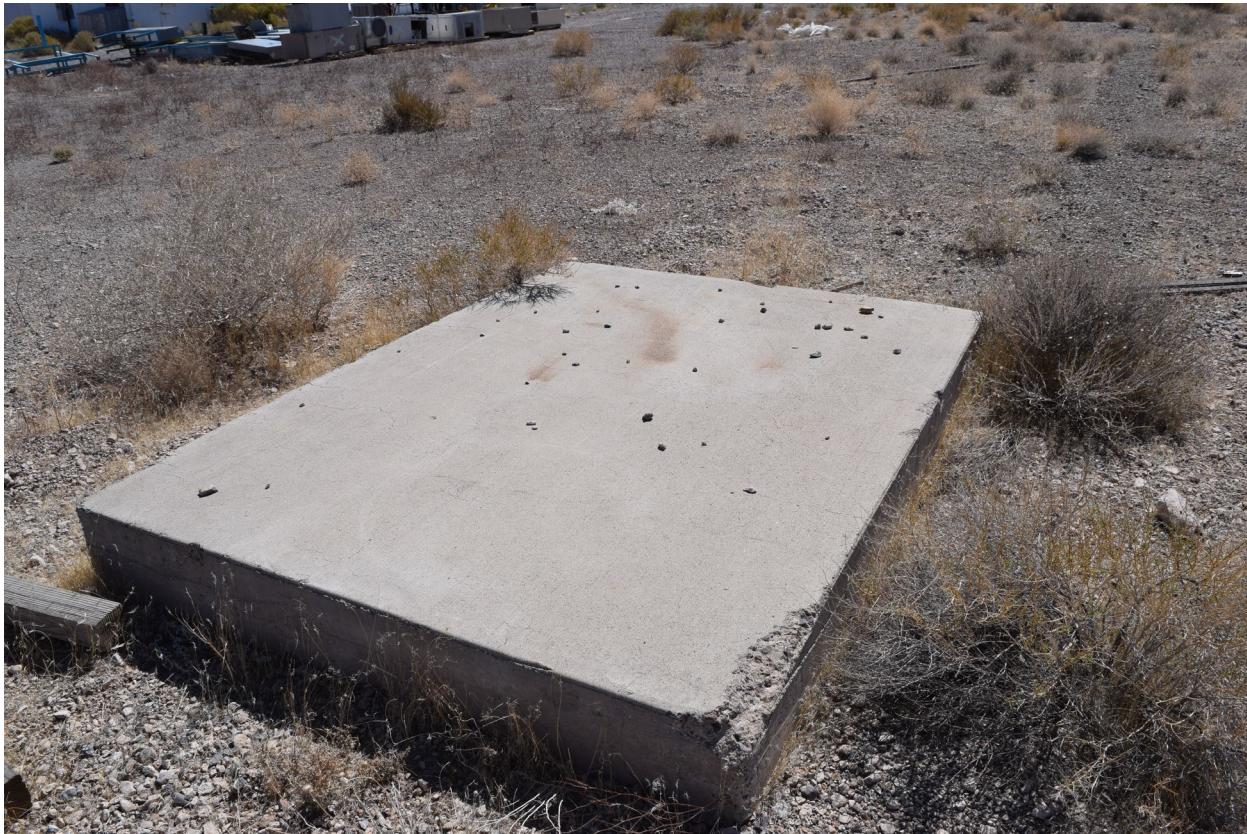
REECO Foundation No. 1, view is southeast (DRI DSC\_0022 2021).

This resource is a small, square, cement foundation associated with the REECo Maintenance Compound. An archival review has not revealed any information regarding its construction, function, and disposition over time. It was installed sometime after 1967 and before 1992.

The size of the foundation is 8 feet north-south x 6 feet east-west. It is raised about 8 inches above the surrounding surface and is estimated to be 1 foot thick. There are no artifacts that appear to be in direct association with this feature, although some wood and other small debris is present in the immediate vicinity.

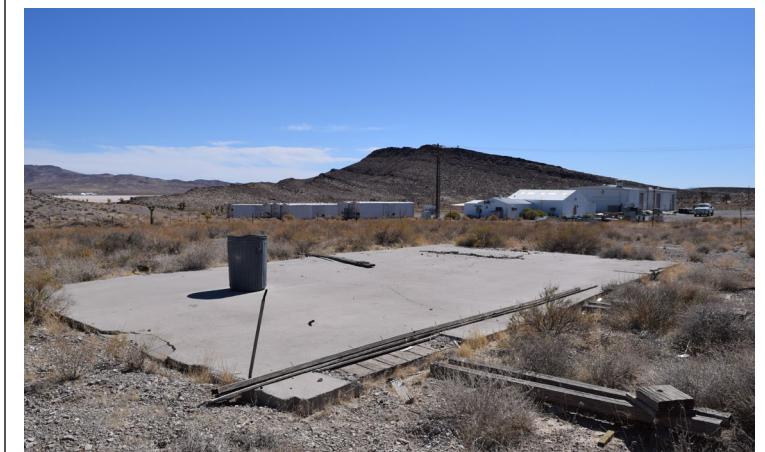
Building 06-612 / 06-614 foundation, view is southeast (DRI DSC\_0019 2021).

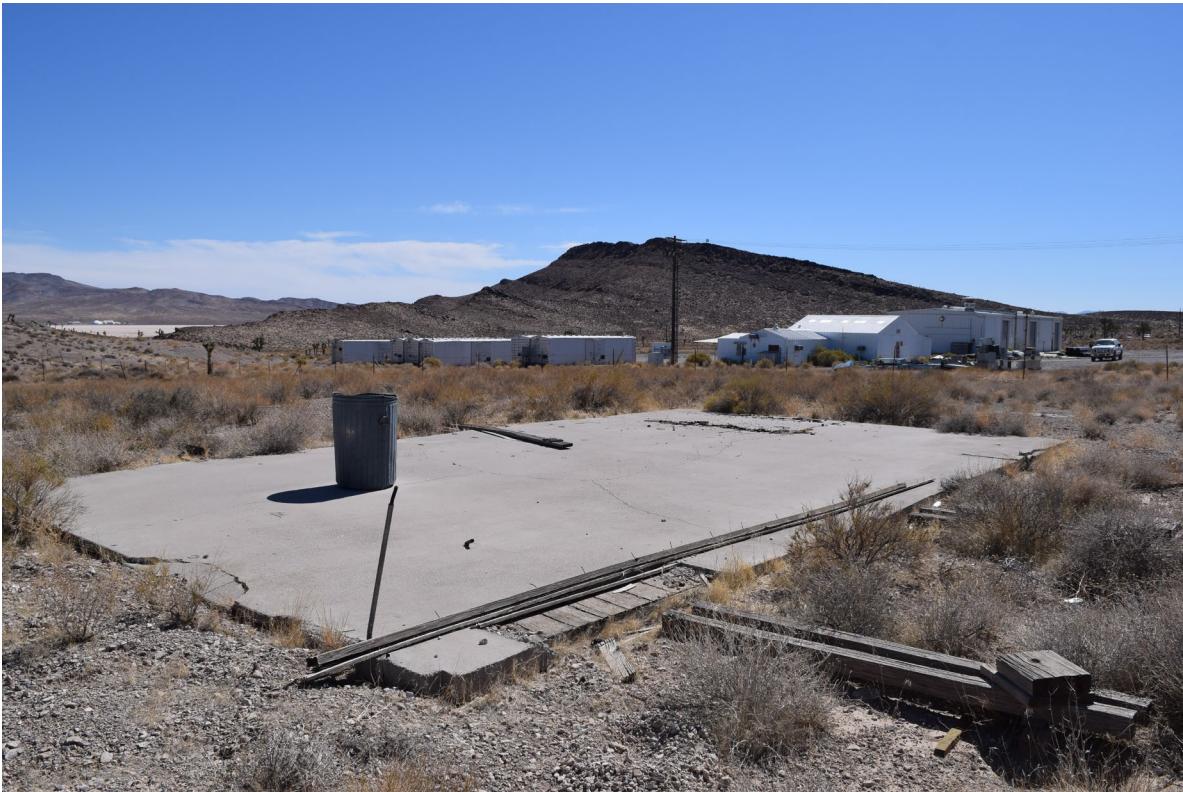
Condition of Resource(s)?
Good <input type="checkbox"/> Fair <input type="checkbox"/> Poor <input checked="" type="checkbox"/>
Explanation: The building has been removed and only the cement pad foundation remains.

This resource is a cement foundation used for Building 06-612/06-614, an electrical shop in the REECO Maintenance Compound. The size of the foundation is 35 feet north-south x 20 feet east-west. It is raised about 3 inches above the surrounding surface. The location of the building's door is at the north end of the west side of the foundation, as indicated by a wooden door sill. Square post emplacements are evident around the perimeter of the foundation. Milled lumber, nails, and various other small metal objects are present on and around the foundation.

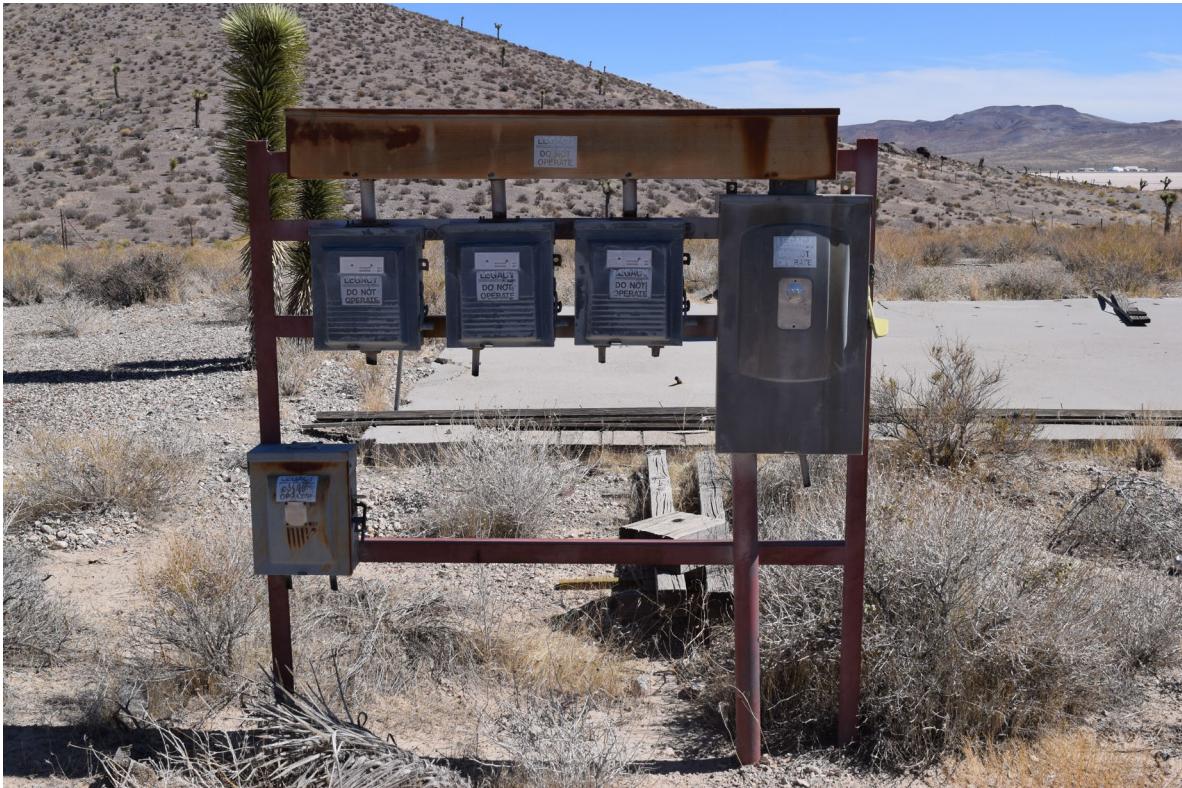
There is one accessory resources (AR1). This is an electrical breaker box panel located approximately 10 feet west of the foundation's northwest corner.

Accessory Resource Name	Electric breaker box panel		
Construction Date	ca. 1967	Contributing?	Yes <input checked="" type="checkbox"/> No <input type="checkbox"/>
UTM (NAD 83, UTM Zone 11 North)	Easting: 584,594 Northing: 4,088,662

AR1: Electrical breaker box panel with Building 06-161 foundation in background.

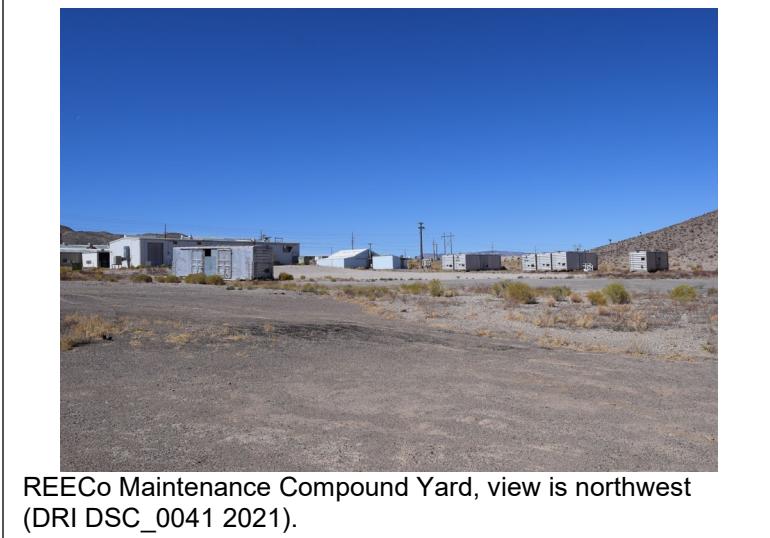
Condition of Resource(s)?
Good <input type="checkbox"/> Fair <input type="checkbox"/> Poor <input checked="" type="checkbox"/>
Explanation: The REECO Maintenance Compound yard has been significantly altered following the Period of Significance (post-1992).

REECO Maintenance Compound Yard, view is northwest (DRI DSC\_0041 2021).

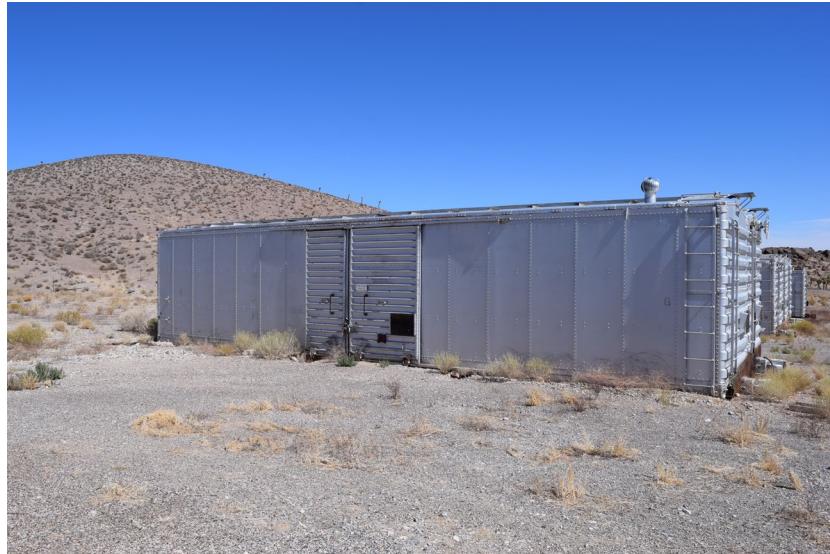
Accessory Resource Name	AR1: Railroad Box Cars Nos. 202002 and 202003, attached		
Construction Date	1955	Contributing?	Yes <input type="checkbox"/> No <input checked="" type="checkbox"/>
UTM (NAD 83, UTM Zone 11 North)	Easting: 584670		Northing: 4088580

Elevation: West

Direction facing: Northeast

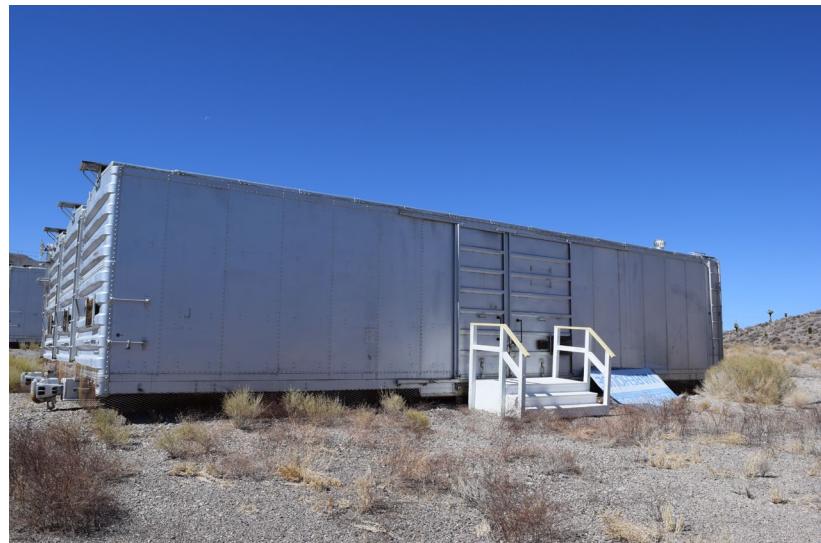
Accessory Resource Name	AR2: Railroad Box Cars Nos. 202004, 202005, and 202006, attached		
Construction Date	1955	Contributing?	Yes <input type="checkbox"/> No <input checked="" type="checkbox"/>
UTM (NAD 83, UTM Zone 11 North)	Easting: 584690		Northing: 4088580

Elevation: East

Direction facing: Northwest

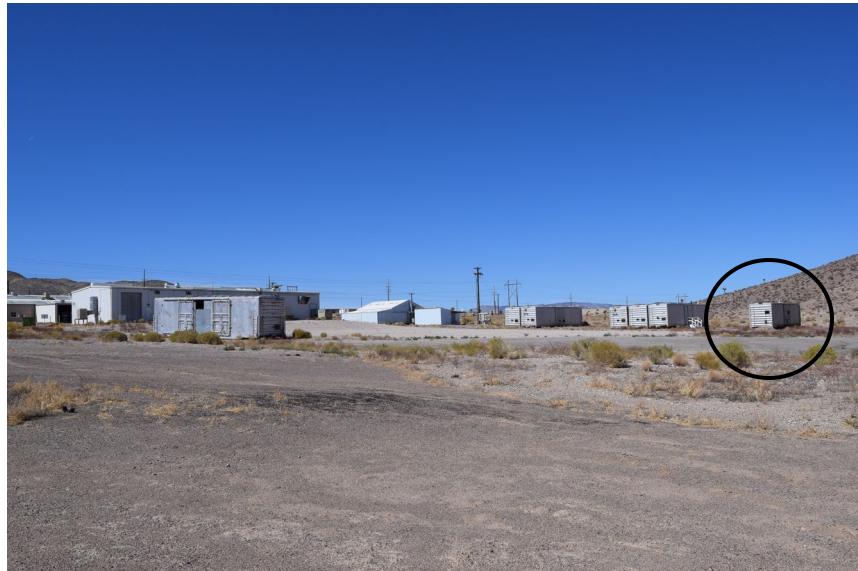
Accessory Resource Name	AR3: Railroad Box Car No. 202631		
Construction Date	1955	Contributing?	Yes <input type="checkbox"/> No <input checked="" type="checkbox"/>
UTM (NAD 83, UTM Zone 11 North)	Easting: 584708		Northing: 4088580

Elevation: South &amp; East

Direction facing: Northwest

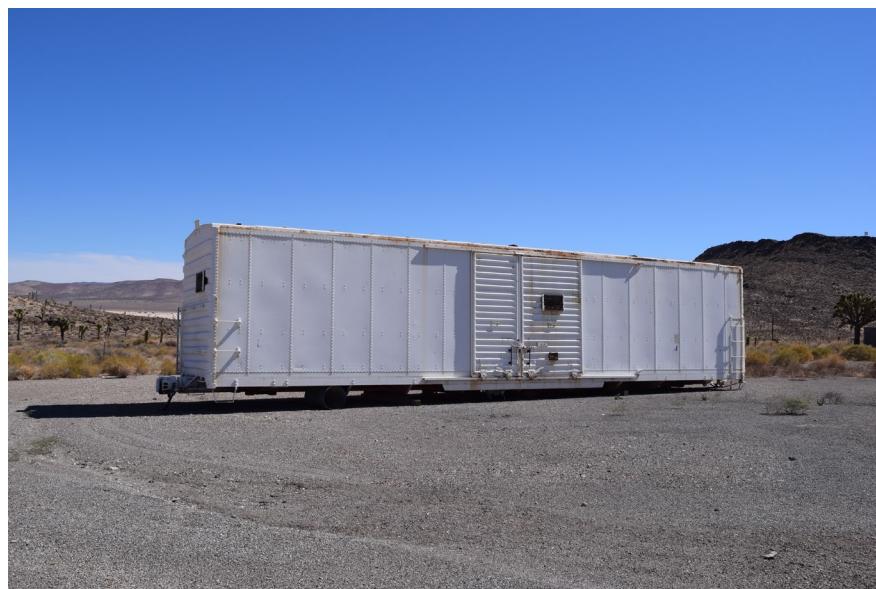
Accessory Resource Name	AR4: Railroad Box Car No. 202378		
Construction Date	1955	Contributing?	Yes <input type="checkbox"/> No <input checked="" type="checkbox"/>
UTM (NAD 83, UTM Zone 11 North)	Easting: 584745		Northing: 4088530

Elevation: West

Direction facing: Southeast

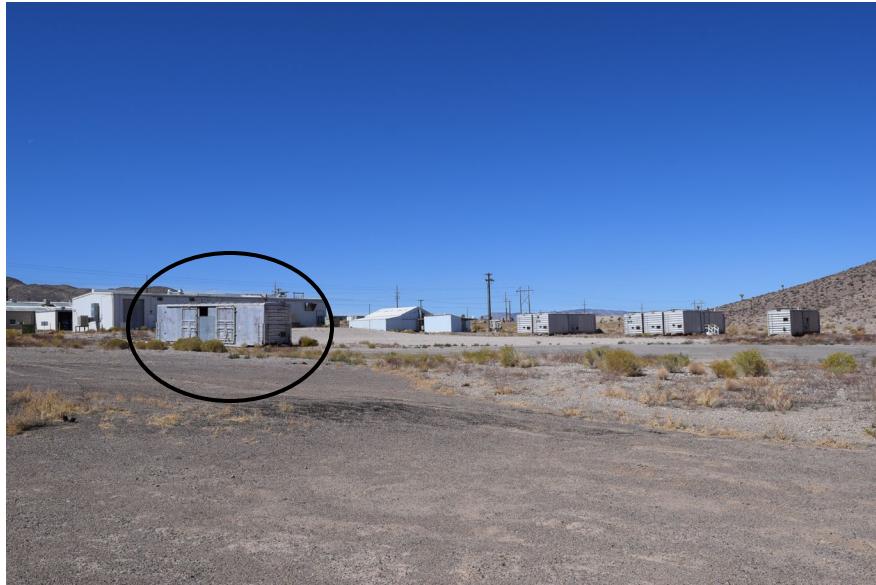
Accessory Resource Name	AR5: Railroad Box Car No. 2-2730		
Construction Date	1955	Contributing?	Yes <input type="checkbox"/> No <input checked="" type="checkbox"/>
UTM (NAD 83, UTM Zone 11 North)	Easting: 584678		Northing: 4088508

Elevation: South and East

Direction facing: Northwest

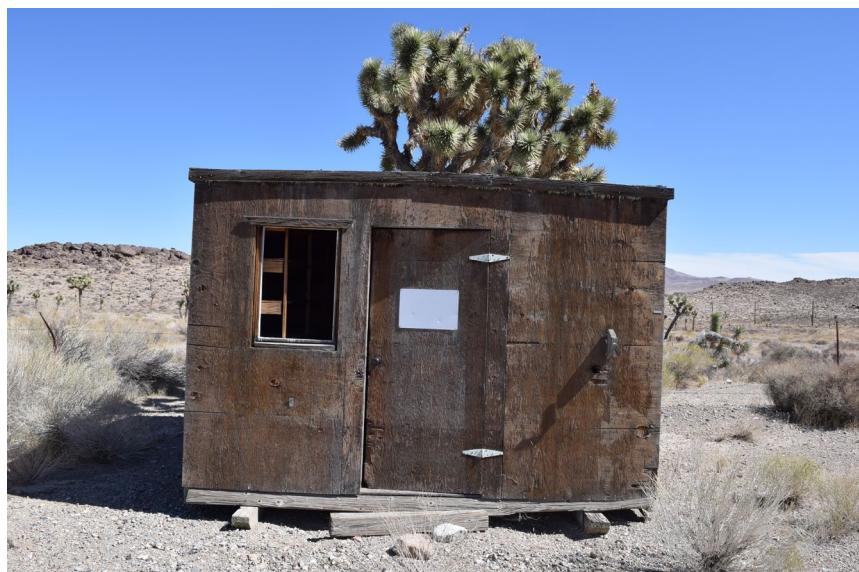
Accessory Resource Name	AR6: Brockhouse – portable wooden structure on skids		
Construction Date	Unknown	Contributing?	Yes <input type="checkbox"/> No <input checked="" type="checkbox"/>
UTM (NAD 83, UTM Zone 11 North)	Easting: 584,766		Northing: 4,088,470

Elevation: West

Direction facing East

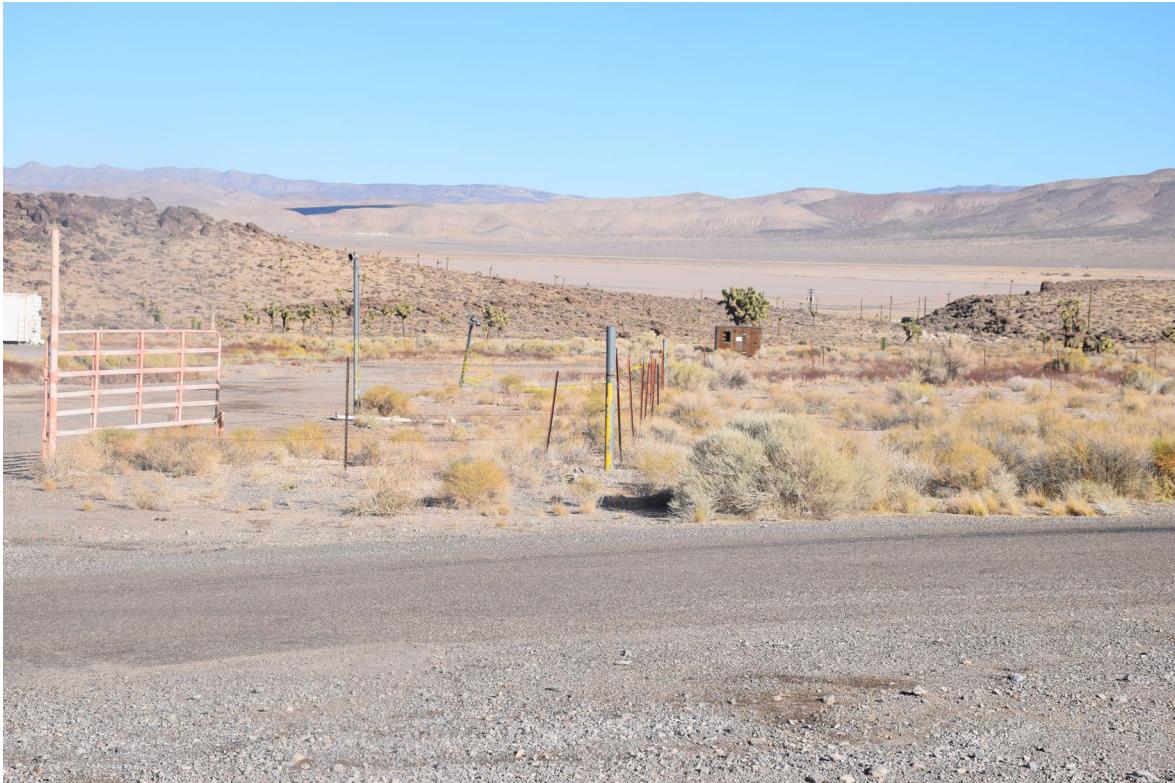
Accessory Resource Name	AR7: perimeter fence			
Construction Date	ca. 1967	Contributing?	Yes	<input checked="" type="checkbox"/>
UTM (NAD 83, UTM Zone 11 North)	Easting: 584,640		Northing: 4,088,429

Elevation: N/A

Direction facing: East

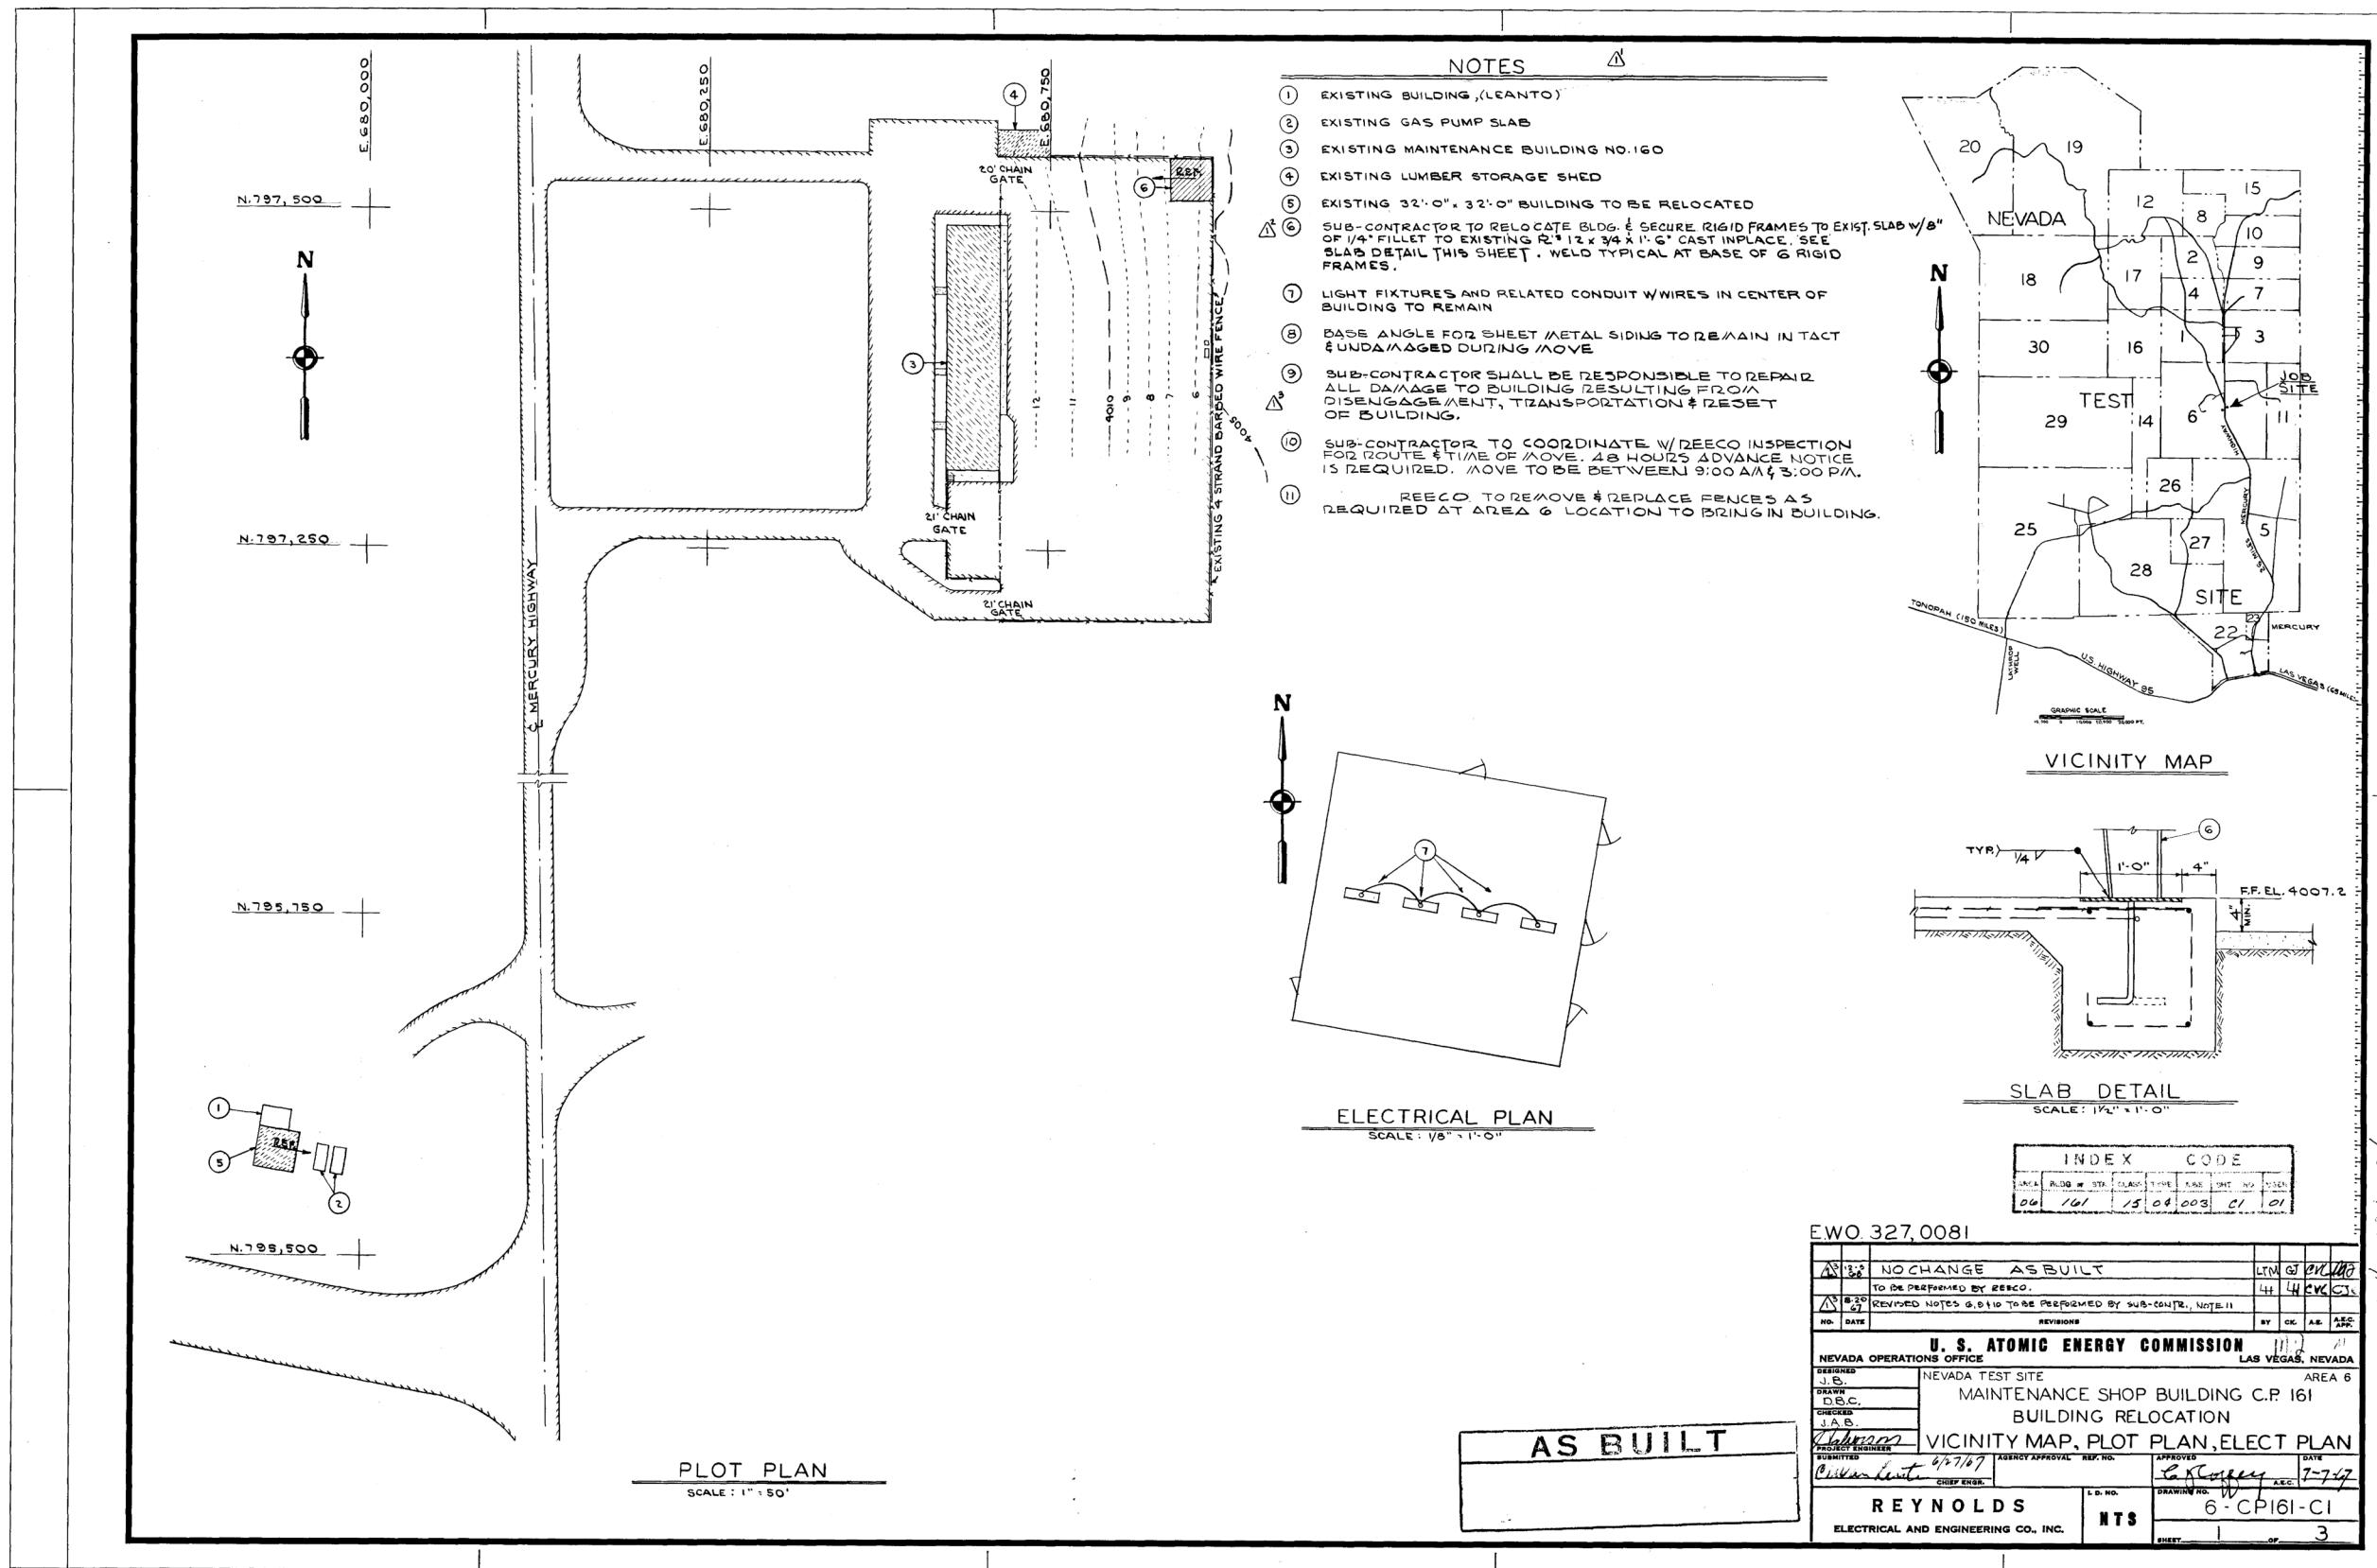
Engineering drawing depicting layout of REECO Maintenance Compound in 1967. Source: Reynolds Electrical and Engineering Company, Inc., 1967.

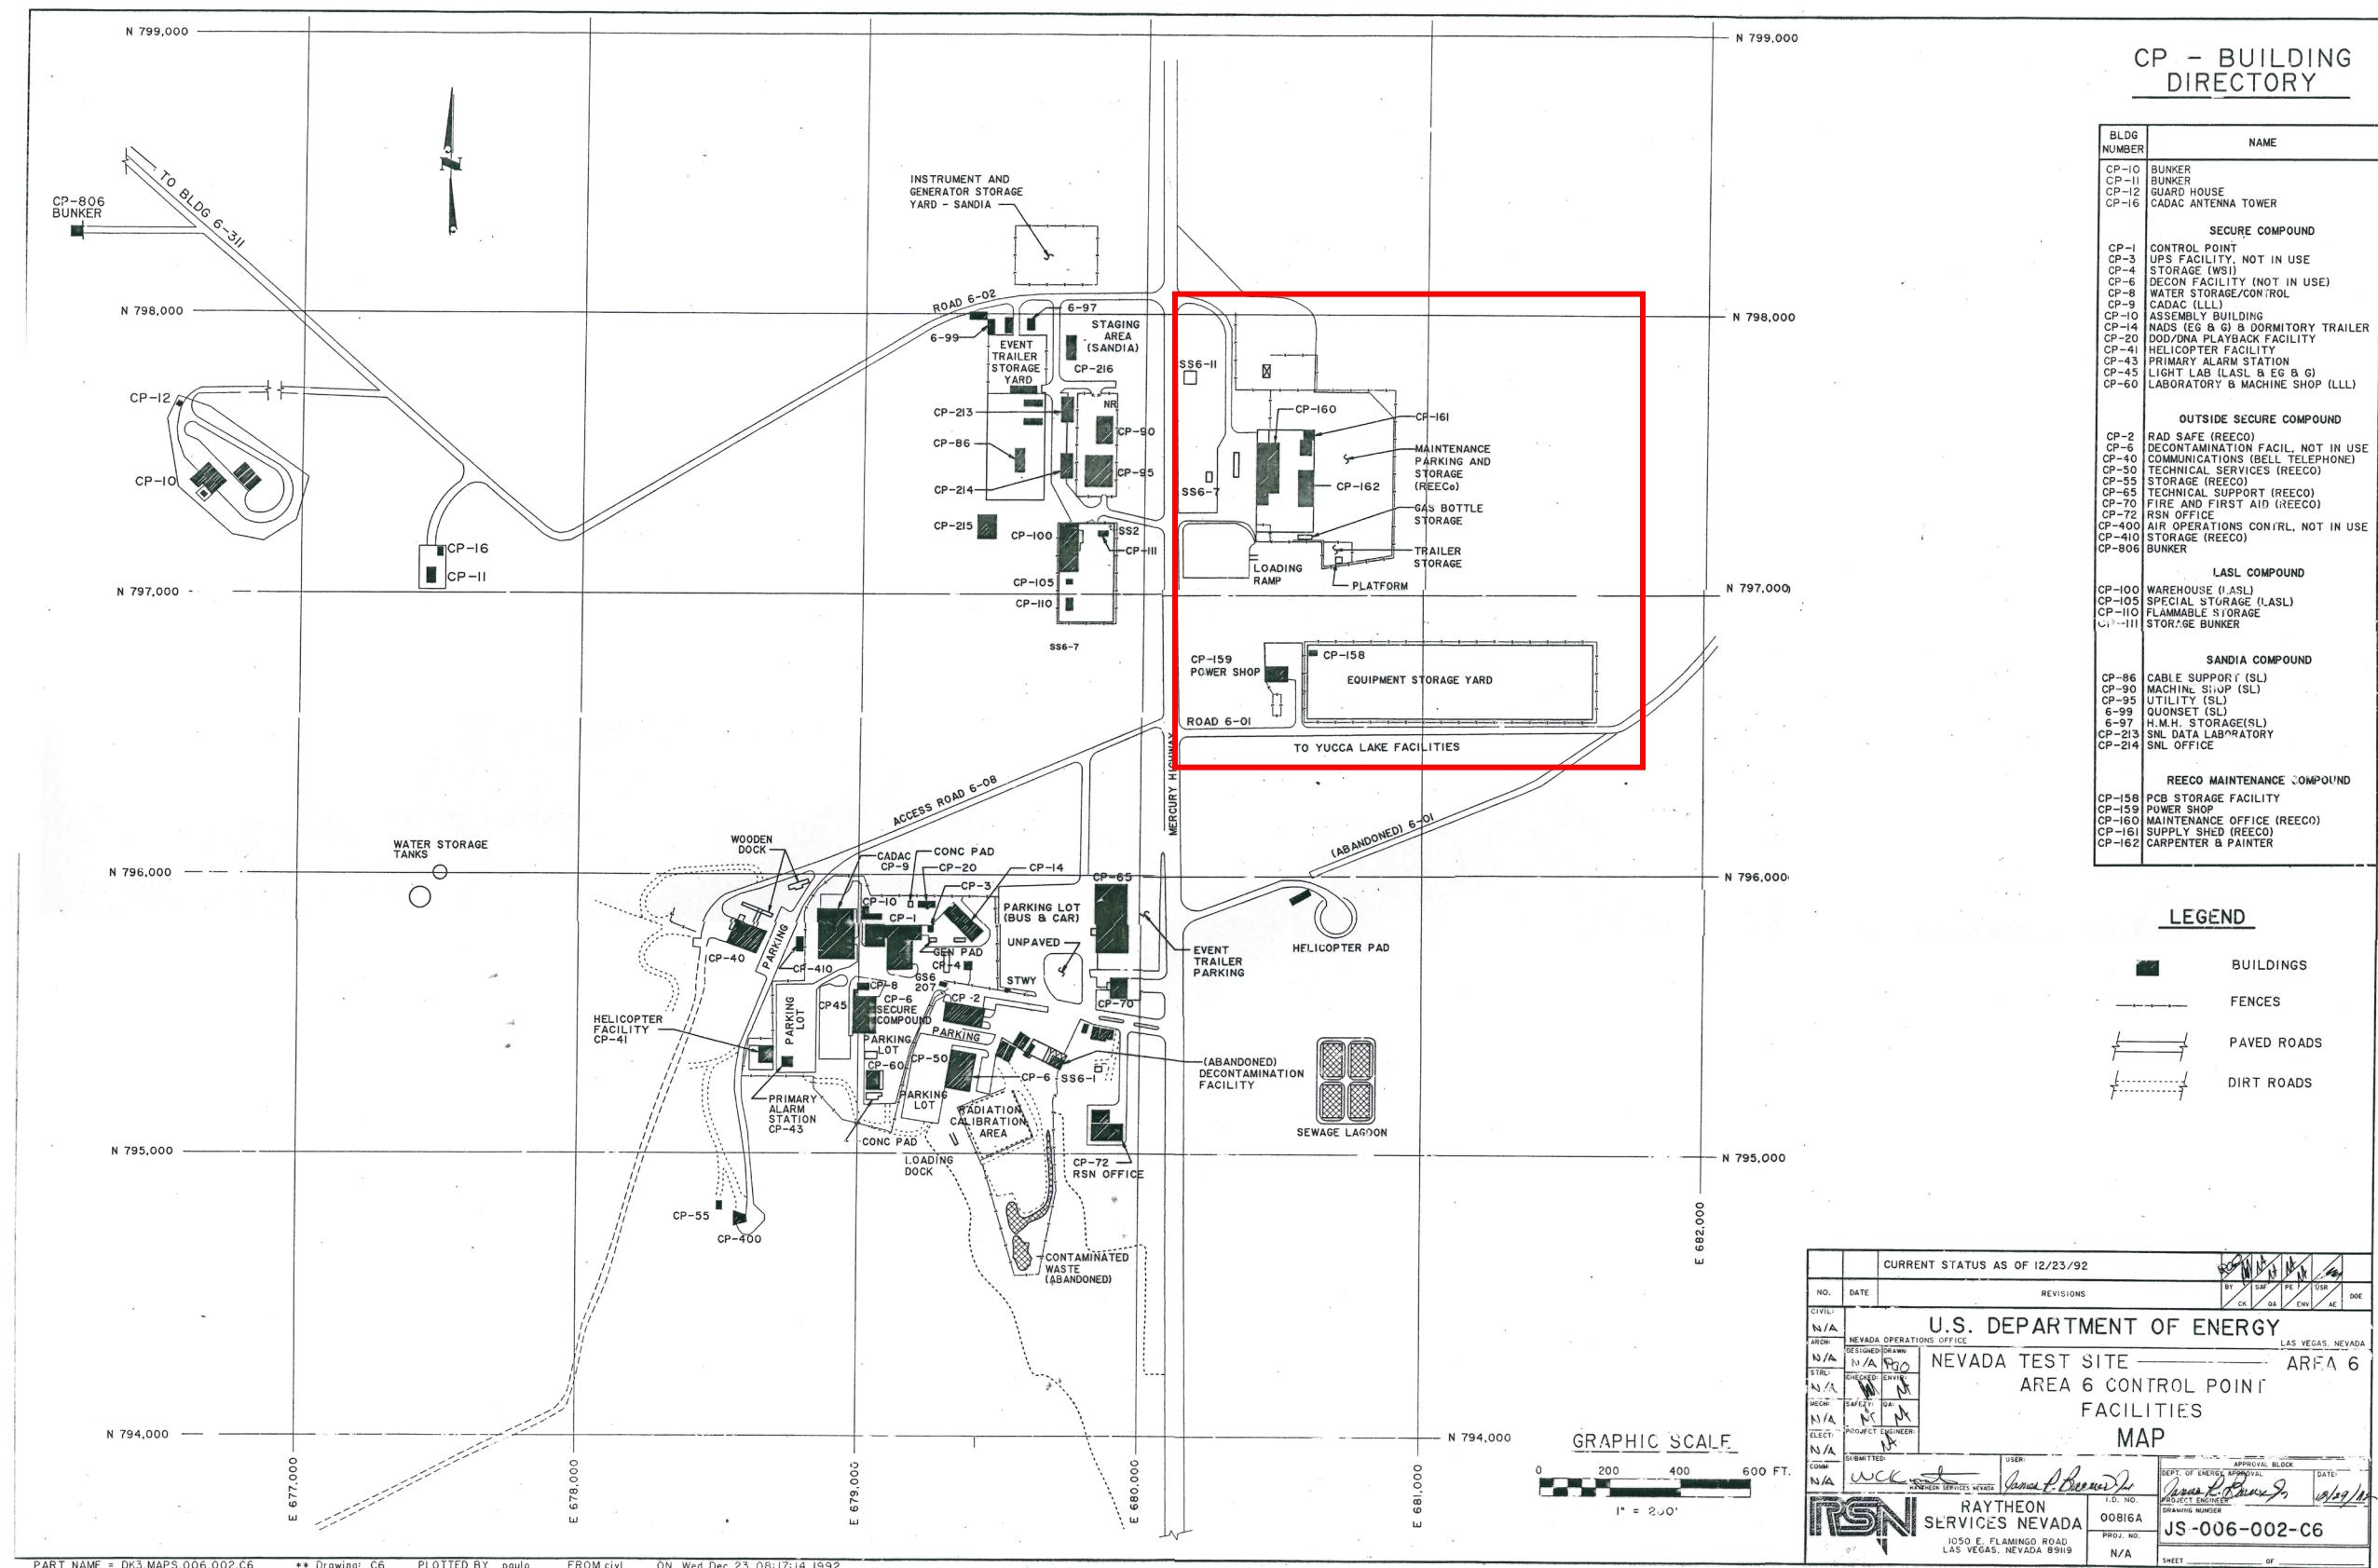
Engineering drawing of Area 6 Control Point vicinity at the end of historic nuclear testing activities with the REECO Maintenance Compound in upper middle portion of drawing. Source: Raytheon Services Nevada, 1992.  
Nevada SHPO – ARA Form Page 17
