# Comparing Neutron and Ion Irradiation by Atom Probe Tomography and In-situ Electron Microscopy

K. Hattar, E. Lang  
Sandia National Laboratories

# TPBAR Design and Reactor Environment

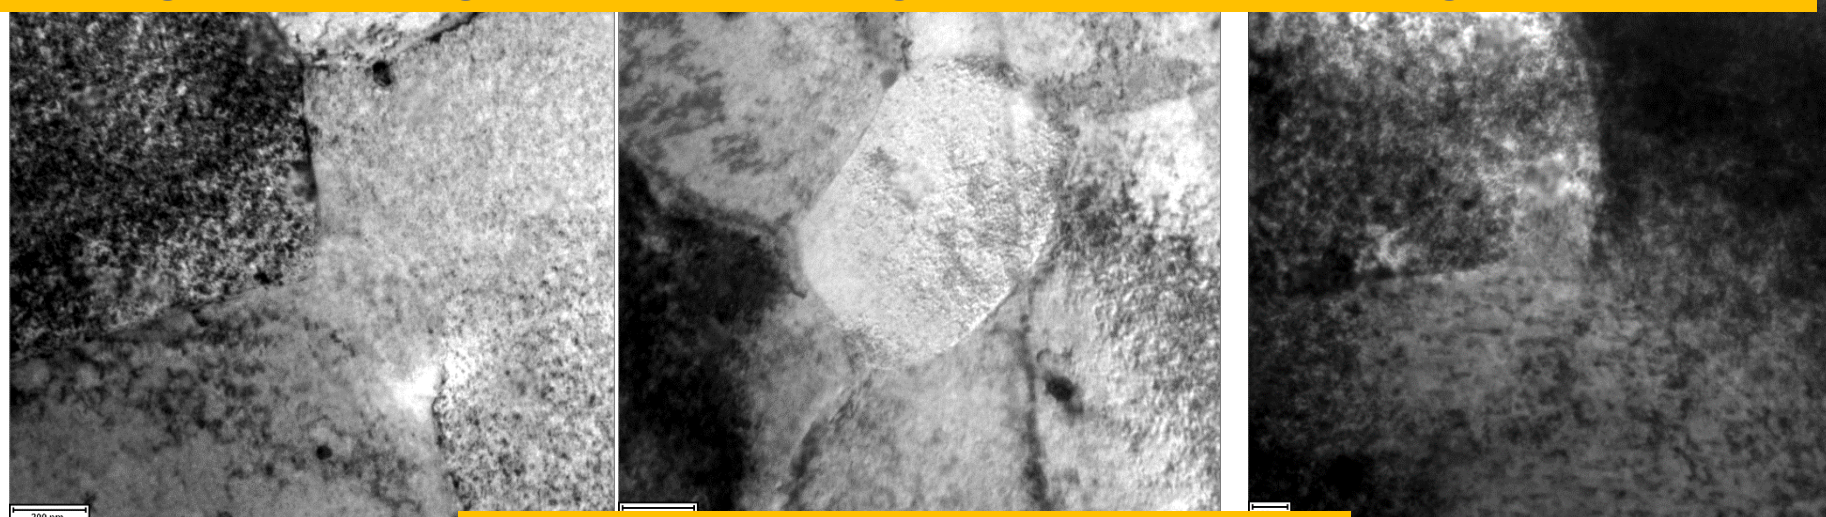
Zr Alloys

Single Ion Damage →

Damage + He →

Damage + He +  $^2\text{H}$

Direct real time observation of heavy ion irradiation, and low energy D and He ion implantation with nanometer resolution

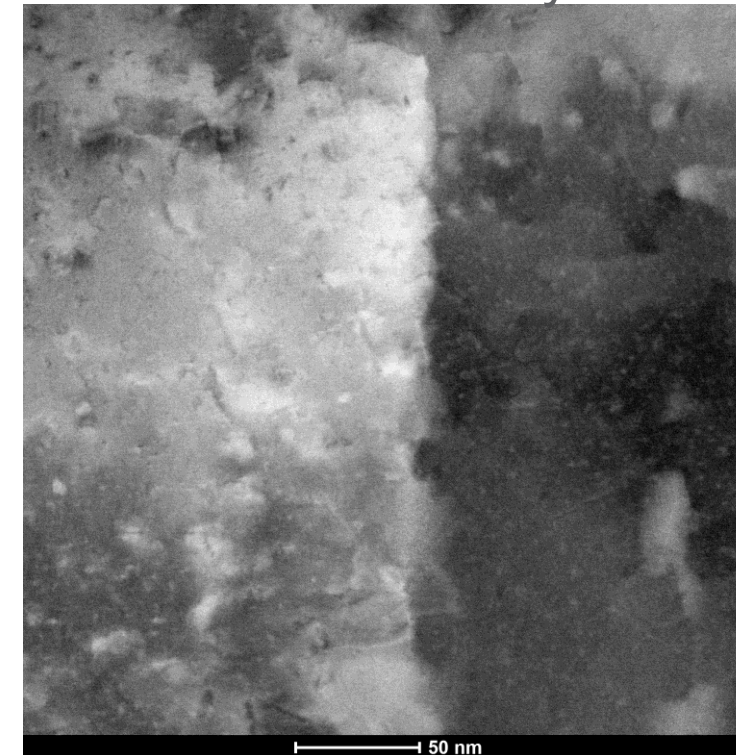
Grain Boundary

- Dislocation loops form during irradiation
- No clear accumulation of defects at grain boundaries
- No void/bubble growth
