# Development of rugged hydrogen sensors for measuring charge-exchange neutral flux at the wall and divertor

Ryan Hood<sup>1</sup>

<sup>1</sup>*Sandia National Laboratories, Livermore, CA*

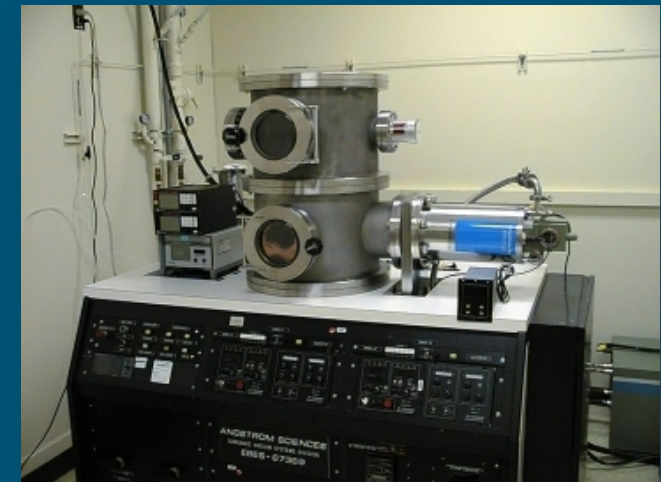
Dual e-beam evaporator located at Sandia Nation Laboratories

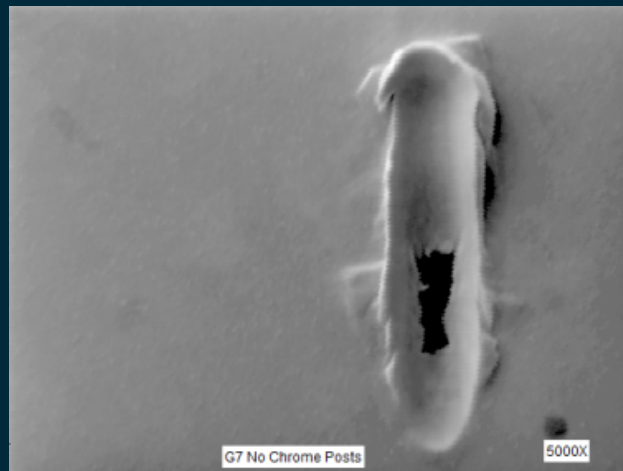
1  $\mu\text{m}$  radius diamond probe dragged across surface of sensor while maintaining normal force

- Pd layer appears to fail above 2 mN force without Cr
- Deeper scratches without Cr

SEM images from J. Whaley

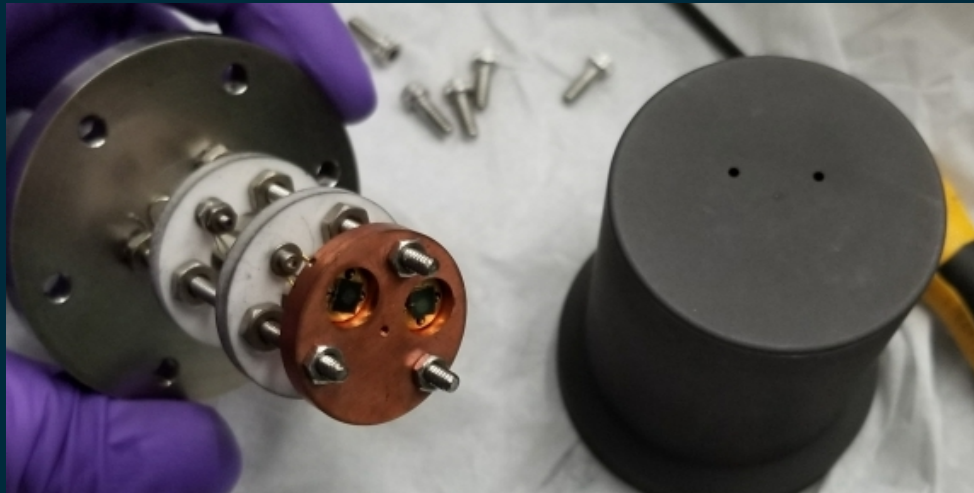
Sensors were mounted in Divertor Material Evaluation System (DiMES) and tested over several days

- Test of sensors and data collection system in the tokamak environment
- Same gold thickness on each sensor (7 nm Au)
