# Failing to Fail: Lessons Learned from Attempting to Fatigue a Bolt Using Structural Dynamics

Ben Pacini, Moheimin Khan, Patrick Hunter

IMAC XL

February 7-10, 2022

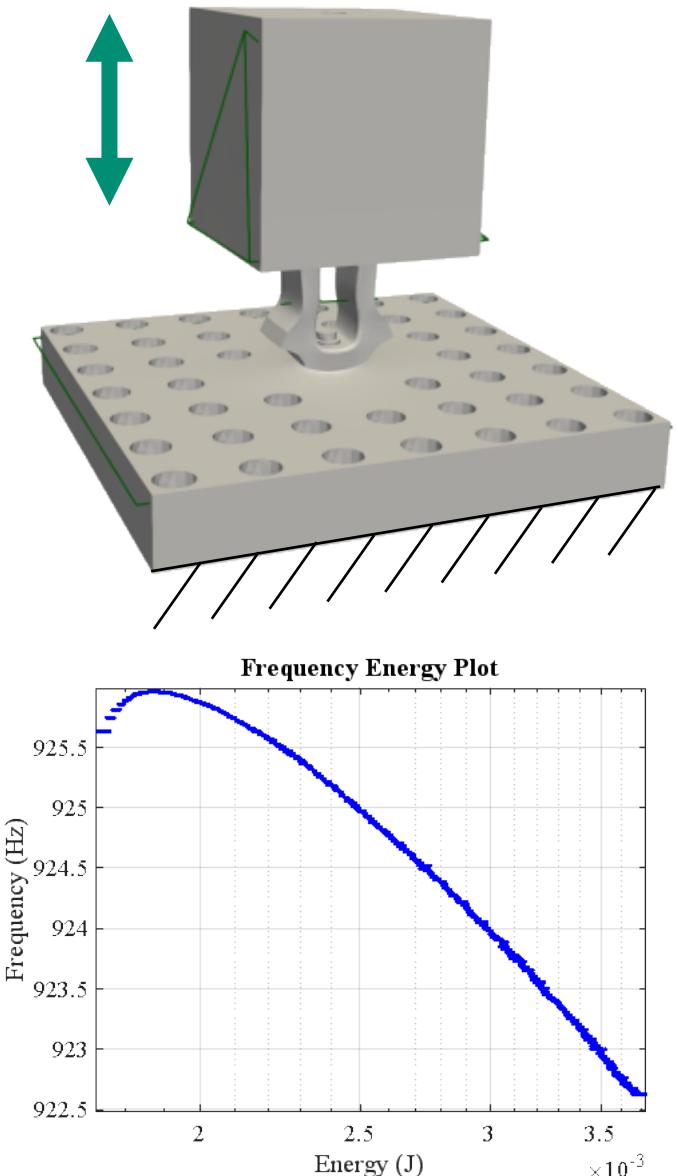
- The motivation for this work is to design and conduct an in-situ fatigue test to study the fatigue failure of a bolt within a joint during a dynamic environment
- As a first attempt, the approach was to excite and dwell at the axial mode of the structure with a modal shaker until the bolt failed
  - The response of the Kettlebell would load the bolt axially
  - Literature review indicated this would be the easier failure mode
- In order to apply the appropriate stress to the bolt, the structure had to be excited to a high level
  - The joint is a source of nonlinearity within the structure, so the resonant frequency shifted as the amplitude of excitation increased
  - Therefore, a closed loop controller was used to maintain resonance as the structure was brought up to the proper testing amplitude. **This test method is called nonlinear**

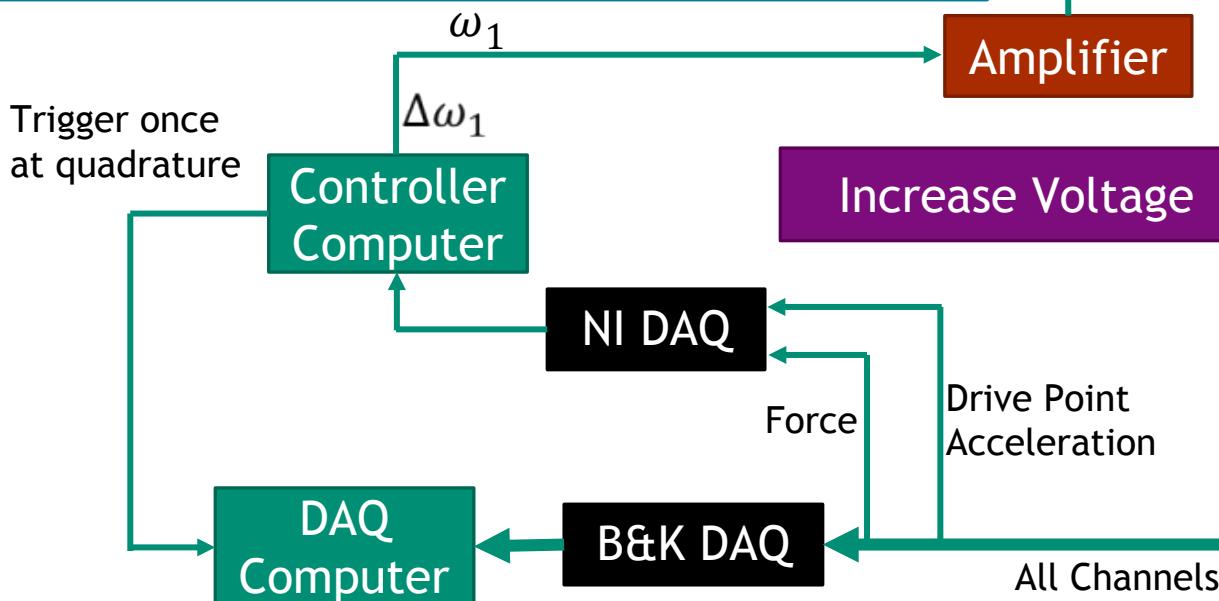
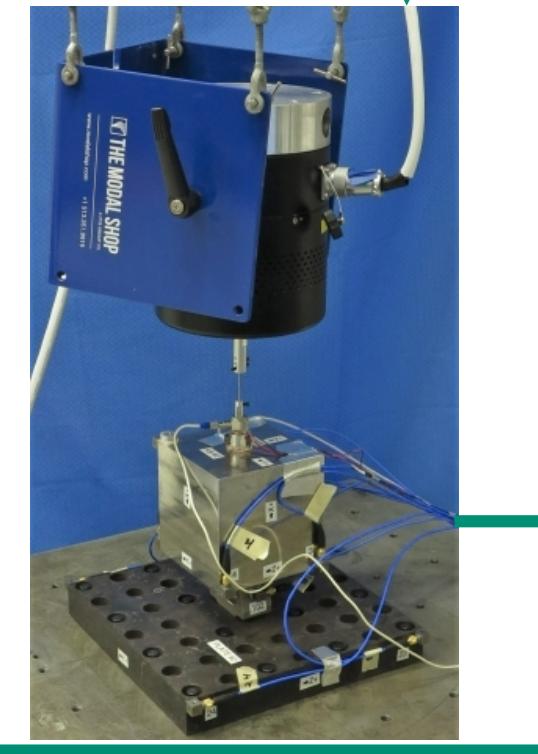
# Test Method—Nonlinear Force Appropriation

- Nonlinear force appropriation is a method used in nonlinear structural dynamics testing where the excitation is maintained at  $90^\circ$  out of phase (i.e. in phase quadrature) with the acceleration response
- Under this phase condition, the excitation is assumed to balance the energy dissipated by the system, and thus the response is that of the underlying ~~conservative system~~, i.e. a Nonlinear

This cycle repeats until the desired excitation level is achieved, after which the controller will maintain the structure at resonance until bolt failure

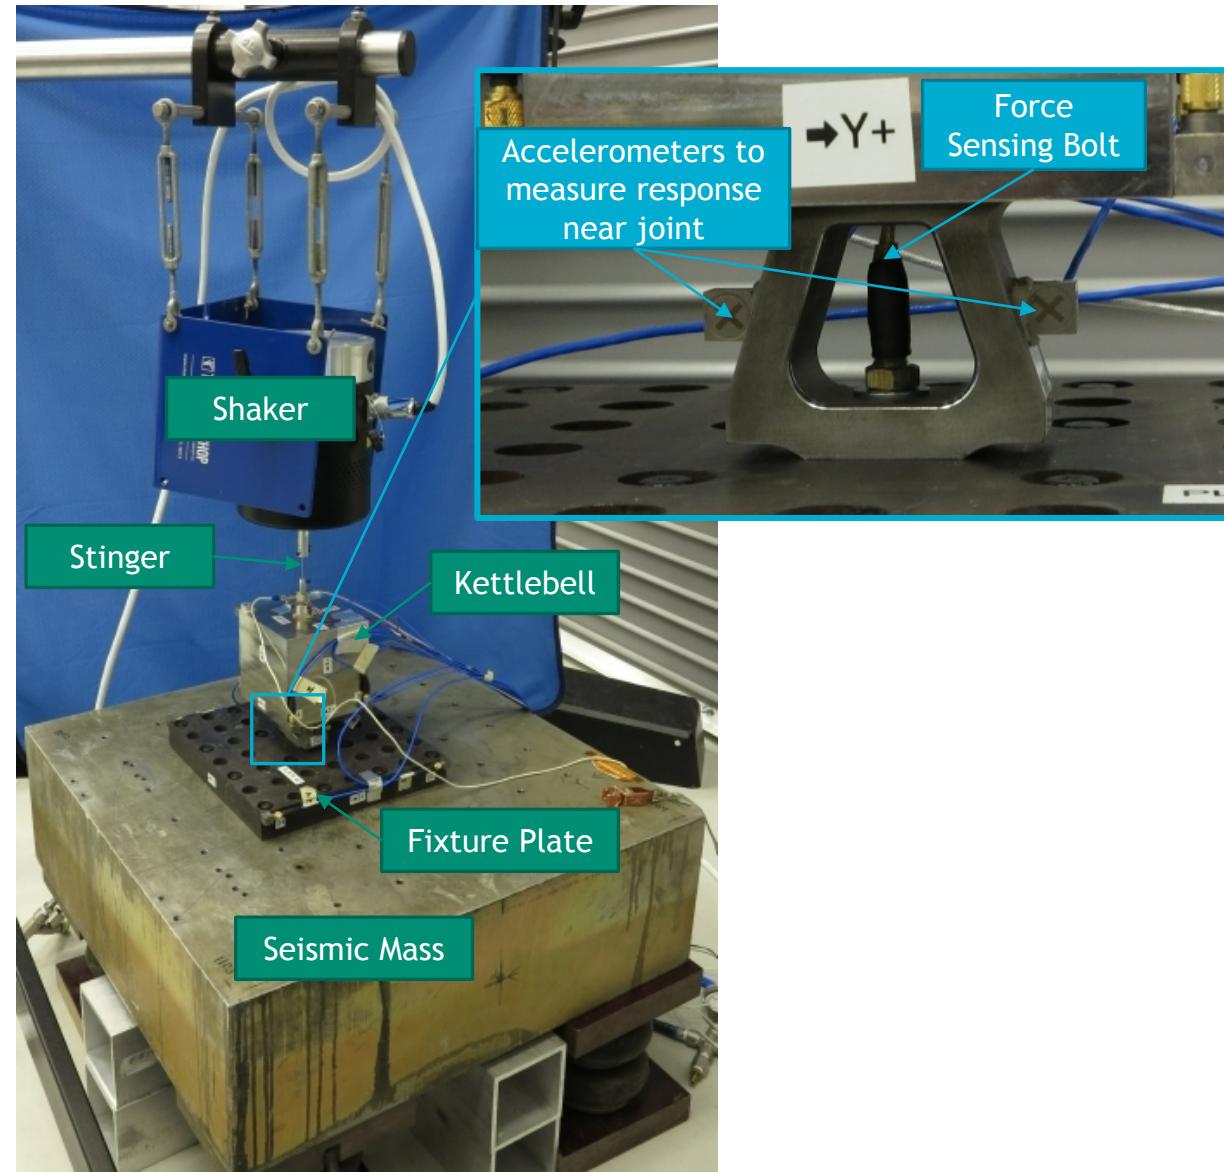
# Test Set Up

- The Kettlebell was attached to Fixture Plate using a force sensing bolt. This allowed for monitoring the force in the bolt during assembly and testing.
- This assembly was bolted to a seismic mass to approximate a fixed-base condition
- A modal shaker was used for excitation
- Excitation force and responses were measured with a load cell and accelerometers, respectively
- According to initial linear analysis results and basic fatigue calculations, **170 lbf are required in the bolt to fail it in fatigue.**
- To accomplish this, the test must satisfy the following
  - Excite only the axial mode
  - 5X amplification from excitation force to bolt force
  - 34 lbf excitation force to top of Kettlebell

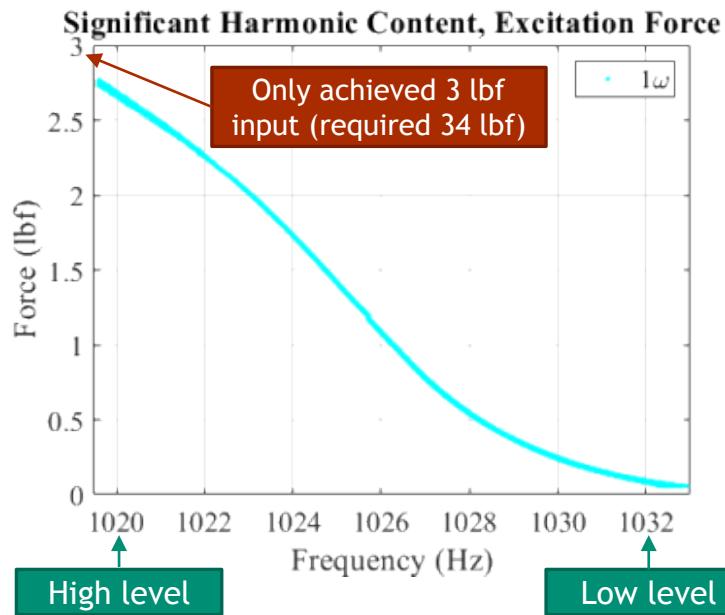
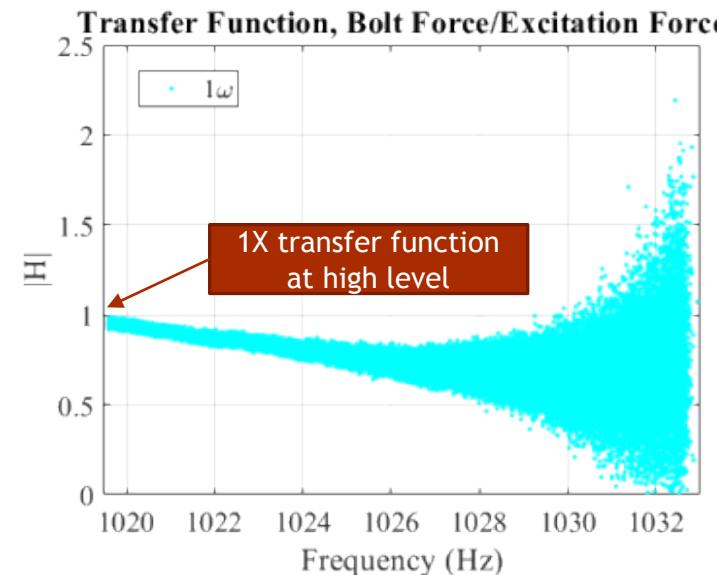
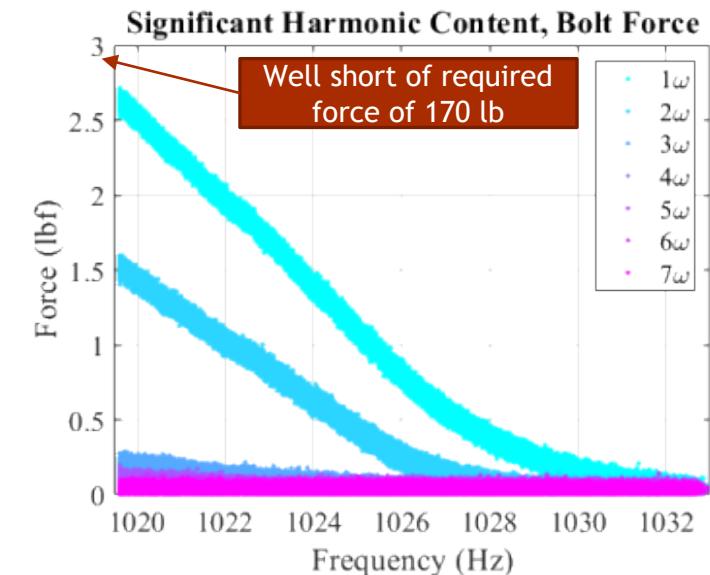
# Attempt #1—Fully Torqued Bolt

- NFA was conducted on the structure where the bolt had a preload of 2,100 lbf.
- During testing, the electrical limit of the shaker amplifier was reached, but insufficient load was applied to the bolt in order to fail it in fatigue

Too much of the joint force was carried by the Kettlebell and Fixture material at the interface. Therefore, the torque was greatly reduced so that the bolt would take more of the load.

- **Attempt #1:** NFA test with fully torqued bolt
  - **Outcome:** Did not fail bolt
  - **Reason:** Reached the amplifier output limitations before desired fatigue test conditions met

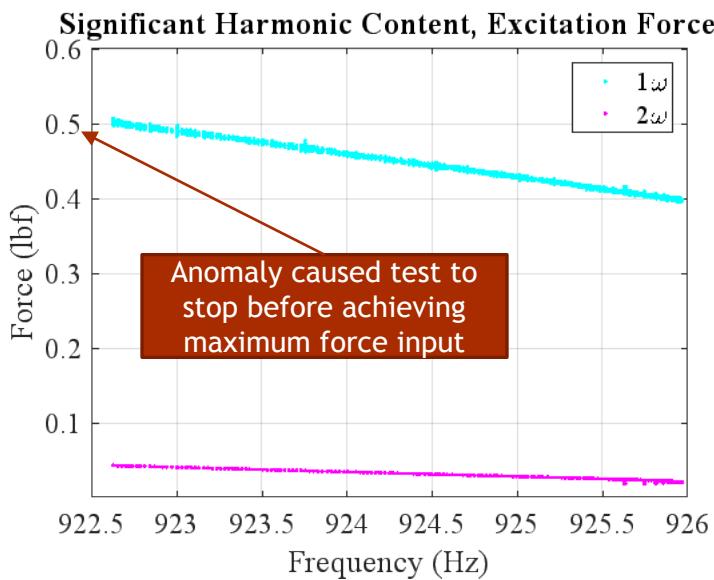
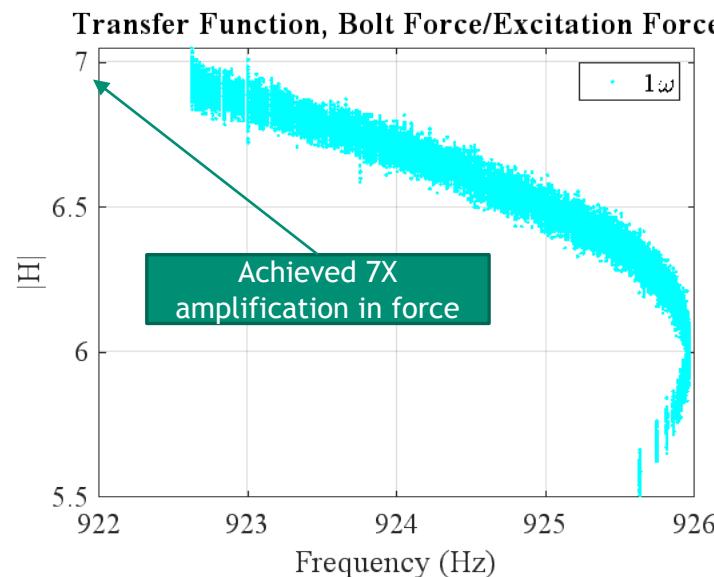
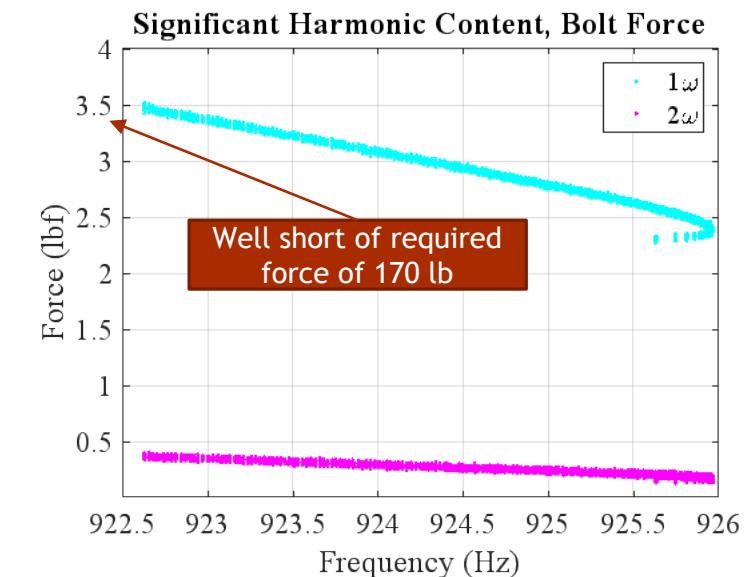
# Attempt #2—Reduced Torque

- The Kettlebell bolt force at assembly was reduced from 2,100 lbf to about 250 lbf
  - This reduced force should quicken the onset of the preload loss of the joint, resulting in larger bolt forces

These results were promising, but an anomaly stopped the test before the desired fatigue conditions could be met.  
WHAT HAPPENED?!

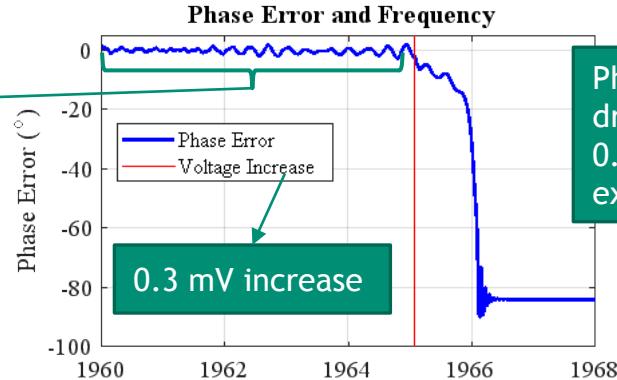
Controller operating as desired,  $<3^\circ$  phase error

- During the NFA, a threshold was reached where
  - There was a noticeable change in the dynamics
  - The controller could no longer maintain the structure at resonance
- Many additional NFAs were conducted and a similar event happened every time

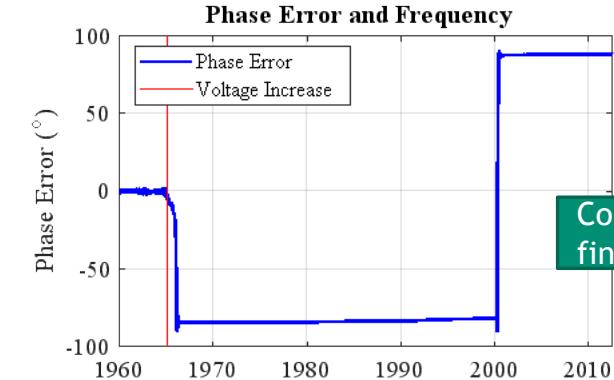
Phase error increases dramatically after 0.3 mV increase in excitation voltage

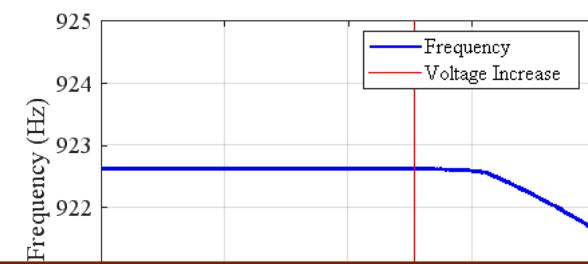
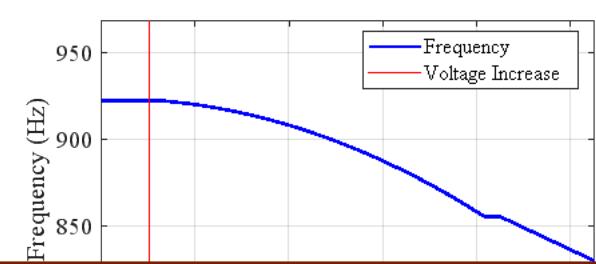
Zoom Out

Structure appears to go unstable at a certain energy level

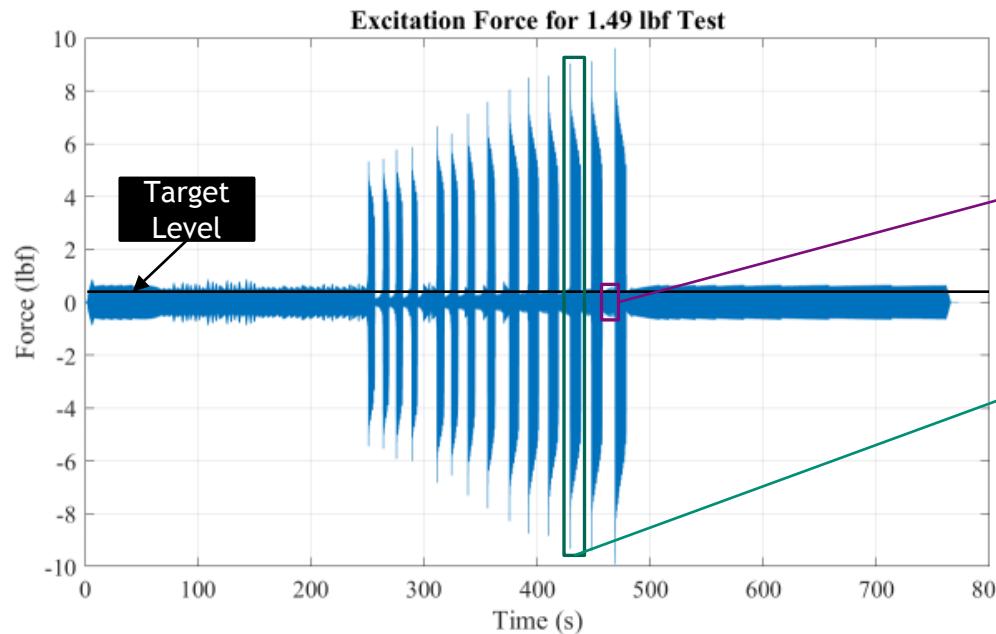
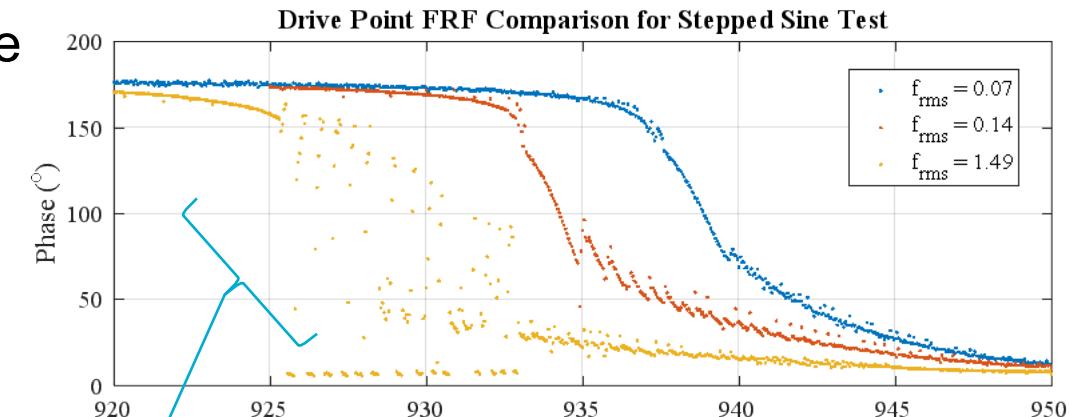
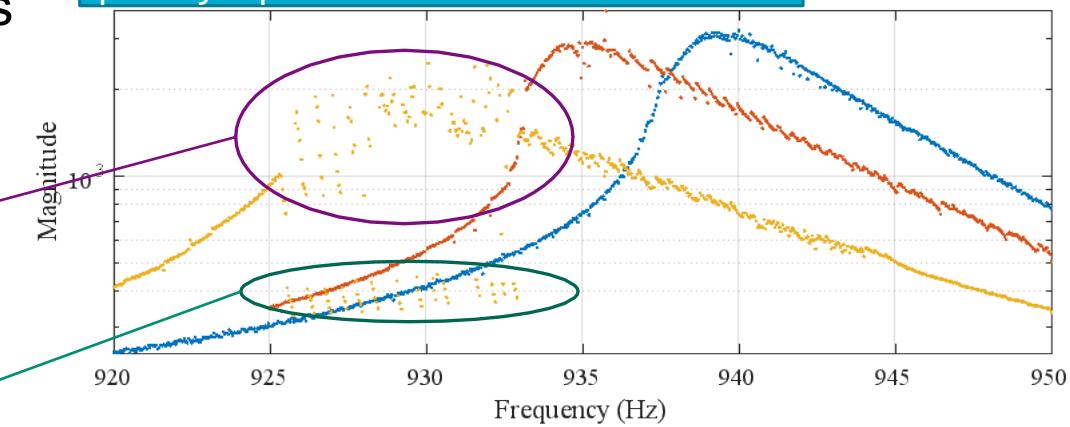
# Attempt #2—Reduced Torque, Stepped Sine Results

- To help diagnose the NFA test results, stepped sine tests were conducted at different force levels
  - Force control used to maintain a specified level throughout each test
  - Generally performed well except in the instances where the system was unstable
- At high forcing, there appeared to be stability issues as the system vacillated between two different states

During jumps between stable solutions, the phase jumps over values near  $90^\circ$

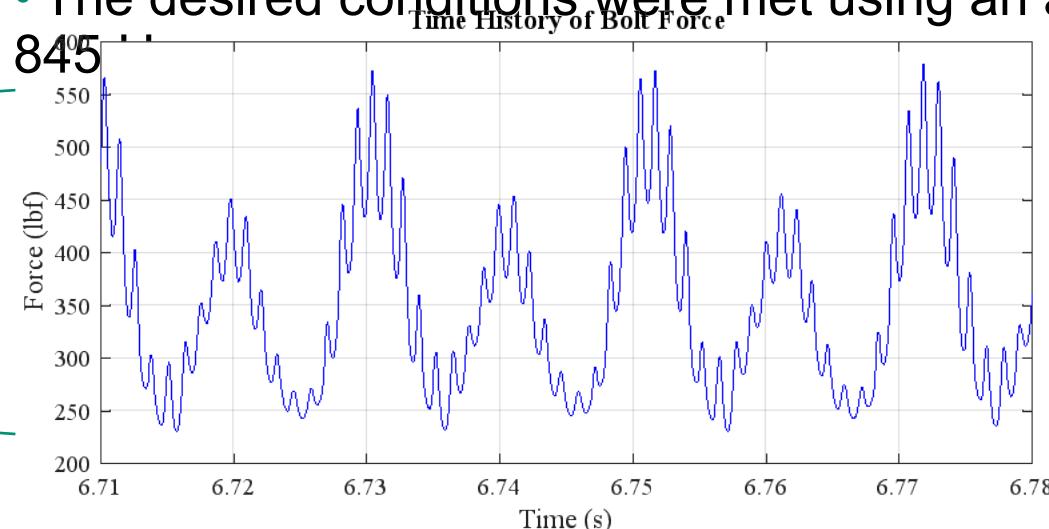
- The Attempt #2 results demonstrated that with the current controller that **NFA was not a viable option** to conduct the fatigue test and **was thus abandoned**
- There was a hope that the instability was only present for a limited voltage range
- A series of sinusoidal ad hoc testing was conducted at different voltage levels with frequencies near 900 Hz to determine if the desired bolt force could be achieved within the physical limitations of the shaker
- The desired conditions were met using an amplifier supply voltage of 0.7V and a frequency of

Bolt force is 300 lbf, nearly double the 170 lbf required according to initial predictions

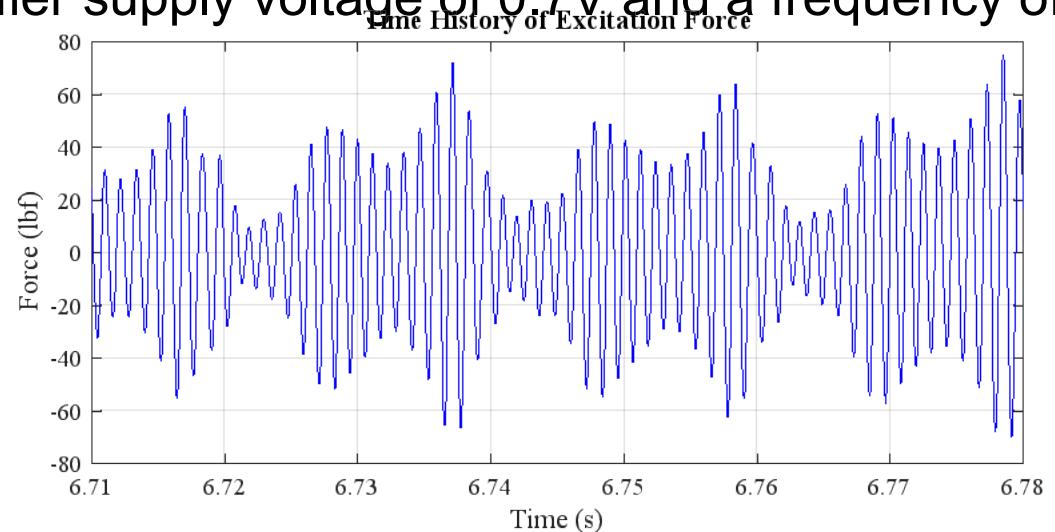
Shaker force remains below 100 lbf

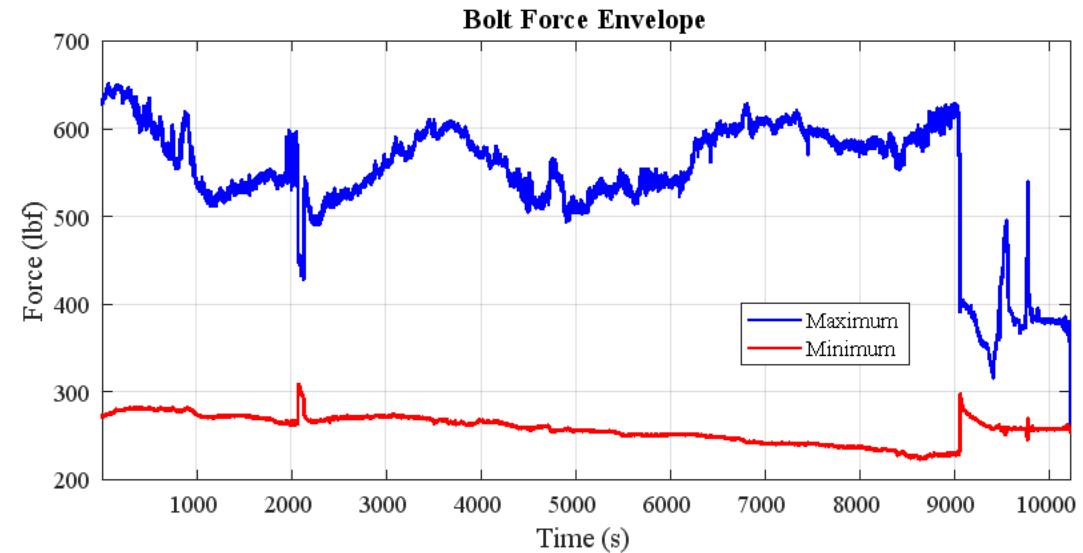
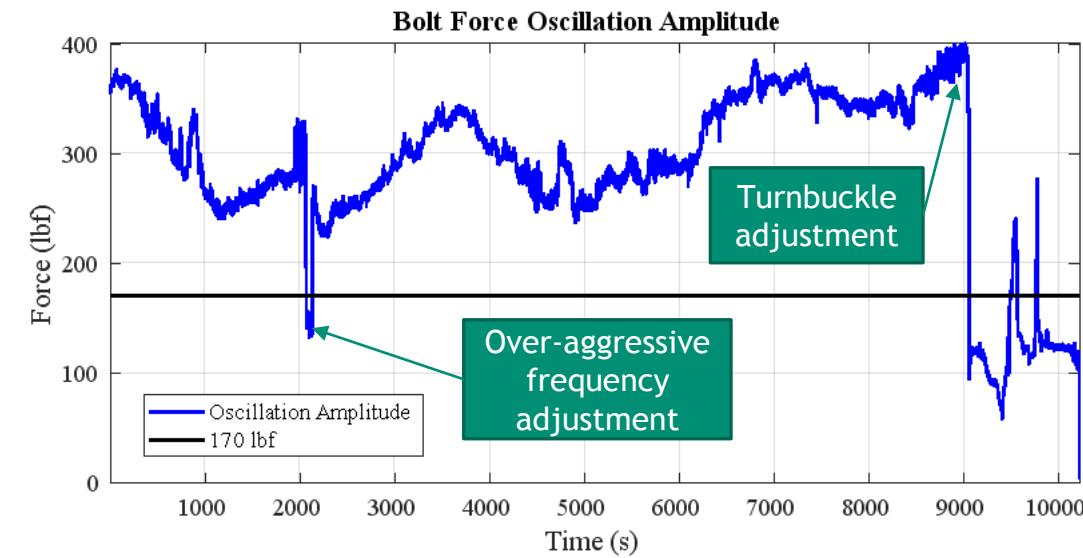
# Attempt #3—Ad Hoc Method, Fatigue Test Results

- The bolt force remained well above the 170 lbf threshold for the majority of the testing
  - The dip near 2000 s was the result of being too aggressive when adjusting the frequency to maximize bolt force
- Just after 9000 s, a slight adjustment of the shaker suspension resulted in an unrecoverable change in the dynamics
  - One of the turnbuckles supporting the shaker was vibrating/rattling so it was slightly adjusted with unfortunate consequences
- **The bolt did not fail during this test**

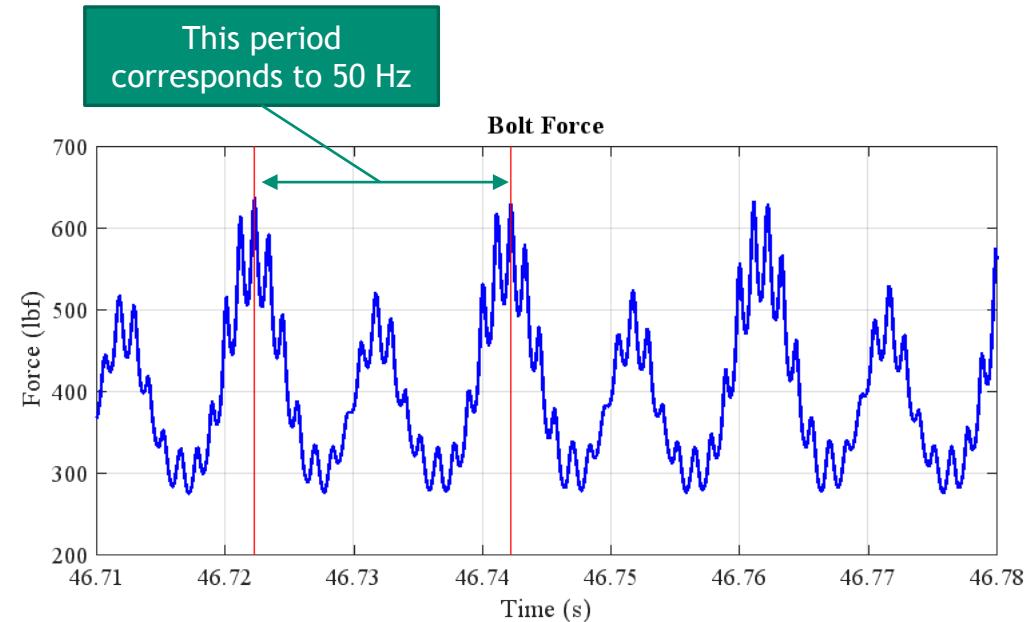
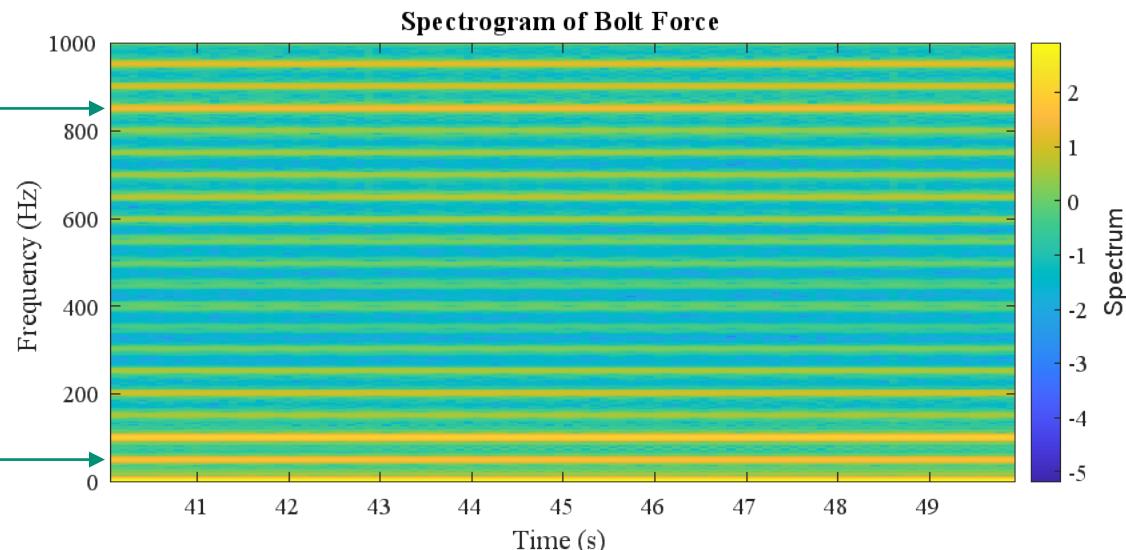
# Attempt #3—Ad Hoc Method, Why Did the Bolt Not Fail?

- The bolt force achieved its peak-to-peak amplitude at a frequency of 50 Hz, not at the excitation frequency of 850 Hz
  - Cycle count for 9000 s
    - $850 \text{ Hz} \times 9000 \text{ s} = 7.65 \text{ million cycles}$
    - $50 \text{ Hz} \times 9000 \text{ s} = 0.45 \text{ million cycles}$
  - Potentially did not achieve sufficient cycles for failure
- The fatigue failure conditions were derived for a Grade 2 bolt, but the force sensing bolt is considered Grade 9

Excitation Frequency

50 Hz

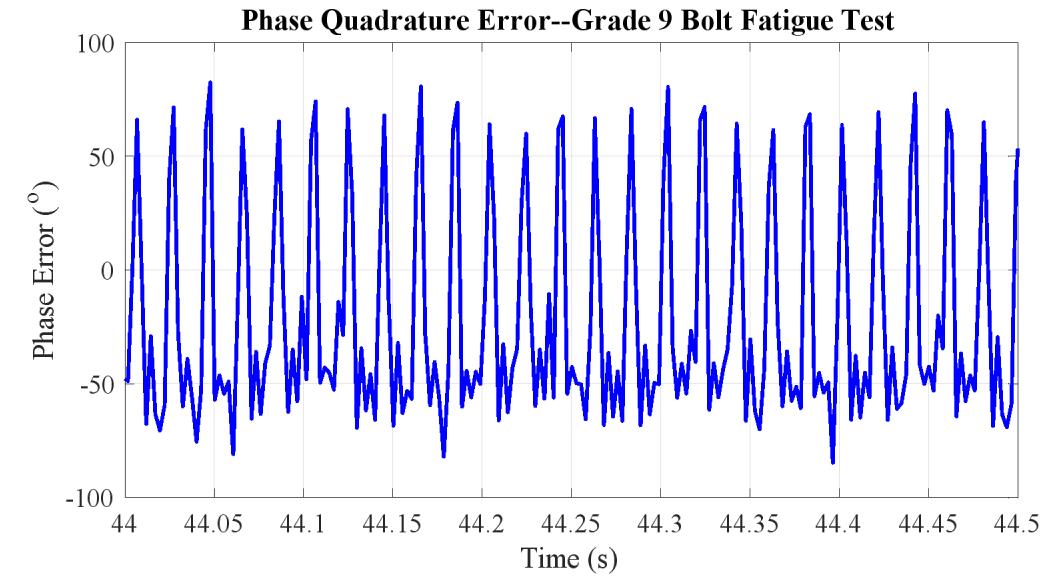
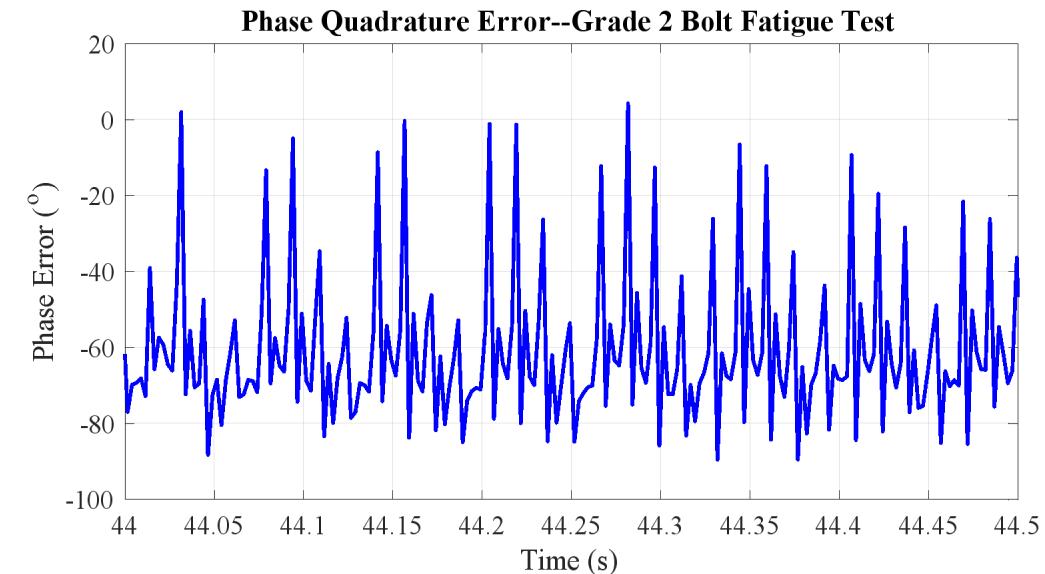
## Attempt #4—Ad Hoc Method with Grade 2 Bolt

- The fatigue test was repeated with a Grade 2 bolt
- However, this bolt was not instrumented to measure force
  - Could not measure clamping force
  - Could not monitor bolt force during fatigue test
- Other measurements had to be used to estimate if the desired fatigue test conditions were met
  - Pattern of the relative phase between excitation force and drive point response
  - This appeared to be the most accurate indicator of the state of the system and was thus deemed the most appropriate to use at the time
- There is no way to be sure if the proper bolt force was applied; the test proceeded with a large uncertainty in this quantity

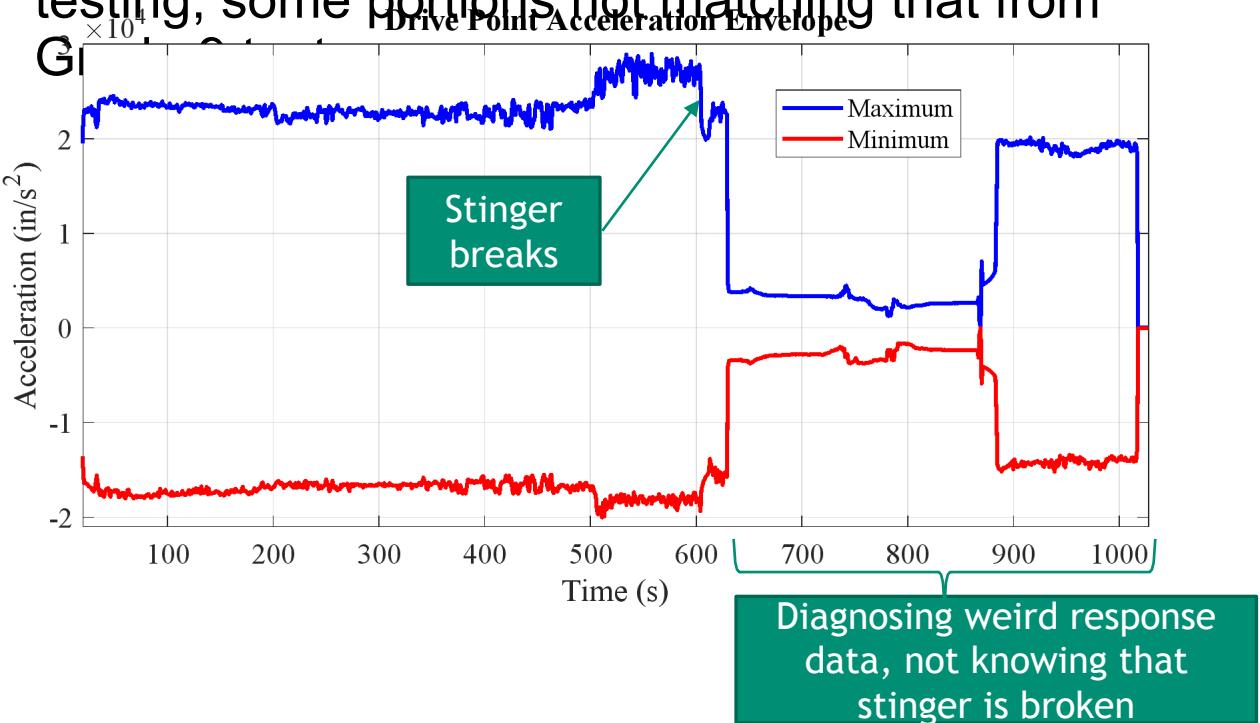
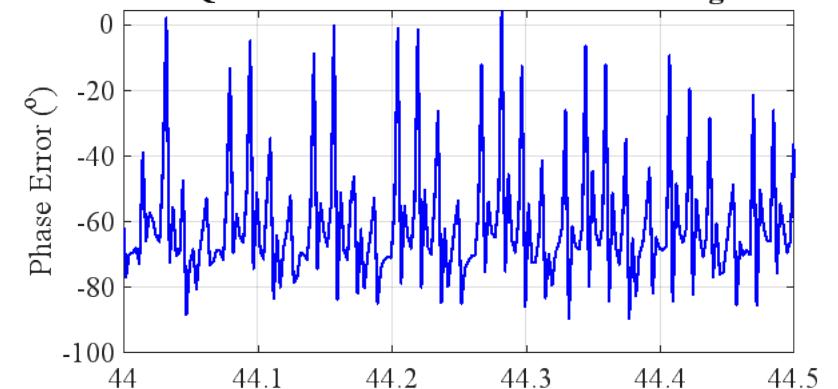
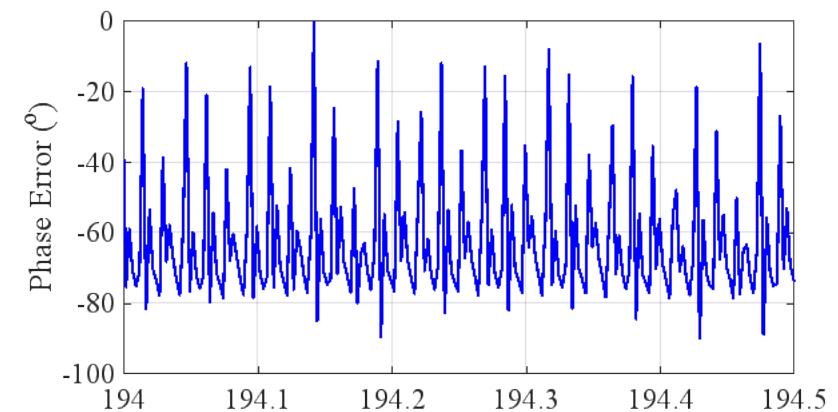
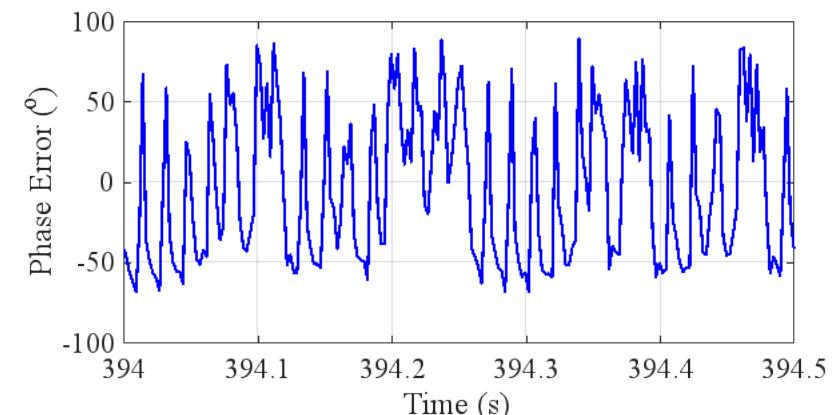
Phase Quadrature Error--Grade 2 Bolt Fatigue Test

- The bolt did not fail
- The stinger failed in fatigue mid-way through the test
  - Stinger was replaced and testing restarted to complete 1 million cycles at 850 Hz
- Phase quadrature pattern changed throughout testing, some portions not matching that from

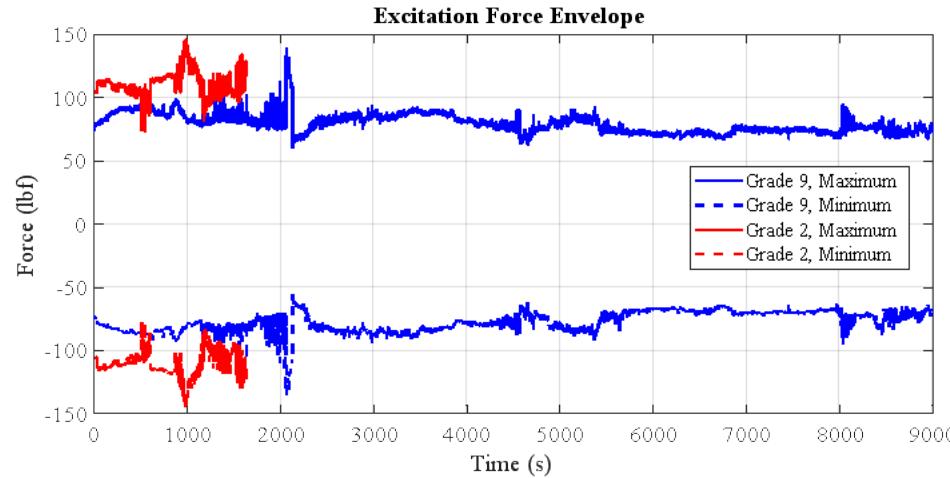
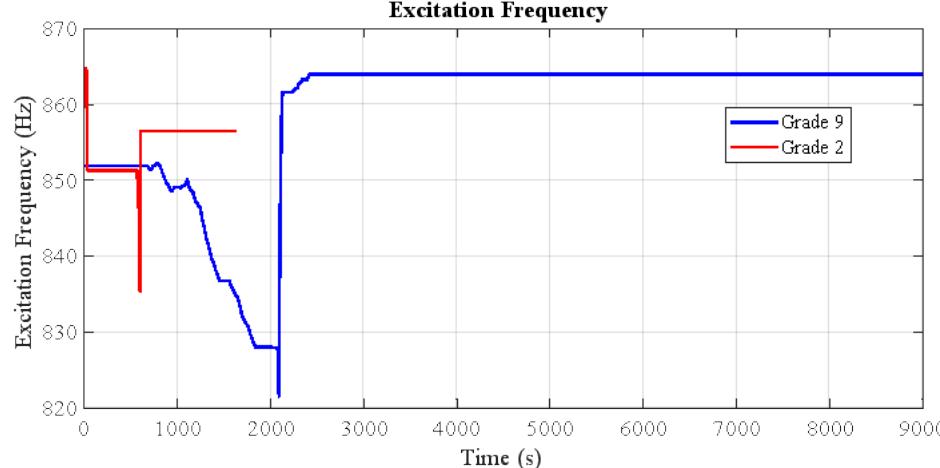
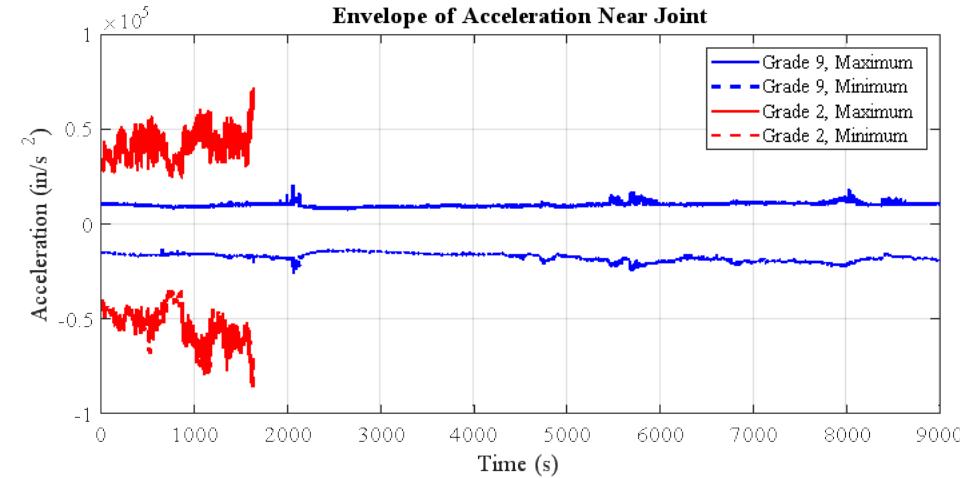
# Grade 9 vs Grade 2 Fatigue Test Comparison

- It was unclear whether the desired bolt force was achieved during the Grade 2 fatigue test
- Select data from the two fatigue tests are compared as an additional method of evaluation of the Grade 2 test results

Larger acceleration near joint  $\Rightarrow$  larger bolt forces in Grade 2

Larger acceleration near joint for similar forces  $\Rightarrow$  lower damping  $\Rightarrow$  joint material taking more of the load  $\Rightarrow$  smaller bolt forces in Grade 2
