Thermal Hydraulic Static Operation of a Chloride Molten Salt Shut-Off Valve

Abstract. The Sandia National Laboratories (SNL) National Solar Thermal Test Facility (NSTTF) conducted efficacy testing on a shut-off isolation valve for use with molten ternary chloride salt. A ball valve was tested under controlled N₂ ullage gas pressure and connected with flanged fittings that featured a spiral-wound gasket. The valve assembly consisted of boronized nickel coated SS316 components, with design features that greatly reduce the cost of overall valve assembly. Testing results showed that the valve did not leak, and post-test analysis demonstrated that the ball, seat, packing, and body all survived both the heat loads and the relative corrosive environment. Spiral-wound gaskets for flanged connections used in the system also functioned nominally, with no leaks or signs of failures during post-test analysis. However, testing was ultimately forced to rapidly stop after testing between 500-530°C as the actuator used on the valve failed in the heat, preventing the valve from sealing in the closed position. In addition, salt plugs and salt vapor plating also prevented the test from continuing.

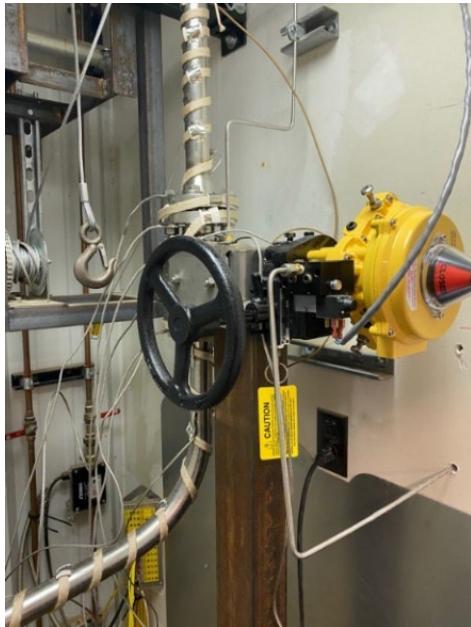
The prototype boronized-nickel ball valve was placed in a piping system made of Inconel 625. The valve was oriented vertically in the piping system with segments of Inconel 625 above and below the valve. The segments of Inconel 625 pipe were schedule 40 and 1.25 NPS. The piping segments were attached to the valve using Inconel 625 raised face class 300 ANSI flanges. This piping system was assembled with the multi-material spiral wound gaskets placed at the interface between the flanged connections. The ends of the piping segments were sealed with welded ¼ inch Inconel 625 plates. The FIGURE 1 setup shows the valve in between the piping segments, supported in position by a steel frame.

FIGURE 1. Prototype Valve Mounted in Piping

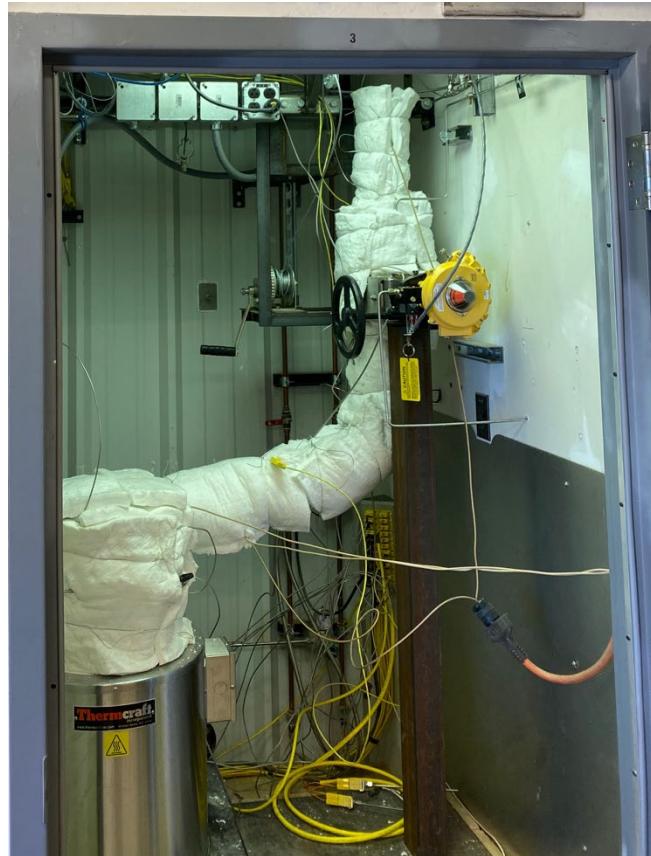
added to the top of the valve and piping. To move salt on demand between the containment vessel and the valve, pressurization of the containment vessel was facilitated with nitrogen while leaving the exhaust valve open. This resulted in a pressure driven transfer of salt into the valve and piping. Before transferring, a vacuum pump was used to facilitate a cycle purge of any contaminant air from the system. A ceramic fiber-heated furnace was used to heat the salt containment vessel, all other wetted components were wrapped in heat trace. All heated test components were subsequently wrapped in insulation. Fig. 4 shows the completed test setup of the valve test system.

FIGURE 4. Photograph of the completed test setup

To cycle the valve safely and remotely for functionality and leak testing at varying operational temperatures, the valve was designed to open and close with a pneumatic actuator. The yellow actuator can be seen attached to the side of the valve in Fig. 4. To deliver air to the pneumatic actuator a compressed air system was added, supplied by an air compressor, and controlled with a solenoid valve. Various equipment was used to monitor test conditions including pressure transducers, flow meters, and thermocouples. A scale was placed under the containment vessel to monitor changes in mass while moving salt between the vessel and valve. A data acquisition (DAQ) system was built to monitor all sensors and allow for remote actuation of the solenoid valve. All heaters were connected to limit controllers which allowed set point programming, thermal hold times, and high limit cut-off temperatures.
