**REPORT SERIES: FINDING OF EFFECT AND MITIGATION DOCUMENTATION FOR  
BUILDING 23-W10, MERCURY,  
AREA 23, NEVADA NATIONAL SECURITY SITE,  
NYE COUNTY, NEVADA**

**FINDING OF ADVERSE EFFECT AND PROPOSED MITIGATION FOR THE  
DEMOLITION OF BUILDING 23-W10, MERCURY, AREA 23,  
NEVADA NATIONAL SECURITY SITE, NYE COUNTY, NEVADA**

**MITIGATION FOR DEMOLITION OF BUILDING 23-W10, MERCURY, AREA 23,  
NEVADA NATIONAL SECURITY SITE, NYE COUNTY, NEVADA**

## Architectural Resource Assessment (ARA) Form (Update)

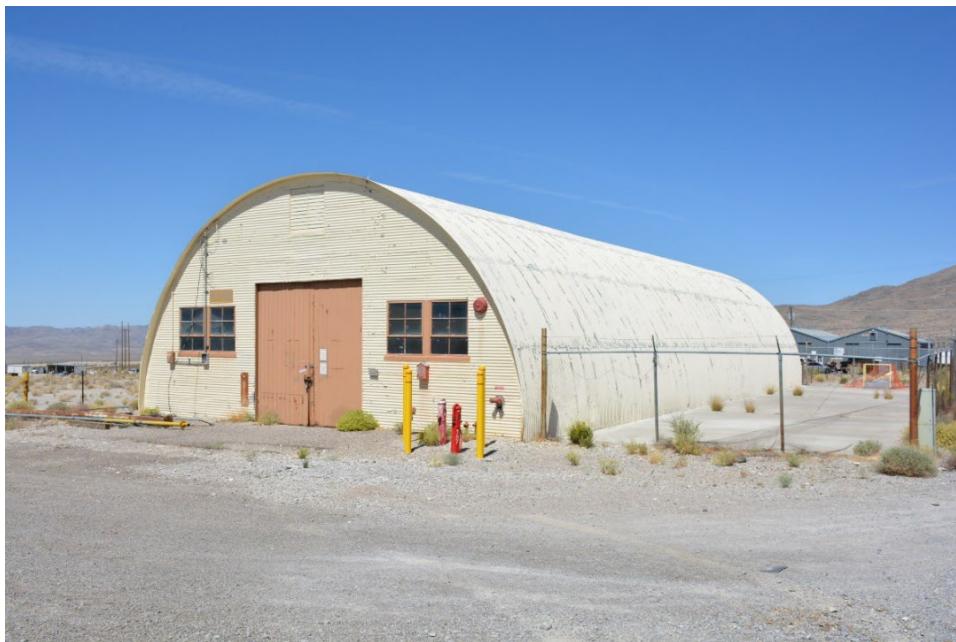
Figure 3. Exterior of Building 23-W10 (2276\_4039, DRI 2022).

Building 23-W10 was installed in Mercury in 1962 and used as a warehouse. It had likely been brought over from Camp Desert Rock after the camp was no longer in service (Reno et al. 2017). It is 100 feet by 40 feet and is a T-Rib Quonset hut, the first type of Quonset hut designed by the U.S. military in support of WWII (Figure 3). It is a one-story, rectangular-plan structure with a steel frame, corrugated steel semicylindrical roof, and corrugated steel end walls. It has a concrete slab foundation. Each end wall has a central, interior, sliding metal door and a large, louvered, metal vent centered above it. There is a pair of steel-framed, four-over-two awning windows at each side of the door.

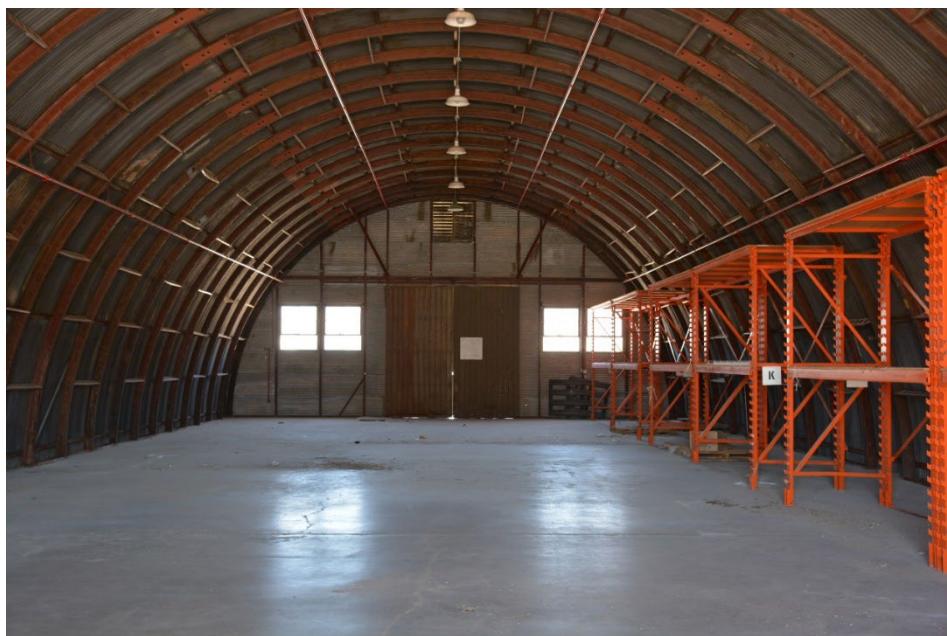
Figure 4. Interior of Building 23-W10 (2276\_4055, DRI 2022).

Building 23-W10 is currently empty except for free-standing shelving and is not in use at this time. The interior consists of open space with no interior walls or partitions (Figure 4). The metal ribs of the structure are visible through the length of the building and there appear to be no changes to the structure since its installation. There is one row of pendant lights in the midline of the ceiling that runs the length of the building.

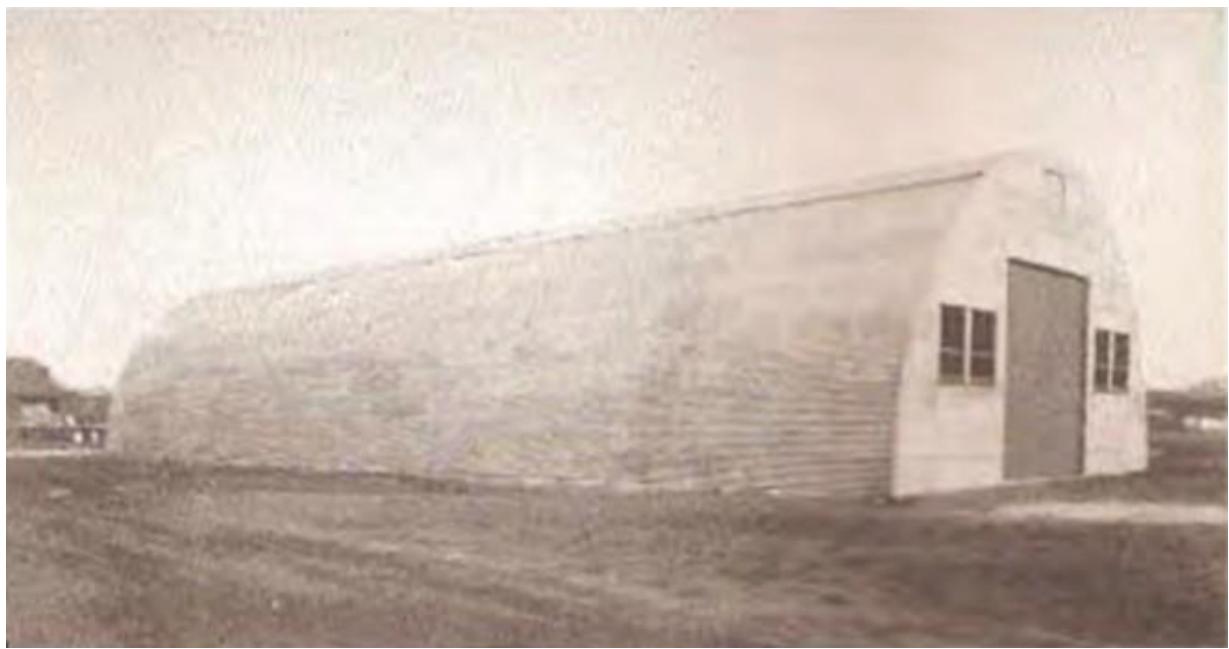
The first design of the Quonset hut, named after the Rhode Island military installation, was named the T-Rib hut. The T-Rib utilized a T-shaped steel and iron arch (Figure 1). The hut had corrugated steel sheets laid across arched steel and iron frames that were spaced four feet apart and affixed with nuts and bolts (Survey LA 2015). This design had the steel sheets laid in a continuous design so that the walls and roof of the hut became a single structural member. There were two main designs of the T-Rib based on size: the 20 and the 40. The 20 measured 20 feet by 48 feet long, and the 40 measured 40 feet by 100 feet long. From this, the T-Rib hut was subsequently adapted to specialized functions and each plan indicated the modifications needed to make the conversion and the location of the equipment necessary for each design (Decker and Chiel 2005). The huts did not require a foundation, although a foundation was sometimes added depending on the condition of the site. The earliest versions were unpainted, but later versions were painted with an olive-drab paint. Most of these huts were repainted to match the local landscape.

Figure 1. T-Rib Quonset hut (National Steel, August 1950).

The first design of the Quonset hut, named after the Rhode Island military installation, was named the T-Rib hut. The T-Rib utilized a T-shaped steel and iron arch (Figure 1). The hut had corrugated steel sheets laid across arched steel and iron frames that were spaced four feet apart and affixed with nuts and bolts (Survey LA 2015). This design had the steel sheets laid in a continuous design so that the walls and roof of the hut became a single structural member. There were two main designs of the T-Rib based on size: the 20 and the 40. The 20 measured 20 feet by 48 feet long, and the 40 measured 40 feet by 100 feet long. From this, the T-Rib hut was subsequently adapted to specialized functions and each plan indicated the modifications needed to make the conversion and the location of the equipment necessary for each design (Decker and Chiel 2005). The huts did not require a foundation, although a foundation was sometimes added depending on the condition of the site. The earliest versions were unpainted, but later versions were painted with an olive-drab paint. Most of these huts were repainted to match the local landscape.

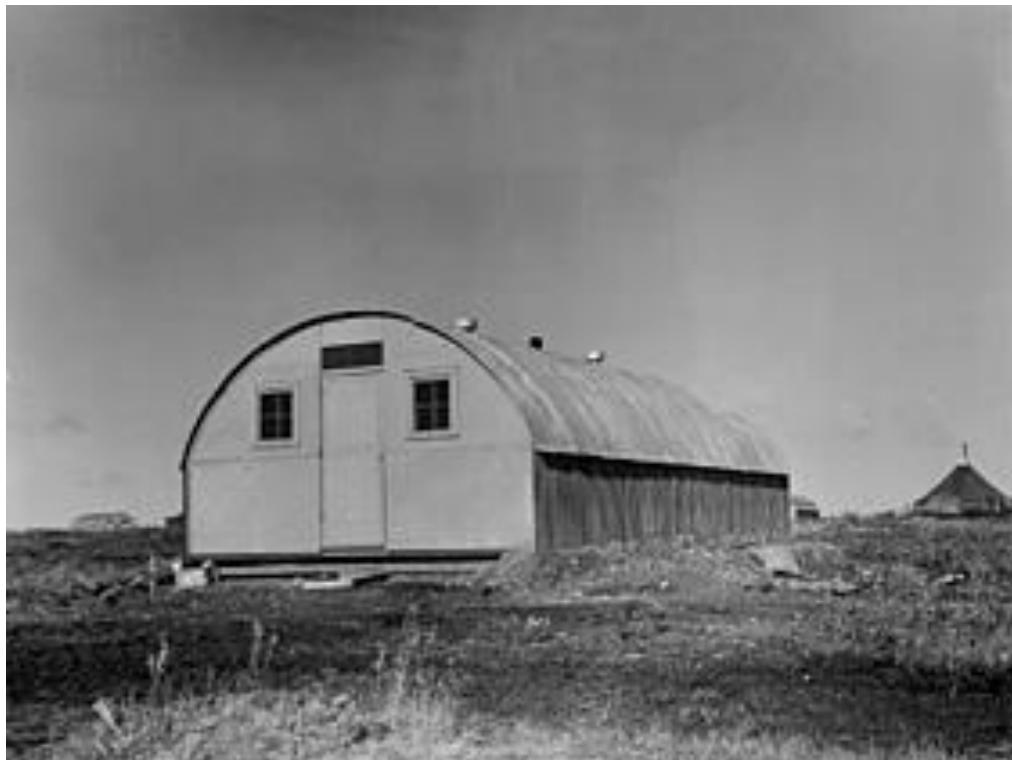
Figure 2. Quonset Redesign hut model (National Archives, Washington, RG 342-FH-3b47102).

heavy to ship. The new design was dubbed the Quonset Redesign and was available in two sizes (Figure 2). This hut had a segmental arch and four-foot-high vertical sidewalls. The new arch design meant that the hut could be erected in two sections instead of three and the framing was changed to a lighter-weight material made by Stran-Steel, which made it easier to ship. It is not clear when the T-Rib design was phased out in favor of the Quonset Redesign hut, but the new design was approved in late 1941.

Although the T-Rib hut was quickly produced and shipped to military installations, Fuller and Company also began a new design. Users of the T-Rib noted that because of its continuous arch, features such as beds, sinks, and washing machines had to be moved inward until they abutted the curve at the top edge of the unit. This resulted in a loss of usable floor space (Survey LA 2015). The T-Ribs were also awkward to crate and heavy to ship. The new design was dubbed the Quonset Redesign and was available in two sizes (Figure 2). This hut had a segmental arch and four-foot-high vertical sidewalls. The new arch design meant that the hut could be erected in two sections instead of three and the framing was changed to a lighter-weight material made by Stran-Steel, which made it easier to ship. It is not clear when the T-Rib design was phased out in favor of the Quonset Redesign hut, but the new design was approved in late 1941.

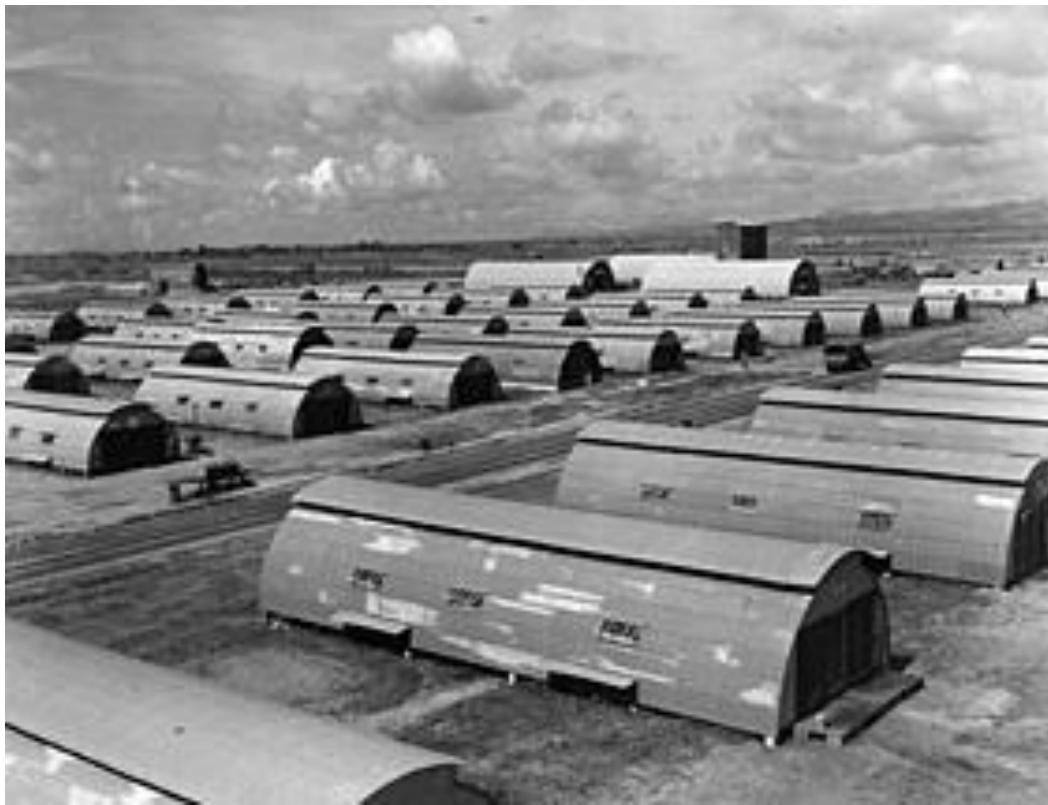
In 1942, Stran-Steel took over production and designed a third Quonset hut called the New Arch Rib Stran-Steel (SSAR) (Figure 3). The new design created an expanded footprint and reverted back to the full arched rib present in the original T-Rib hut. Although this design resulted in the loss of some floor space, the new modifications allowed easier fabrication and erection, and the huts could be made larger to compensate for the loss of size. As with the T-Rib design, the SSAR hut was clad with curved, corrugated metal applied vertically to the arch. A new cladding system was introduced with the SSAR that used the factory-curved panel at the ridge but applied the corrugated metal sheets horizontally.

Figure 3. Stran-Steel Quonset hut (National Archives, Washington, D.C., RG 80-G 347017).

In 1942, Stran-Steel took over production and designed a third Quonset hut called the New Arch Rib Stran-Steel (SSAR) (Figure 3). The new design created an expanded footprint and reverted back to the full arched rib present in the original T-Rib hut. Although this design resulted in the loss of some floor space, the new modifications allowed easier fabrication and erection, and the huts could be made larger to compensate for the loss of size. As with the T-Rib design, the SSAR hut was clad with curved, corrugated metal applied vertically to the arch. A new cladding system was introduced with the SSAR that used the factory-curved panel at the ridge but applied the corrugated metal sheets horizontally.

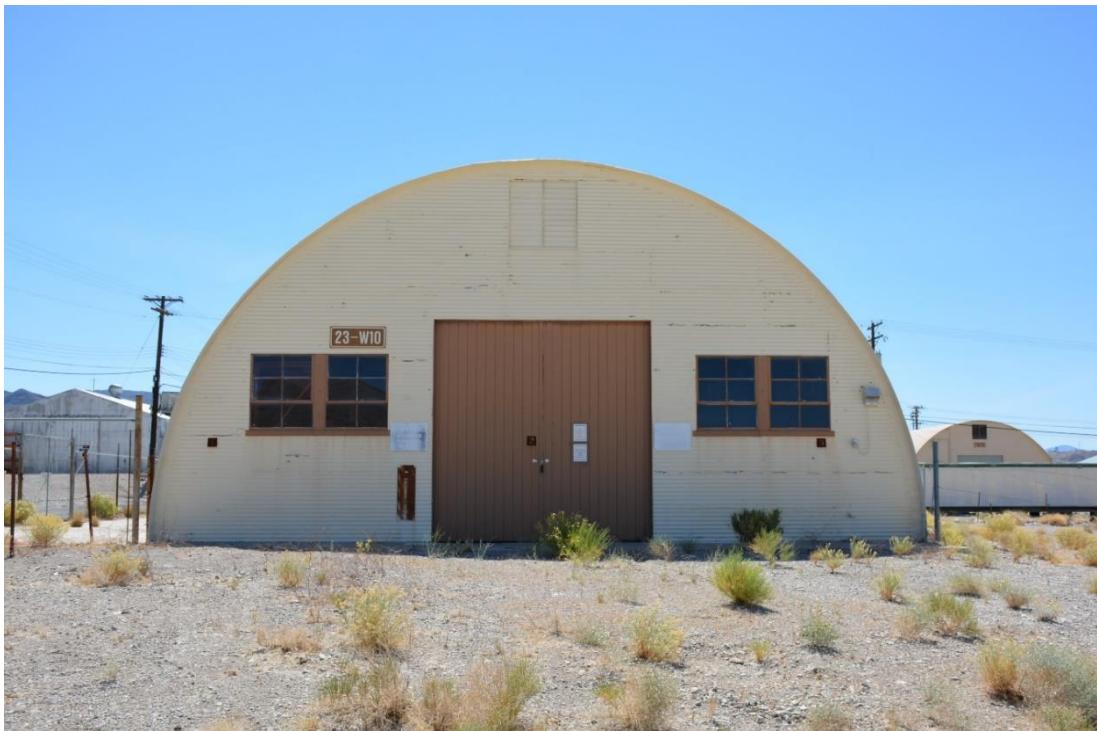
Figure 4. Building 23-W10, facing west (227623\_4038, DRI 2022).

Building 23-W10 was installed in Mercury in 1962 and used as a warehouse (Figure 4) to support Cold War efforts. It had likely been brought over from Camp Desert Rock after the camp was no longer in service (Reno et al. 2017). It is 100 feet by 40 feet and is a T-Rib Quonset hut. By the 1950s, Quonset huts and other prefabricated buildings made up a majority of the structures in Mercury. Quonset huts housed a variety of facilities, such as dormitories, a movie theater, a gym, science and research areas, and storage (Figures 5-6). Based on historic photos of Mercury, some of the Quonset huts were the smaller version of the T-Rib, which were used as dormitories. Others appear to have been either a modified version of the Redesign model with straight sidewalls or possibly a model that was built by a private company not intended for the federal government. Although there is not a total count of how many Quonset huts were in Mercury during its height of use, at least 30 Quonset huts appear to have been used as dormitories based on Reno et al. (2017). In addition to the dormitories, there were at least six other Quonset huts that were likely used as warehouses. These were scattered throughout Mercury.

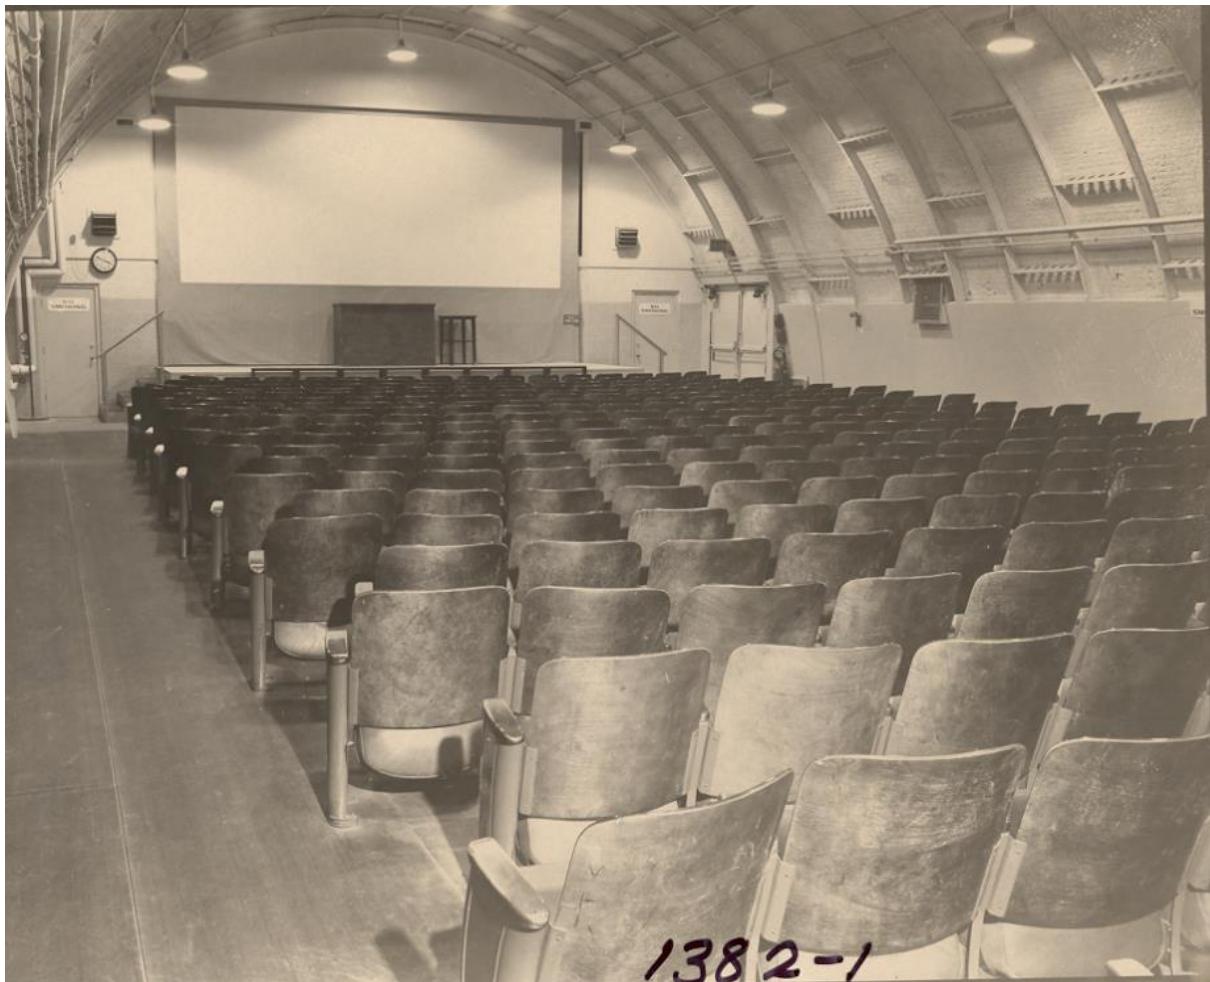
Figure 6. Interior of Quonset hut movie theater in Mercury (REECo1382-1, 1962).

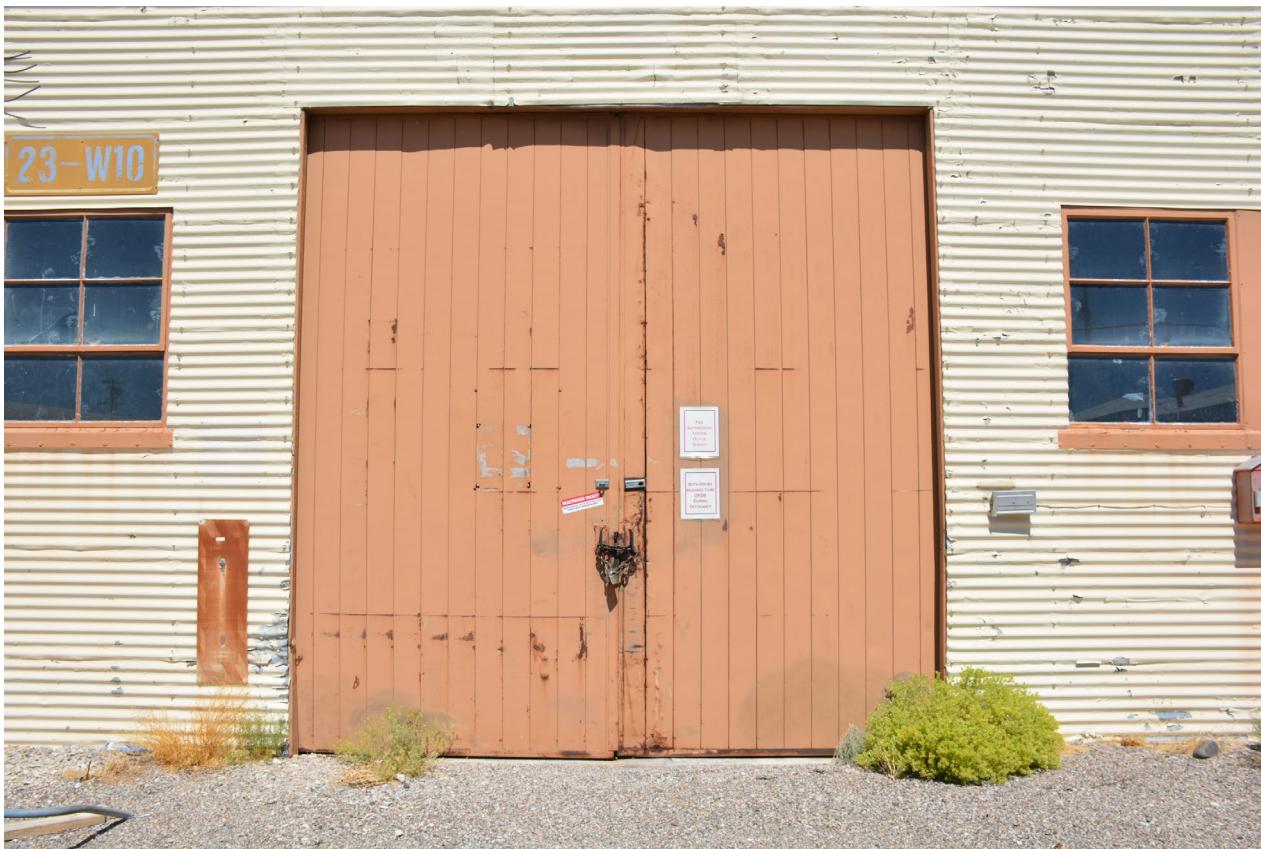
Photograph 9. Entry doors on east elevation (2276\_4047, DRI 2022).

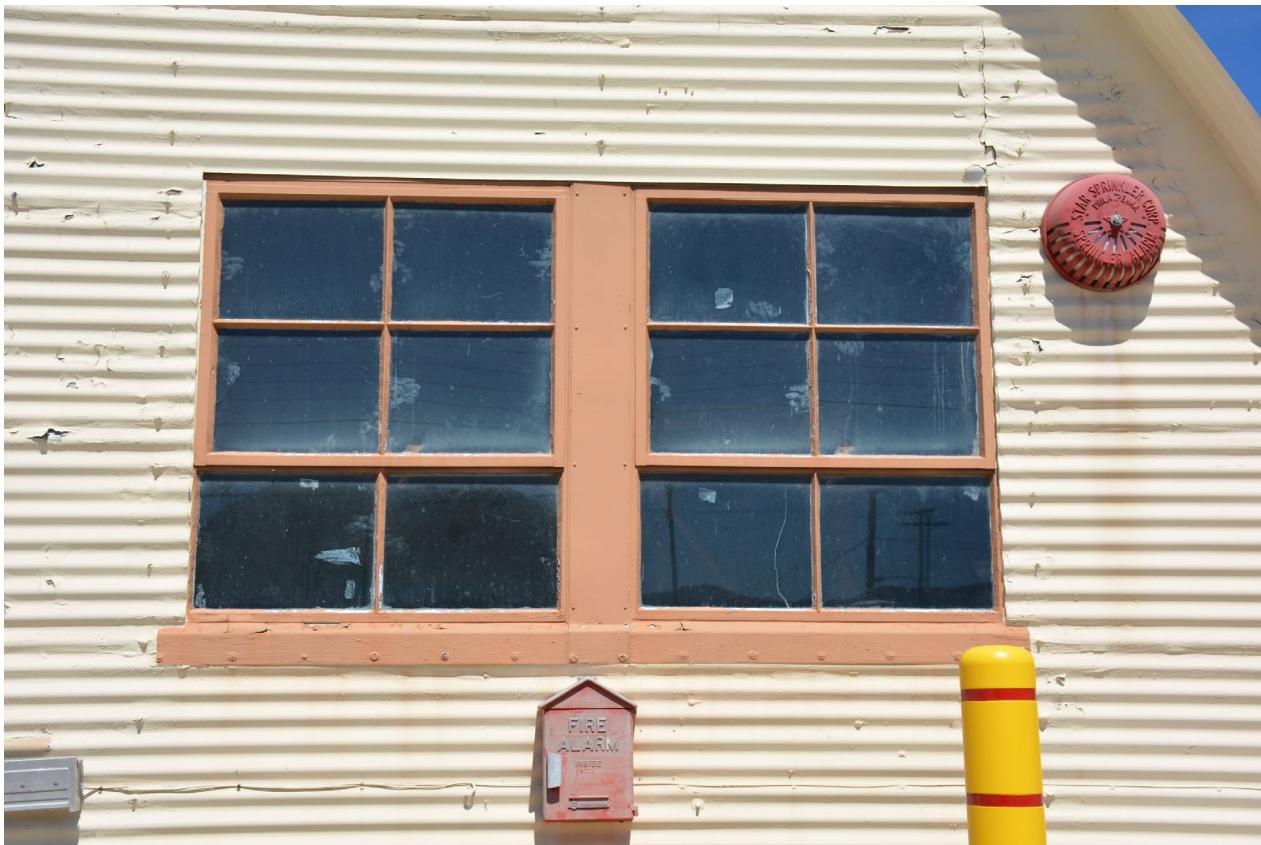
Photograph 10. Windows located on the north side of doors, east elevation (2276\_4049, DRI 2022).

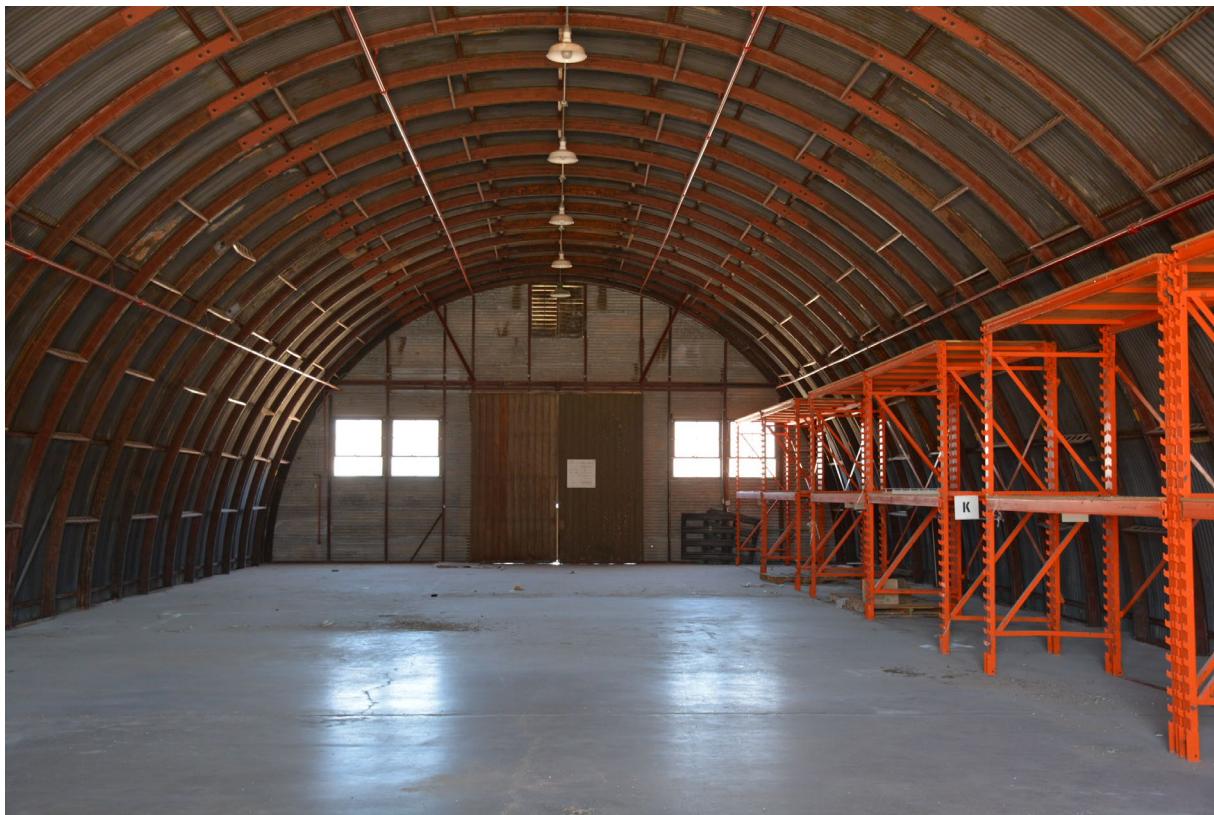
Photograph 11. Interior of 23-W10 from east entry, view to the west/northwest (2276\_4056, DRI 2022).

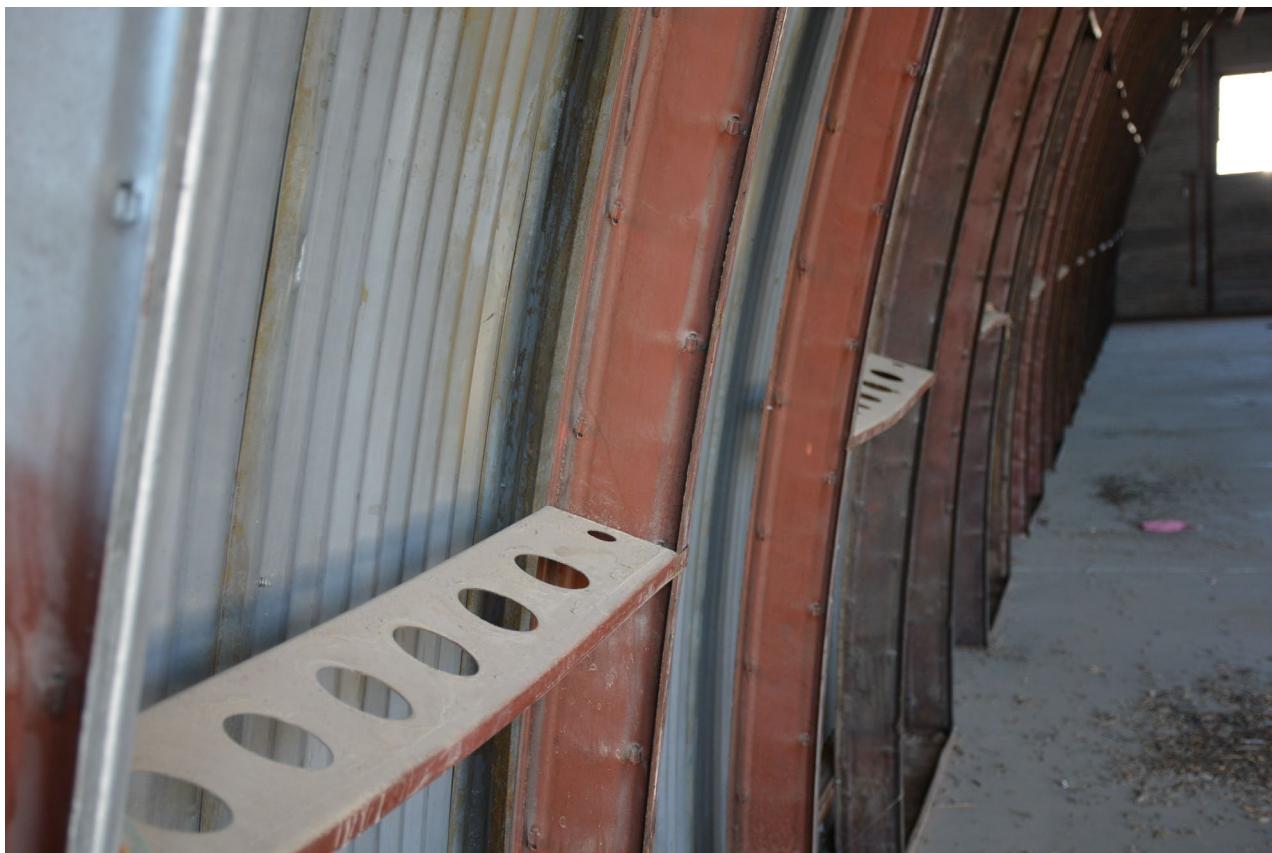
Photograph 14. Southern wall detail, facing west (2276\_4062, DRI 2022).  
Nevada SHPO – ARA Form Page 14

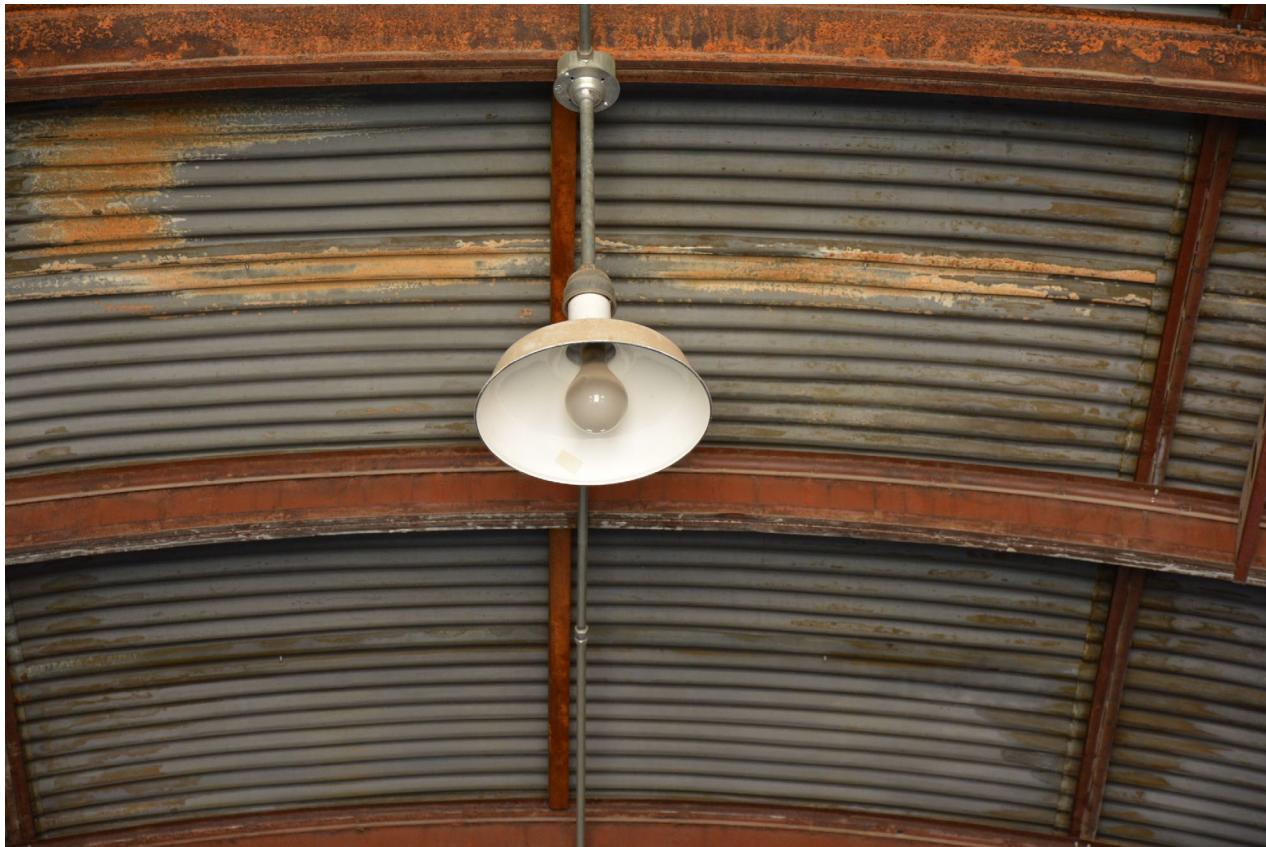
Photograph 15. Ceiling detail and light fixture, eastern end of 23-W10 (2276\_4064. DRI 2022).
