Corrosion Testing of Inconel and K-3 in LAW Glass, VSL-17R4240-1

Vitreous State Laboratory of The Catholic University of America

Date Published
January 2023

Final Report

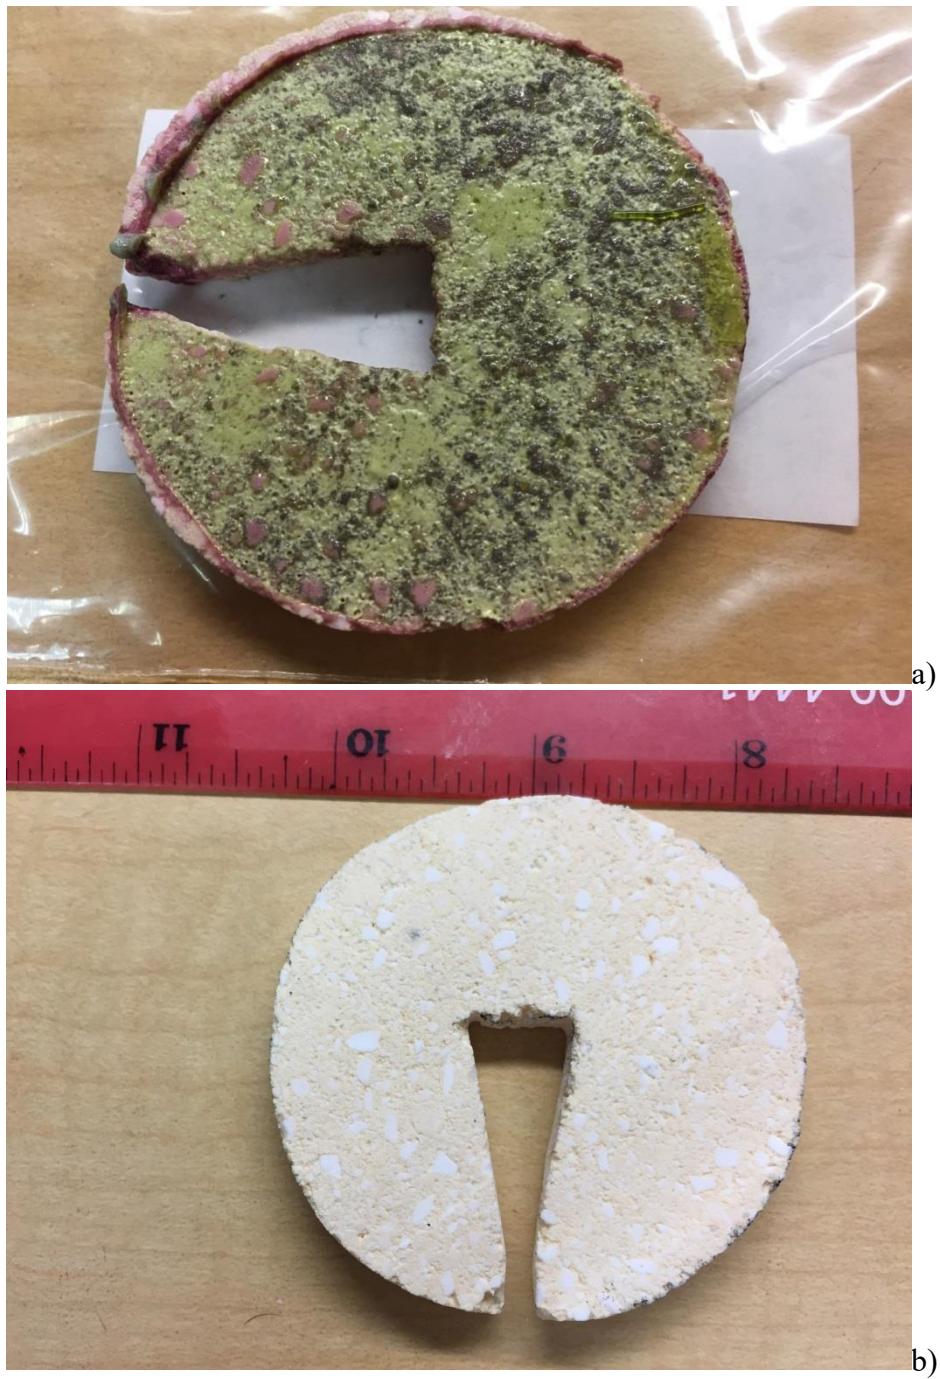
Figure 3.2. Cross sectional images of K-3 test coupons after corrosion experiments in ORPLE12 (* Measured by Microscope. ** Measured from Scanned image).
