**Contamination Source Review for Building E7995,
Edgewood Area, Aberdeen Proving Ground, Maryland**

Contamination Source Review for Building E7995, Edgewood Area, Aberdeen Proving Ground, Maryland

M.N. Booher, G.A. Miller, A.K. Draugelis, M.A. Glennon, J. Rueda, and R.E. Zimmerman

September 1995

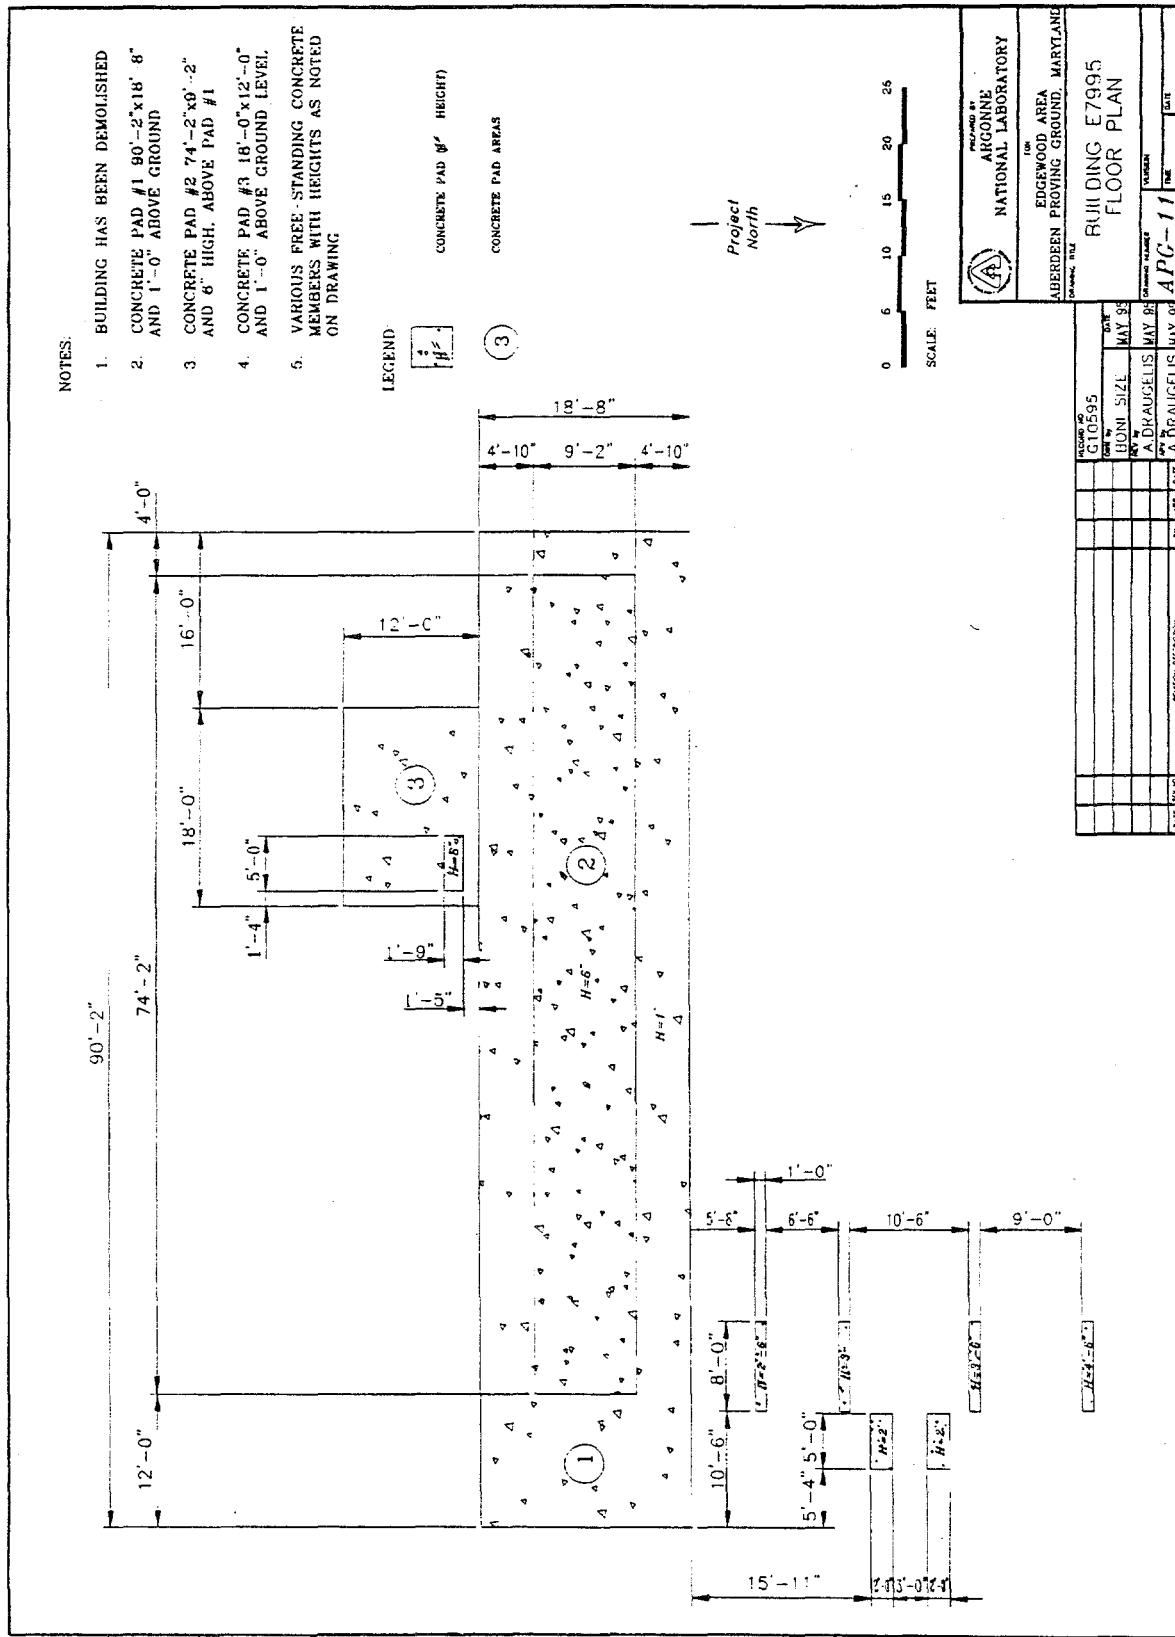
Building E7995 has been removed. At the time of this investigation, all that remains of Building E7995 is the concrete floor slab and, possibly, underground foundations. Figure 3 presents a building floor slab plan, as surveyed at the time of ANL's inspection. Figures 4 and 5 provide photographs of the building slabs.

The concrete slabs measure 90 ft 2 in. long on the north and south sides. The east and west sides measure 18 ft 8 in. long. A connected concrete slab on the south side of the foundation, 16 ft from the southwest corner, measures 12 ft wide by 18 ft long.

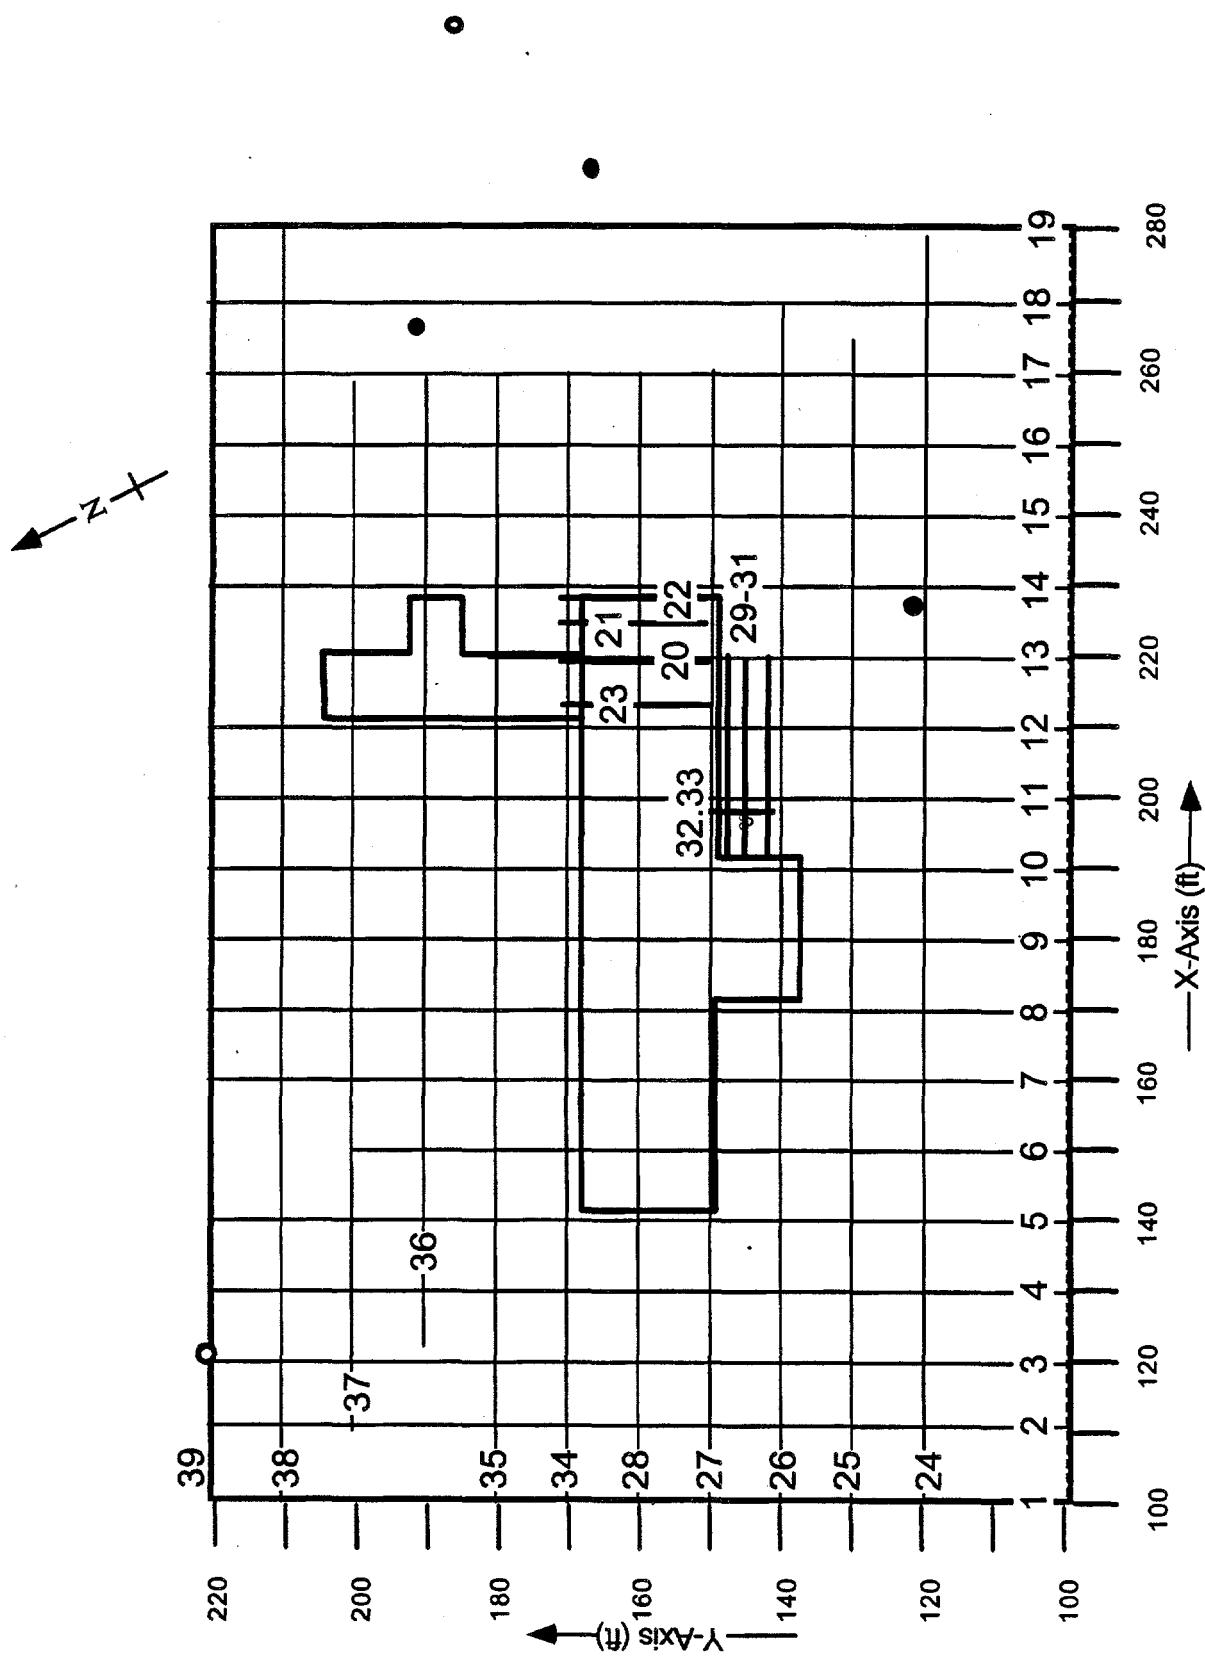
FIGURE 3 Map of GPR transects conducted near Building E7995

1. Continuously recording, total-field magnetometer (EG&G Geometrics G822L), with Y transects spaced 5 ft apart and X tie lines spaced 20 ft apart.
2. Geonics EM conductivity meter (EM-31), with Y transects spaced 5 ft apart and X transects spaced 20 ft apart.
3. Time-Domain Geonics EM (EM-61), designed for detection of metals, with Y transects spaced 5 ft apart and X tie lines spaced 20 ft apart.
4. Ground-Penetrating radar GSSI, with Y transects spaced 10 ft apart and X tie lines spaced 10 ft apart. The locations of GPR profiles and their assigned reference numbers are shown as dashed lines in Figure 3.

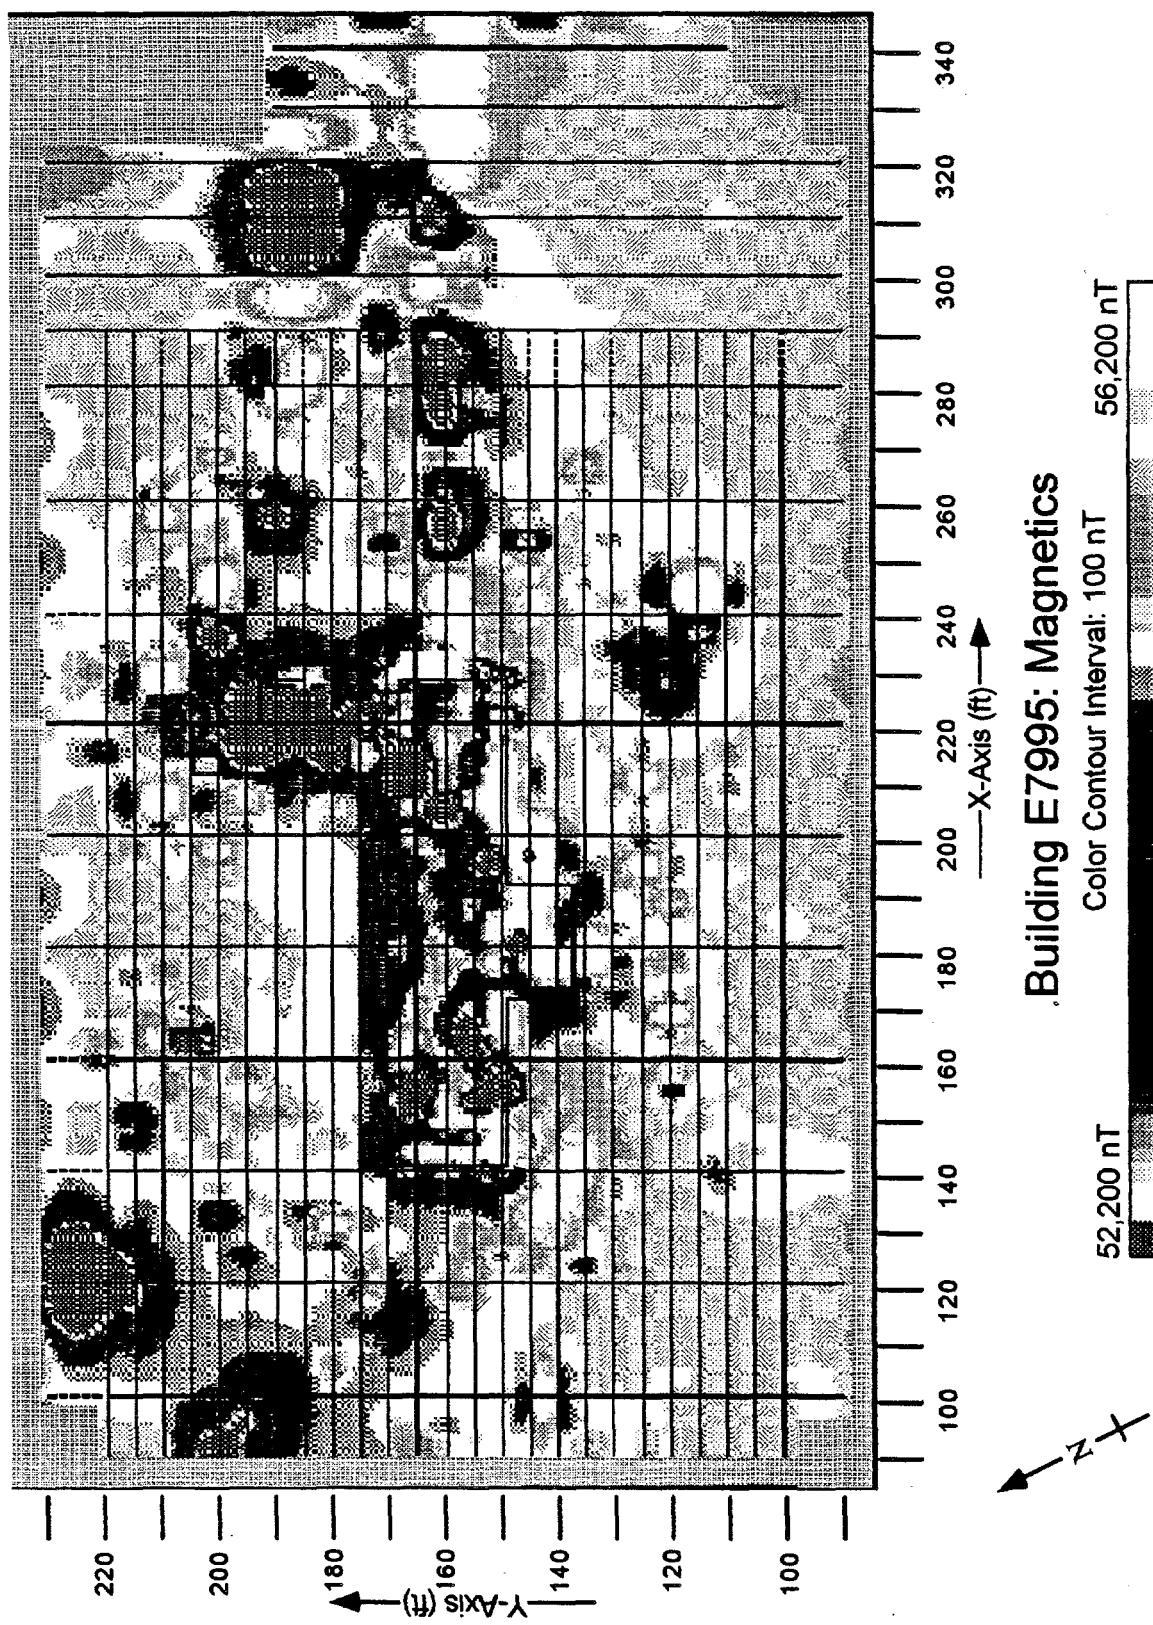
FIGURE 4 Total Magnetic Field Anomaly Map. Also depicted are the positions of data points collected along the geophysical profiles

Another lineation is defined by a series of high/low magnetic pairs along line Y=160 starting near the northeast side of the main building. Although this anomaly extends along an old road bed made of amphibolitic fill material, its amplitude (~1400 nT) is too large to be sourced by road fill alone (Figure 4). Therefore, a buried iron-rich source, such as a pipeline, must cause this anomaly.

Point magnetic anomalies are observed throughout the entire geophysical survey area. Several are caused by known anthropogenic sources such as metal signs at (260, 190), (290, 172), and (230, 120) and wells at (120, 220) and (310, 185). The positive anomalies on either side of the well at (310, 185) are gridding artifacts. High gradients cause the minimum curvature algorithm to overshoot. Magnetic anomalies larger than 5' in diameter are observed at (242, 115), (281, 185), (245, 200), (228, 210), (206, 210) and (162, 205). Other smaller-diameter point magnetic anomalies are listed in Table 2. The sources of these anomalies are unknown.

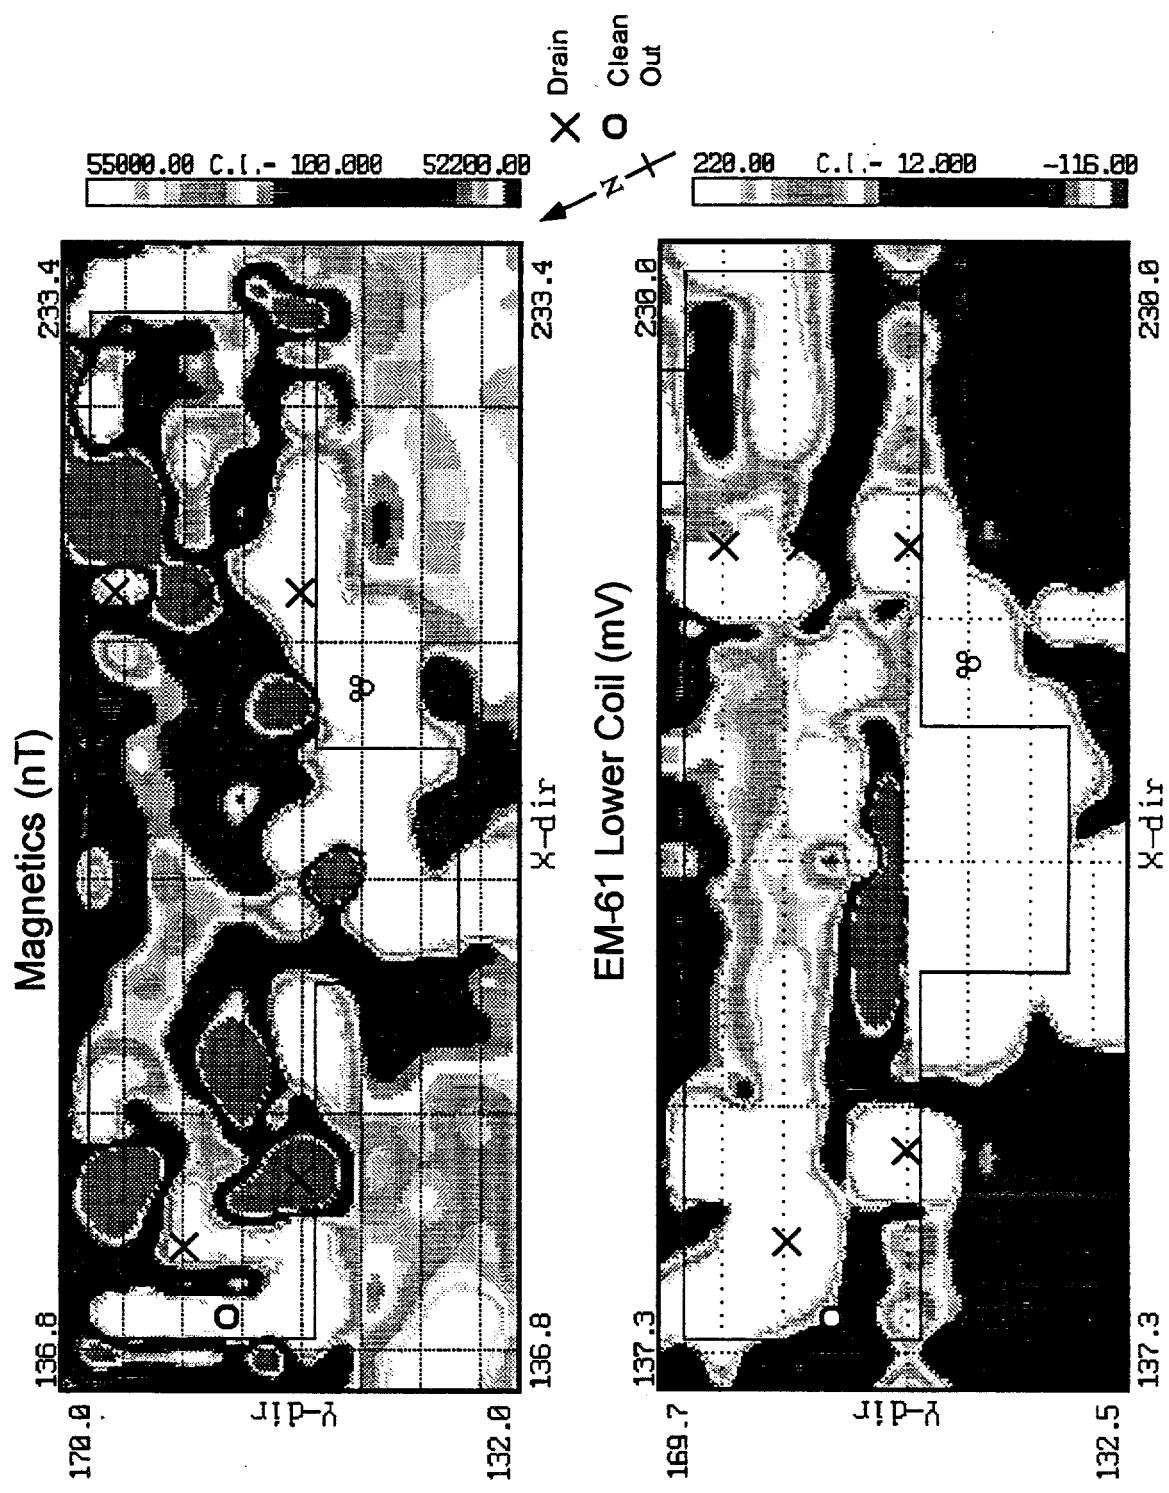
A complicated set of magnetic anomalies is observed on the foundation of E7995 (Figure 5). Magnetic highs and lows are observed on, or near each drain shown by EAI Corp. (1989). The cleanout is located on a linear magnetic high on the northwest edge of the slab. Metal anchor bolts were noted by ANL personnel along edges of the main slab. Although the exact locations of each bolt were not specified, these metal spikes could cause some of the magnetic anomalies along the periphery of the slab. Other magnetic anomalies with unknown sources are also observed on the foundation. The buried tank identified from an earlier geophysical survey near (195, 145) probably caused the observed magnetic high.

FIGURE 5 A. Total magnetic field anomaly and B. EM-61 Lower Coil Millivolt Anomaly map of the foundation of E7995

A complex pattern of EMF anomalies covers the foundation of E7995 (Figure 5). The five drains listed by EAI Corp. (1989) correlate with EMF lower coil positive anomalies. Metal within or buried beneath the concrete probably cause these anomalies. Other EMF lower coil anomalies are observed beneath the slab. Metal anchors along the edge of the slab may explain some of these EMF positive anomalies. An EMF positive is observed at (195, 145), near the buried tank identified by an earlier geophysical survey.

The locations of known drains and cleanouts within E7995 are superimposed on the magnetic and EMF anomaly maps. Argonne personnel did not notice these features on the slab during the geophysical survey and it is not known if these drains were removed with the building. However, magnetic, EMF and GPR anomalies correlate with the locations of both the drains and the cleanout. In addition, linear EMF anomalies extend from the building near drains along X=140 and X=200, suggesting metal drainage pipes occur in this area. Metal anchor bolts were observed along the edges of the slab and could explain some of the other geophysical anomalies. However, the sources of many magnetic and EMF anomalies observed on the slab remain unknown. Magnetic, EMF and conductivity highs are observed near (195, 145), where a UST was identified by an earlier GPR survey.

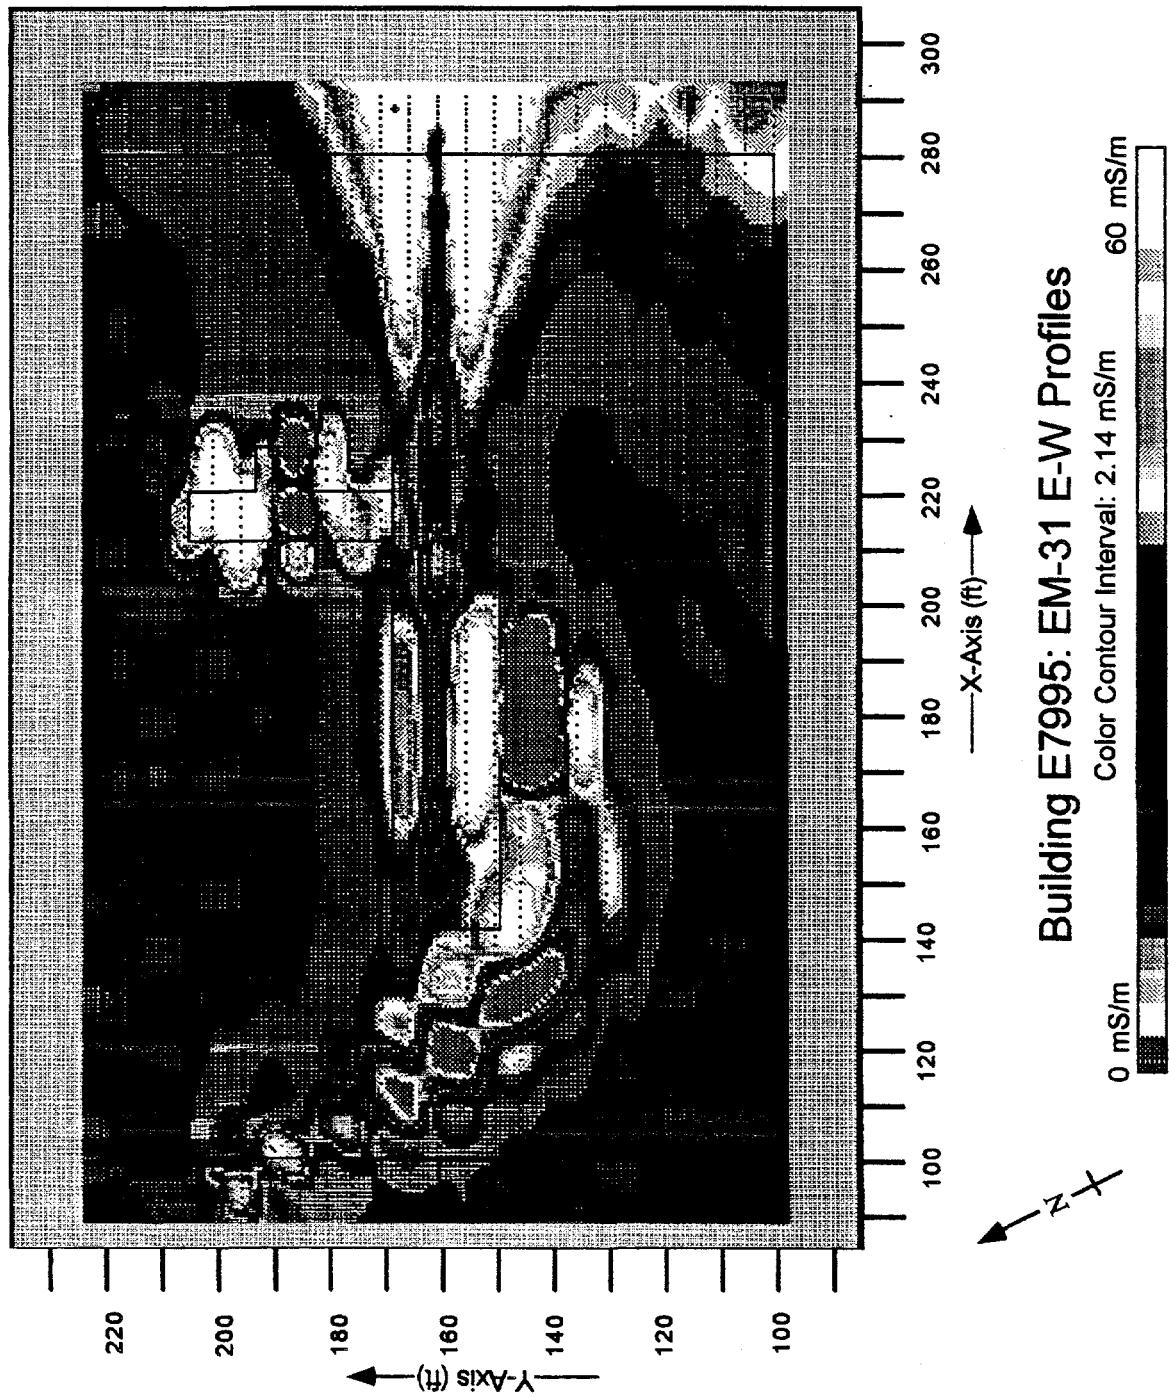
The most likely source for the three-banded anomaly along a diagonal between (90, 200) and (140, 140) is a buried metal pipeline or utility (Figure 6). Other three-banded anomalies are observed beneath the slab of the addition at the southwest end of the wind-tunnel building and beneath the footings for the scrubber at the northeast end of the building (Figures 6 and 7). These anomalies could be sourced by reinforced concrete or unidentified buried metal. A conductivity low is detected along the amphibolitic road bed at Y=160 (Figure 7).

FIGURE 6 E-W EM-31 transects. Also depicted are the positions of data points collected along the geophysical profiles

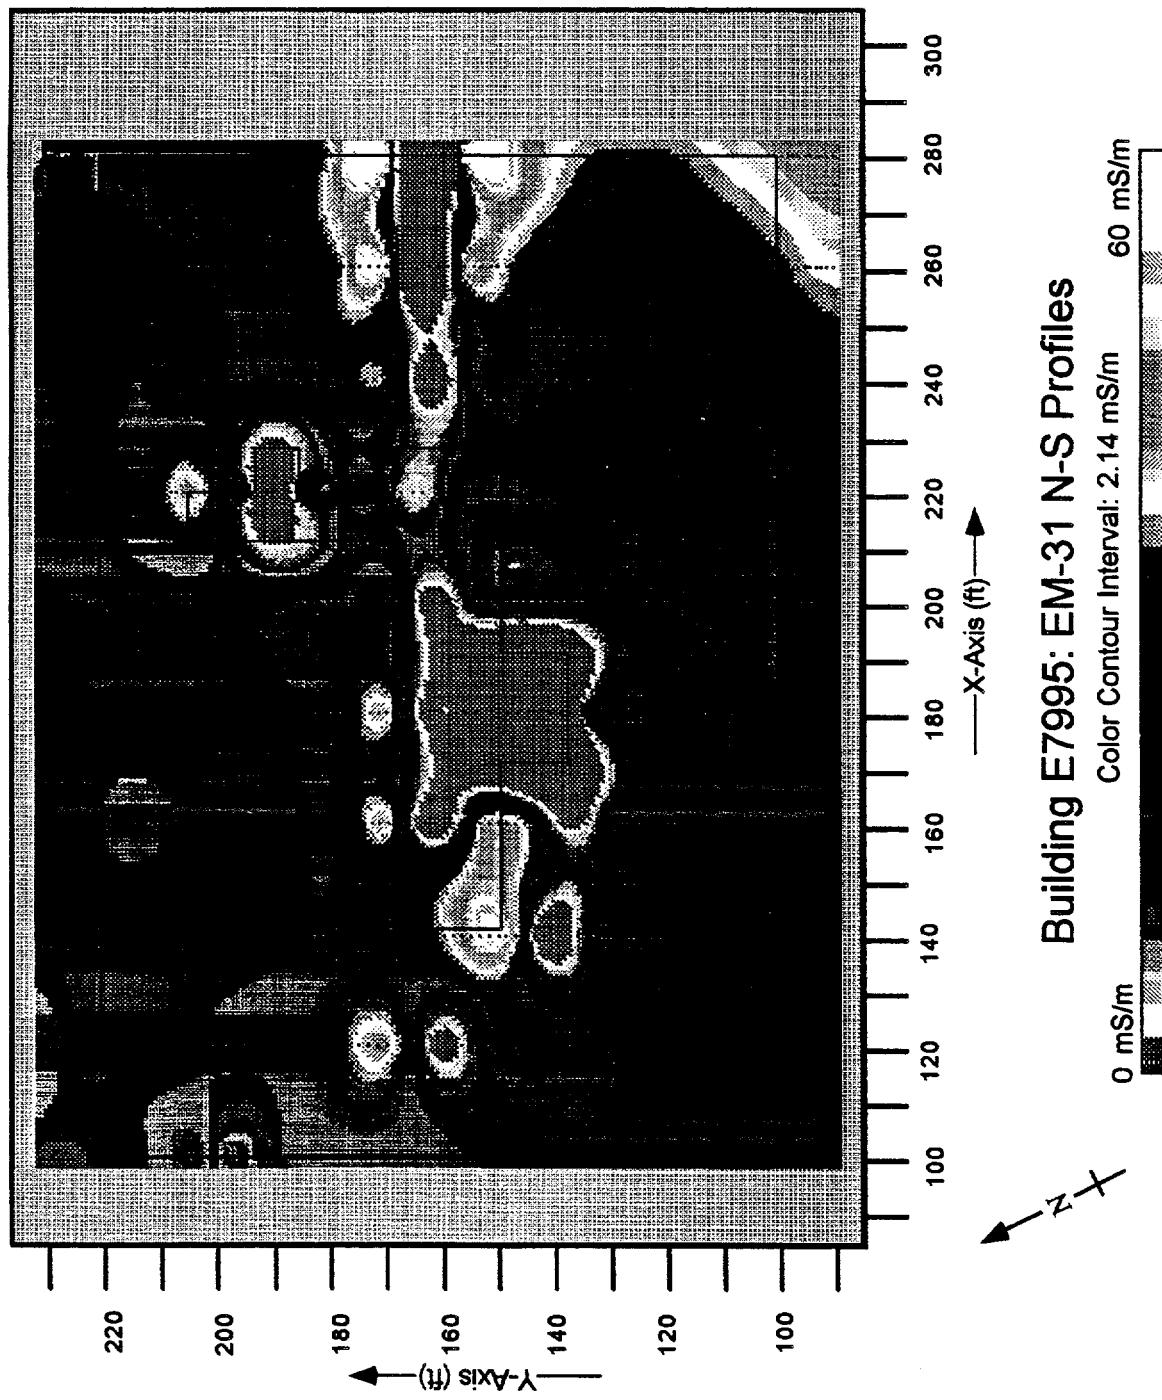
FIGURE 7 N-S EM-31 transects. Also depicted are the positions of data points collected along the geophysical profiles

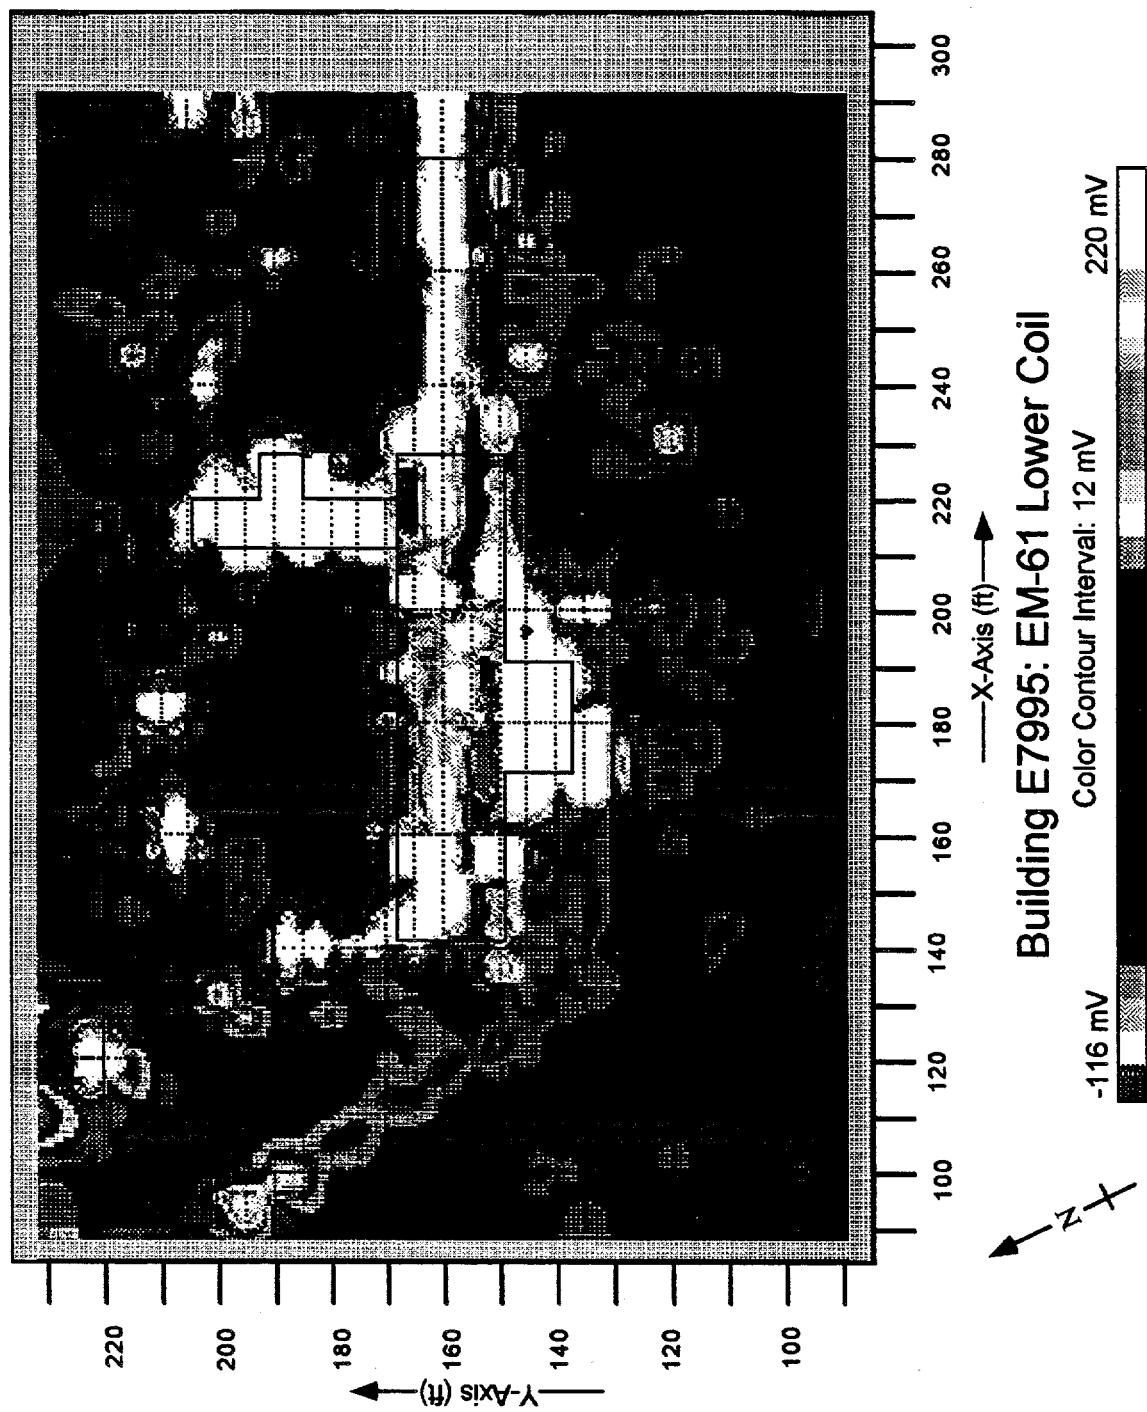
Two prominent lineations dominate the observed EMF (lower coil) near Building E7995 (Figure 8). The narrow EMF positive anomaly observed along the diagonal between (200, 90) and (140, 140), near the western corner of the building is sourced by a buried metal pipeline or utility. Along Y=160, another lower coil EMF positive follows the old road made of amphibolitic fill, which typically produces an EMF positive. However, along Y=160 a positive EM-61 coil difference is observed from the northwestern edge of the slab to the northeastern edge of the survey area at X=300 (Figure 9). If buried metal is causing the signal along Y=160 beneath the slab, then buried metal, such as a pipeline, may also contribute to the observed signal along Y=160 northeast of the building.

Along X=140 between Y=170-190 and along X=200 between Y=114-140, linear positive EMF anomalies are observed on both the lower coil (Figure 8) and the coil difference (Figure 9) channels. These anomalies are sourced by buried metal. Notice that they adjoin the slab near the drains listed by EAI Corp. (1989) and could be sourced by metal drainage pipes.

Point EMF anomalies (lower coil, in Figure 8) are associated with the three metal signs in the survey area and the well at (120, 220). Other point EMF anomalies are observed throughout the geophysical survey and are summarized in Table 1. These anomalies are probably sourced by shallowly buried metal.

FIGURE 8 EM-61 Lower Coil Millivolt Anomaly Map. Also depicted are the positions of data points collected along the geophysical profiles

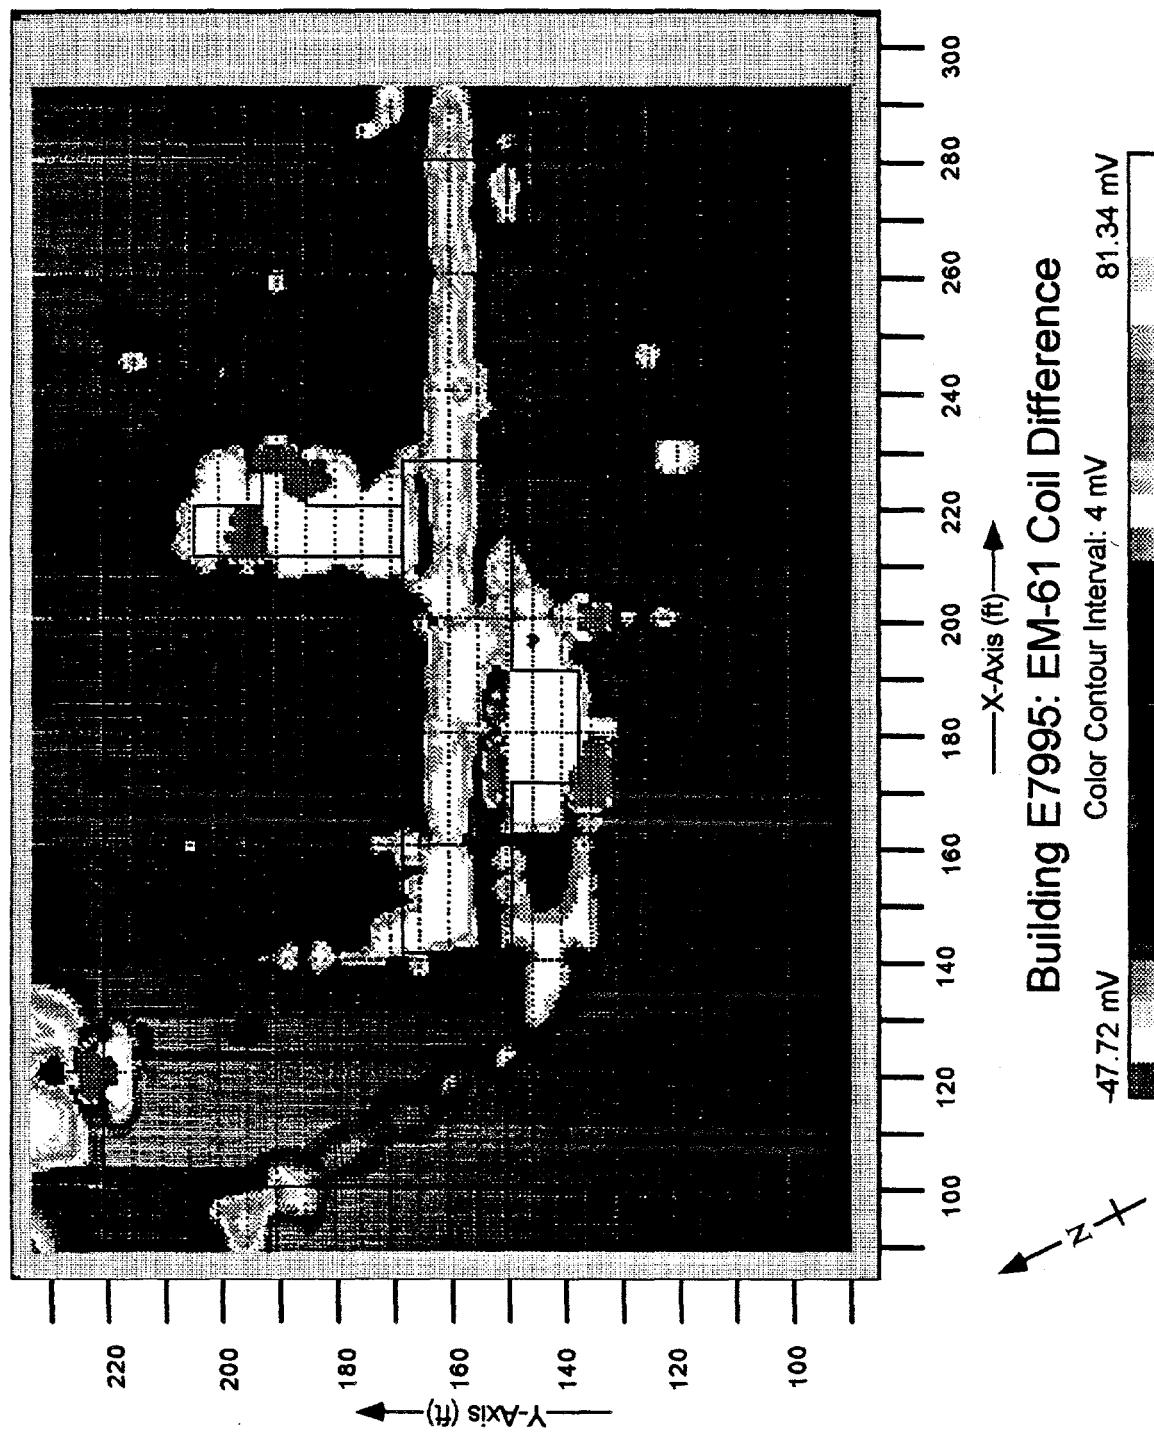
FIGURE 9 EM-61 Coil Difference Millivolt Anomaly Map. Also depicted are the positions of data points collected along the geophysical profiles

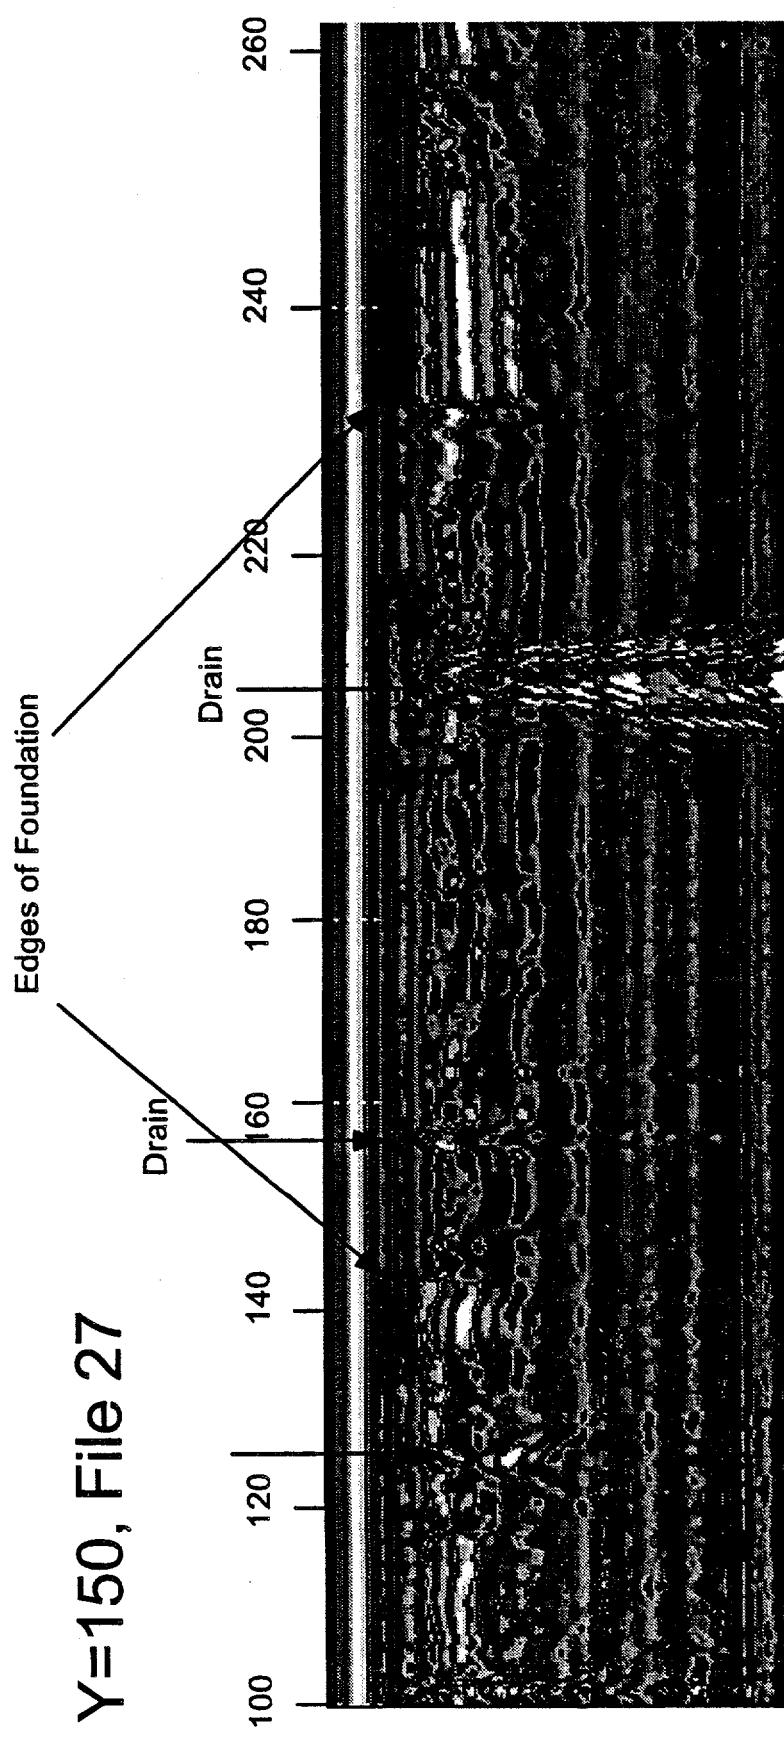
Y=150, File 27

The GPR transect along Y=150 outlines the foundation of E7995, in addition to several isolated GPR anomalies beneath the foundation of E7995. At about (205, 150), a large hyperbola correlates with the location of a known drain (Figure 10). Another smaller hyperbola at (158, 150) is observed near another drain listed by EAI Corp. (1989). On the other hand, strong GPR reflections are uniformly observed beneath the entire control room foundation, suggesting that either the control room's concrete slab is constructed of different material than the main slab, perhaps reinforced with rebar, or is underlain by a large object.

FIGURE 10 Ground Penetrating Radar Profile along Y=150

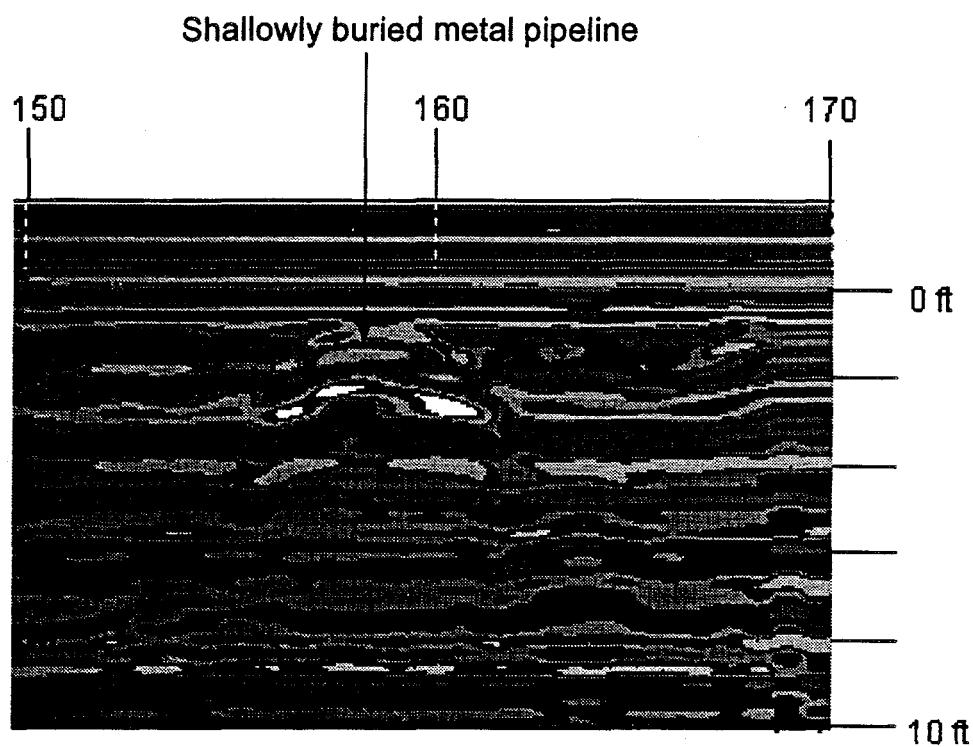
Line 21, X=225

Isolated hyperbolas are observed near Y=160 at a depth of less than 2 ft along four of the five short GPR transects conducted over the northeastern edge of the foundation for E7995, forming an apparent lineation (Figure 11). This lineation has a magnetic, conductivity and EMF counterparts and must be sourced by buried metal. A hyperbola was also detected near (195, 145), above the location of the underground storage tank.

FIGURE 11 Ground Penetrating Radar Profile along X=225

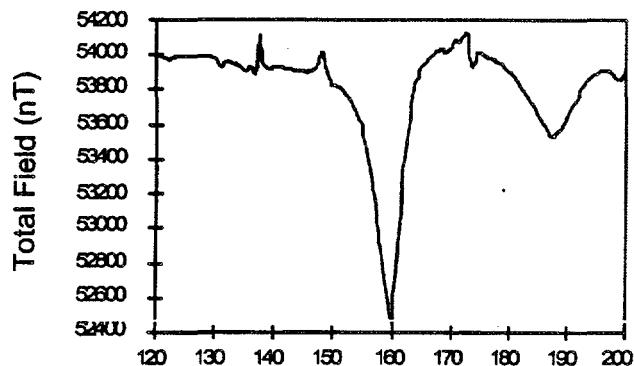
**Total Field Magnetics (nT)**

$$1.5 < x_{1/2} > 2.3$$

$$2 < z_C > 3$$

$z_C = x_{1/2} / 0.768$, assuming point anomaly and source magnetized in direction of current magnetic field.

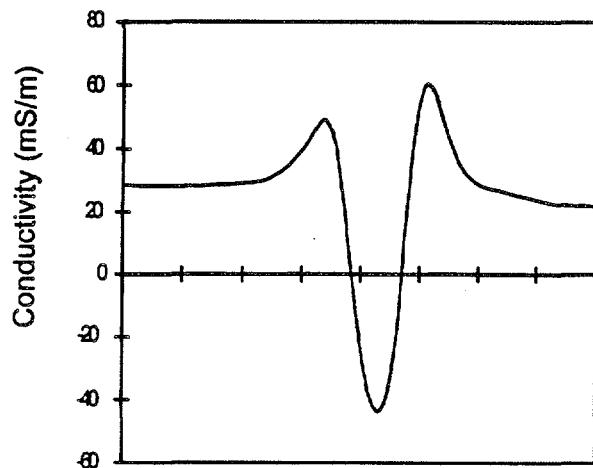
**EM-31 (Conductivity mS/m)**

Can not predict

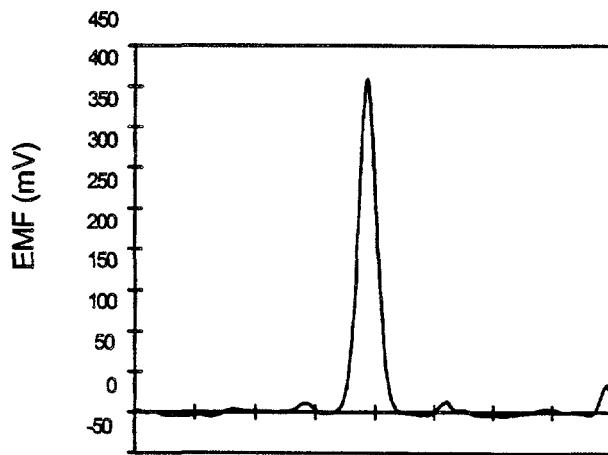
**EM-61 (EMF mV)**

Apparent depth~1.0-1.7 ft
(Pawlowski and others 1995)

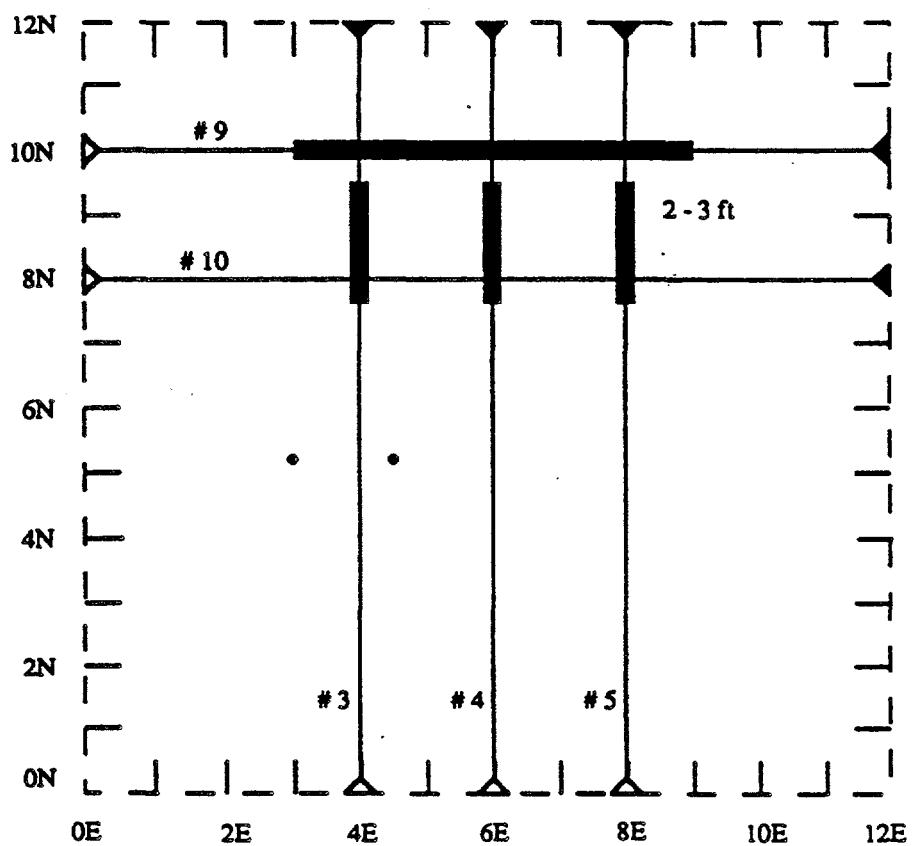
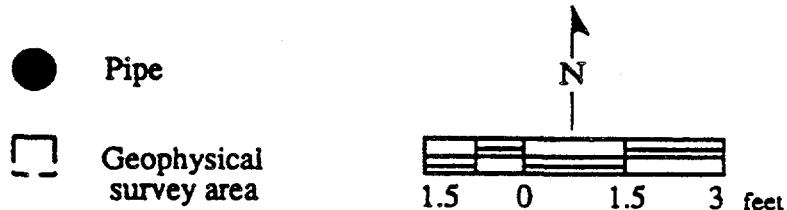
FIGURE 3 Location of GPR Anomalies over the HMF at Building E-7995

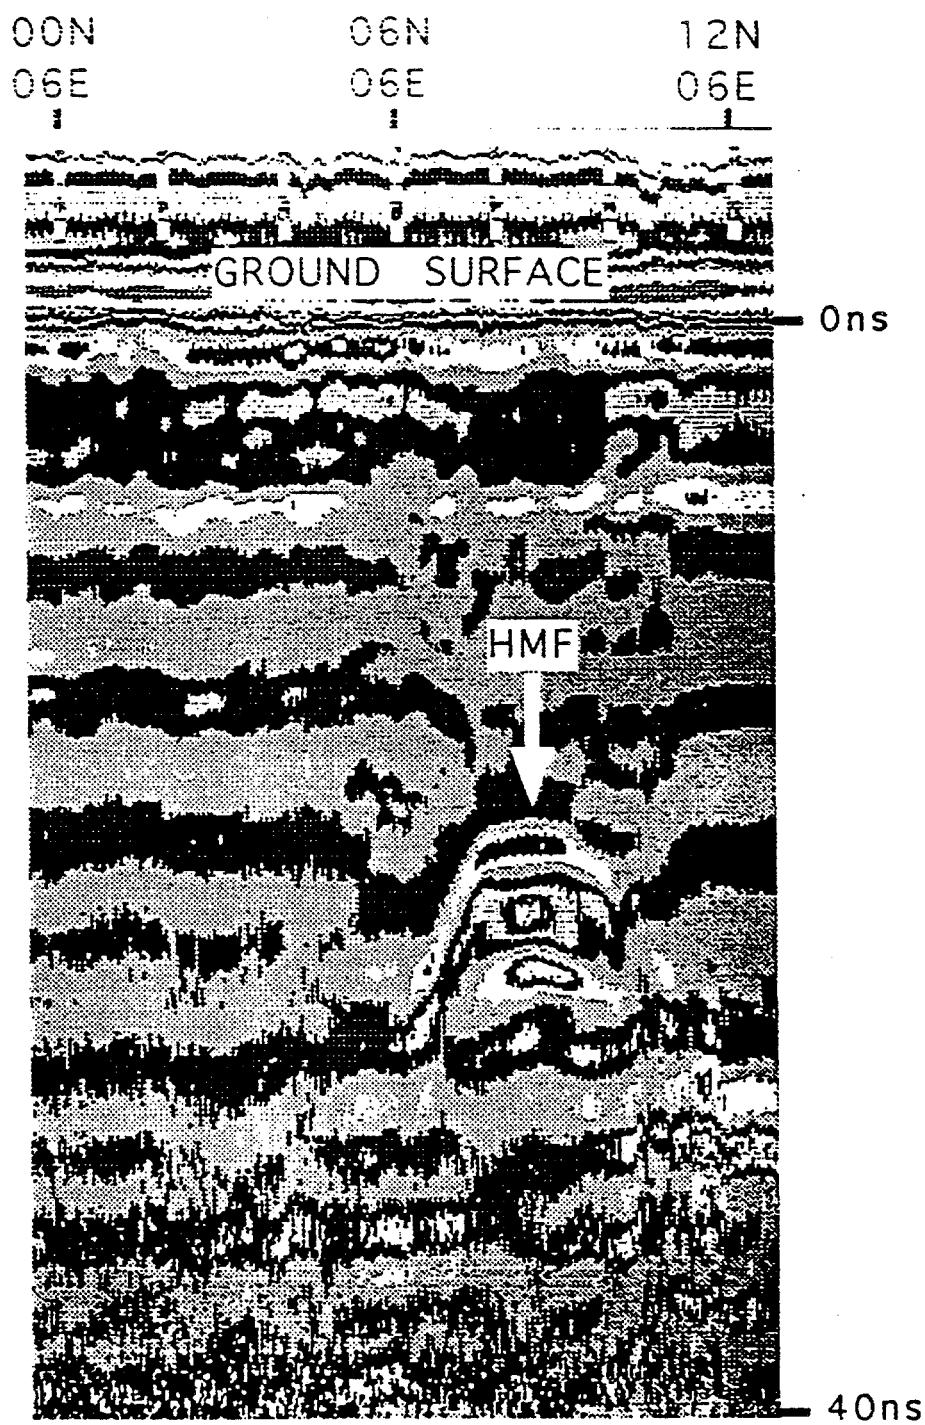
FIGURE 4 South-North Ground-Penetrating-Radar Profile over an HMF at Building E-7995 (The location of this profile is shown in Figure 3 as line No. 4.)
