Post-Closure Inspection Report for the Tonopah Test Range and Nevada Test and Training Range, Nevada

For Calendar Year 2020

U.S. Department of Energy
Environmental Management Nevada Program

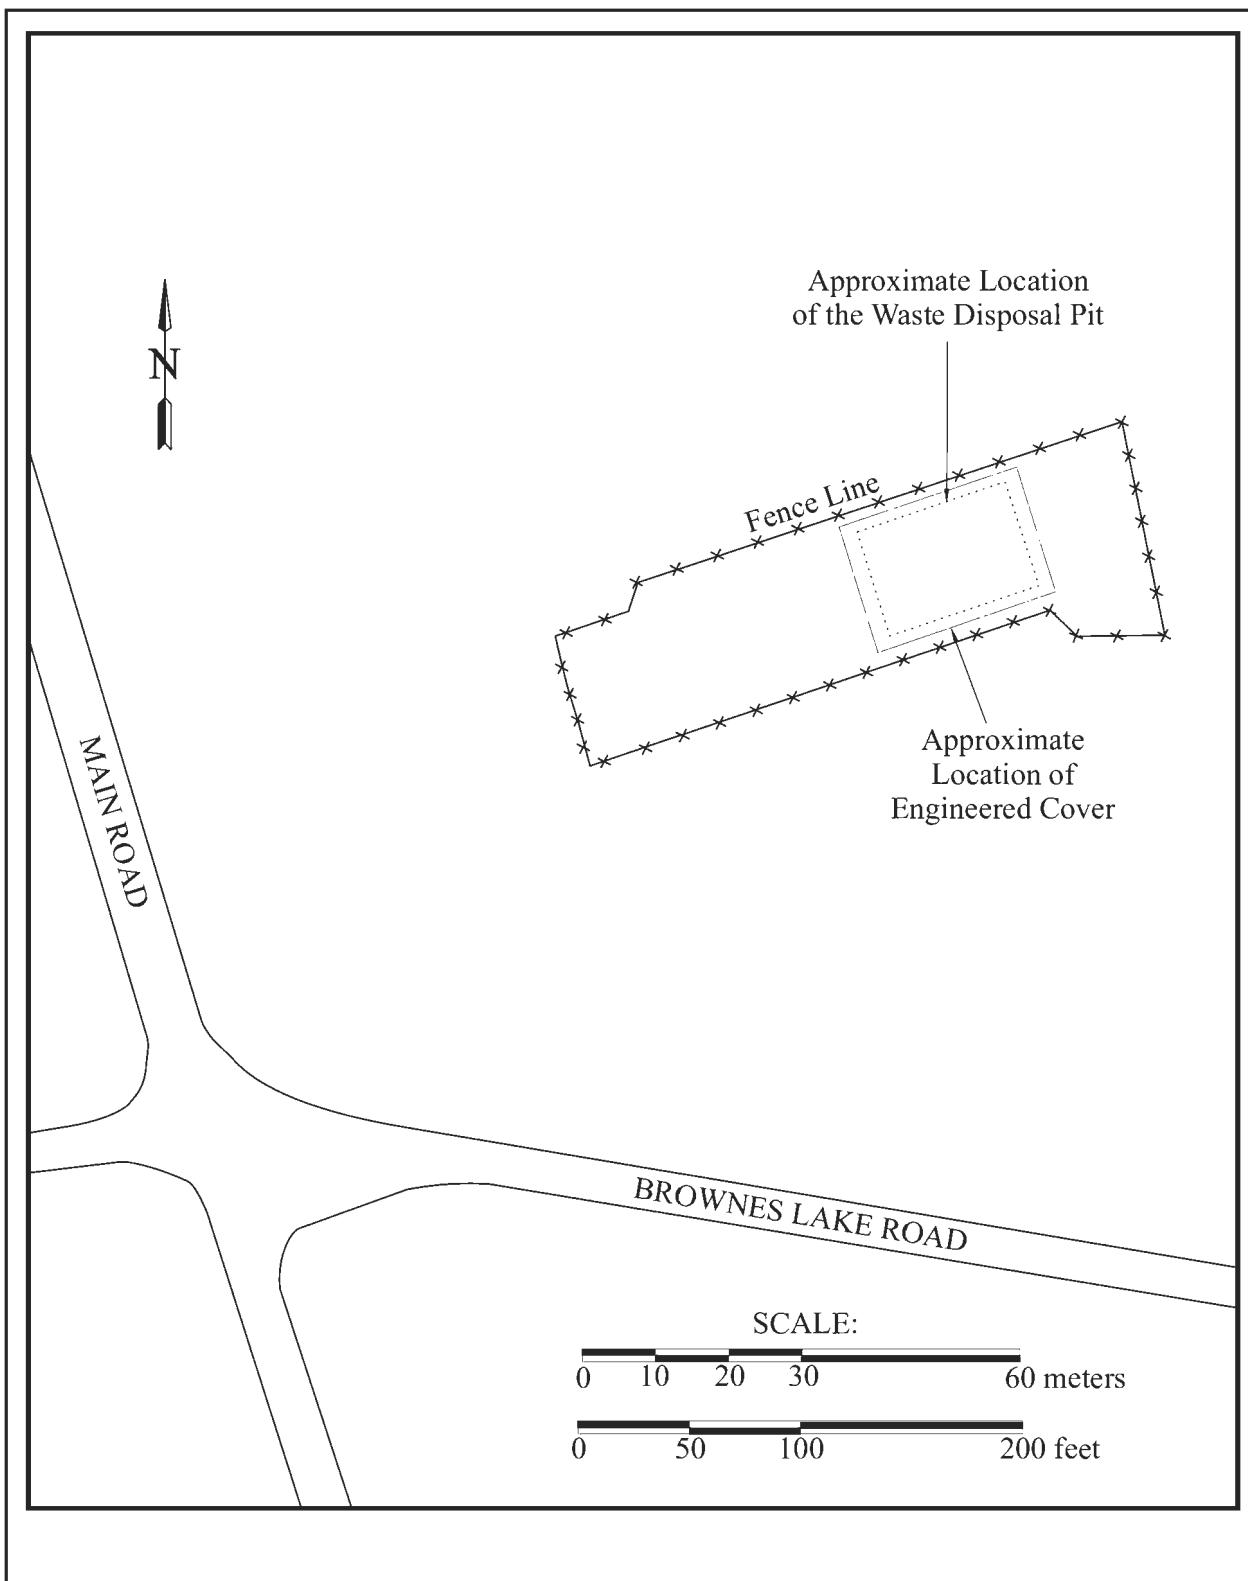
Figure A-2
CAU 407 Roller Coaster RadSafe Area Location Map

The visual inspection was conducted on May 20, 2020. All signs are legible. However, one sign was loose and was rehung during the inspection. No other issues or concerns were identified.

One sign was loose and was rehung during the inspection. No other issues or concerns were identified, and no additional recommendations are proposed at CAS TA-23-001-TARC, Roller Coaster RadSafe Area.

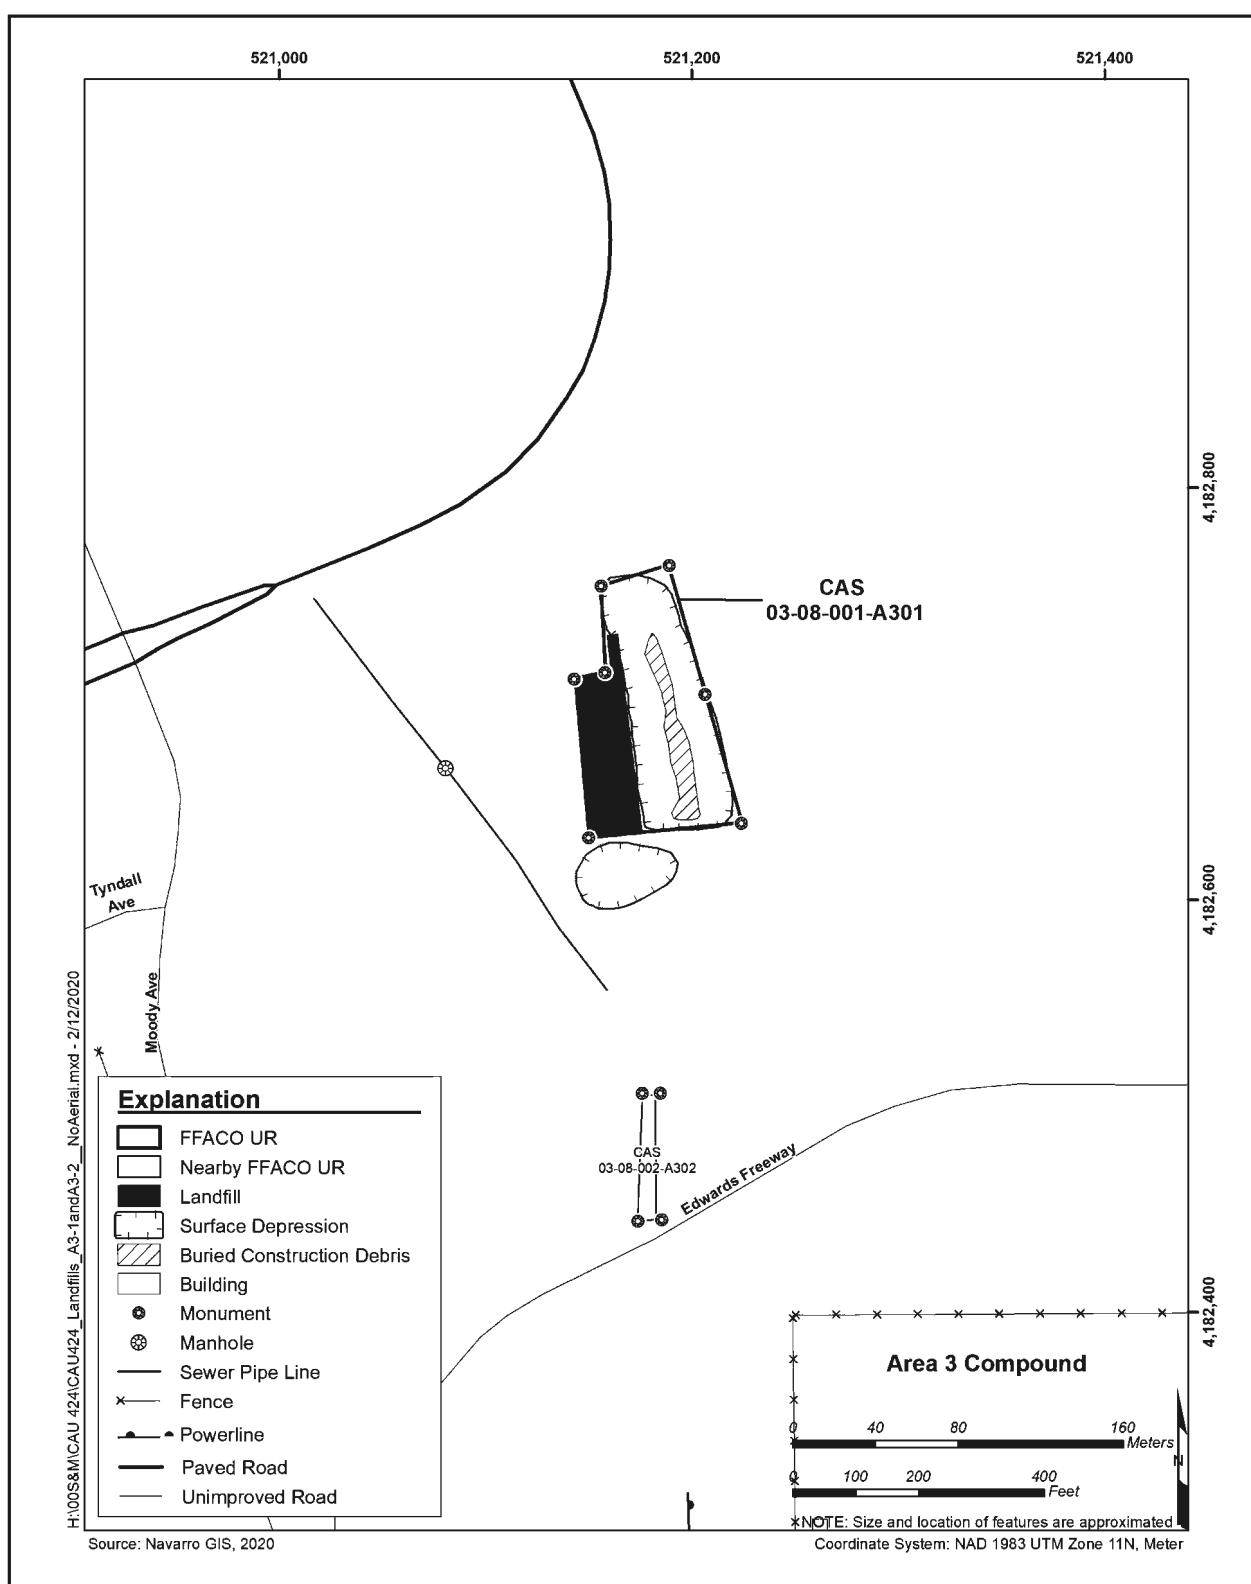
Figure A-4
CAU 424 Landfills A3-1 and A3-2

Landfill Cell A3-1 (CAS 03-08-001-A301): All signs, monuments, survey markers are in good order. Markers denoted landfill identification, and Northings and Eastings. All corner monuments have warning signs. No issues were noted. The site is shown in [Figure A-4 of Appendix A](#).

Landfill Cell A3-2 (CAS 03-08-002-A302): All signs, monuments, survey markers are in good order. Markers denoted landfill identification, and Northings and Eastings. All corner monuments have warning signs. No issues were noted. The site is shown in [Figure A-4](#) of [Appendix A](#).

- **Landfill Cell A3-1 (CAS 03-08-001-A301).** No issues or concerns were identified, and no additional recommendations are proposed.
- **Landfill Cell A3-2 (CAS 03-08-002-A302).** No issues or concerns were identified, and no additional recommendations are proposed.

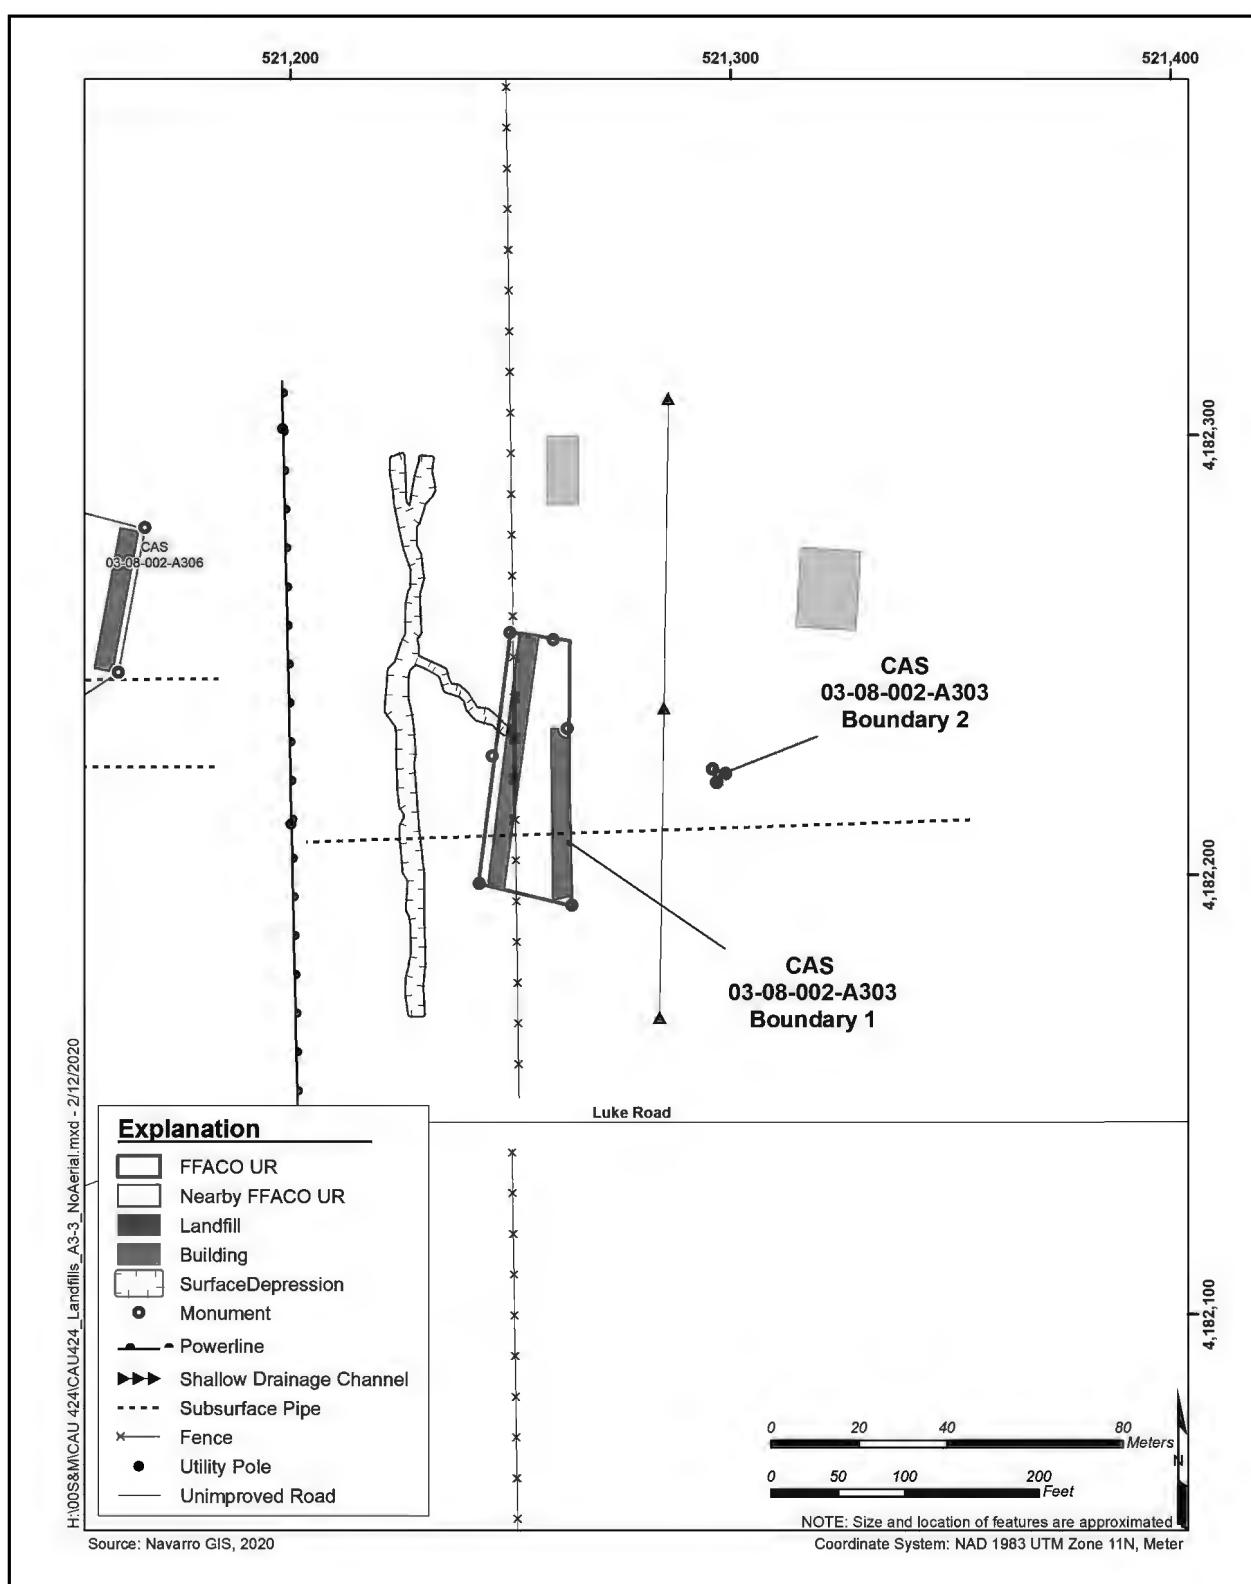
Figure A-5
CAU 424 Landfill Cell A3-3

Landfill Cell A3-3 (CAS 03-08-002-A303): All signs, monuments, survey markers (on the monuments), and ground survey markers are in good order. Markers embedded in aboveground monuments denoted landfill identification, and Northings and Eastings. All aboveground monuments have warning signs. All markers embedded in ground flush monuments denoted landfill identification, and Northings and Eastings. Two markers embedded in ground flush monuments (one per parcel) denoted warning. No issues were noted. The site is shown in [Figure A-5](#) of [Appendix A](#).

- **Landfill Cell A3-3 (CAS 03-08-002-A303).** No issues or concerns were identified, and no additional recommendations are proposed.
- **Landfill Cell A3-4 (CAS 03-08-002-A304).** All monuments (except the northeast) have warning signs. No other issues were noted. A warning sign was mounted on the northeast monument on August 11, 2020. No other issues or concerns were identified, and no additional recommendations are proposed.

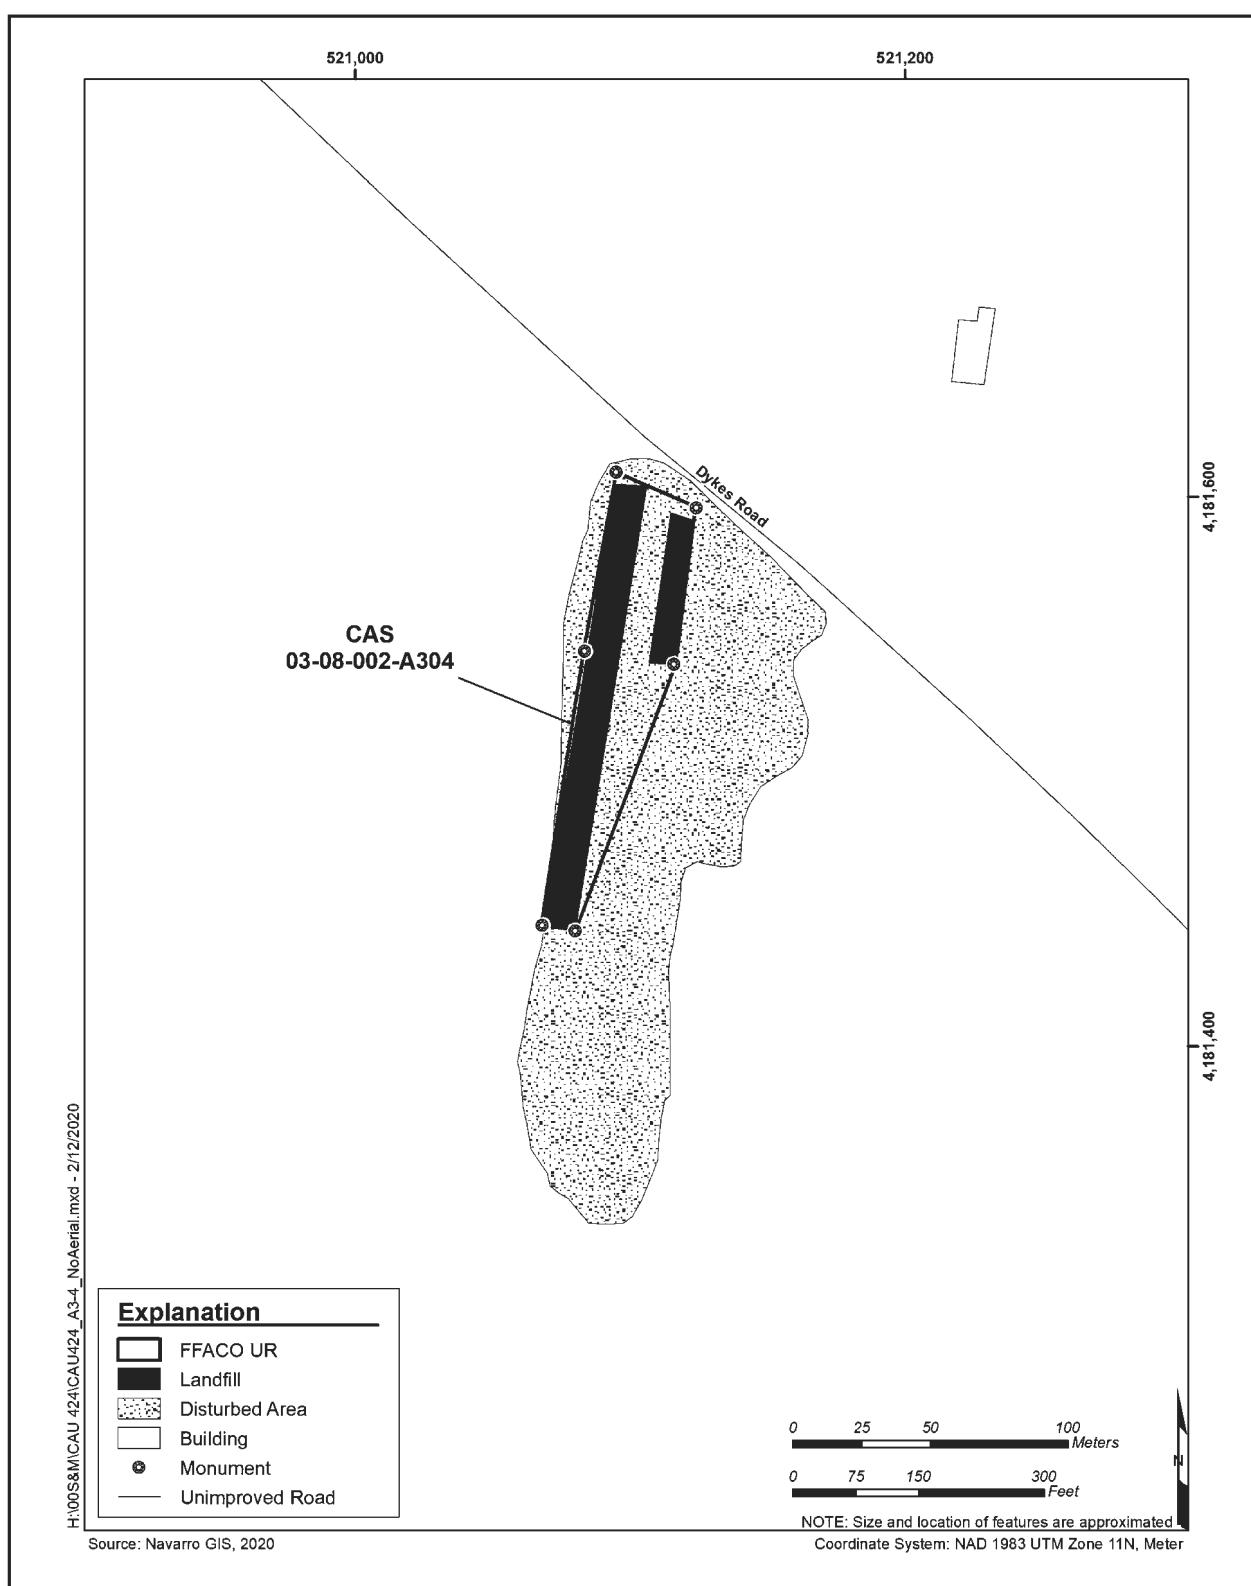
Figure A-6
CAU 424 Landfill Cell A3-4

Landfill Cell A3-4 (CAS 03-08-002-A304): A UR sign needed to be hung on the northeast monument. All other signs, monuments, and survey markers are in good order. Markers denoted landfill identification, and Northings and Eastings. All monuments (except the northeast) have warning signs. A warning sign was mounted on the northeast monument on August 11, 2020. No other issues were noted. The site is shown in [Figure A-6](#) of [Appendix A](#).

- **CAU 407, CAS TA-23-001-TARC (Roller Coaster RadSafe Area):** A UR sign was loose and was rehung during the inspection.
- **CAU 424, CAS 03-08-002-A304 (Landfill Cell A3-4):** The northeast monument needed a UR sign. The UR sign was attached to the monument on August 11, 2020.
- **CAU 424, CAS 03-08-002-A308 (Landfill Cell A3-8):** The southeast monument needed additional lava rock. The lava rock was added during the inspection.

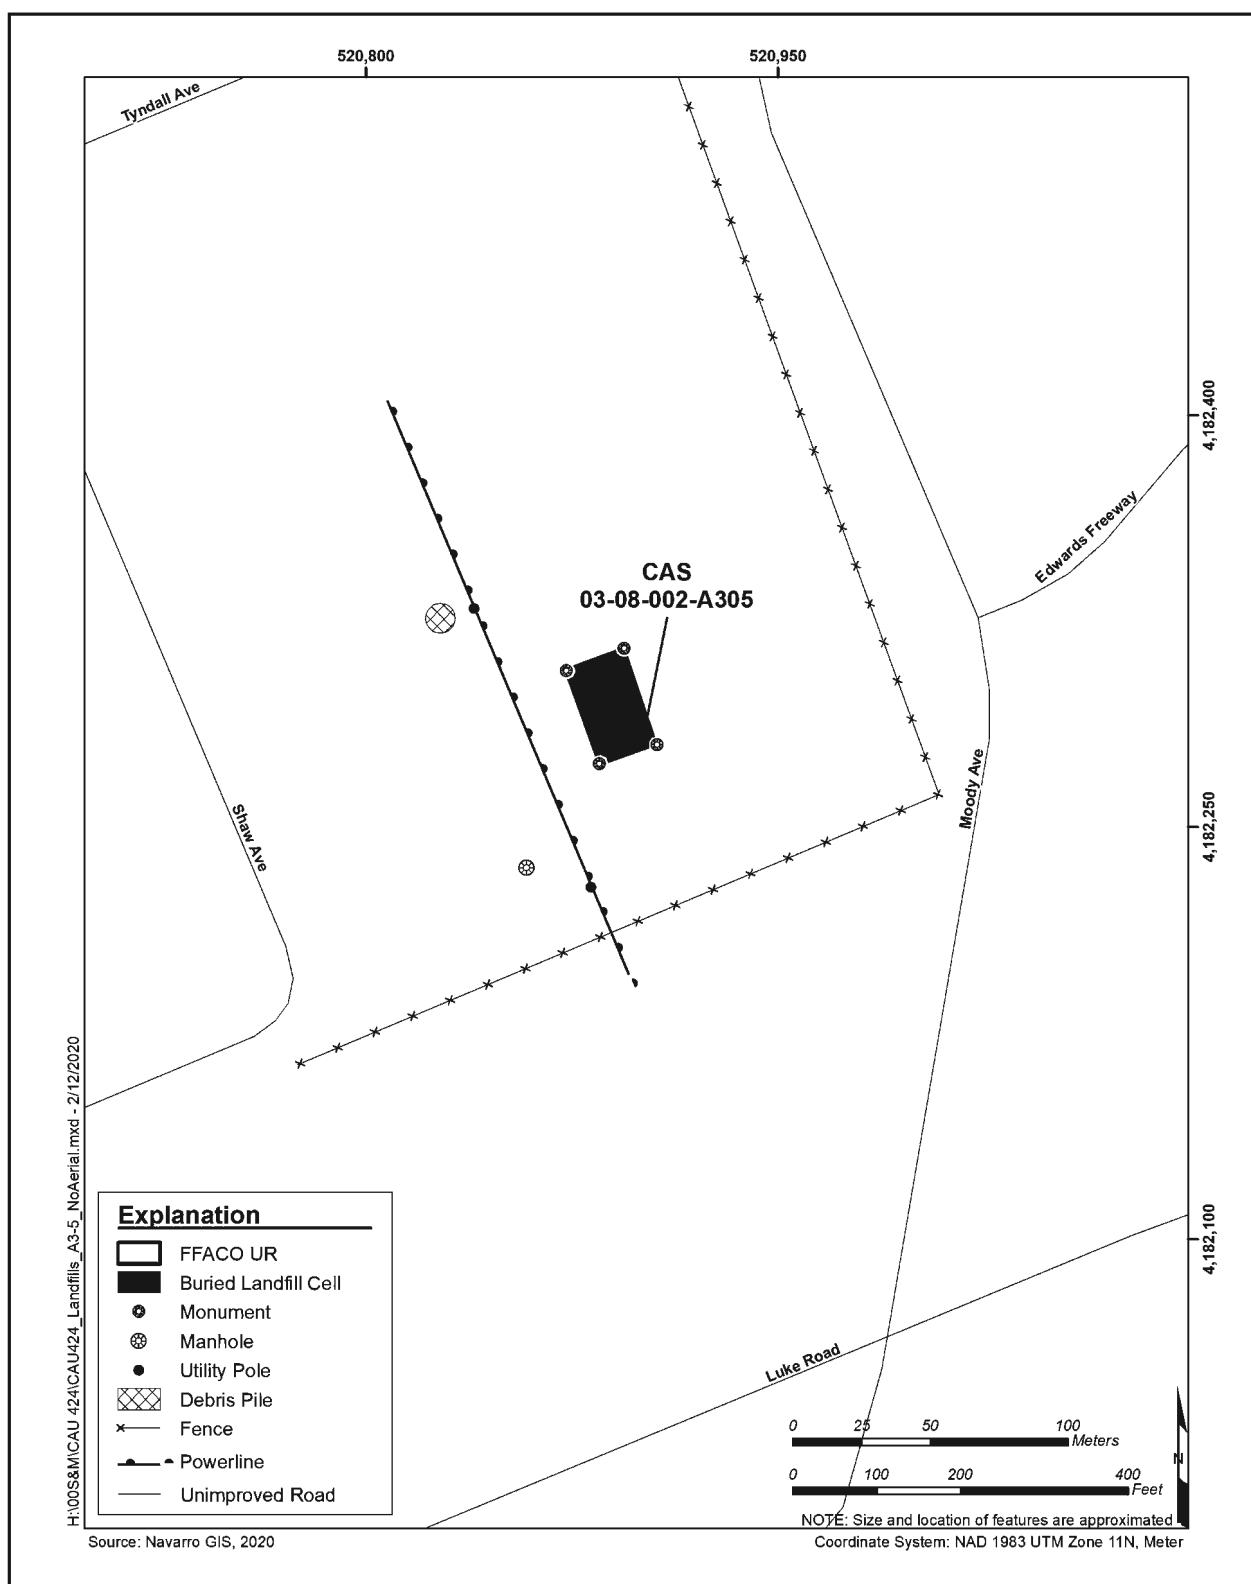
Figure A-7
CAU 424 Landfill Cell A3-5

Landfill Cell A3-5 (CAS 03-08-002-A305): All signs, monuments, and survey markers are in good order. Markers denoted landfill identification, and Northings and Eastings. All monuments have warning signs. No issues were noted. The site is shown in [Figure A-7](#) of [Appendix A](#).

- **Landfill Cell A3-5 (CAS 03-08-002-A305).** No issues or concerns were identified, and no additional recommendations are proposed.
- **Landfill Cell A3-6 (CAS 03-08-002-A306).** No issues or concerns were identified, and no additional recommendations are proposed.

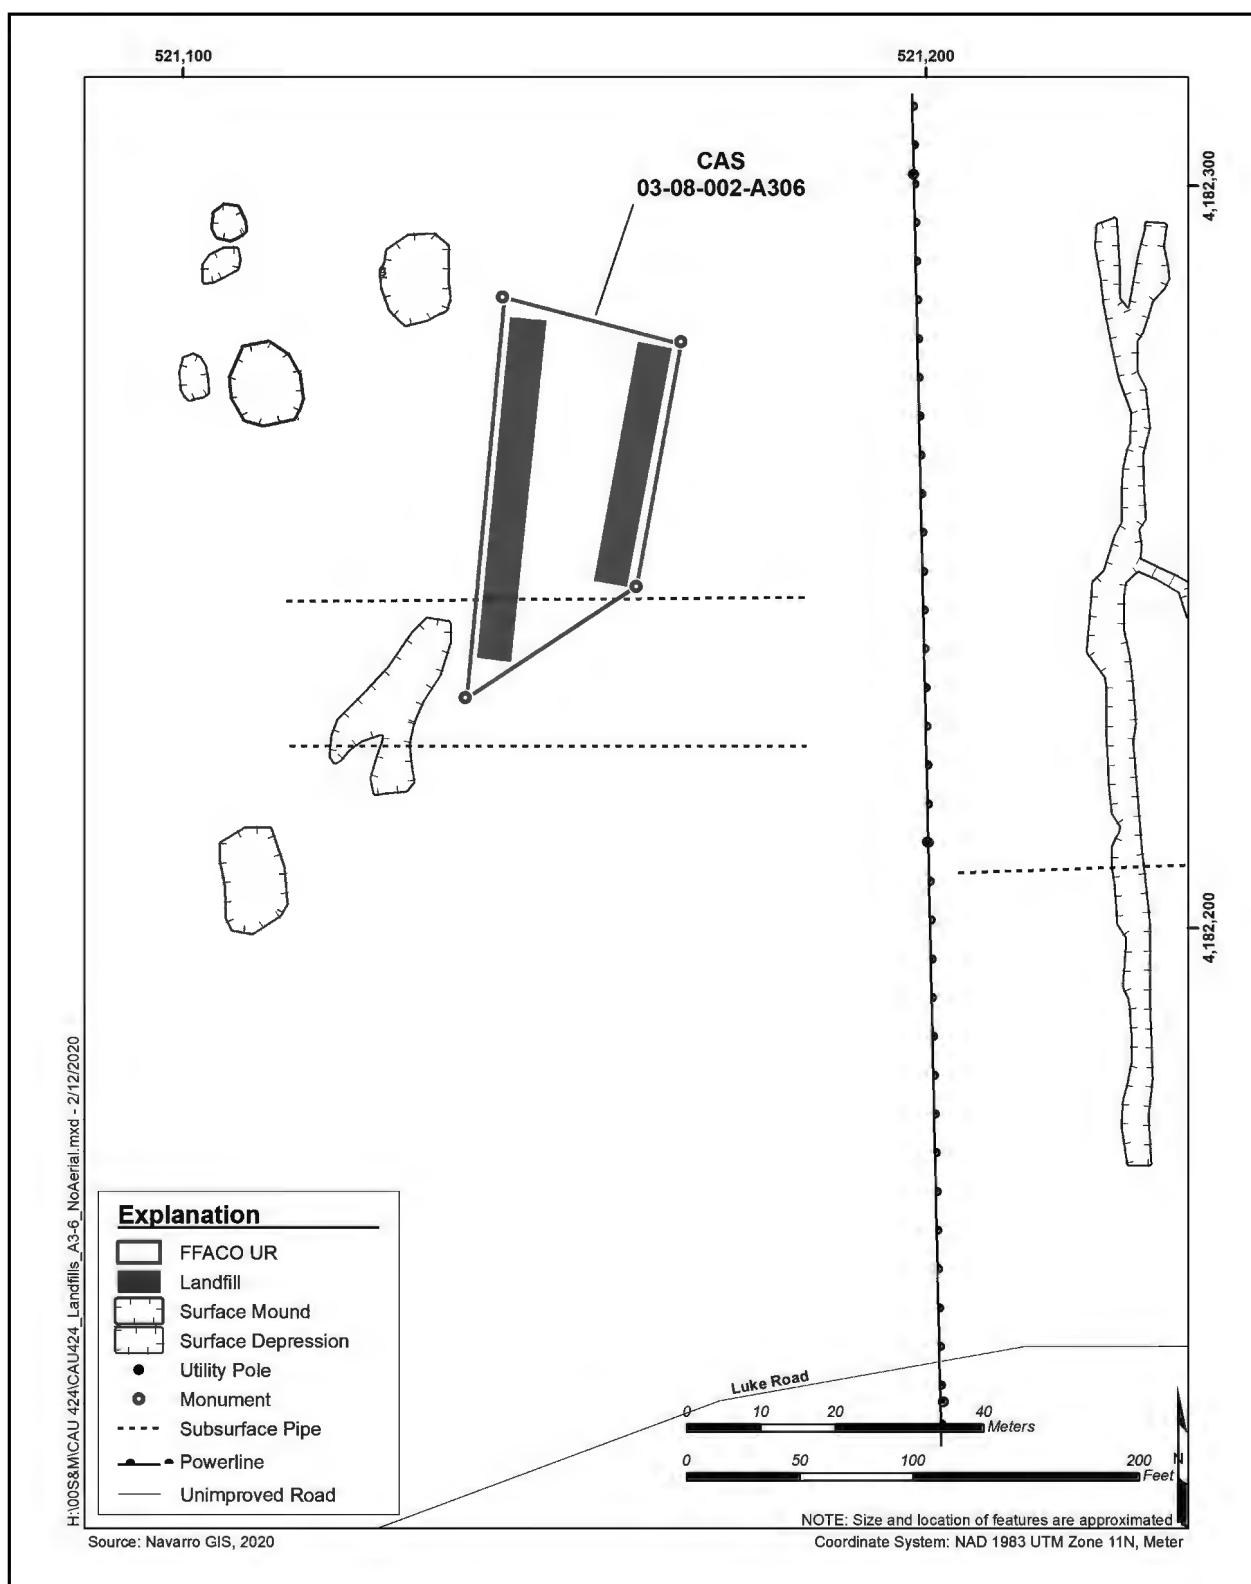
Figure A-8

Landfill Cell A3-6 (CAS 03-08-002-A306): The site is made up of two land parcels: a small triangle-shaped area to the east, and a rectangle-shaped area to the west. All signs, monuments, and survey markers are in good order. Markers denoted landfill identification, and Northings and Eastings. All monuments have warning signs. No issues were noted. The site is shown in [Figure A-8](#) of [Appendix A](#).

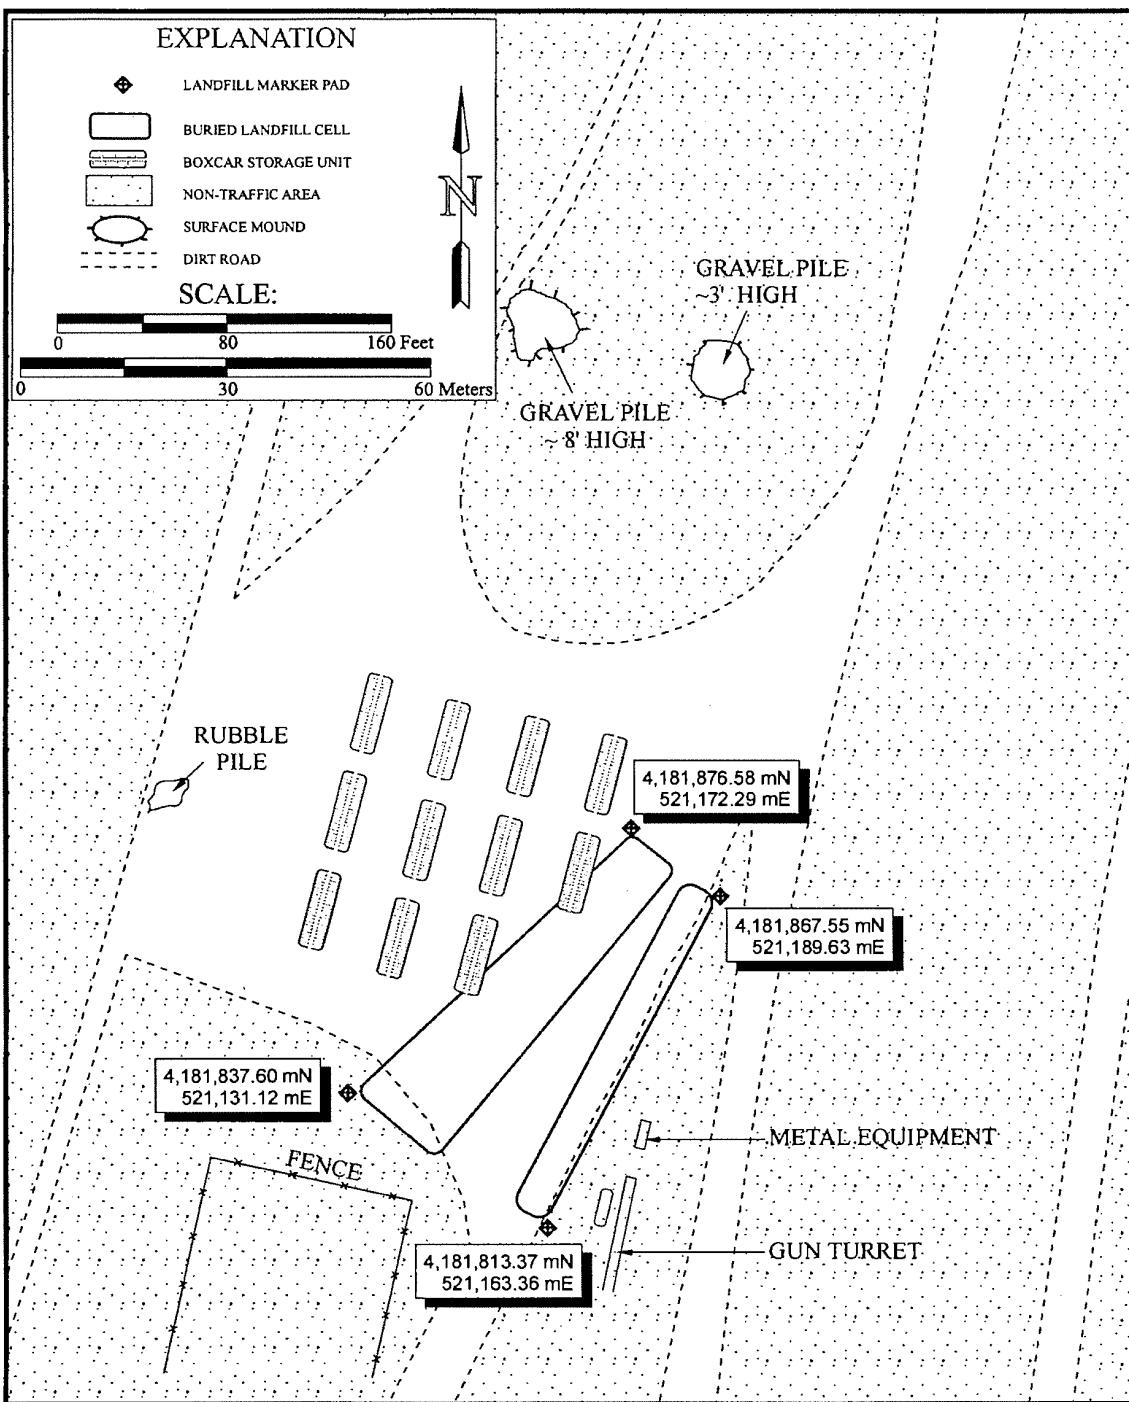
Figure A-9
CAU 424 Landfill Cell A3-8

ground survey marker during the inspection. No other issues were noted. The site is shown in Figure A-9 of Appendix A.

- **Landfill Cell A3-8 (CAS 03-08-002-A308).** Although all ground survey monuments and markers are in good order, additional colored marking rock was added to the southeast ground survey marker during the inspection. No other issues or concerns were identified, and no additional recommendations are proposed.

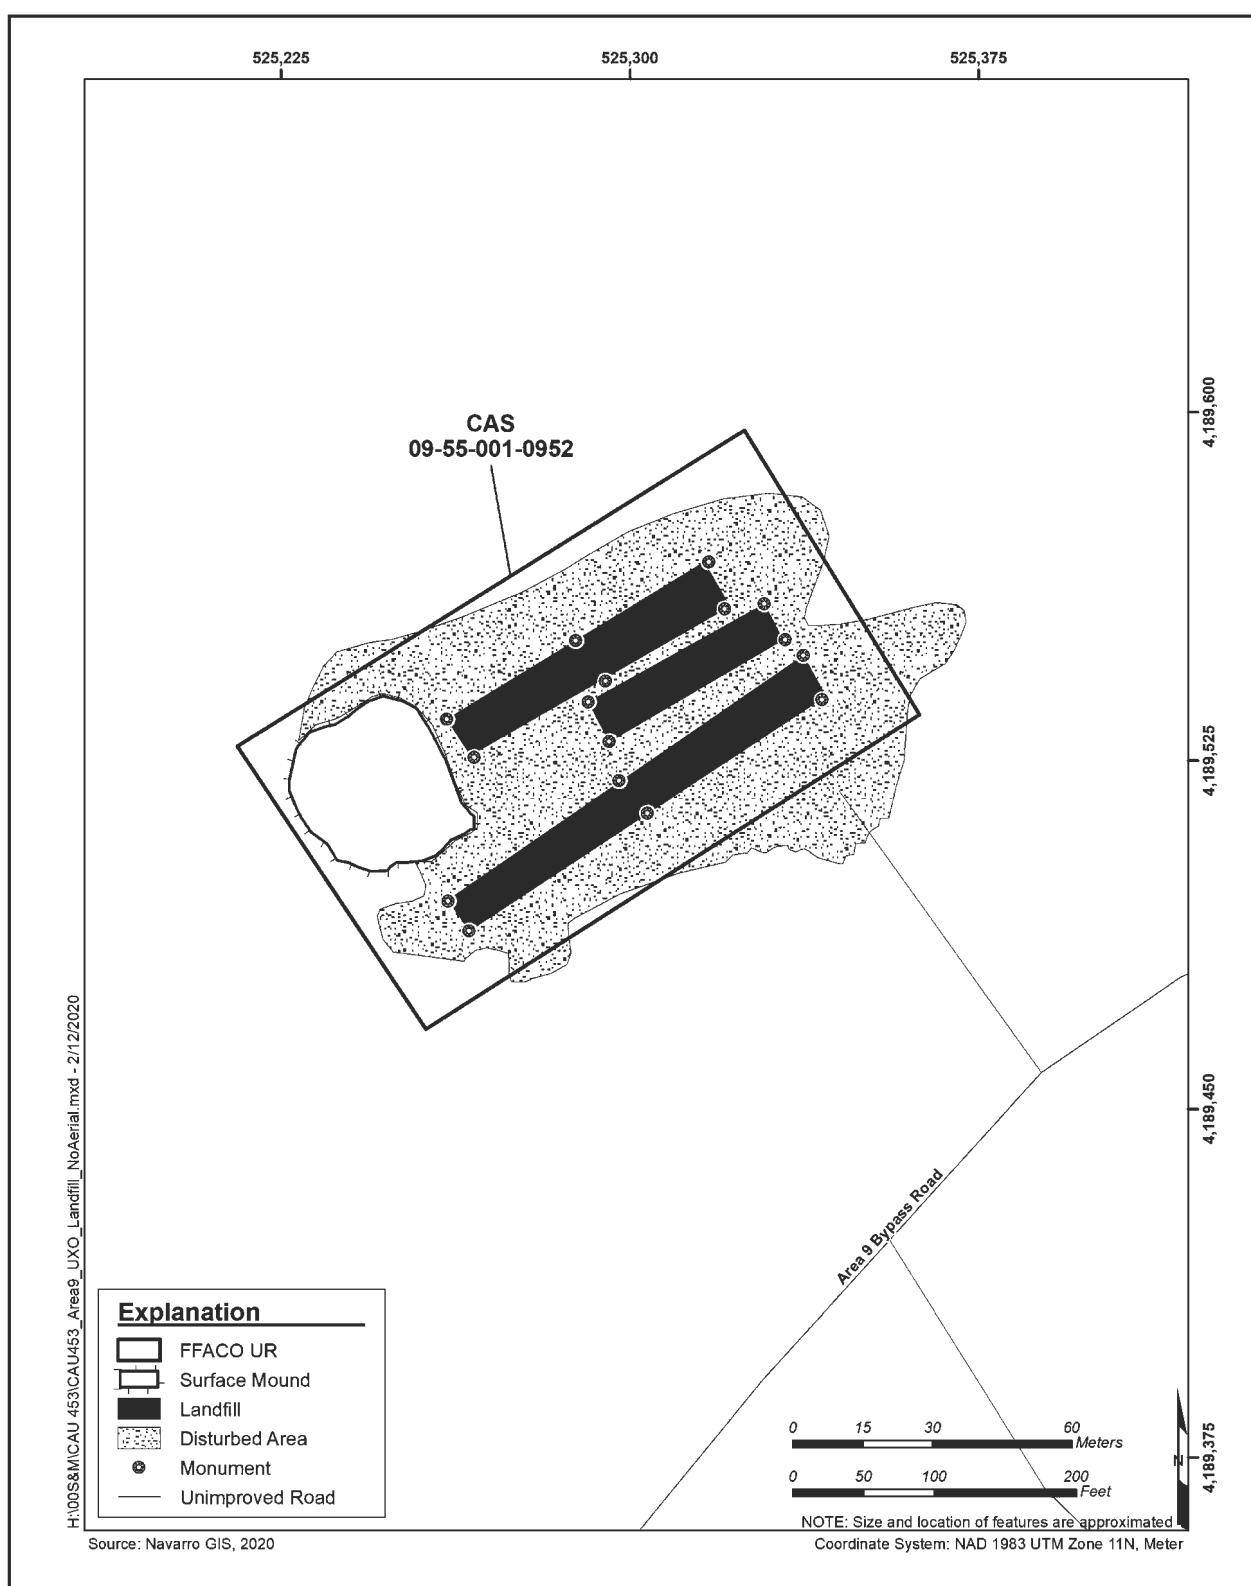
Figure A-10
CAU 453 Area 9 UXO Landfill Location Map

- **CAU 453, CAS 09-55-001-0952 (Area 9 Landfill):** Two animal burrows were noted in the western portion of the northern and southern trenches (one burrow per trench). The animal burrows were repaired on August 11, 2020.

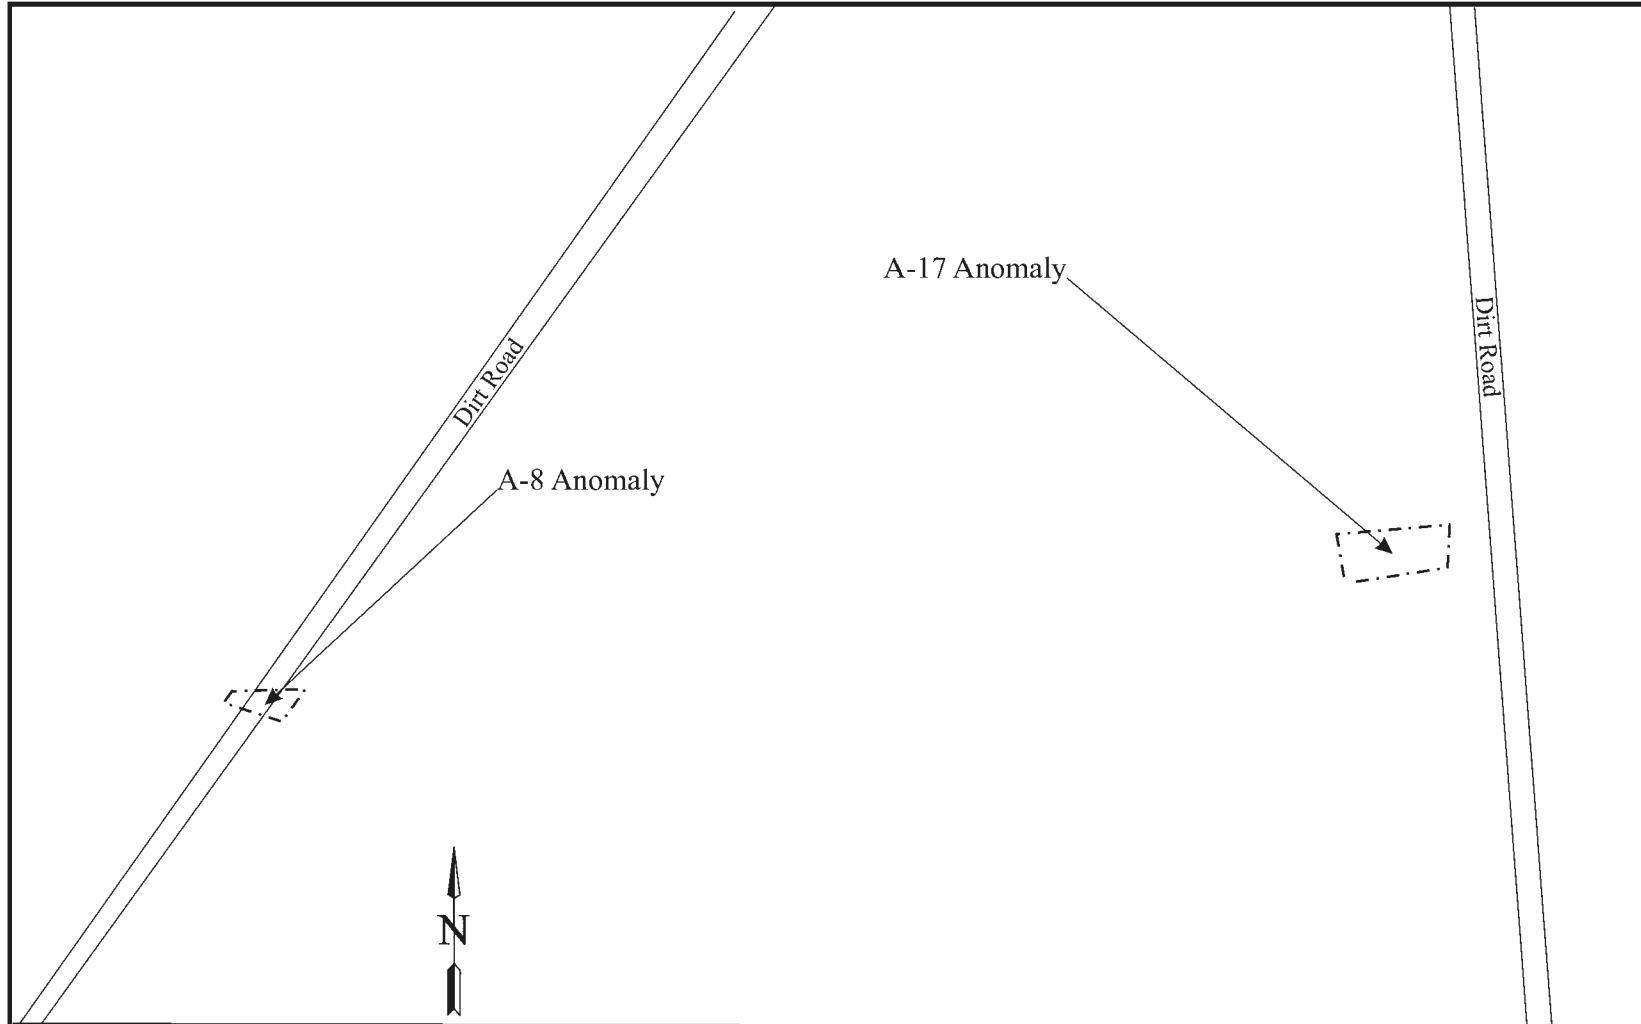
Figure A-11
CAU 487 Thunderwell Site Location Map

Visual inspections are conducted according to the post-closure requirements for CAU 487, Thunderwell Site (TTR), CAS RG-26-001-RGRV, Thunderwell Site, as described in the CAU 487 UR (DOE/EMNV, 2019d). The site is shown in Figure A-11 of Appendix A. The annual inspection was conducted on May 20, 2020. The site is made up of two land parcels: the eastern area of A-17 Anomaly, and the western area of A-8 Anomaly. All signs, monuments, and survey markers are in good order. Markers denote Northings and Eastings. All monuments have warning signs. No issues were noted.

No issues or concerns were identified, and no additional recommendations are proposed at CAS RG-26-001-RGRV, Thunderwell Site.
