PNNL-33428, Rev 0  
DVZ-RPT-085, Rev 0

# Geophysical Characterization and Monitoring of the 200 Area Treated Effluent Disposal Facility to Support Permit Renewal

TEDF Geophysical Monitoring

September 2022

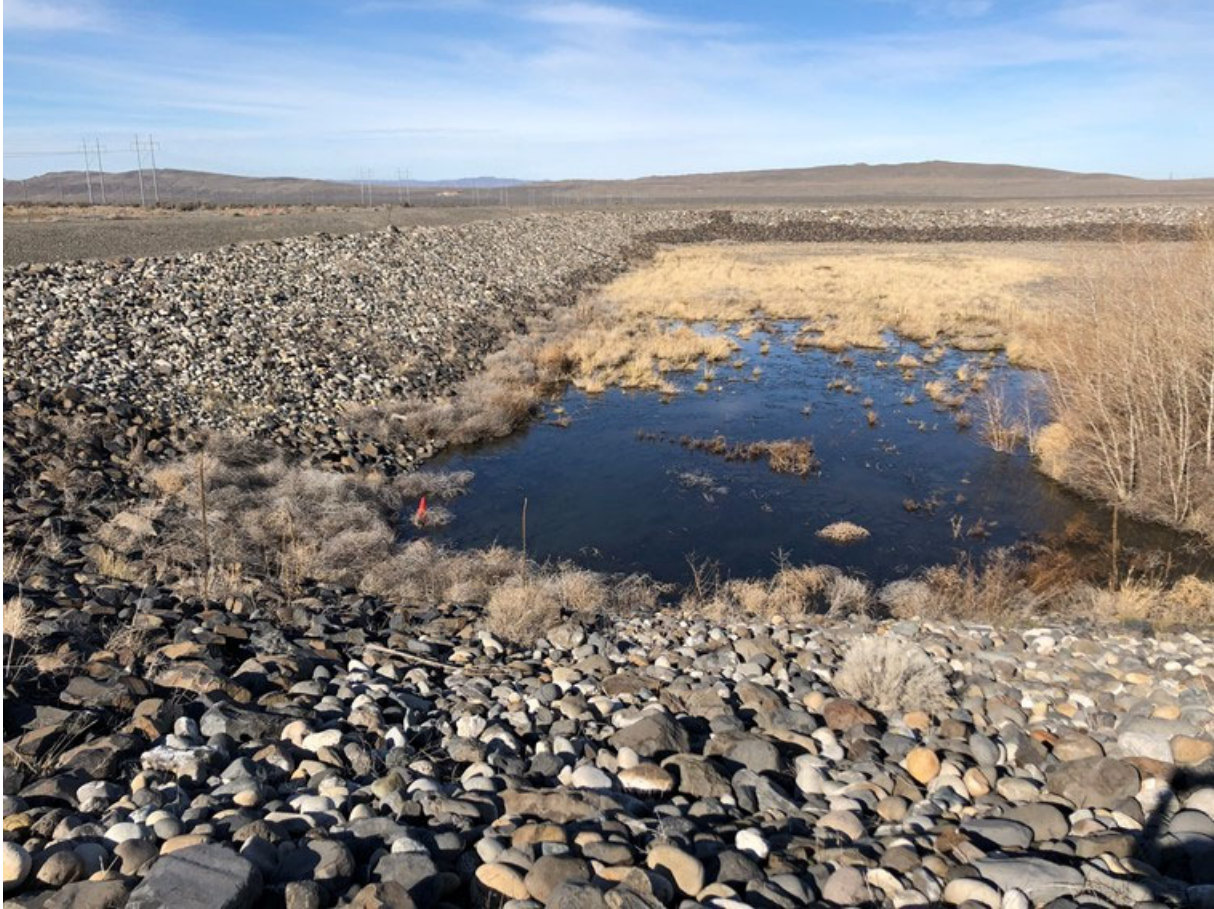
Figure 13. Photograph of the western boundary of the north pond, taken from between the two ponds at approximately (175570 m east, 135900 m north), facing north. The outline of the ponded zone and plant growth (lightly colored region within in the ponded zone) match the surface expression of the change in BEC during north pond discharge (Figure 11).

Figure 13 shows a photograph of the north pond during infiltration. The outline of the ponding water (and the plant growth where water ponds) matches the surface expression of the increase in BEC shown in Figure 12.

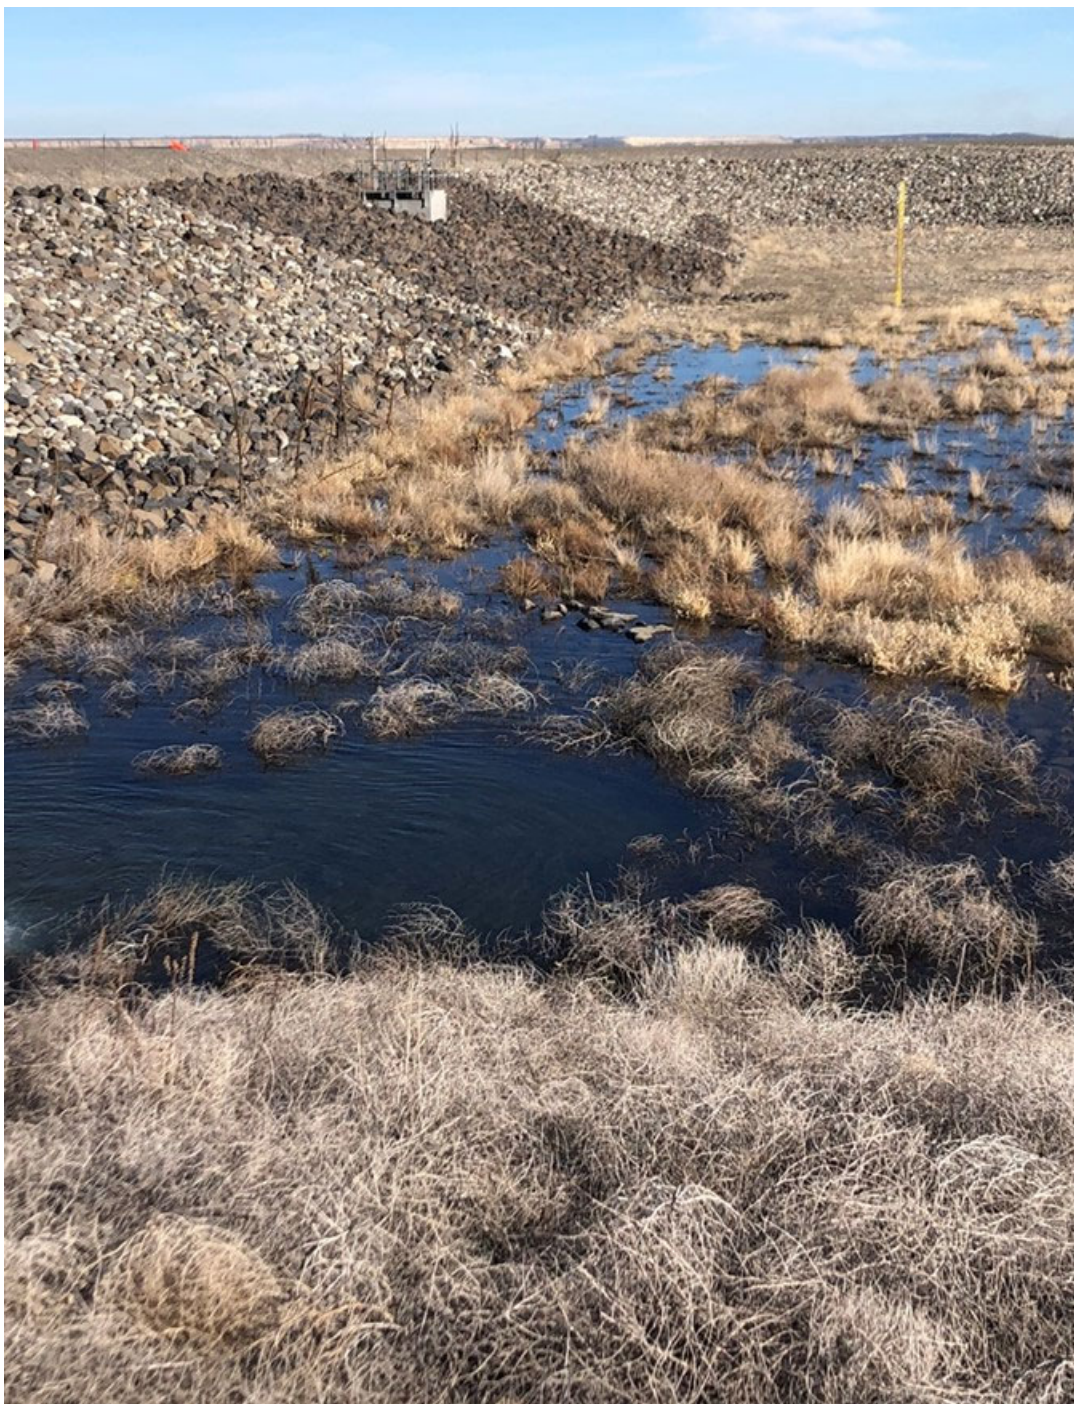
Figure 16. Photograph of the northern boundary of the south pond, standing between the two ponds at approximately (175570 m east, 135880 m north), facing east. The outline of the ponded zone and plant growth (lightly color region within in the ponded zone) match the surface expression of the change in BEC during north pond discharge (Figure 15).

Figure 16 shows a partial photograph of the south pond during discharge, including the northern boundary. The photo was taken from the western margin of the pond facing east and shows that ponded water extends farther to the east in the south pond than in the north pond, just as shown in the time-lapse ERT images. The southern extent of the ponded zone is not visible in the photograph, but also matches the increase in conductivity at the surface shown in Figure 15.
