# Atmospheric Corrosion Of Laser Powder Bed Fusion 316L Stainless Steel

AMPP 2022 Annual  
Conference + Expo  
March 6<sup>th</sup> to 10<sup>th</sup>, 2022 -  
San Antonio, TX

Michael A. Melia  
Senior Member of Technical Staff - R&D S&E Material Science

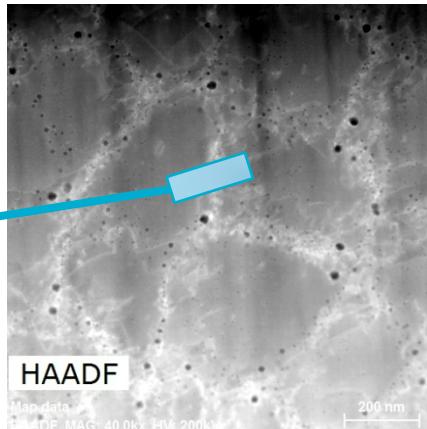
### Recast layer from a part removed with wire EDM

Cu and Zn penetrate 5 to 10 μm deep.

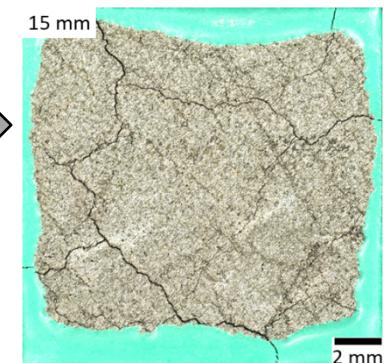
## Residual stress of 316L cubes

### Stress XX (MPa)

Leads to susceptibility to stress corrosion cracking

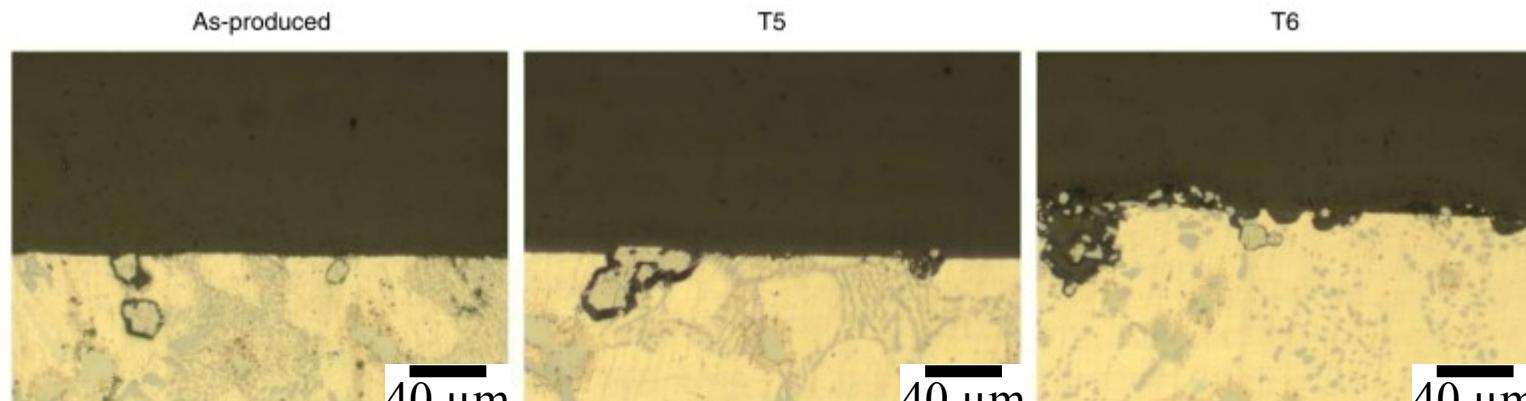
Cast Al-10Si-Mg

Cross-section images after 31 days of ASTM G85-A2 exposures

- Corrosion damage morphology was dictated by AM microstructure. They hypothesize that melt pool boundaries act as barriers to corrosion propagation.
- Maximum corrosion depth was greater for AM compared to cast.

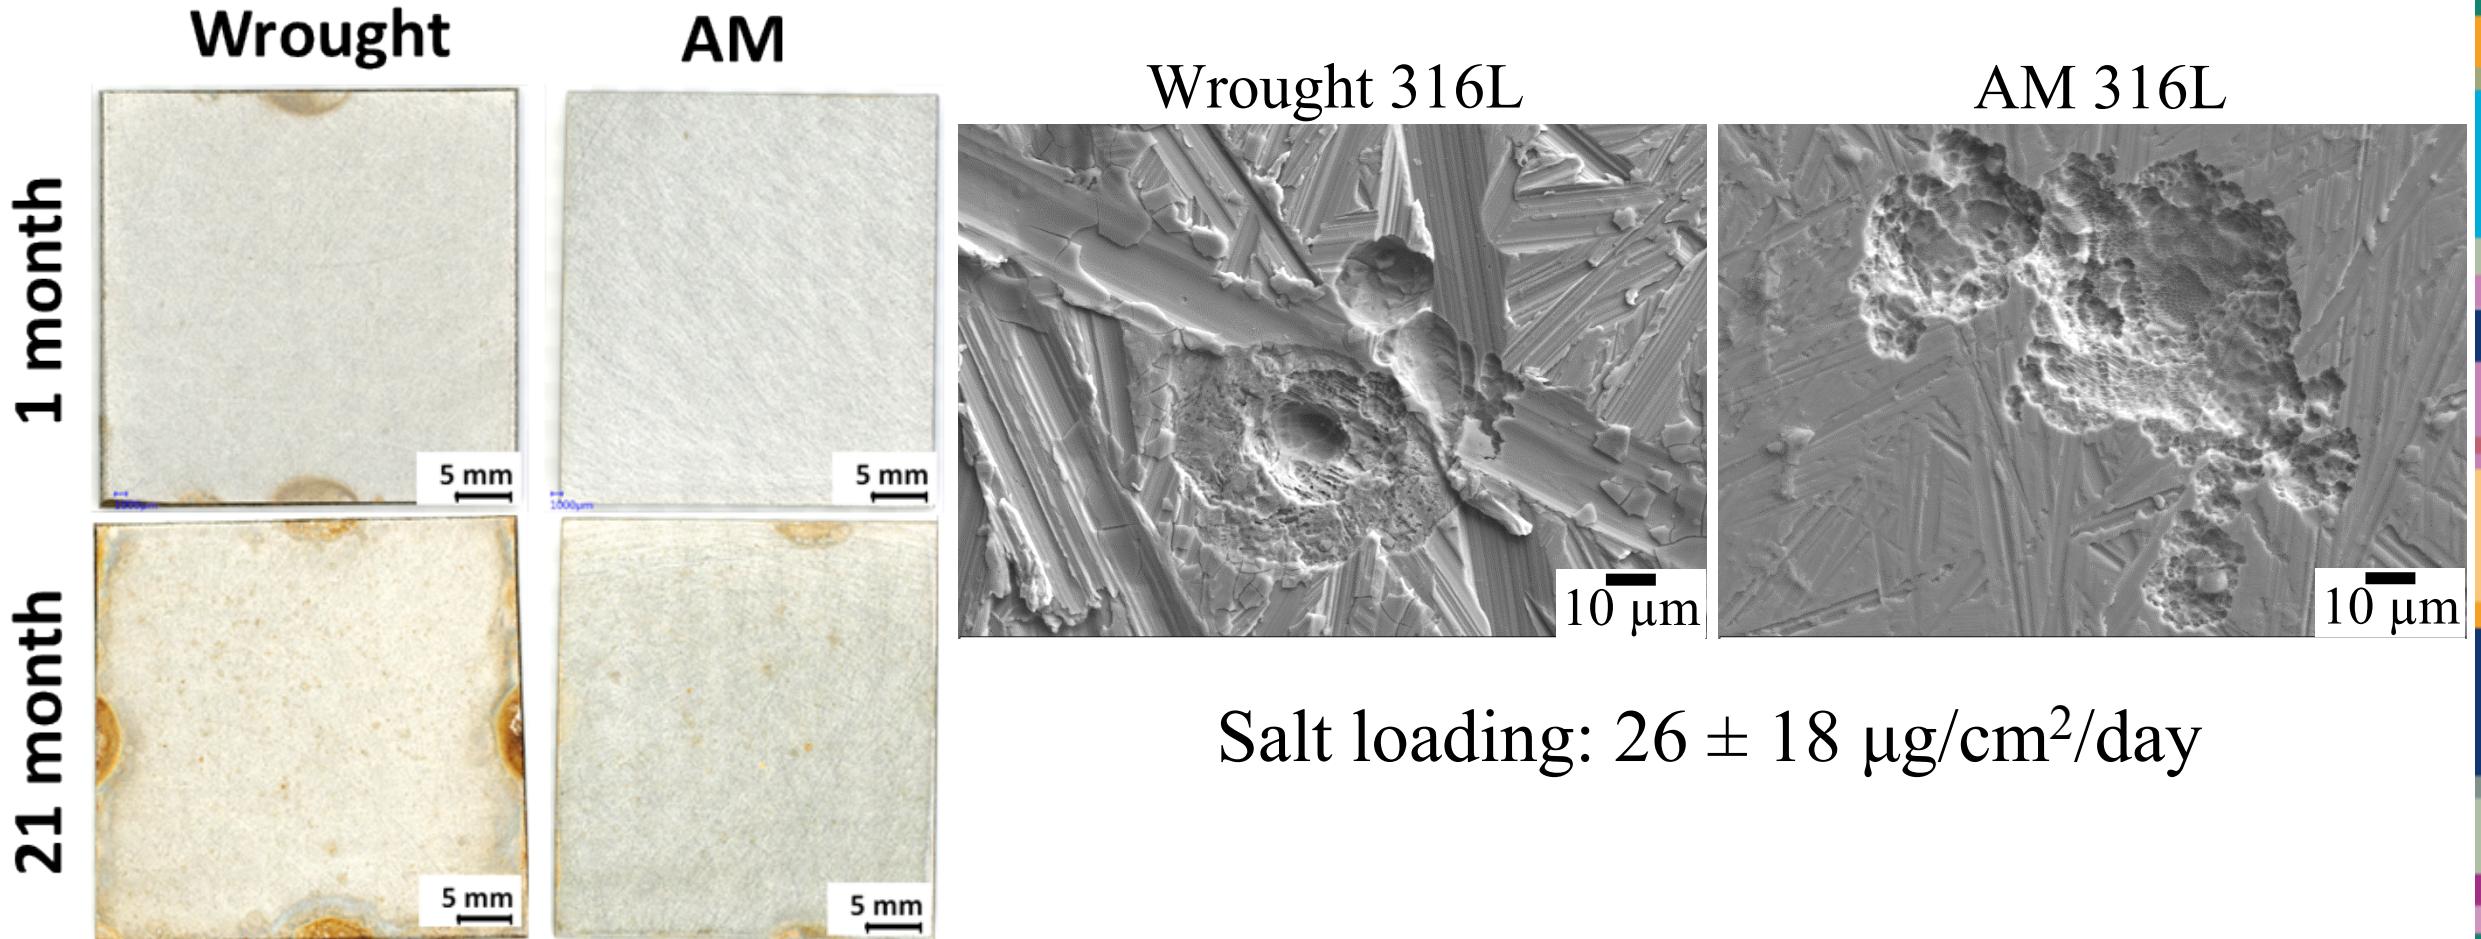
# Background – Coastal exposures of AM 304L/316L

- The pit morphology for AM 316L showed significant preferential corrosion attack of the cellular microstructure, the cell boundaries were not as vulnerable.
- Pit depth of AM samples were smaller than wrought samples (often larger pit density).

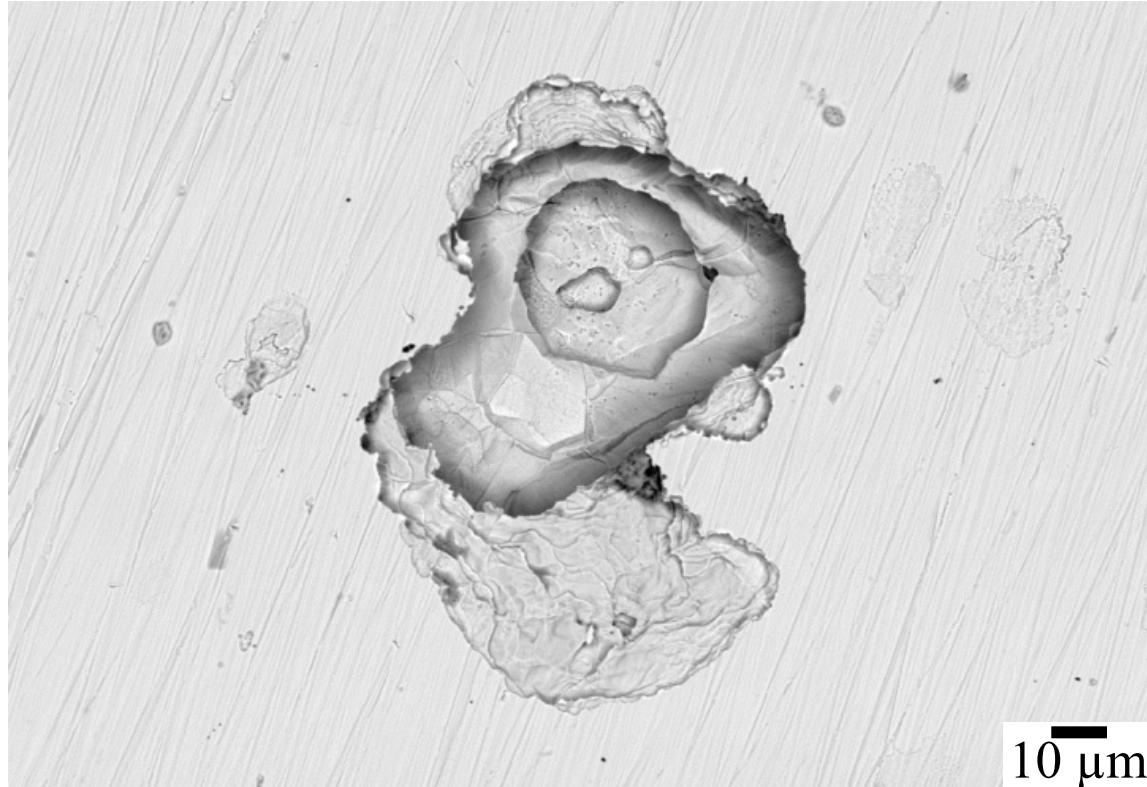
**Wrought**

# Optical images of 316L specimen with $300 \mu\text{g}/\text{cm}^2$ ASW at 40% RH

Cleaned surfaces with nitric acid solution.

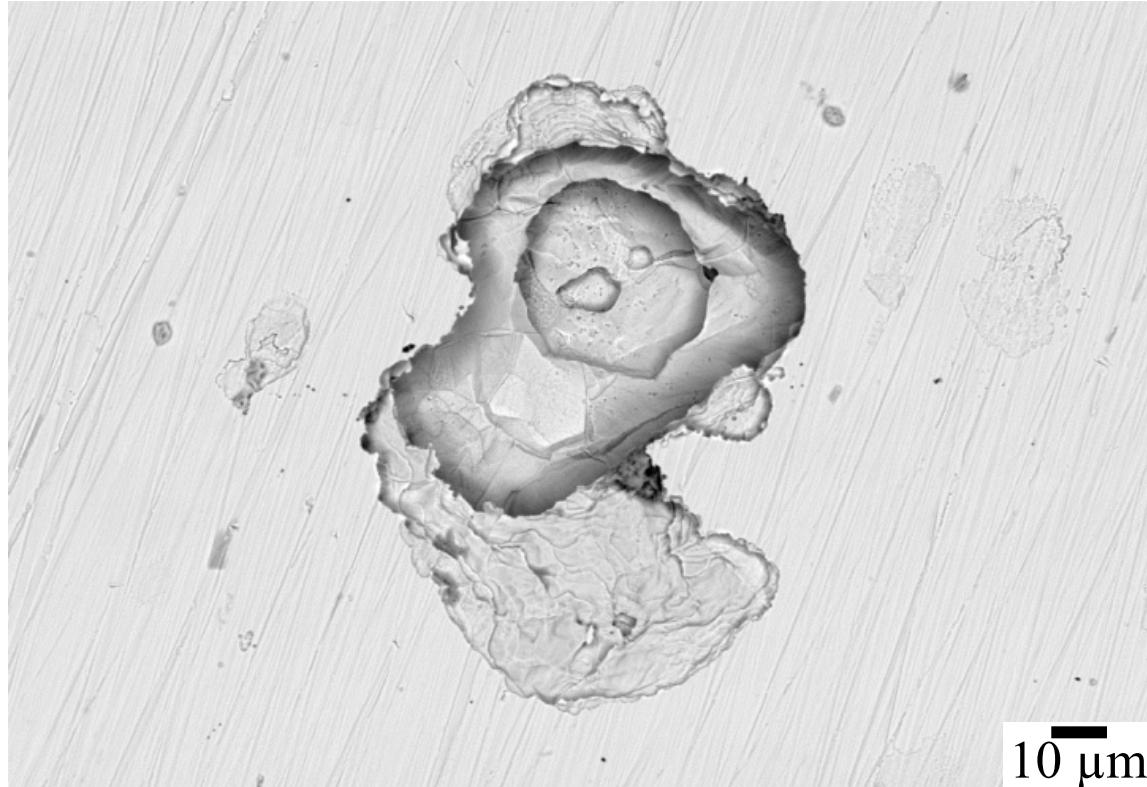
# SEM images of Wrought 316L specimen - Comparison

**40% RH - 300  $\mu\text{g}/\text{cm}^2$  of ASW**

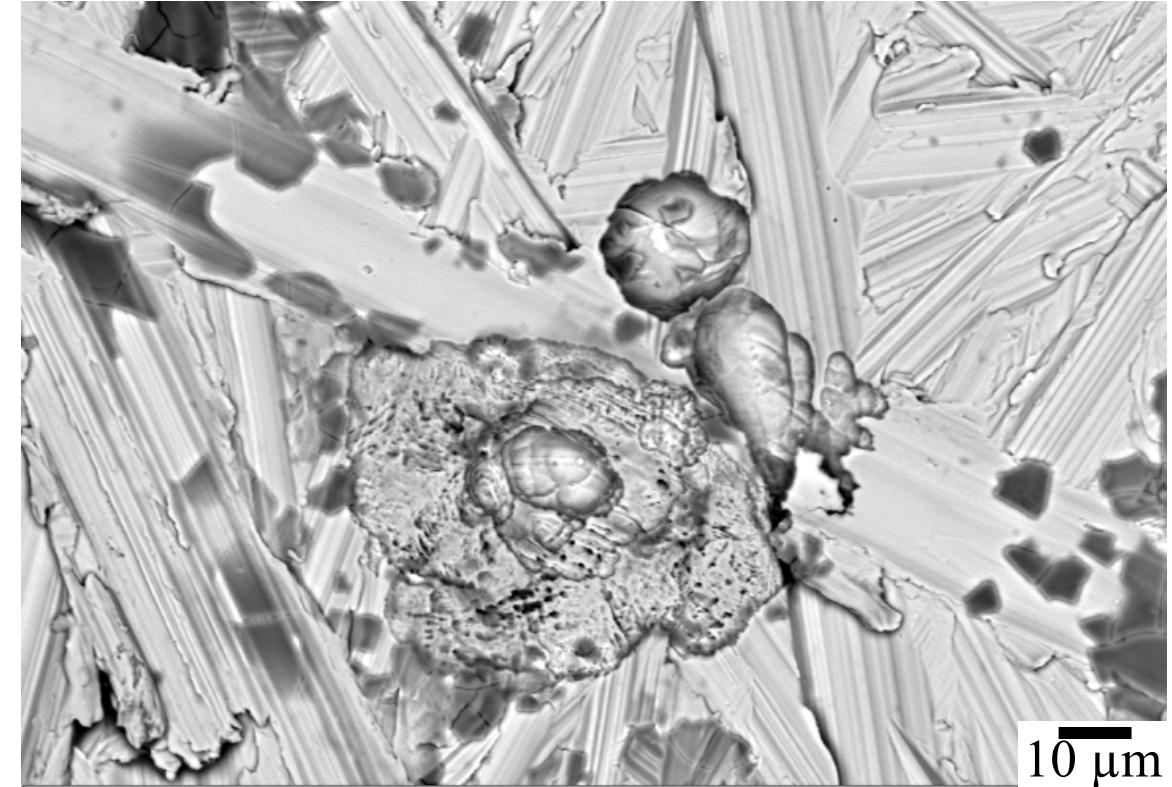
**From 21 month exposure off coast of Florida**

*These samples were prepared to 120 grit ground finish.*

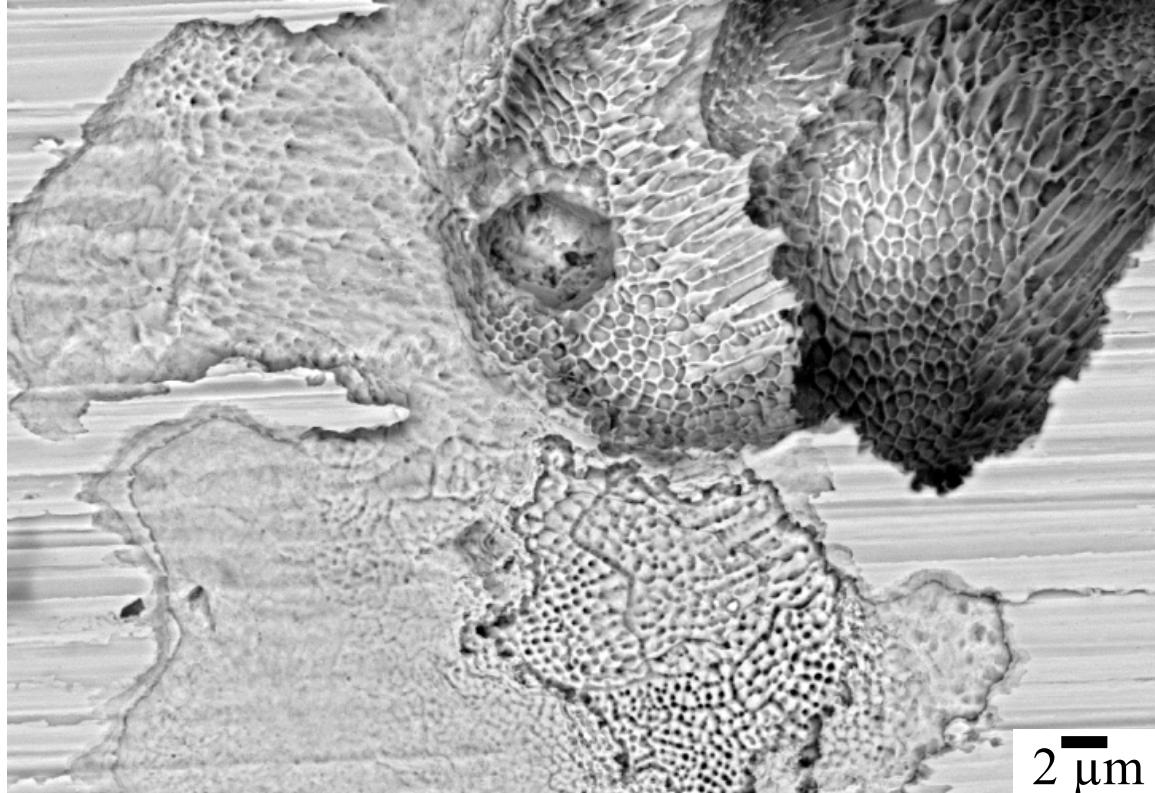
# SEM images of AM 316L specimen - Comparison

**40% RH - 300  $\mu\text{g}/\text{cm}^2$  of ASW**

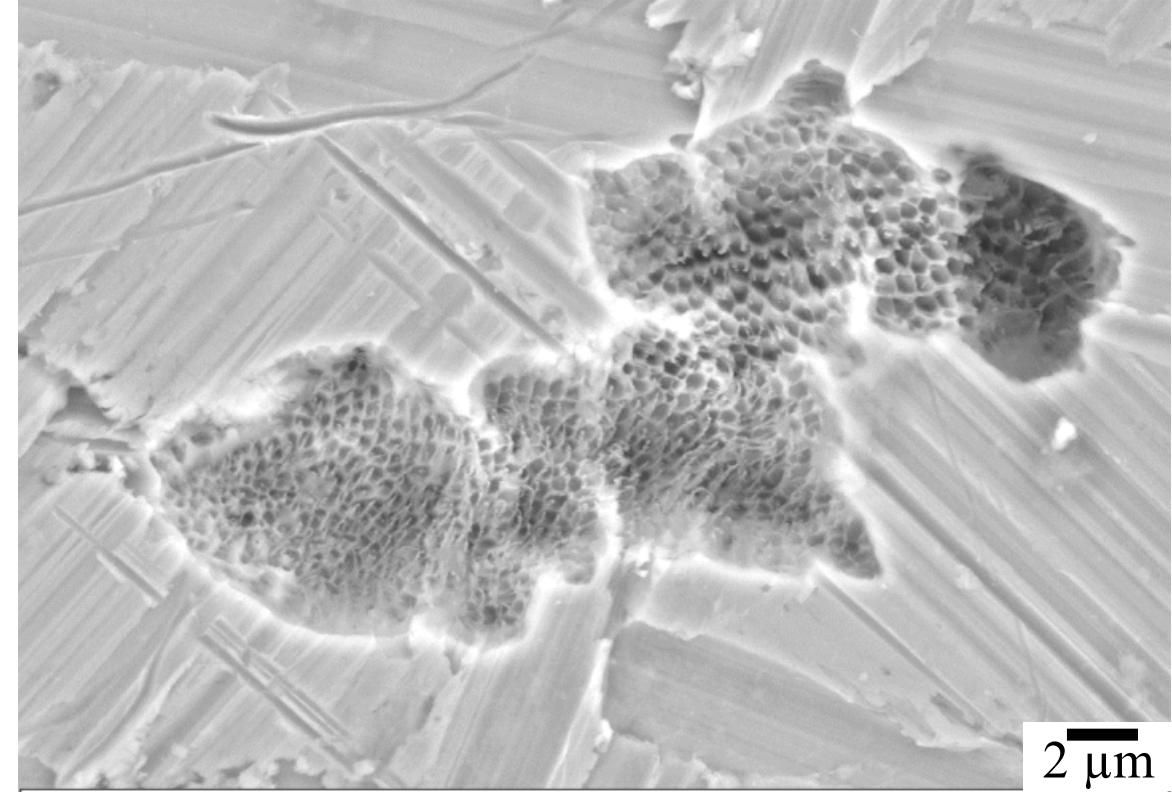
**From 21 month exposure off coast of Florida**

*These samples were prepared to 120 grit ground finish.*

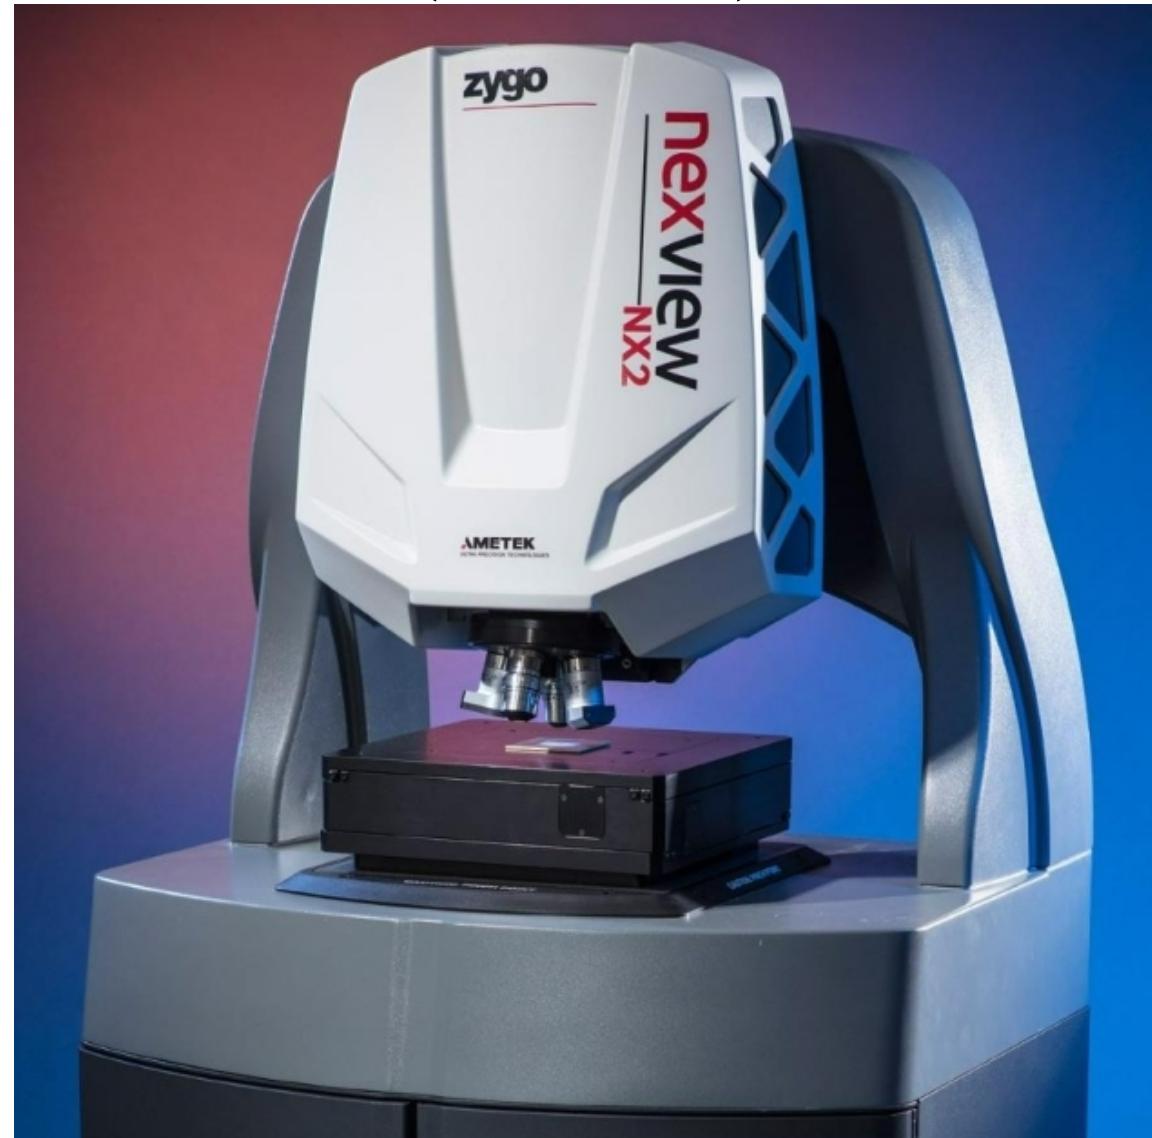
White light interferometry  
(Nexview™)

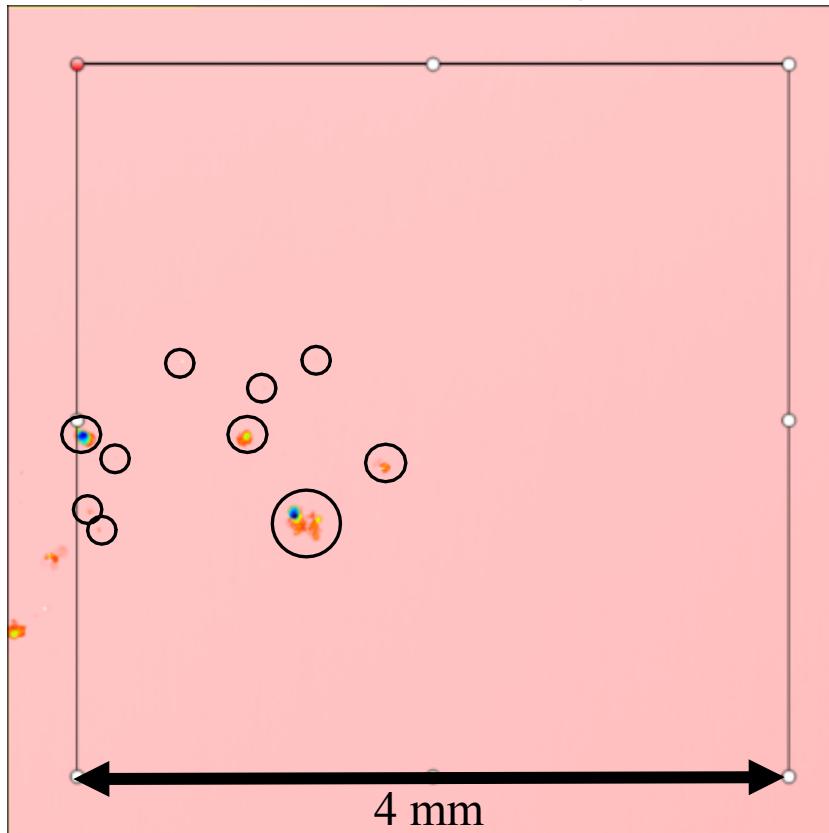
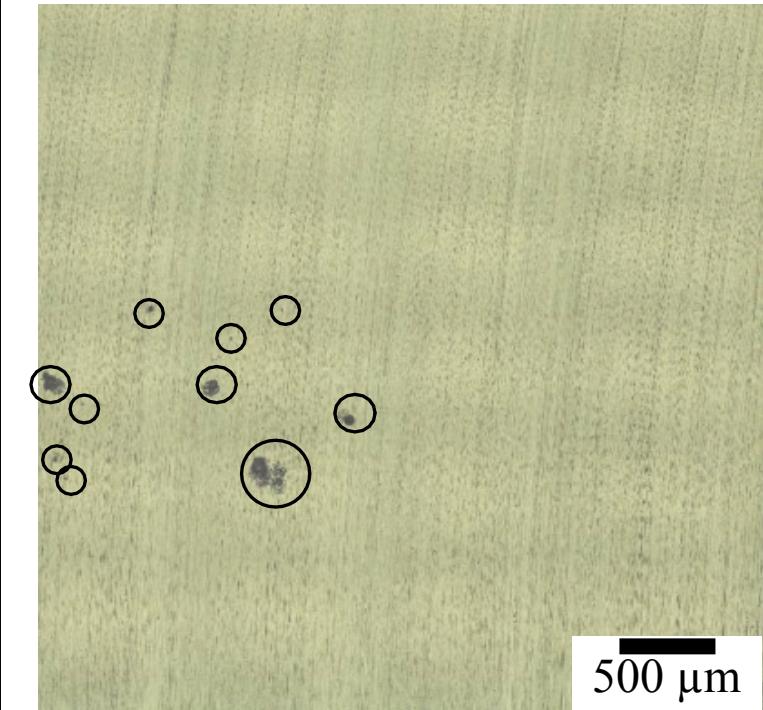
## Raw profilometry data

- White light interferometry measurements of cleaned surfaces to detect pits were processed to smooth surfaces.
- Mean plane threshold was used to eliminate scratch marks: **0.5 μm below surface**.
- Filtering criteria: **Maximum Height (Depth) > 0.2 μm** and **Volume/Area ratio > 0.2 μm**.
- Each circle contains one pit. *There were a total of 10 pits through the filtering process.*
- Through visual inspection, the particles are verified to be pits.

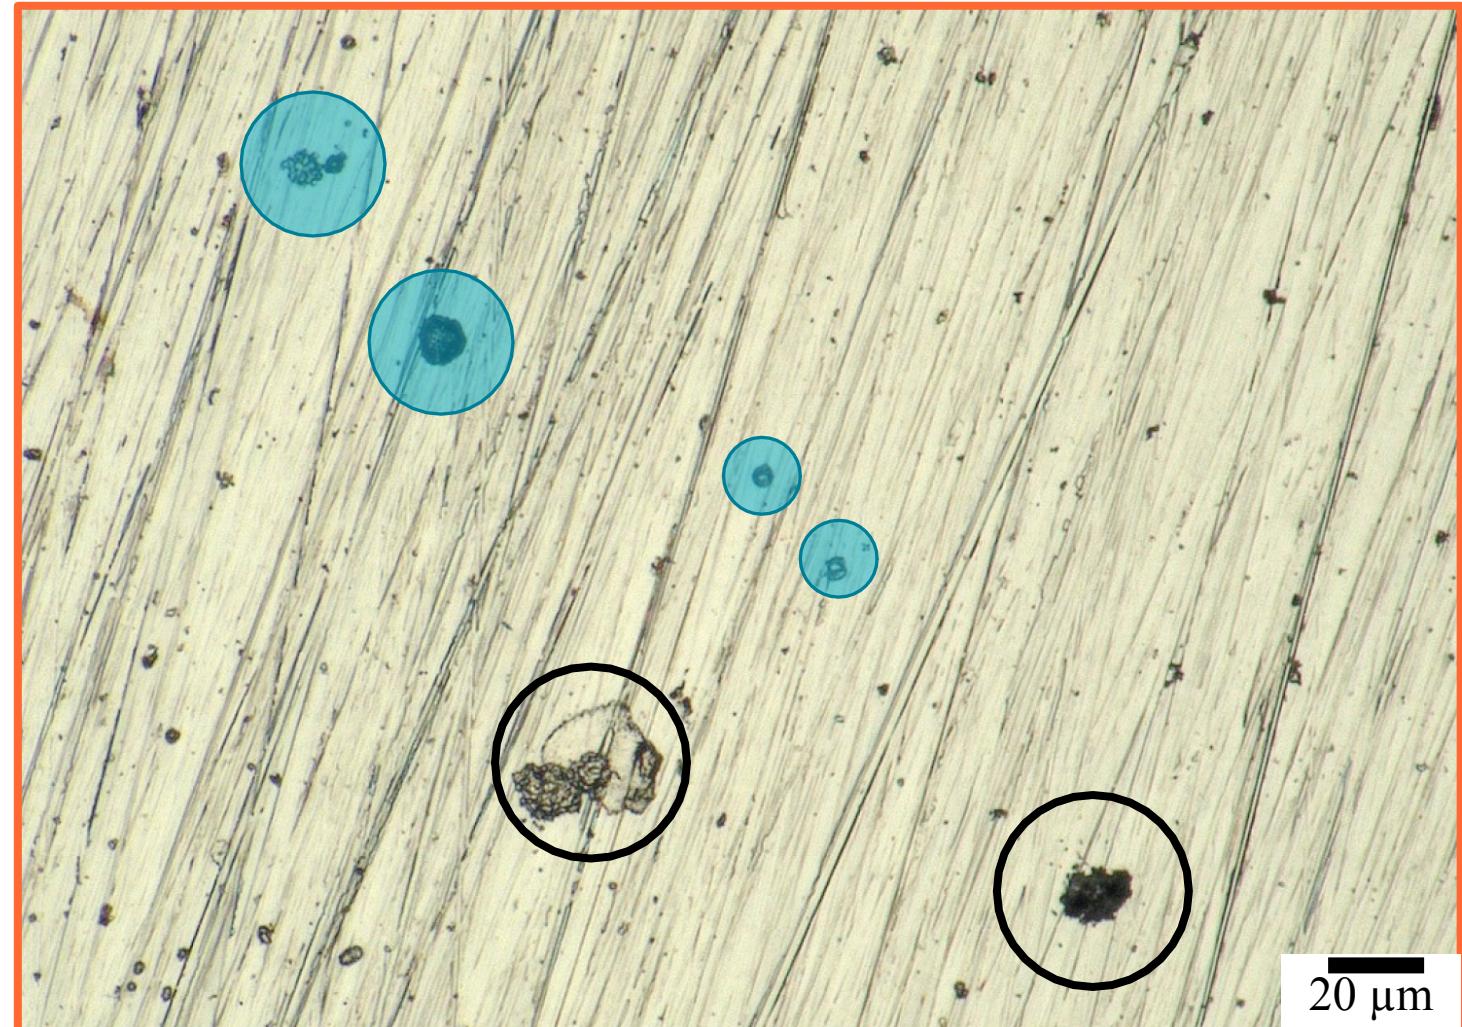
- Pits not picked up from interferometry analysis because they are **too small**.
- Specific to AM – lack of fusion **porosity** can cause outlier pit information.
- **Contamination** of the surface can lead to unexpected pits – make sure surfaces are clean before measurements!

Another filter based on Height/Area ratio was used to eliminate contamination/pore outliers.

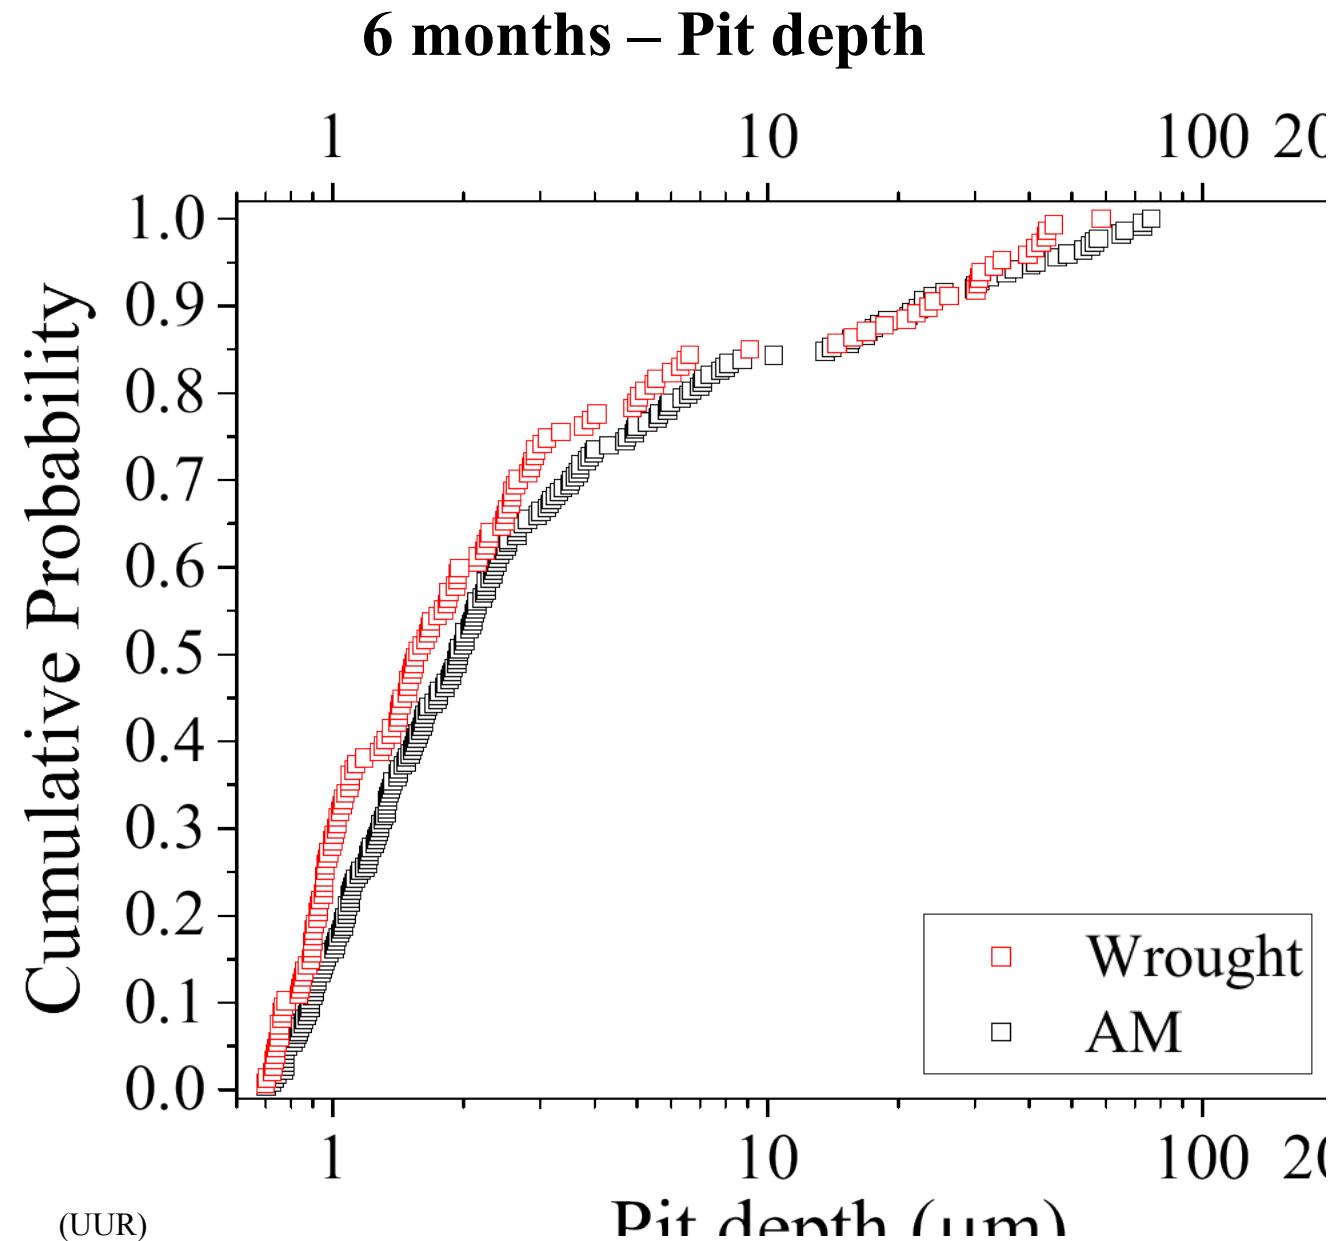
Average pit depth ( $\mu\text{m}$ )	Measured deepest pit ( $\mu\text{m}$ )
1 week	2.9	35.1
1 month	7.0	41.8
6 months	6.3	58.5
12 months	11.7	118.1

Average pit depth ( $\mu\text{m}$ )	Measured deepest pit ( $\mu\text{m}$ )
1 week	4.0	32.6
1 month	10.1	210.4 (73.3)
6 months	7.6	76.2
12 months	9.4	80.2

Likely porosity

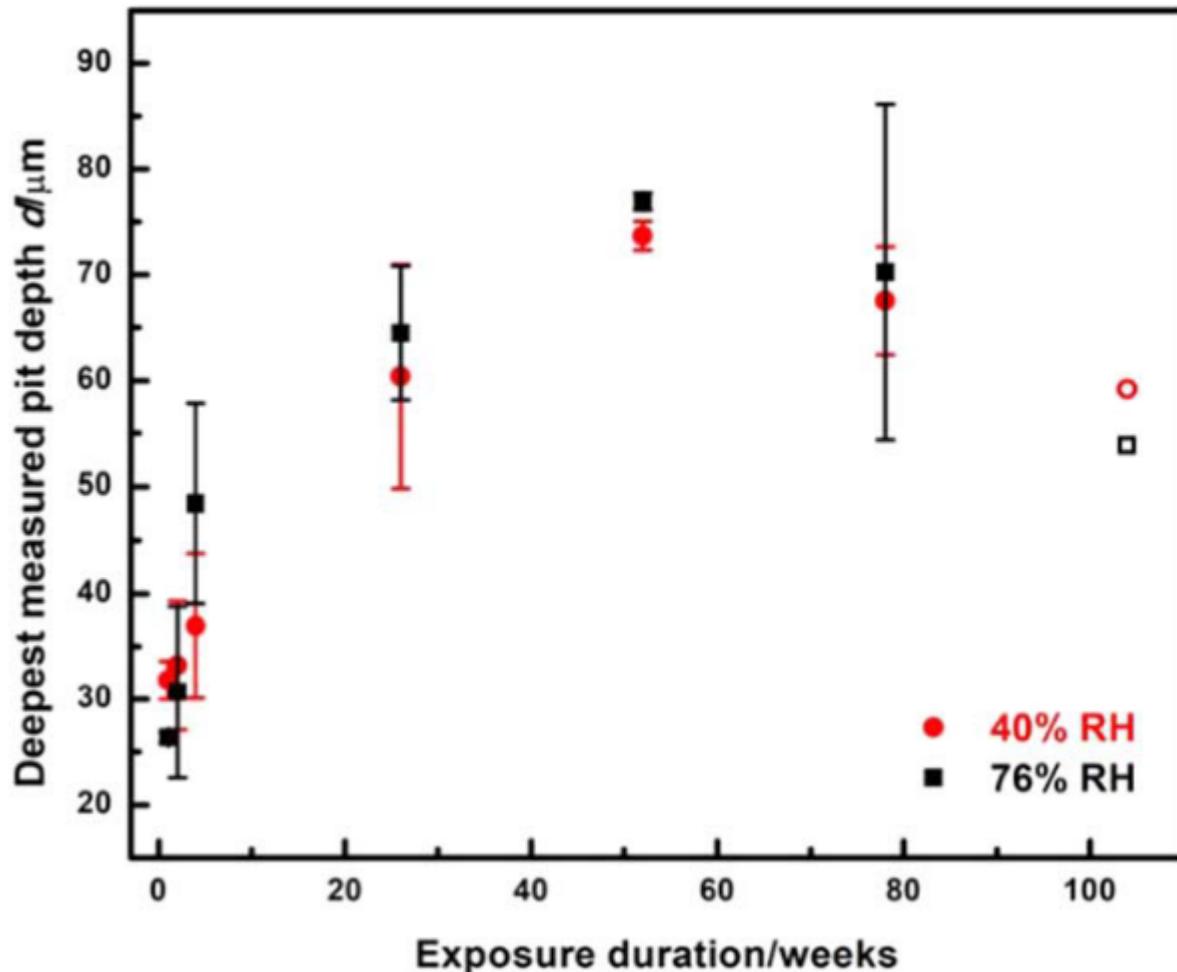
## 10 deepest pits/area from literature – 304L

Source: Srinivasan (2021)

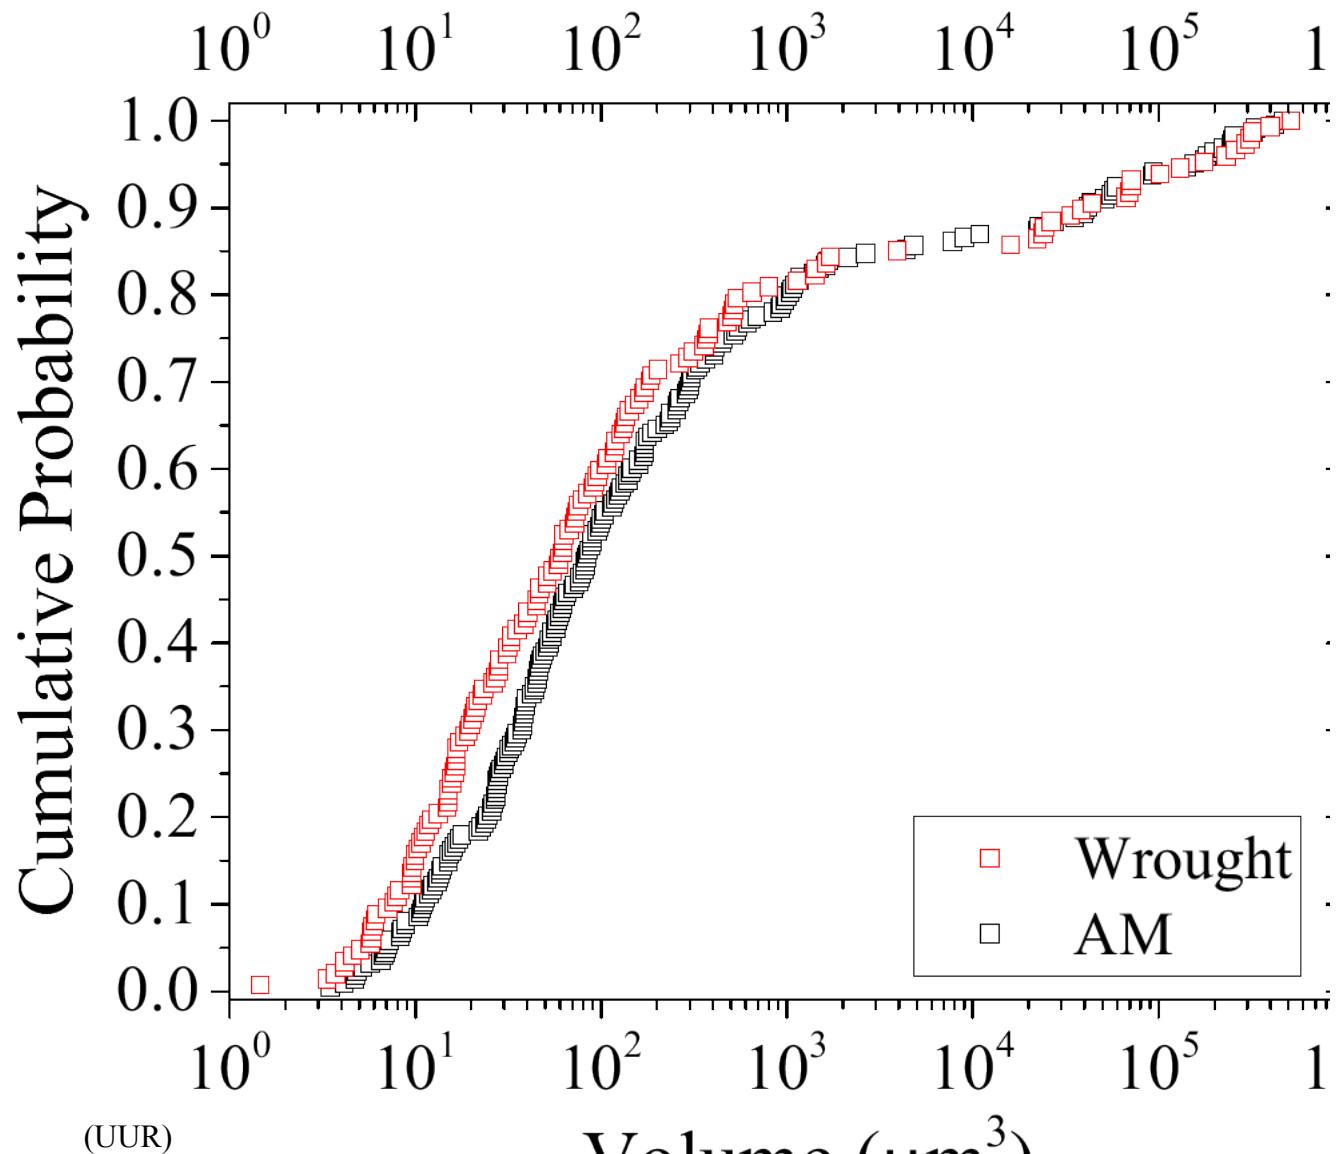
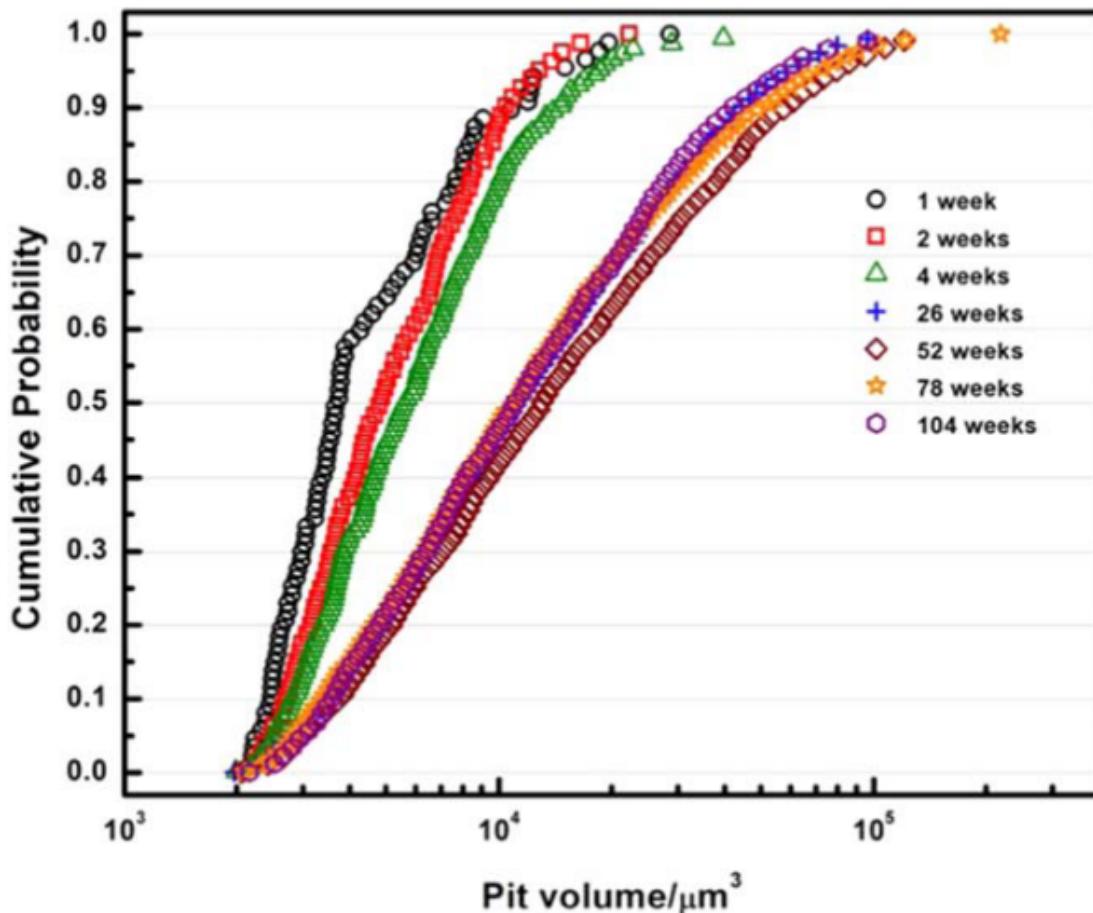
## 6 months – Pit volume

Volume per area ( $\mu\text{m}^3/\text{cm}^2$ )	# of Pits/ $\text{cm}^2$
1 week	$1.15 \times 10^5$	50
1 month	$9.28 \times 10^5$	65
6 months	$2.34 \times 10^6$	105
12 months	$2.75 \times 10^6$	96

Volume per area ( $\mu\text{m}^3/\text{cm}^2$ )	# of Pits/ $\text{cm}^2$
1 week	$3.66 \times 10^5$	89
1 month	$9.35 \times 10^5$	88
6 months	$2.97 \times 10^6$	155
12 months	$1.74 \times 10^6$	53

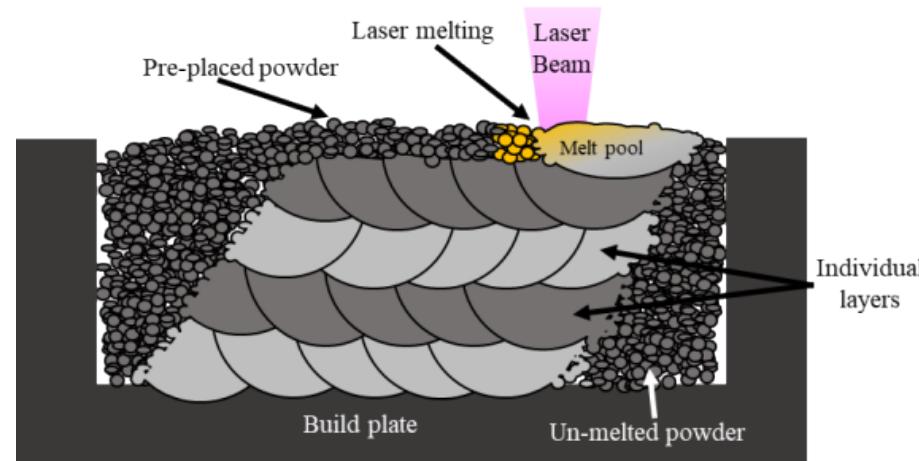
Build plate of 20 samples

Samples were prepared using 316L powder with a powder bed fusion (PBF) technique.

- Samples were printed on 5 different PBF machines, all with the machines optimized parameters for part density.
- SEM images of powder.
- Composition determined by ICP-MS and LECO.
- Powder analysis with laser diffraction.

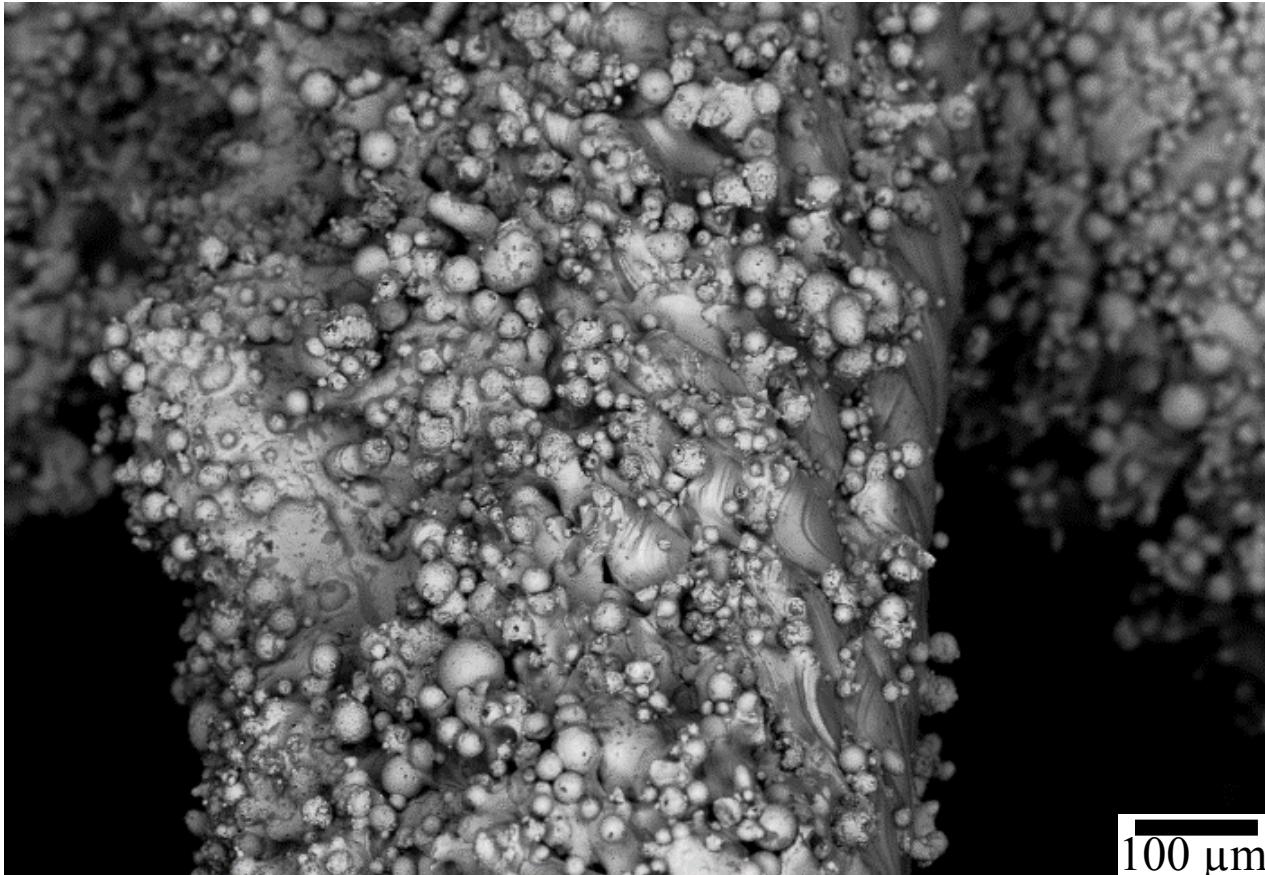
# As-printed lattices?

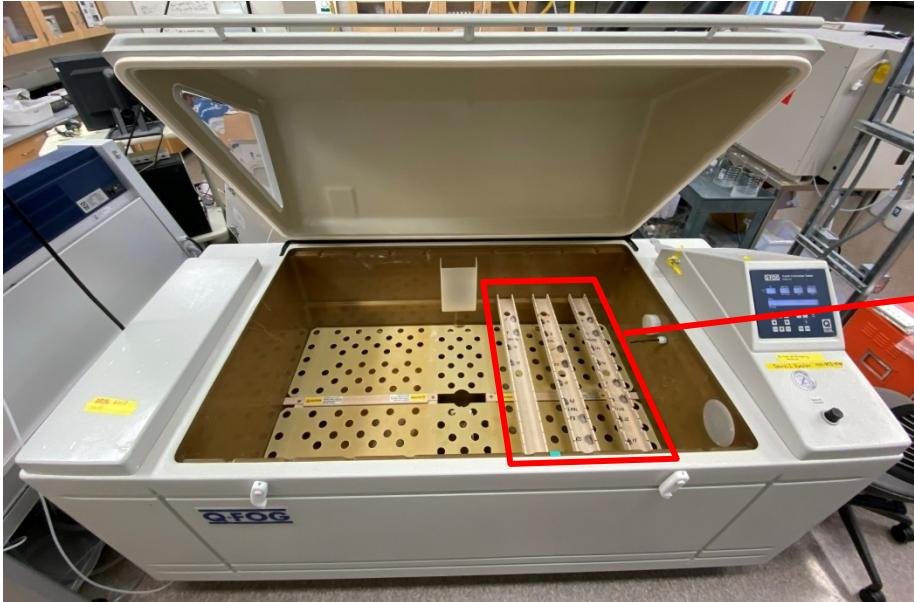
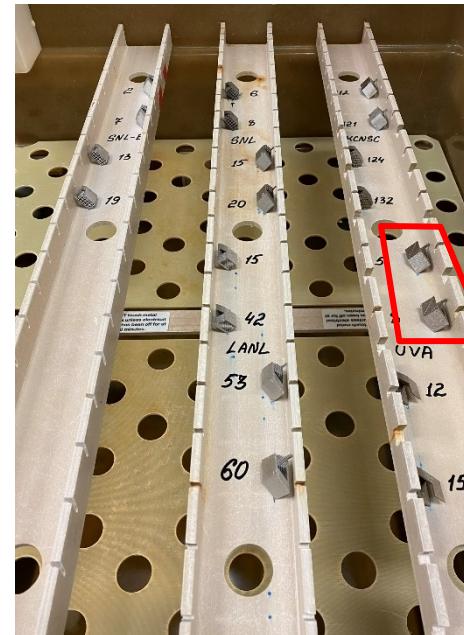
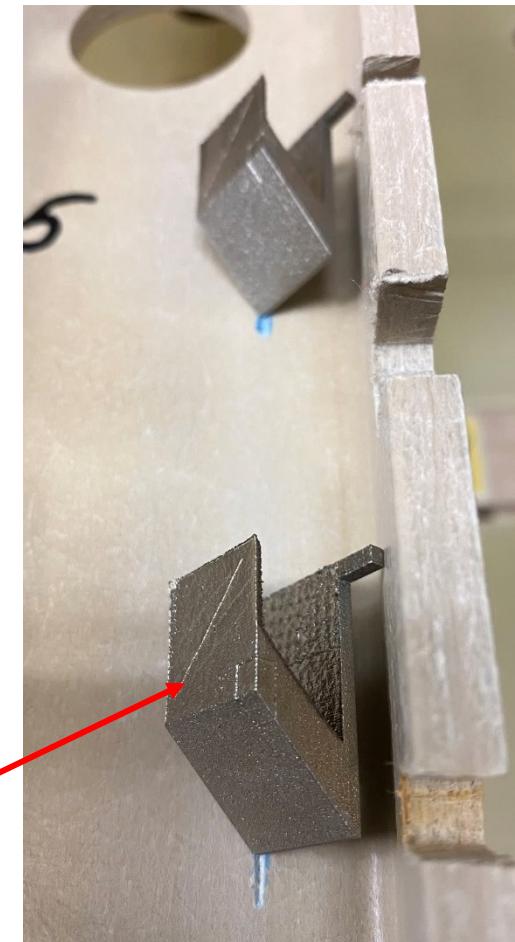
- **ASTM for sample testing: G85 A2 with wet bottom**
  - Equipment: Q-fog cyclic corrosion tester.
  - Solution: 0.9M NaCl acidified to pH 3 with acetic acid.
  - Test temperature: 49°C.
  - Duration: 2000 hr.
  - Sample holder: PEEK rack with milled paths to place AM 316 samples.

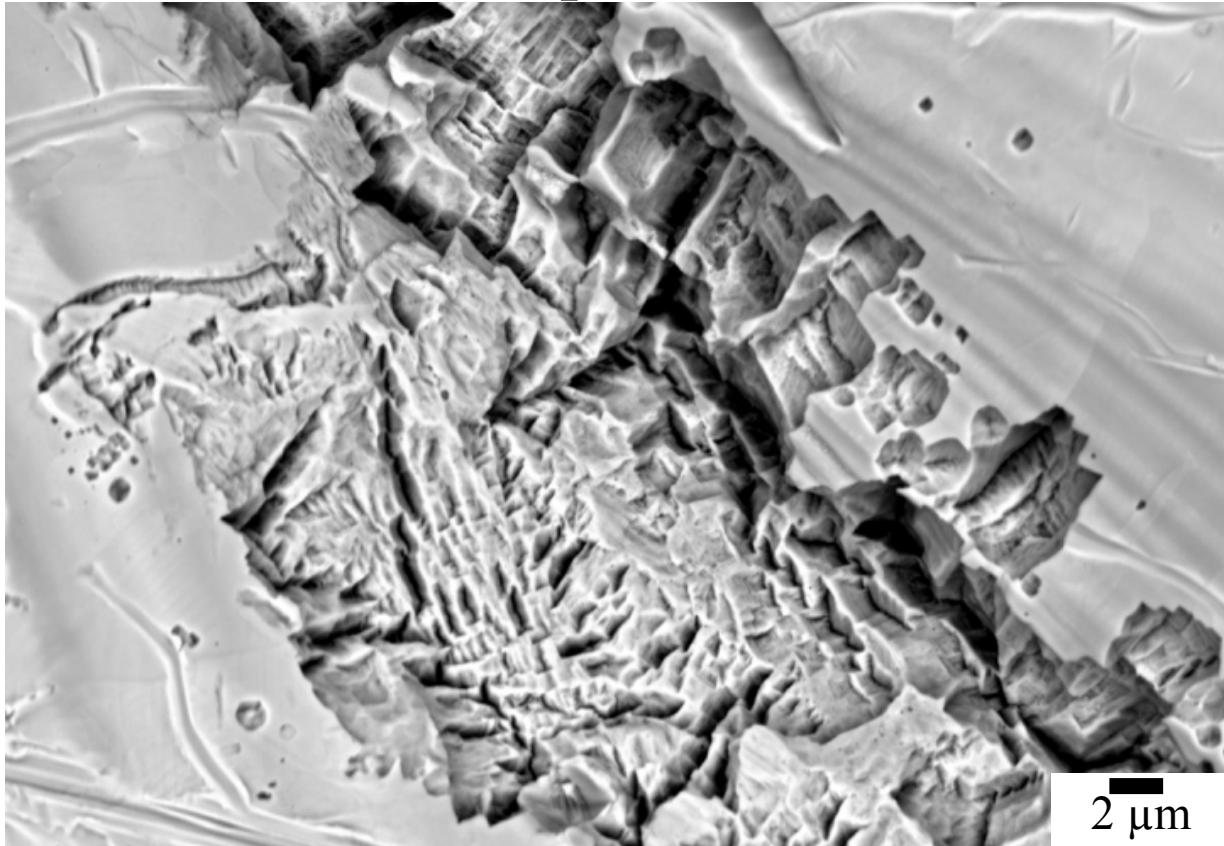
ProX 200  
As-printed

- Wire EDM as-cut surface had the most aggressive corrosion based on optical analysis.
- Electropolished surfaces were least susceptible to corrosion.
- As-printed samples had different quantities of corrosion based on optical, but similar morphology (many pits appeared to initiate from melt pool boundaries).
