# Atmospheric Corrosion Of Laser Powder Bed Fusion 316L Stainless Steel

AMPP 2022 Annual  
Conference + Expo  
March 6<sup>th</sup> to 10<sup>th</sup>, 2022 -  
San Antonio, TX

Michael A. Melia  
Senior Member of Technical Staff - R&D S&E Material Science

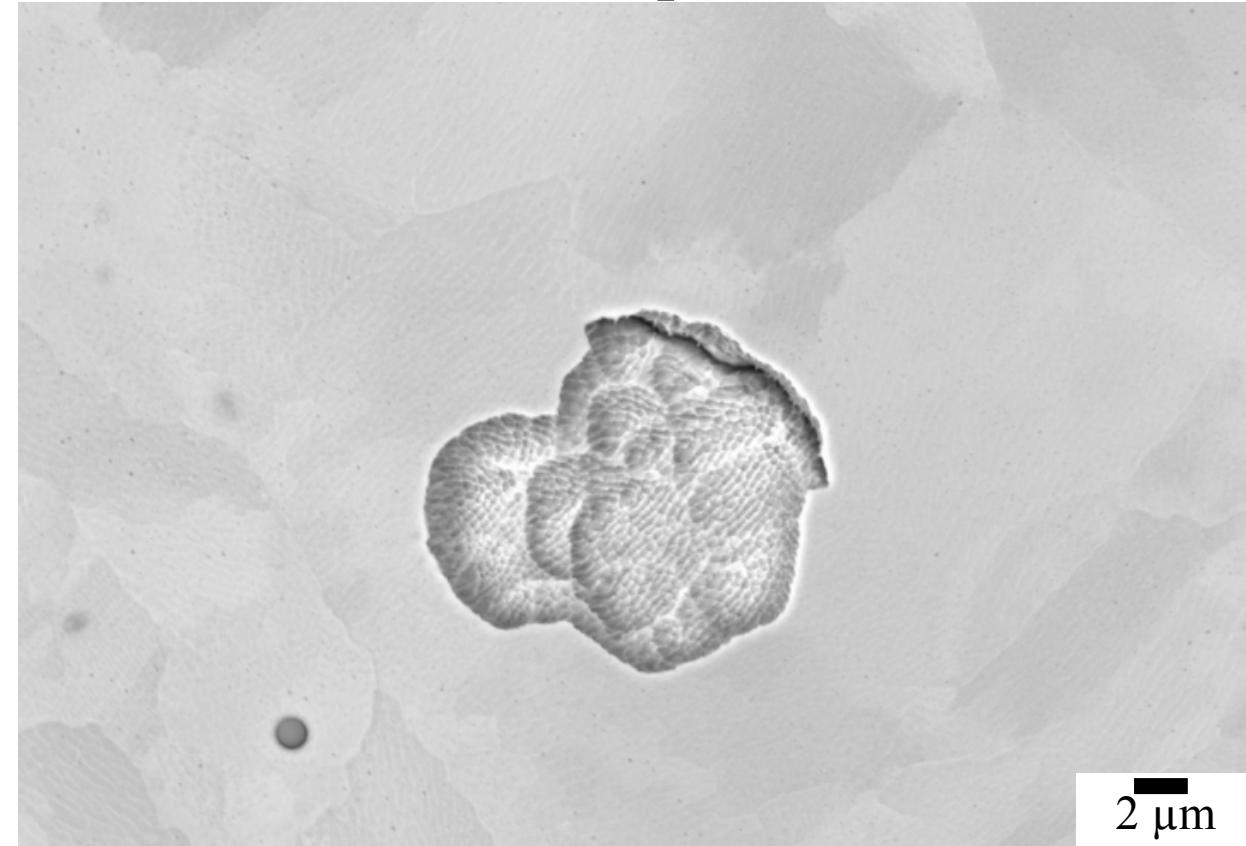
ProX 200  
Electropolish

- Wire EDM as-cut surface had the most aggressive corrosion based on optical analysis.
- Electropolished surfaces were least susceptible to corrosion.
- As-printed samples had different quantities of corrosion based on optical, but similar morphology (many pits appeared to initiate from melt pool boundaries).

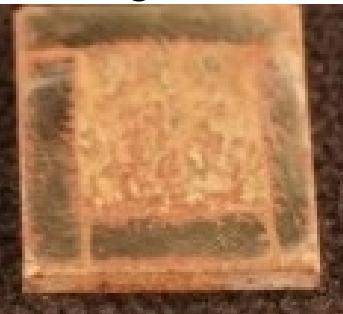
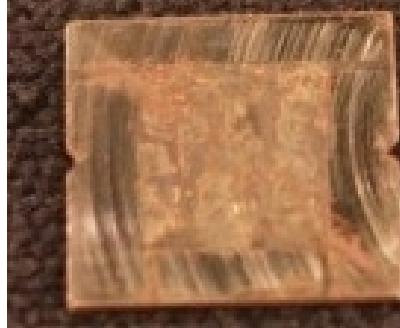
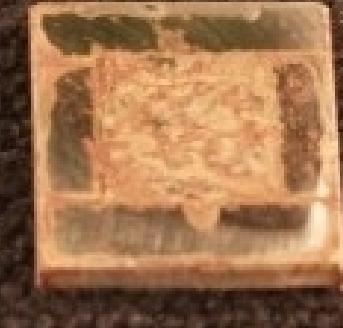
## Images after electrochemical tests

## Images after 48 hrs of ASTM B117 exposures

- No noticeable difference in electrochemical response, but surface corrosion morphology was dramatically different.
- Initial ASTM B117 results suggest minimal difference (only analysis was with optical imaging).

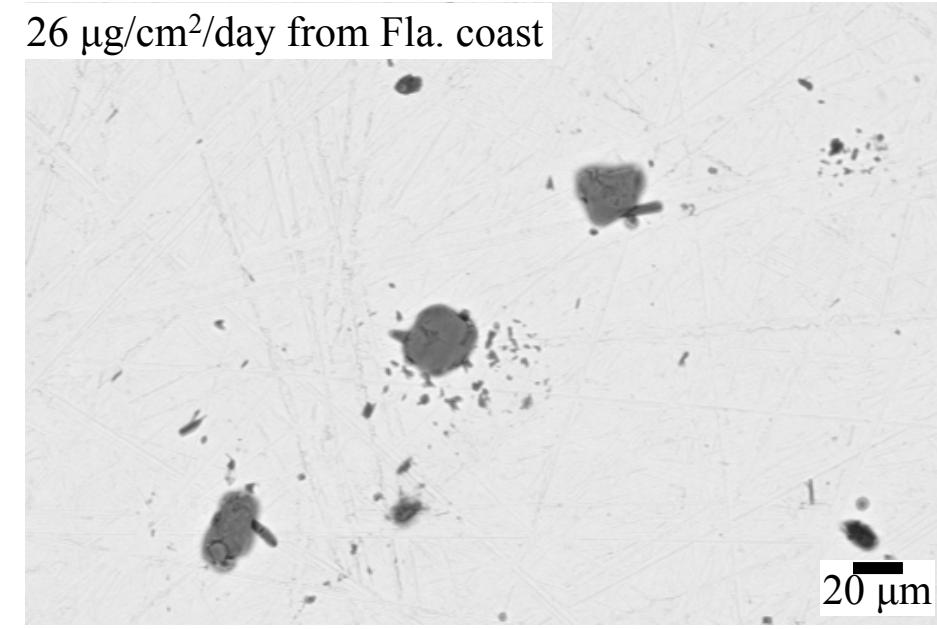
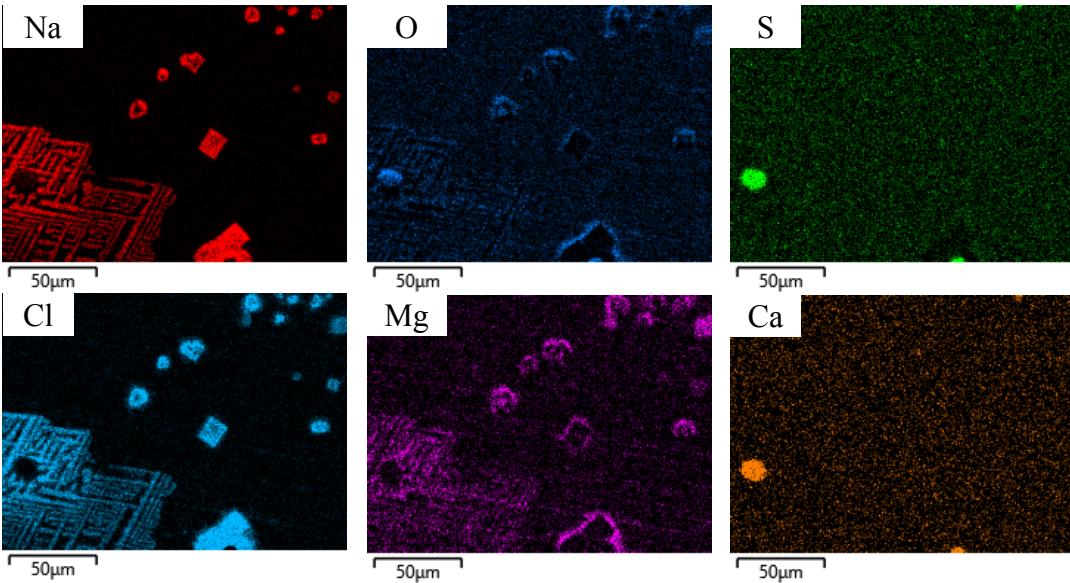
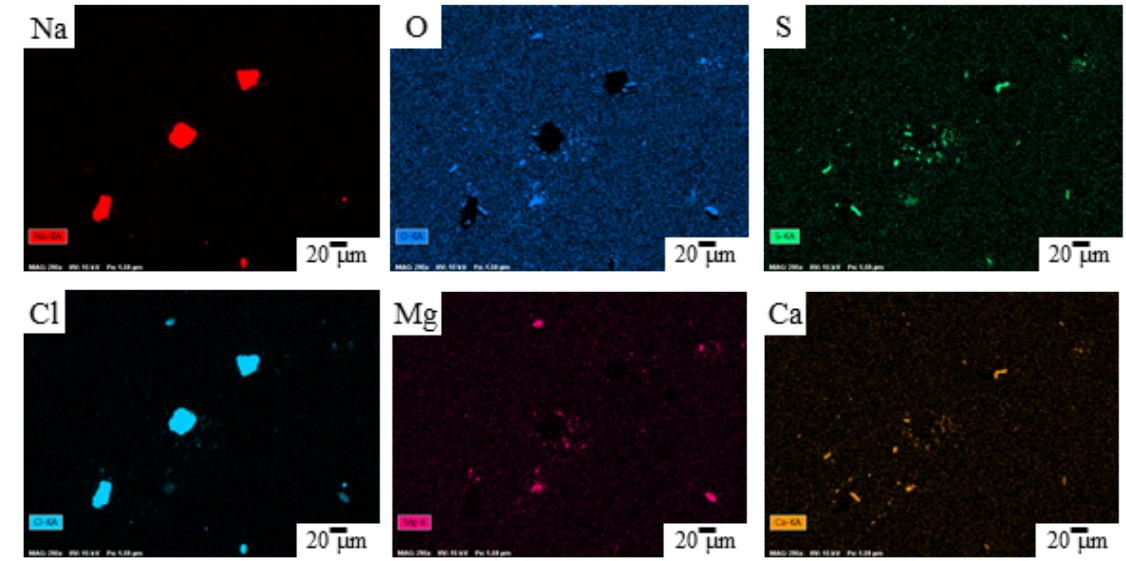
300  $\mu\text{g}/\text{cm}^2$  ASW printed with inkjet

26  $\mu\text{g}/\text{cm}^2/\text{day}$  from Fla. coast

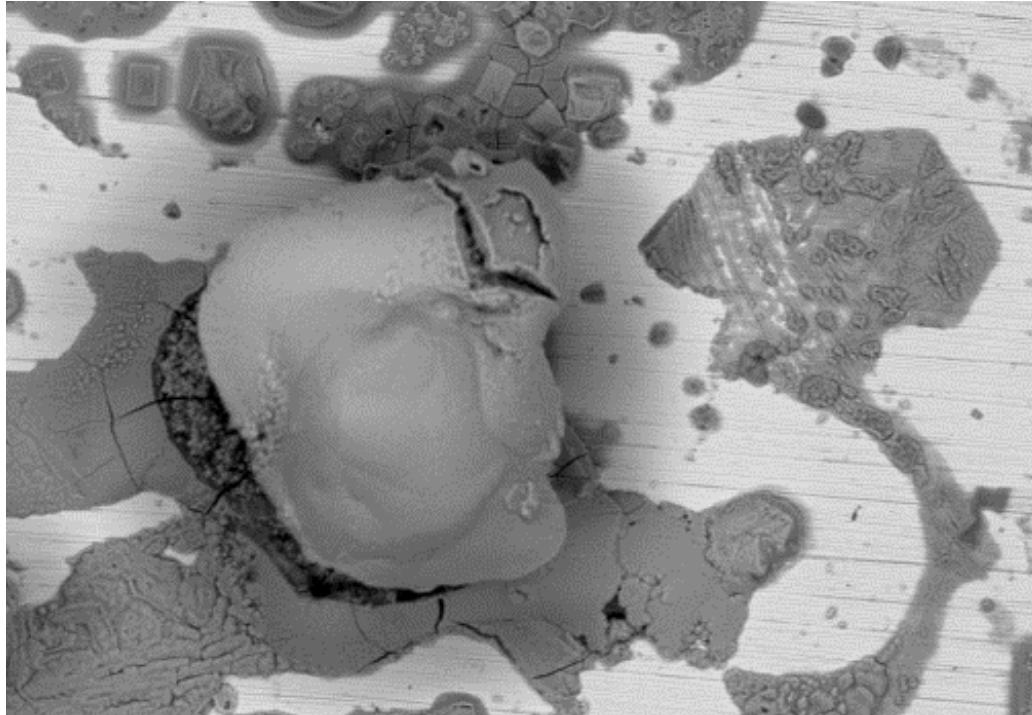
Wrought

SEM images of 316L specimen with 300  $\mu\text{g}/\text{cm}^2$  ASW at 40% RH

20  $\mu\text{m}$ EHT = 15.00 kV WD = 8.8 mm Signal A = BSD Width = 400.0  $\mu\text{m}$

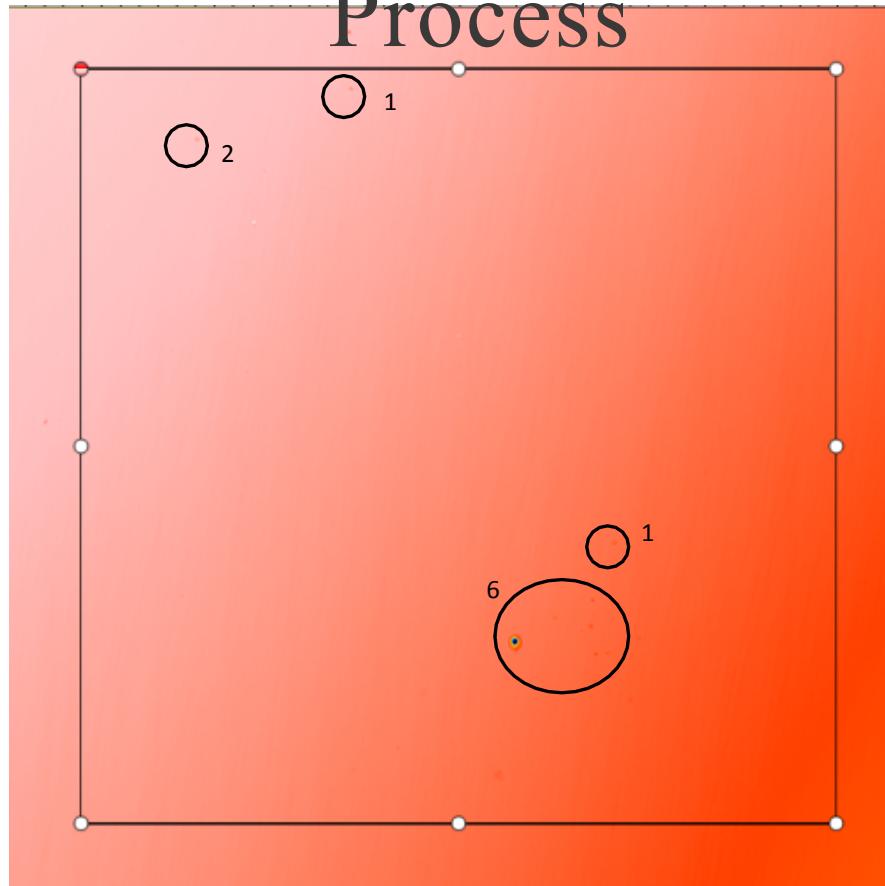
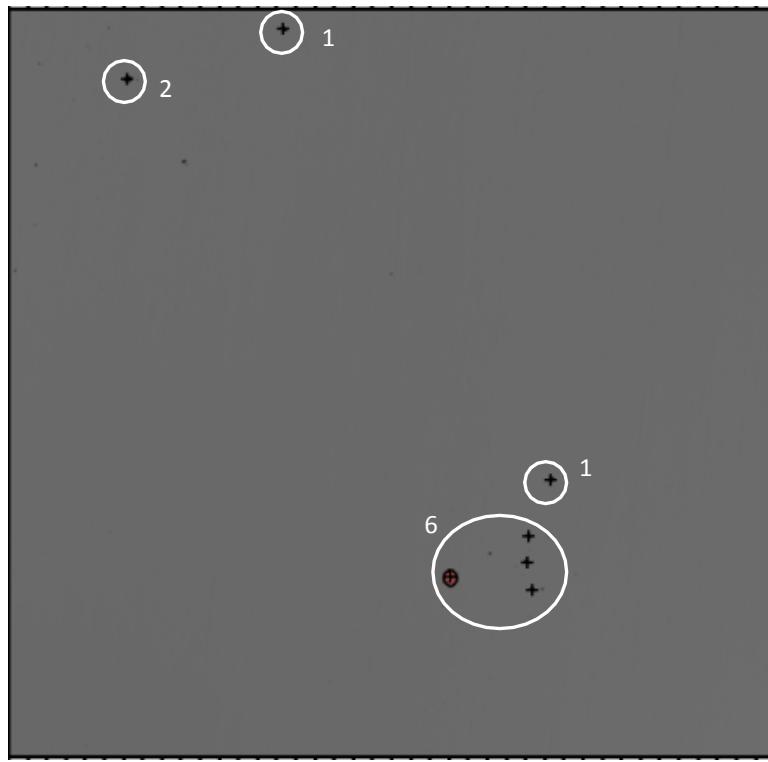
316L\_W\_35C\_40RH\_300ug  
ASW\_Perp\_1wk-Sample51

The process for pit verification begins by filtering data taken from a Particle Analysis in MountainsMap. The filtering criteria depends on the Maximum Height (Depth) of a pit exceeding  $0.2 \mu\text{m}$  and the Volume/Area ratio exceeding  $0.2 \mu\text{m}$ .

Once the data is filtered, the remaining particles are verified by comparing the raw data to the processed data. Through visual inspection, the particles are verified to be pits.

The particles that were considered pits through the filtering process are outlined in the above images. The numbers next to the circles indicate the amount of pits located within the circle. For example, the largest circle contains 6 pits. This results in a total of 10 pits.

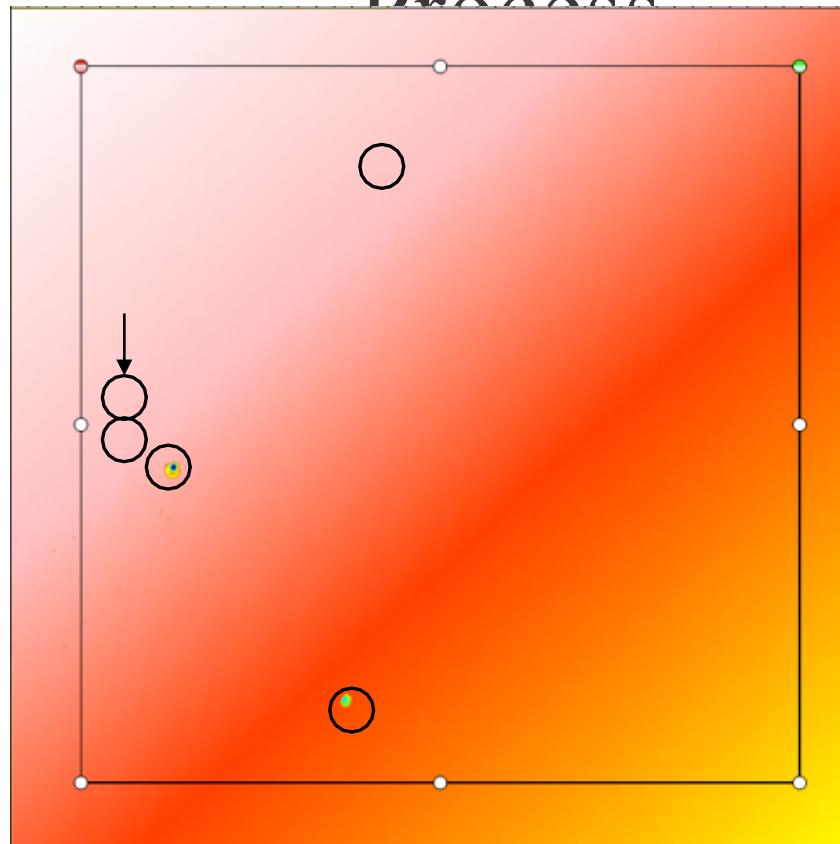
316L\_AM\_35C\_40RH\_300  
ASW\_Perp\_1wk-Sample116

The process for pit verification begins by filtering data taken from a Particle Analysis in MountainsMap. The filtering criteria depends on the Maximum Height (Depth) of a pit exceeding  $0.2 \mu\text{m}$  and the Volume/Area ratio exceeding  $0.2 \mu\text{m}$ .

Once the data is filtered, the remaining particles are verified by comparing the raw data to the processed data. Through visual inspection, the particles are verified to be pits.

The particles that were considered pits through the filtering process are outlined in the above images. The circle with the arrow pointing to it contains two pits, all others contain 1 pit. This created a total of 6 pits.

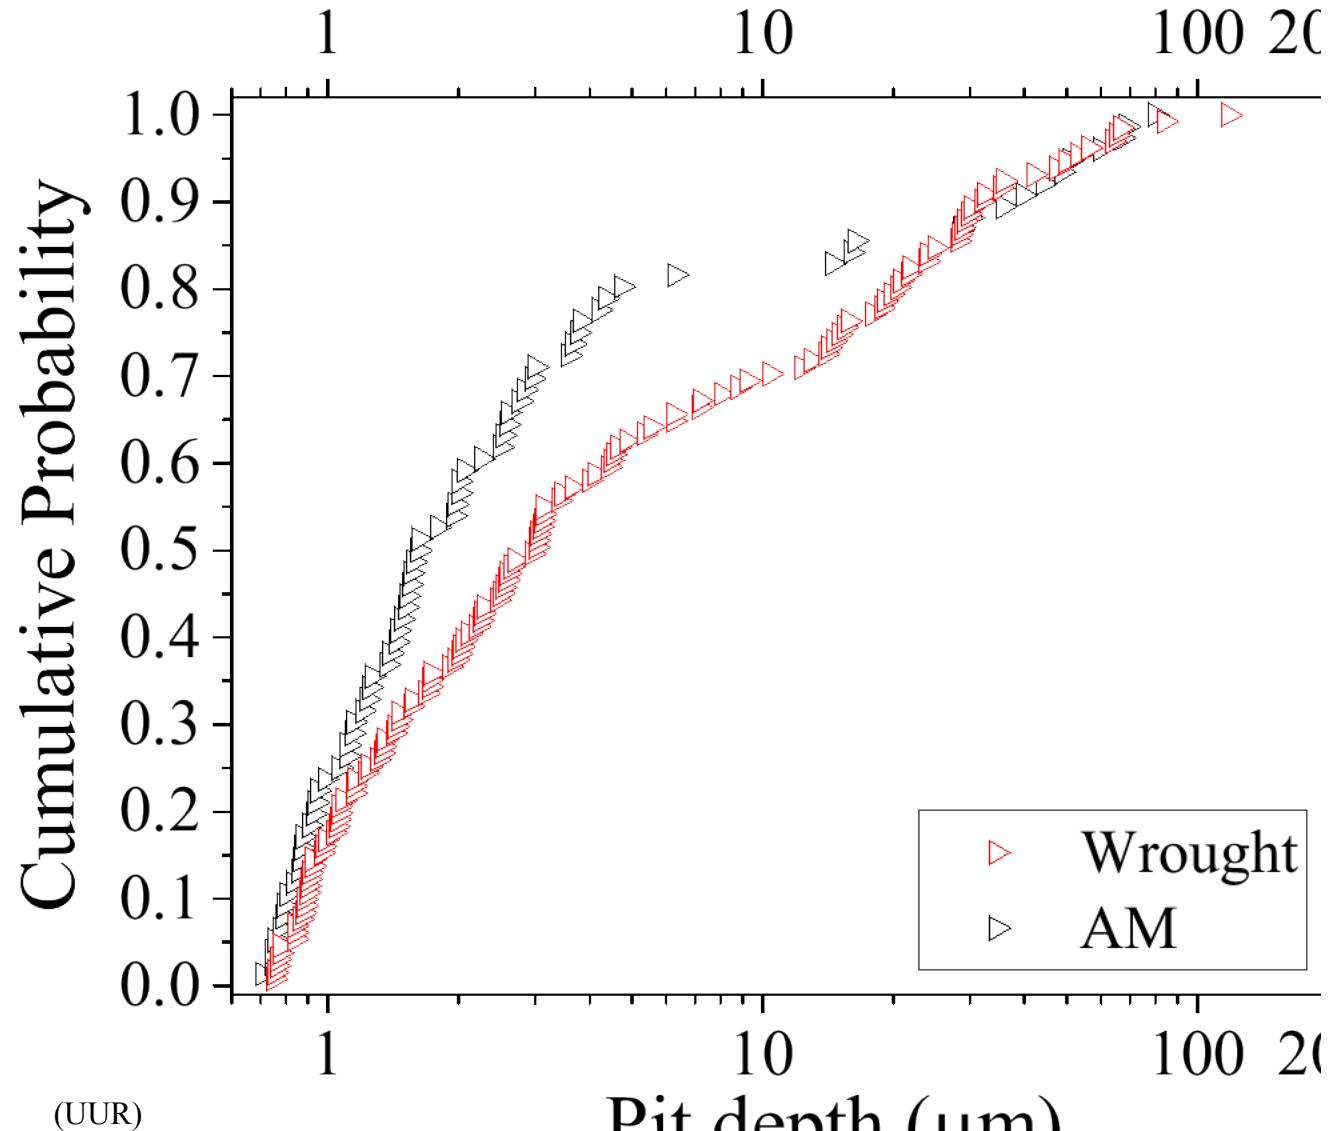
**12 months – Pit depth**

Average pit depth ( $\mu\text{m}$ )	Max pit depth ( $\mu\text{m}$ )
1 week	2.9	35.1
1 month	7.0	41.8
6 months	6.3	58.5
12 months	11.7	118.1

Average pit depth ( $\mu\text{m}$ )	Max pit depth ( $\mu\text{m}$ )
1 week	4.0	32.6
1 month	10.1	210.4 (73.3)
6 months	7.6	76.2
12 months	9.4	80.2

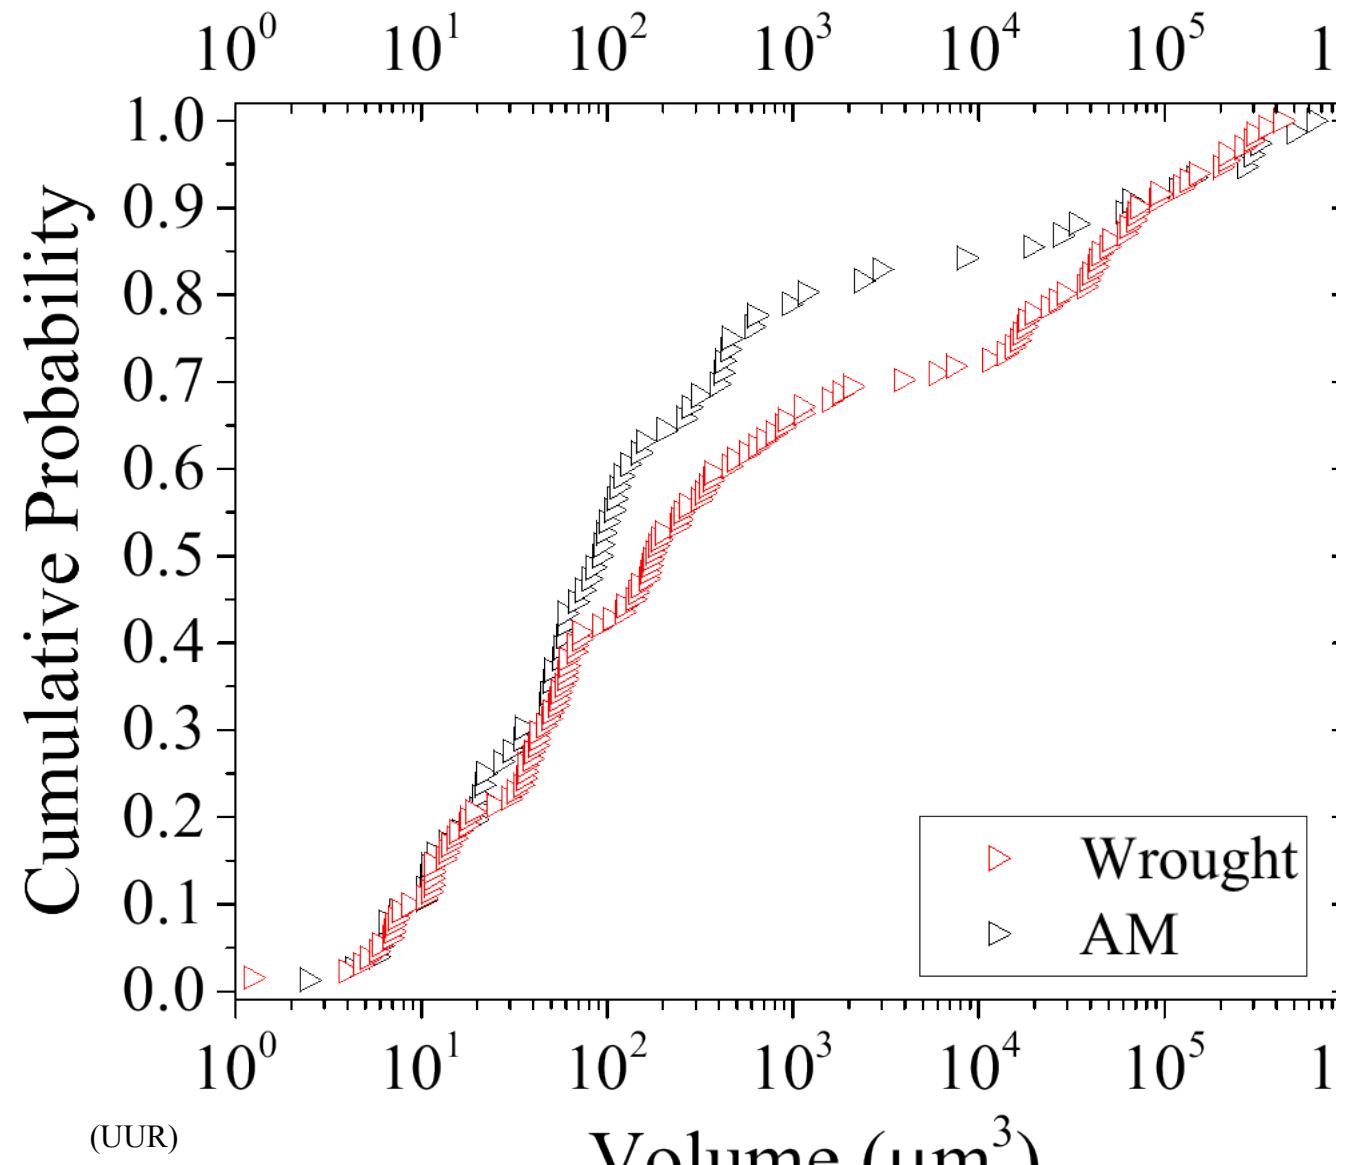
## 12 months – Pit volume

Volume per area ( $\mu\text{m}^3/\text{cm}^2$ )	# of Pits/ $\text{cm}^2$
1 week	$1.15 \times 10^5$	50
1 month	$9.28 \times 10^5$	65
6 months	$2.34 \times 10^6$	105
12 months	$2.75 \times 10^6$	96

Volume per area ( $\mu\text{m}^3/\text{cm}^2$ )	# of Pits/ $\text{cm}^2$
1 week	$3.66 \times 10^5$	89
1 month	$9.35 \times 10^5$	88
6 months	$2.97 \times 10^6$	155
12 months	$1.74 \times 10^6$	53

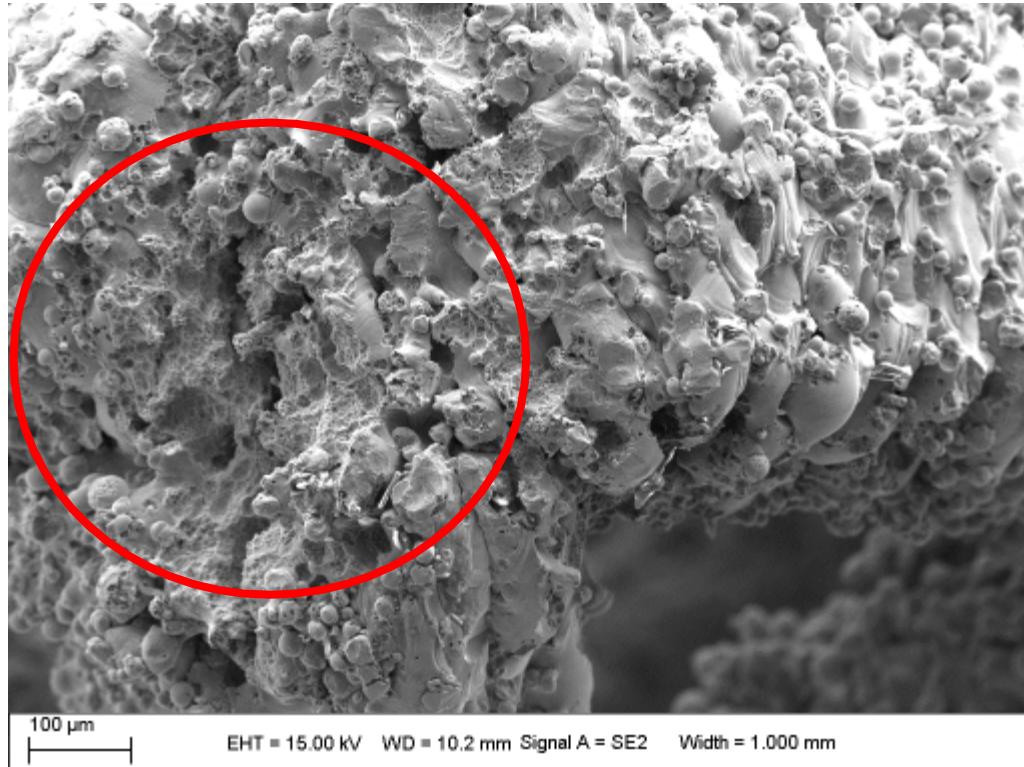
ProX 200  
As-printed

# Pit morphology - Lattices

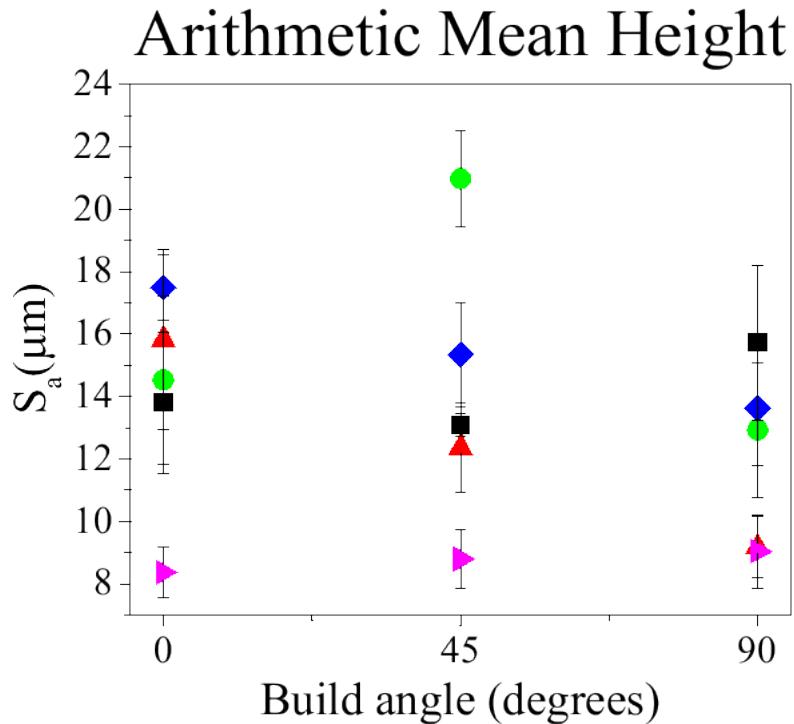
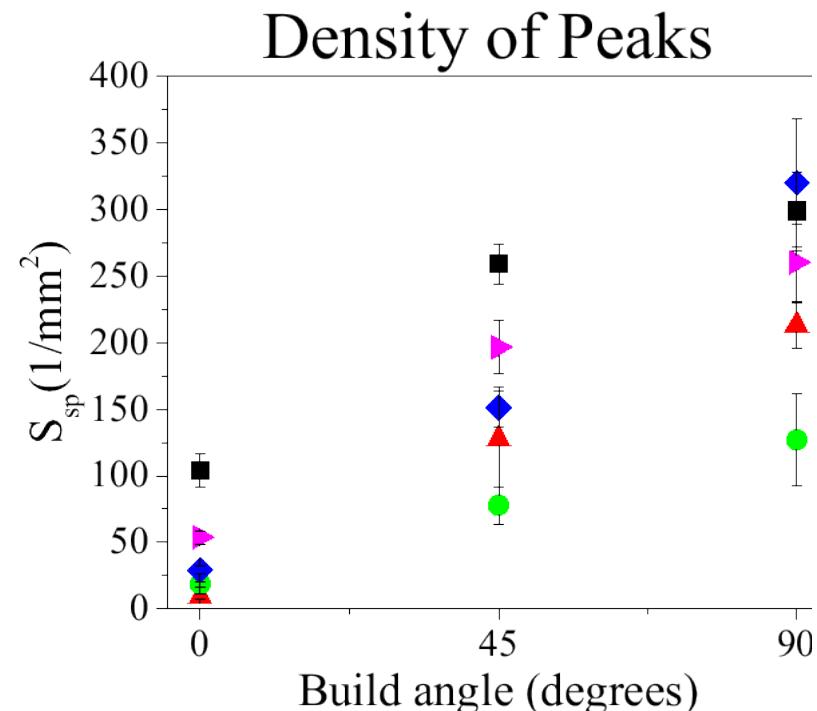
# <sup>49</sup> Zygo measurements from all material

- Without any filtering (but some data processing),  $S_{pd}$  shows a linear trend with respect to build angle for all printed machines.
- The  $S_a$  values are generally all dissimilar when comparing machine to machine (influence from waviness).

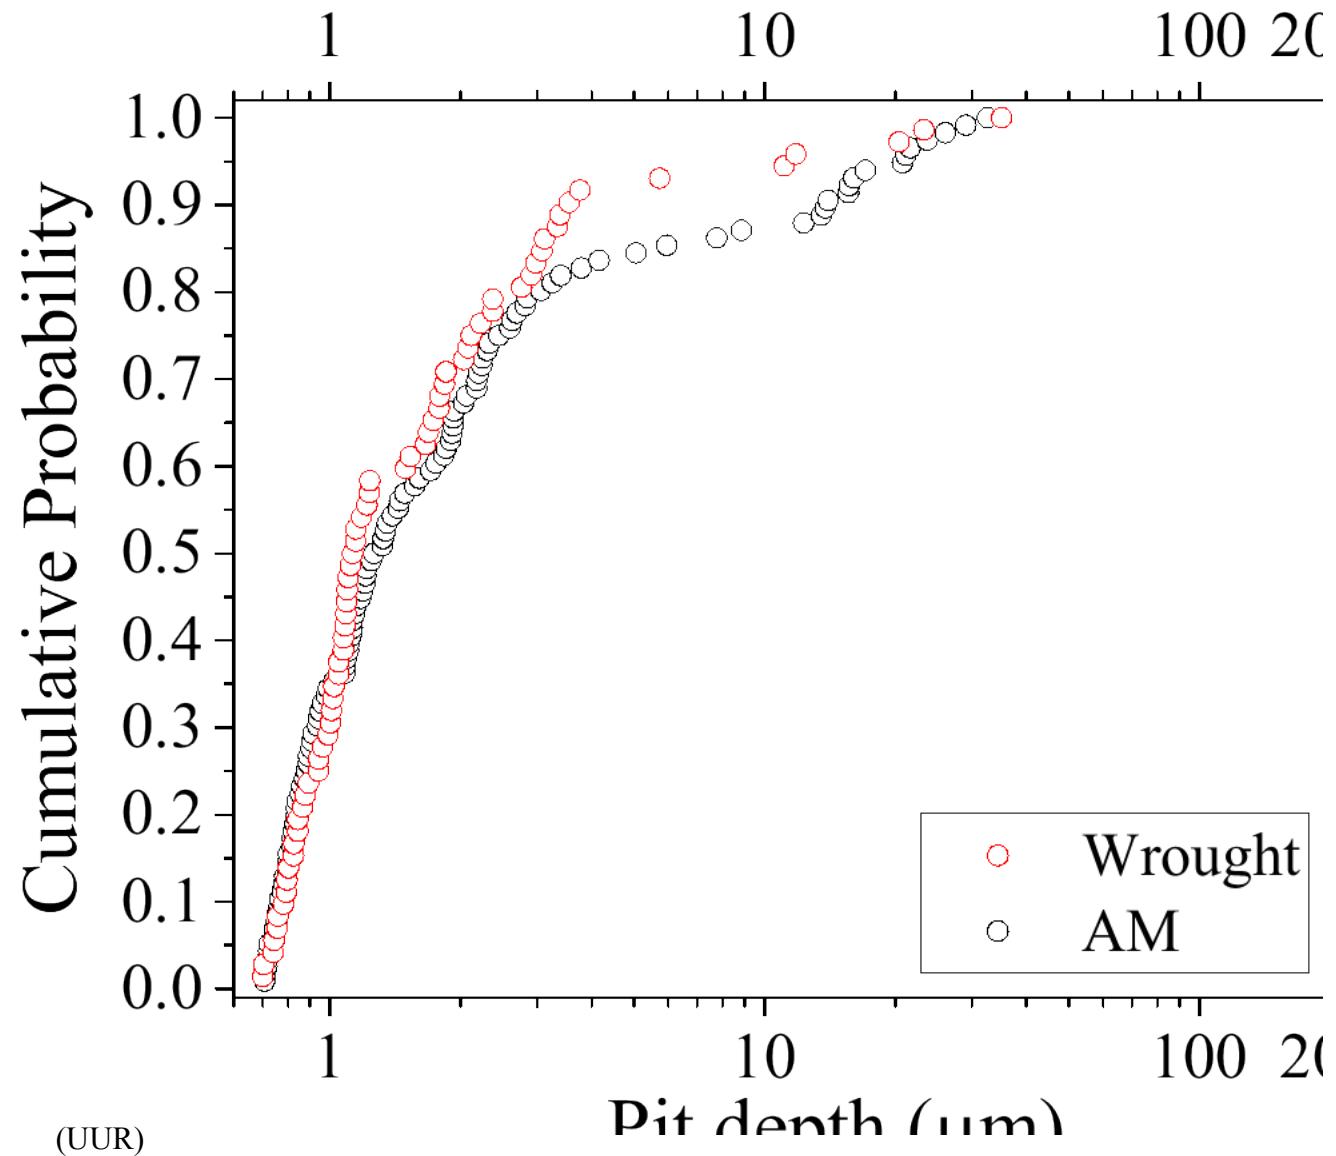
## 1 week – Pit depth

Average pit depth ( $\mu\text{m}$ )	Max pit depth ( $\mu\text{m}$ )
1 week	2.9	35.1
1 month	7.0	41.8
6 months	6.3	58.5
12 months	11.7	118.1

Average pit depth ( $\mu\text{m}$ )	Max pit depth ( $\mu\text{m}$ )
1 week	4.0	32.6
1 month	10.1	210.4 (73.3)
6 months	7.6	76.2
12 months	9.4	80.2

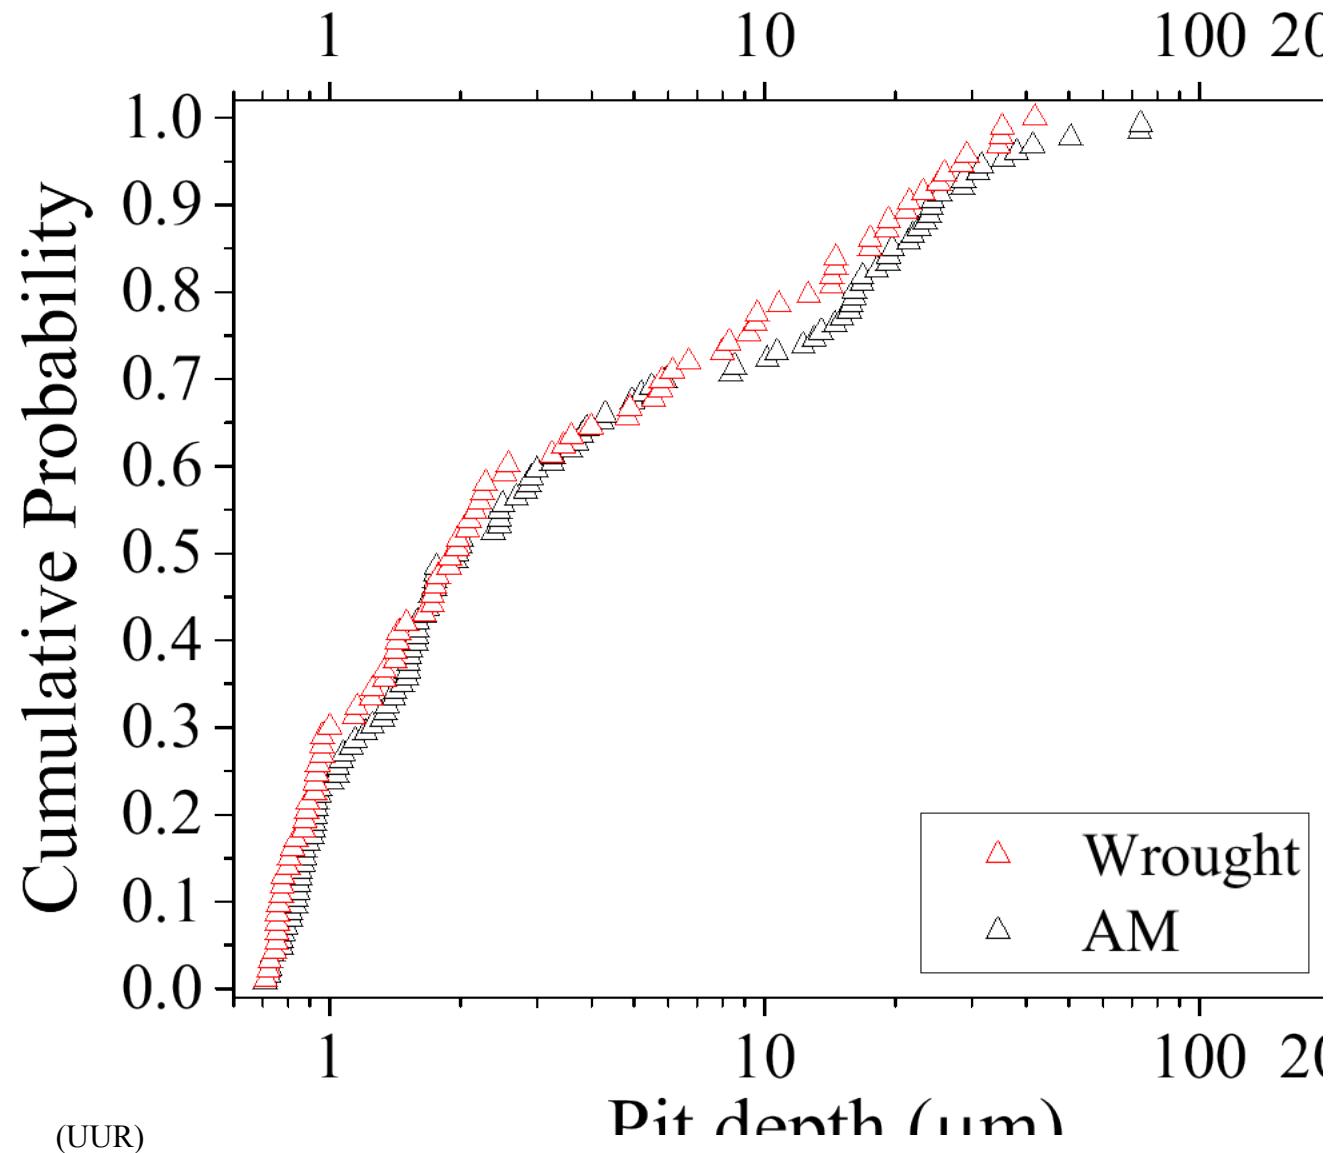
**1 month – Pit depth**

Average pit depth ( $\mu\text{m}$ )	Max pit depth ( $\mu\text{m}$ )
1 week	2.9	35.1
1 month	7.0	41.8
6 months	6.3	58.5
12 months	11.7	118.1

Average pit depth ( $\mu\text{m}$ )	Max pit depth ( $\mu\text{m}$ )
1 week	4.0	32.6
1 month	10.1	210.4 (73.3)
6 months	7.6	76.2
12 months	9.4	80.2

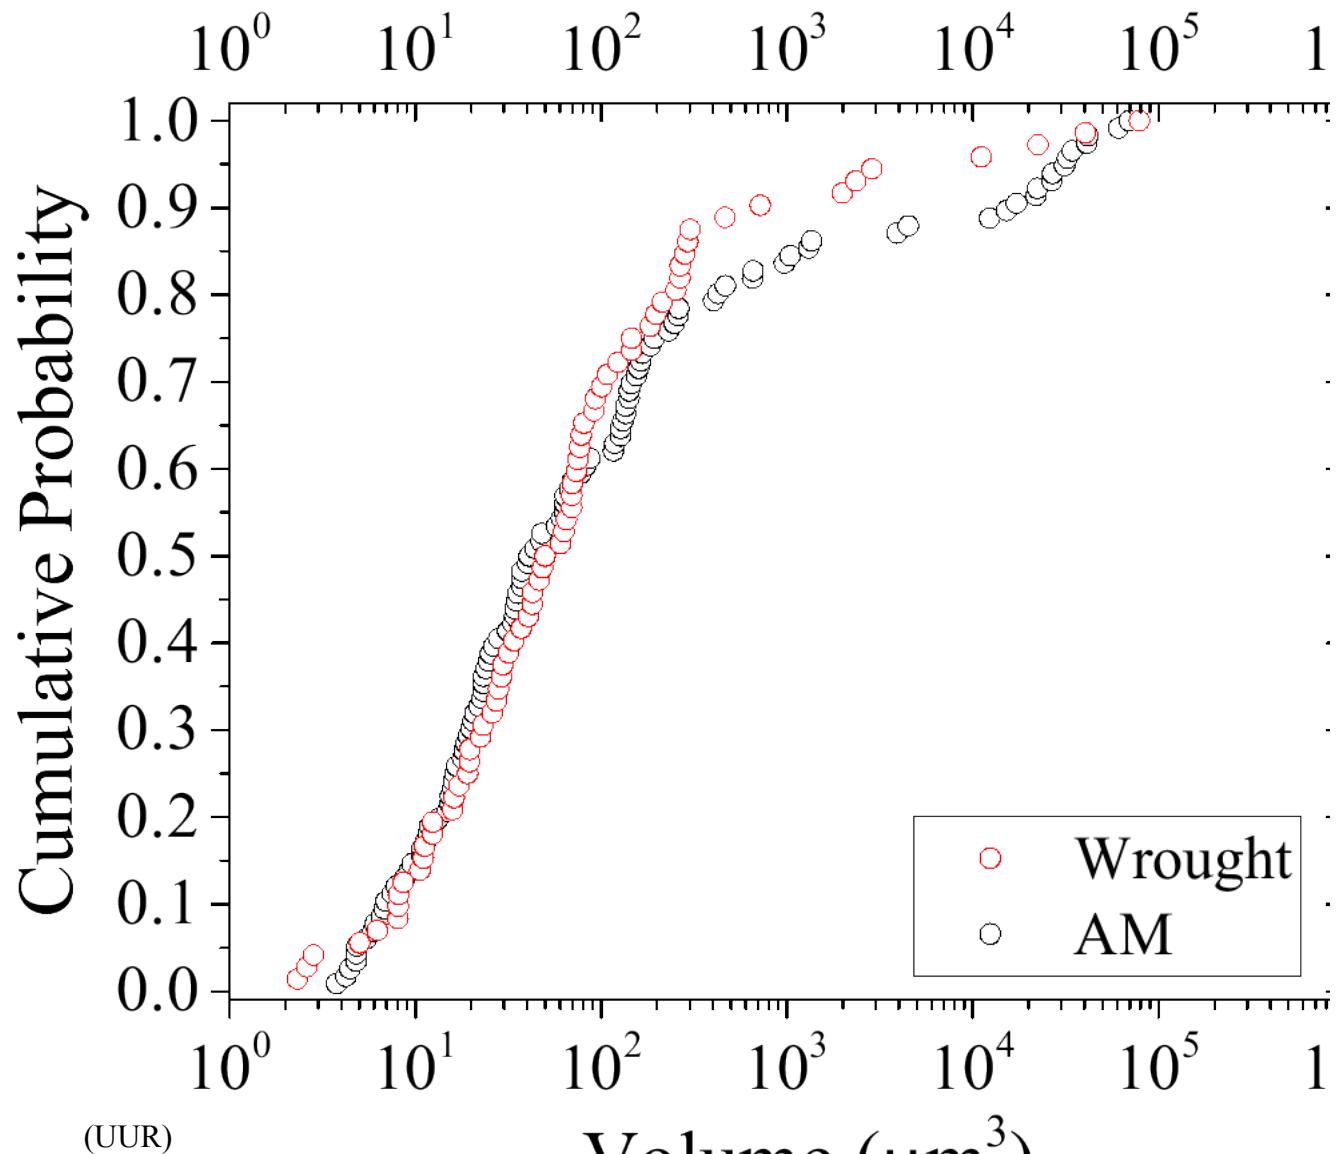
## 1 week – Pit volume

Volume per area ( $\mu\text{m}^3/\text{cm}^2$ )	# of Pits/ $\text{cm}^2$
1 week	$1.15 \times 10^5$	50
1 month	$9.28 \times 10^5$	65
6 months	$2.34 \times 10^6$	105
12 months	$2.75 \times 10^6$	96

Volume per area ( $\mu\text{m}^3/\text{cm}^2$ )	# of Pits/ $\text{cm}^2$
1 week	$3.66 \times 10^5$	89
1 month	$9.35 \times 10^5$	88
6 months	$2.97 \times 10^6$	155
12 months	$1.74 \times 10^6$	53

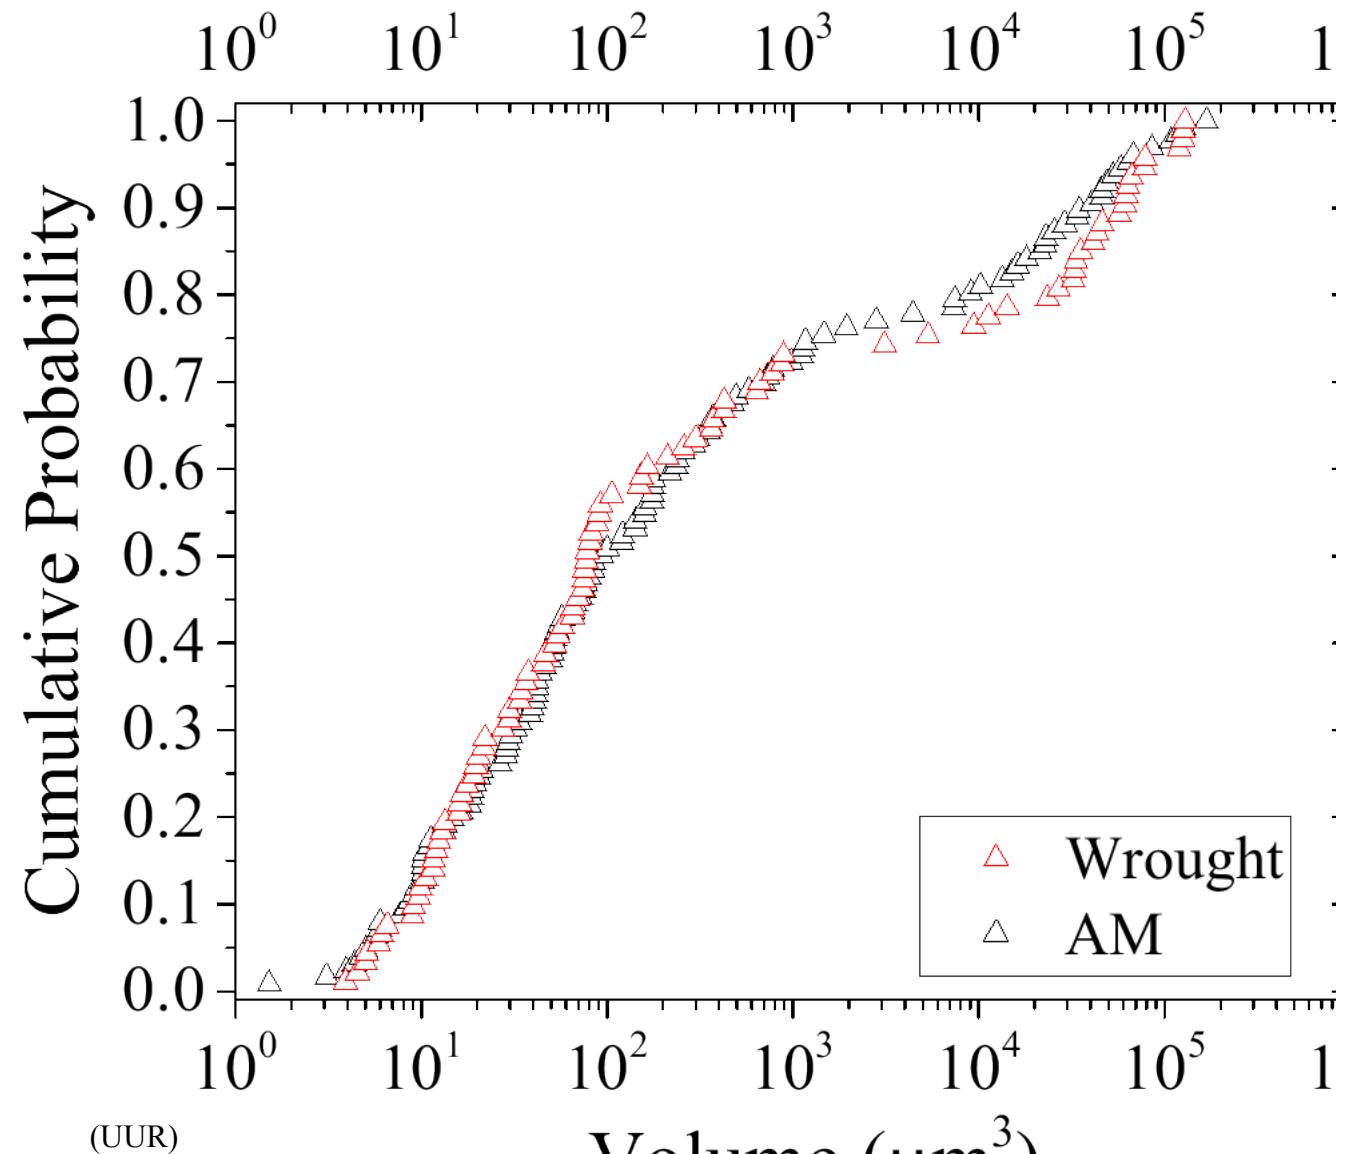
**1 month – Pit volume**

Volume per area ( $\mu\text{m}^3/\text{cm}^2$ )	# of Pits/ $\text{cm}^2$
1 week	$1.15 \times 10^5$	50
1 month	$9.28 \times 10^5$	65
6 months	$2.34 \times 10^6$	105
12 months	$2.75 \times 10^6$	96

Volume per area ( $\mu\text{m}^3/\text{cm}^2$ )	# of Pits/ $\text{cm}^2$
1 week	$3.66 \times 10^5$	89
1 month	$9.35 \times 10^5$	88
6 months	$2.97 \times 10^6$	155
12 months	$1.74 \times 10^6$	53
