Stress Corrosion Cracking of Austenitic Stainless Steels in Concentrated Chloride Environments

Ryan M. Katona

Sandia National Laboratories, Albuquerque, New Mexico 87123,
USA

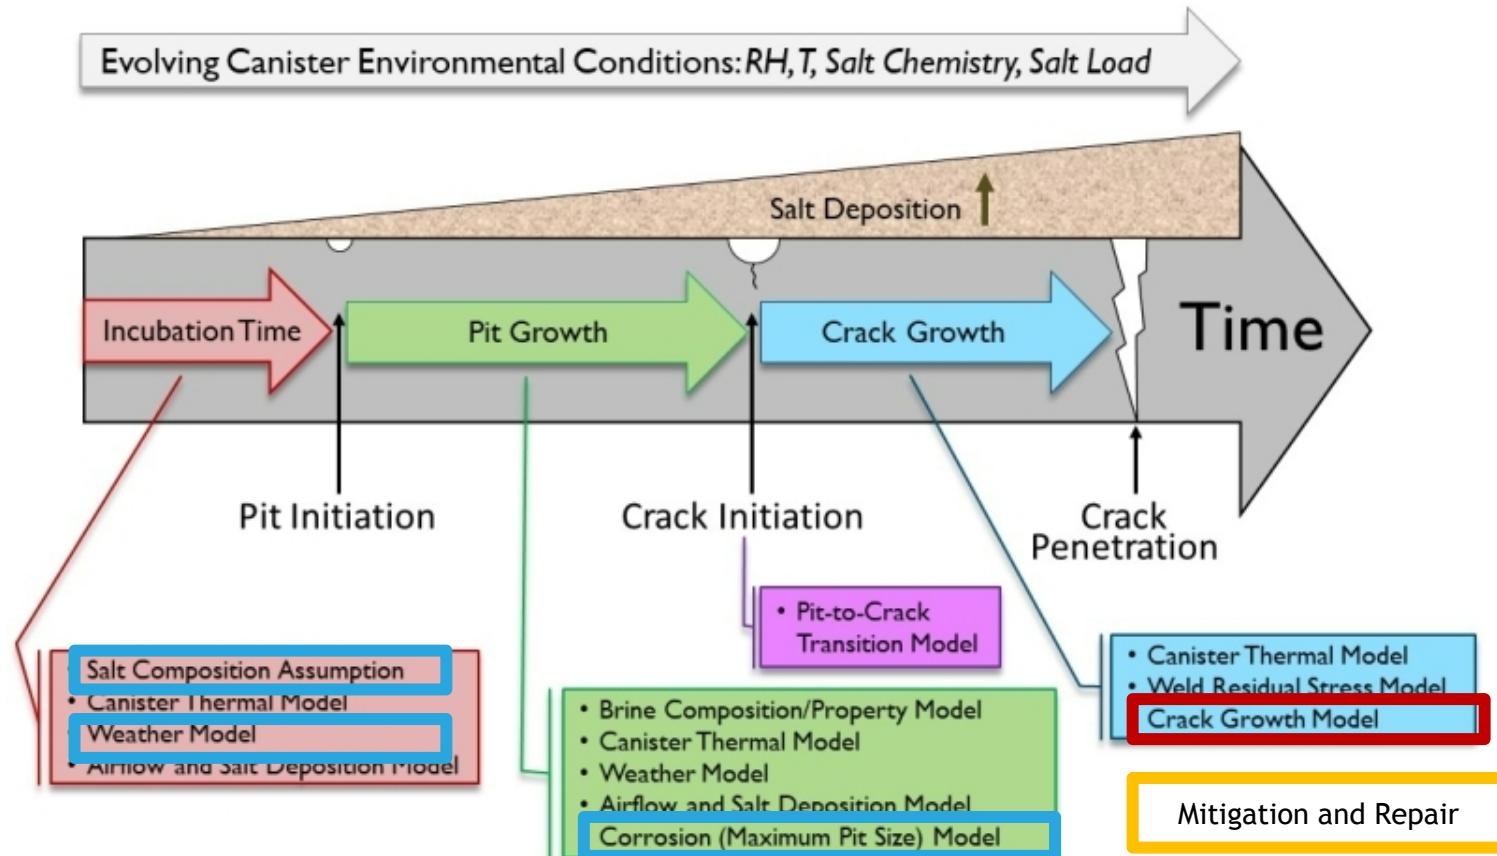
Integrated Mechanistic/Probabilistic Model for Canister SCC

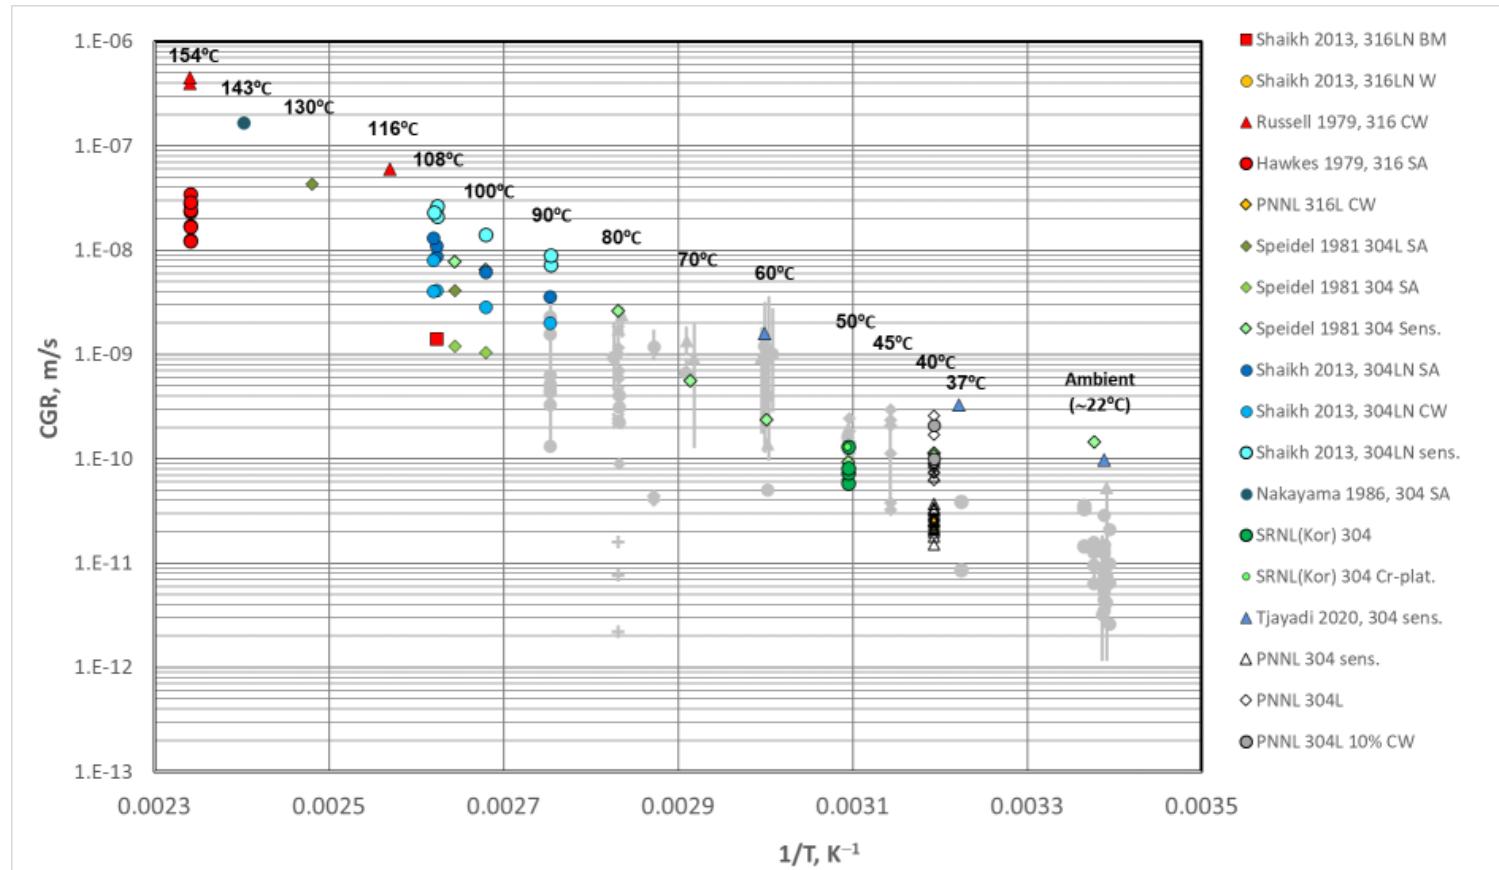
Arrhenius Temperature Dependence of Crack Growth

- Various collection methods, environments, lot of material, sensitization state, etc.
- ***What are the governing factors and will certain factors cause accelerated growth?***

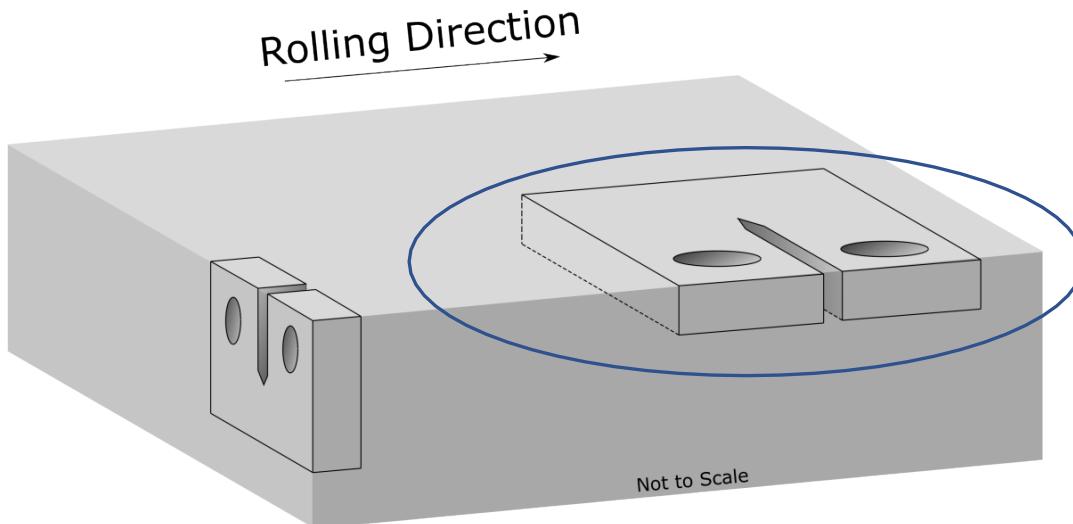
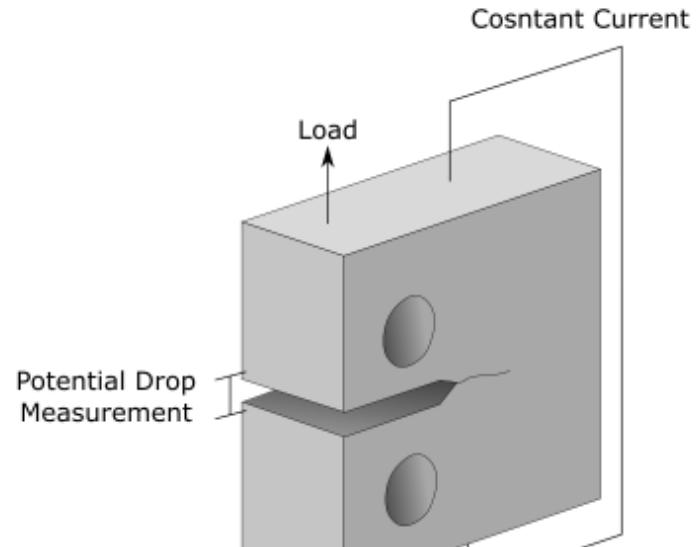
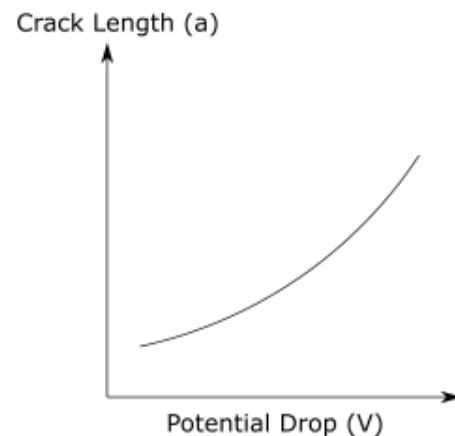
Sample Orientation and *In-Situ* Testing Methodology

- Majority of samples presented will be in the L-T orientation
- Annealed ASTM SS304L (information in supplemental)
- Utilizing Direct Current Potential Drop (DCPD)

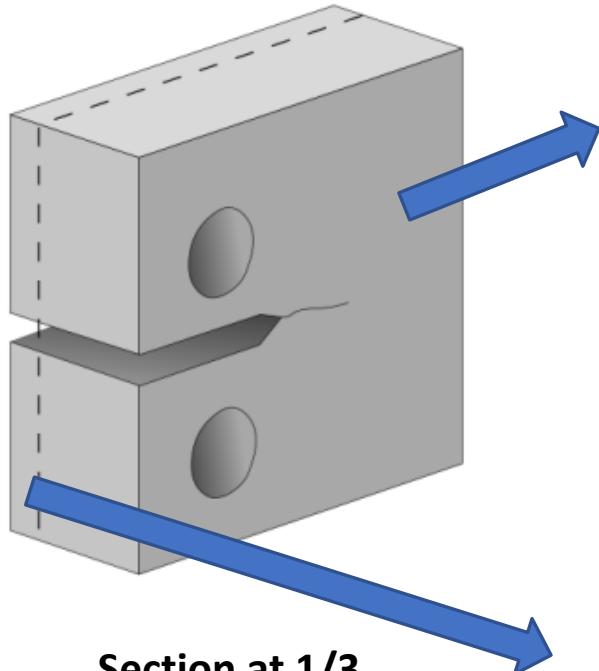
After Heat Tint

Methods for Post Test Sample Analysis

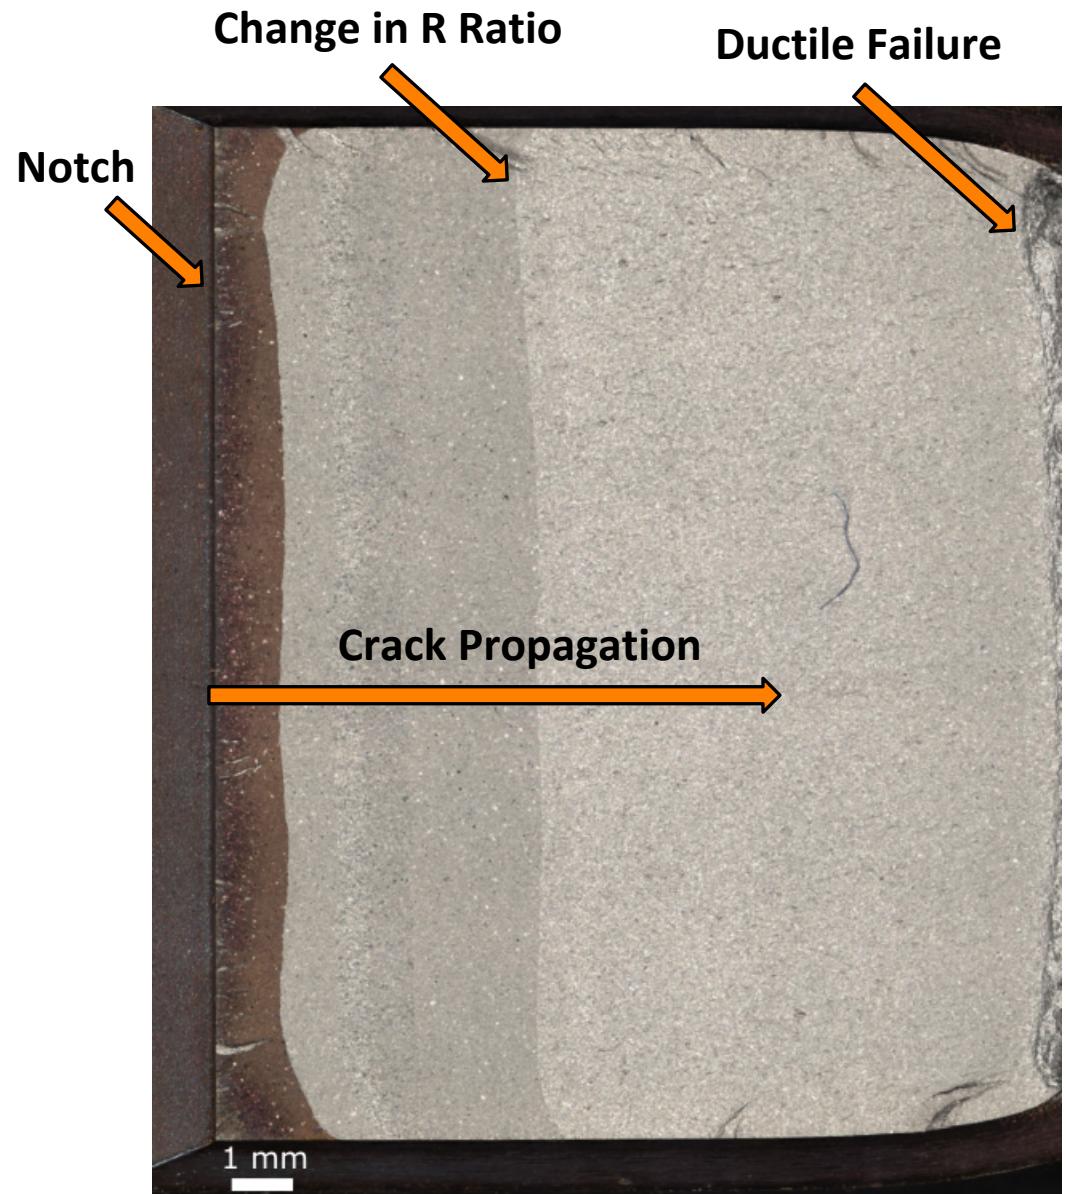
Calibration of DCPD Set-up

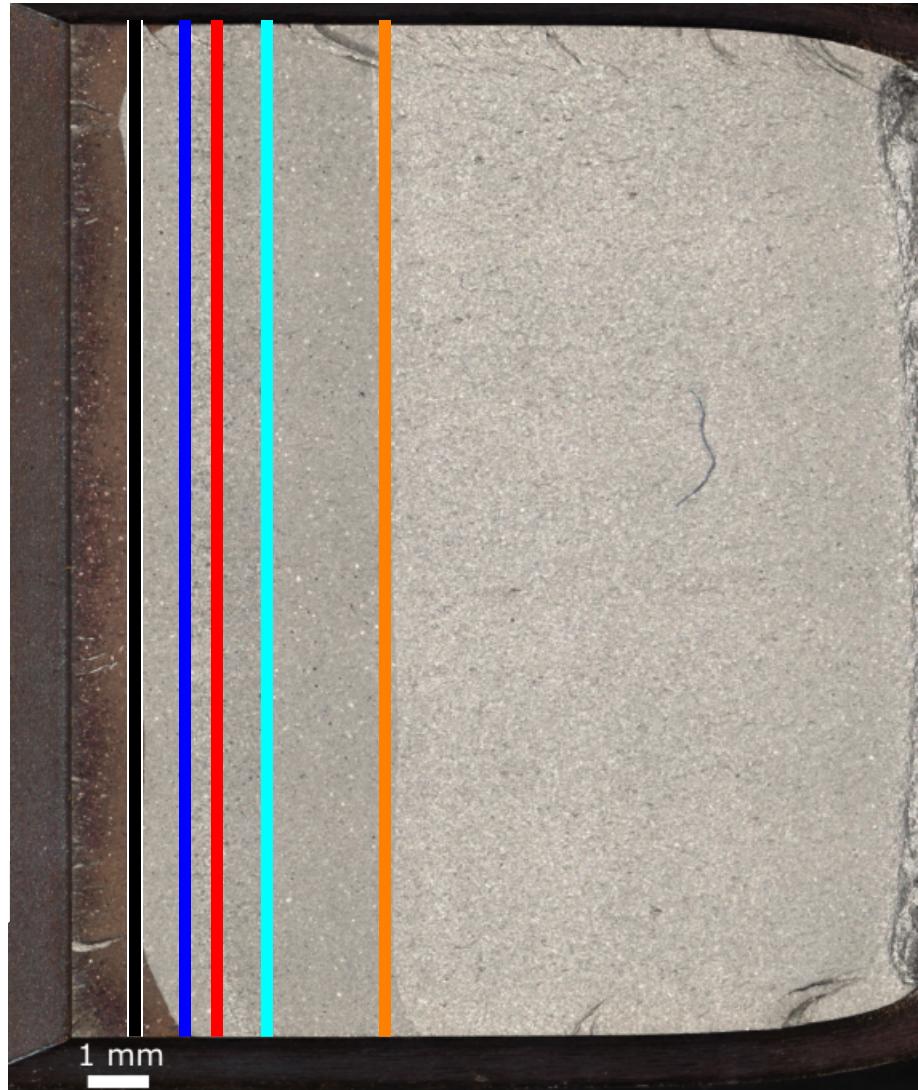
Calibration of DCPD Set-up

- Performed on two different load frames
- Confidence DCPD system is set-up correctly

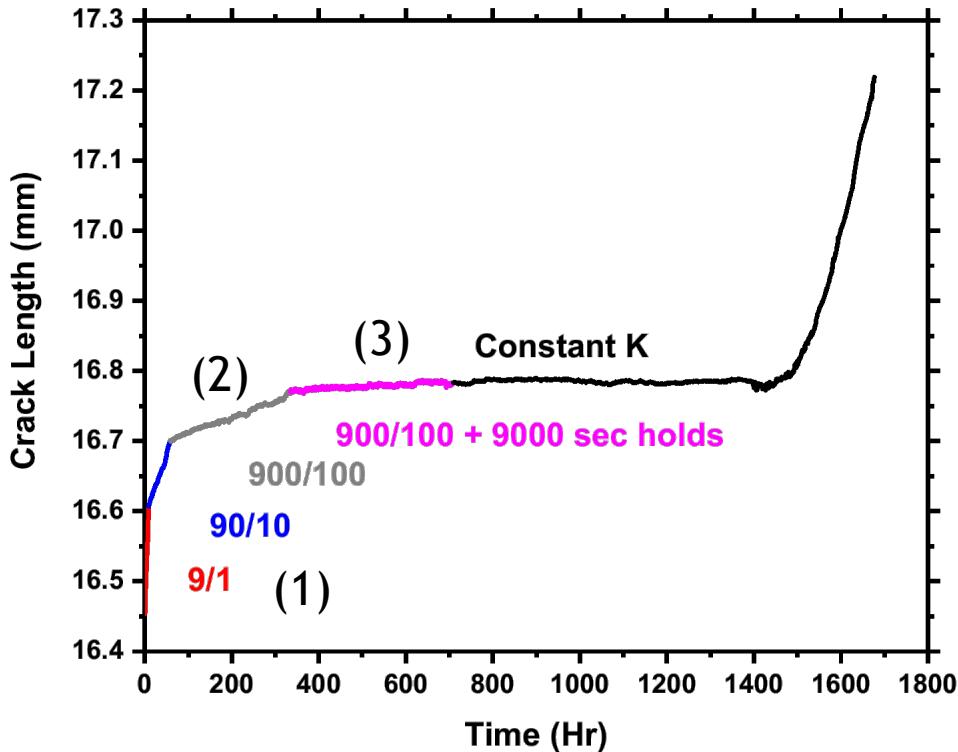
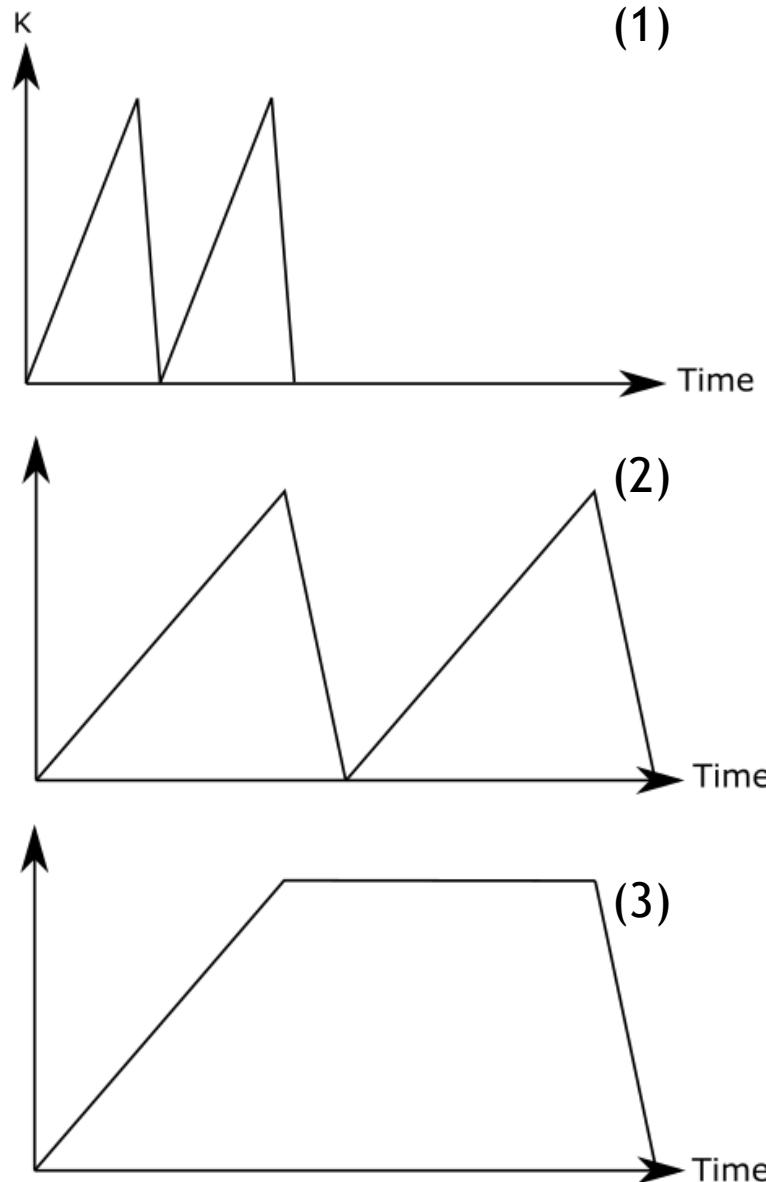
SS304L Exhibits Delayed Crack Growth Under Constant K in $MgCl_2$ at 55 °C

- Decreasing frequency under K control to constant K state
 - 'True' crack plane for constant K SCC
- $K_{max} = 20 MPa\sqrt{m}$

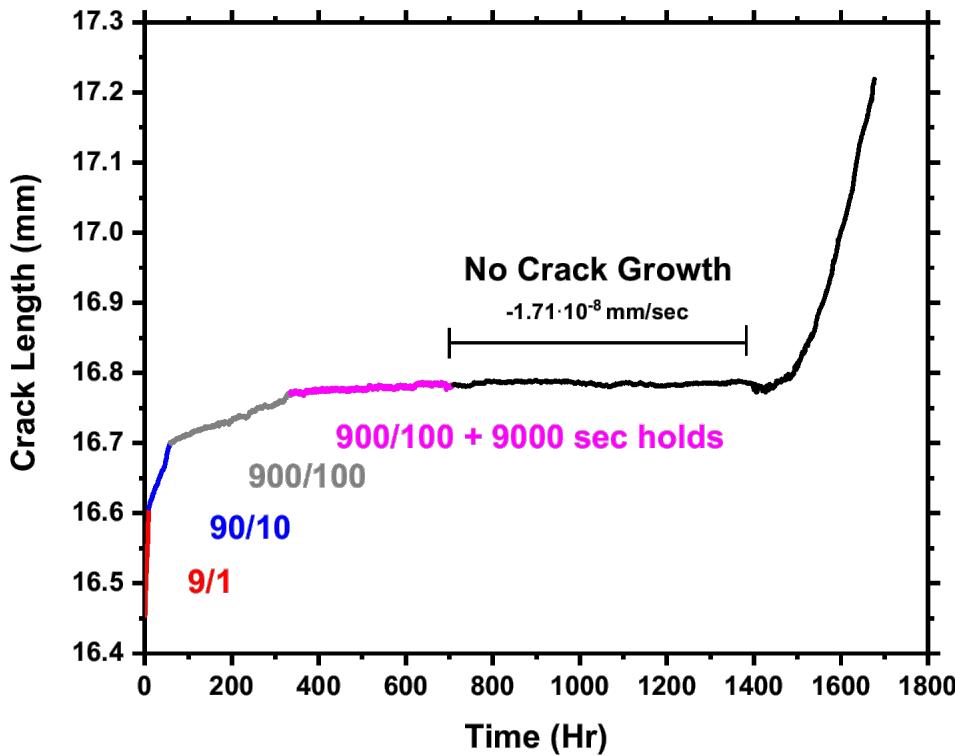
SS304L Exhibits Delayed Crack Growth Under Constant K in MgCl₂ at 55 °C

- No growth for ~ 700 hours

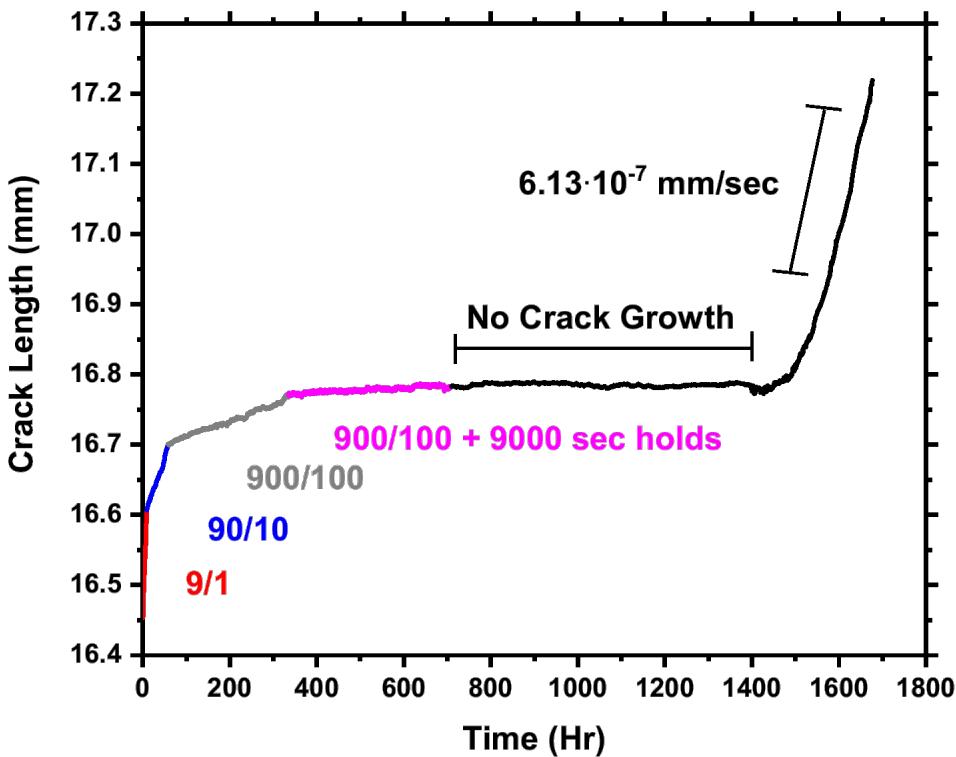
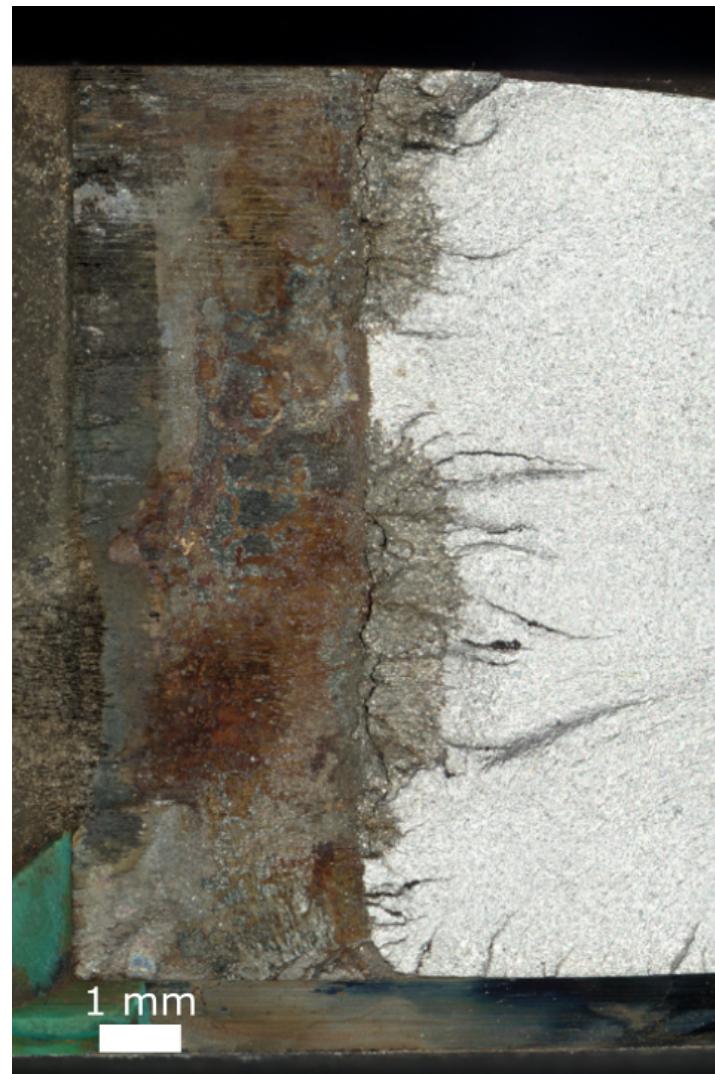
SS304L Exhibits Irregular Crack Front in Saturated MgCl₂ at 55 °C

- After roughly 1500 hours of total test time, cracking ensues
- Sample was cut at 1/3 of thickness

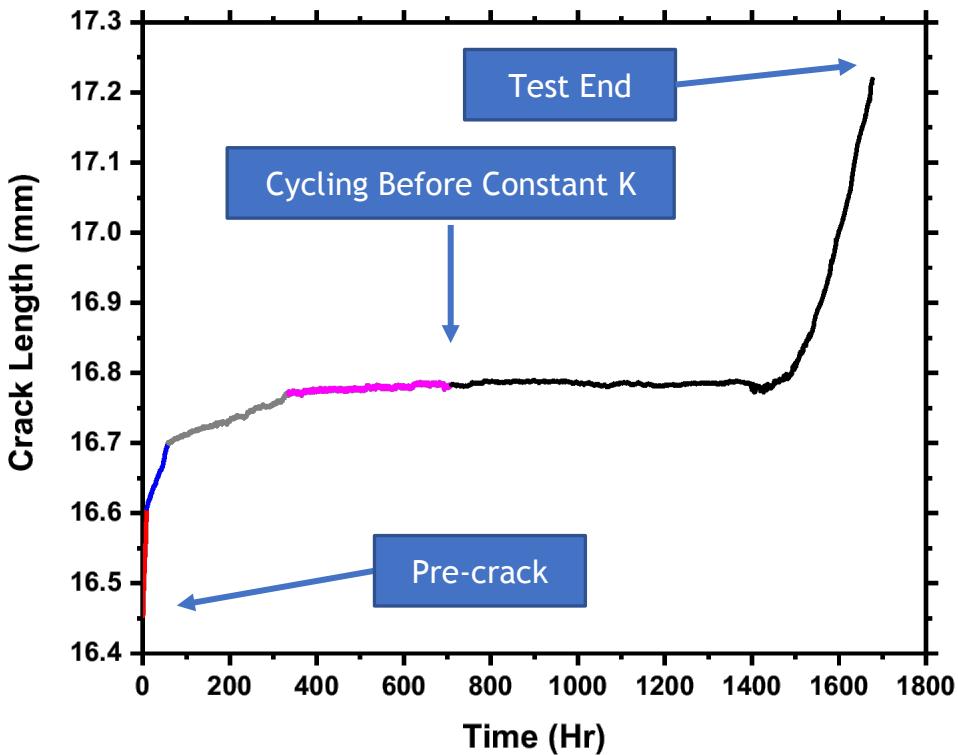
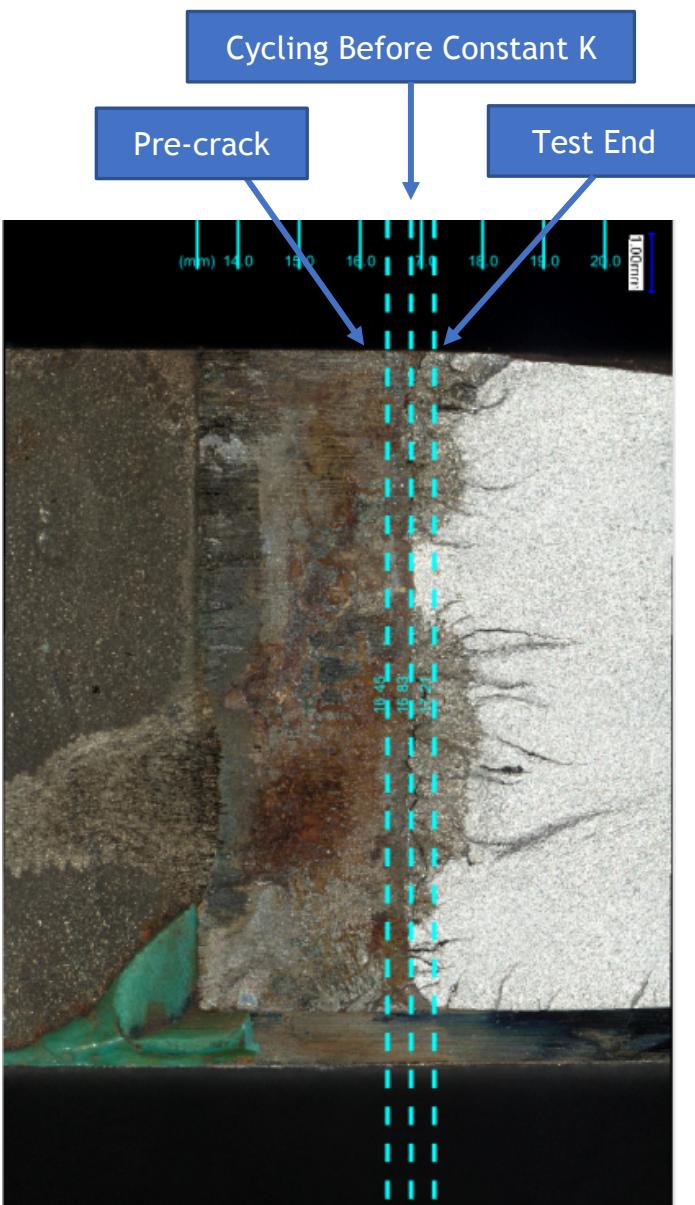
SS304L Exhibits Irregular Crack Front in Saturated $MgCl_2$ at 55 °C

- Overlay of DCPD on fractography potentially suggests cracking halted at the uniform 'ledge'

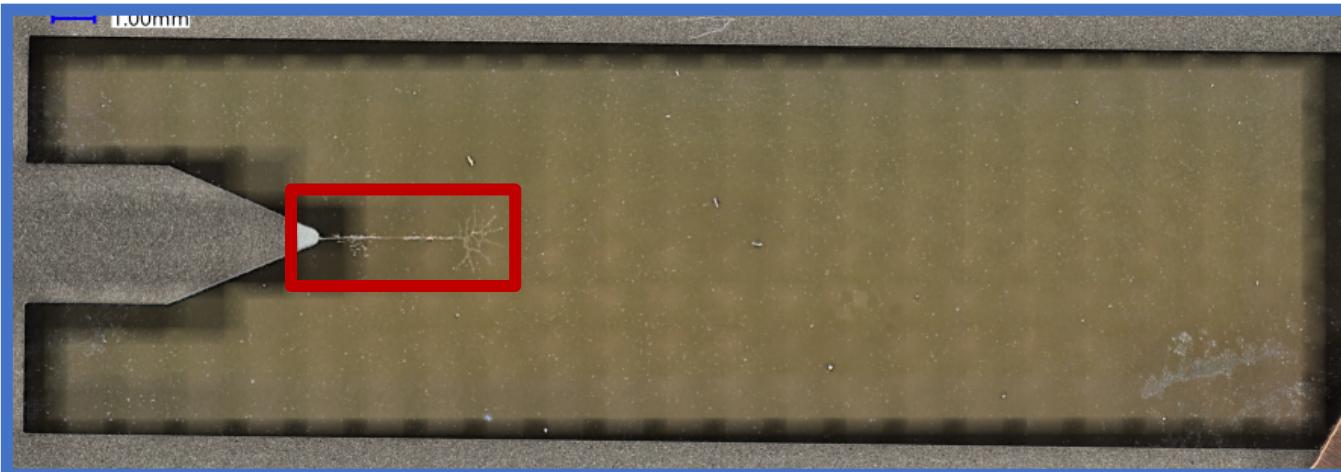
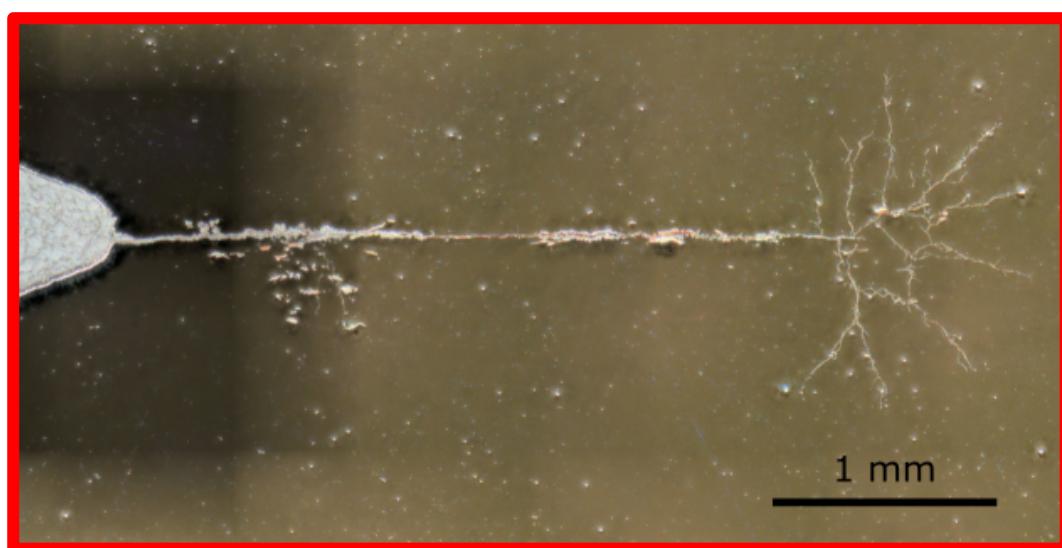
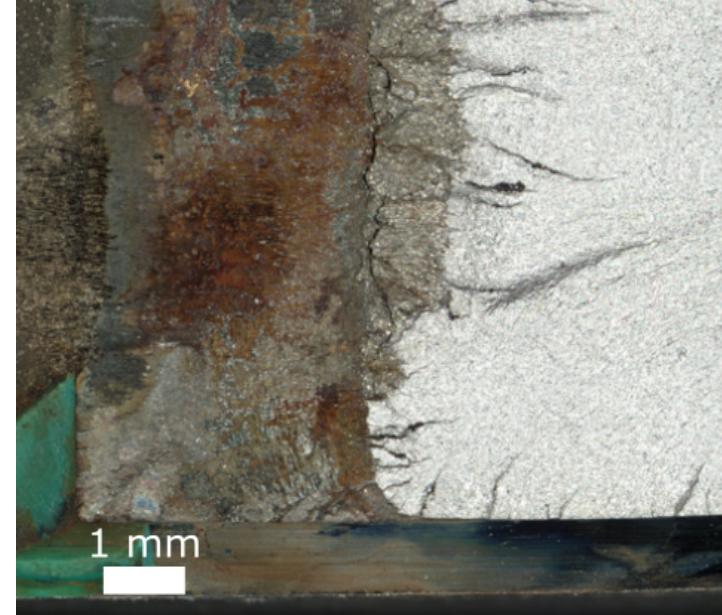
SS304L Exhibits Crack Branching in Saturated MgCl_2 at 55 °C

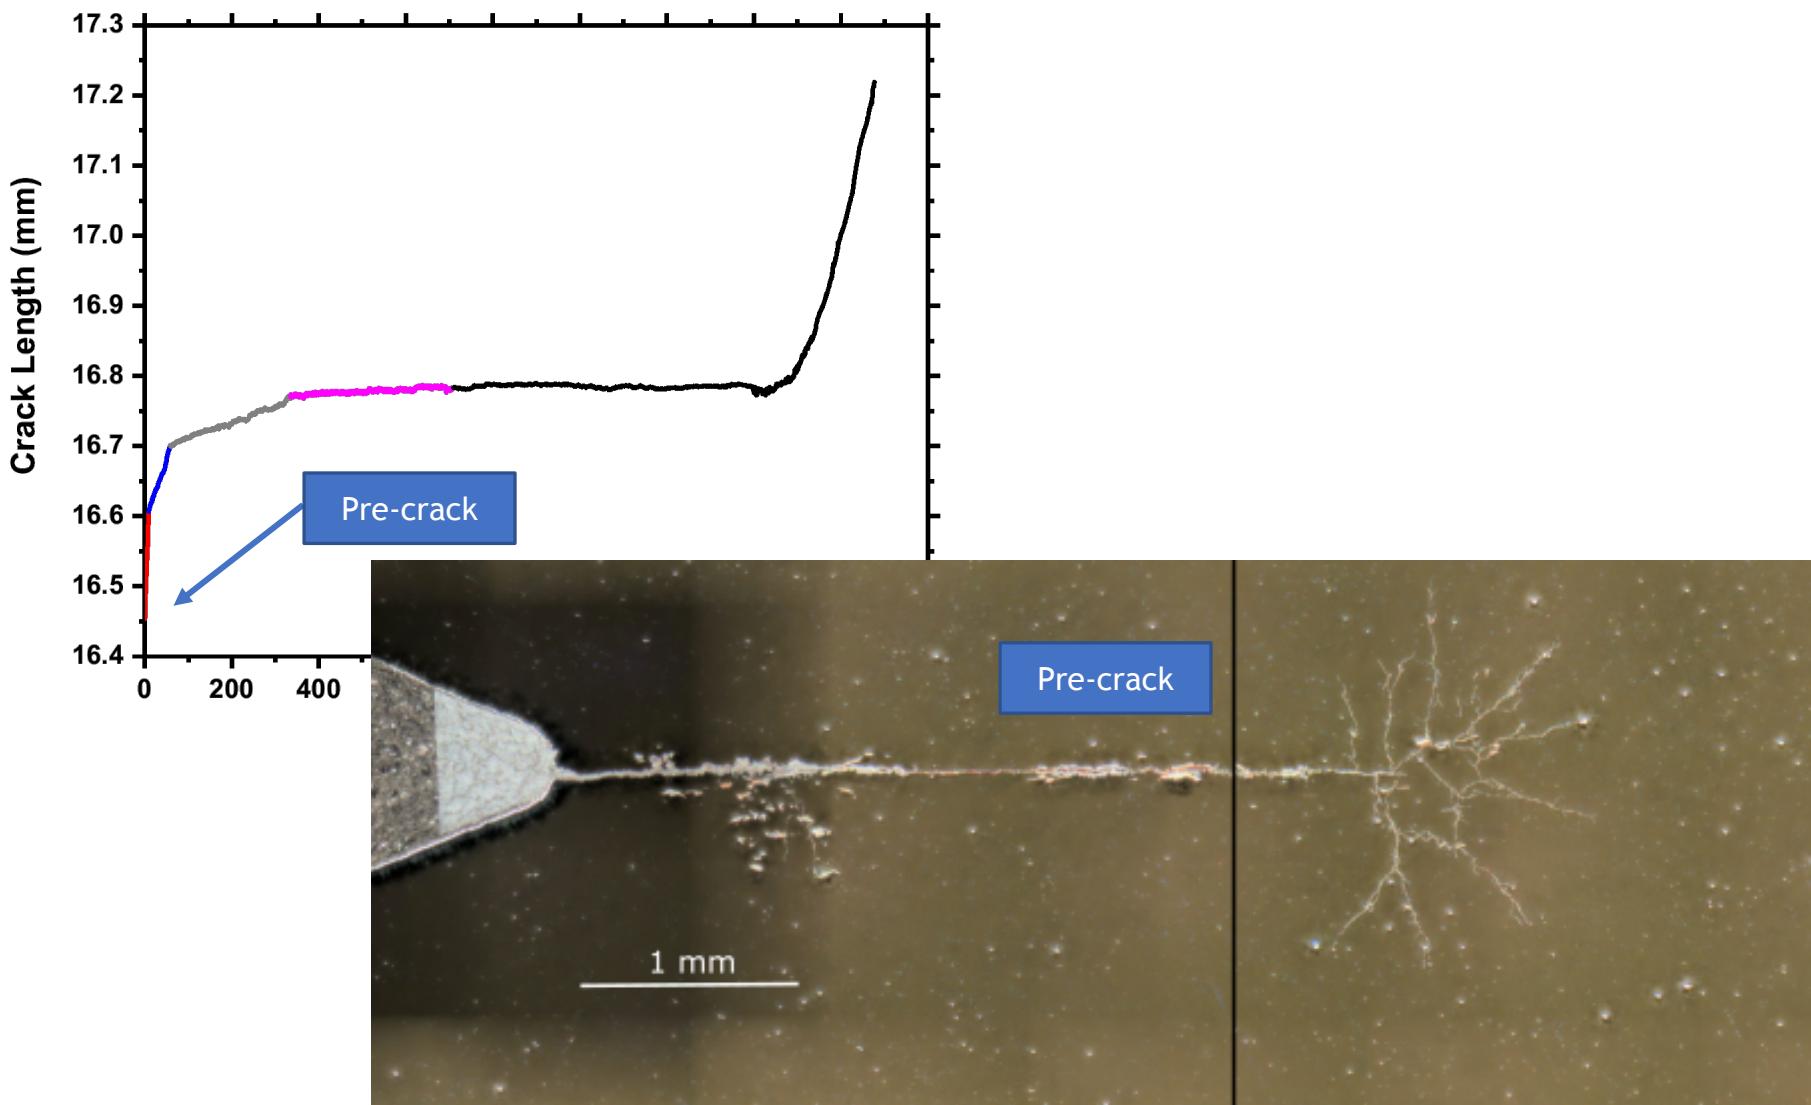
SS304L Exhibits Crack Branching in Saturated MgCl_2 at 55 °C

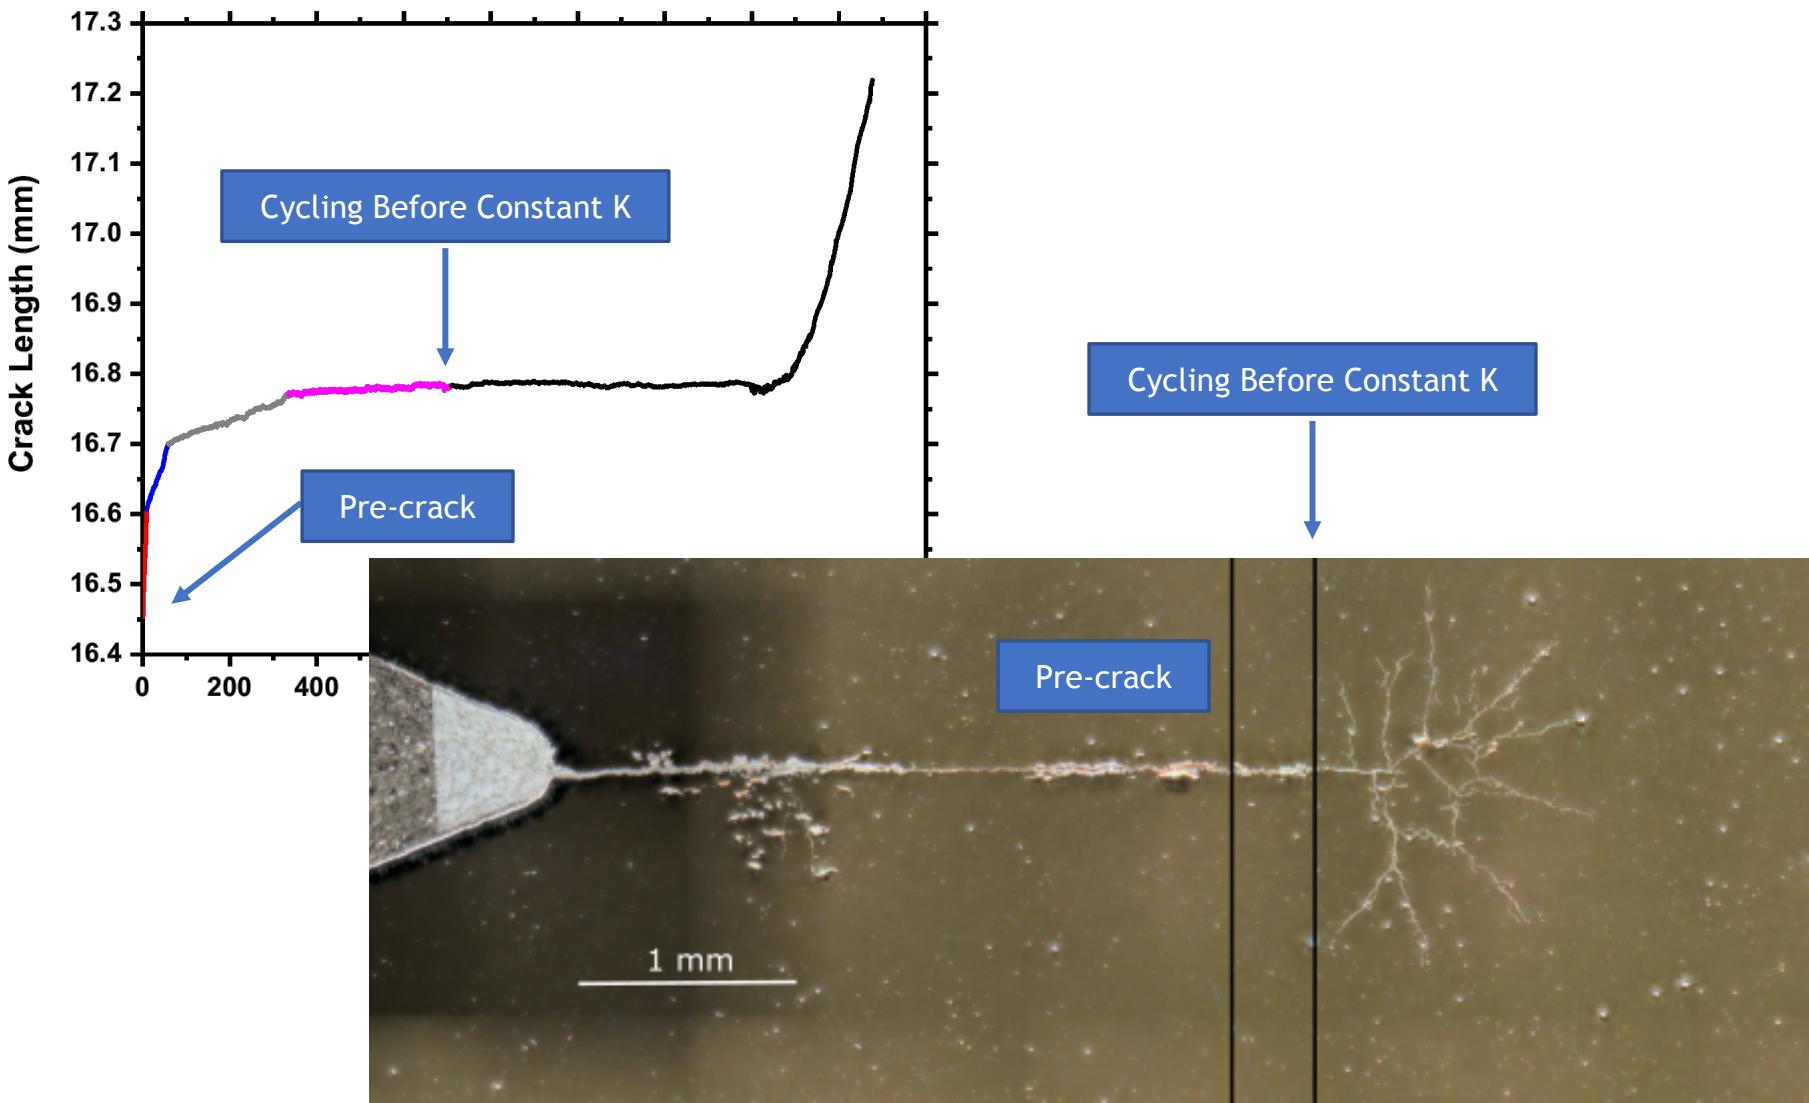
SS304L Exhibits Crack Branching in Saturated MgCl_2 at 55 °C

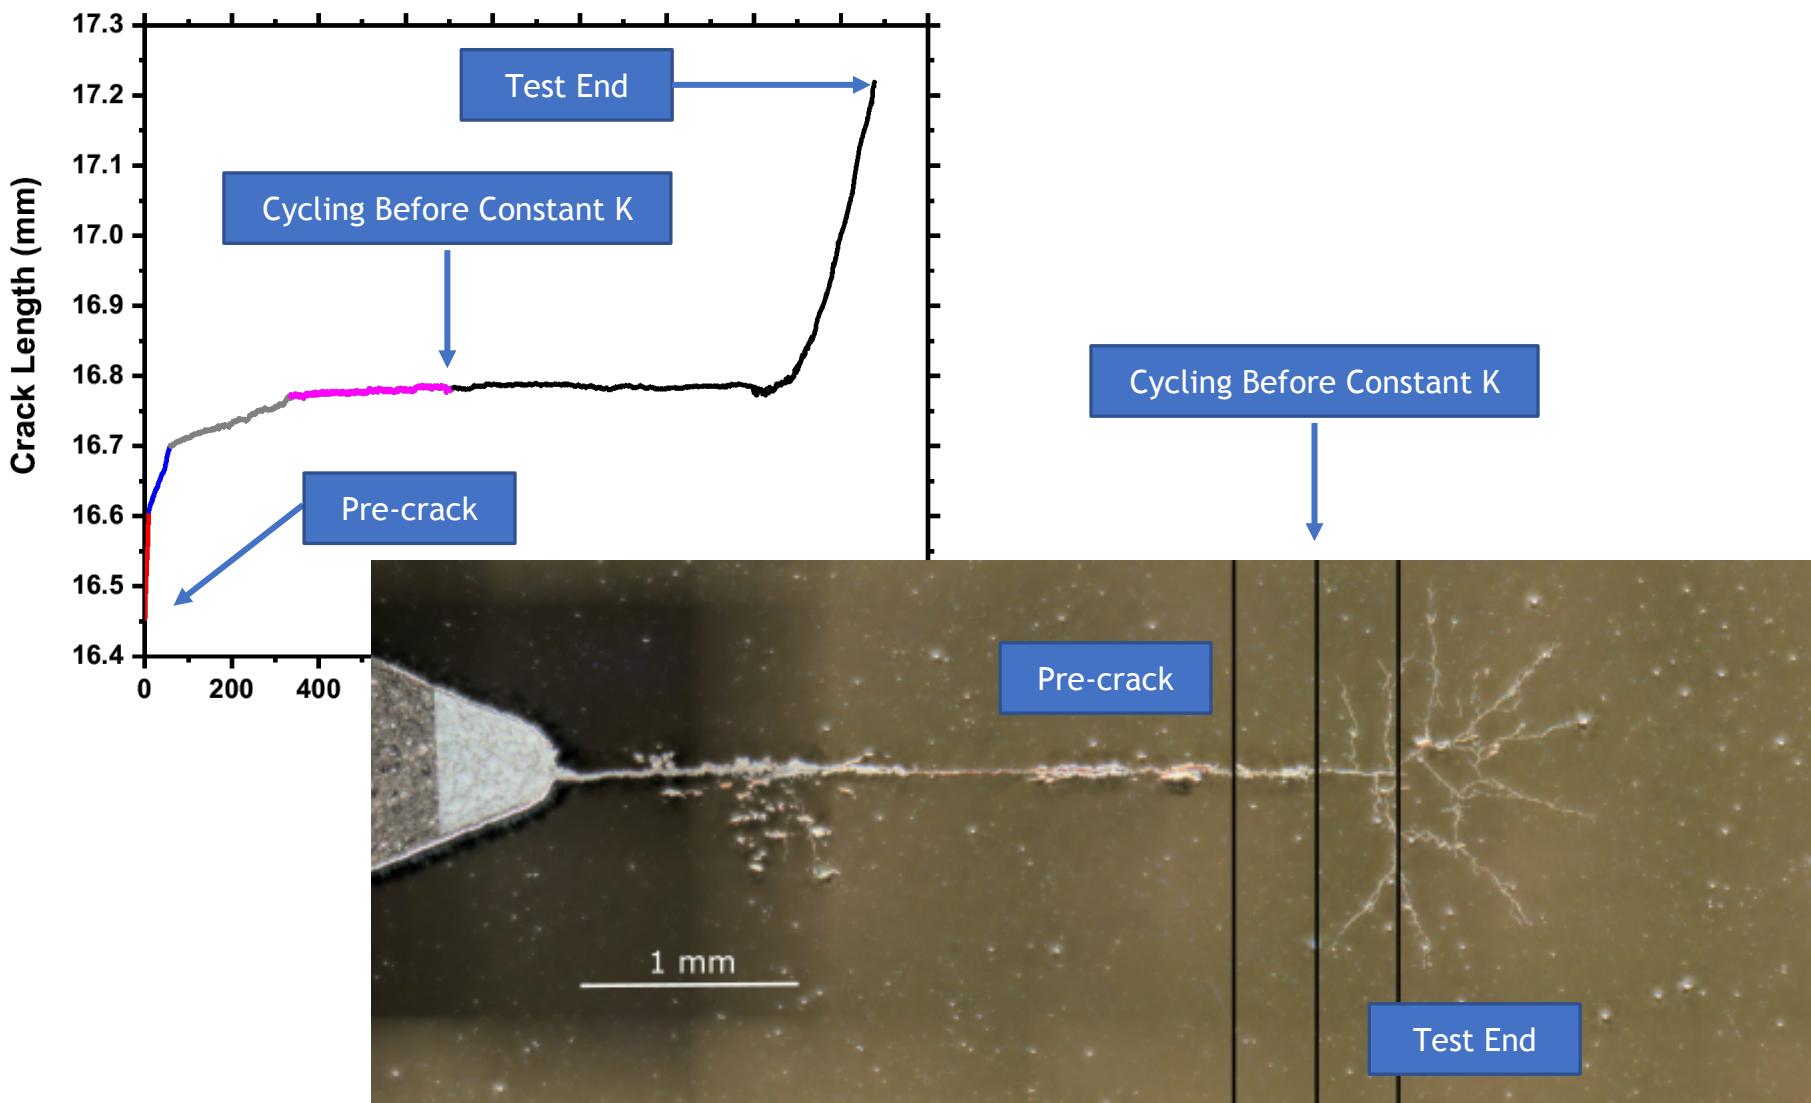
SS304L Exhibits Crack Branching in Saturated MgCl_2 at 55 °C

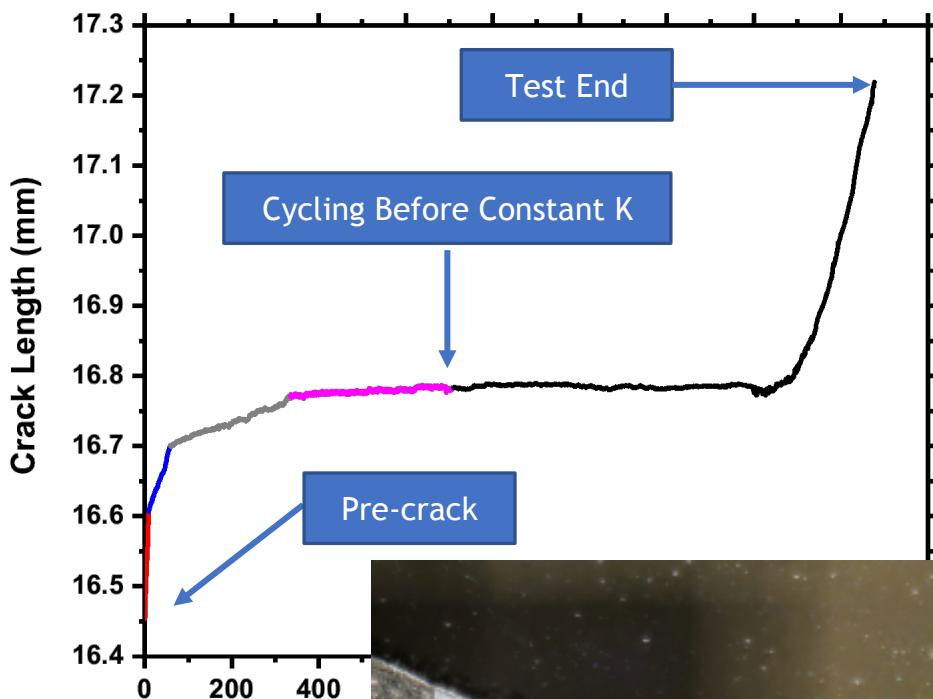
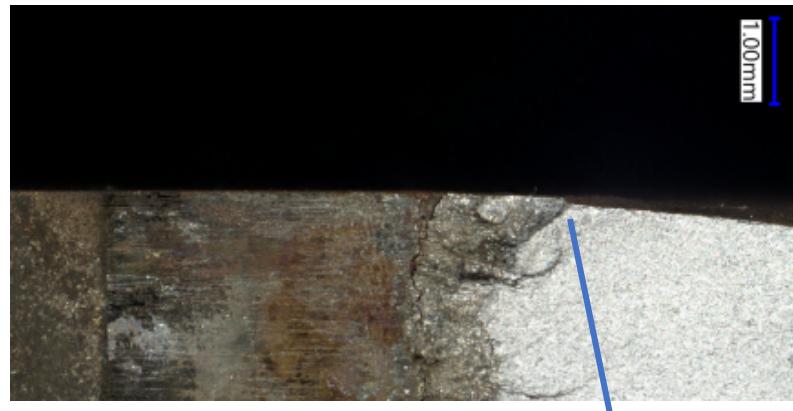
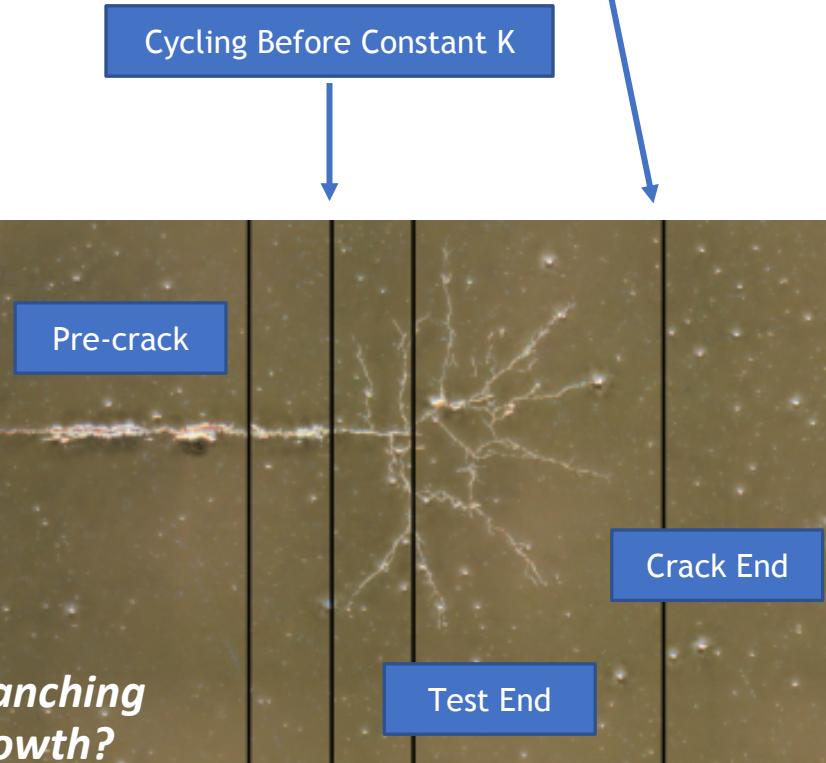
SS304L Exhibits Crack Branching in Saturated $MgCl_2$ at 55 °C

Is it possible that crack branching caused delayed crack growth?

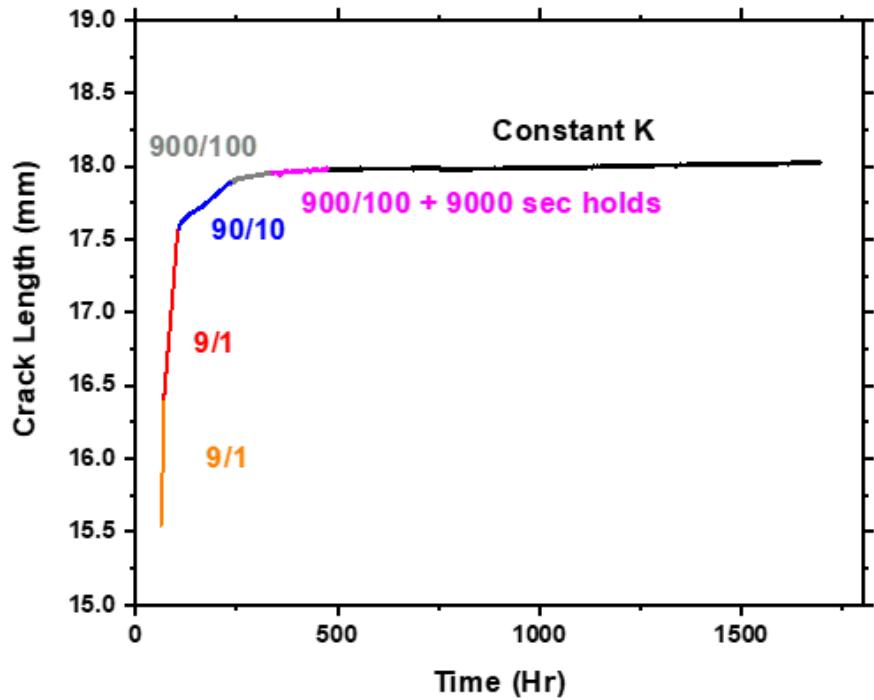
Low Crack Growth Rate for in Saturated MgCl_2 at 25 °C
