Stress Corrosion Cracking of Austenitic Stainless Steels in Concentrated Chloride Environments

Ryan M. Katona

Sandia National Laboratories, Albuquerque, New Mexico 87123,
USA

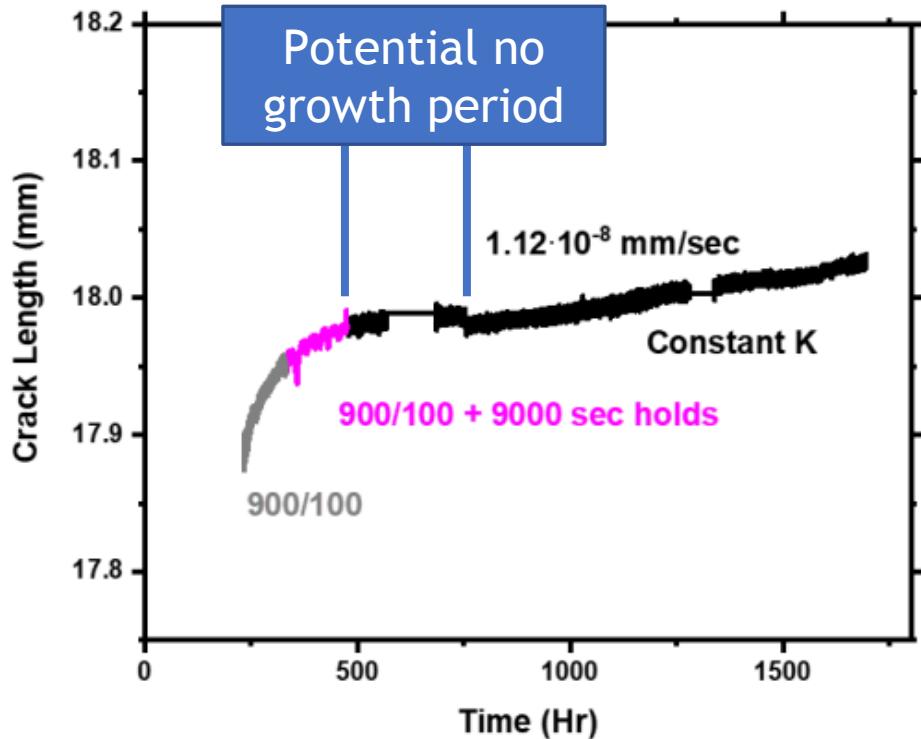
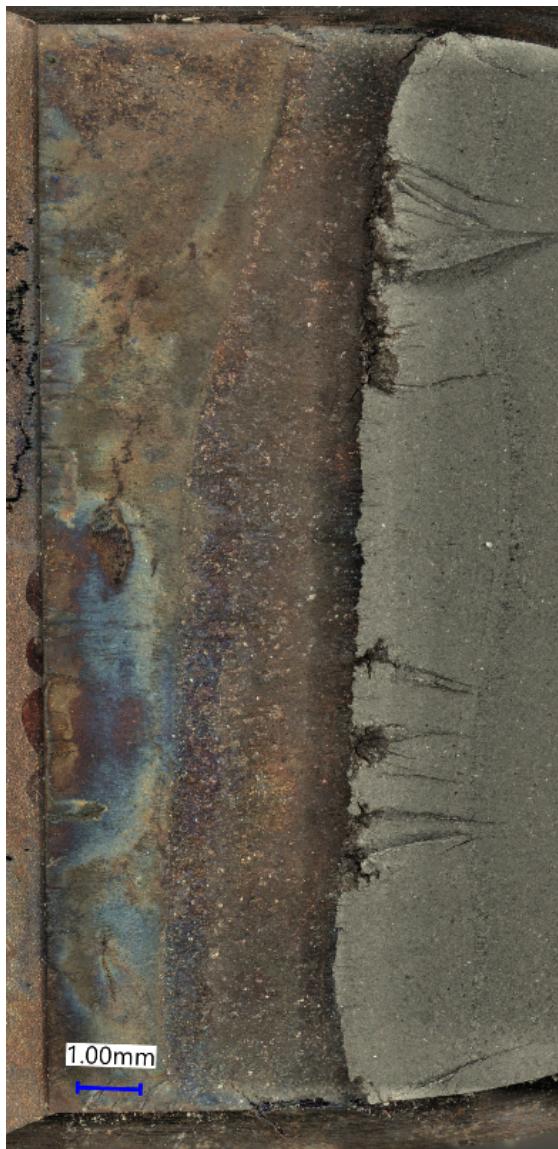
Low Crack Growth Rate for in Saturated MgCl₂ at 25 °C Experienced Localized Cracking

- Similar delay in indicated crack growth to 55 °C
- Sample was not sliced but fractured open
- Similar crack morphology to 55 °C however are thinner regions

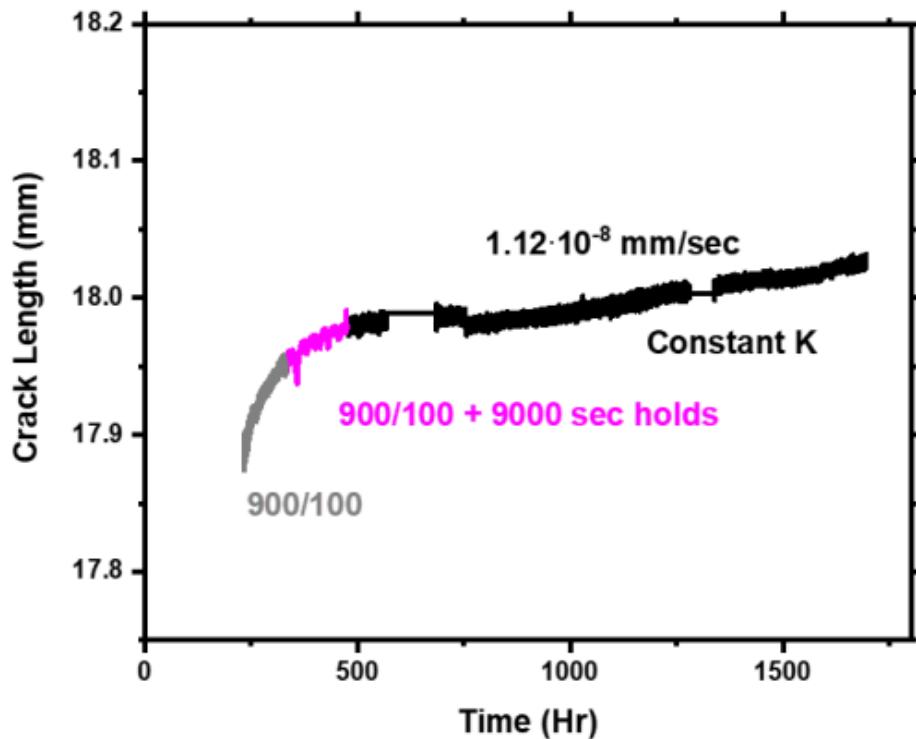
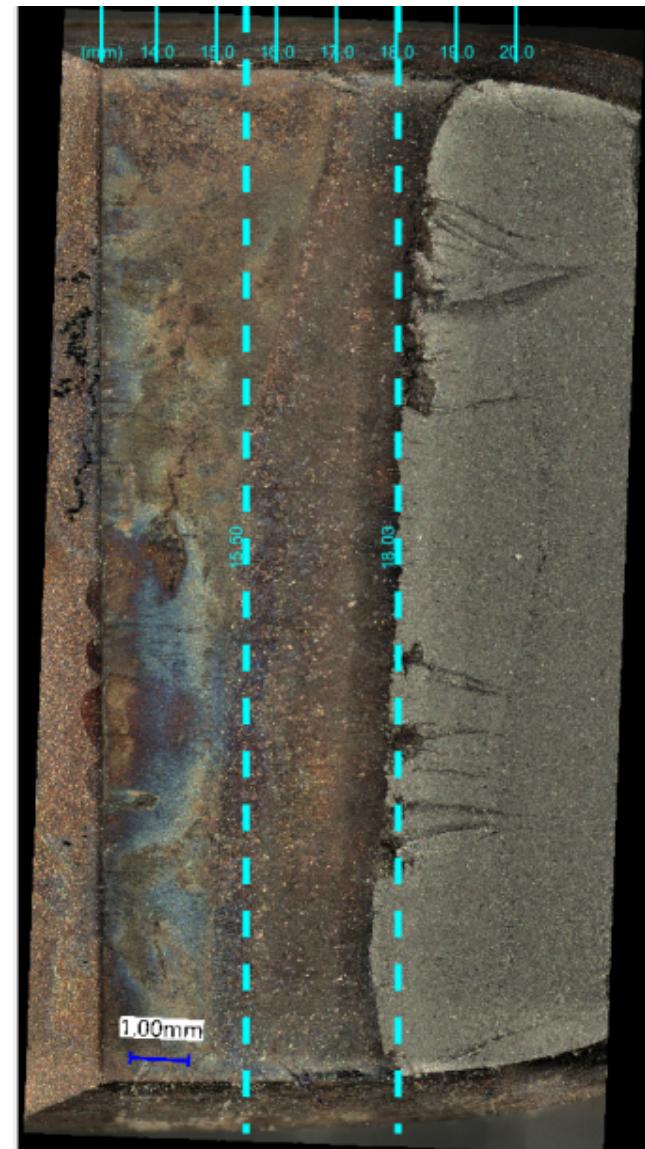
SS304L Exhibits Irregular Crack Front in Saturated MgCl₂ at 25 °C

- Slightly curved crack front makes overlay of DCPD difficult

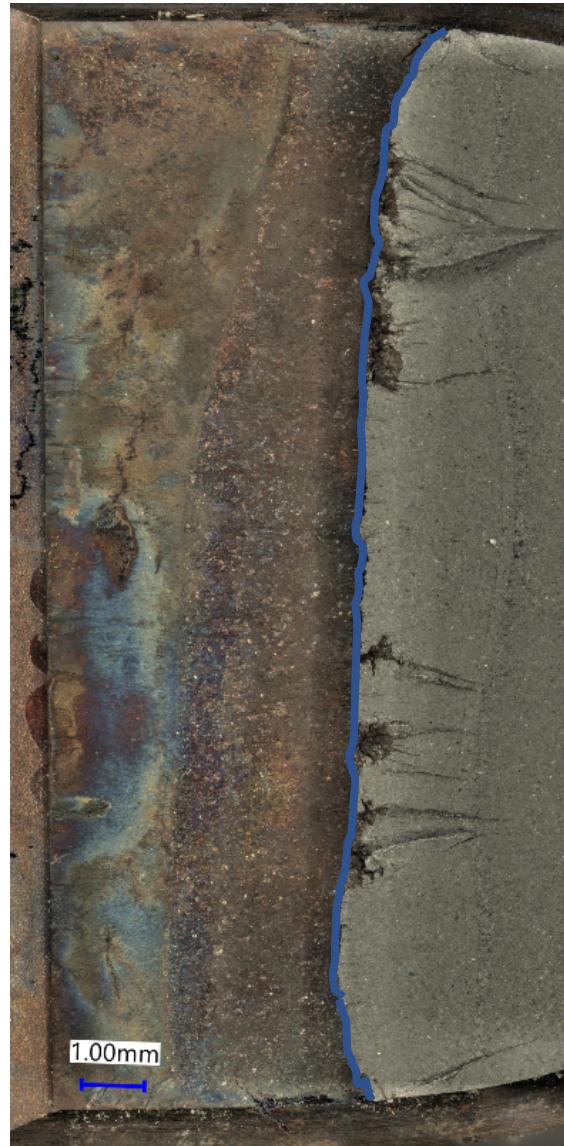
SS304L Exhibits Irregular Crack Front in Saturated MgCl₂ at 25 °C

- Measured 100 points of extension from the drawn blue line and averaged
 - Integration of crack extension by hand

Method	Δa
DCPD	53.8 mm
Fractography	60.1 mm

- Compared to total crack extension during constant K portion
- Possible that growth in 'protrusions' ahead of blue line occurred during the constant K portion

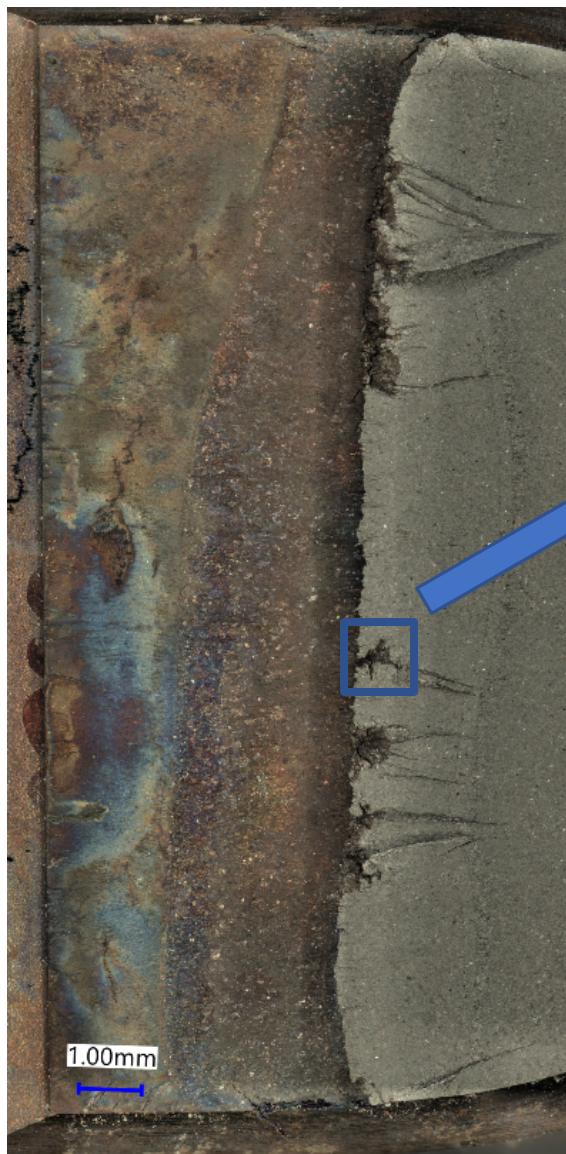
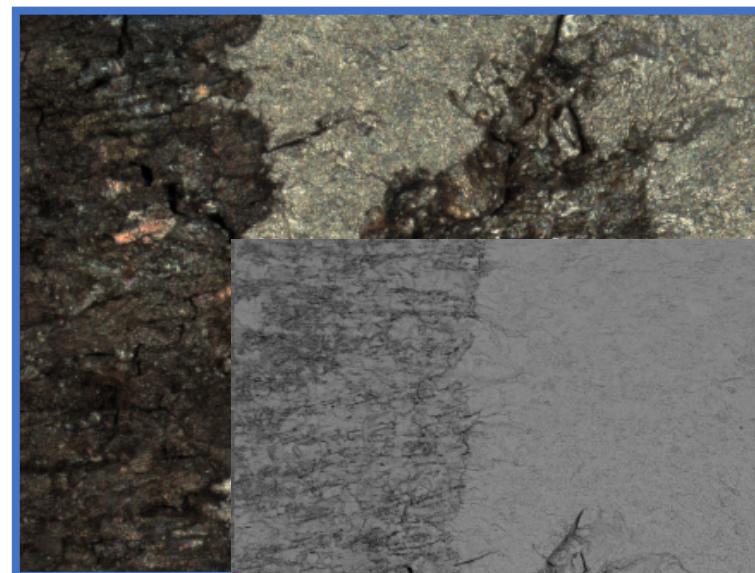
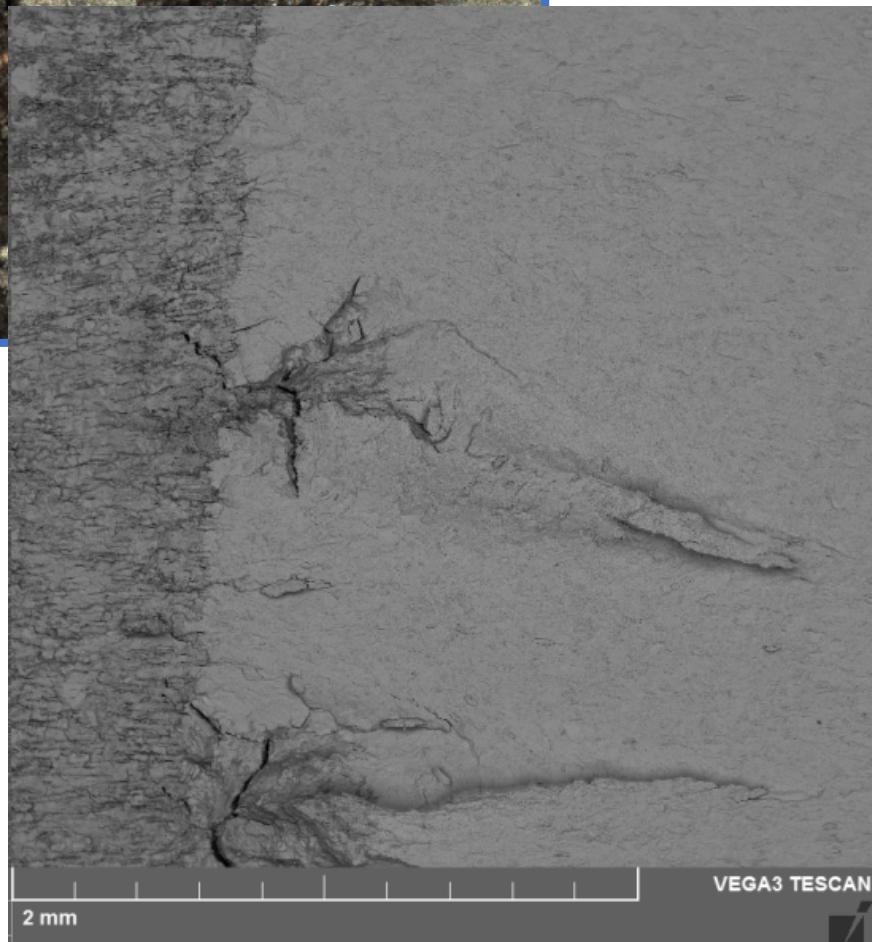
SS304L Exhibits Irregular Crack Front in Saturated MgCl_2 at 25 °C

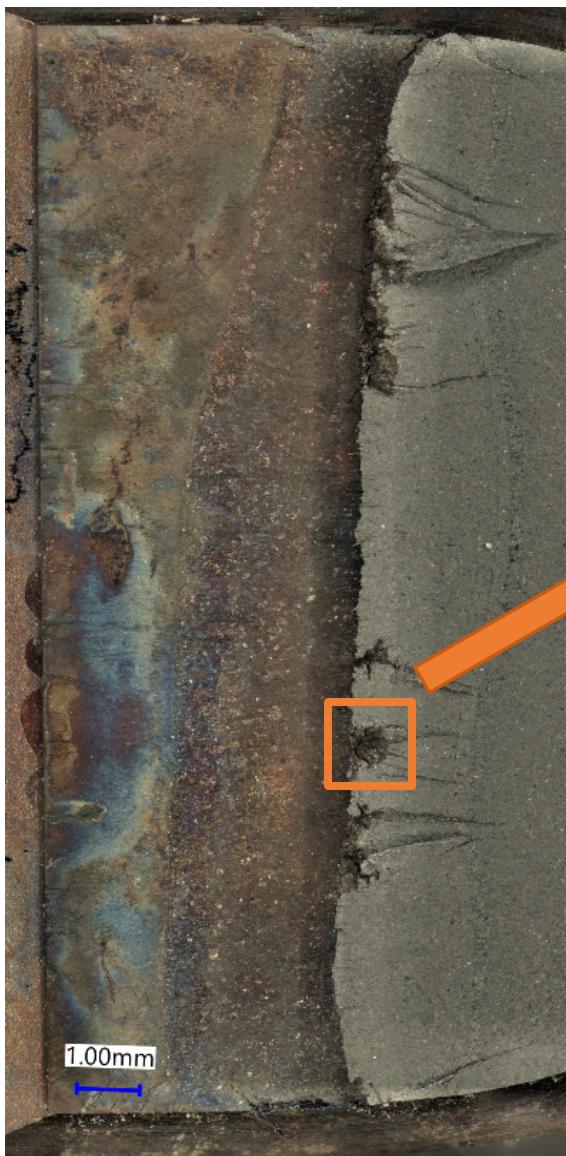
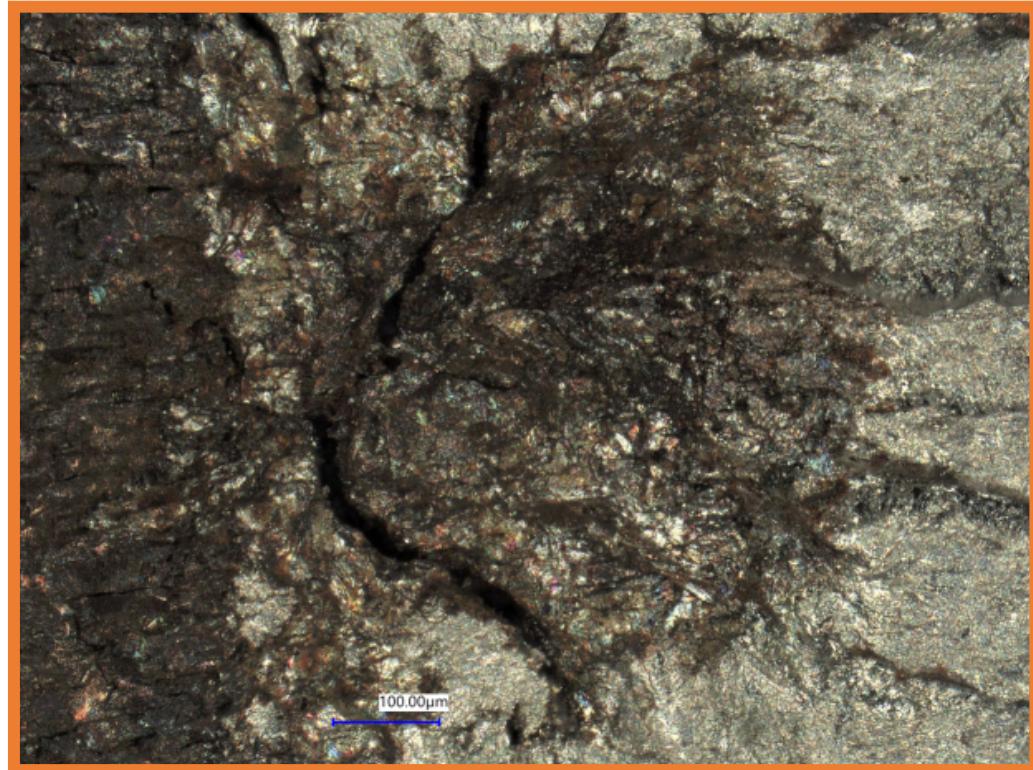
SS304L Exhibits Irregular Crack Front in Saturated MgCl₂ at 25 °C

- Significant corrosion products on the surface
- Enhanced cleaning needed, however, crack wake corrosion could be eliminating features of interest
 - Looking for intergranular/transgranular fracture

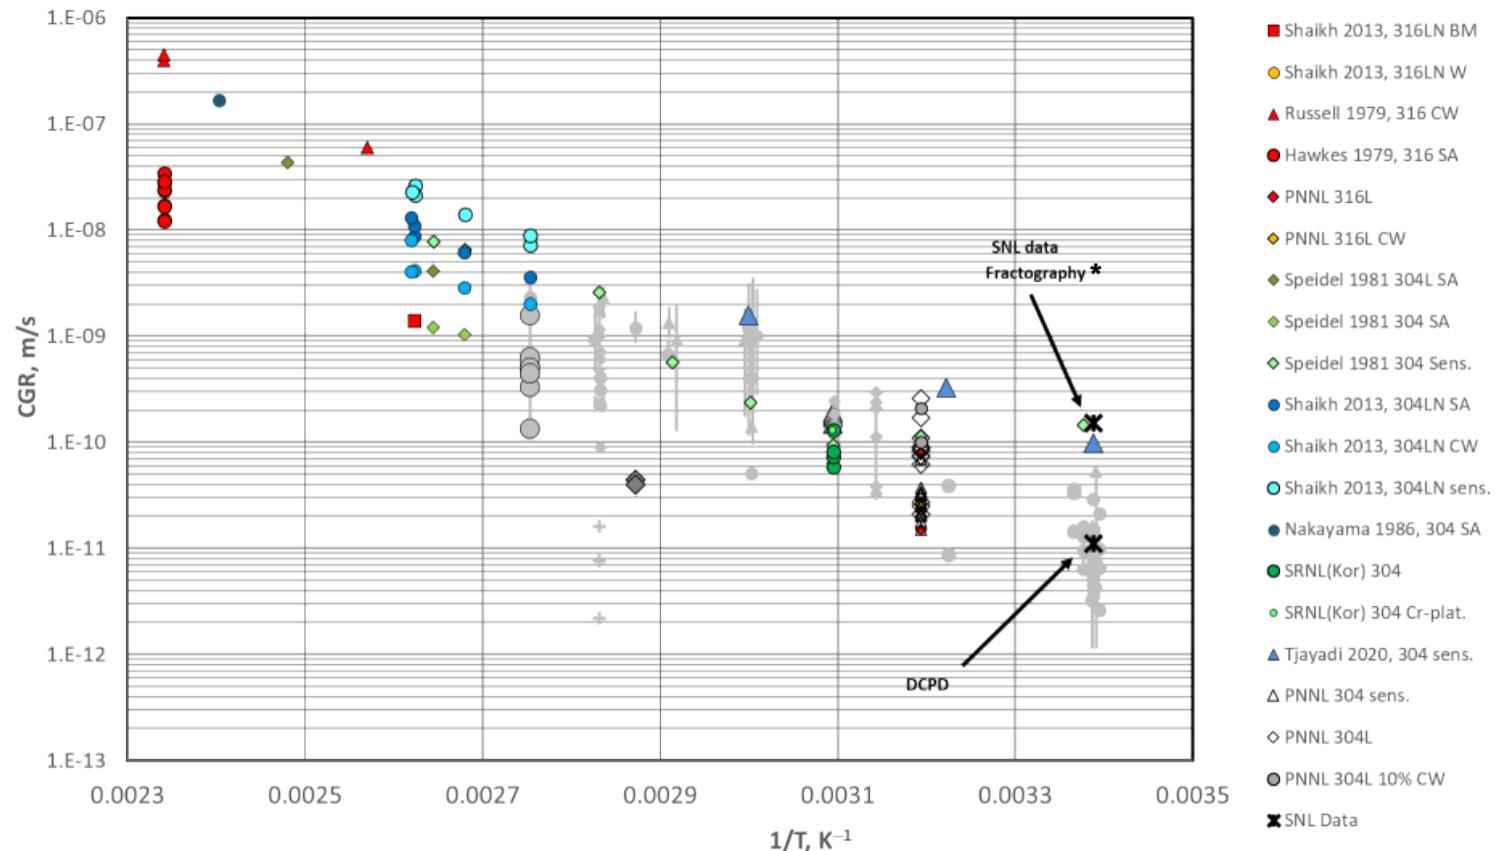
Crack Growth of Furthest 'Protrusion' Potentially Order of Magnitude Higher Than DCPD

- Considering protrusion occurs during constant K portion of the test, an increased crack growth rate is calculated
 - *measured from deepest point of protrusion

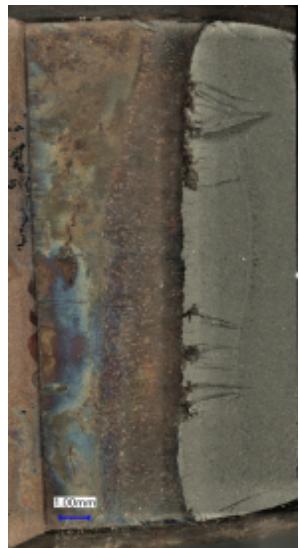
Lot 1 – RT
(1218 hours)

- Crack morphologies show influence from temperature, lot, and direction

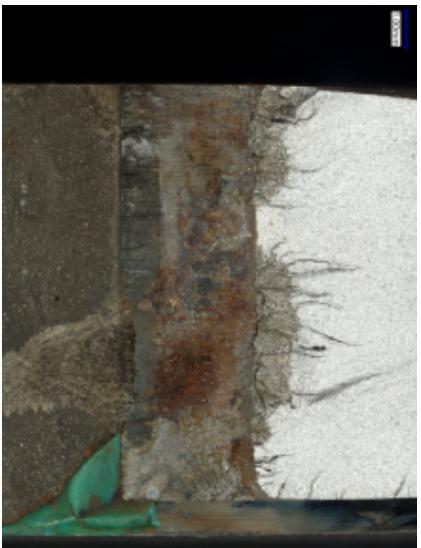
Lot 1 - 55 °C
(709 Hours)

(450 hours of
growth)

(Time under Constant K)

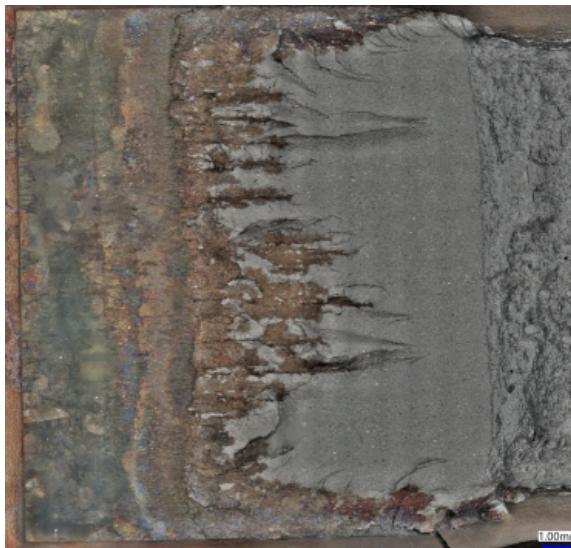
Lot 3 - 55 ° C
(650 Hours)

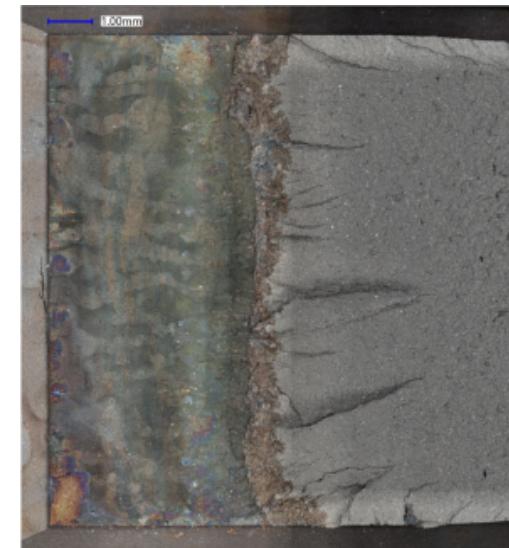
Lot 3 - 55 ° C (T-S)
(800 Hours)

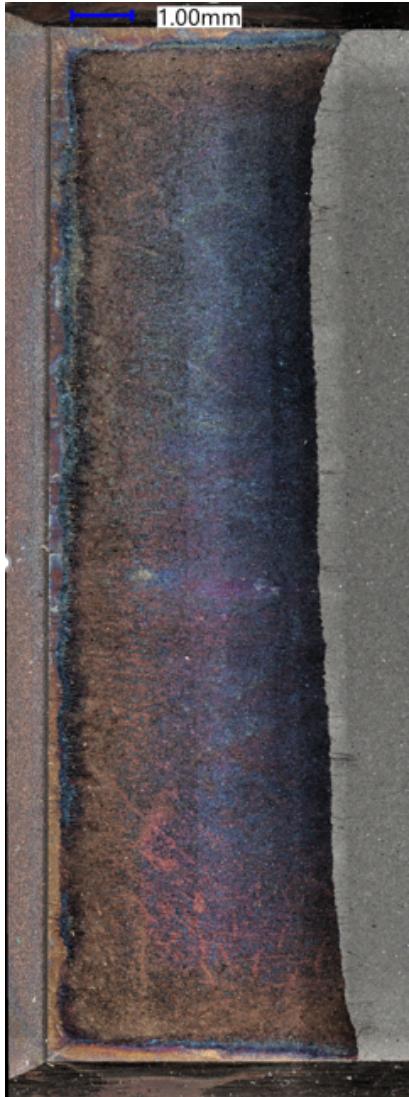
Lot 1 – RT

No indicated crack growth

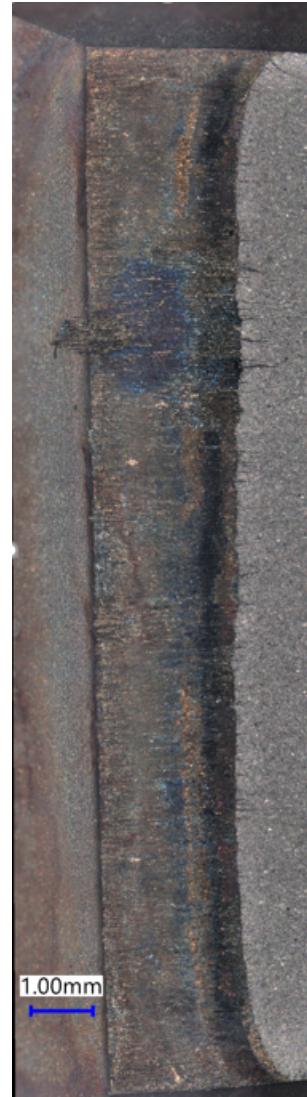
Lot 3 – 60 °C

Roughly 50 μm of crack extension during constant K

Crack growth rate of $2.1 \cdot 10^{-8} \text{ mm/sec}$

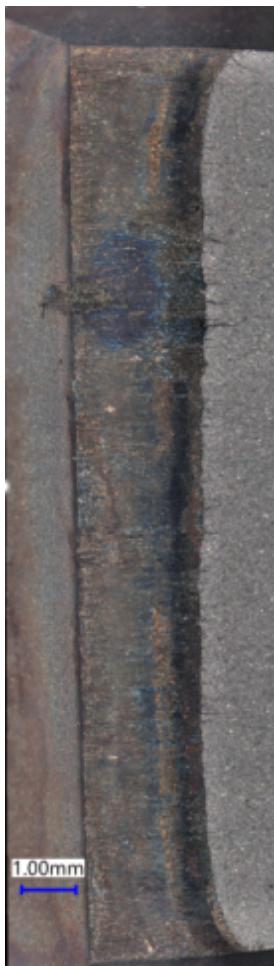
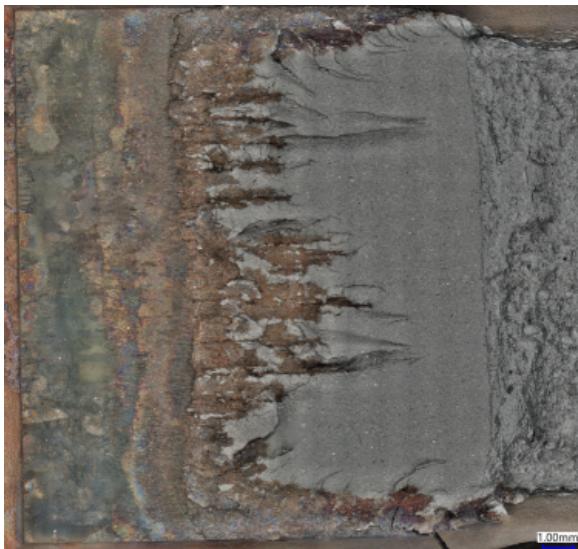
What Causes Different Morphology Between Solution?

NaCl
Lot 3 – 60 °C

MgCl₂

Lot 3 – 55 °C

- Similar to differences in morphologies from corrosion exposures
- Potentially due to differences in cathodic reduction reaction
- Possibility for different crack tip chemistry changing pH and embrittlement

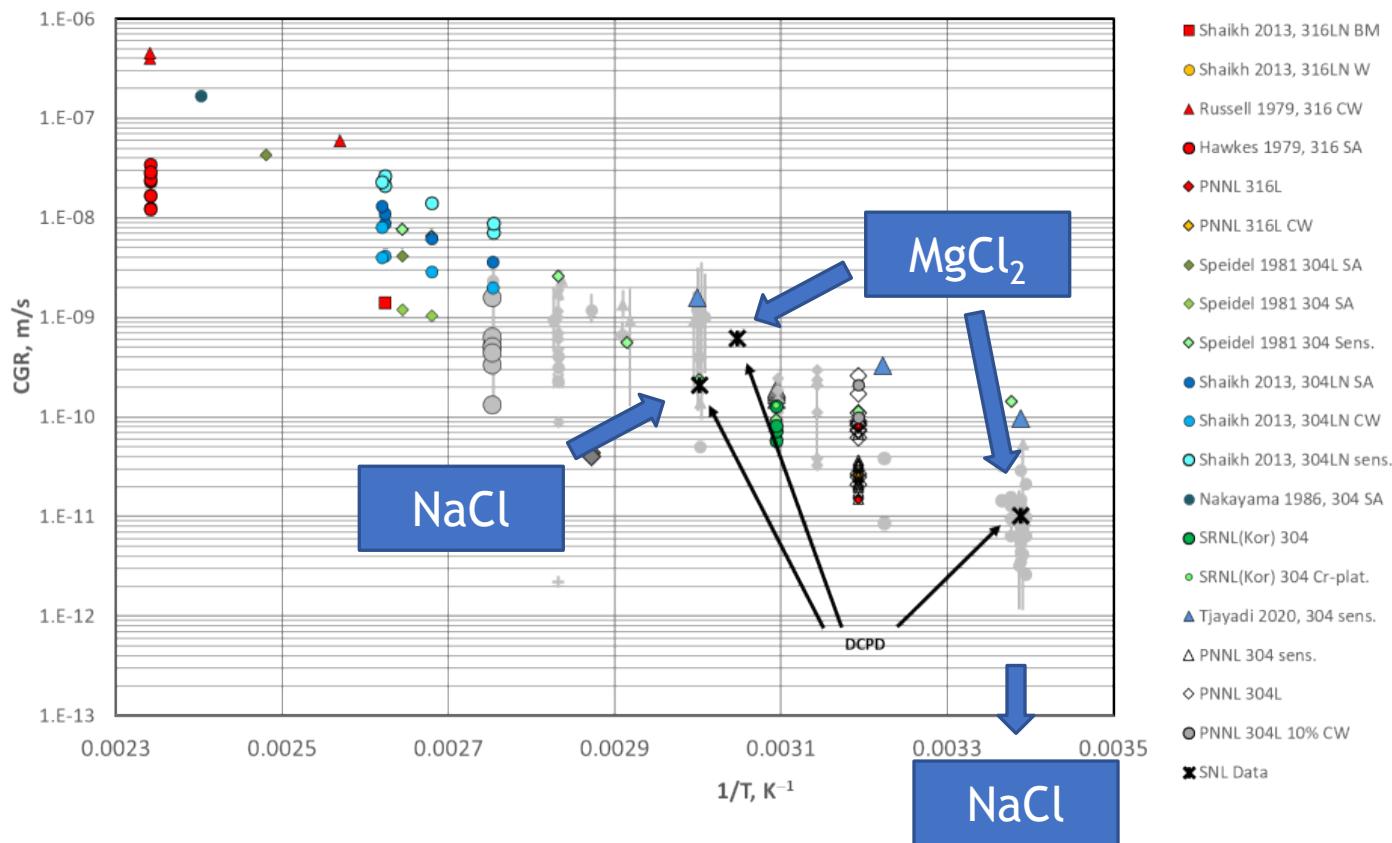
Measured Crack Growth Agrees with Literature Trends

- Similar crack growth rate trend with temperature to other studies in literature
- Potential influence of solution composition on crack growth rate but does influence morphology

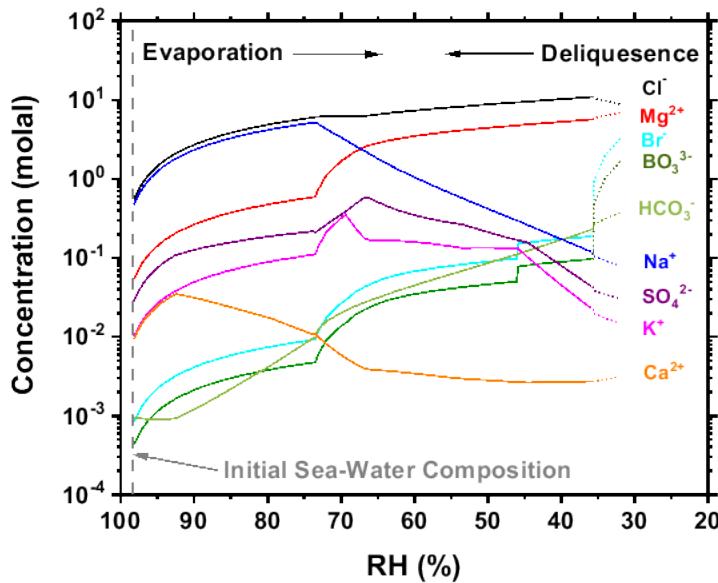
Salt Composition and Concentration Change with RH

- Initial assumption of sea water brine

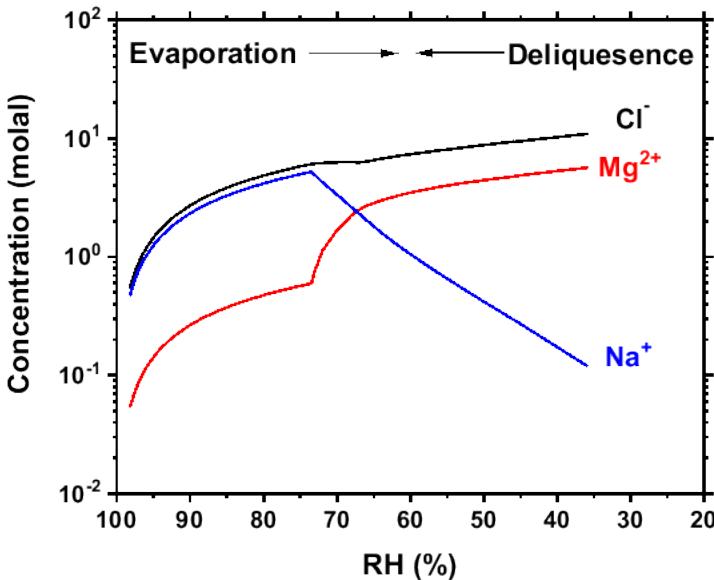
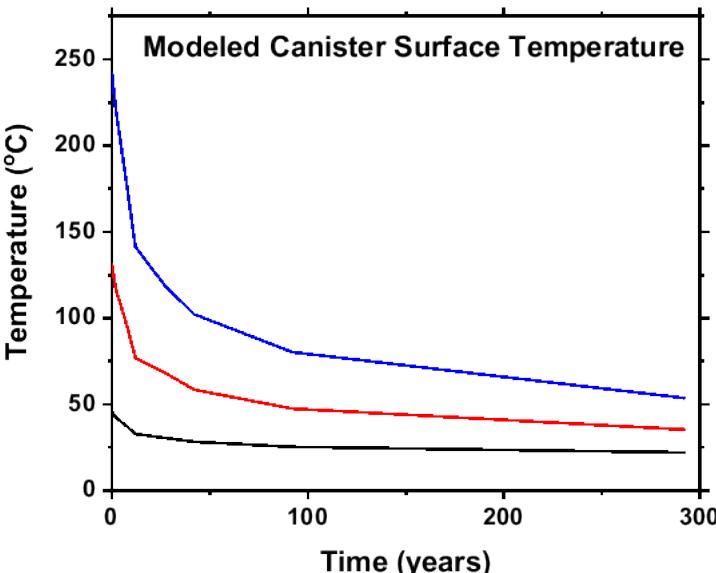
Salt Composition and Concentration Change with RH

- Initial assumption of sea water brine
- Evaporation of sea water:
 - Concentration of chloride (Cl^-)
 - Change in brine composition ($\sim 75\% \text{ RH}$)
- Canister surface physically hot

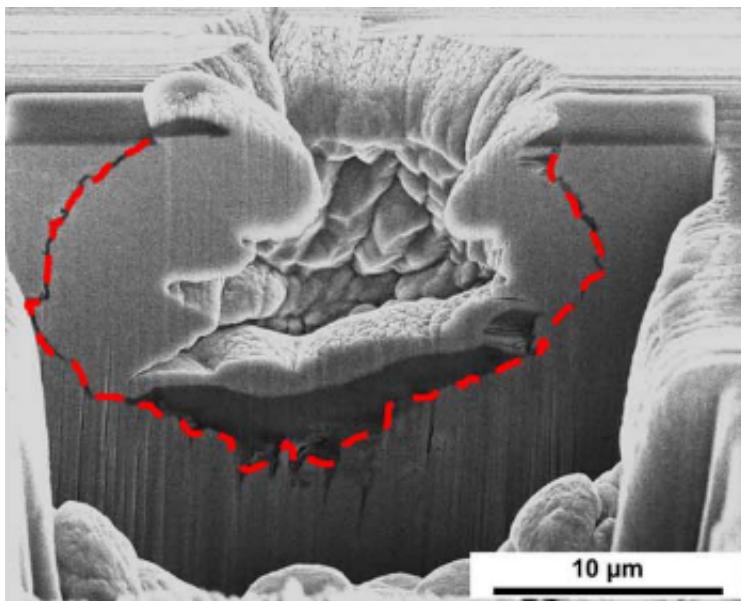
Sample exposed at **40 % RH** and **35 °C**

- Anode shape dependent upon RH
- Potential influence on diffusion and whether or not propagation is under a salt film
- Pit kinetics are a function of position (what is the bounding case?)

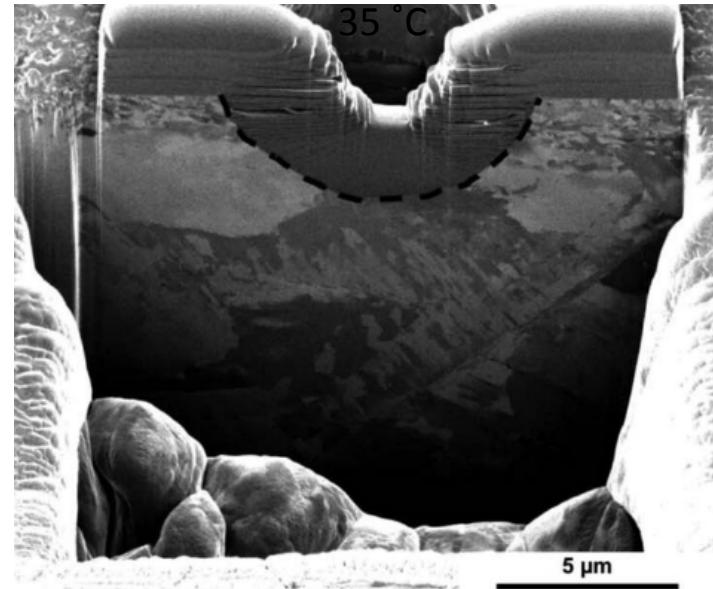
Sample exposed at **76 % RH** and

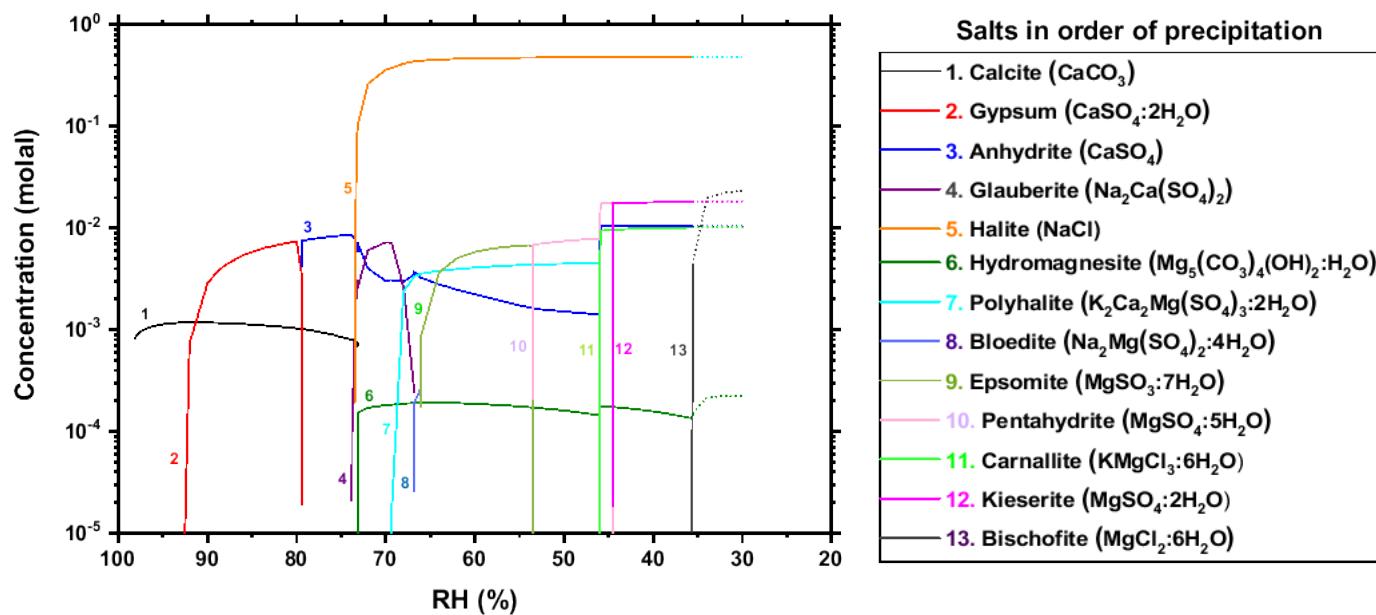
Future Consideration of Precipitated Species in Cathode

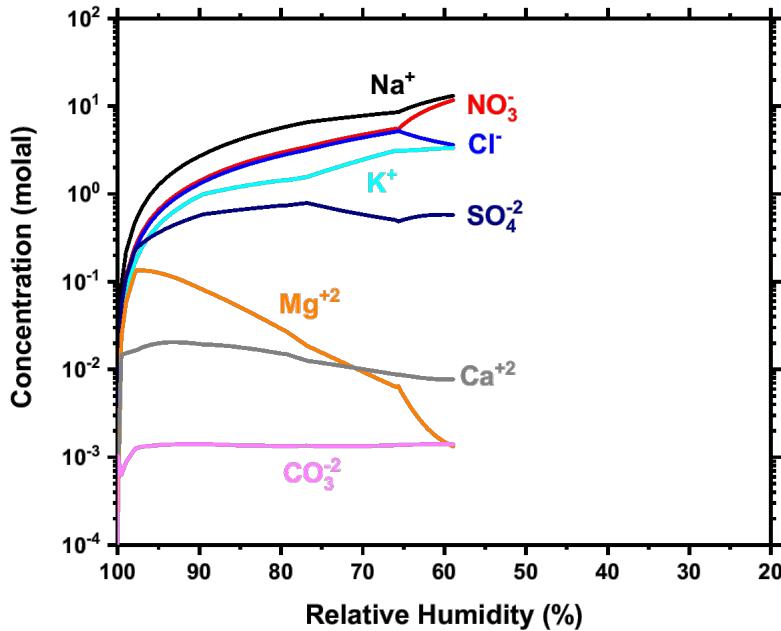
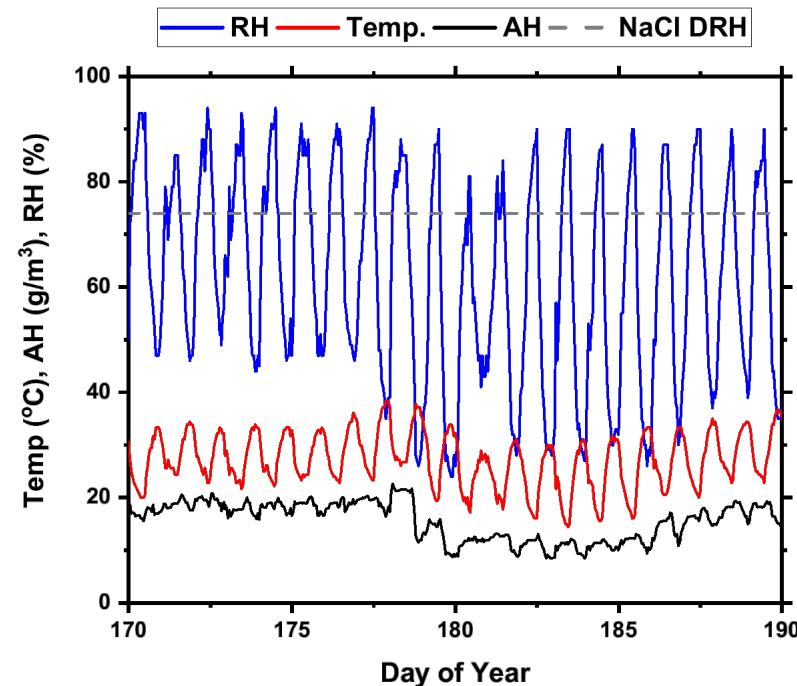
Salt Composition and Temperature Vary by Location

- Composition and deliquescence RH change by geolocation
- Daily/Seasonal temperature and RH changes
