Sandia
National
Laboratories

Kinetics of Phase Transformations in Boron-containing 304L Stainless Steel

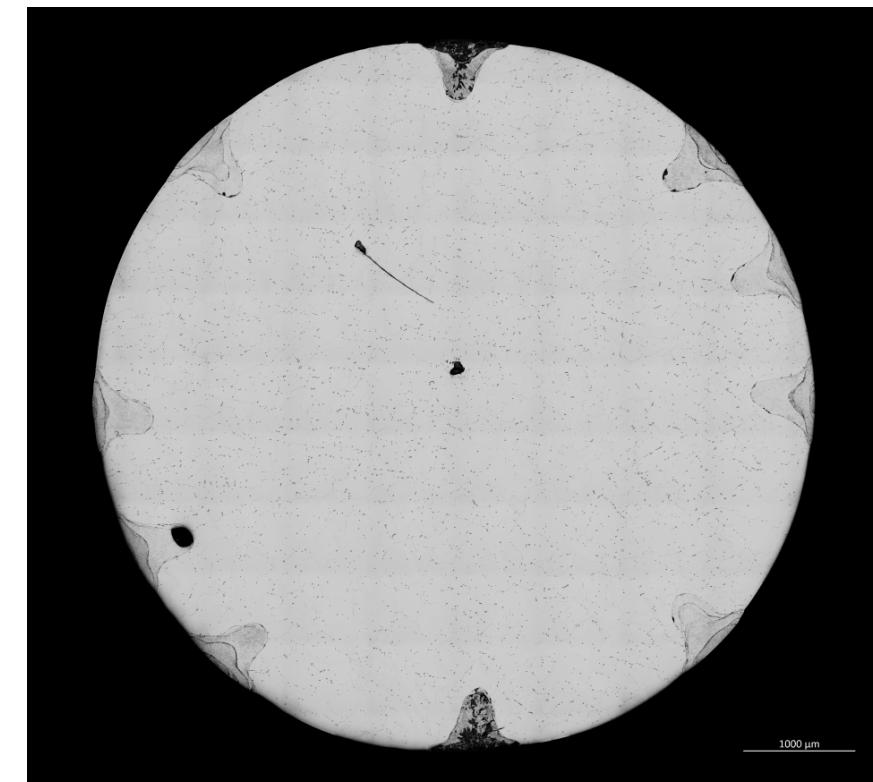
Step 3: Section welds in transverse, scan HAZ for cracks

60 weld cross-sections surveyed per Gleeble condition
