Exploring the Stress Corrosion Cracking Susceptibility of Additively Manufactured 316L in Boiling Magnesium Chloride

Speaker: Erin Karasz

2022 TMS

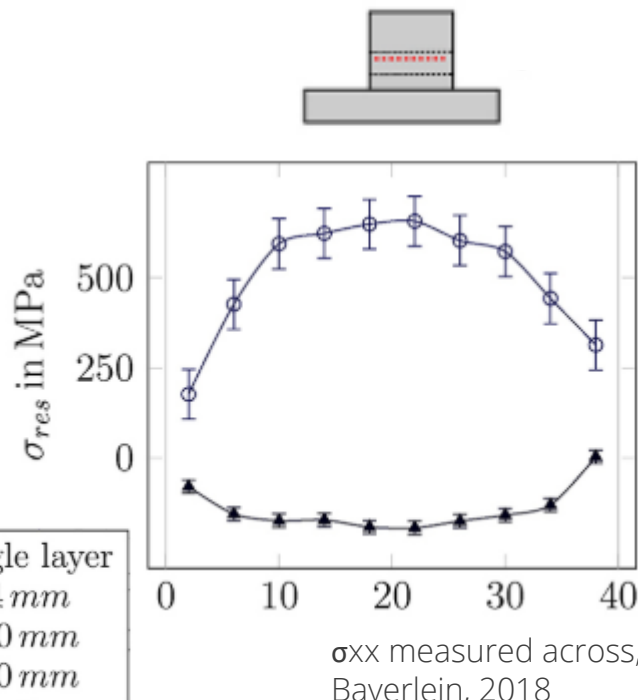
Bayerlein, 2018

From Bayerlein et al.

- Cutting samples at different heights results in different residual stresses

σ_{xx} measured across, horizontal; (cut 18 mm, 2 mm)

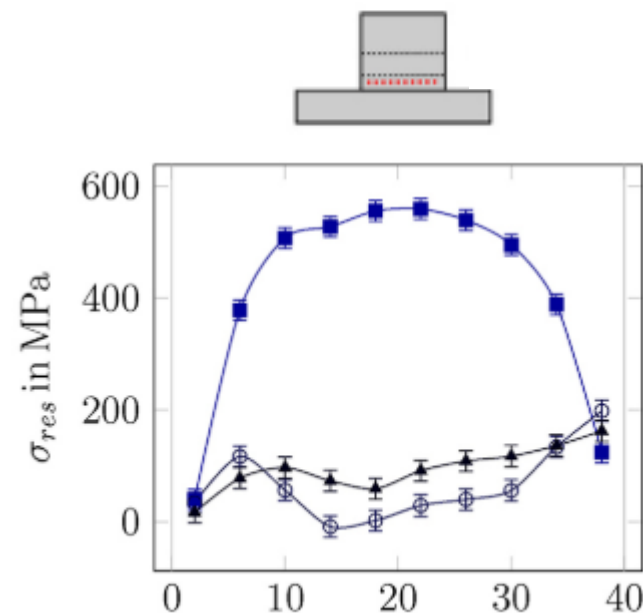
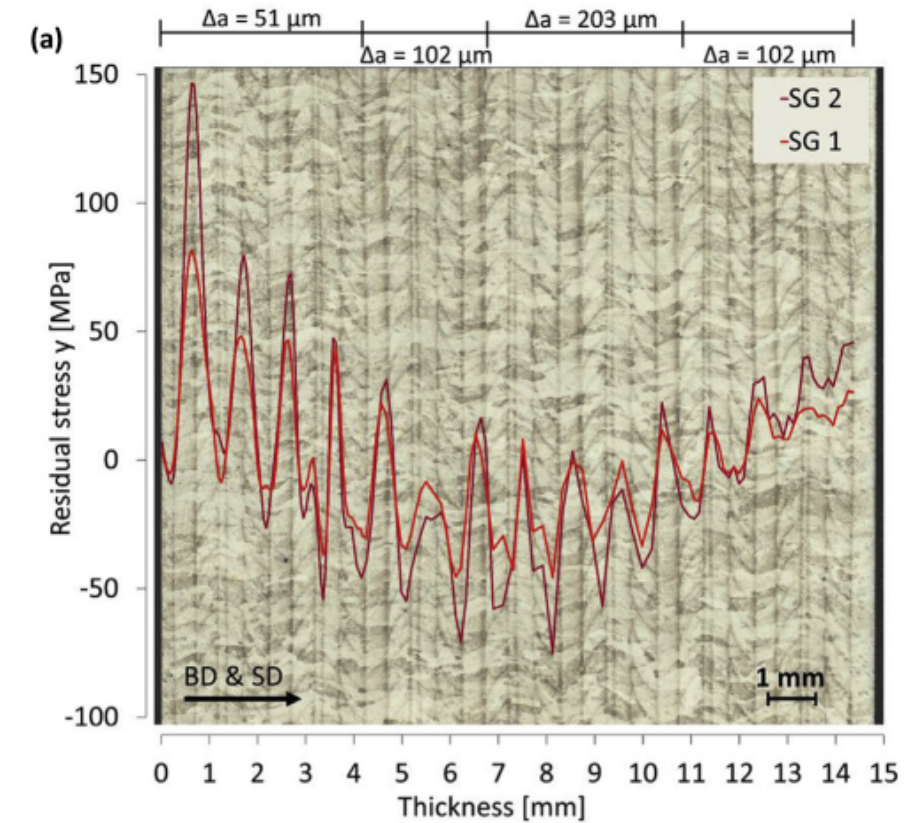
Strantza, 2019

From Strantza et al.

- Each layer of can have fluctuations in residual stress
- Residual stress varies on scale of part

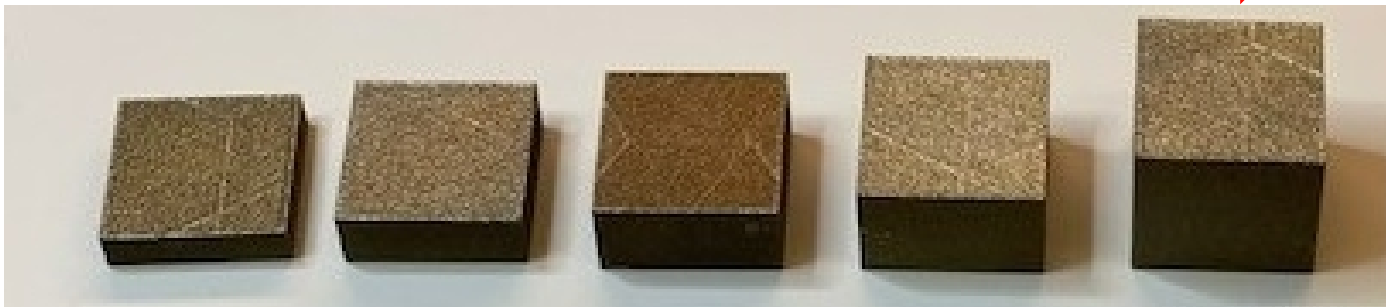
- Cut samples at different heights from build plate → preserve microstructure
 - 4, 6, 8, 10, 15 mm
- Heat treatment → change microstructure/mechanical properties
 - 600, 800, 1200 °C; 1 hour

316L Stainless Steel Laser Powder Bed Fusion
15 x 15 x 15 mm blocks

Increasing residual stress

Large residual stress
on top surface after cut

Small residual stress
on top surface after cut

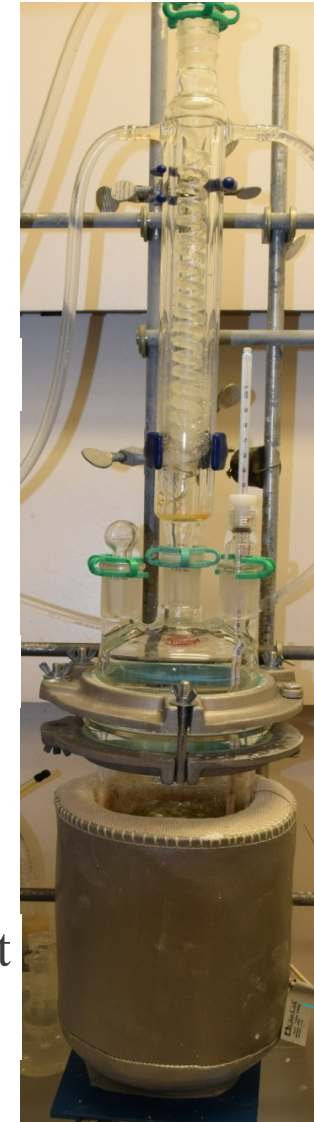
Boiling MgCl_2 Experiments

Sides (except for top surface), coated in epoxy
3M Scotchkote liquid epoxy 323

ASTM G36-94

Full immersion in saturated, boiling MgCl_2
155 °C

- Samples were checked after 24 hrs
- If no cracks were visible, resubmerged and checked every 72 hours, up to 350 hours of exposure

Condenser

Vessel

Heating jacket

Thermometer

Thermocouple control

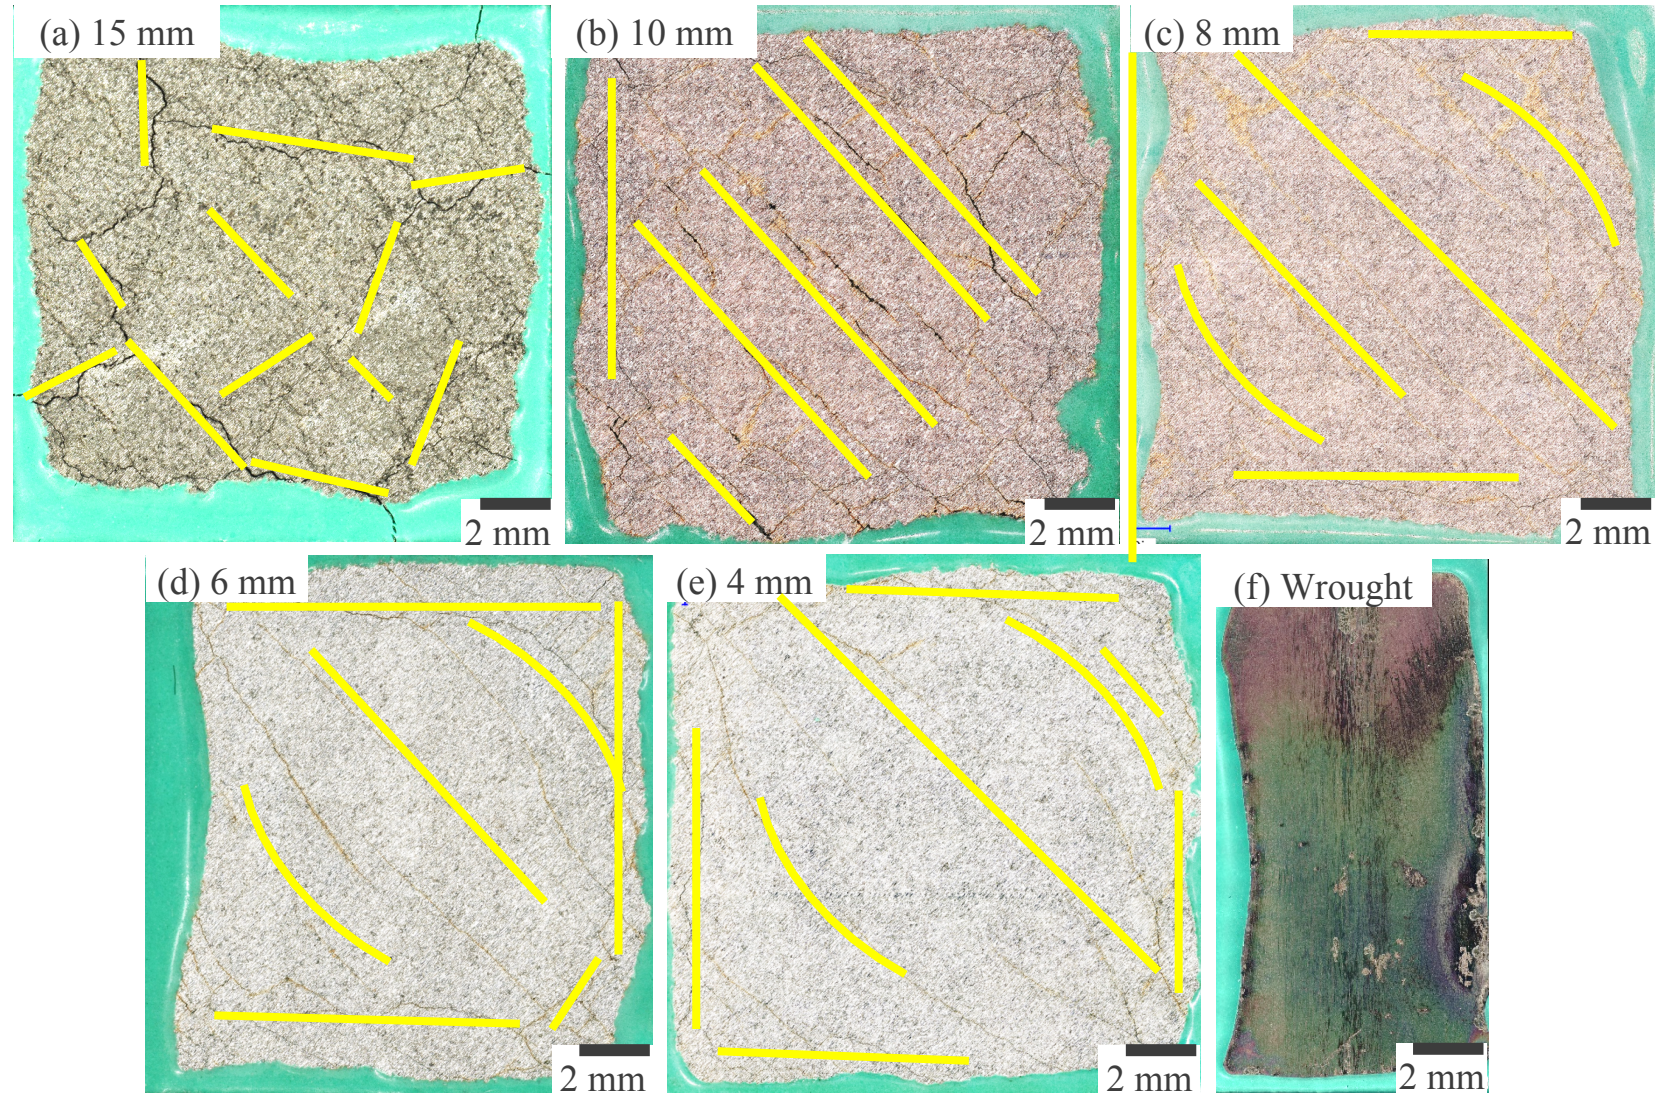
As-Built Samples

- All as-built showed cracking within 24 hours
- Shorter samples show oriented cracking
- Tallest sample more distributed cracking
- 15 & 10 mm tall samples show more pronounced cracks

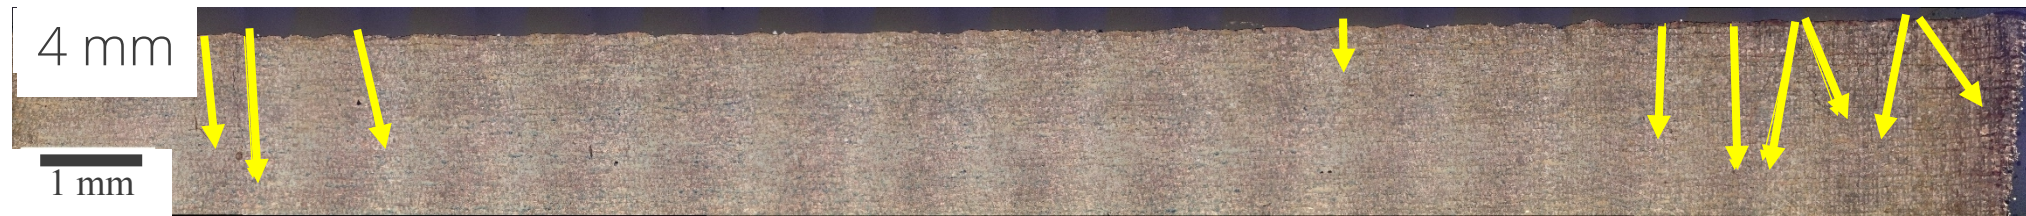
As-Built Sample Crack Depth

Cross-sectioned on the diagonal
Imaged with Keyence

Shorter Samples

- Deeper cracks near sample edge (higher stress regions)
- Cracks in the center probably too small to optically image

Taller Samples

- Deepest cracks distributed across the cross-section
