Evaluating HEAC Possibility in RH-dependent Microcracking Observed in Austenitic Stainless Steels

J. Srinivasan, R. F. Schaller, E. J. Schindelholz, J. S. Locke

AMPP CORROSION 2022

Research in Progress - EAC

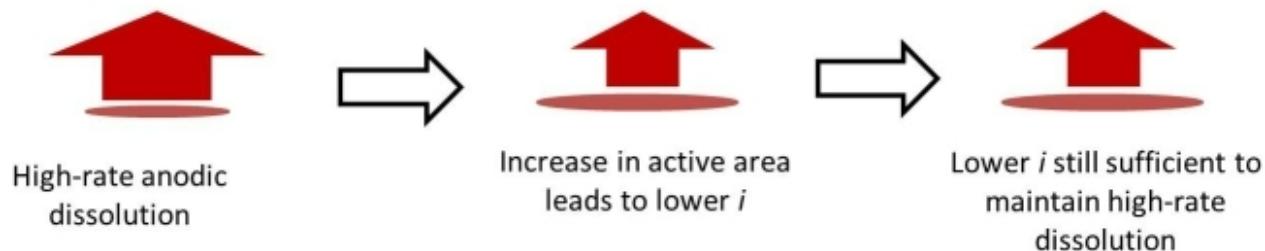
High RH: Growth at conditions between critical stability and saturation with increasing active area
