Efficacy of MIL-DTL-5541 Compliant, Non-Chromate Conversion Coating Repair Materials

D.G. Enos and D. Wichhart

AMPP Annual Conference

SAND2022-xxxx P

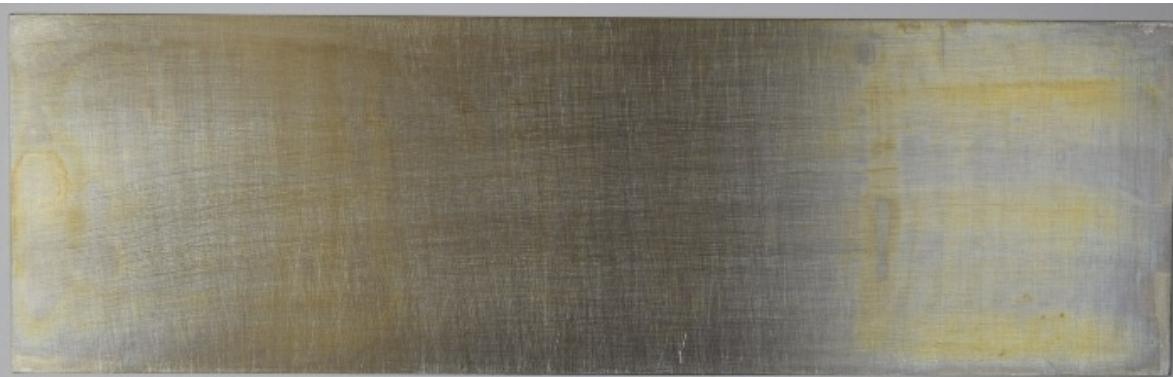
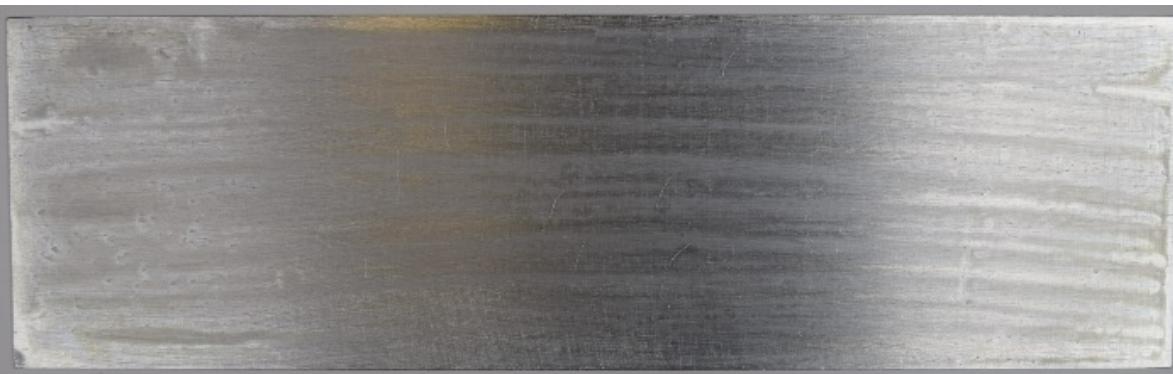
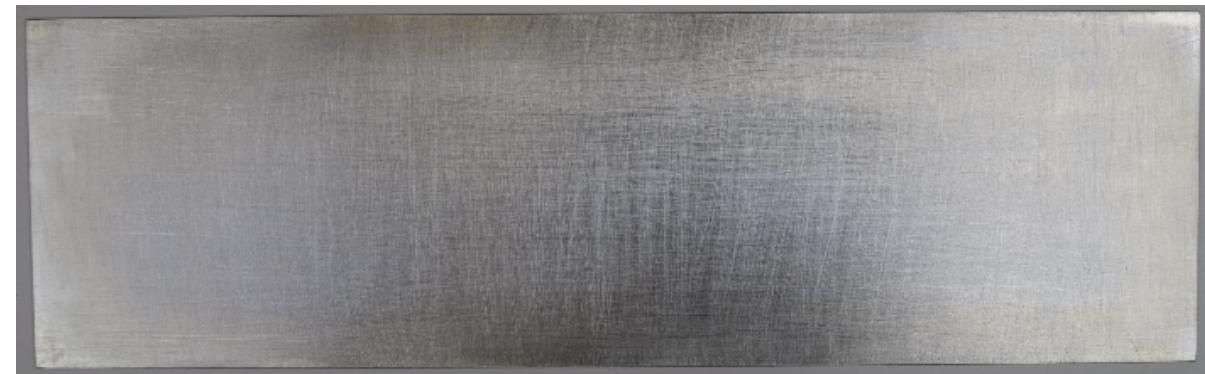
Appearance/nonuniformities

- Coatings dramatically more non-uniform than their bath applied counterparts
- Coatings where the solution is allowed to dry have more significant staining

- All of the coatings where the manufacturers procedure allowed or required that the coating material dry on the aluminum surface were non-uniform in appearance.

- The visual heterogeneities observed on the sample surfaces often corresponded to regions where the corrosion performance of the coating was substantially compromised.
