# Electrolytes Exposed to Thermal and Electrochemical Cycling in Molten Sodium Environment

Part of SNL's Sodium Battery Program (PI: Leo Small)

# Motivation: Low Temperature Molten Sodium (Na-NaI) Batteries

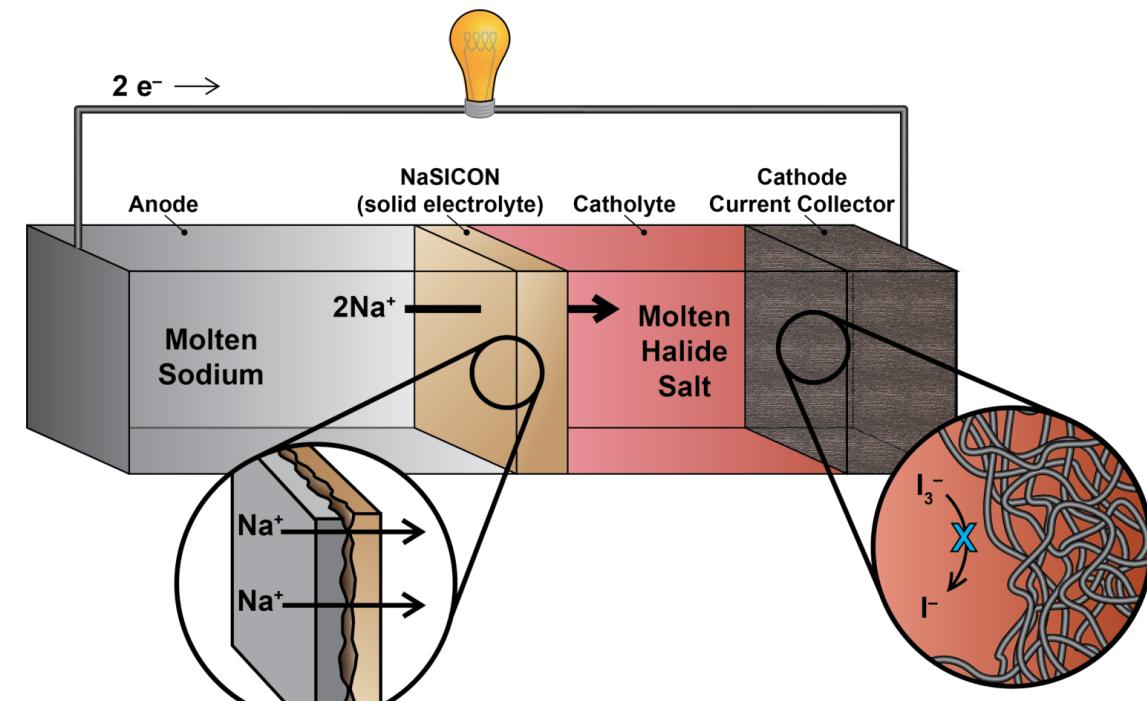
### Na-NaI battery:

*Realizing a new, low temperature molten Na battery requires new battery materials and chemistries – particularly in **sodium ion conductors***

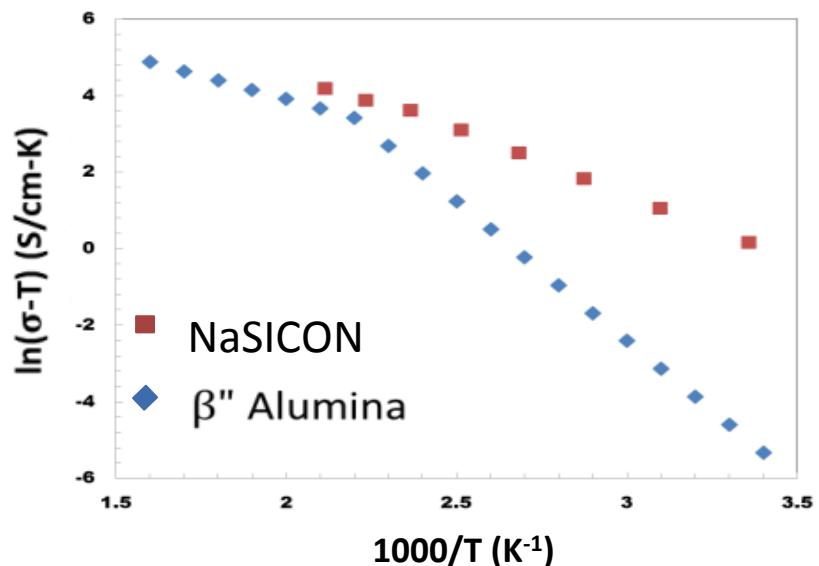
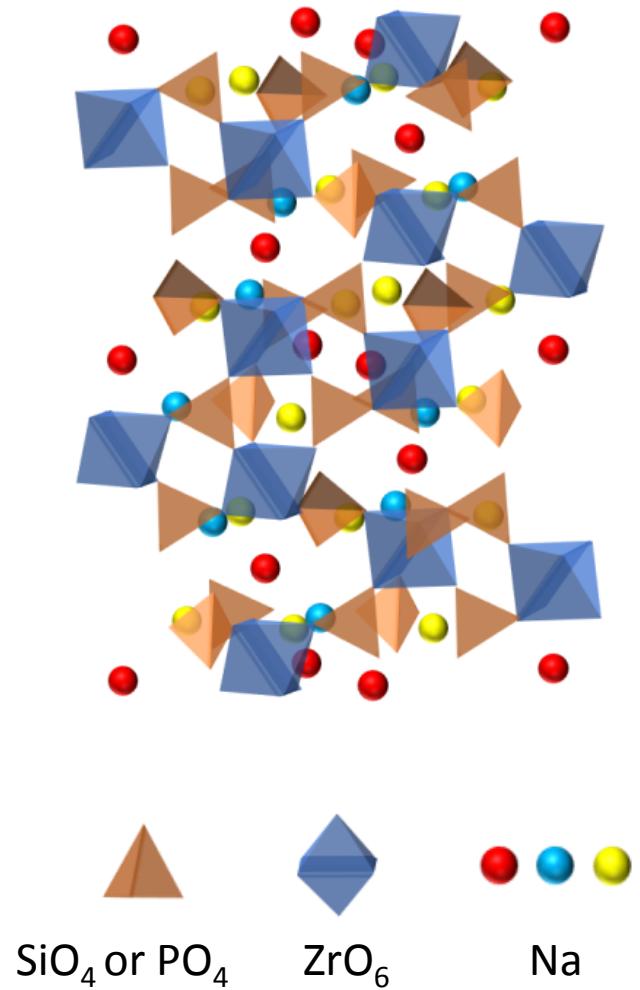
## Key Qualities of NaSICON Ceramic Ion Conductors

- $\text{Na}_{3.4}\text{Zr}_2\text{Si}_{2.4}\text{P}_{0.6}\text{O}_{12}$
- High Na-ion conductivity ( $>10^{-3}$  S/cm at 25°C)
- Zero-crossover (high-density after sintering)
- Chemically compatible with molten Na and halide salts (at low T!)
- Mechanical integrity? After exposure to battery materials?

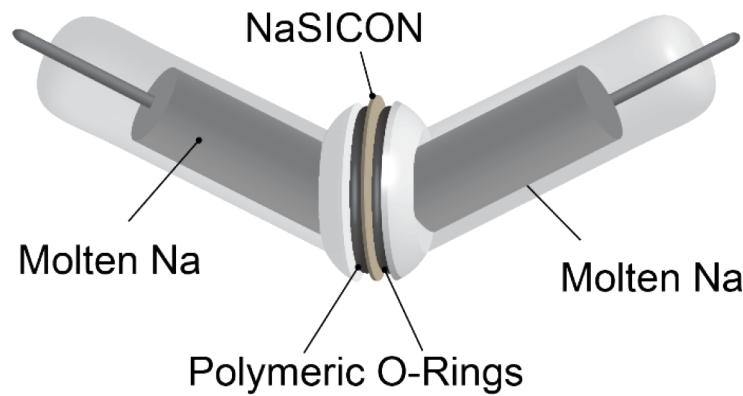
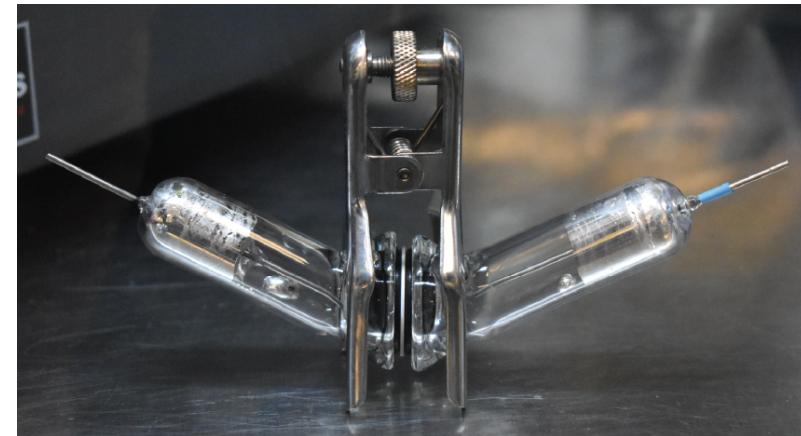
- Exploring mechanical properties after:
  - NaSICON heated to 110 °C
  - NaSICON exposed to molten Na at 110 °C
  - NaSICON (x2) cycled up to 50 mA/cm<sup>2</sup> in Na | NaSICON | Na cell at 110 °C

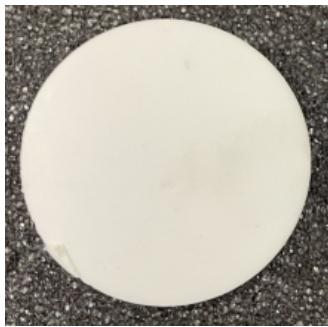
Pristine

- Saw changes in NaSICON's mechanical response
  - Modulus increased after exposure to molten Na metal
  - Modulus and hardness decreased after cycling in Na|NaSICON|Na

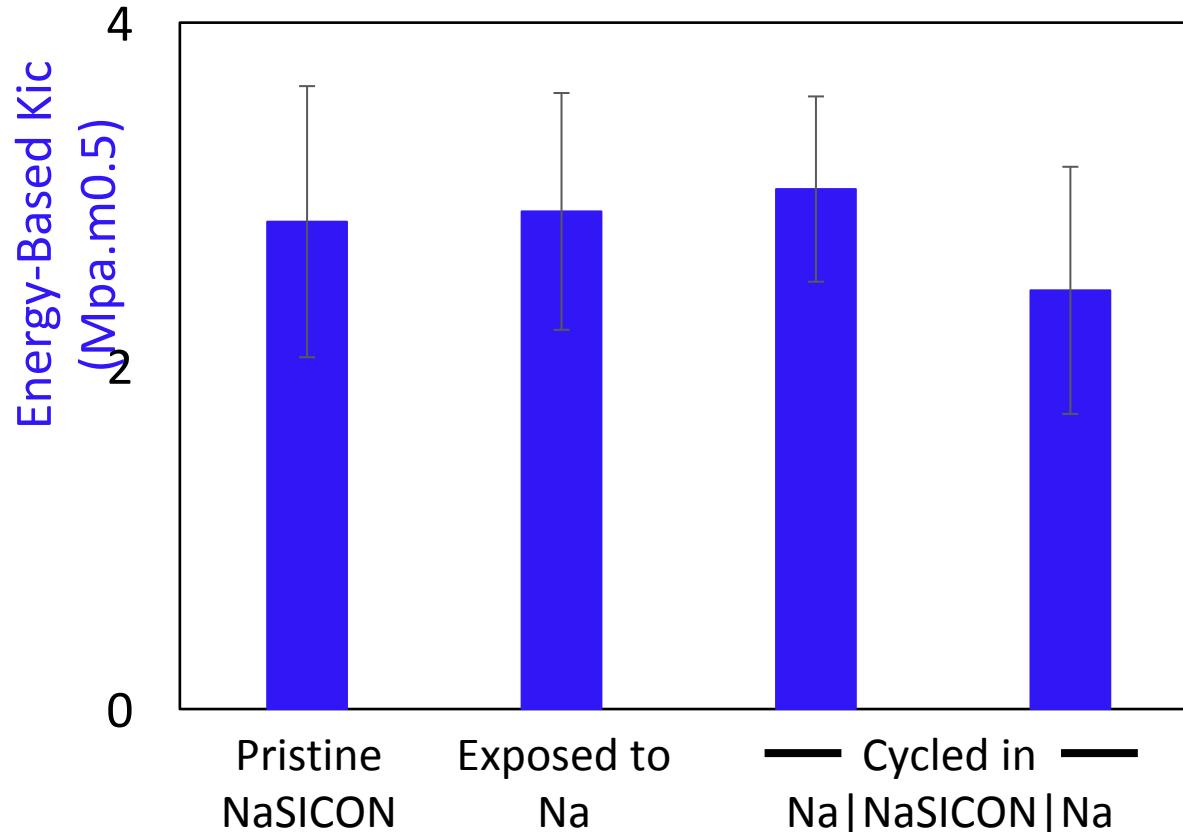
Fracture toughness is intimately related to critical current density (CCD)

$$W_{\text{irr}} = W_{\text{irrev}} - W_{\text{pp}}$$

$$K_{ic} = \sqrt{\frac{E_r W_{\text{crack}}}{A_m}}$$

***Fracture toughness not significantly impacted by Na<sup>+</sup> conduction***

***Cycling NaSICON should not affect ability to handle higher current densities***

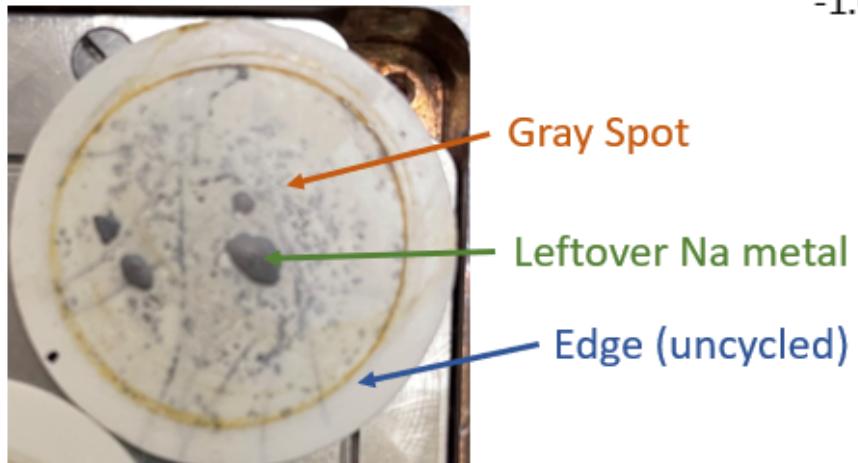
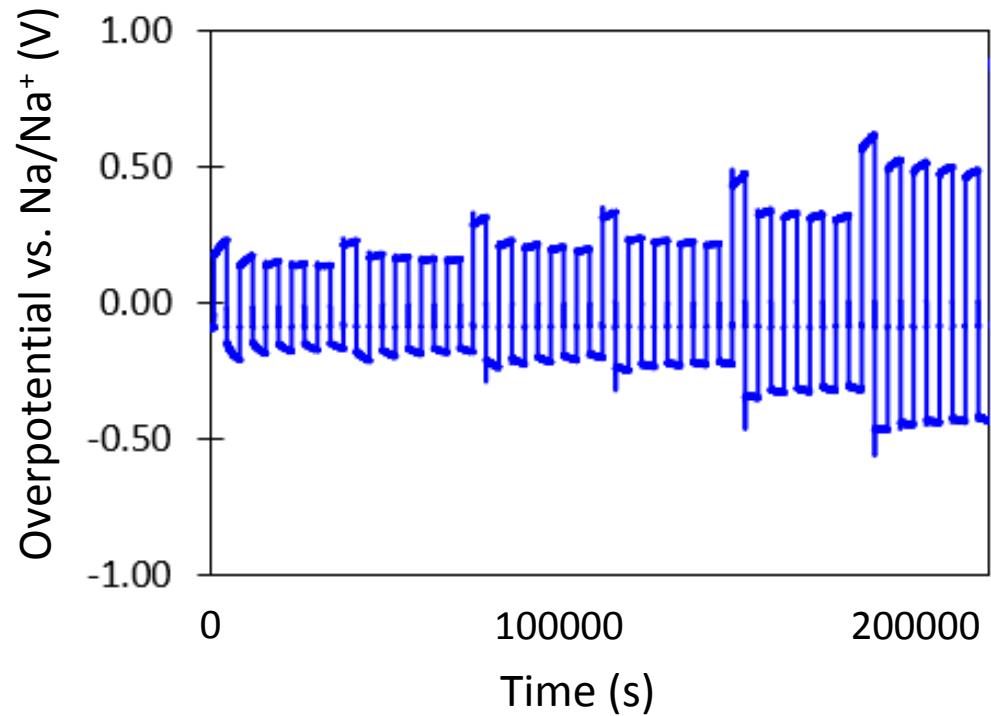
- NaSICON cycled up to 225 mA/cm<sup>2</sup> in Na|NaSICON|Na symmetric cell at 110 °C
  - High current density to induce chemical changes
  - Typical CCD in SEs @ RT is ~0.1-1 mA/cm<sup>2</sup>
- Permanent gray spots (and lines) appeared across NaSICON surface

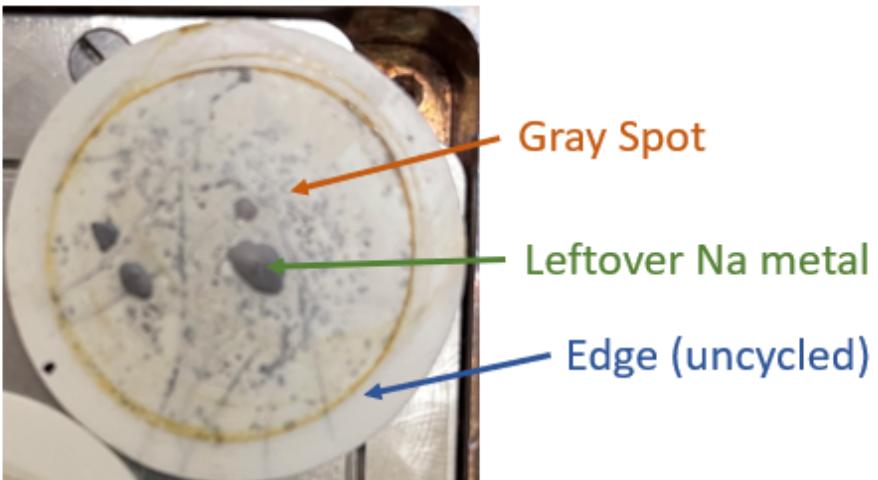
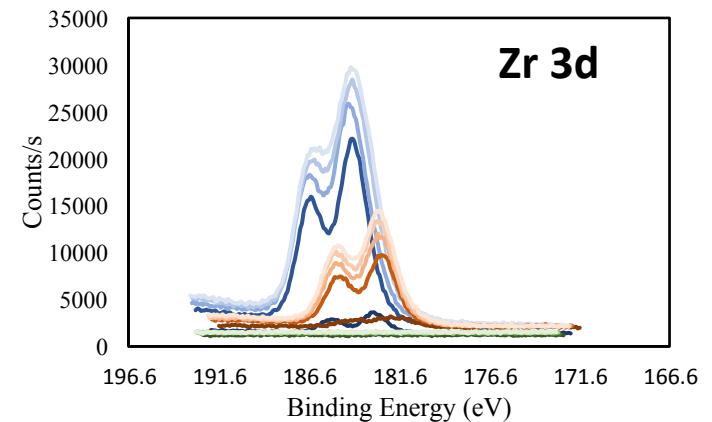
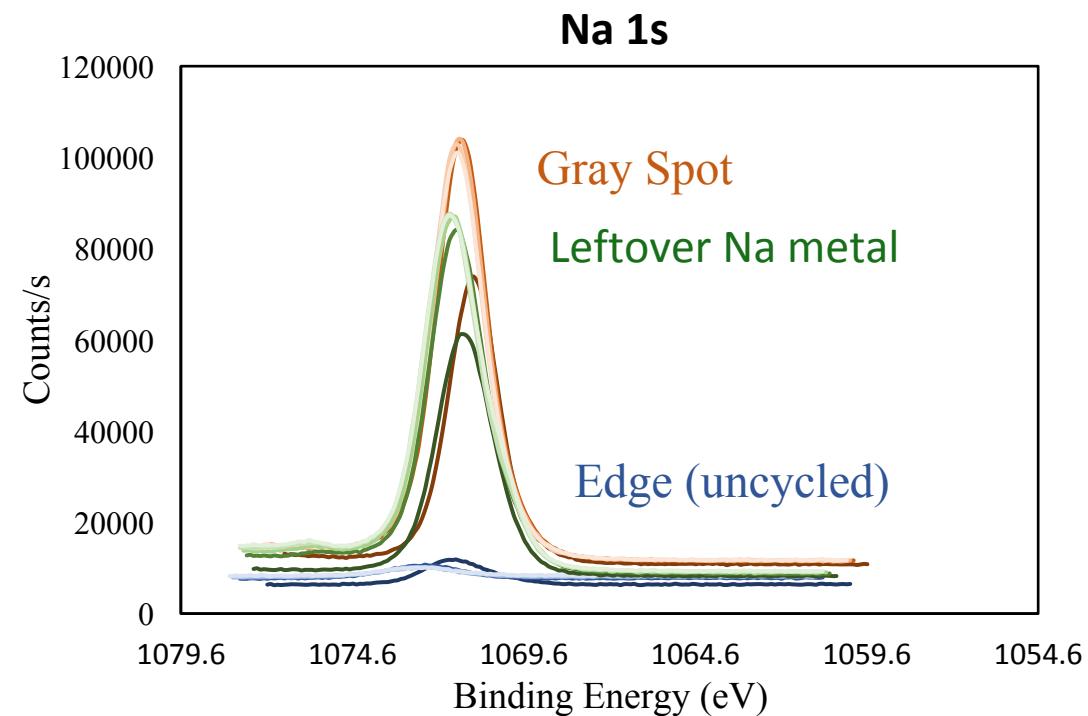
- XPS to determine composition in various areas
  - Gray spots have much higher Na1s signal than edge (uncycled) area - more similar to leftover “pure” Na metal
  - Gray spots still show expected Zr and Si signals

***“Dendrites”?***

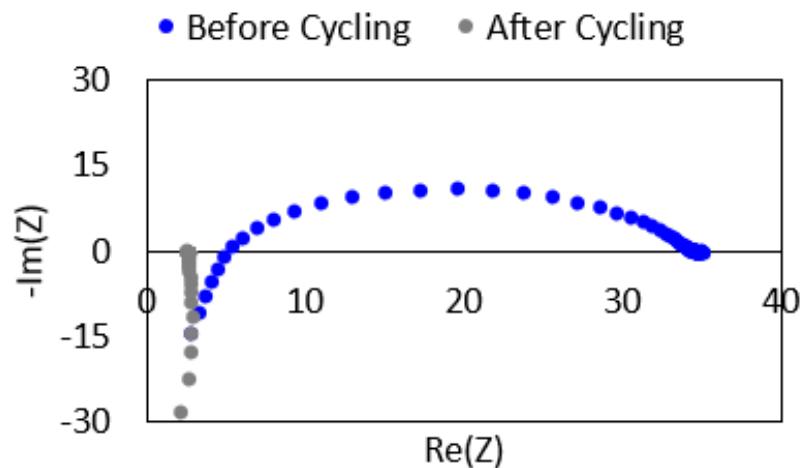
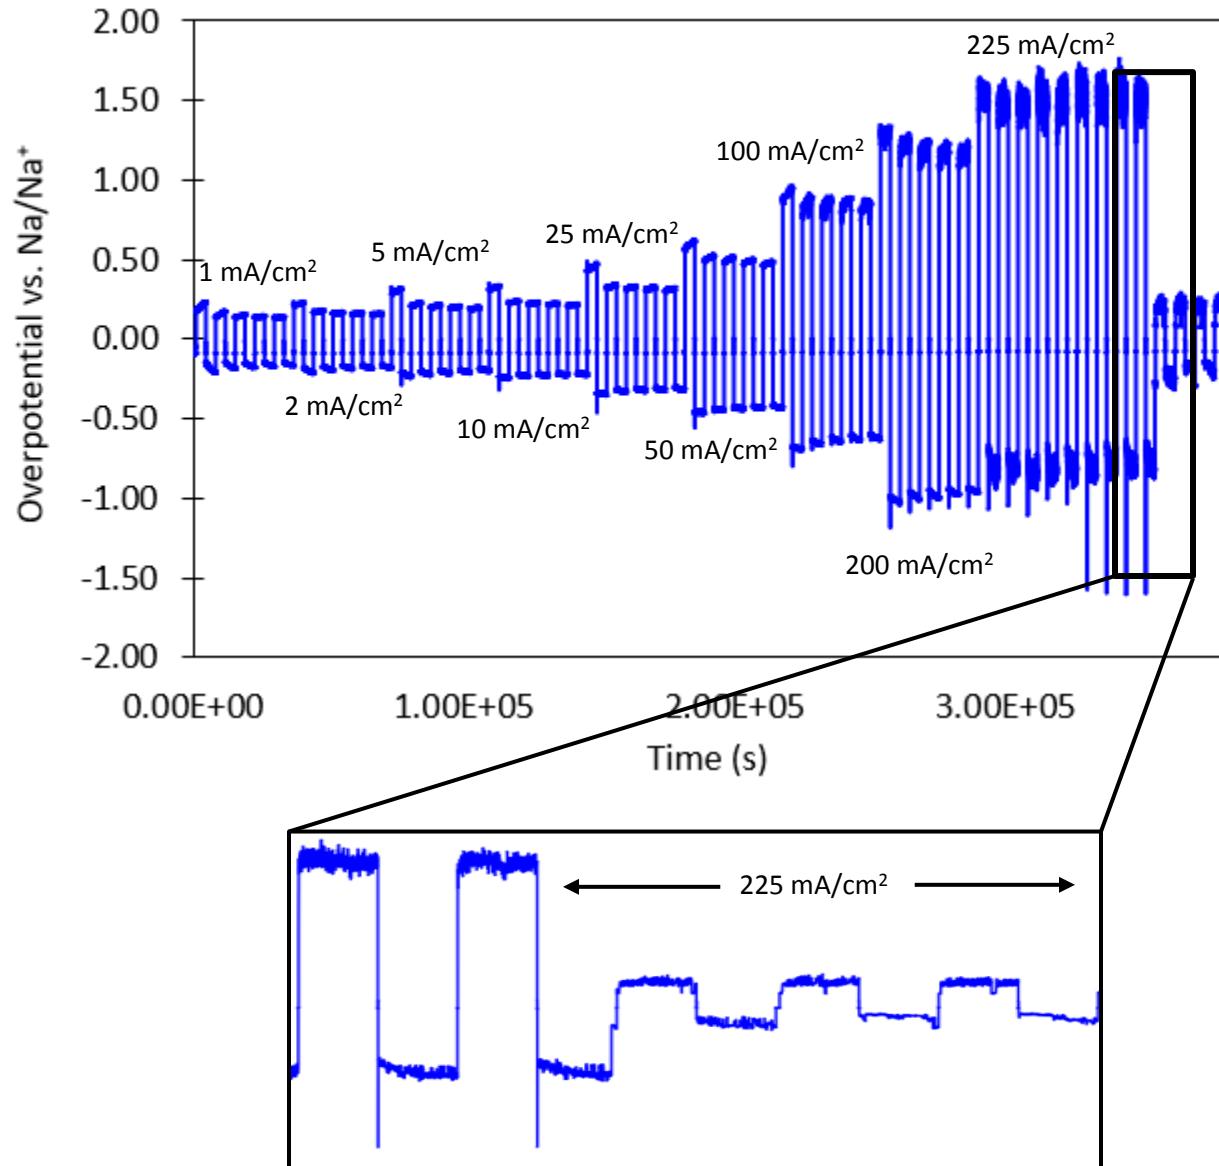
- Cycling above  $100 \text{ mA/cm}^2$  led to unstable voltage plateaus
- Continued cycling at  $225 \text{ mA/cm}^2$  led to eventual voltage drop
  - Very small impedance measured by impedance spectroscopy
  - Consistent with electronic short

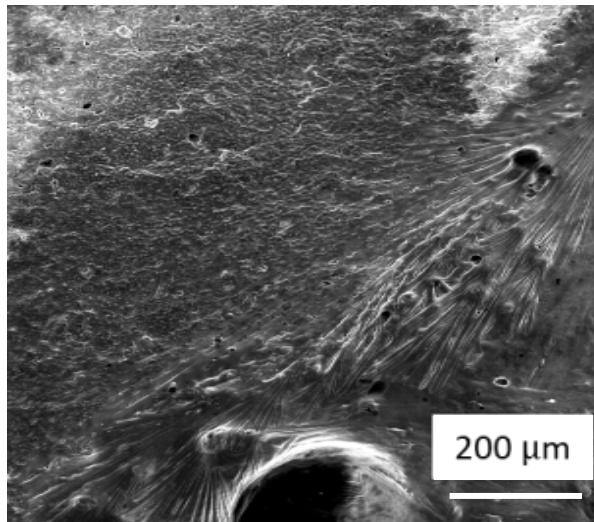
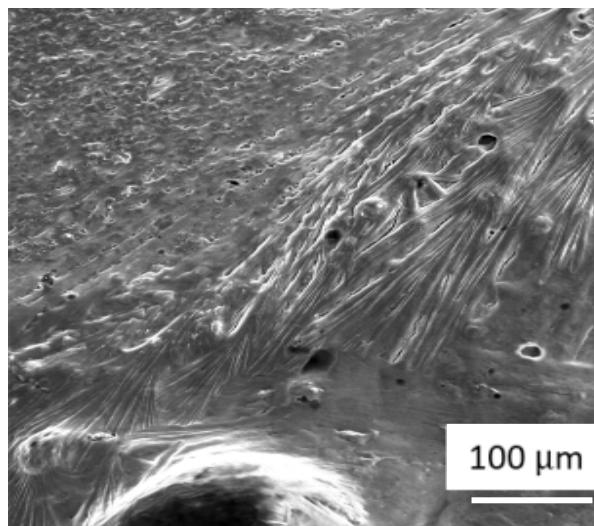
Na propagation in NaSICON

- Na can propagate through NaSICON causing an electronic short

- Morphology of Na within NaSICON is vastly different than Li within LLZO
  - Needle-like vs. grain boundary accumulation
