Spent Fuel and Waste Science and Technology (SFWST)

Stress Corrosion Cracking of Austenitic Stainless Steels in Concentrated Chloride Environments

Ryan M. Katona, J. Taylor, E. Karasz, B. Nation, A. W. Knight, C. R. Bryan, and R. F. Schaller

**SWFST Annual
Meeting**

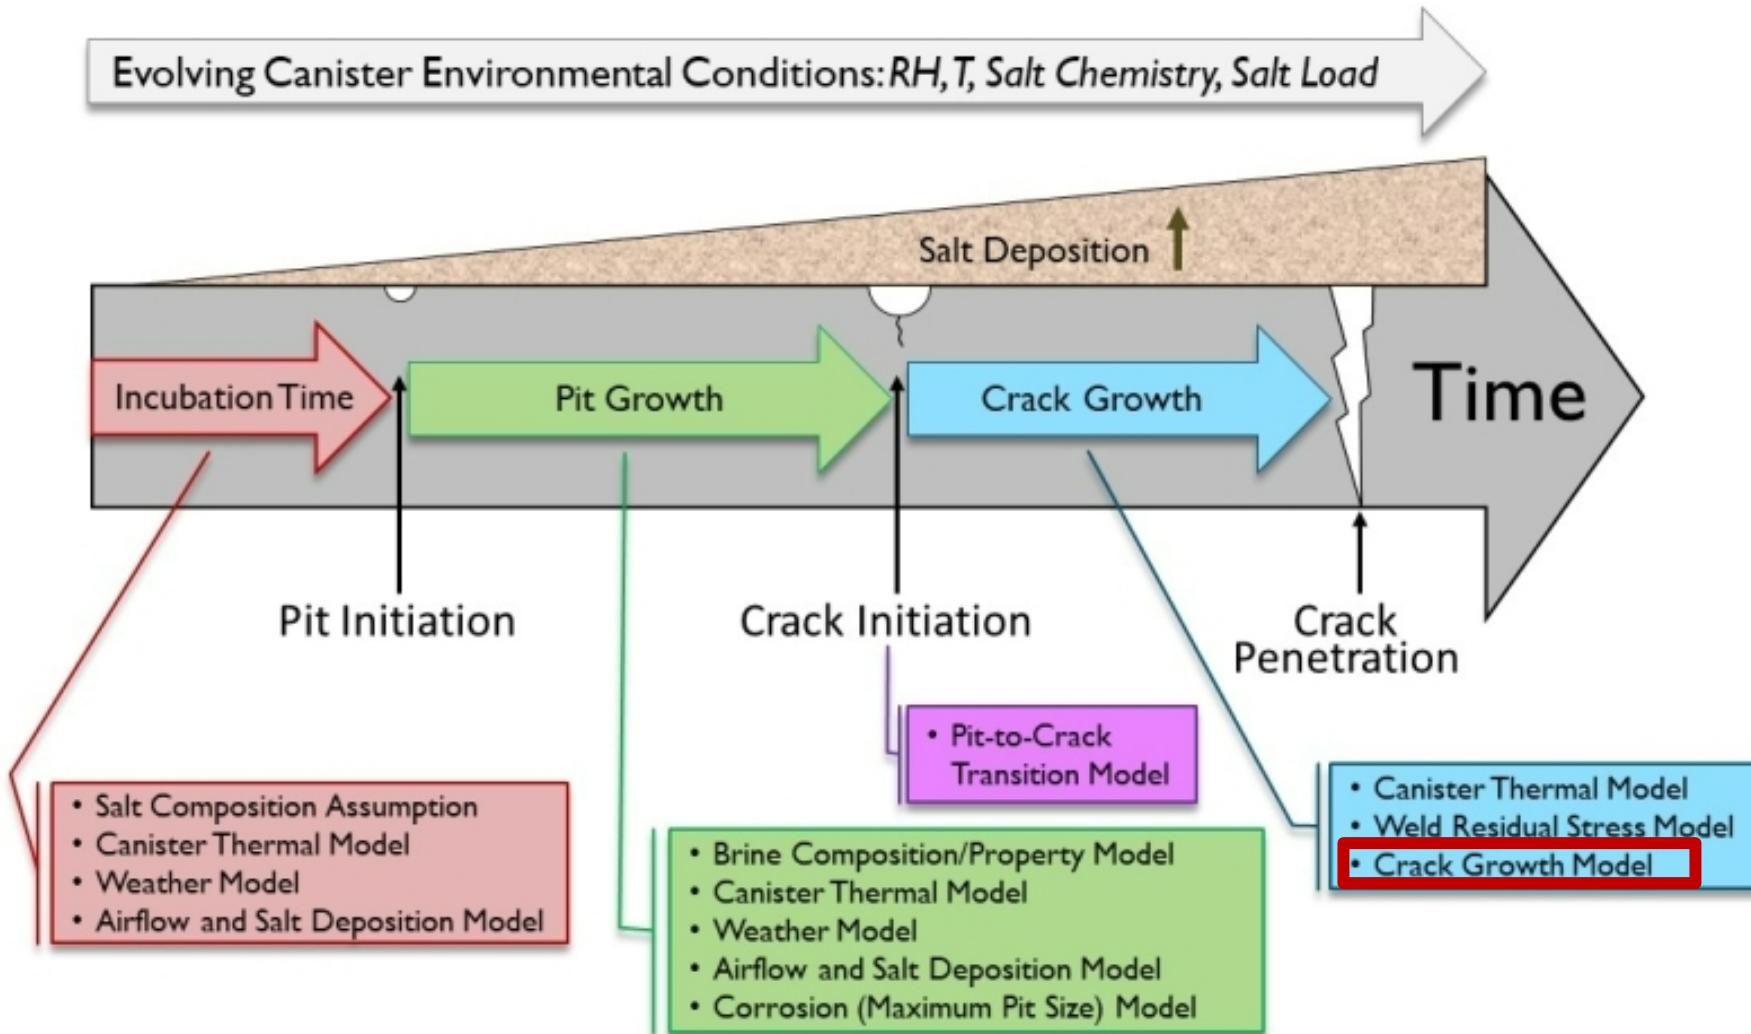
Integrated Mechanistic/Probabilistic Model for Canister SCC

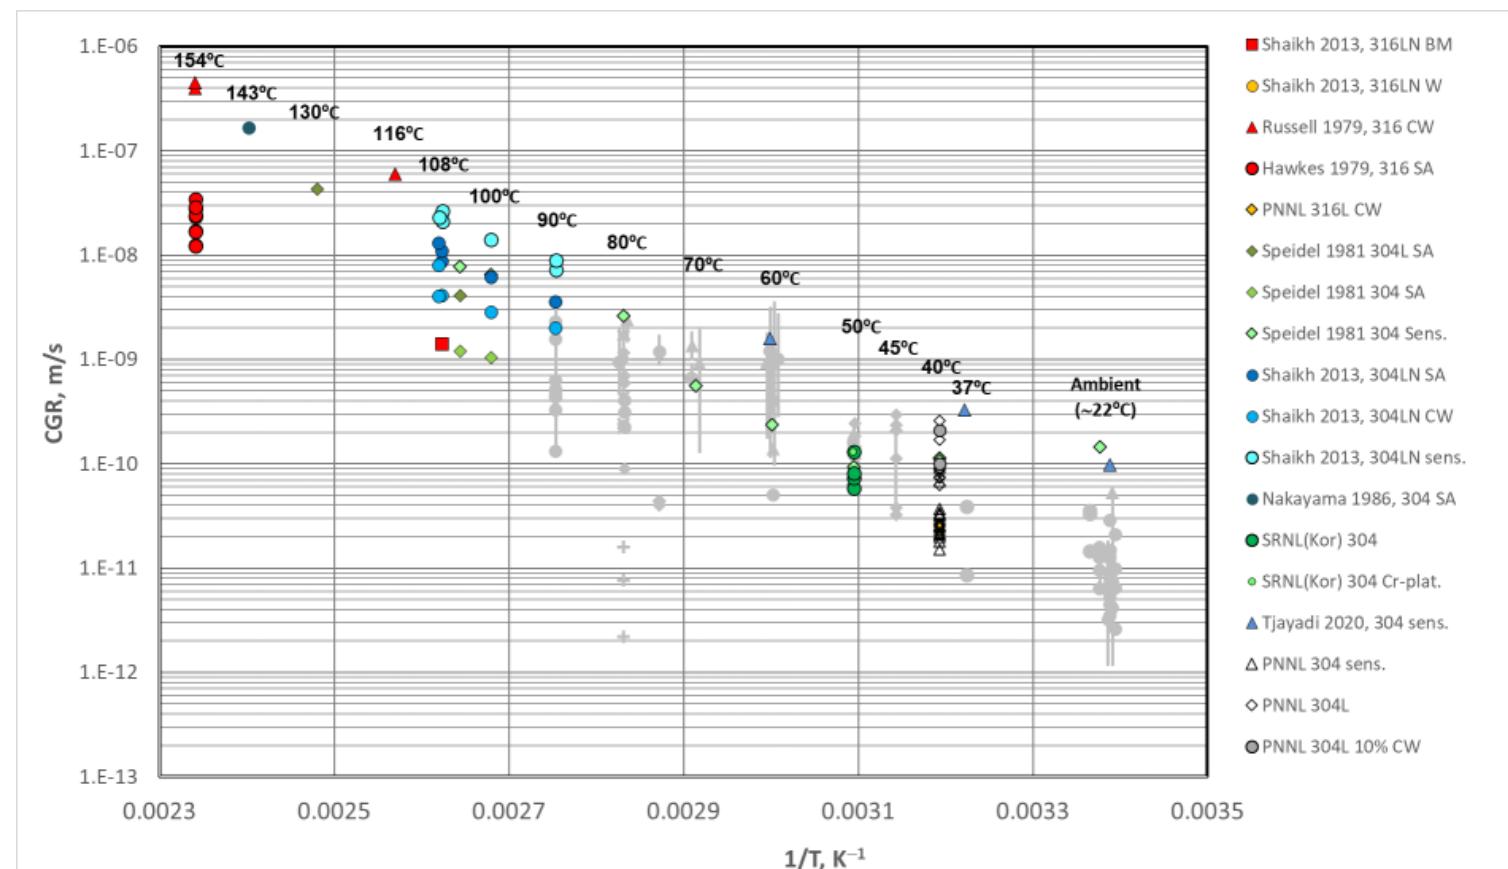
Arrhenius Temperature Dependence of Crack Growth

- Various collection methods, environments, lot of material, sensitization state, etc.

What are the governing factors and will certain factors cause accelerated growth?

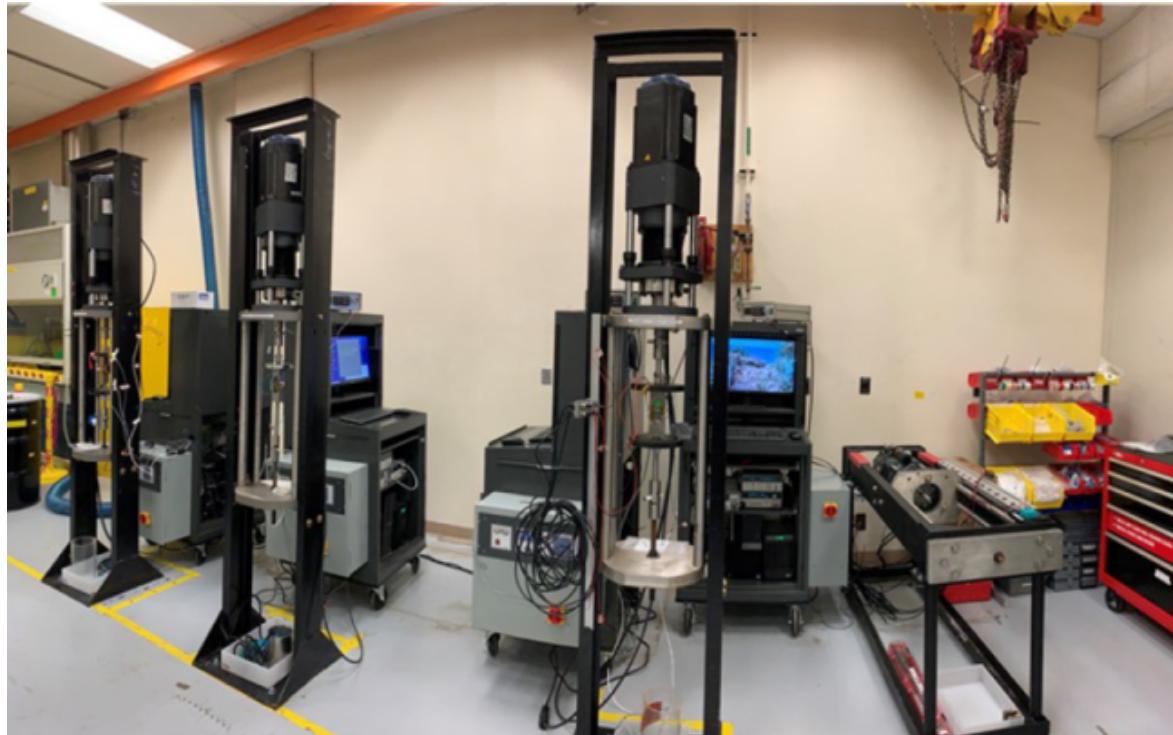
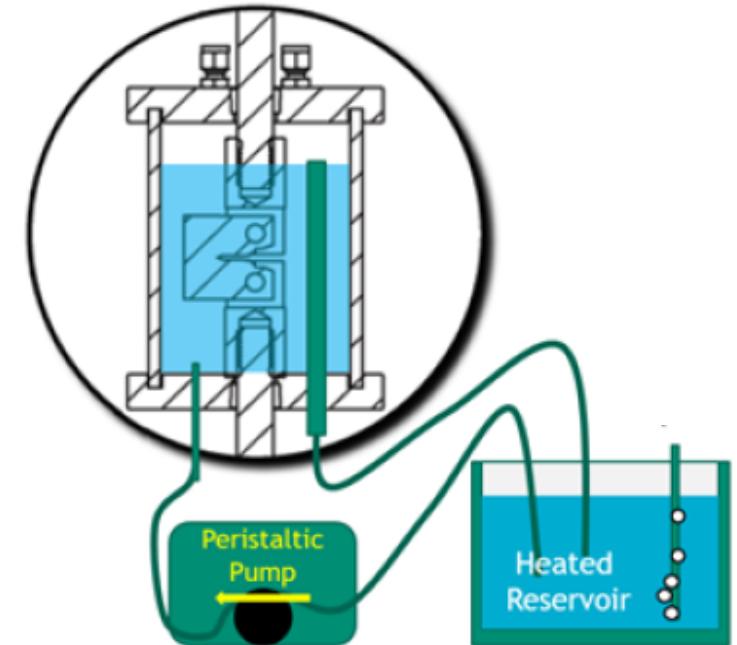
Capabilities

- Measure in-situ crack growth rate ($\sim 10^{-12}$ m/sec) in a corrosive solution under heated flow
- Development of atmospheric SCC set-up

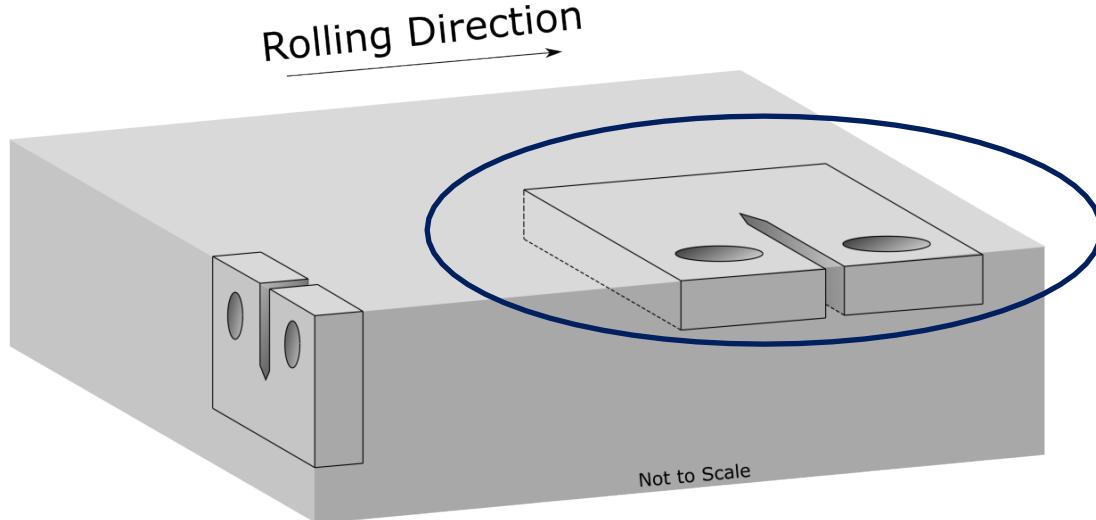
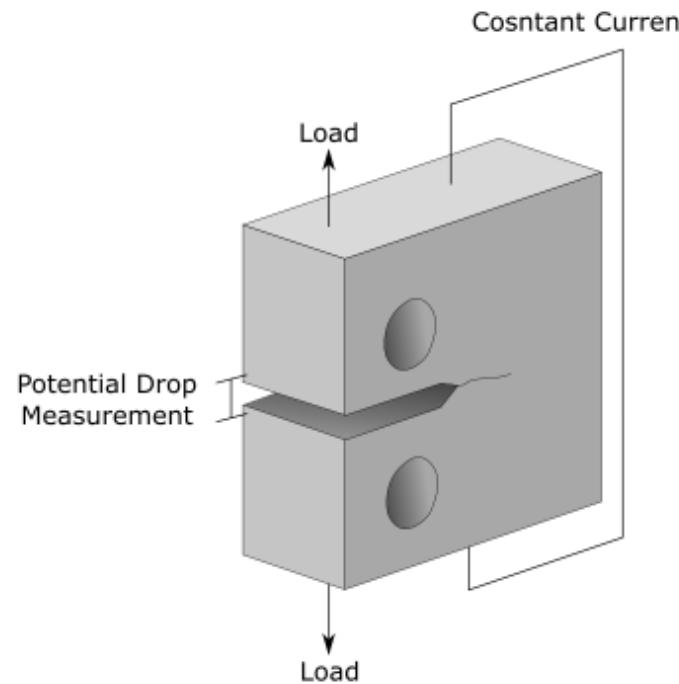
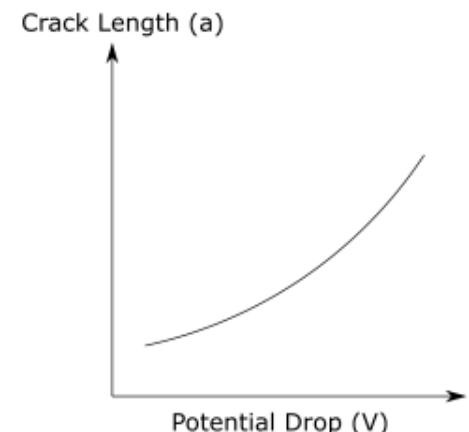
Sample Orientation and *In-Situ* Testing Methodology

- Majority of samples presented will be in the L-T orientation
- Annealed ASTM SS304L (information in supplemental)
- Utilizing Direct Current Potential Drop (DCPD)

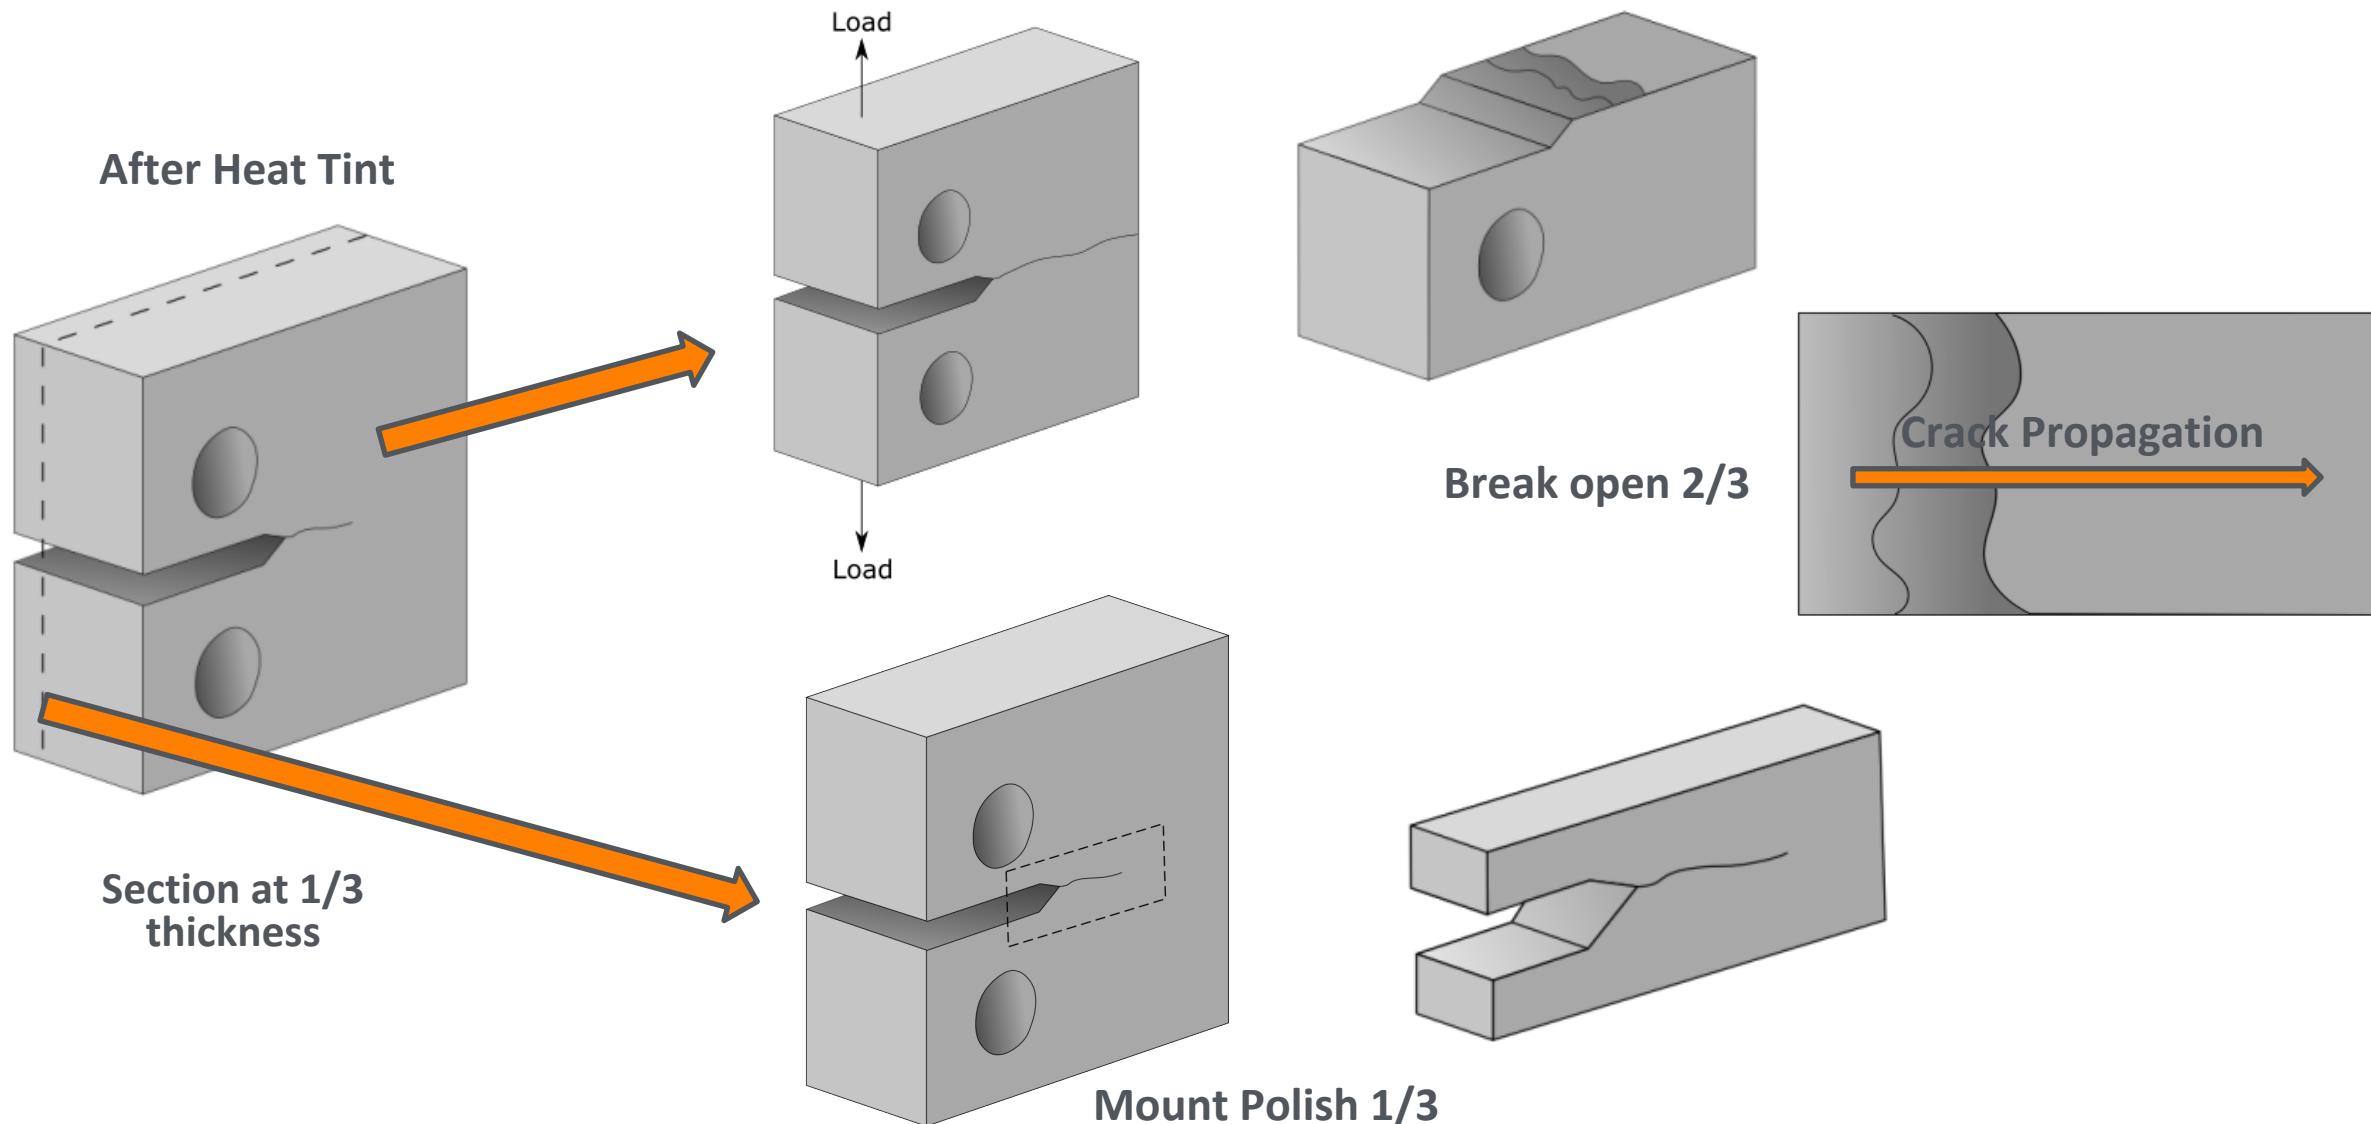
Methods for Post Test Sample Analysis

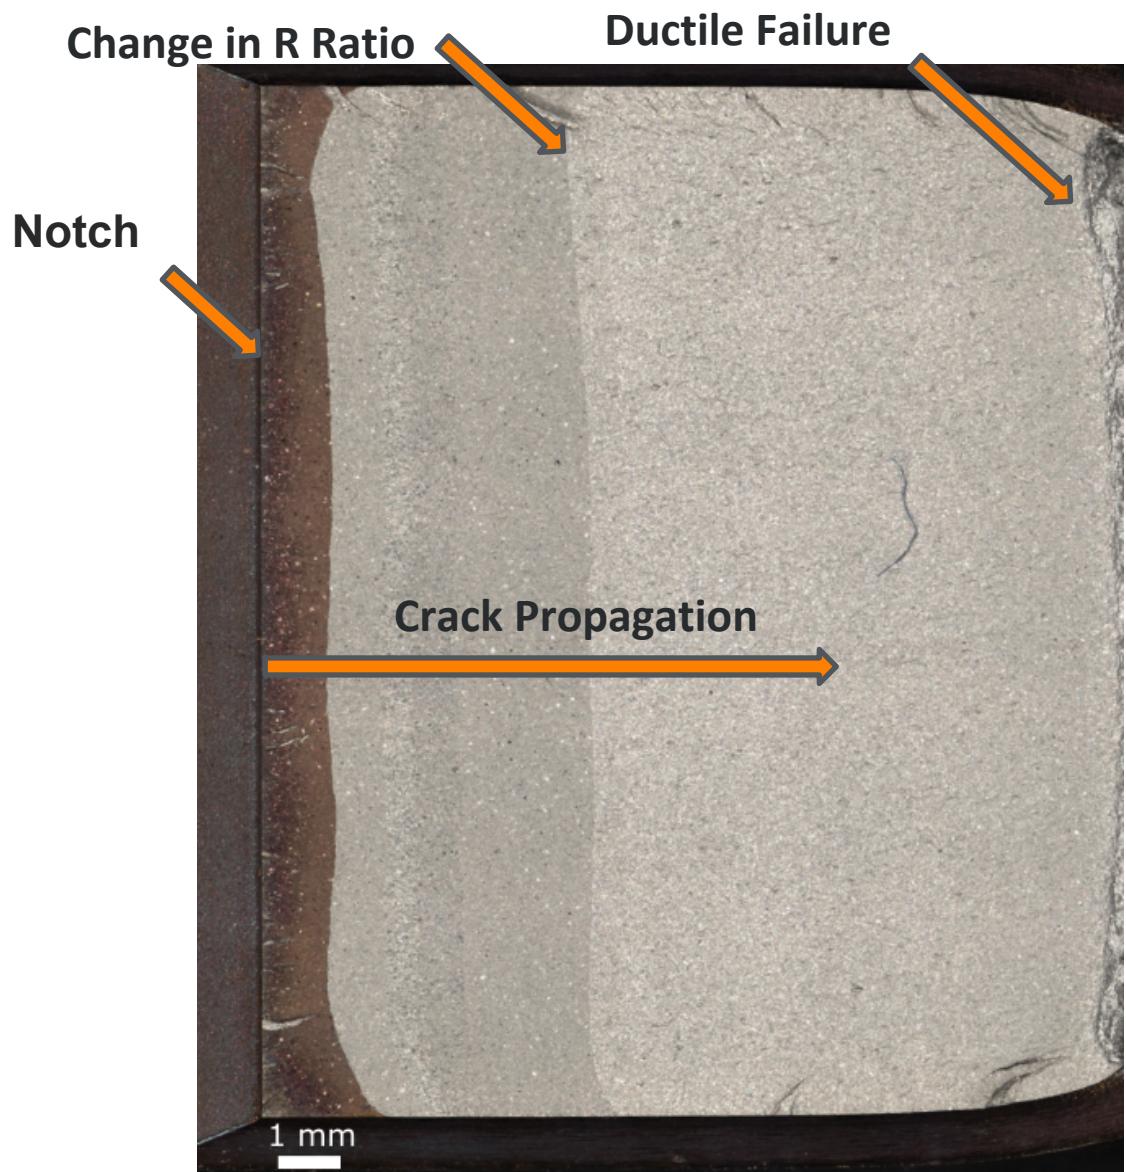
Calibration of DCPD Set-up

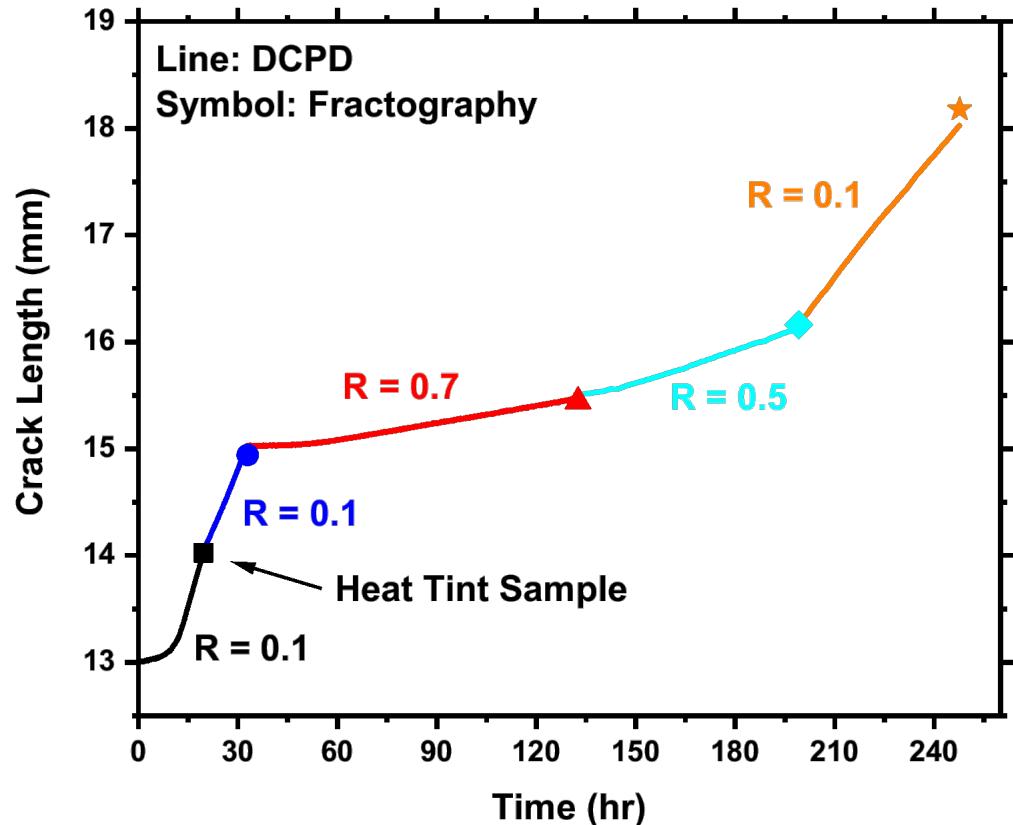
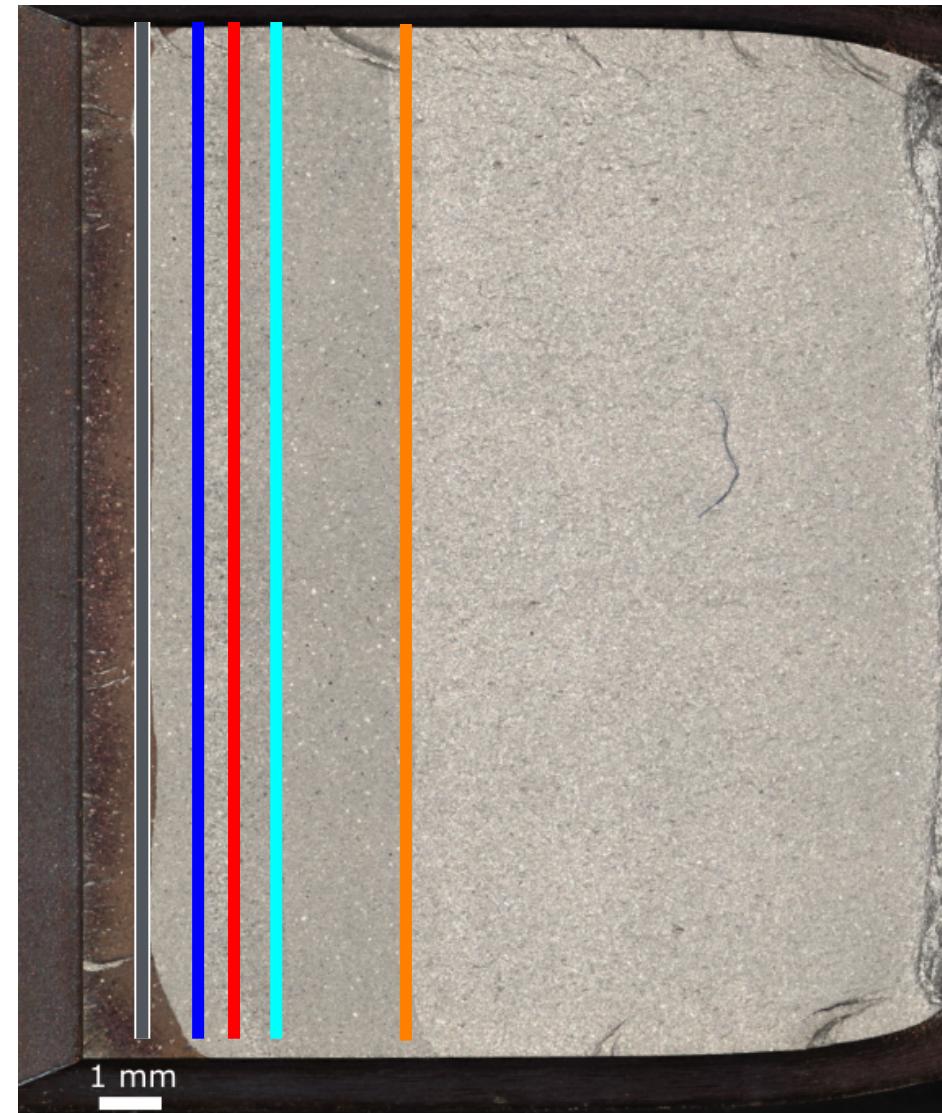
Calibration of DCPD Set-up

- Performed on two different load frames
- Confidence DCPD system is set-up correctly

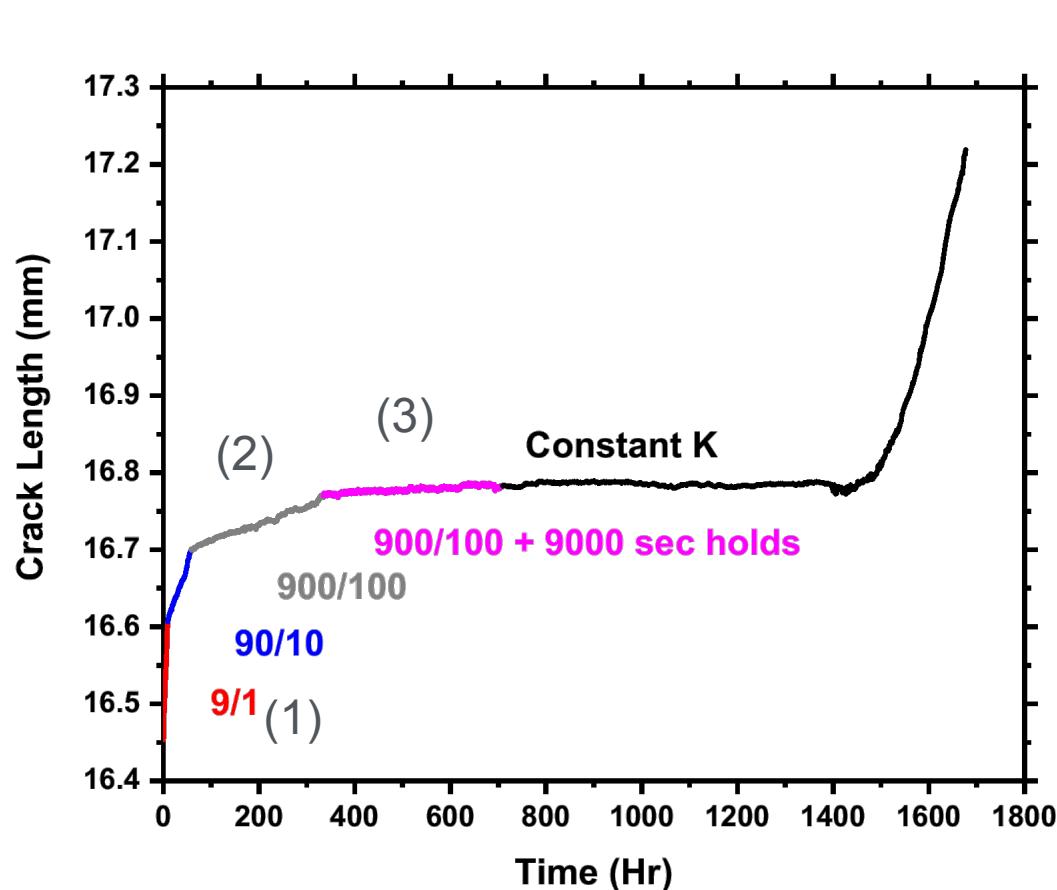
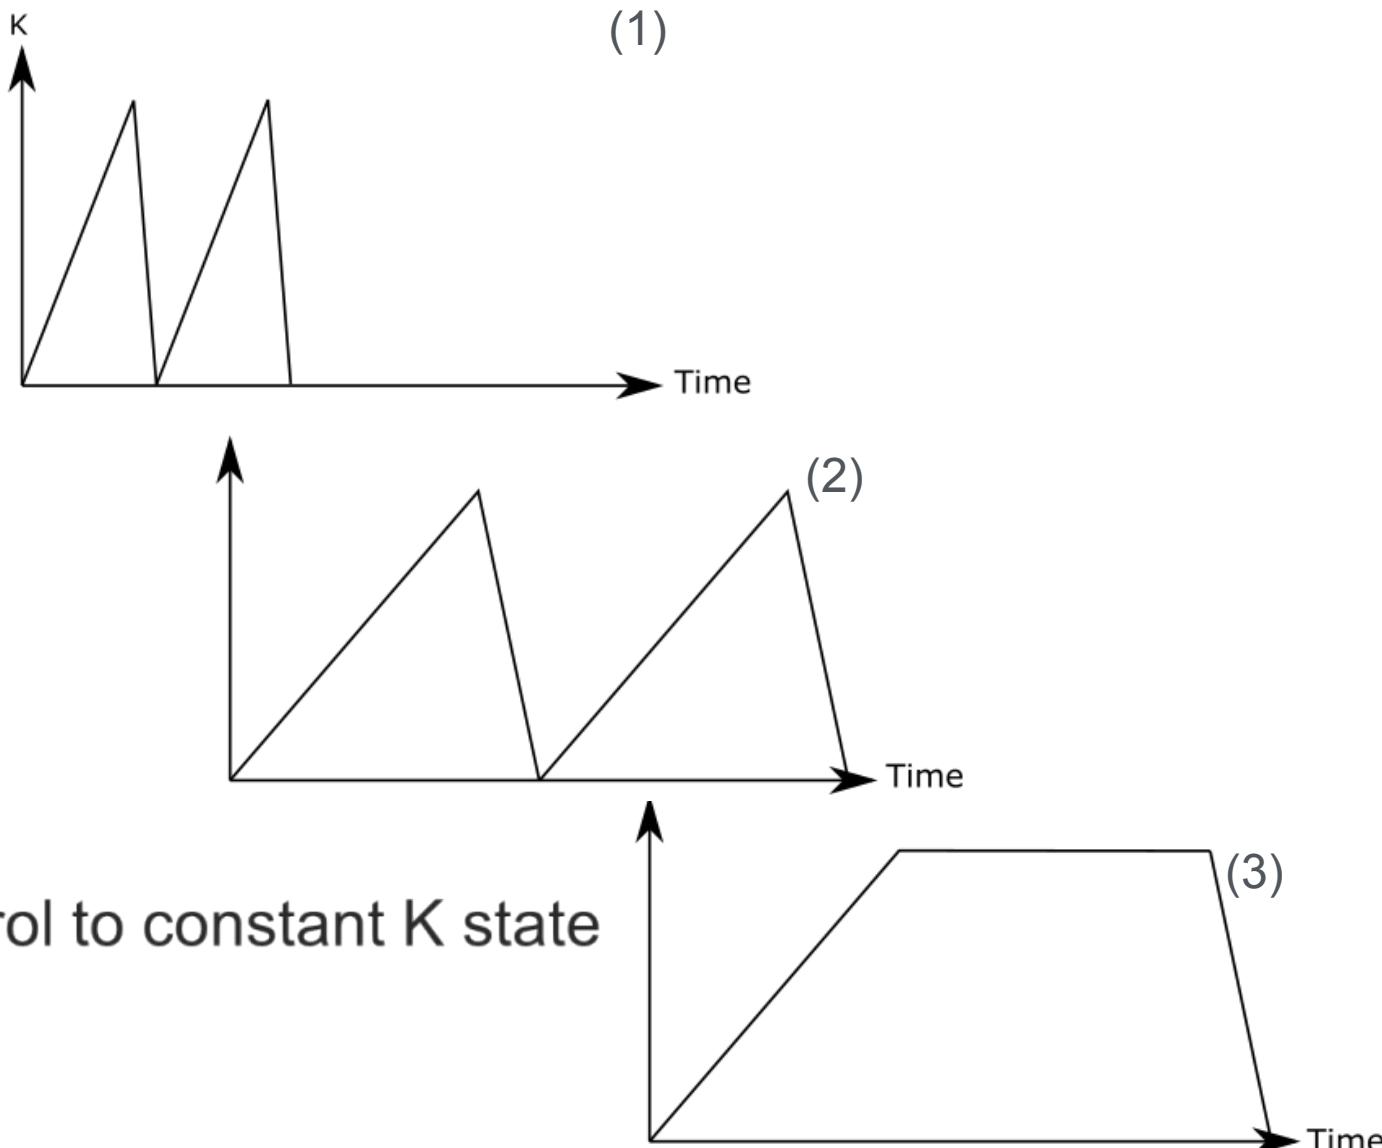
Testing Methodology

- Decreasing frequency under K control to constant K state
 - 'True' crack plane for constant K SCC
- $K_{max} = 20 \text{ MPa}\sqrt{m}$

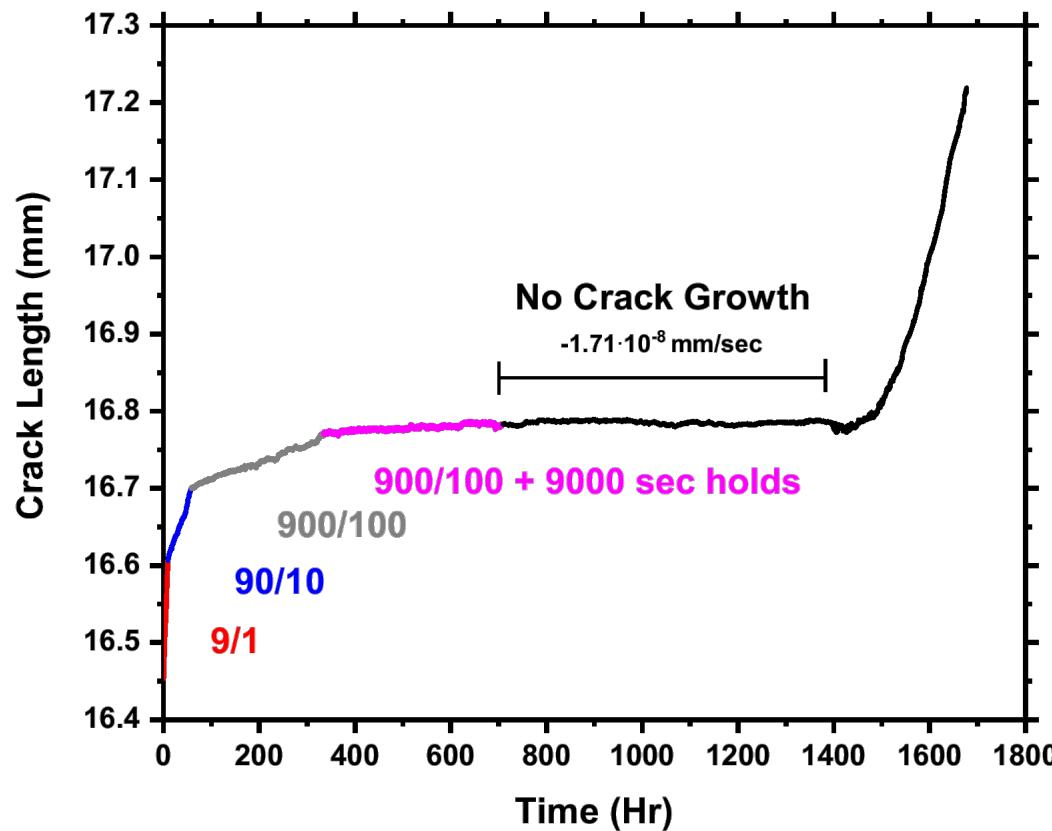
SS304L Exhibits Delayed Crack Growth Under Constant K in MgCl_2 at 55 °C

- No growth for ~ 700 hours

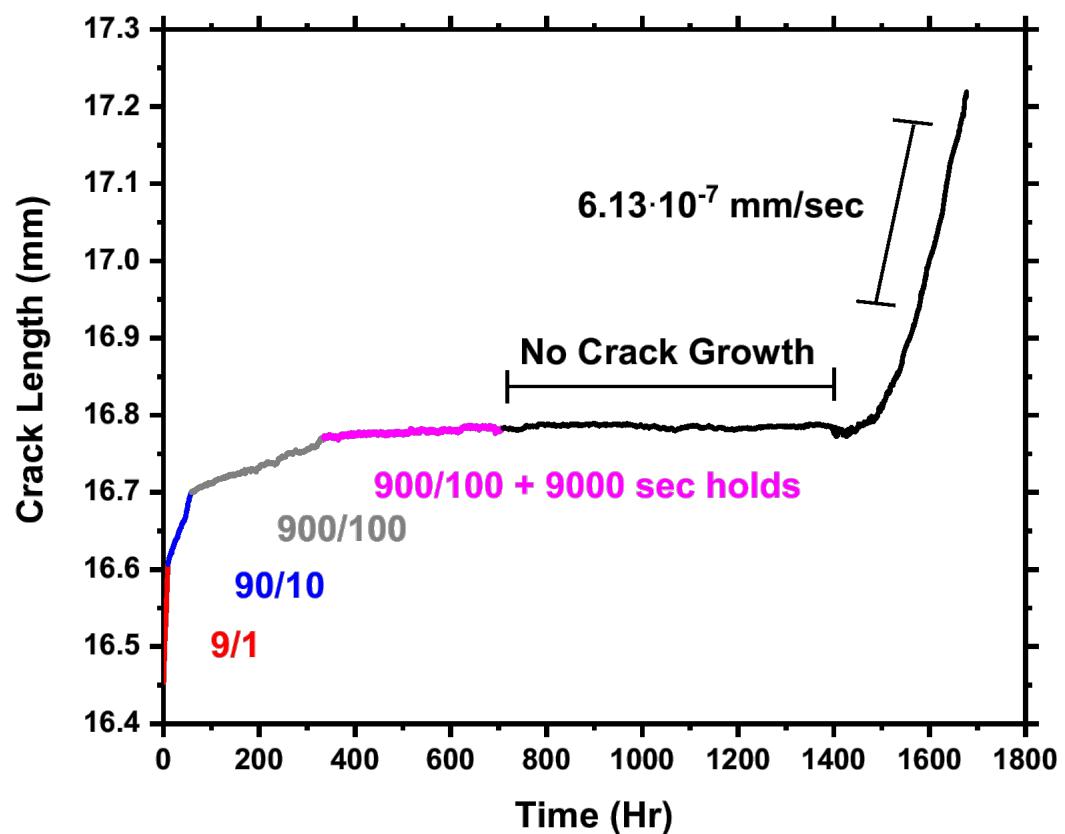
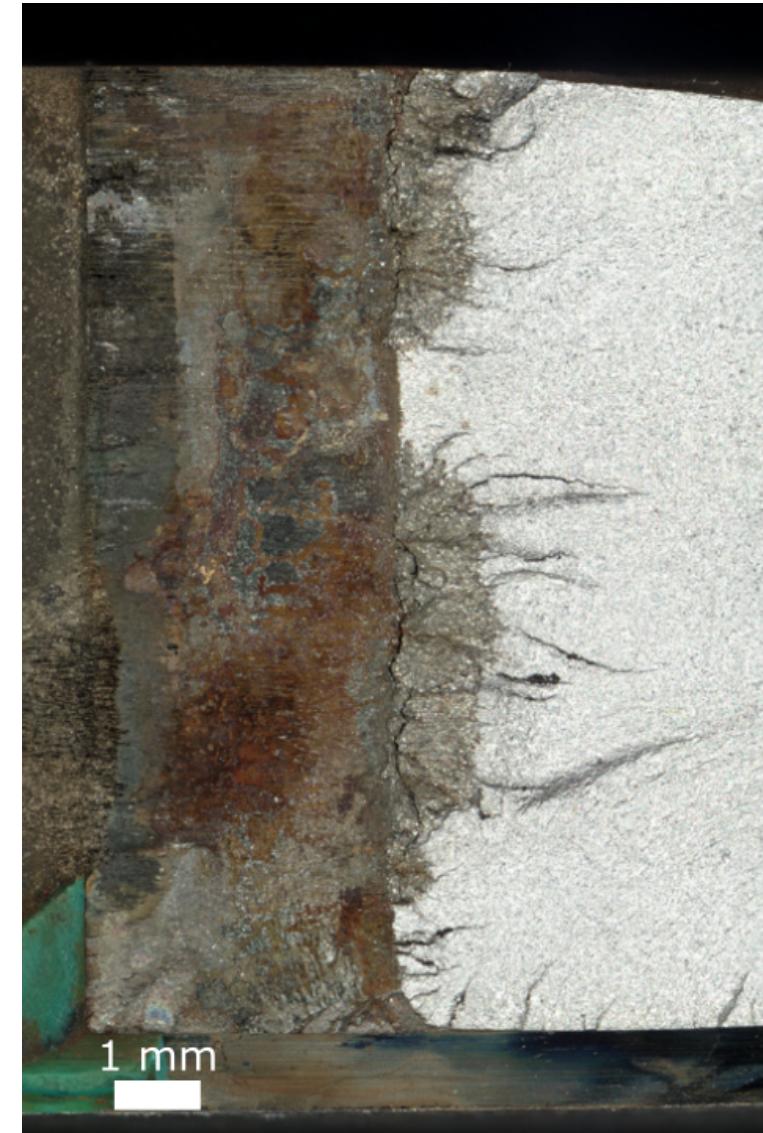
SS304L Exhibits Irregular Crack Front in Saturated MgCl₂ at 55 °C

- After roughly 1500 hours of total test time, cracking ensues
- Sample was cut at 1/3 of thickness

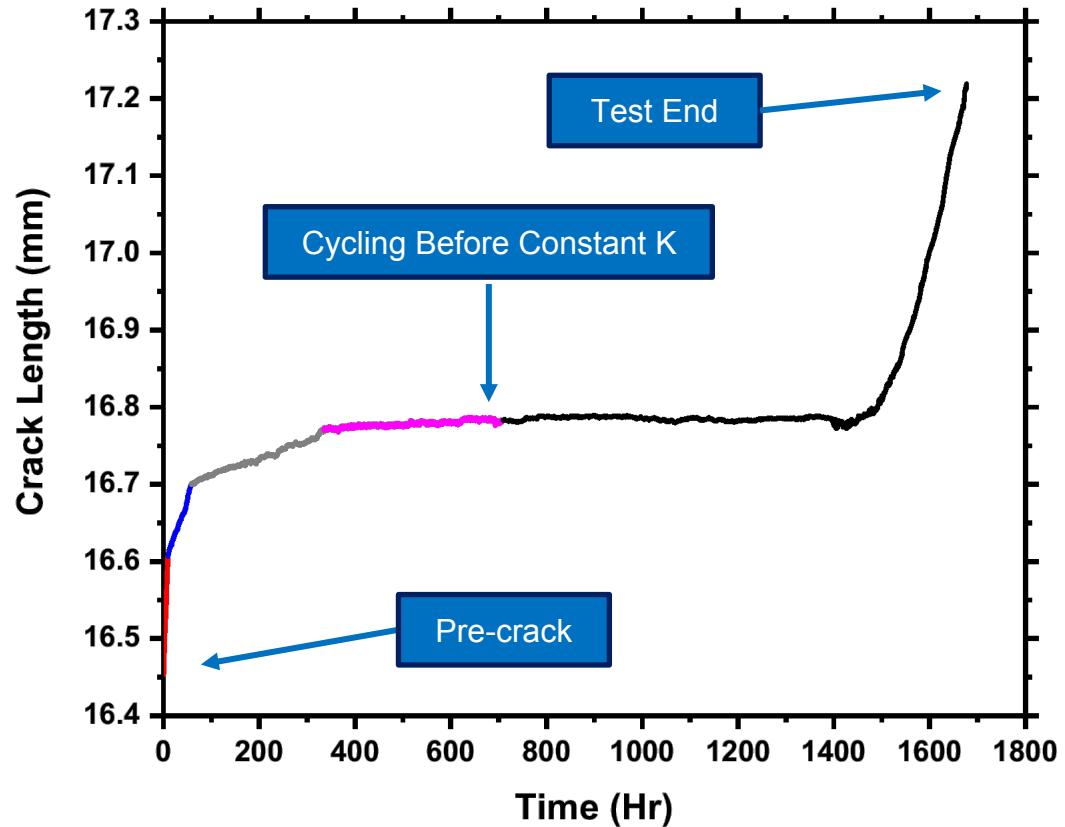
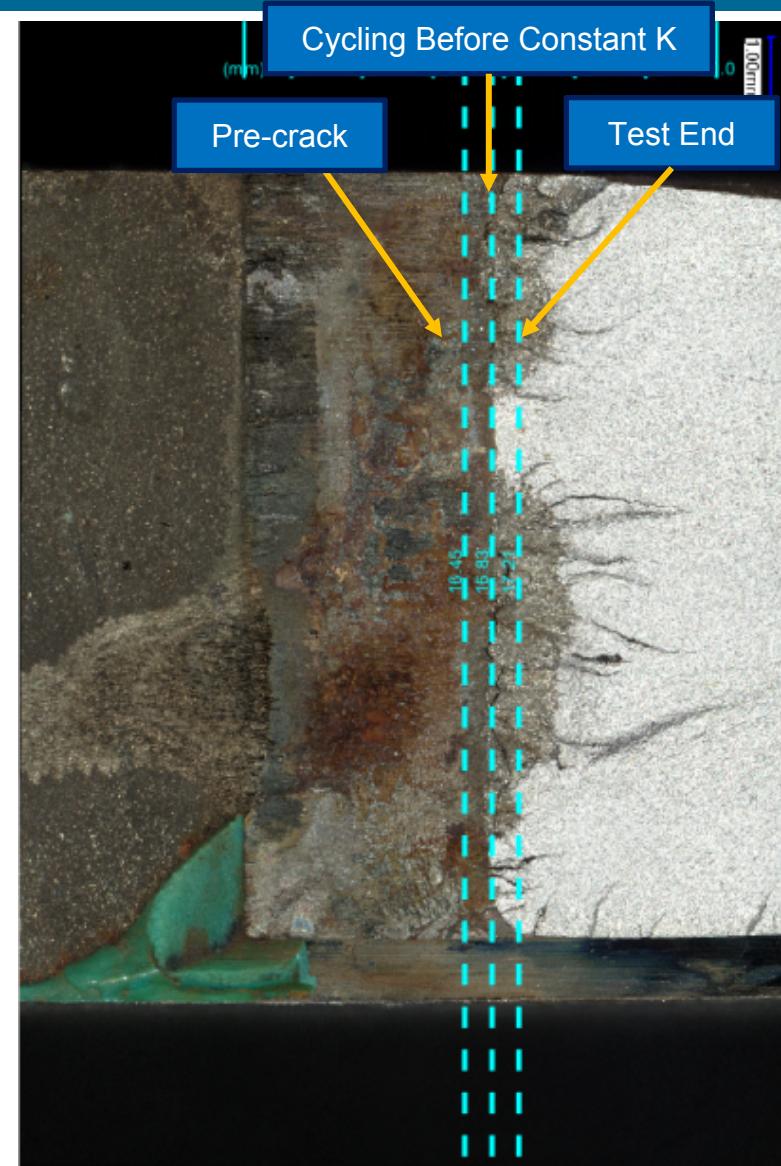
SS304L Exhibits Irregular Crack Front in Saturated $MgCl_2$ at 55 °C

- Overlay of DCPD on fractography potentially suggests cracking halted at the uniform 'ledge'

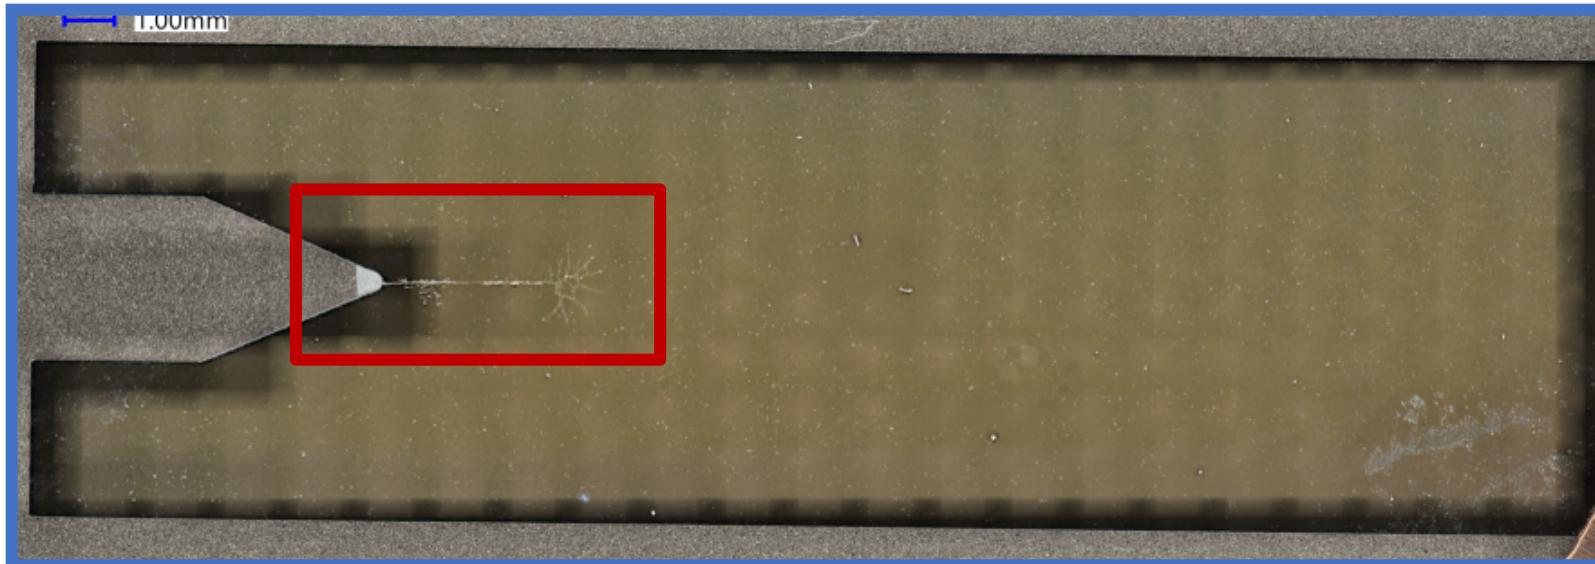
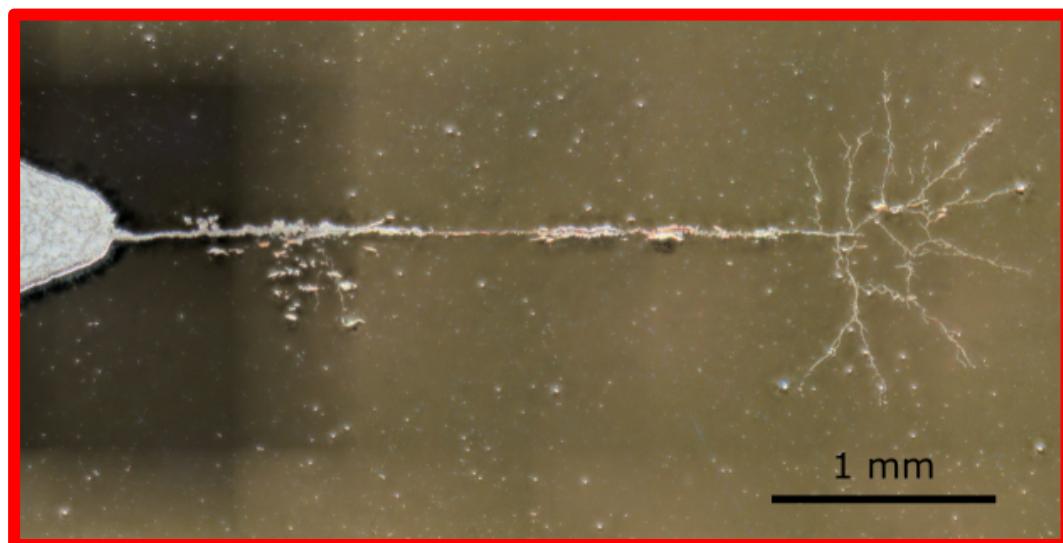
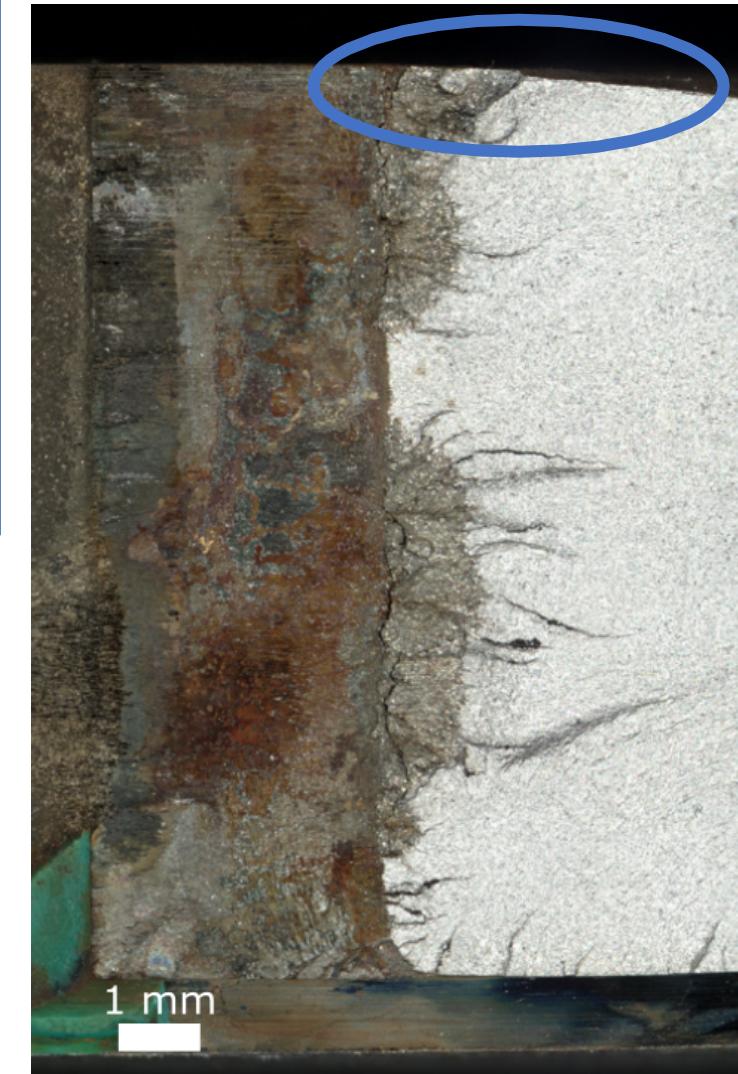
SS304L Exhibits Crack Branching in Saturated MgCl₂ at 55 °C
