Spent Fuel and Waste Science and Technology (SFWST)

Stress Corrosion Cracking of Austenitic Stainless Steels in Concentrated Chloride Environments

Ryan M. Katona, J. Taylor, E. Karasz, B. Nation, A. W. Knight, C. R. Bryan, and R. F. Schaller

**SWFST Annual
Meeting**

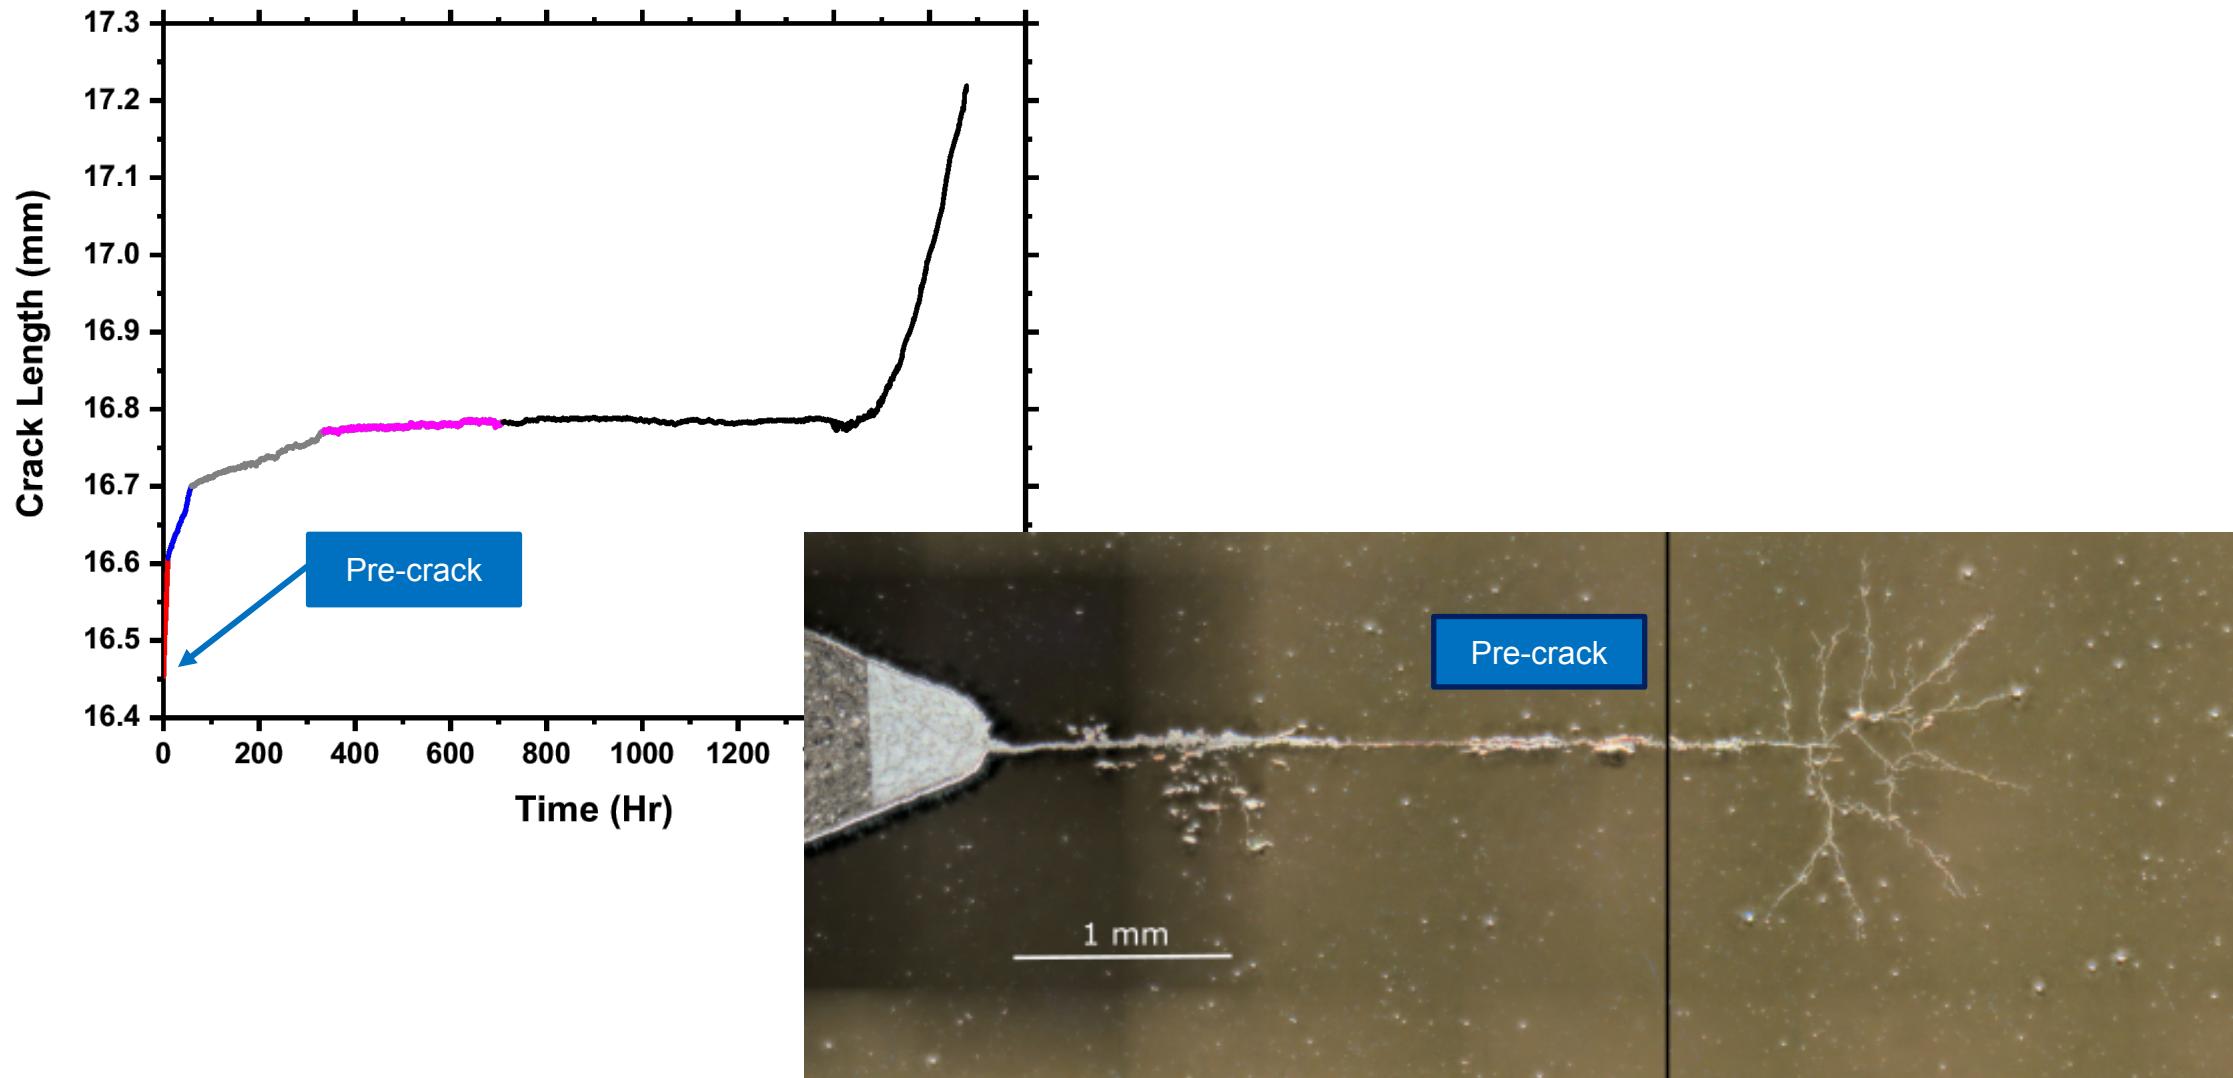
SS304L Exhibits Crack Branching in Saturated MgCl₂ at 55 °C

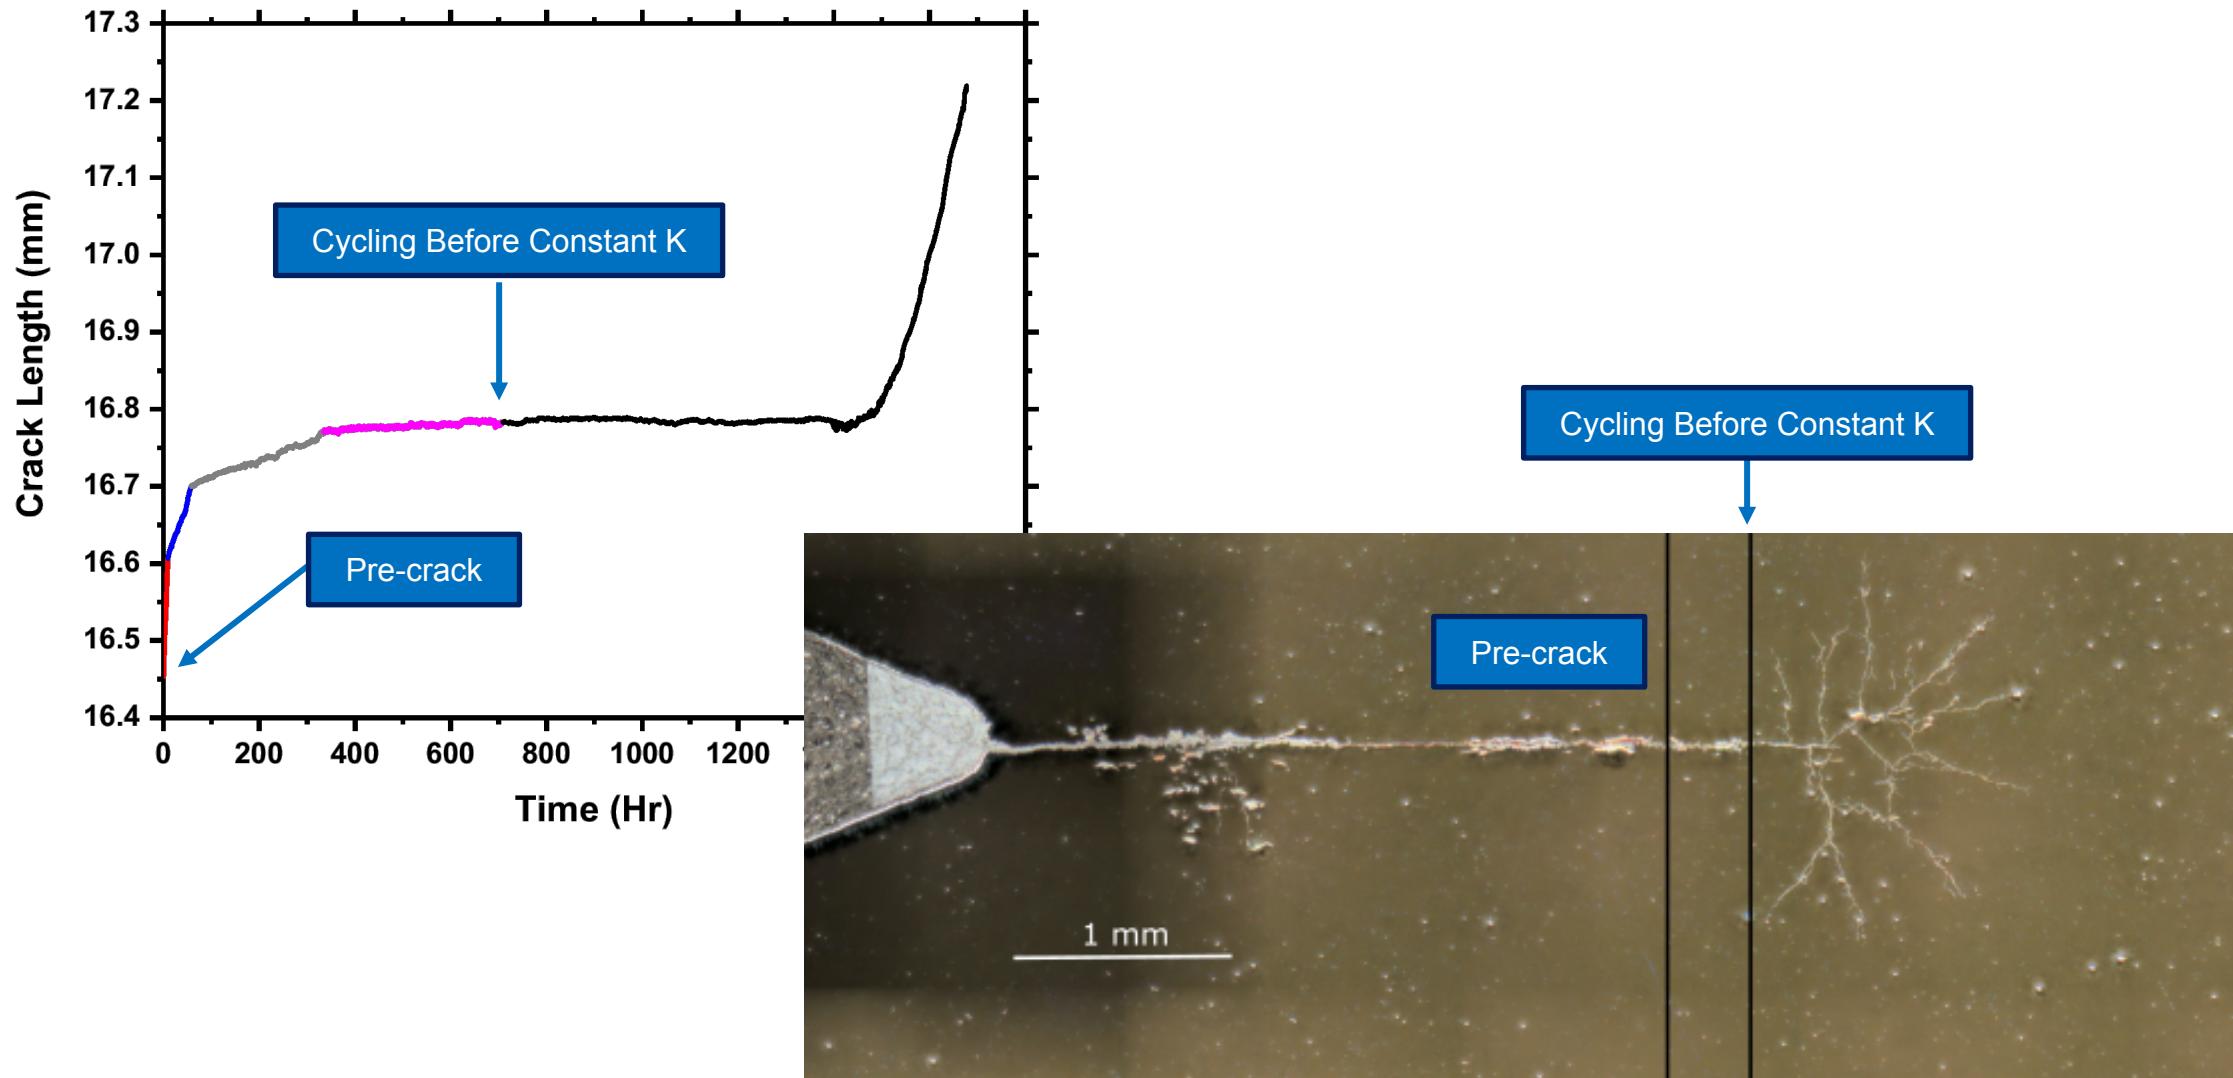
SS304L Exhibits Crack Branching in Saturated MgCl₂ at 55 °C

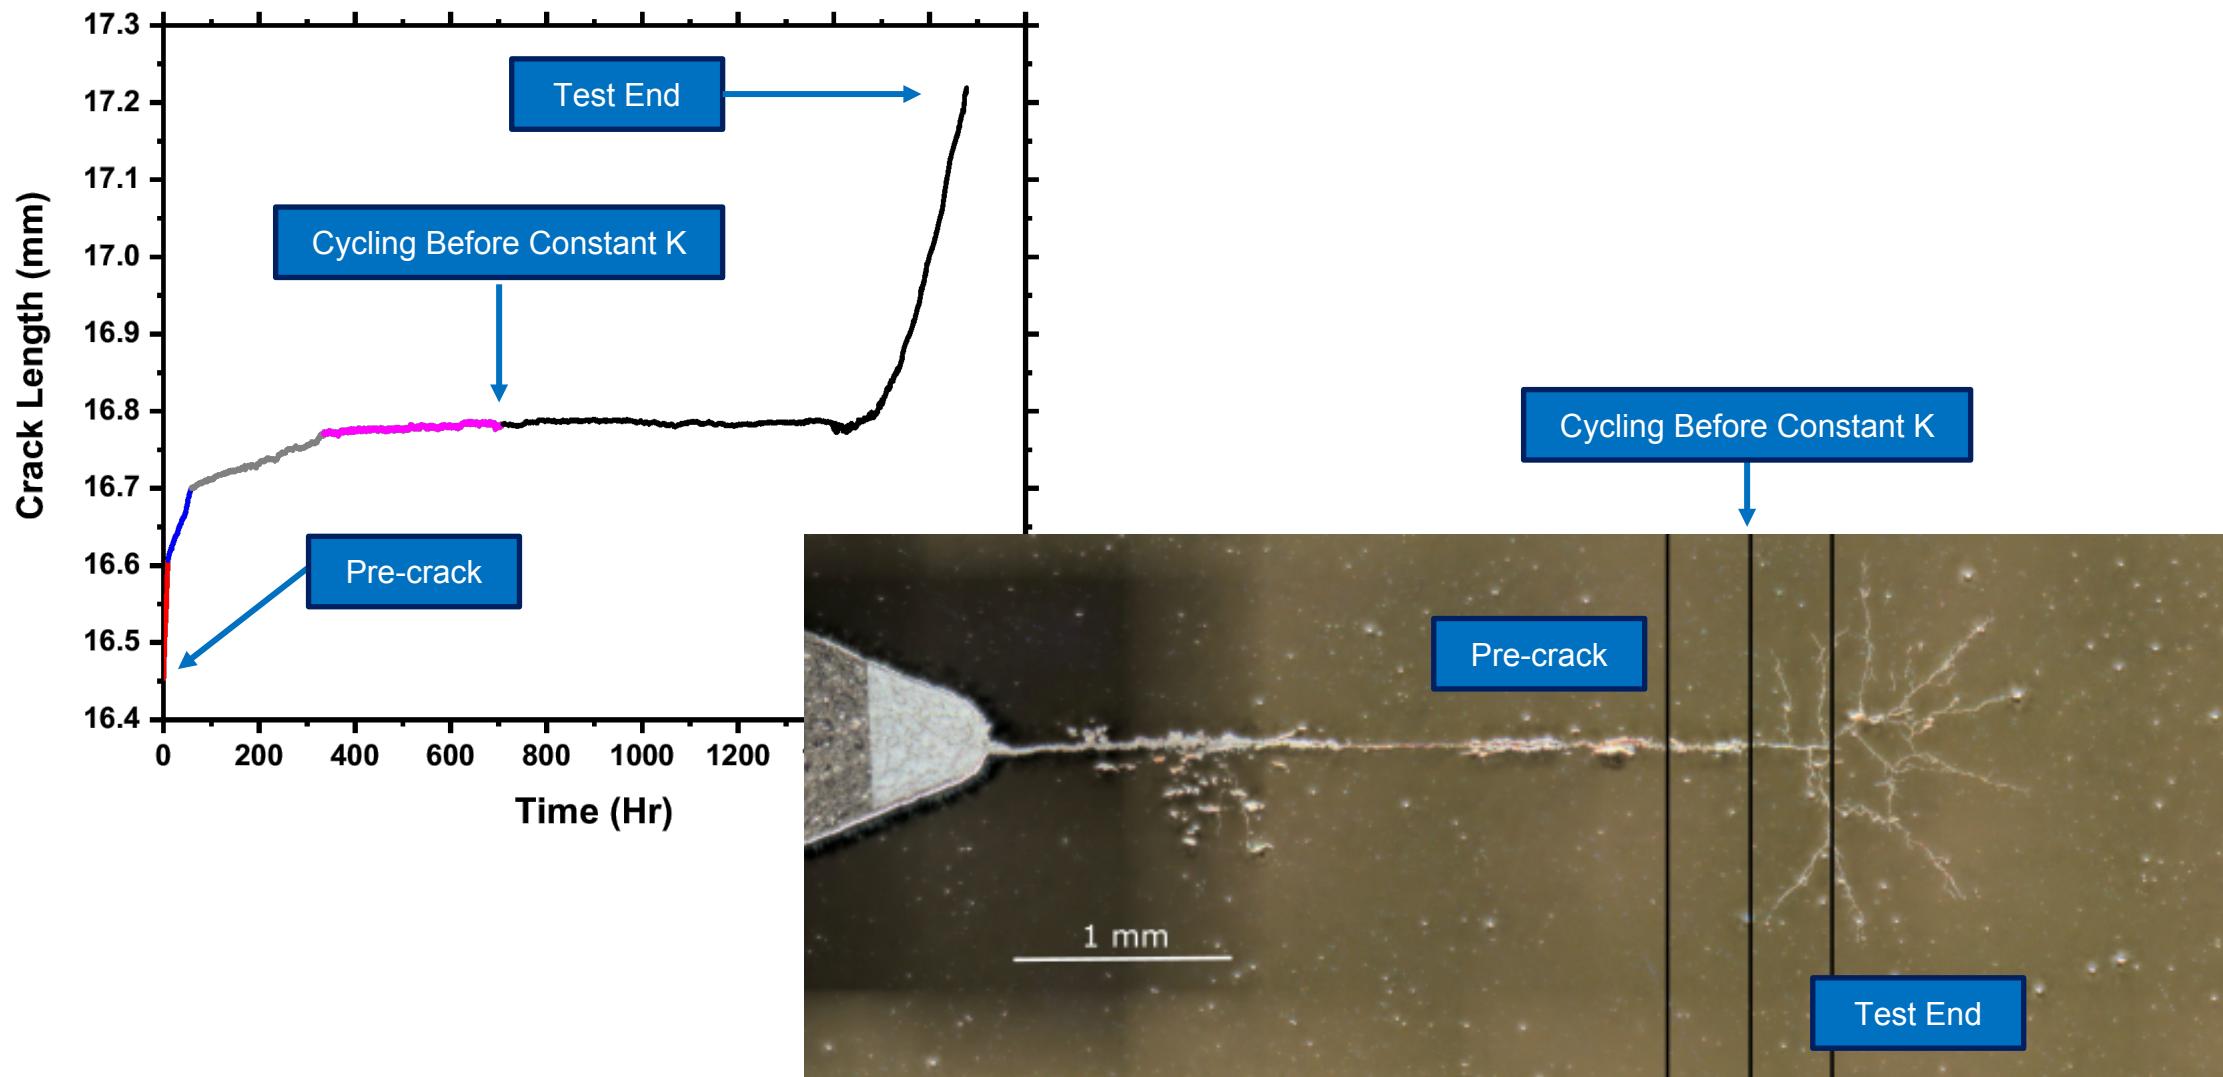
SS304L Exhibits Crack Branching in Saturated MgCl₂ at 55 °C

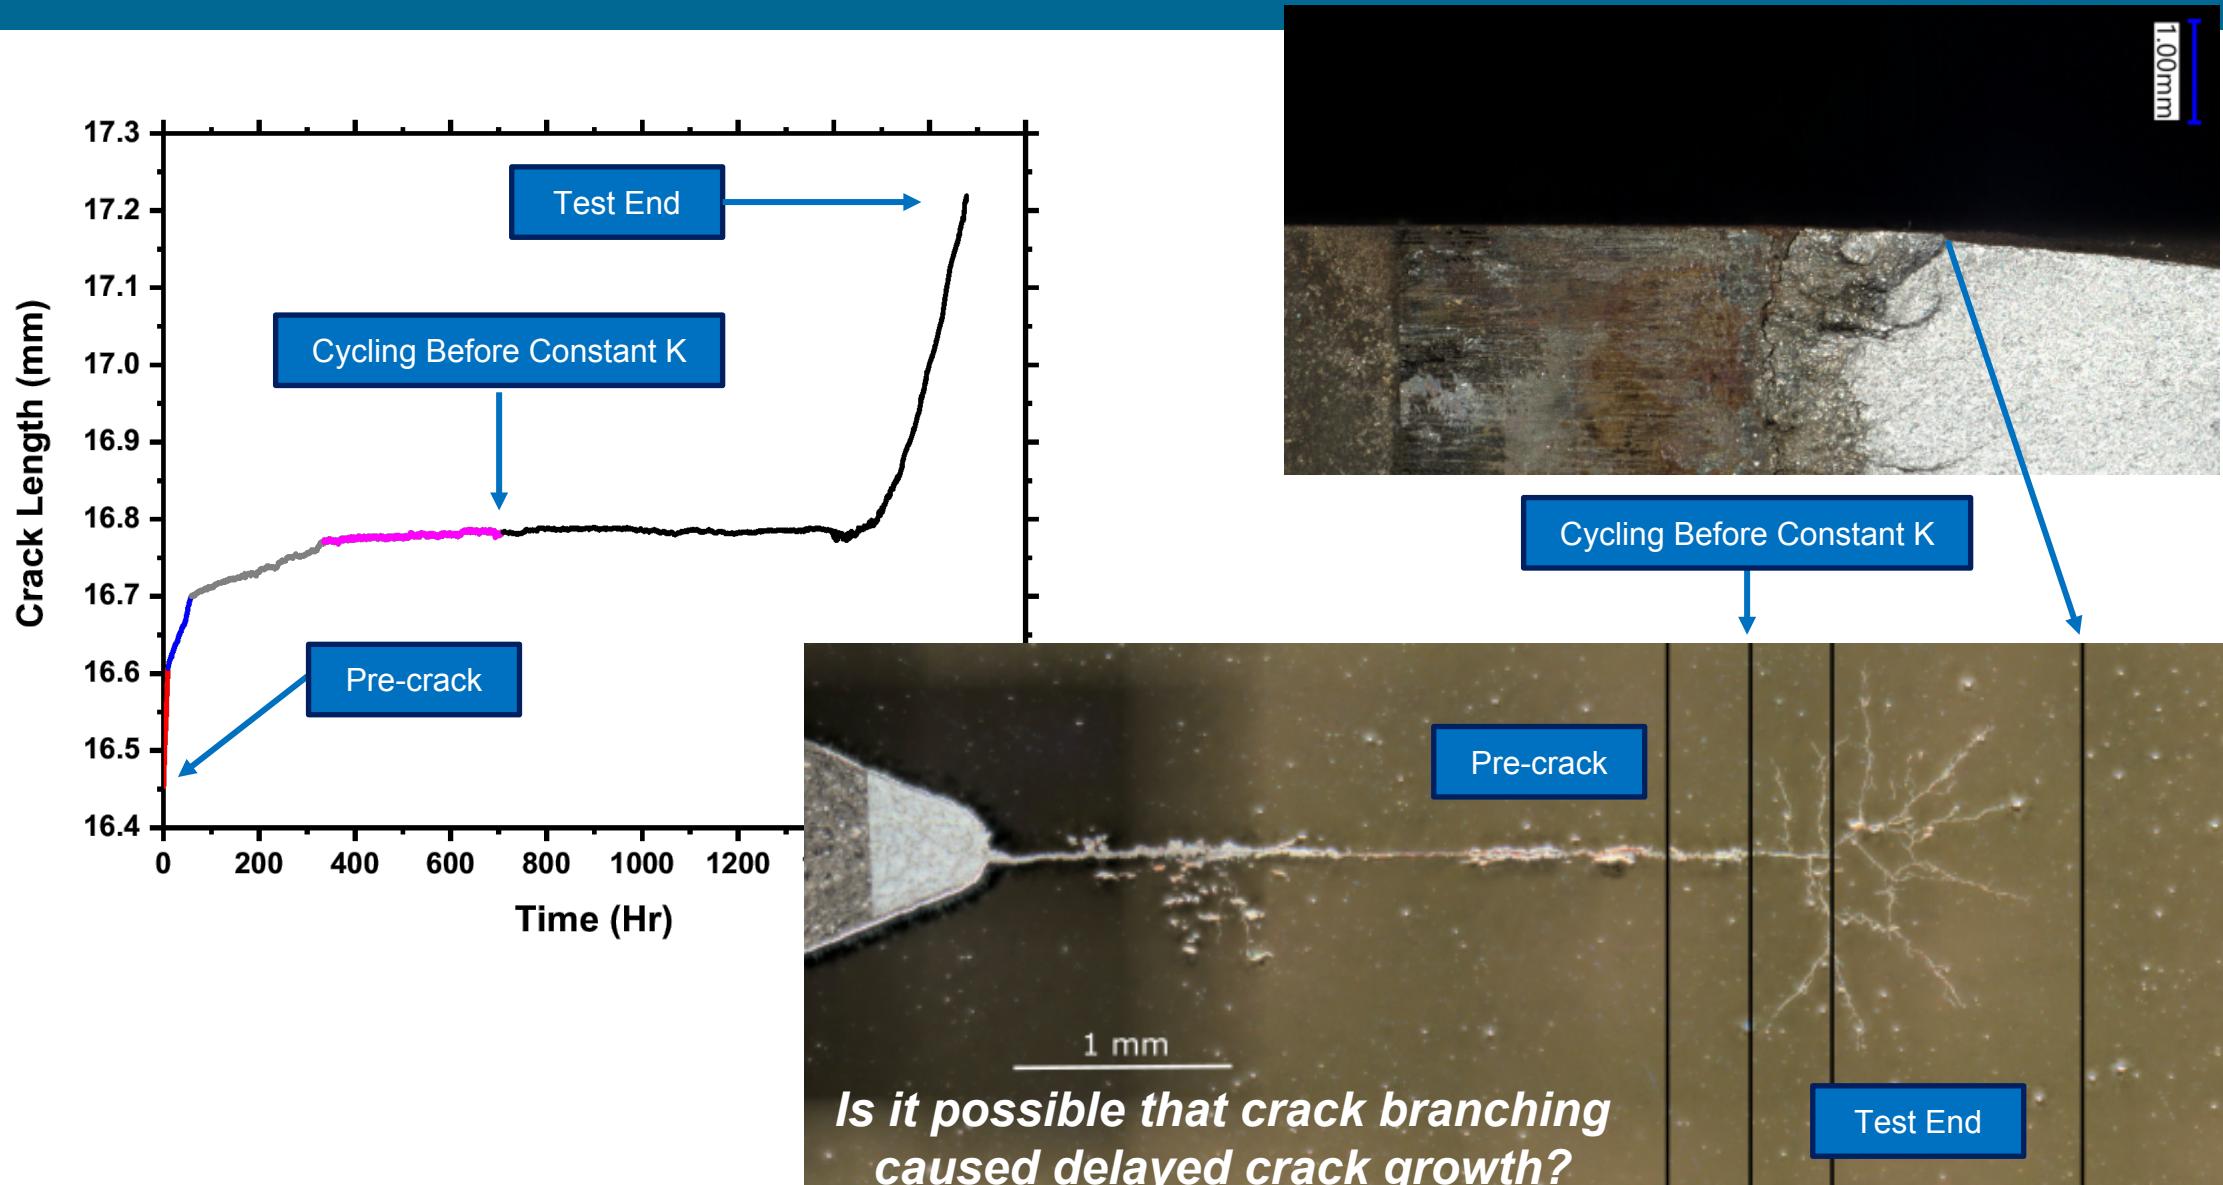
SS304L Exhibits Crack Branching in Saturated MgCl₂ at 55 °C

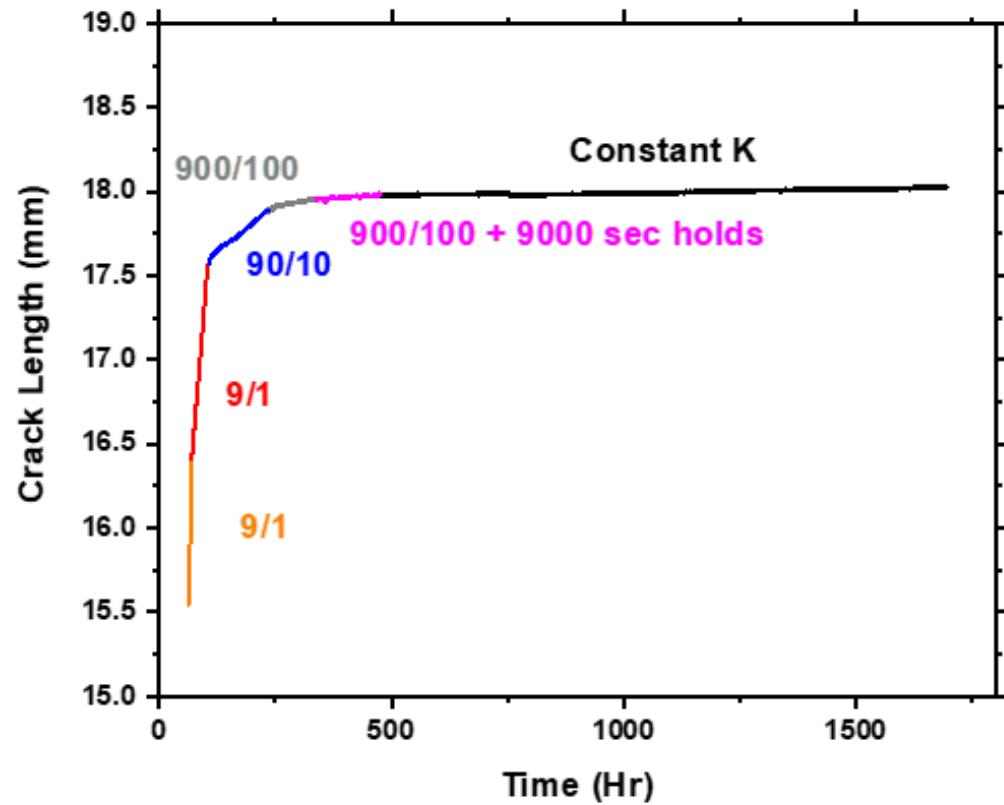
Low Crack Growth Rate for in Saturated MgCl₂ at 25 °C

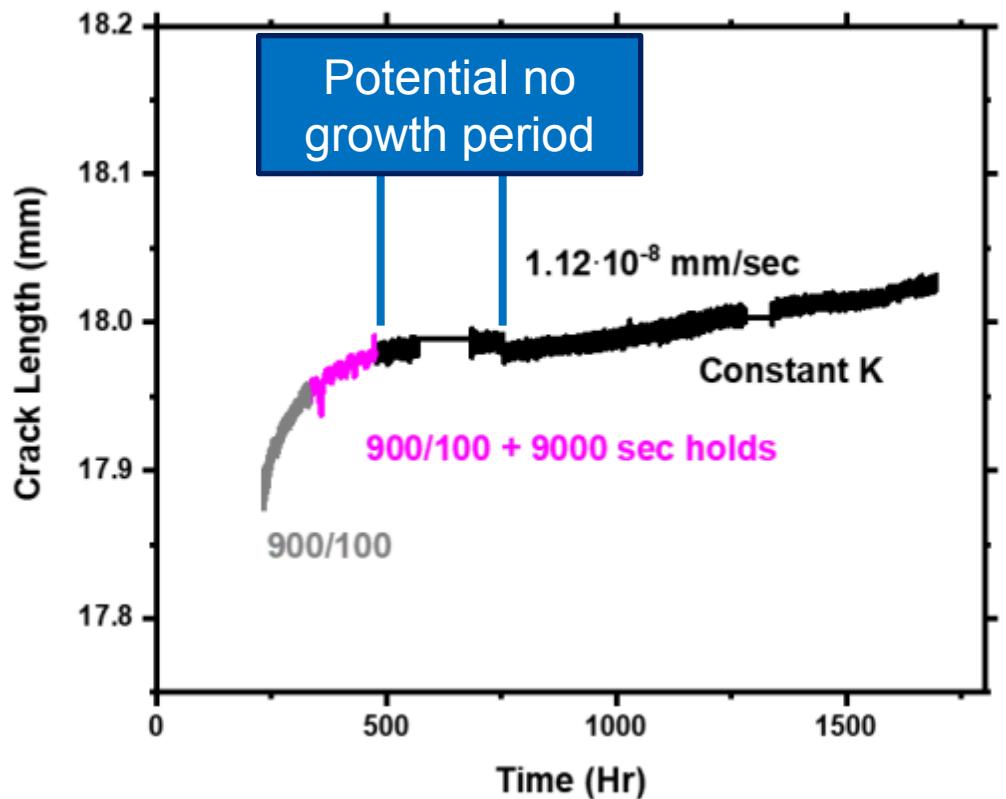
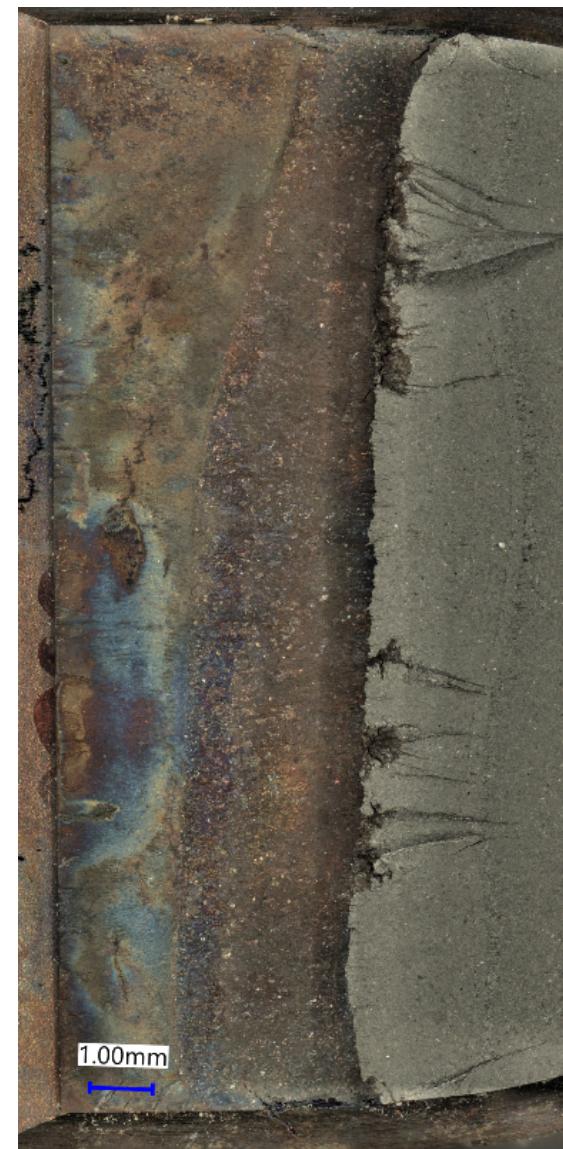
Low Crack Growth Rate for in Saturated MgCl₂ at 25 °C Exhibited Localized Cracking

- Possible delay in indicated crack growth similar to 55 °C
- Sample was not sliced but fractured open
- Similar crack morphology to 55 °C however are thinner regions

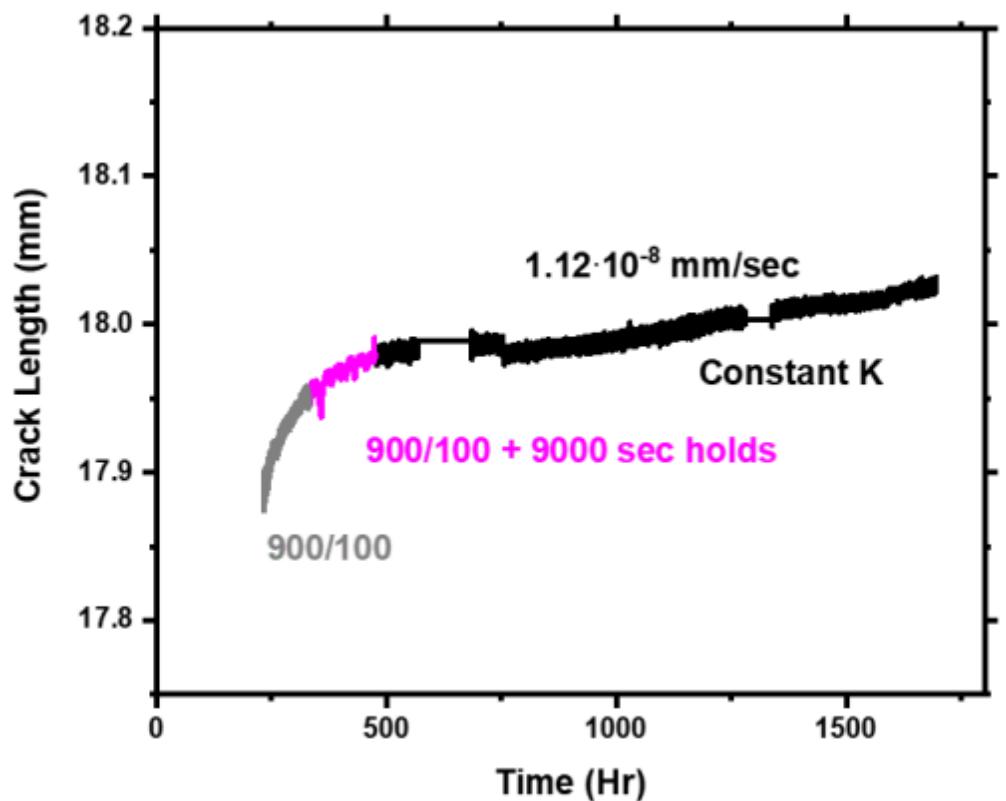
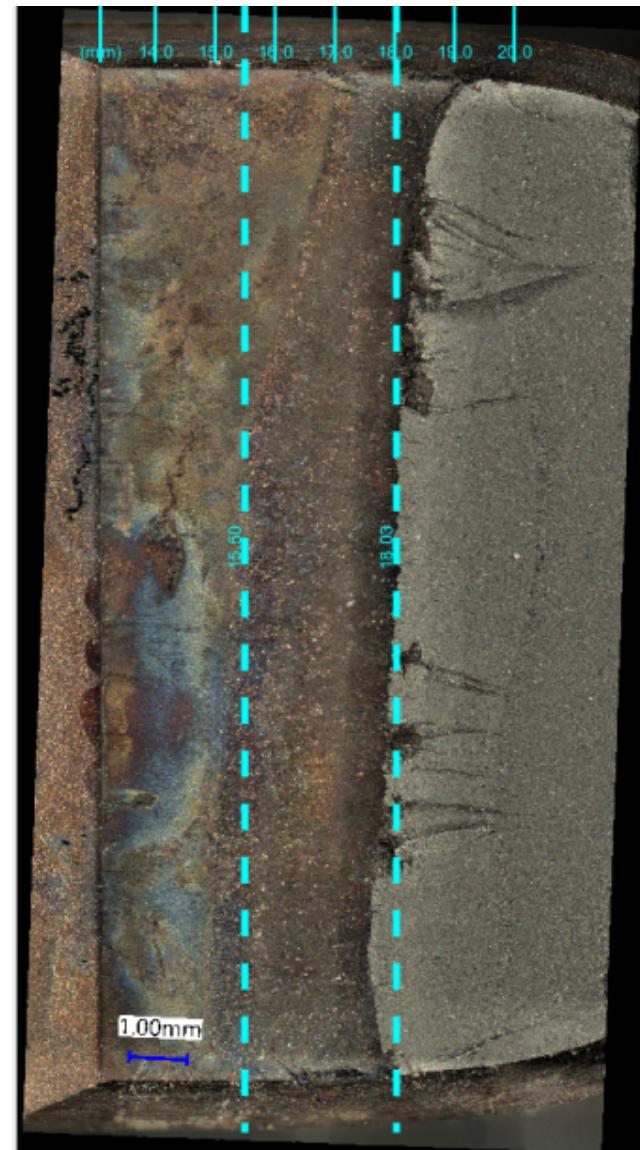
SS304L Exhibits Irregular Crack Front in Saturated MgCl₂ at 25 °C

- Slightly curved crack front makes overlay of DCPD difficult

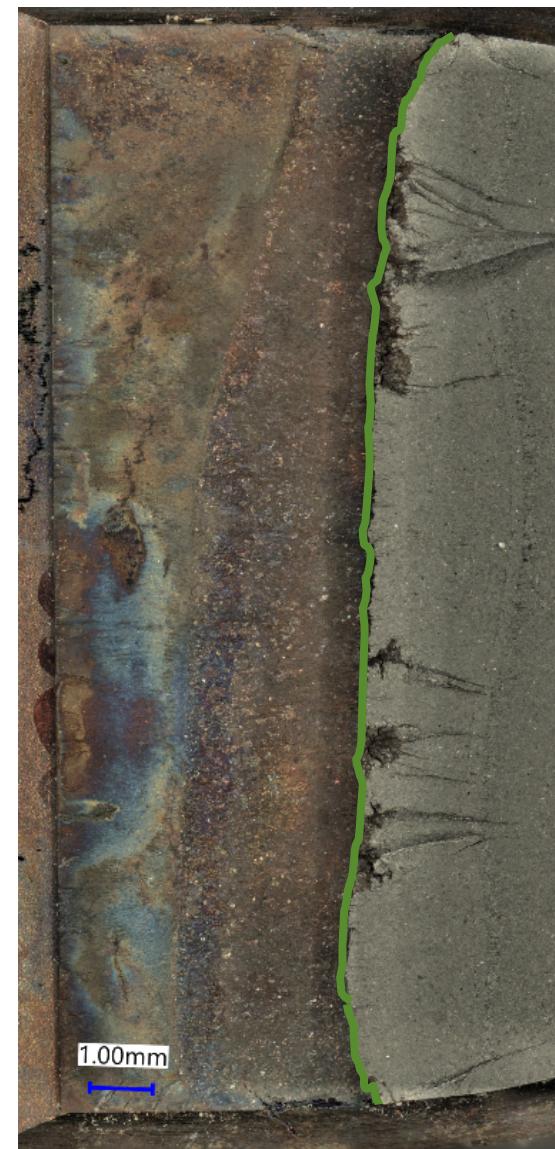
SS304L Exhibits Irregular Crack Front in Saturated MgCl₂ at 25 °C

- Measured 100 points of extension from the drawn blue line and averaged
 - Integration of crack extension by hand
 - Similar to area integration

Method	Δa
DCPD	53.8 mm
Fractography	60.1 mm

- Compared to total crack extension during constant K portion
- Possible that growth in 'protrusions' ahead of blue line occurred during the constant K portion

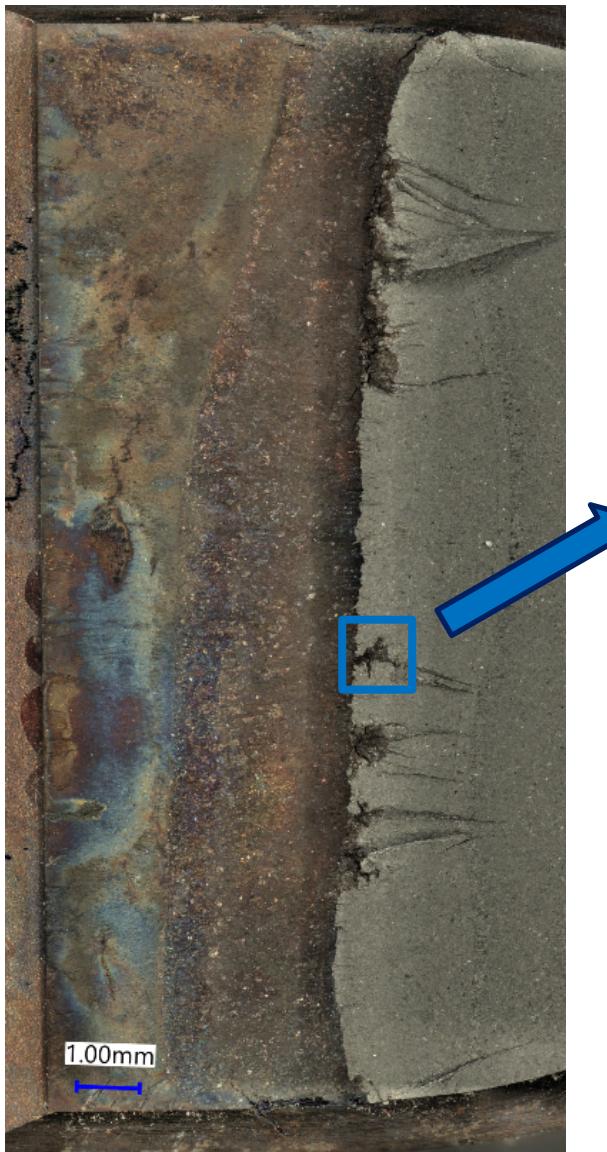
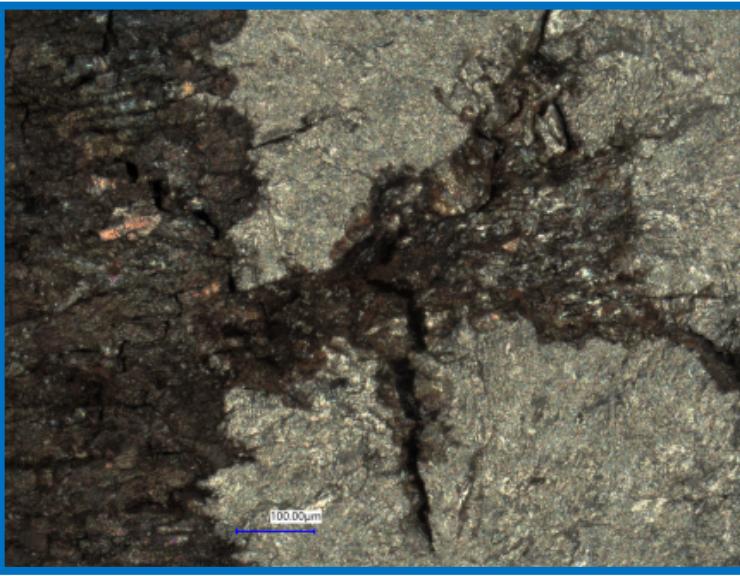
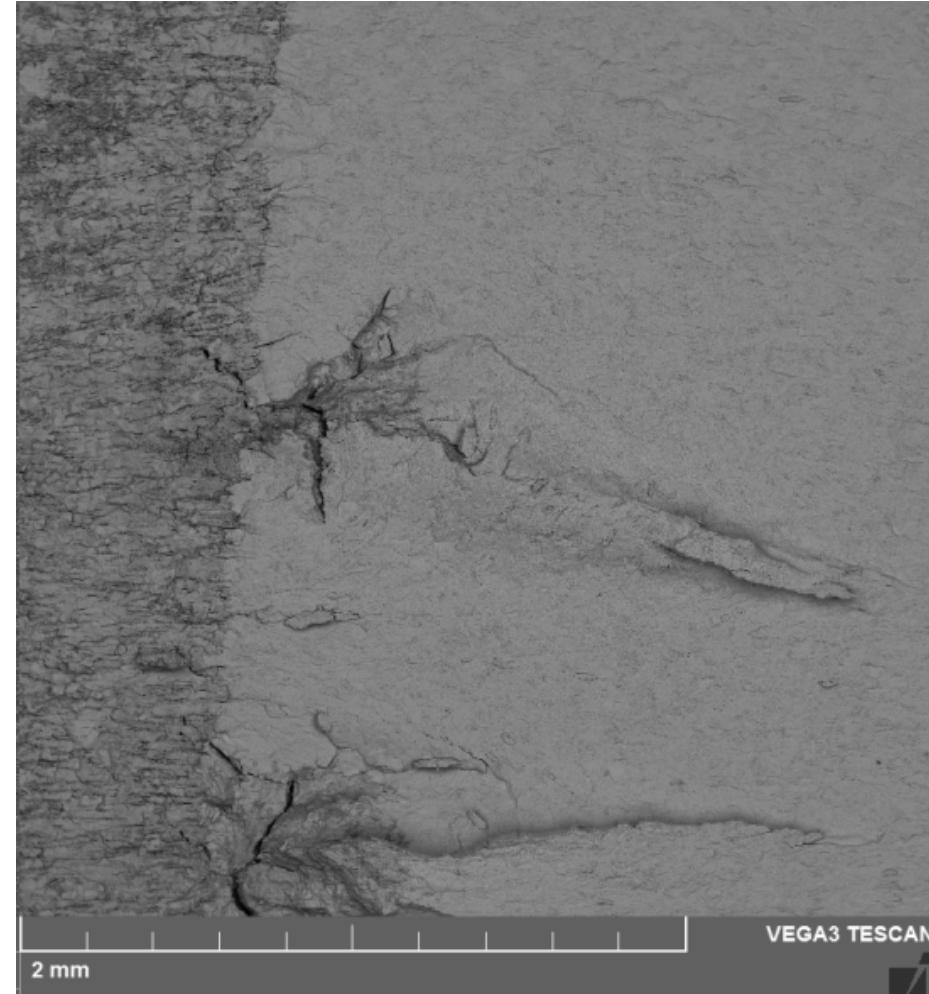
SS304L Exhibits Irregular Crack Front in Saturated MgCl₂ at 25 °C

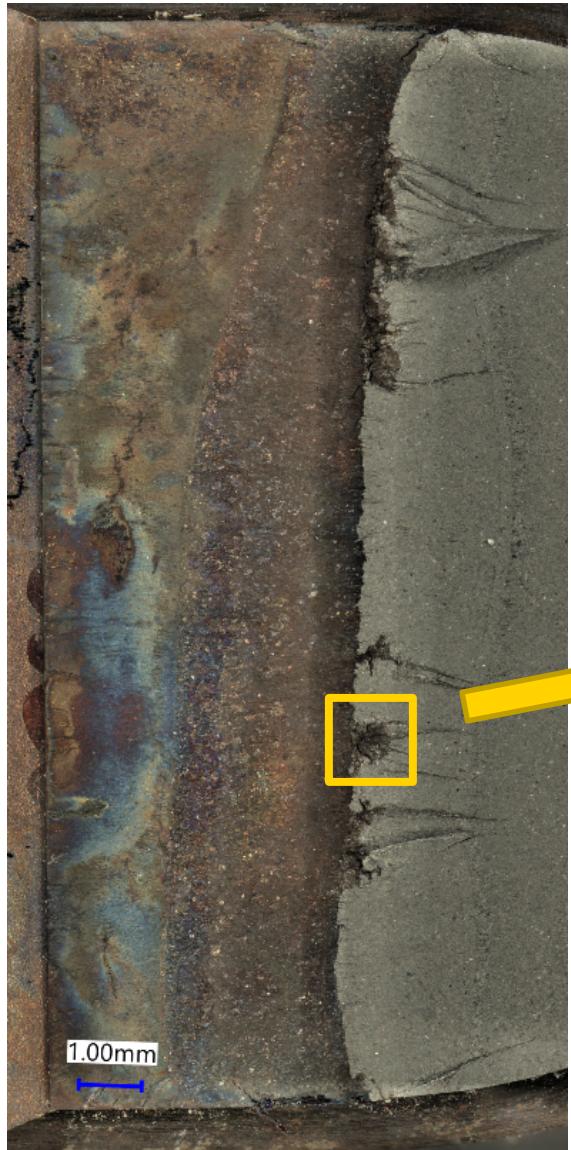
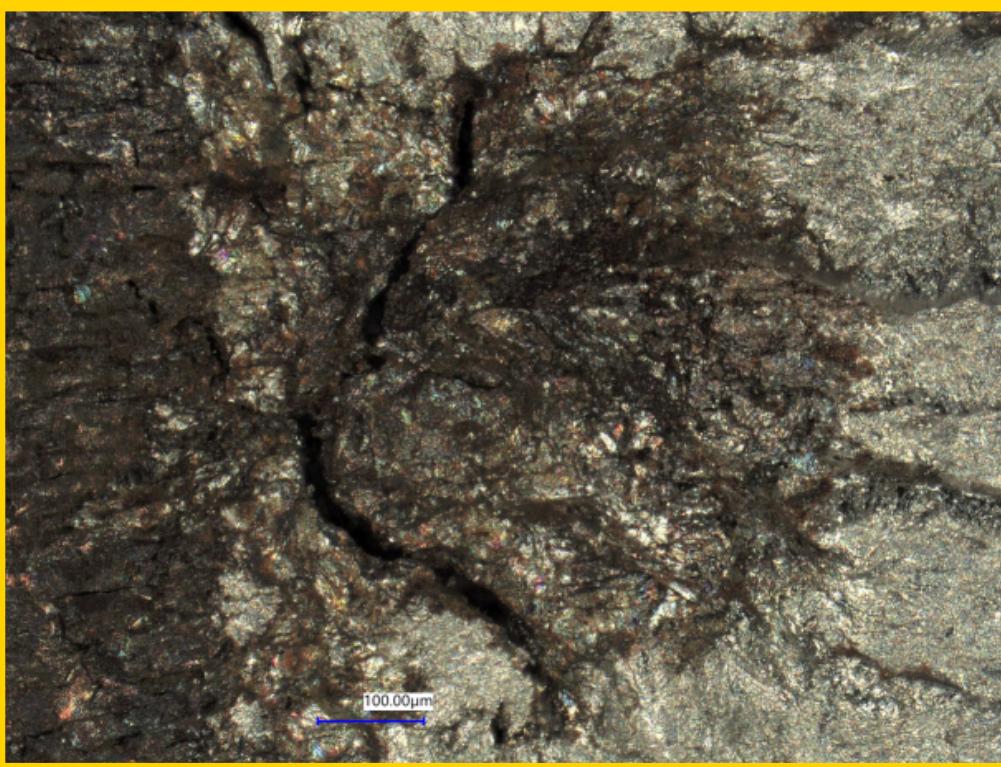
SS304L Exhibits Irregular Crack Front in Saturated MgCl₂ at 25 °C

- Significant corrosion products on the surface
 - Enhanced cleaning needed, however, crack wake corrosion could be eliminating features of interest
- Looking for intergranular/transgranular fracture

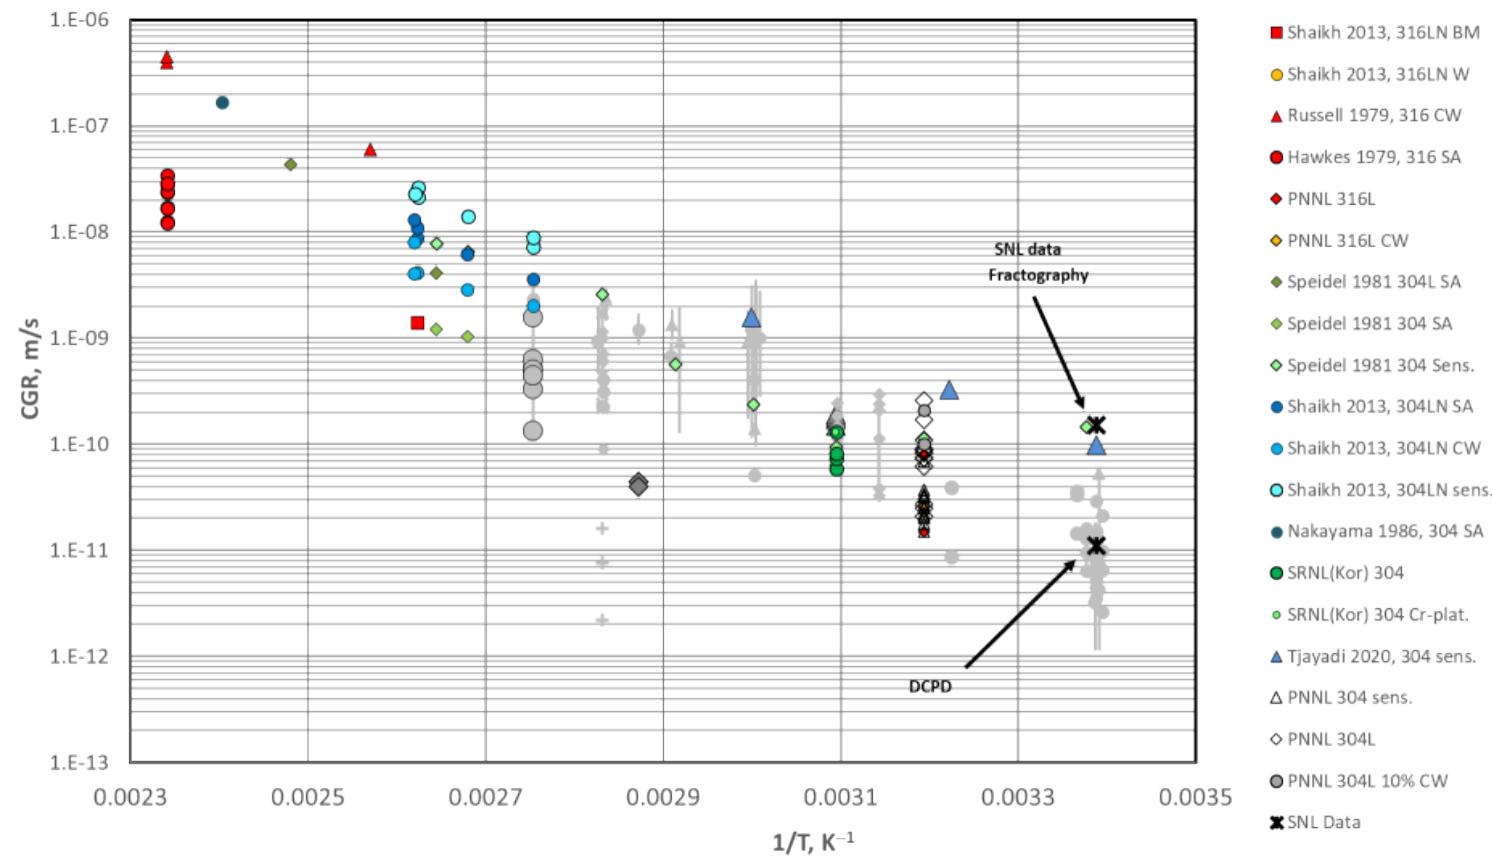
Crack Growth of Furthest 'Protrusion' Potentially Order of Magnitude Higher Than DCPD

- Considering protrusion occurs during constant K portion of the test, an increased crack growth rate is calculated
 - *measured from deepest point of protrusion

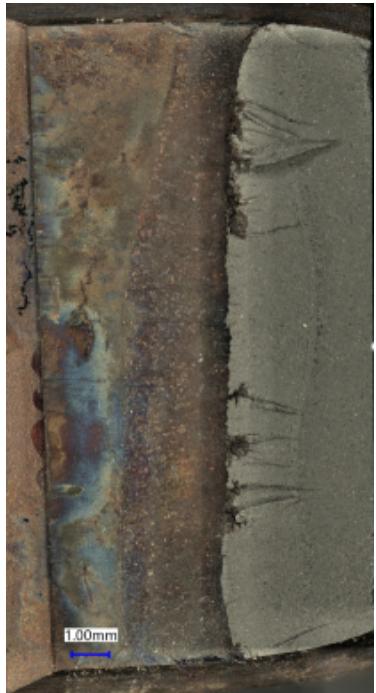
Lot 1 – RT
(1218 hours)

Overview of MgCl₂ Samples

- Crack morphologies show influence from temperature, lot, and direction

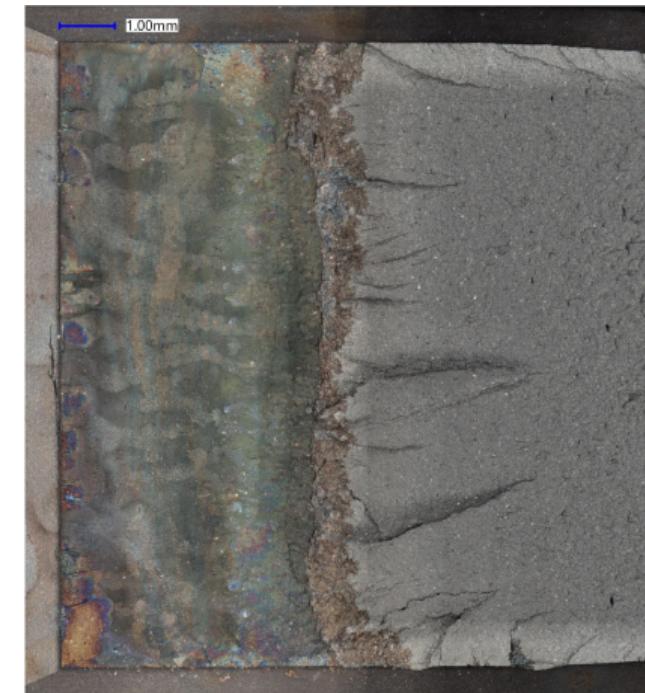
Lot 3 – 55 °C (T-S)
(800 Hours)

(Time under Constant K)

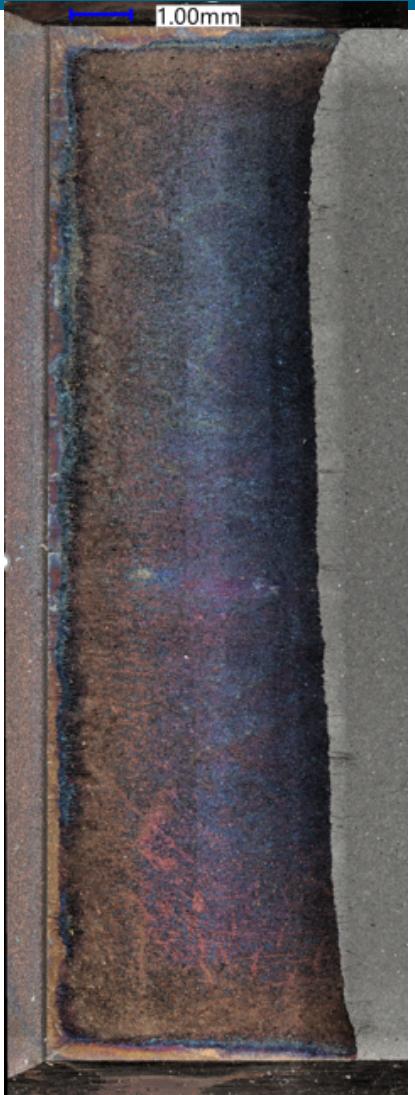
Lot 1 – 22 °C

Overview of Saturated NaCl Samples

No indicated
crack growth

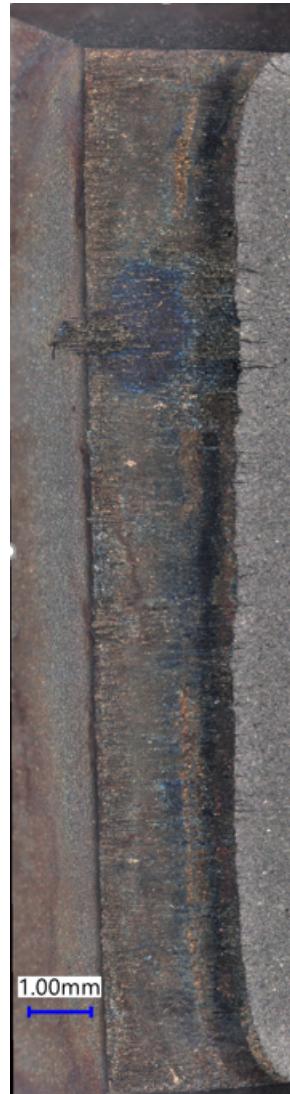
Lot 3 – 60 °C

Roughly 50 μm of
crack extension during
constant K

Crack growth rate of
 $2.1 \cdot 10^{-8} \text{ mm/sec}$

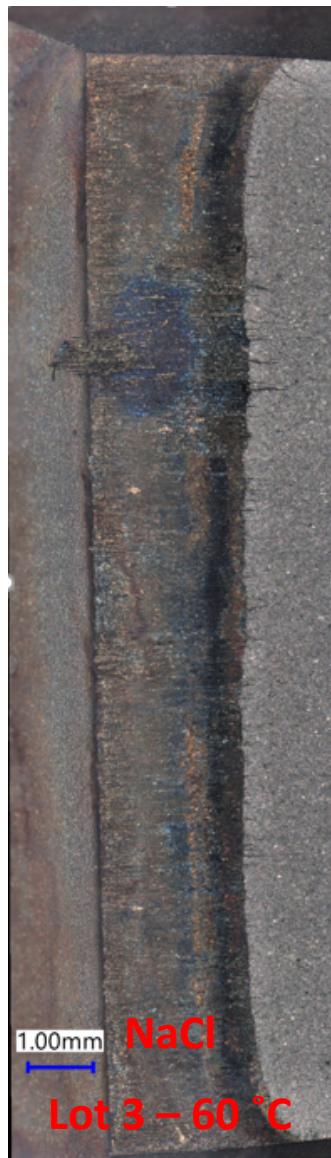
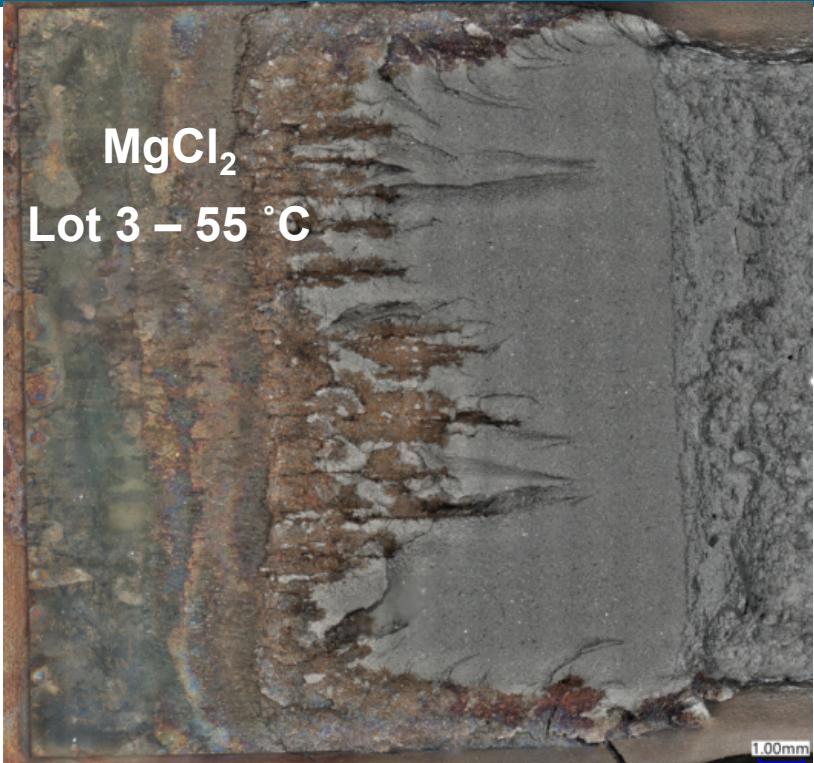
- Similar to differences in morphologies from corrosion exposures
- Potentially due to differences in cathodic reduction reaction
- Possibility for different crack tip chemistry changing pH and embrittlement
