Spent Fuel and Waste Science and Technology (SFWST)

Stress Corrosion Cracking of Austenitic Stainless Steels in Concentrated Chloride Environments

Ryan M. Katona, J. Taylor, E. Karasz, B. Nation, A. W. Knight, C. R. Bryan, and R. F. Schaller

**SWFST Annual
Meeting**

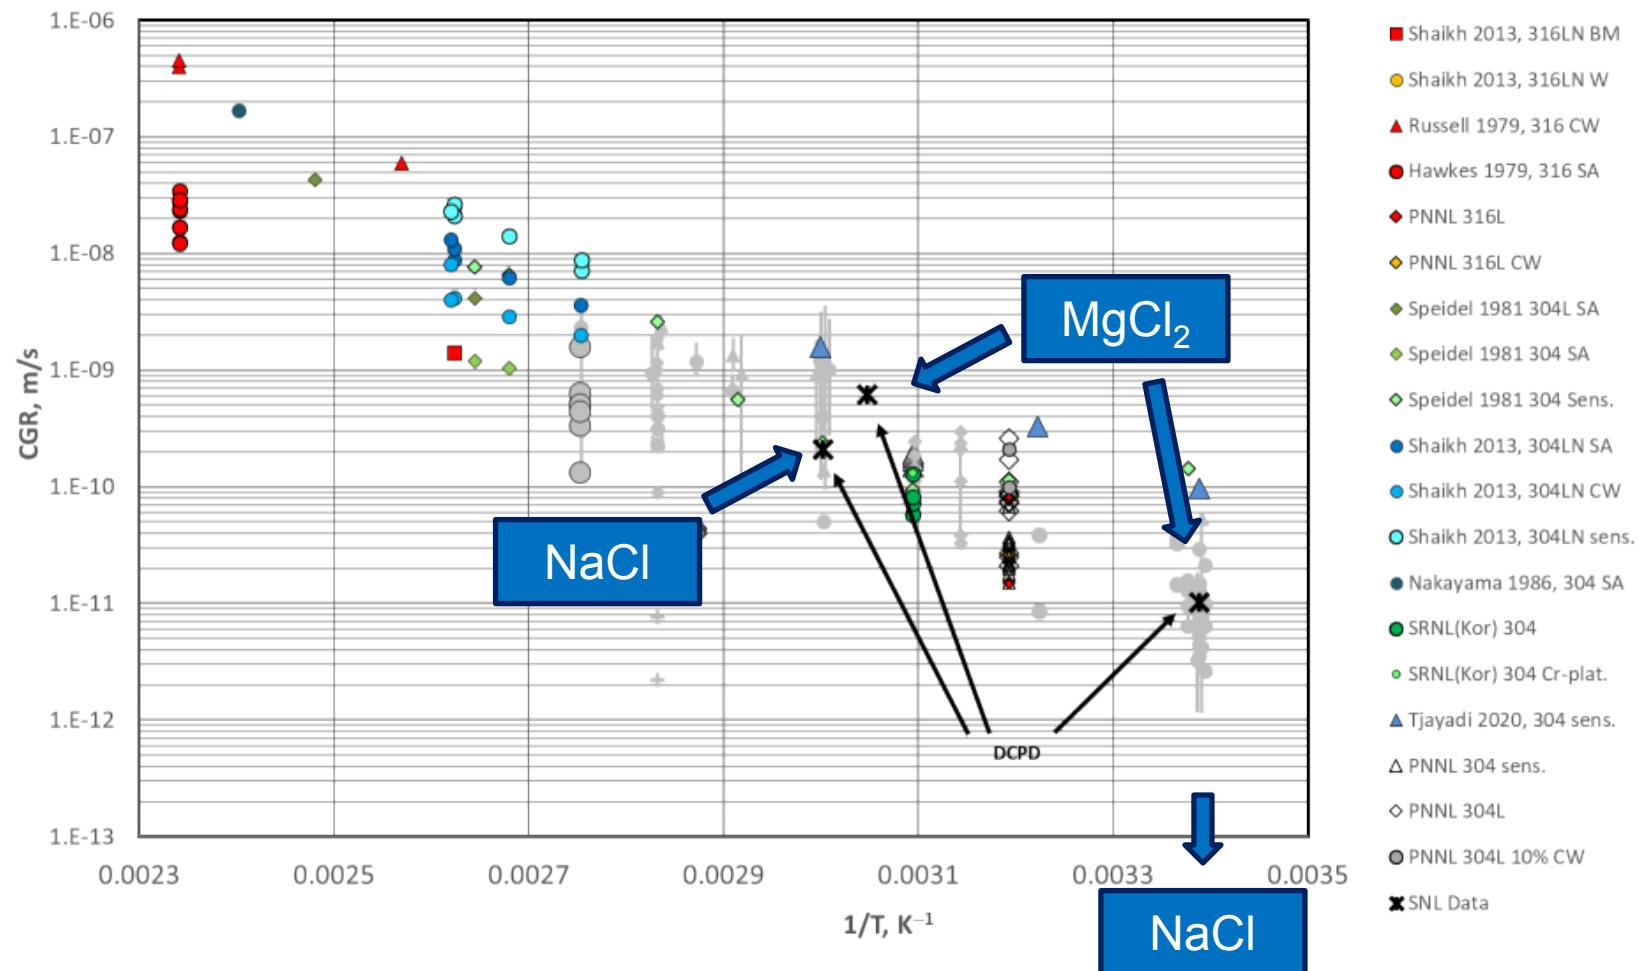
Measured Crack Growth Agrees with Literature Trends

- Similar crack growth rate trend with temperature to other studies in literature
- Potential influence of solution composition on crack growth rate but does influence morphology

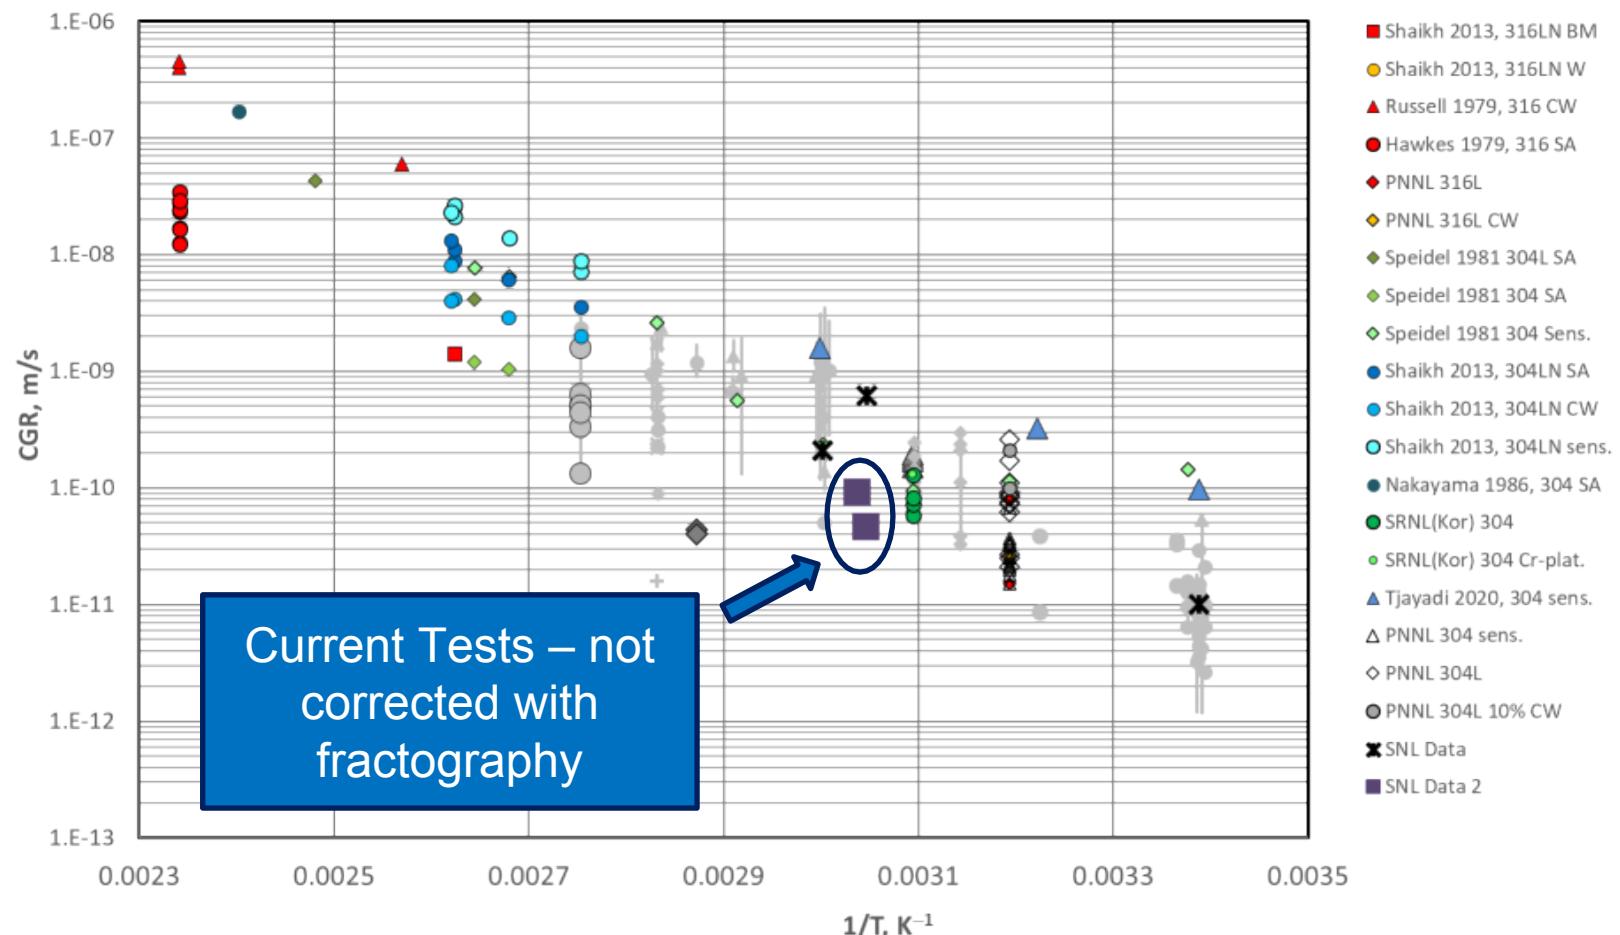
Measured Crack Growth Agrees with Literature Trends

- Replicated tests show fairly good agreement

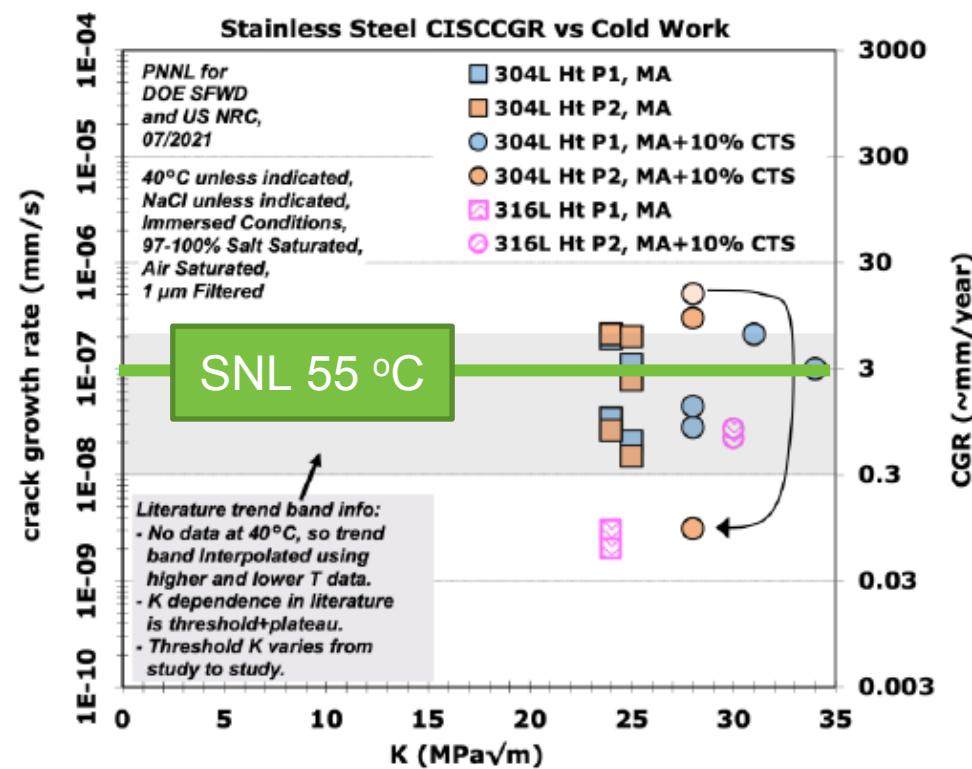
Figure 23. Effect of 10% cold work on CISCCGR of two heats of 304L.
